# Structural Integrity Reserve Study -SIRS (Structural Assets)

## Admiralty House, Inc.

140 Seaview Ct.  
Marco Island, FL 34145

Prepared on:  
6/7/2023

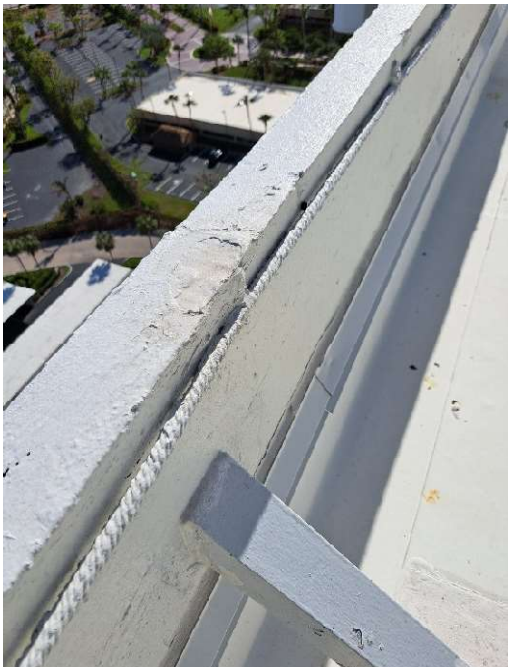
1.2 Parapet Waterproofing

The parapet waterproofing is in urgent need of repair which will be done this year (2023) along with the concrete repair it also requires.

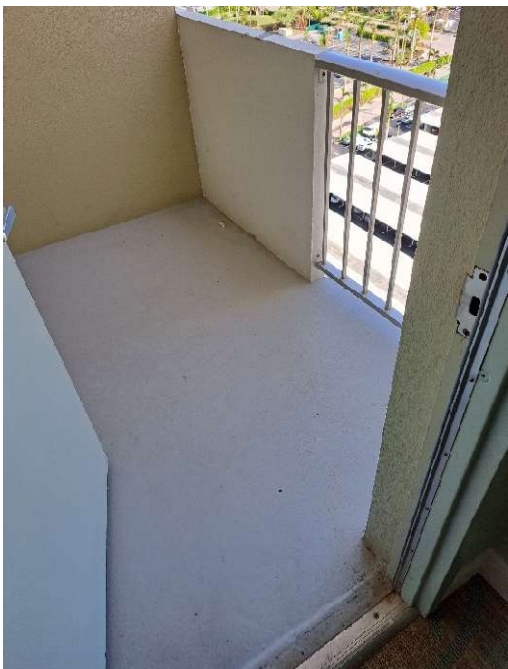
2.3 Balconies, Stairs, Waterproofing

None of these balconies are tiled. They are only waterproofed.

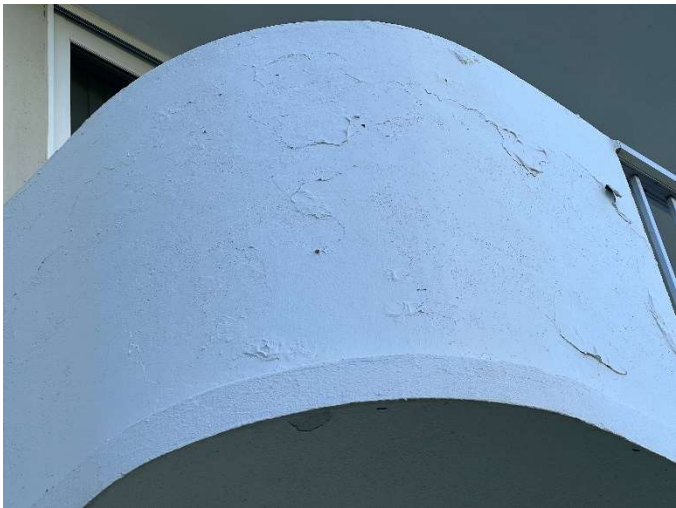
3.1 Stucco Repair on Primary Structural Members

This allowance can be fine-tuned in the future as stucco projects reveal the rate that damage progresses for this particular building.

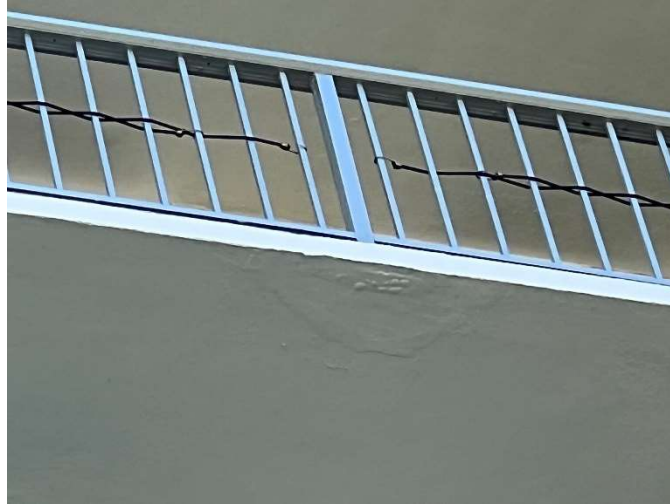
### 3.2 Concrete Repair on Primary Structural Members

This allowance can be fine-tuned in the future as concrete projects reveal the rate that damage progresses for this particular building.

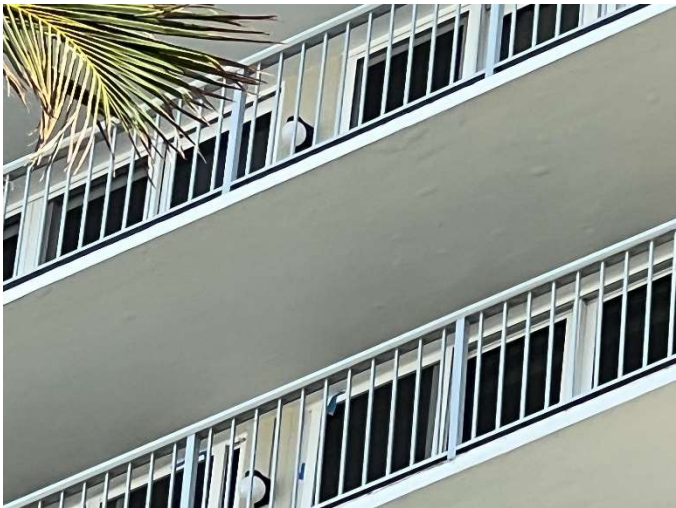
3.3 Railings Replacement

These railings are in better shape than some of their fasteners.

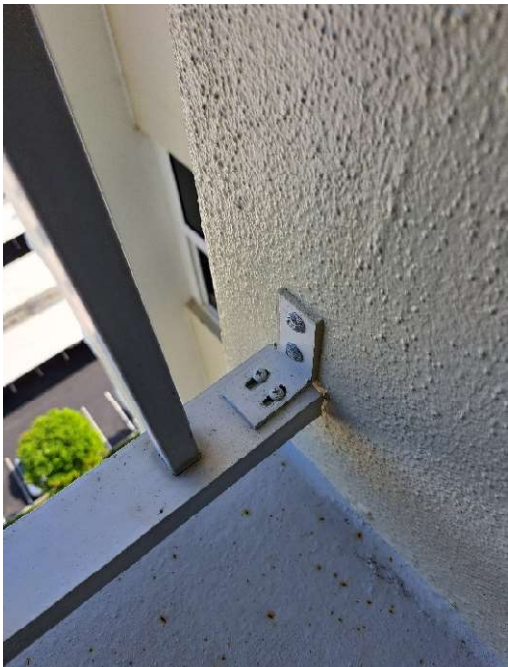
3.4 Concrete & Fastener Repair Along Railings

Railing fastening hardware and fastening substrate (in this case, concrete) can degrade faster than the railing itself. This is the case for this building. This allowance can be fine-tuned in the future as railing maintenance projects reveal the rate damage progresses for this particular building. All fasteners entering the concrete should be stainless steel.

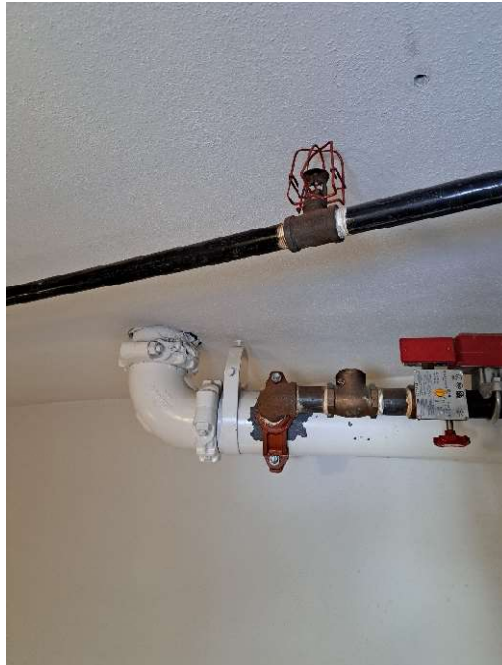
### 4.3 Sprinkler Head Replacement

This allowance starts reserving funds for a full changeout or partial replacement as testing schedules find faulty sprinkler heads over the 29 year estimated lifetime.

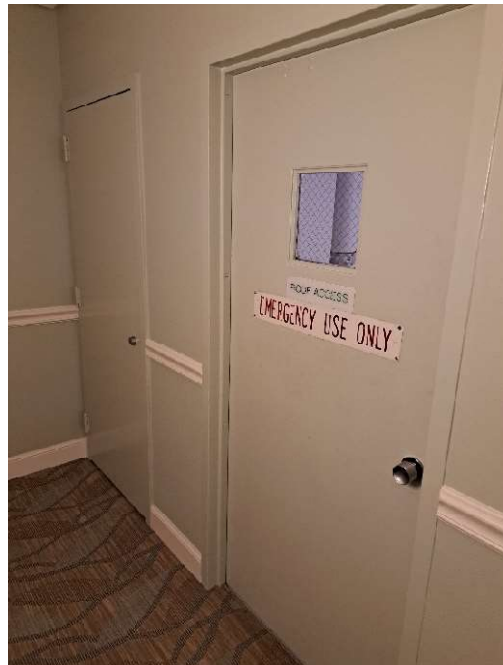
**4.5 Interior Doors, Stairwell Fire**

These interior fire doors experience very little degradation from the environment but hardware must be maintained to ensure automatic closure.

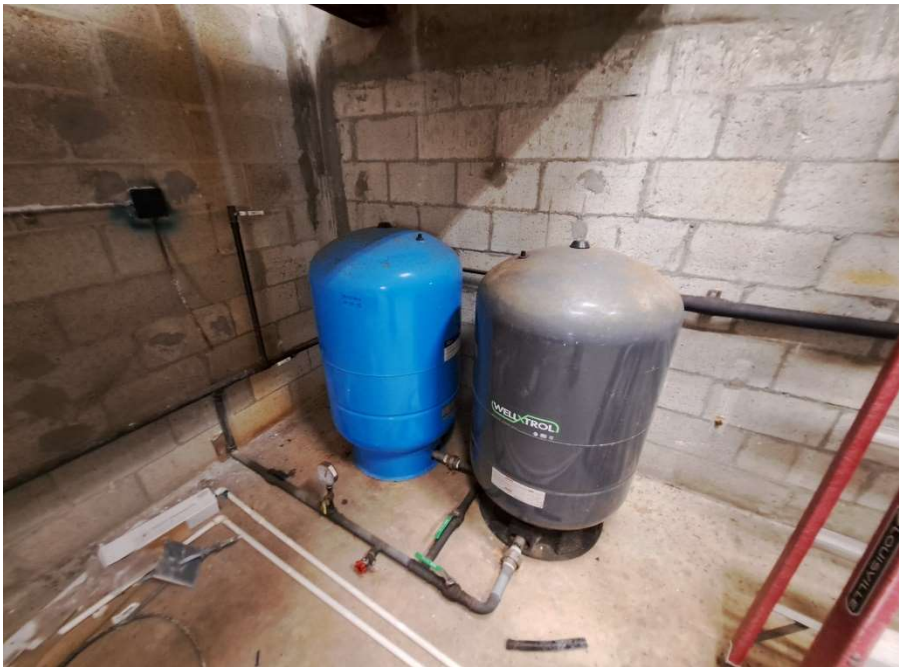
5.2 Central AC System, Plumbing & Bladder Tanks Maintenance

There is an uncommonly large amount of water traveling through this building at high pressures due to the central HVAC system with cooling towers. These pipes, in addition to all association-funded unit water supply lines; should be maintained well, which requires this robust maintenance schedule.

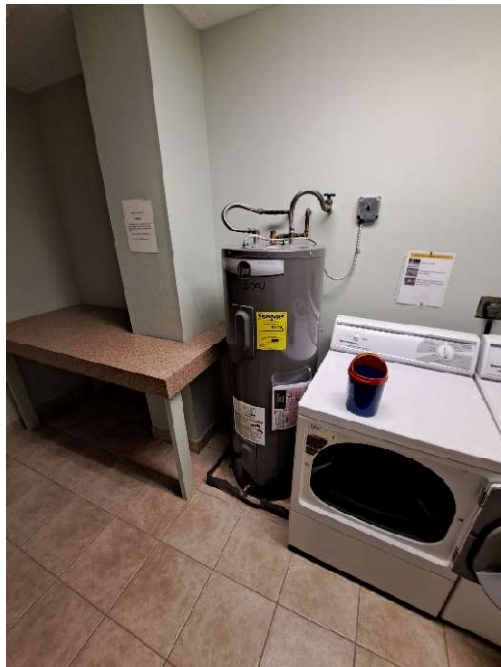
## 5.5 Hot Water Heaters Replacement

This estimated useful life enables 3 heaters to be replaced every 3 years. The 3 heaters will be approximately 10 years old by the time of replacement. It is set to cycle this way because not all the heaters are the same age.

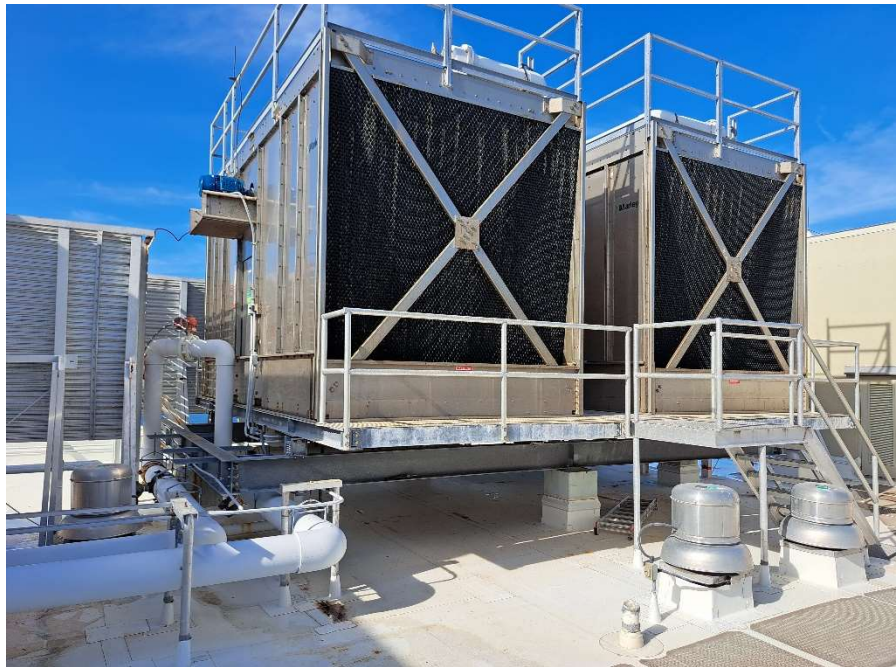
**5.8 Cooling Towers, Common HVAC**

These cooling towers should be maintained as part of Item 5.2. It is listed here as insurance even though they are typically replaced for reasons of decreased performance before they start leaking unsustainably.

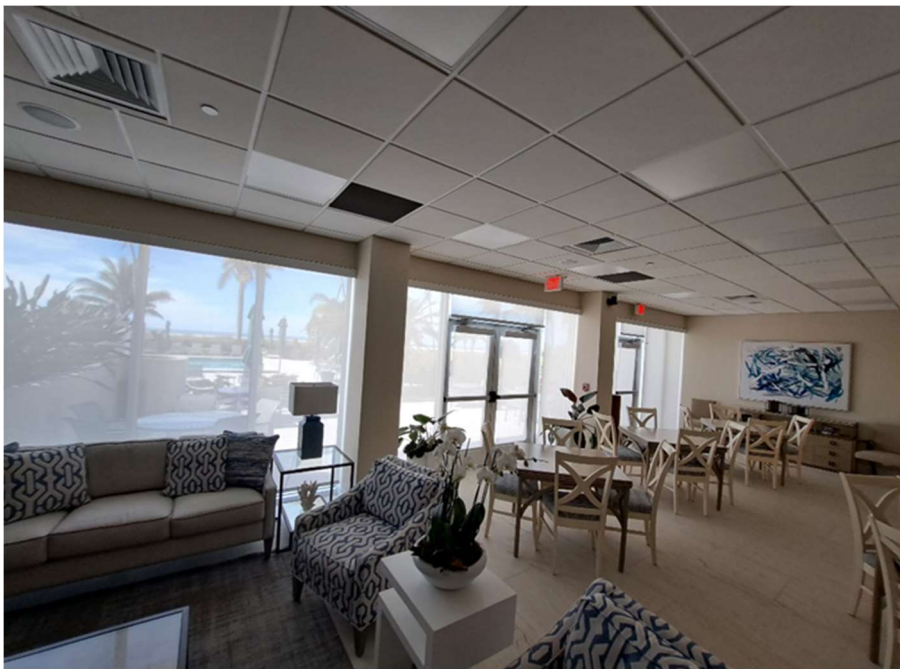
7.1 Exterior Windows, Common

The front and rear automatic slider doors have been overhauled in order to gain an estimated extra 10 years on their lifespan.
