July 21, 2023

**ANGLERS COVE CONDOMINIUM ASSOCIATION, INC.**

**Subject:** Report of Engineering Consulting Services  
**MILESTONE INSPECTION – PHASE I**  
Anglers Cove – Building K  
1003 Anglers Cove  
Marco Island, Collier County, Florida  
SOCOTEC Project Number 1384-003.01

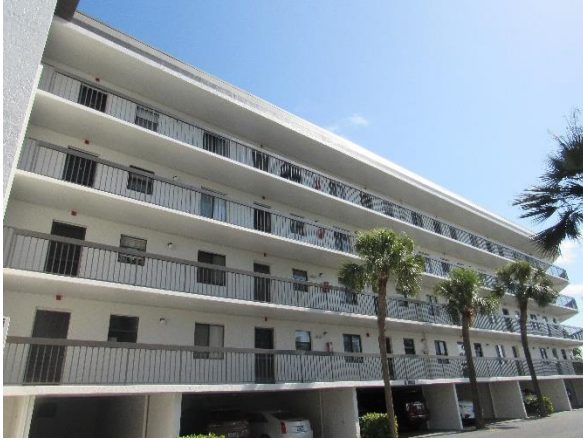
View of front of building.

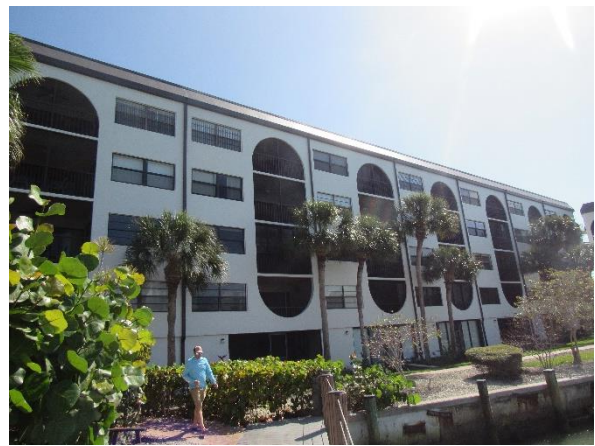
View of rear of building.

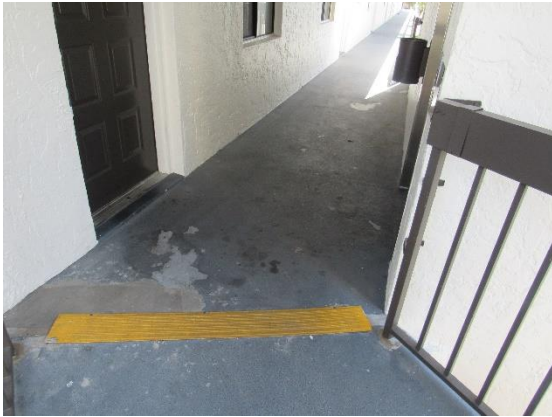
- Peeling coating in several locations on the building breezeways.

View of coating failure on breezeway.

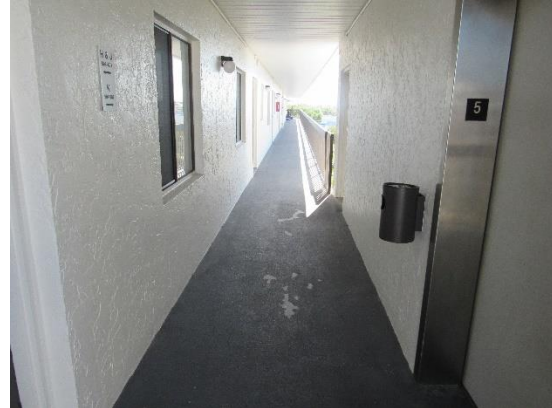
View of coating failure on breezeway.

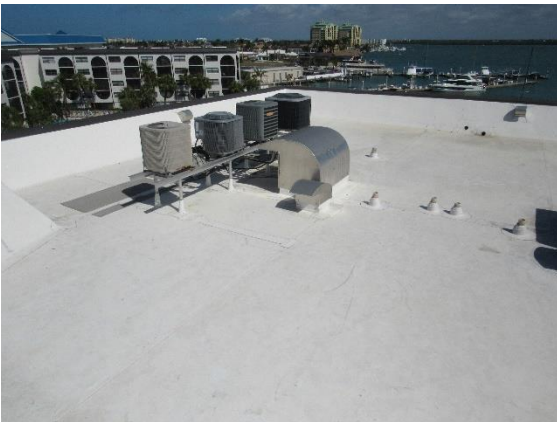
View of TPO roof system.

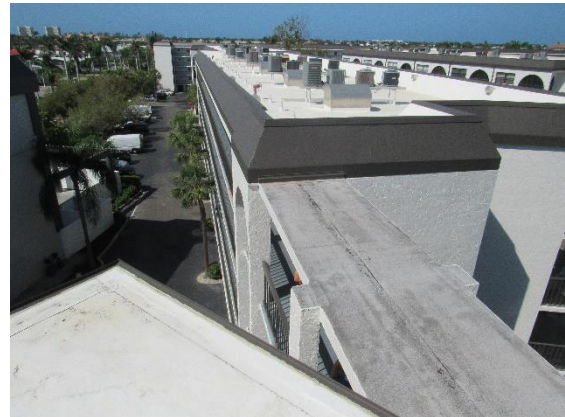
View of flat roof system.
