## STRUCTURAL INTEGRITY RESERVE STUDY

**Breezy Point Condominium, Inc.**

**880 Huron Ct.  
Marco Island, Florida 34145**

**Project Number: 2409428**

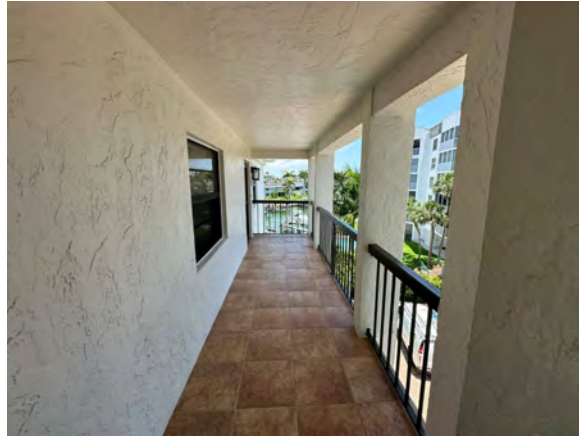
**PHOTO 10**

| <b>Item</b> | <b>Description/Observations/Comments</b> |
|---|---|
| <b>Exterior Walkways</b> | <p>The elevated concrete walkways are supported by the structural systems of the buildings and are equipped with aluminum handrails. The walkways are finished with outdoor tiles. There were no significant deficiencies noted to the exterior walkways.</p> |

VIEW OF TYPICAL ELEVATED WALKWAY

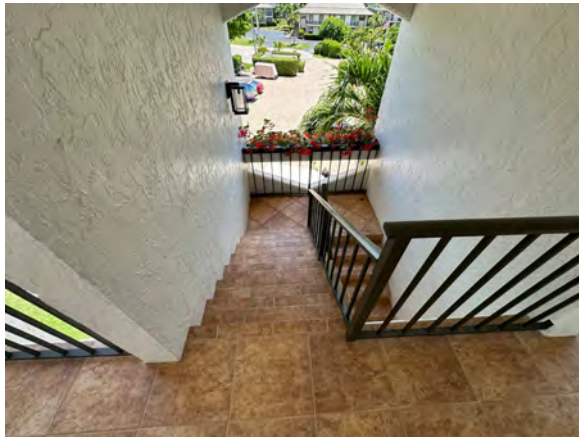
**PHOTO 11**

| Item | Description/Observations/Comments |
|---|---|
| Stairs | <p>There are a total of 4 sets of concrete stairs that are equipped with aluminum handrails. Each building has two sets of stairs. The stairs are finished with outdoor ceramic tiles.</p> <p>The stairs appeared to be in good condition with no significant deficiencies noted.</p> <p>In addition, periodic repainting and waterproofing of the stairs, including any anticipated repairs, are addressed as part of the Structural recommendations discussed above.</p> |

VIEW OF TYPICAL STAIR SYSTEM

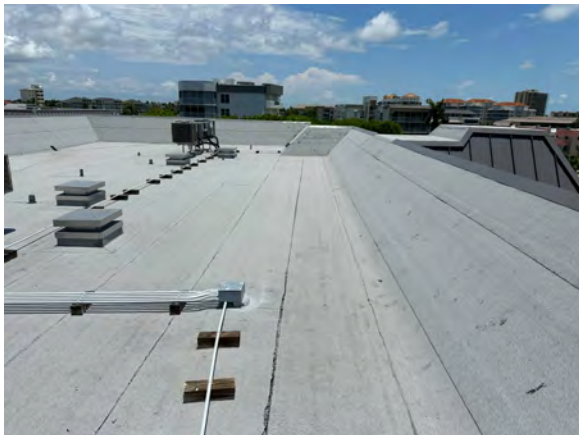
**PHOTO 12**

The flat roof is supported by a concrete roof deck that is covered with Modified Bitumen. The mansards are wood framed and covered with metal roofing panels. The roof coverings were reported to have been replaced in 2020. The roofs were observed to be in good condition with no significant deficiencies noted. No roof replacement is anticipated during the evaluation period. However, funds have been spread throughout the Reserves Table to ensure the availability of funds at the end of the element's EUL, beyond the evaluation period.

VIEW OF ROOFTOP

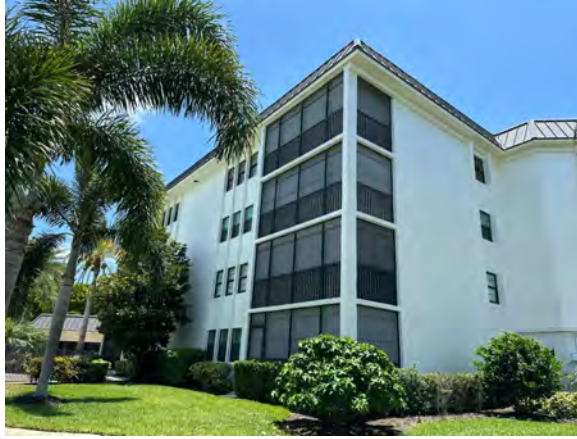
**PHOTO 13**

| <b>Item</b> | <b>Description/Observations/Comments</b> |
|---|---|
| <b>Balconies</b> | <p>The concrete balconies are supported by the structural systems of the buildings and are equipped with aluminum rails and screens. There were no significant deficiencies noted to the balconies.</p> |

VIEW OF TYPICAL BALCONY

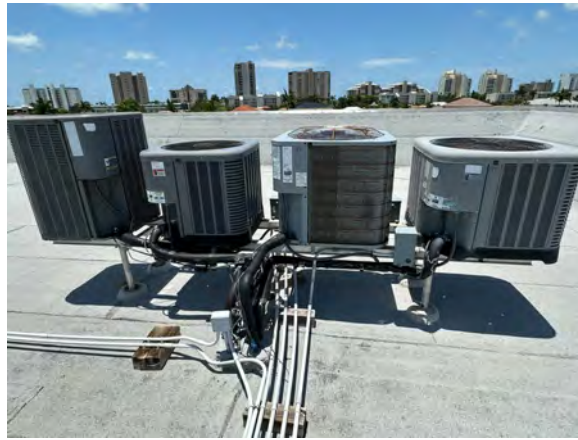
**PHOTO 14**

| Item | Description/Observations/Comments |
|---|---|
| <b>HVAC</b> | <p>A/C condensing units are mounted to elevated stands and are located on the roof tops. There were no significant deficiencies reported or observed to the HVAC systems.</p> <p>HVAC handling units and A/C condensers were reported to be the responsibility of the condominium owners to maintain and replace.</p> |

VIEW OF HVAC EQUIPMENT

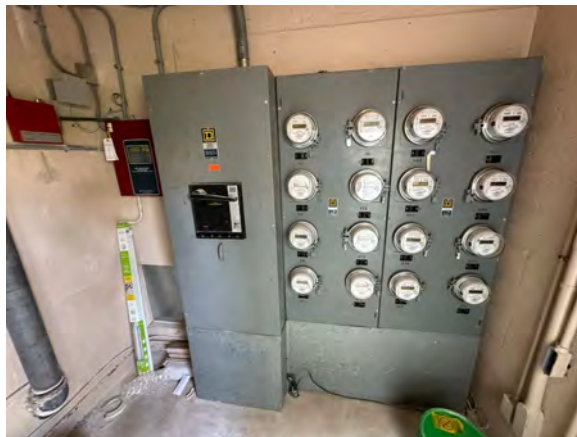
**PHOTO 15**

**The electrical system components were observed to be in good condition. In general, the electrical systems for the Property, including main switchboards, transformers, distribution circuit breaker panels, contactors, lighting, and wiring system were noted to be adequately sized for the intended use of the facility. With proper maintenance, no significant expenditures are anticipated. We have allocated some funds in the Reserve Table.**

VIEW OF ELECTRICAL EQUIPMENT

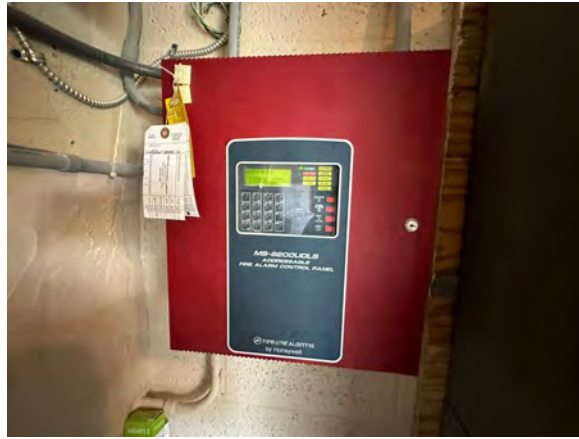
## PHOTO 16

| Item | Description/Observations/Comments |
|---|---|
| <b>Fire Protection</b> | <p>Portable fire extinguishers are in common areas.</p> <p>The Property's fire alarm systems utilize central panels for monitoring manual pull stations in the three-story buildings. The fire alarm panels were reported to have been upgraded in 2007.</p> <p><b>The fire extinguishers were noted to be in general condition requiring routine maintenance over the evaluation period.</b></p> <p><b>The central alarm panels are in good condition. Central fire alarm panels typically have an EUL of 25 years. Funds have been spread throughout the Replacement Reserves Cost Estimate Table, adopting the straight-line accounting method to ensure the availability of funds at the end of the replaced element's EUL, beyond the evaluation period of this assessment.</b></p> <p>Fire protection and life safety systems within the dwelling units are reported to be the responsibility of the respective condominium unit owner to maintain and replace.</p> |

VIEW OF FIRE ALARM PANEL

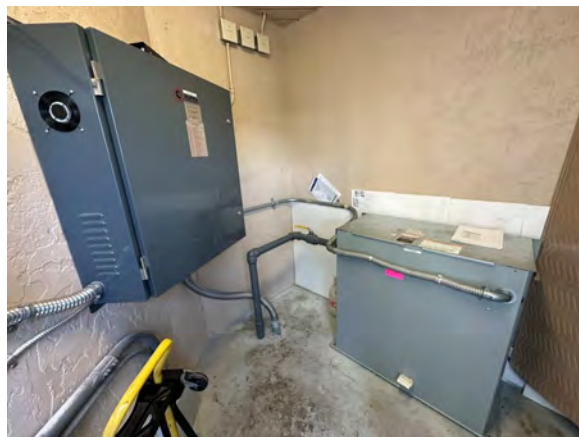
## PHOTO 18

| Item | Description/Observations/Comments |
|---|---|
| Elevators | <p>There is one hydraulic passenger elevator in each building with a load capacity of 2,000 pounds that provides access to all levels.</p> <p>The elevators were noted to be in generally good operating condition and reportedly serviced regularly by an elevator service contractor.</p> <p>We don't anticipate any work needed at this time for the elevator that is in excess of \$10,000. As such it is not considered part of the Reserve Table.</p> |

VIEW OF ELEVATOR EQUIPMENT
