# Structural Milestone Inspection

### *Phase I*

Caxambas Tower Condominium Association, Inc.

Rimkus Matter No: 100240433

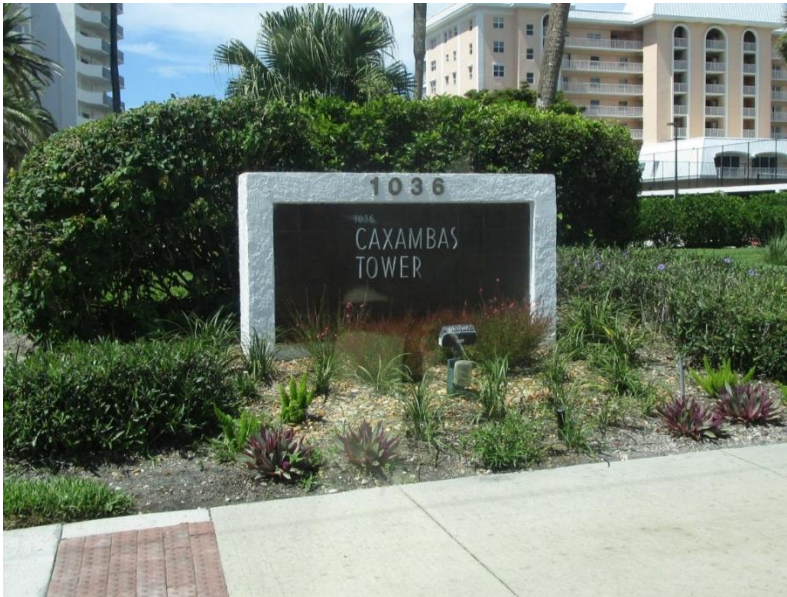
**PHOTOGRAPH #1**

**PROPERTY SIGNAGE**

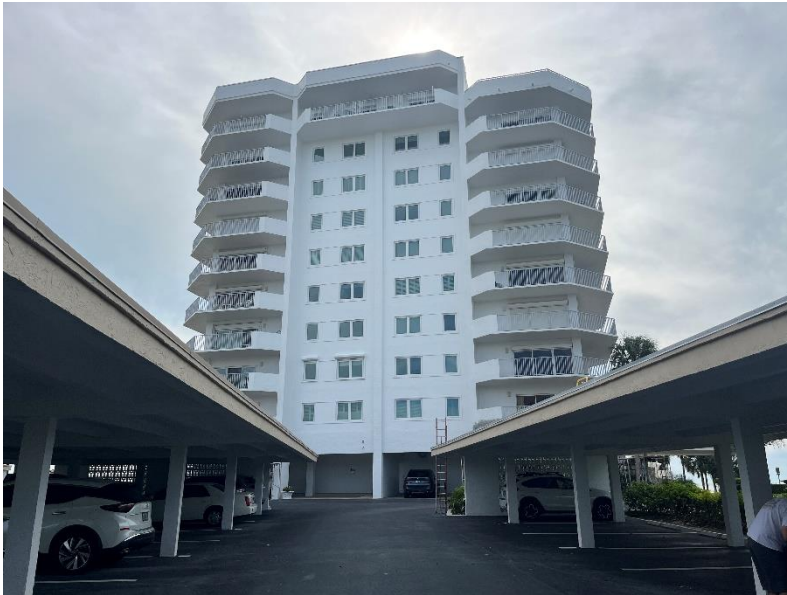
**PHOTOGRAPH #2**

- The exterior walls were found to be in good condition, and there were no indications of substantial structural damage present (**Photographs 2 through #6**).

**EXTERIOR WALLS  
NORTH ELEVATION**

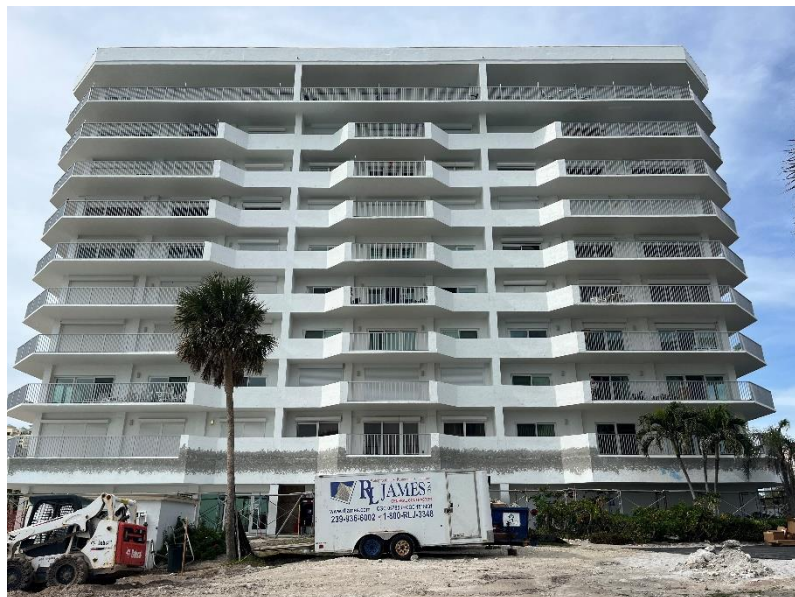
**PHOTOGRAPH #3**

**EXTERIOR WALLS  
EAST ELEVATION**

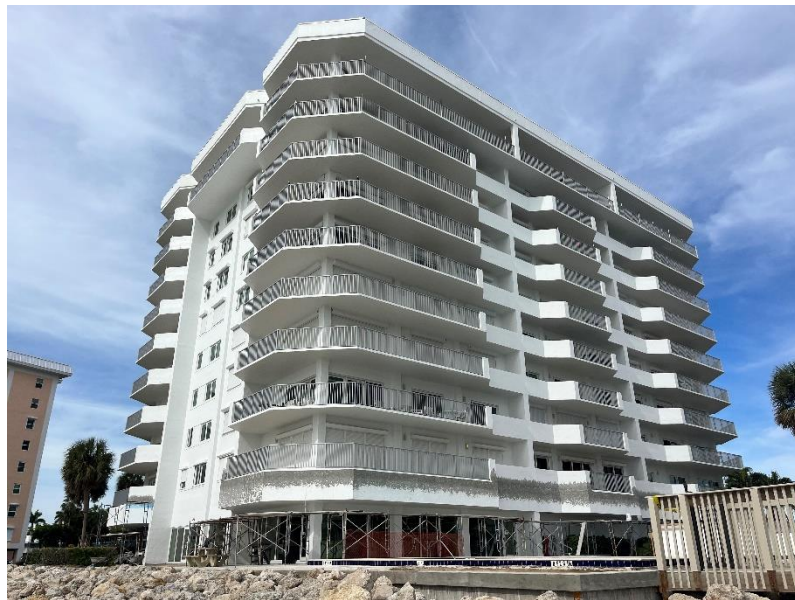
**PHOTOGRAPH #4**

**EXTERIOR WALLS  
SOUTHEAST BUILDING CORNER**

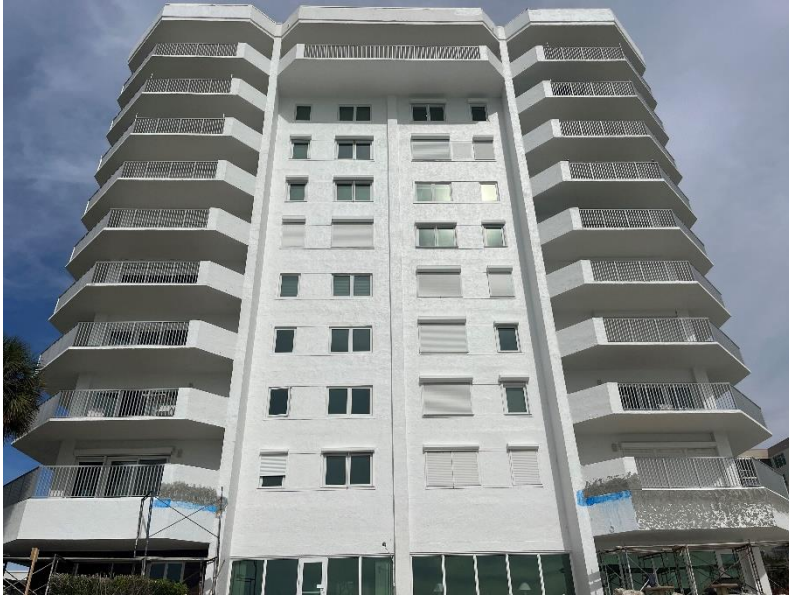
**PHOTOGRAPH #5**

**EXTERIOR WALLS  
SOUTH ELEVATION**

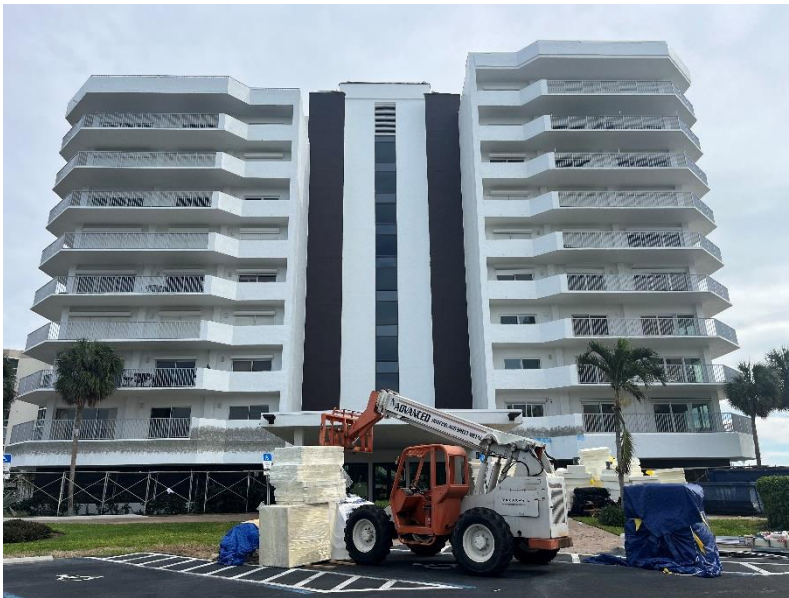
**PHOTOGRAPH #6**

**EXTERIOR WALLS  
WEST ELEVATION**

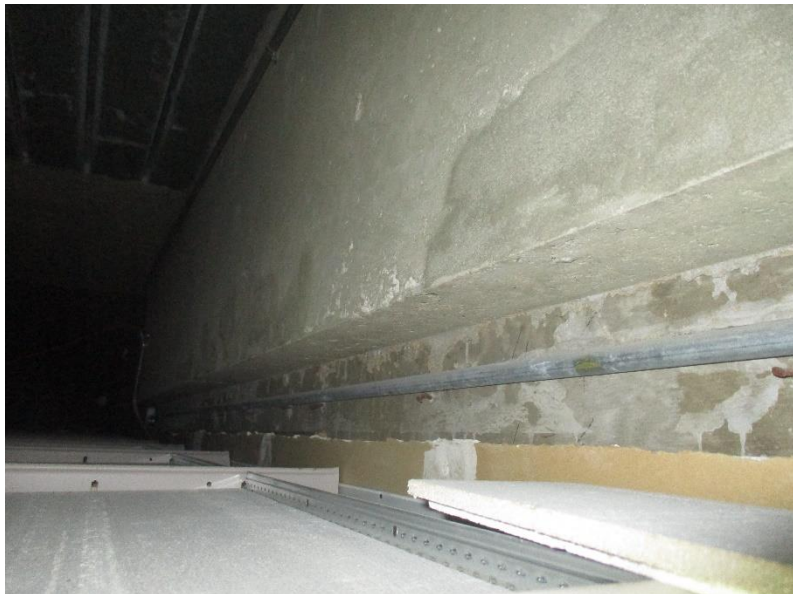
**PHOTOGRAPH #7**

- Majority of the columns and beams were not visible. There were no indications of substantial structural deterioration present at limited locations where columns and beams were visible (**Photograph #7**).

**COLUMNS AND BEAMS  
FIRST FLOOR  
OVERVIEW**

Mild-steel reinforced concrete beam (note composite decking above).

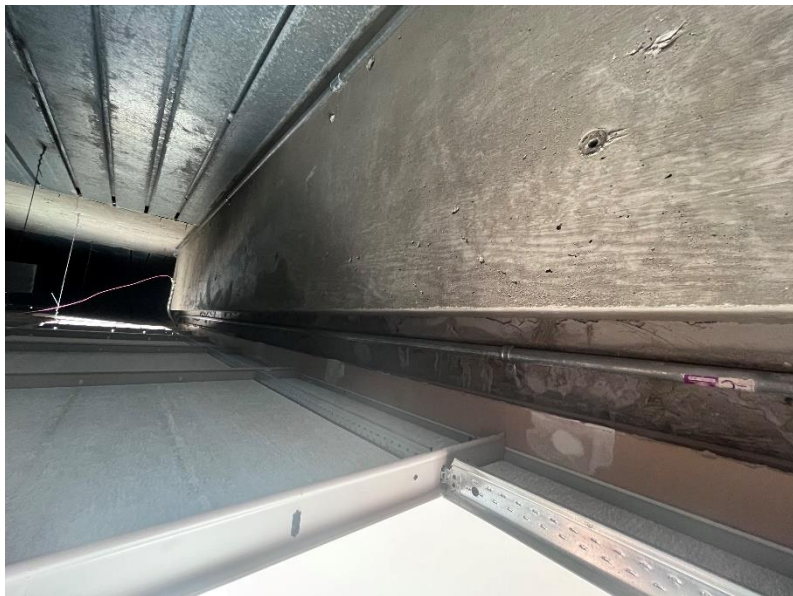
**PHOTOGRAPH #8**

- The floor system was found to be in good condition, and although the majority of the floor system was not visible, there were no indications of substantial

structural deterioration present (**Photographs #8 and #9**).

**FLOOR SYSTEMS  
FIRST FLOOR  
OVERVIEW**

Composite decking bearing on mild-steel reinforced concrete beams and columns.

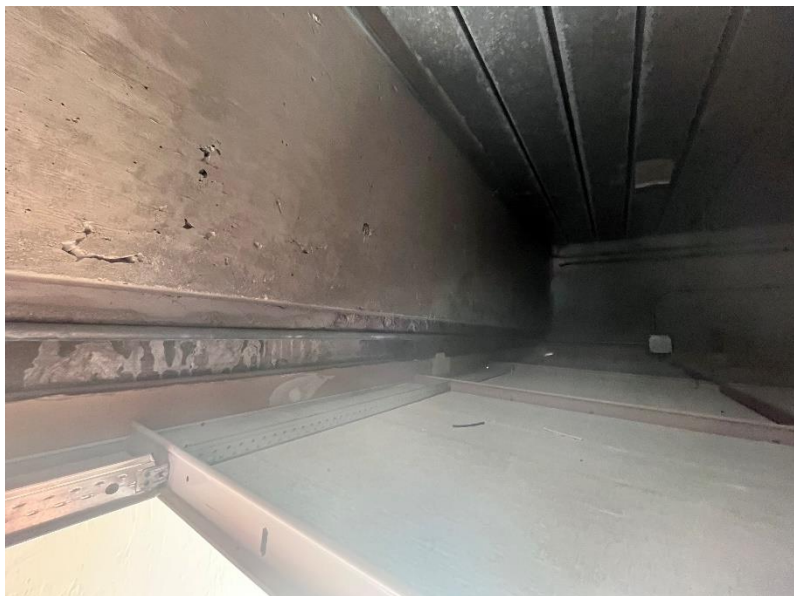
**PHOTOGRAPH #9**

**FLOOR SYSTEMS  
FIRST FLOOR  
OVERVIEW**

Composite decking bearing on mild-steel reinforced concrete beams and columns.

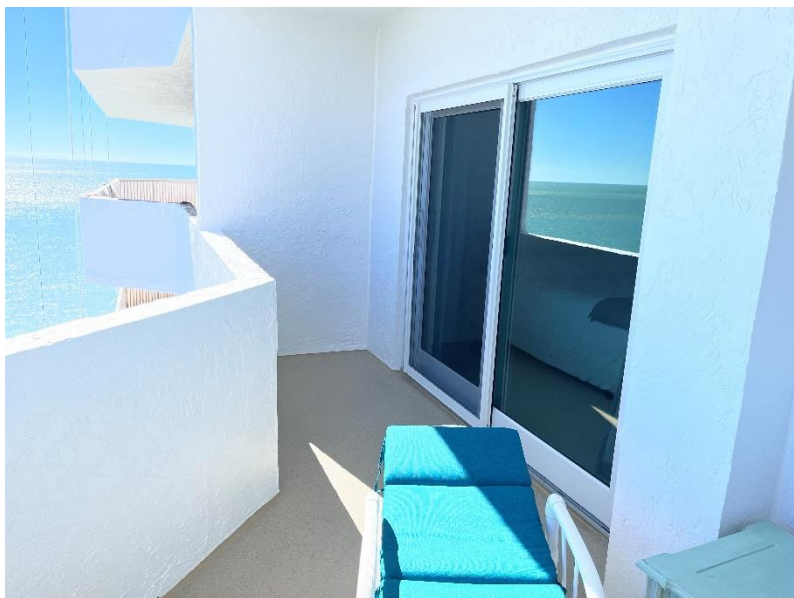
**PHOTOGRAPH #10**

- The balconies were found to be in good condition with no indications of substantial structural deterioration present (**Photographs #10 through #12**).

**BALCONIES  
UNIT 403  
TYPICAL OVERVIEW**

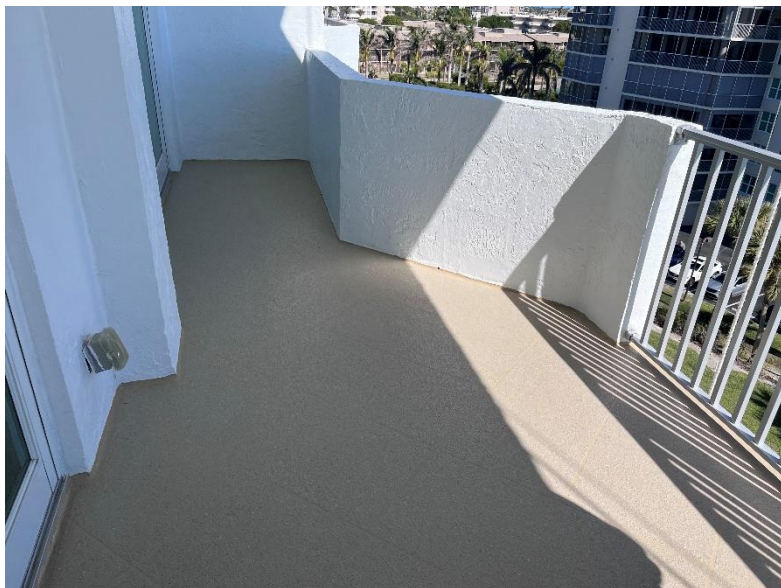
**PHOTOGRAPH #11**

**BALCONIES  
UNIT 503  
TYPICAL OVERVIEW**

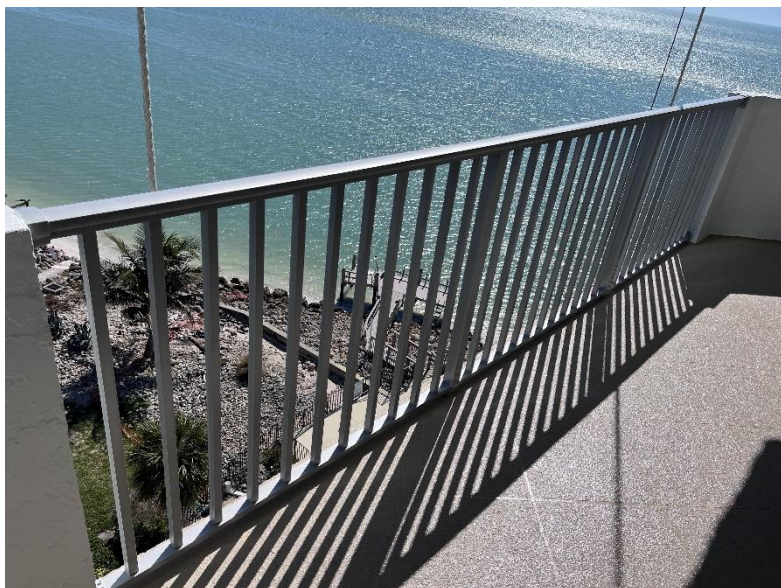
**PHOTOGRAPH #12**

**BALCONIES  
UNIT 703  
TYPICAL OVERVIEW**

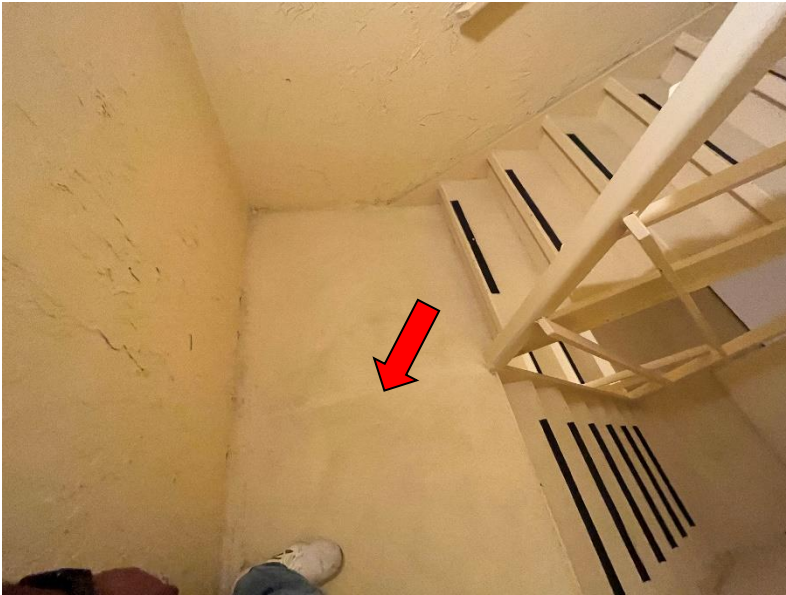
**PHOTOGRAPH #13**

- The exterior stairs were found to be in good condition, and there were no indications of substantial structural deterioration present.
- Minor cracking was observed at landings and walls. This condition does not represent substantial structural deterioration (**Photographs #13 through #15**).

**STAIR ASSEMBLIES  
STAIR # 1  
TYPICAL OVERVIEW**

Note concrete crack at landing. This condition does not represent substantial structural deterioration.

For areas that did not rise to the level of substantial deterioration, Rimkus recommends routine building maintenance which includes but is not limited to repair of cracks in concrete and stucco and repair of exterior painted surfaces and sealants of the building (**Photographs #13 and #15**). Forgoing repairs and routine maintenance may adversely affect the integrity of the structure.

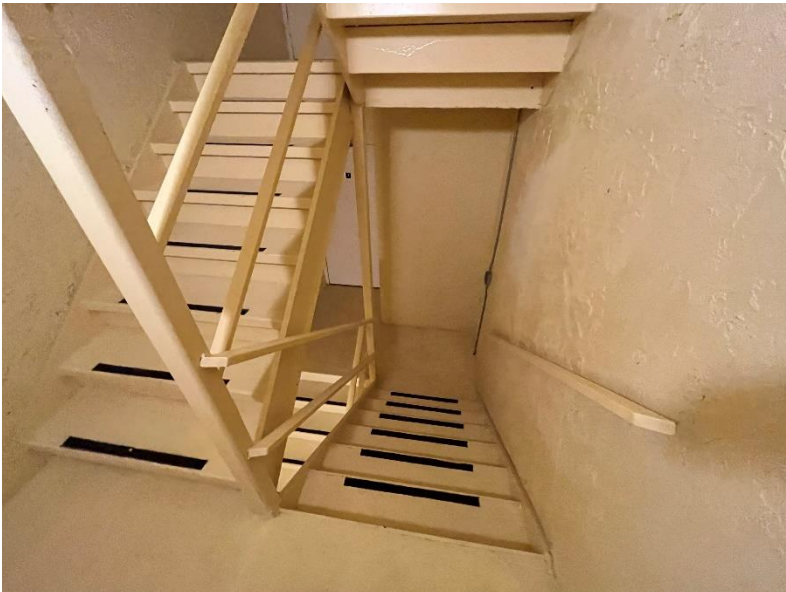
**PHOTOGRAPH #14**

**STAIR ASSEMBLIES  
STAIR # 1  
STAIR LANDING FLOOR SYSTEM**

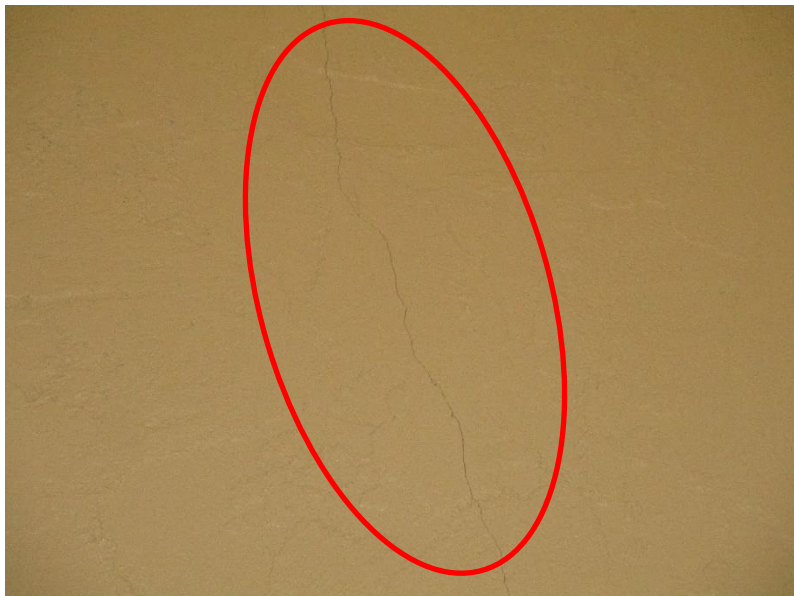
**PHOTOGRAPH #15**

**STAIR ASSEMBLIES  
STAIR # 1**

Stucco cracks were observed at several areas throughout the stair assemblies. This condition does not represent substantial structural deterioration.

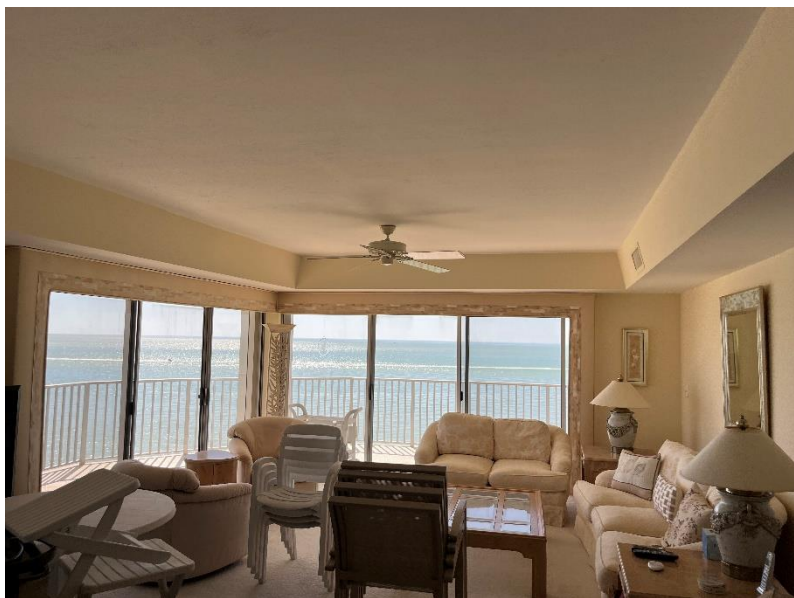
**PHOTOGRAPH #16**

- Interior units were found to be in good condition, and there was no indication of substantial structural deterioration present (**Photographs #16 through #21**).

**INTERIOR UNITS  
UNIT 304  
TYPICAL OVERVIEW**

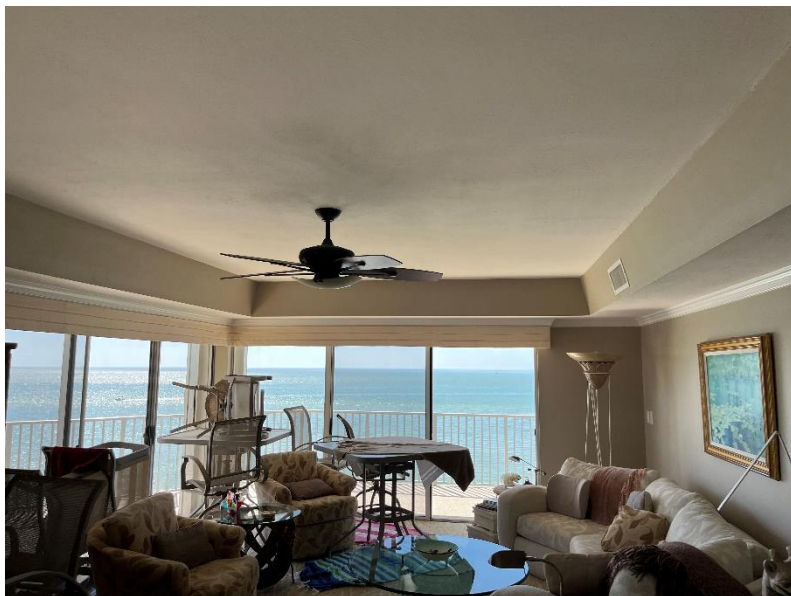
**PHOTOGRAPH #17**

**INTERIOR UNITS  
UNIT 404  
TYPICAL OVERVIEW**

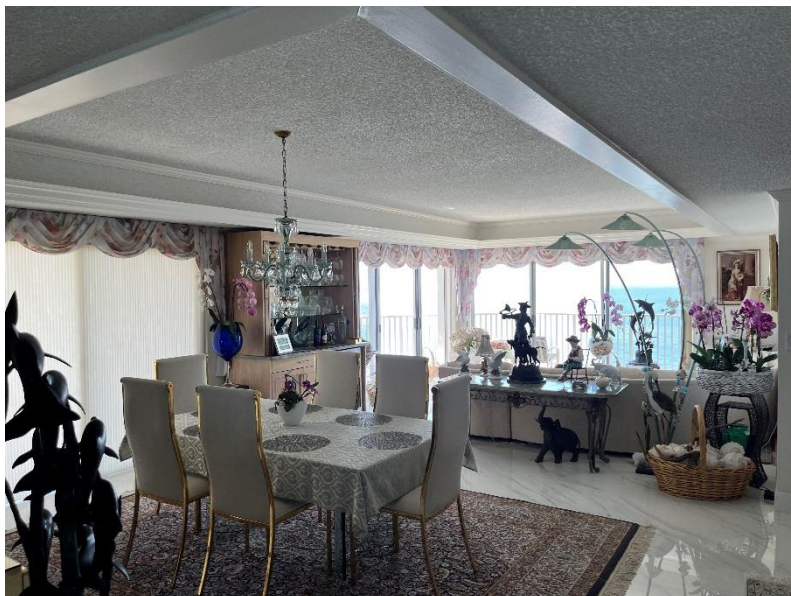
**PHOTOGRAPH #18**

**INTERIOR UNITS  
UNIT 504  
TYPICAL OVERVIEW**

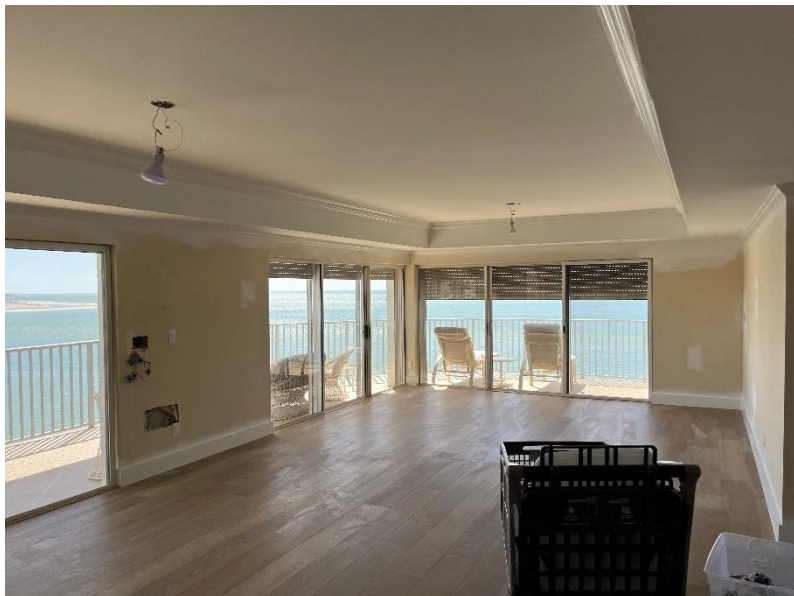
**PHOTOGRAPH #19**

**INTERIOR UNITS  
UNIT 604  
TYPICAL OVERVIEW**

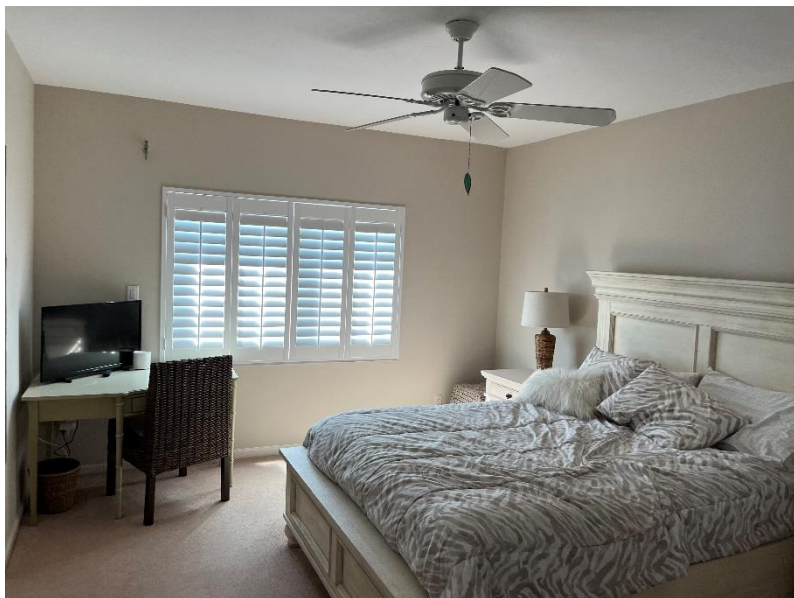
**PHOTOGRAPH #20**

**INTERIOR UNITS  
UNIT 704  
TYPICAL OVERVIEW**

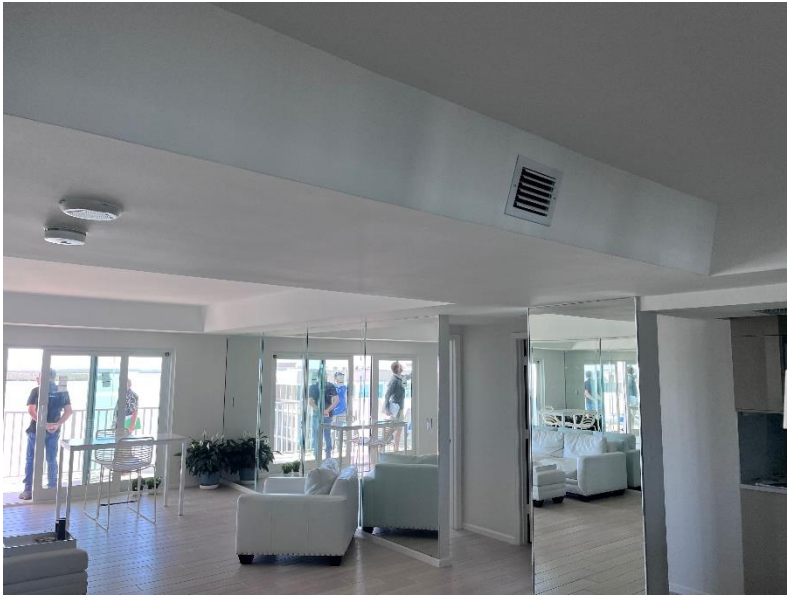
**PHOTOGRAPH #21**

**INTERIOR UNITS  
UNIT 803  
TYPICAL OVERVIEW**

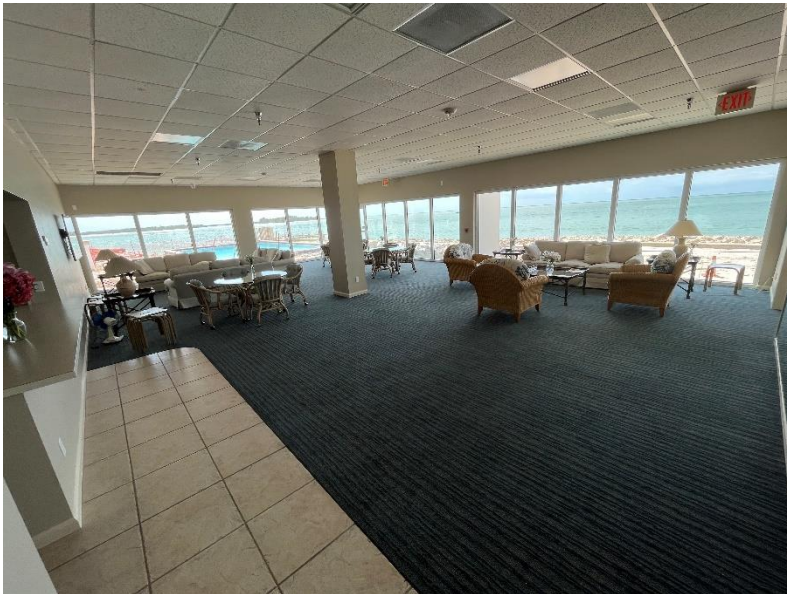
**PHOTOGRAPH #22**

- Common areas were found to be in good condition, and there was no indication of substantial structural deterioration present (**Photograph #22**).

**COMMON AREAS  
CLUBHOUSE  
TYPICAL OVERVIEW**
