# **STRUCTURAL INTEGRITY RESERVE STUDY**

## **CHALET OF SAN MARCO CONDOMINIUMS**

520 SOUTH COLLIER BOULEVARD  
MARCO ISLAND, FLORIDA 34145

DECEMBER 2024

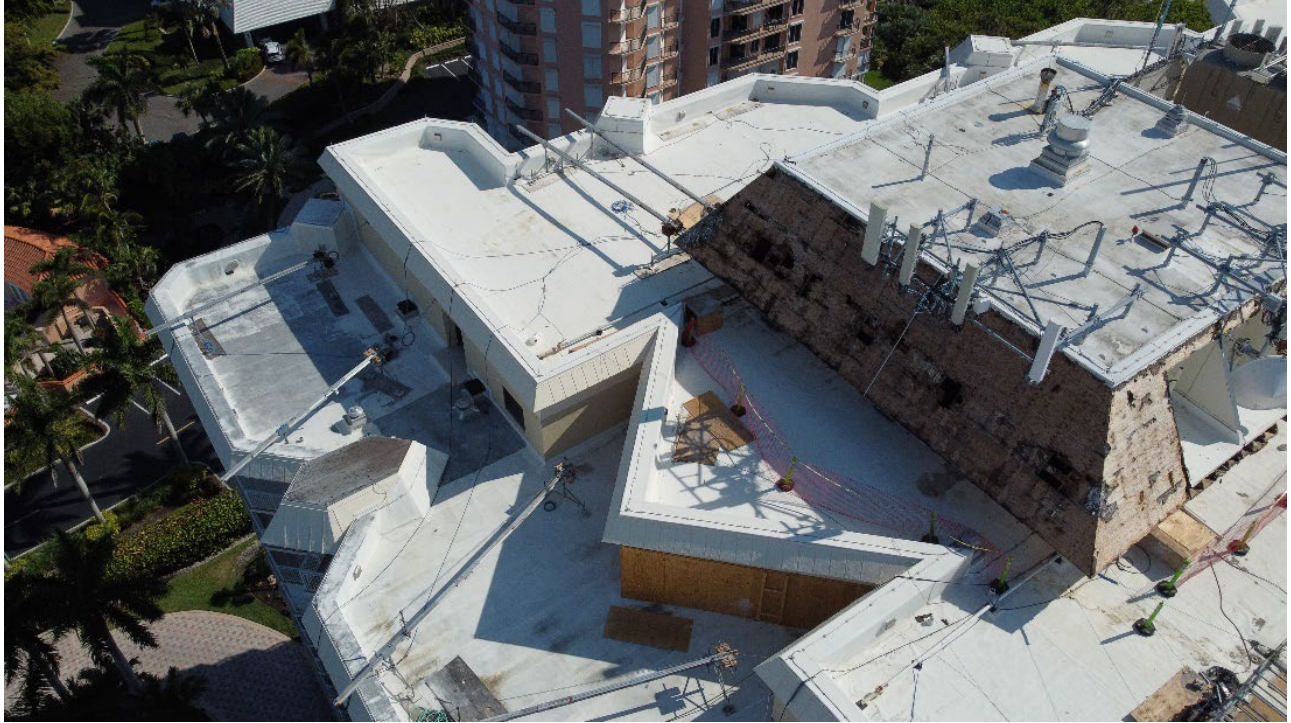
3. View of the work that is being performed on the terrace (middle roof section).

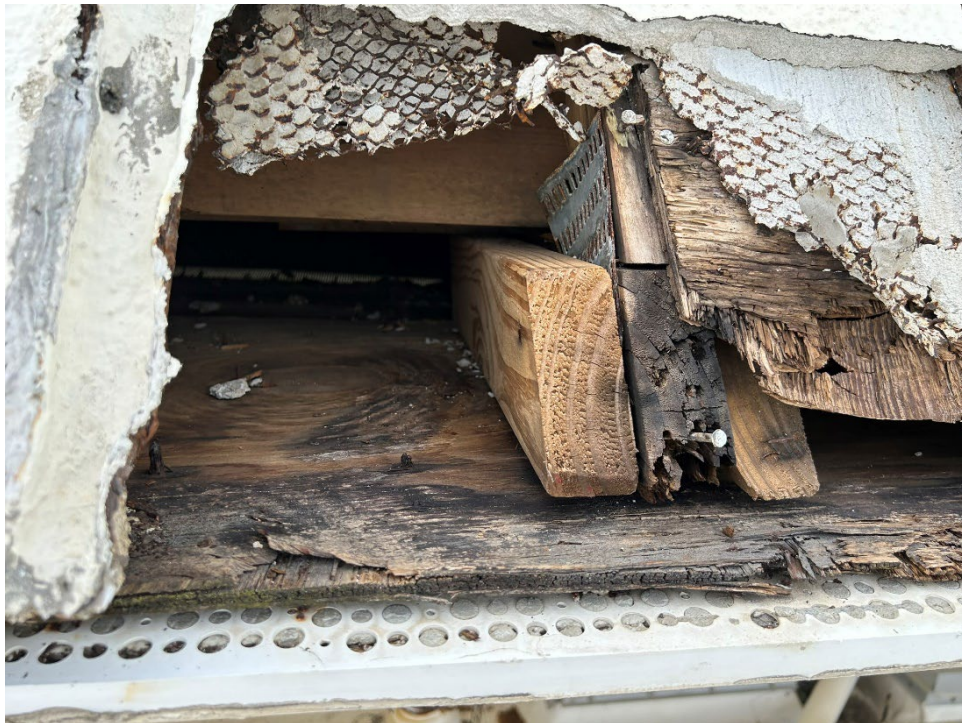
4. View of the observed water damage impacting the wood framing and sheathing of the middle roof section.

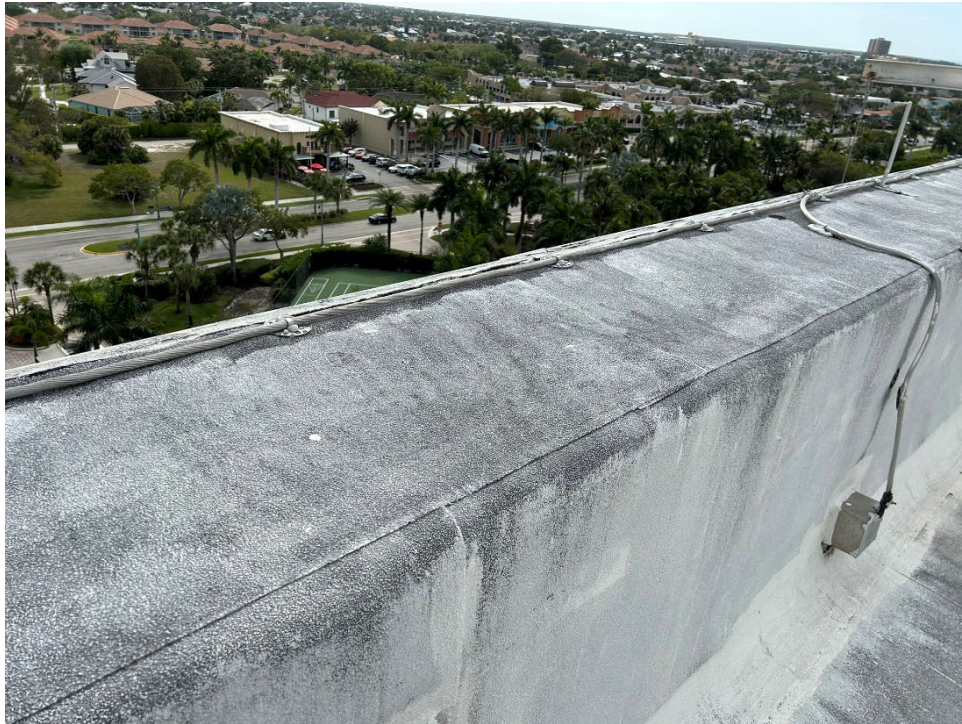
5. View of the failing joint sealant at the parapet walls.

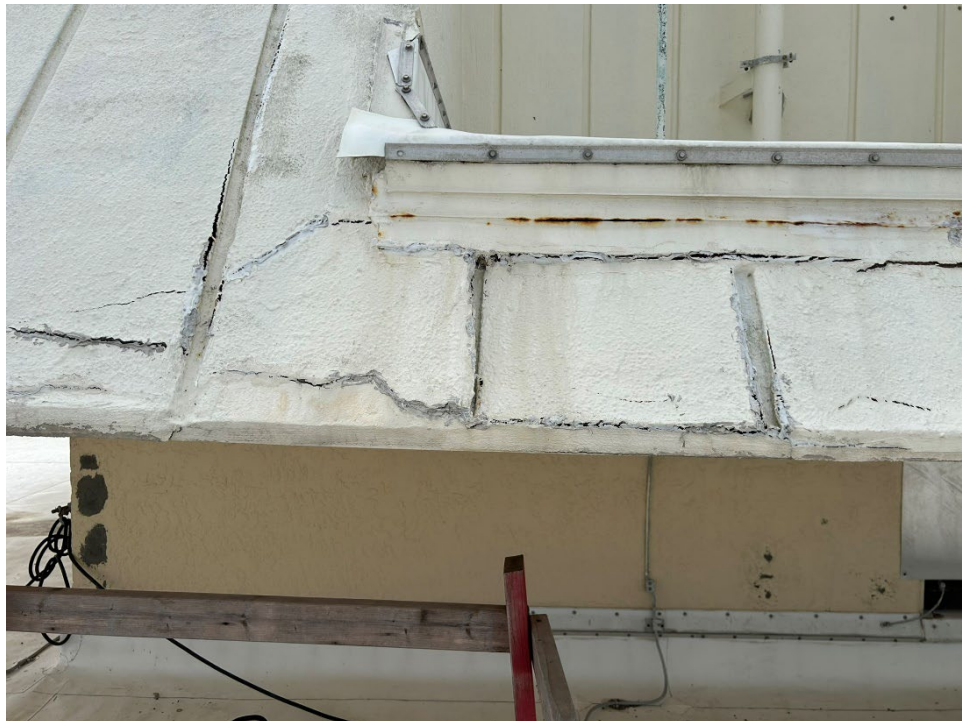
6. View of the cladding and failing finishes on the roof.

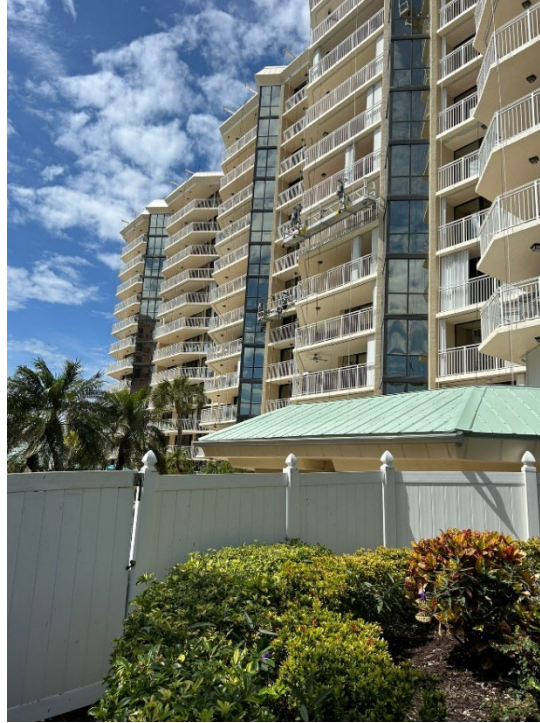
7. View of the repairs being performed on the exteriors and balconies.

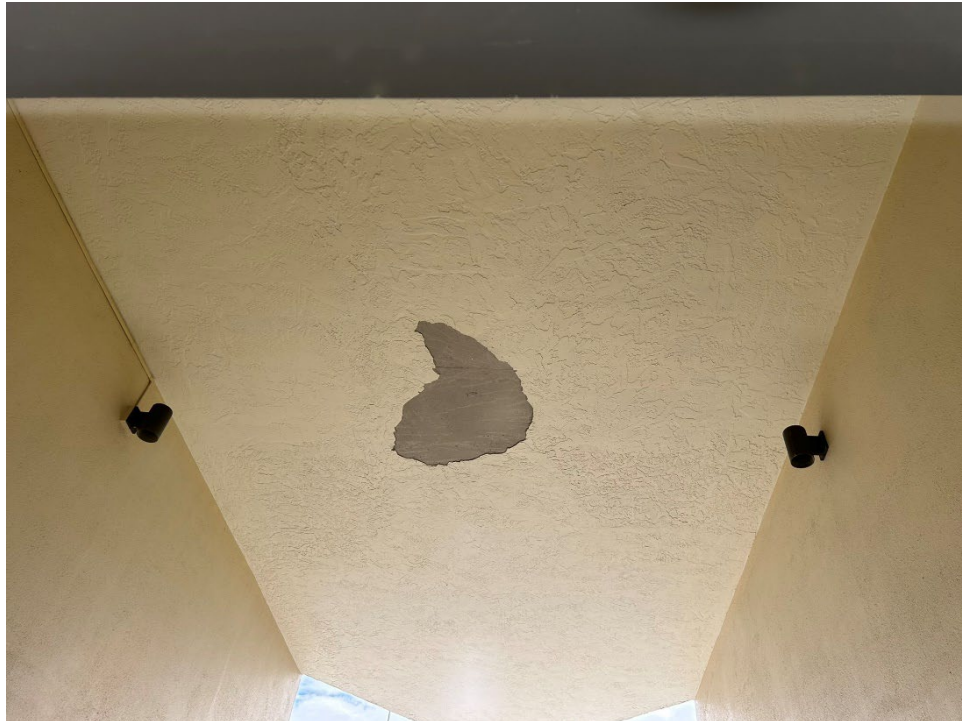
8. View of the observed delamination on the stucco.

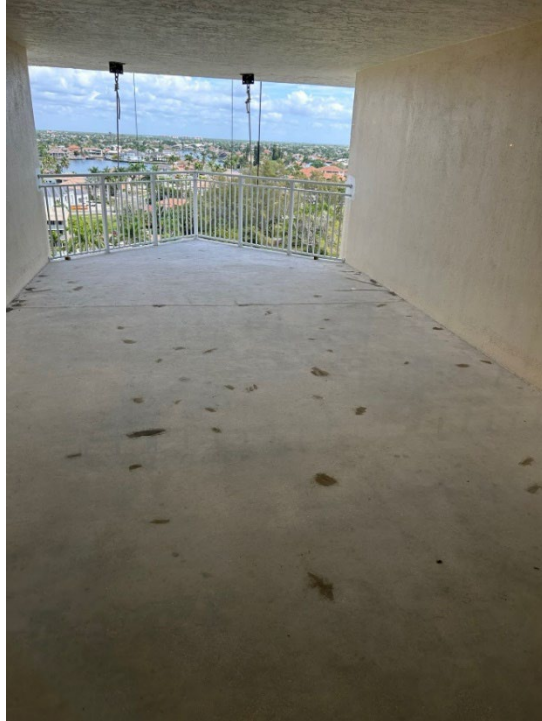
11. View of the concrete repairs being performed on the exterior of the building.

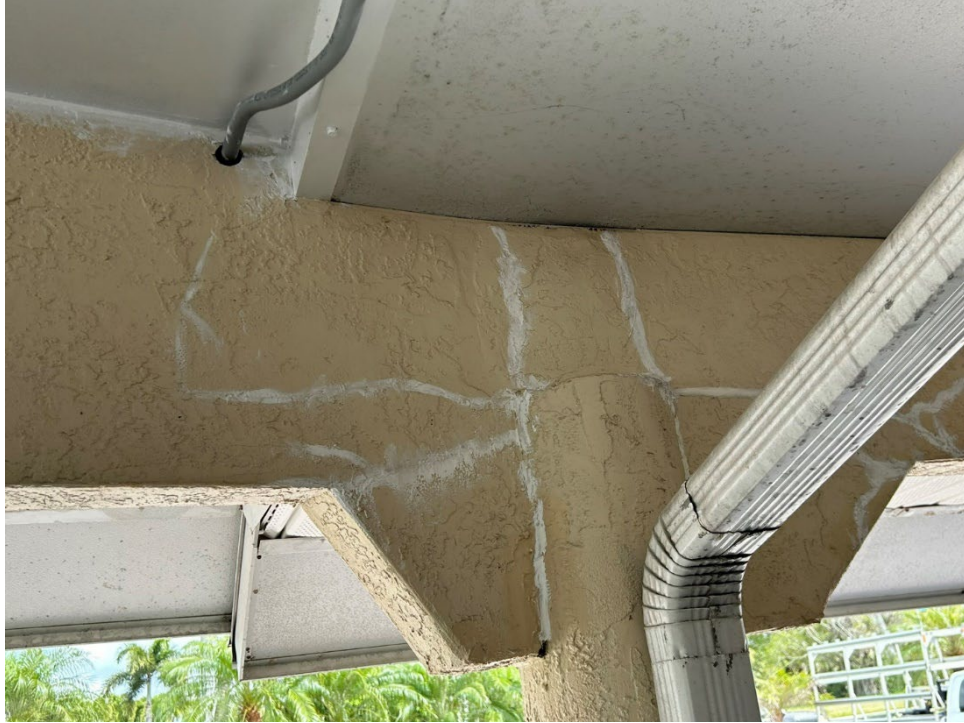
13. View of the observed cracks that have been repaired.

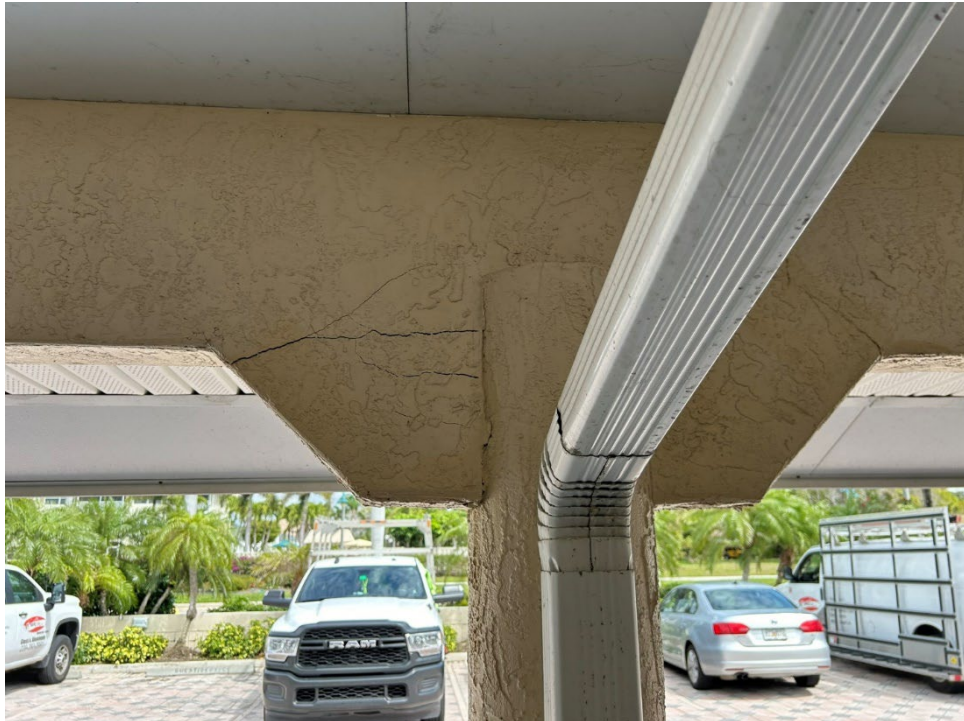
The significant issues we observed during the inspection include interior and exterior water damage, shear failure cracks in the parking deck, cracks in the parking garage floor, and delaminated tiles on the balconies. Based on the construction date of the community and the conditions observed, it appears that the exteriors, roof, and components of the fire and life safety systems are at the end of their useful service life and will need to be replaced.

14. The observed cracks at the shear caps are indicative of a shear failure; therefore, we recommend the stucco be removed to determine the extent of the structural damage.

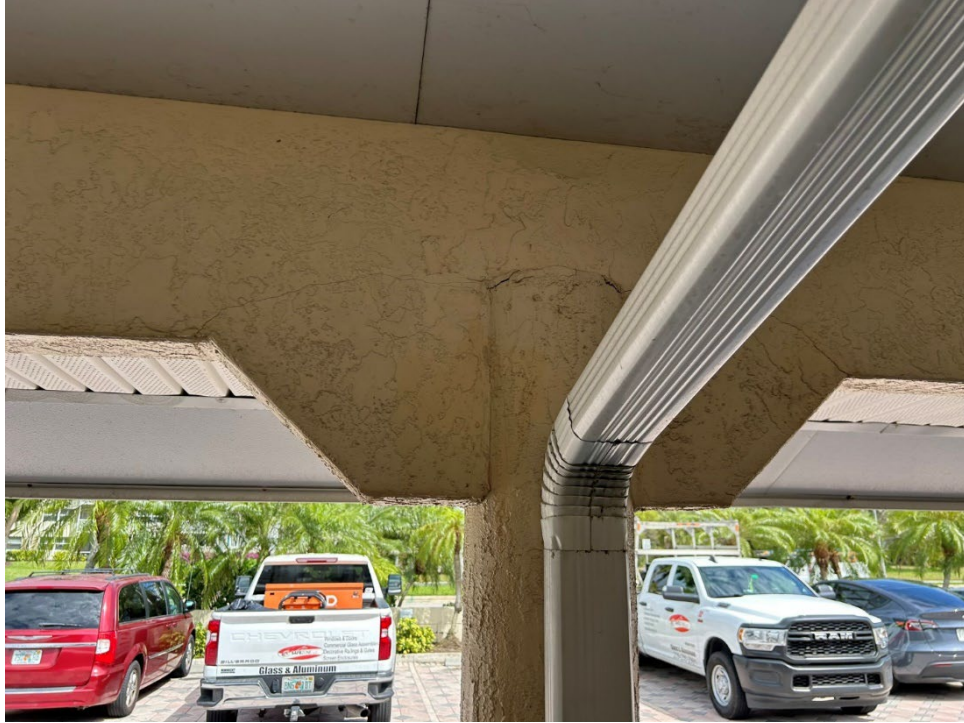
15. View of the additional shear failure cracks at the shear caps.

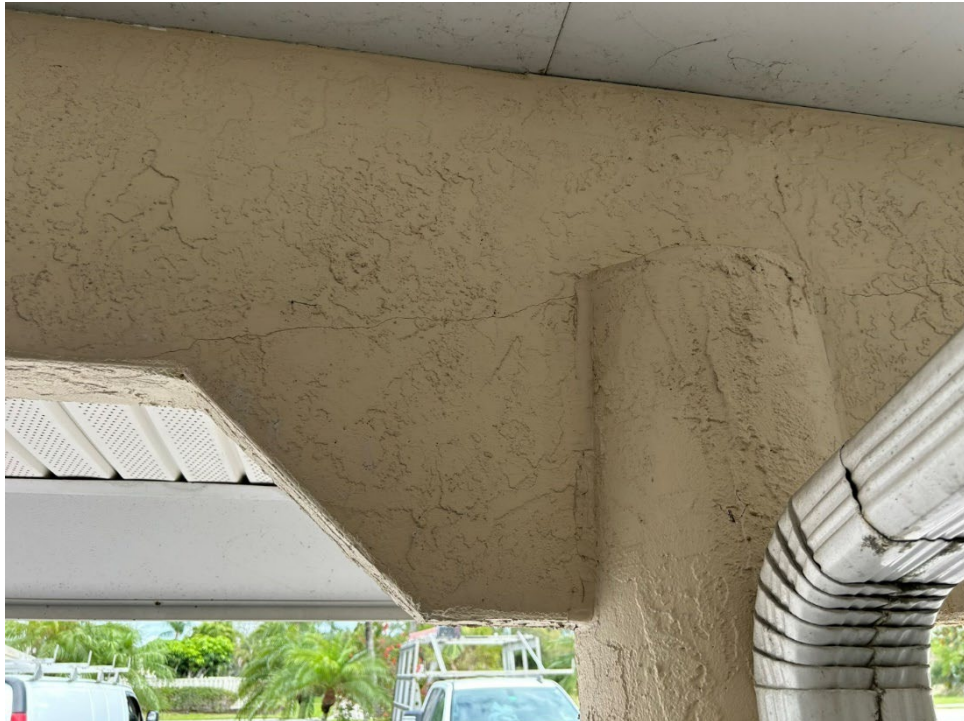
16. View of the additional shear failure cracks at the shear caps.
