# JMC Engineering Inc.

Reference: MILESTONE PHASE 1 INSPECTION REPORT  
Marco Courtyard Towers Condominium  
1111, 1121, 1131, & 1141 Swallow Ave.  
Marco Island, FL 34145  
JMC Project Number: 208MCT.02

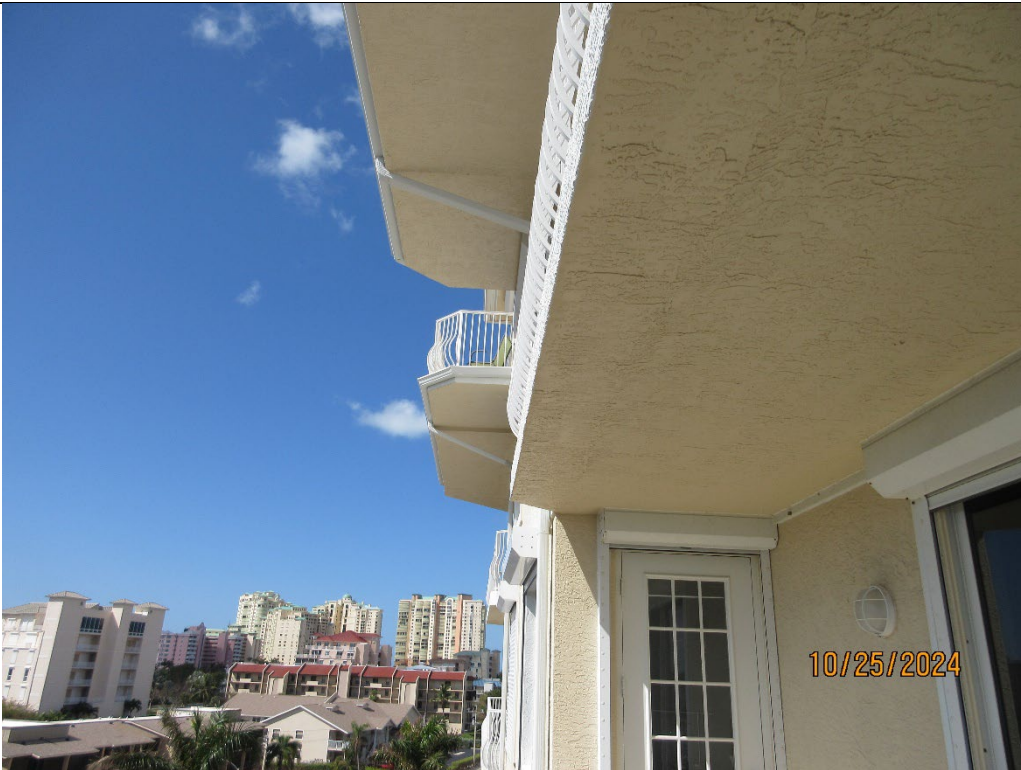
Photo 12. Typical Unit Balcony Ceiling Stucco with No Gutter

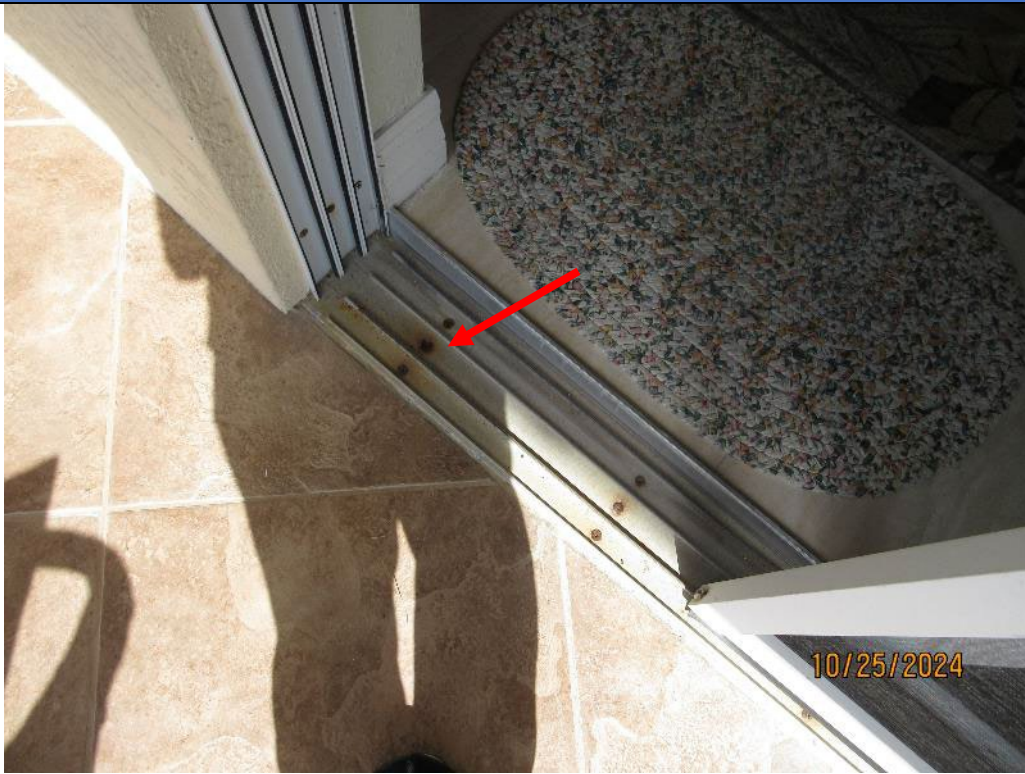
Photo 17. Select Sliding Glass Door Threshold Fasteners with Corrosion

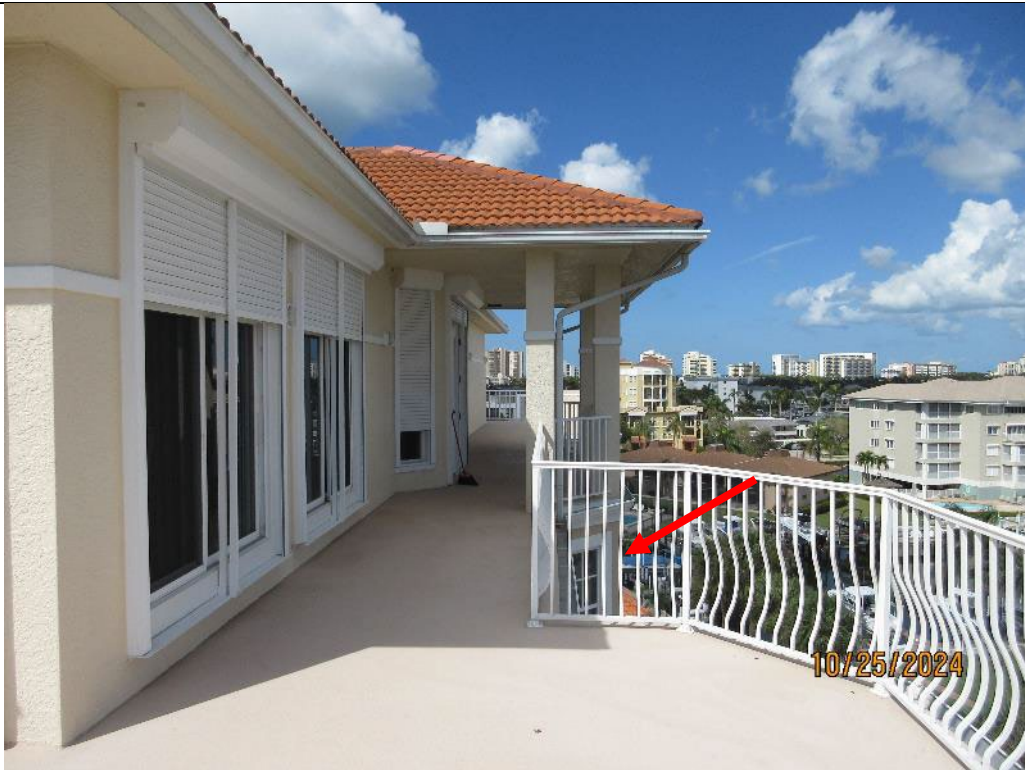
Photo 22. Penthouse Balcony Over Occupied Space

Additionally, JMC noted multiple locations where balconies at the penthouse level and the 2nd-floor levels of the eight-story buildings function as roof surfaces over occupied living spaces. While no water intrusion or indicators of failed waterproofing were observed during the inspection, due to the age of the current system, JMC recommends the association proceed with the replacement as recommended in the Structural Integrity Reserve Study.

- The condition of private unit balcony waterproofing is unknown due to existing floor finishes. Given the age of the buildings, any existing waterproofing is nearing the end of its useful life. JMC strongly recommends installing fluid-applied waterproofing membranes on all horizontal structural concrete surfaces with exterior exposure, especially at penthouse balcony locations over living spaces.

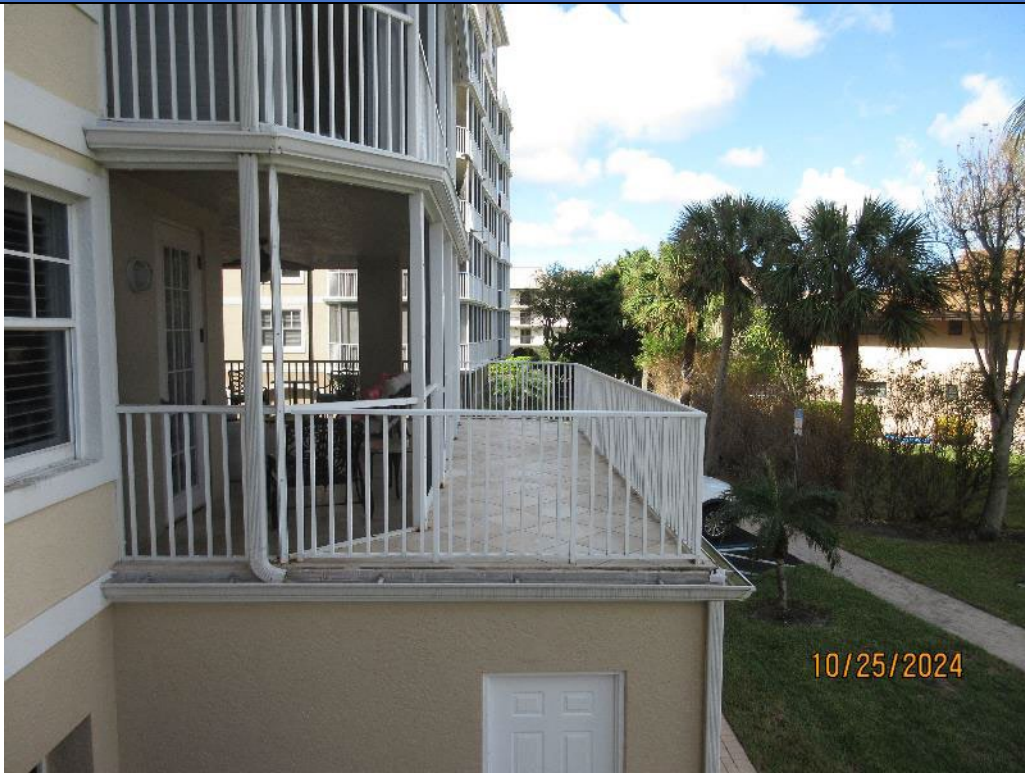
Photo 23. 2<sup>nd</sup> Floor Balcony Over Occupied Space

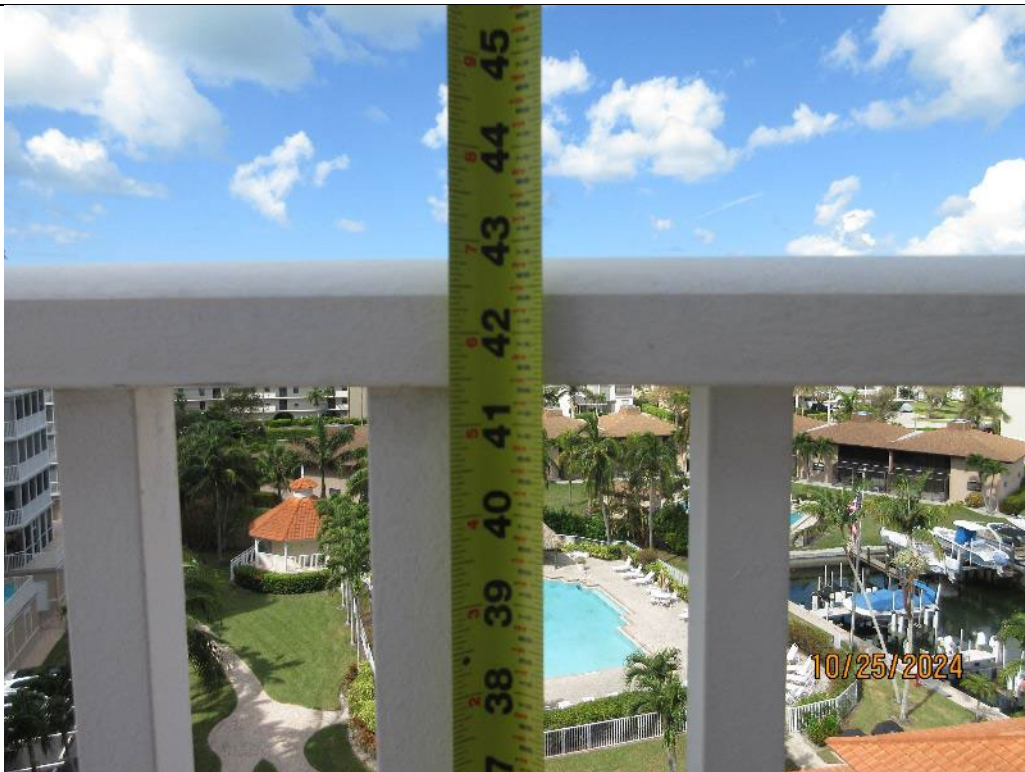
Photo 24. Typical Measured Railing Height > 42"

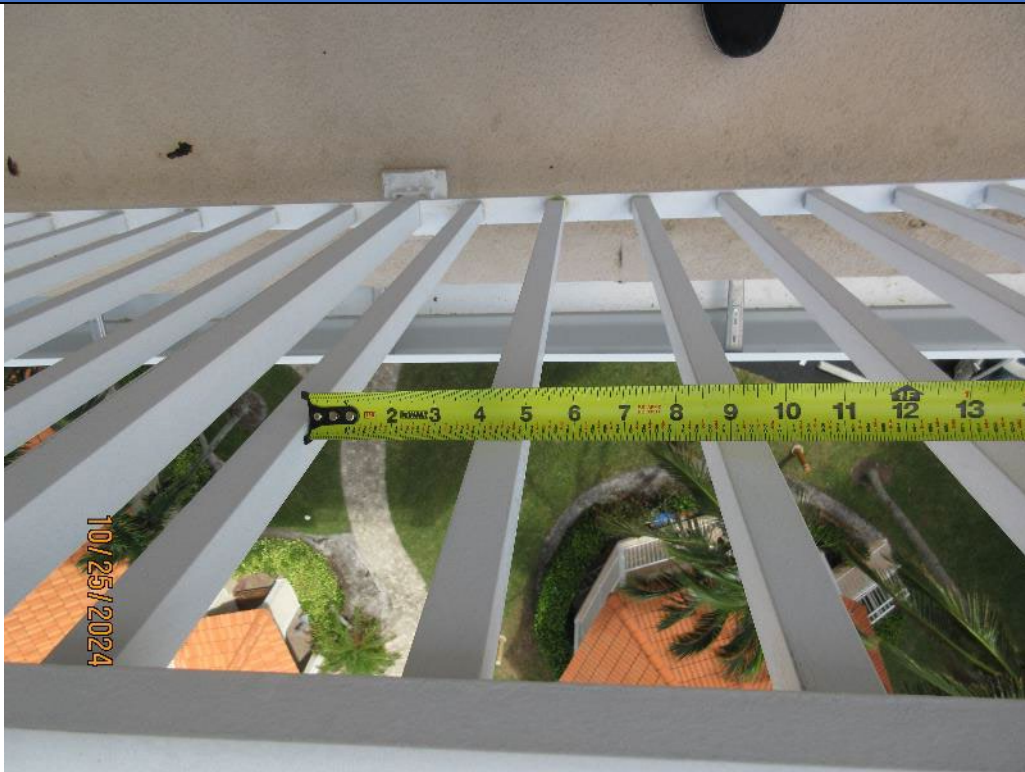
Photo 25. Typical Railing Picket Spacing Measured 4" or Less

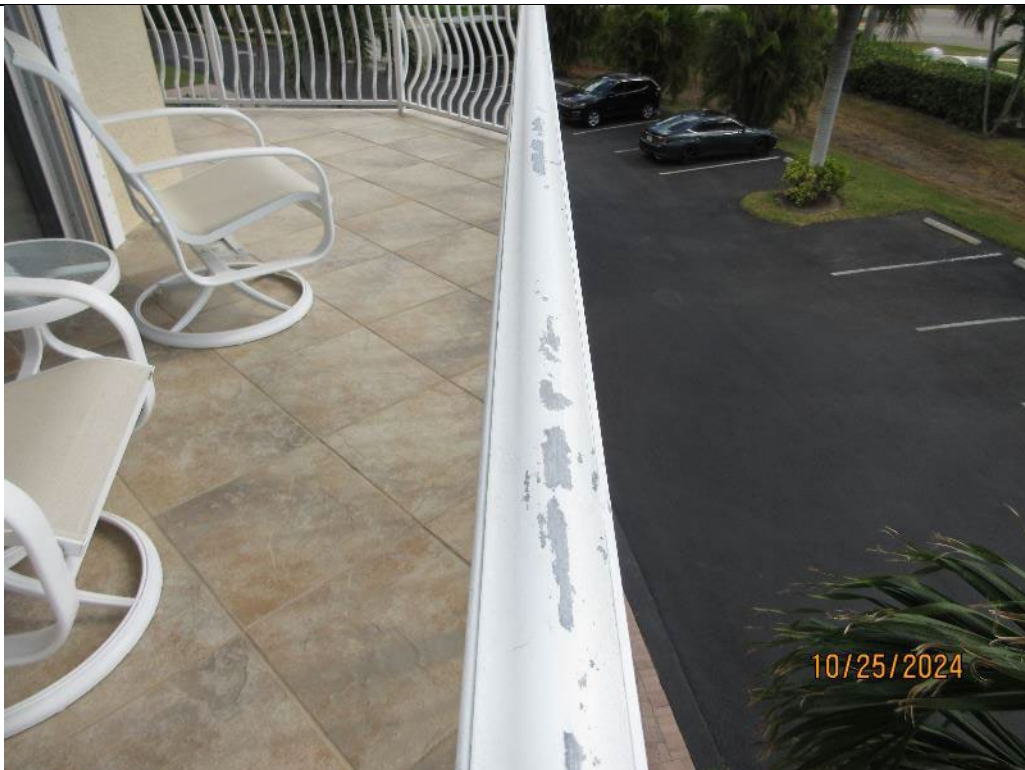
Photo 26. Railing Coating Exhibiting Signs of Wear

The interior stair railings were observed to be in good condition, as expected, due to their lack of exterior exposure to the elements. The balcony railings were observed to be in fair condition, consistent with the age of the components. Select locations were noted with failing coatings and fasteners with corrosion. JMC recommends that the association consider a railing coating replacement to prolong the useful life of the components. JMC also recommends the association follow the recommendations for replacement per the association's structural integrity reserve study.

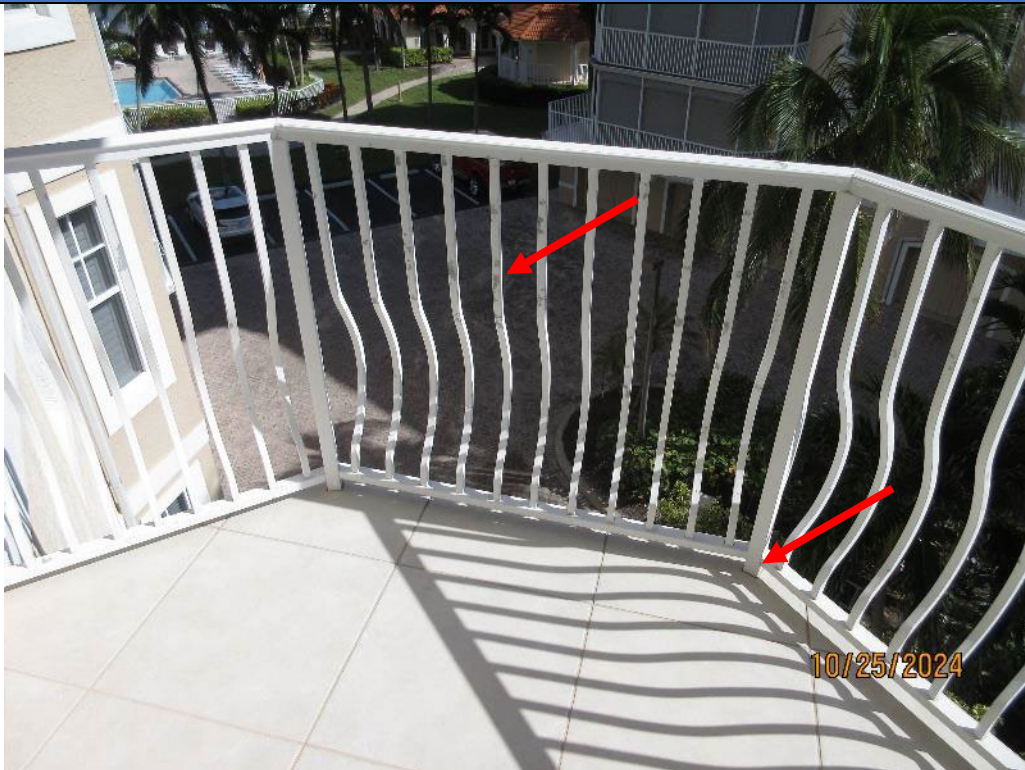
Photo 27. Railing Coating Exhibiting Signs of Wear and Typical Core Mounted Posts

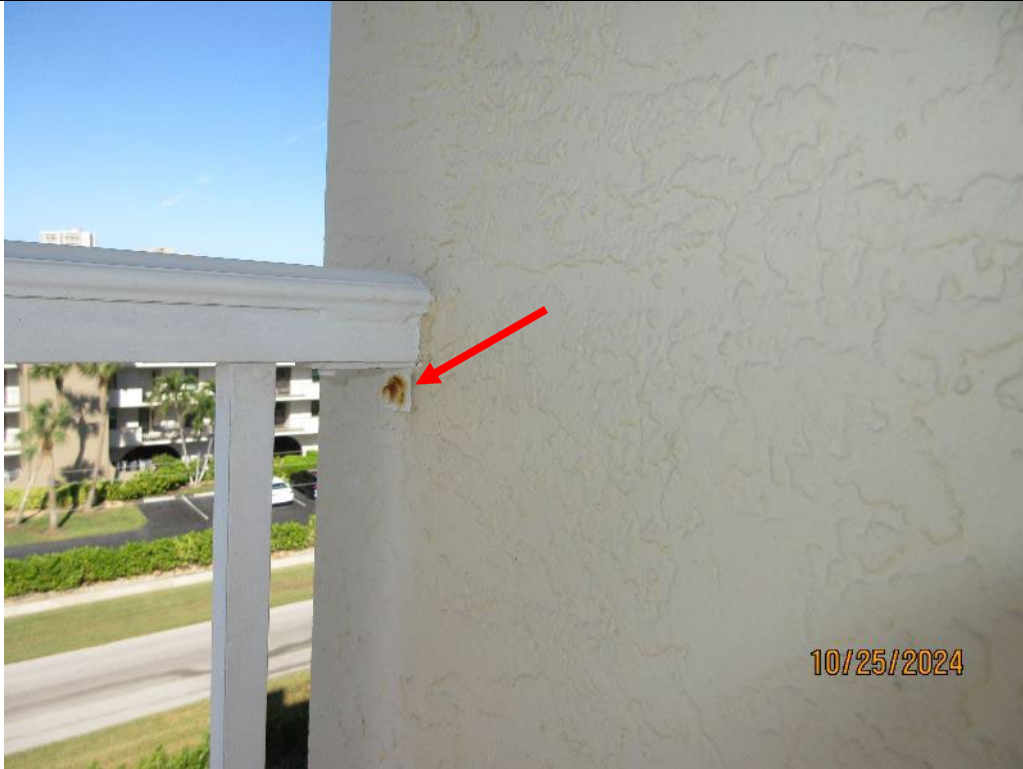
Photo 29. Corrosion at Select Railing Fasteners

- The property is in a hurricane-prone and wind-borne debris region. Loose materials and debris on the roof and property can become wind-borne during high winds, causing impact damage. Roof inspections should be performed twice a year and after storms. Regularly clean the roof of dirt and algae with manufacturer-approved methods. Immediately repair any isolated roof tile damage to maintain the roof system's useful life and prevent further damage.
- It is recommended that owners upgrade windows and doors that do not meet current code compliance, as any original windows or doors would be beyond their intended useful life.
- Replace existing ferrous metal fasteners with signs of advanced corrosion with new-sized stainless-steel fasteners set in urethane sealant.

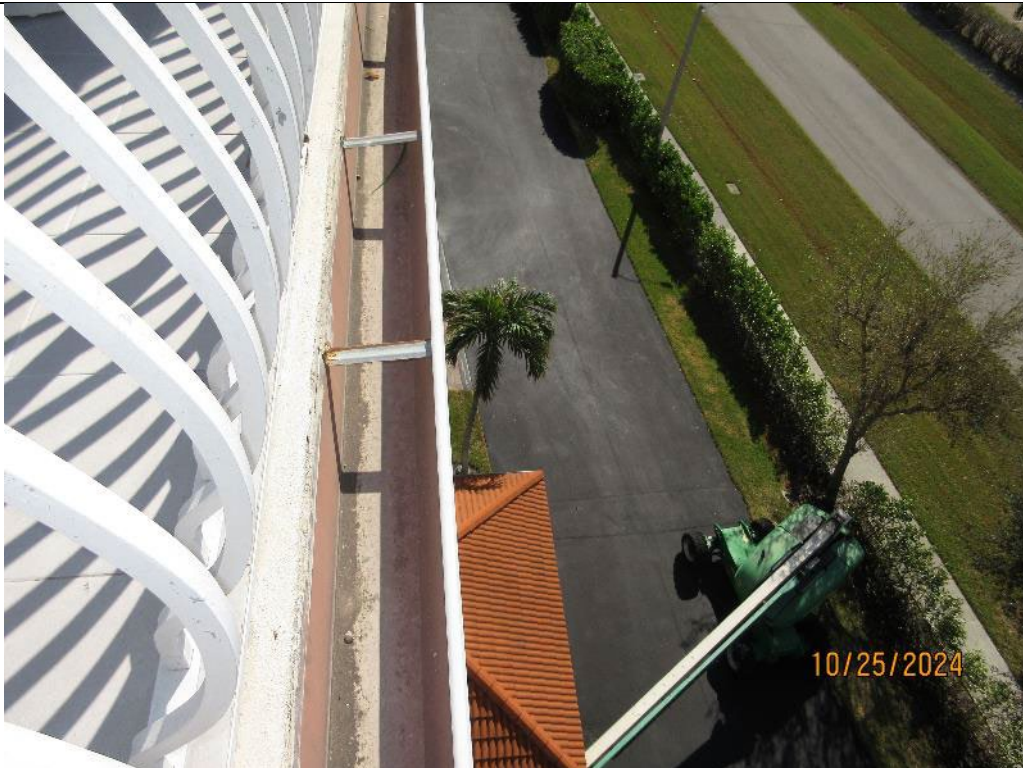
Photo 30. Typical Balcony Slab Edge Gutter Feature

- JMC also recommends replacing balcony slab edge gutters during future balcony waterproofing projects, due to the age of the elements and the need for proper flashing during the waterproofing project.

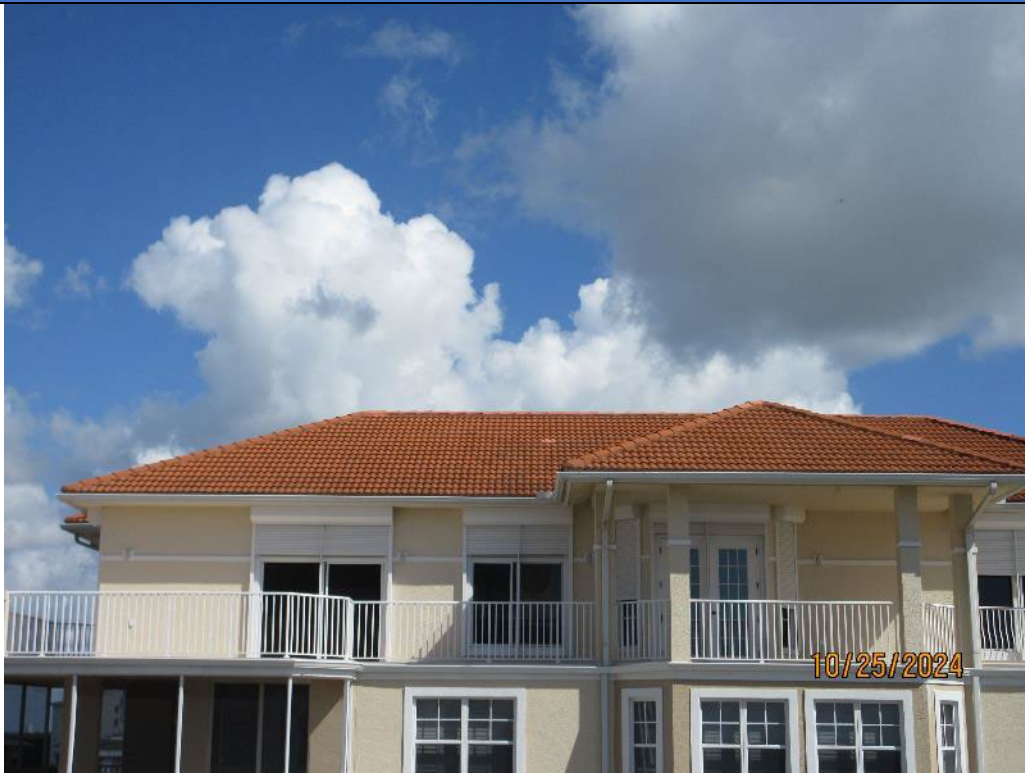
Photo 31. Overview Typical Concrete Tile Roof

Based on our observations, the existing concrete tile roofs appear to be in fair condition, consistent with the age of the components. Observations of the accessible roof trusses and framing members revealed no visual damage or signs of active water intrusion. However, at the modified bituminous flat roof locations, JMC noted that the roofs are nearing the end of their useful service life and recommends replacing them in accordance with the recommendations in the association's structural integrity reserve study.

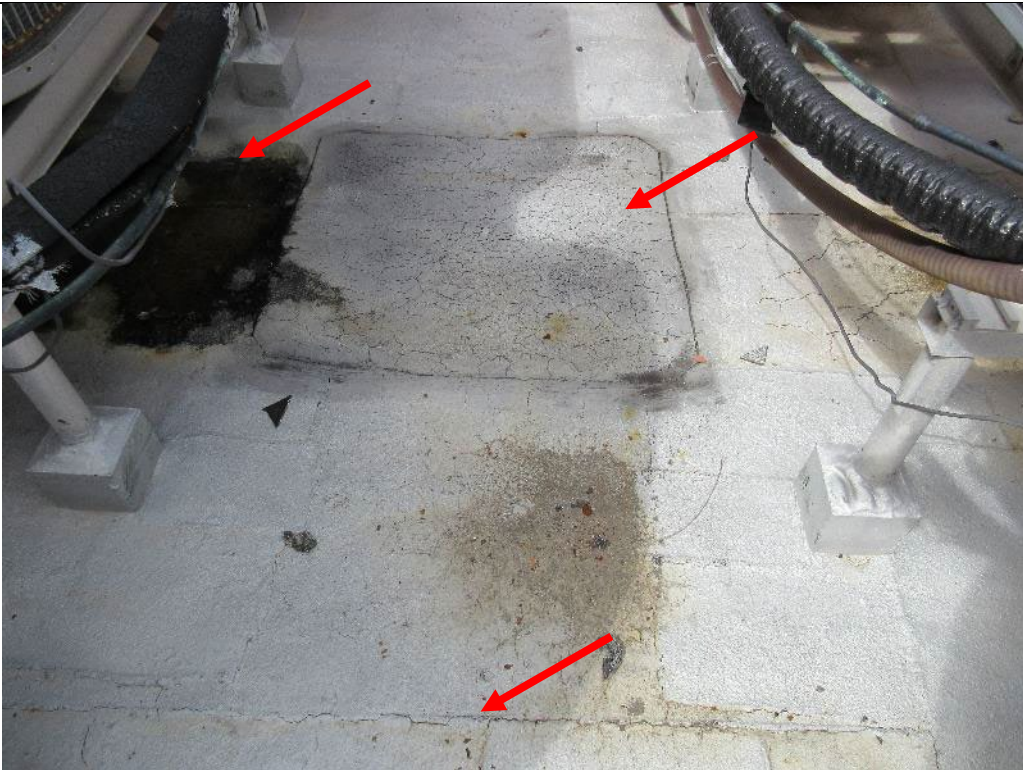
At the modified bituminous flat roof locations, no indicators of active leaking was observed. However, in general, the roofs appear to be nearing the end of their useful service life, consistent with JMC's understanding of the age of the components. An apparent fluid-applied coating has been installed over the modified roof to extend its useful service life and at multiple locations that coating is exhibiting signs of wear and cracking along seam lines and patch locations. JMC noted that no unsafe or dangerous conditions were present.

Photo 36. Modified Bituminous Roof Showing Signs Of Wear and Isolated Ponding

- Due to the age and condition of the existing modified bituminous roof system at all buildings, JMC recommends that the association start the process for developing roof system replacement specifications with a licensed commercial roofing contractor. Similarly, the concrete tile roof system should be replaced in accordance with the association's structural integrity reserve study.

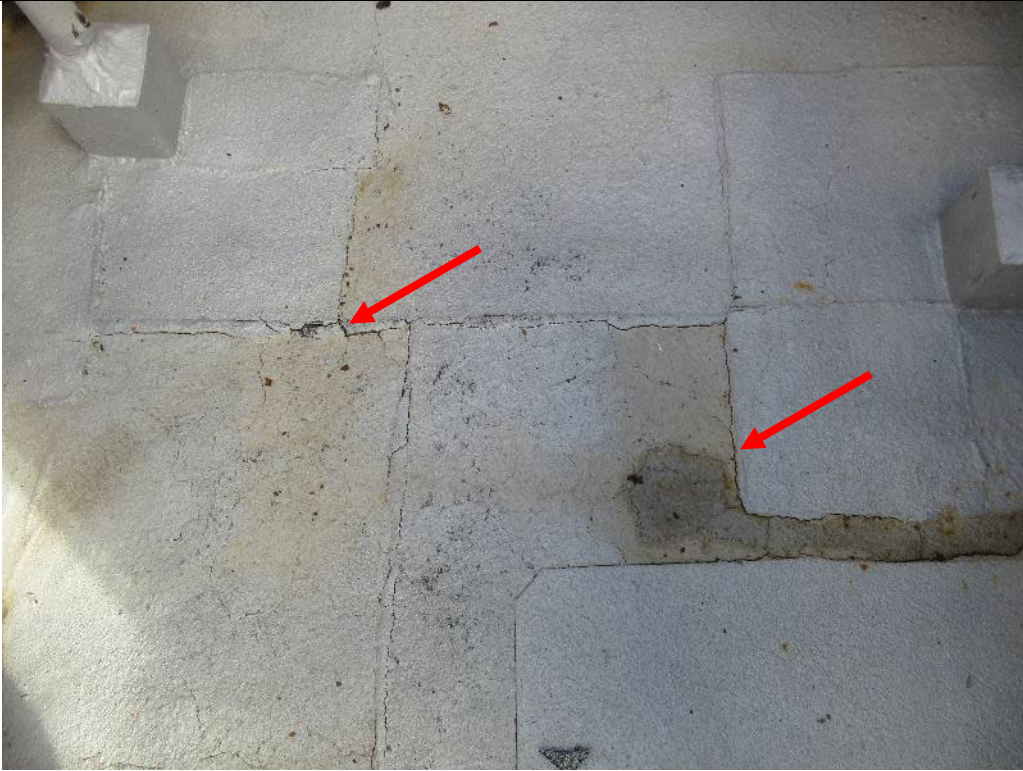
Photo 37. Modified Bituminous Roof Showing Signs Of Wear and Failed Prev Repairs

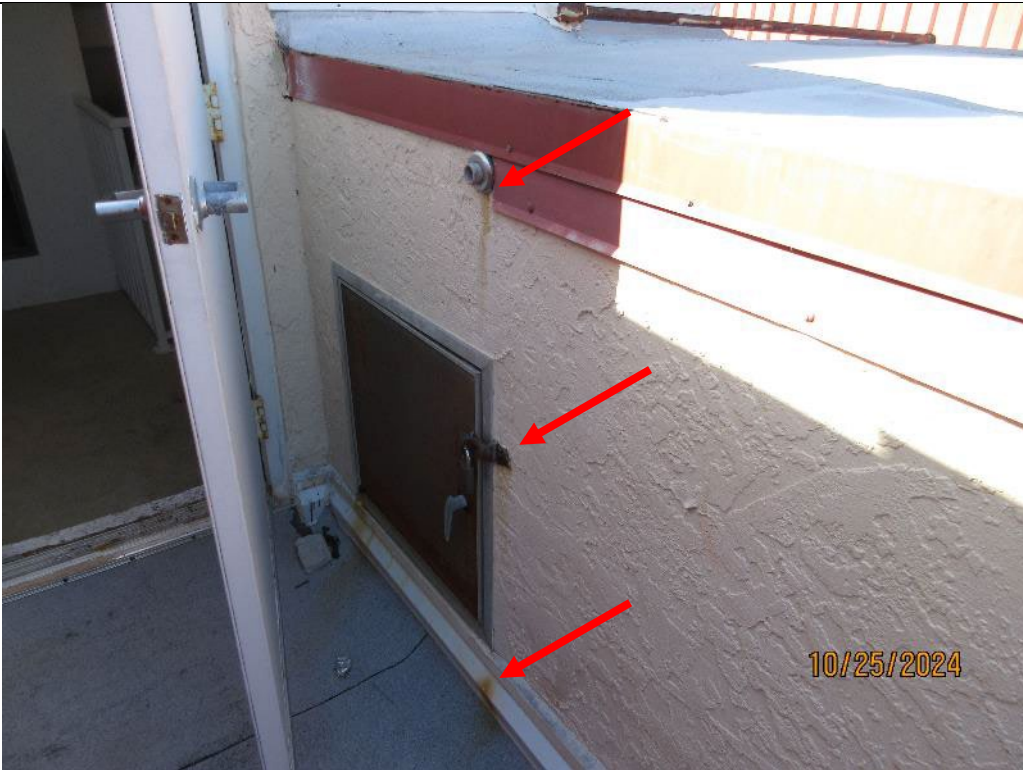
Photo 38. Corrosion at Ferrous Metal Fasteners

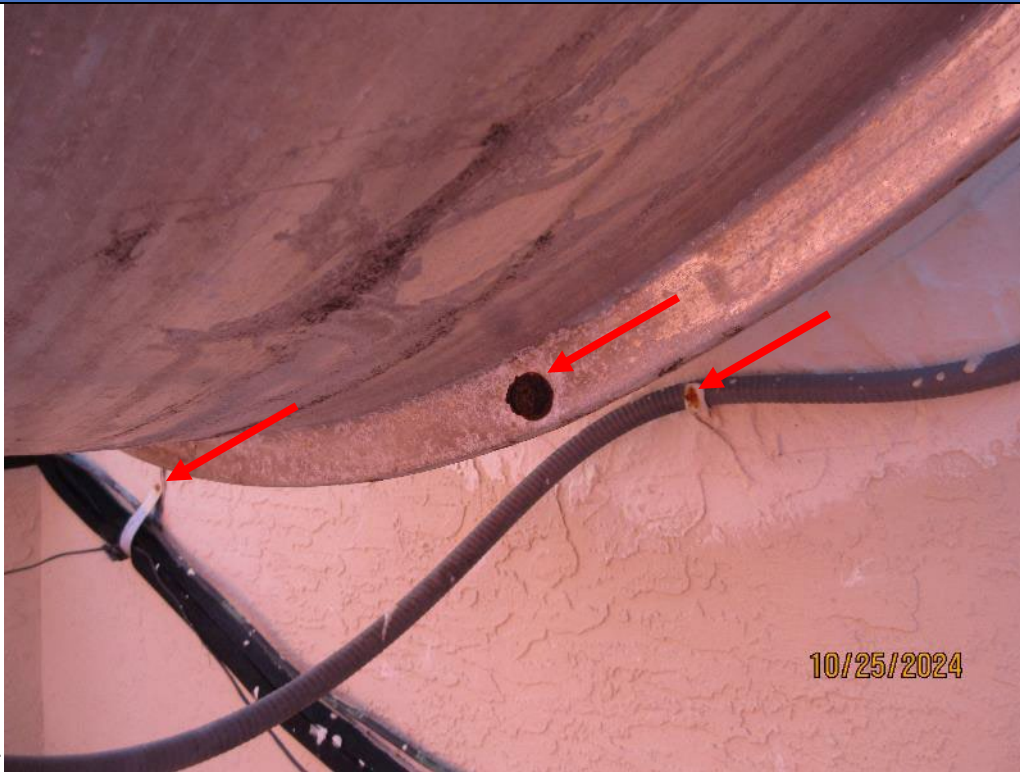
Photo 39. Corrosion at Ferrous Metal Fasteners
