# *Structural Integrity Reserve Study*

## **Marco Courtyard Towers Condominium Association, Inc.**

Marco Island, Florida

December 29, 2024

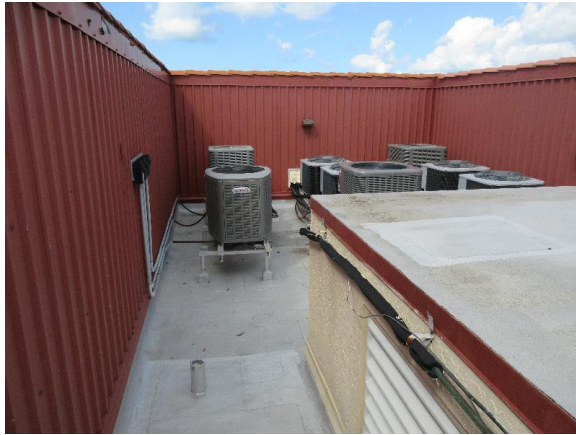
Typical Condo Modified Bituminous Roof

Based on visual observations, it is MSC's opinion that the concrete tile roof systems are in good to fair condition consistent the age of the element and the maintenance records provided by the board related to storm damage in 2018. The modified bituminous low sloped roof systems were observed to be in fair condition nearing the end of their useful service life.

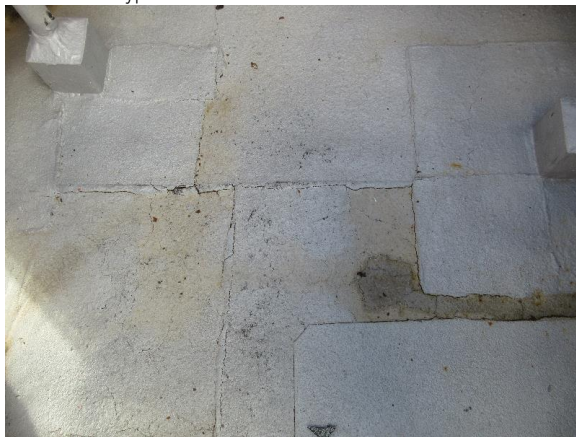
Cracking and UV Degradation at Seams

It is recommended that inspections of the roofs occur annually as well as after major storm events. Recommended maintenance includes regular cleaning and removal of debris accumulation, trimming trees and plants, cleaning gutters, repairing damaged flashing details at penetrations and damaged panels as well as replacing missing fasteners. All work should be performed by licensed roofing contractors experienced with commercial roof systems.

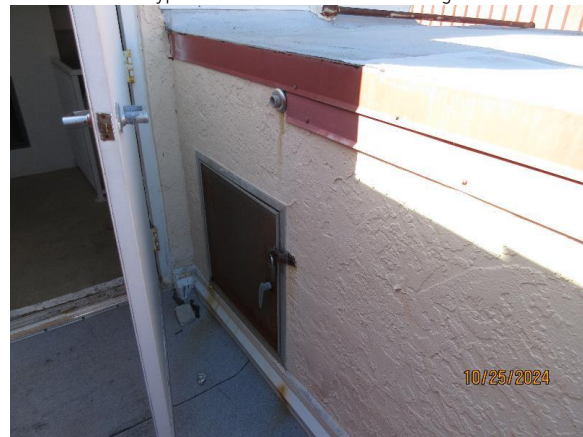
Corrosion Present at Ferrous Metal Fasteners

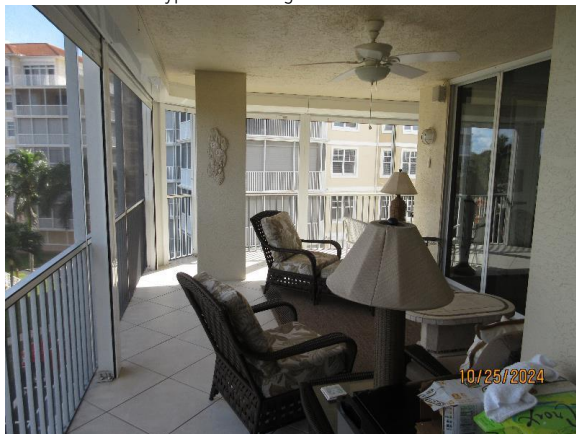
Typical Rear Balcony Overview and Column

MSC believes the buildings are in a good, well-maintained condition, and have recently completed a structural concrete restoration project at select private unit balcony locations throughout the community. These restoration efforts are vital for maintaining the structural integrity of the buildings, especially given their exposure to the harsh coastal environment.

The deferred maintenance projects should address isolated spalling concrete at structural members and systems throughout the buildings, repairs to the stucco cladding protecting the underlying steel structure, and any structural repairs not specifically reserved for in other lines described in this report.

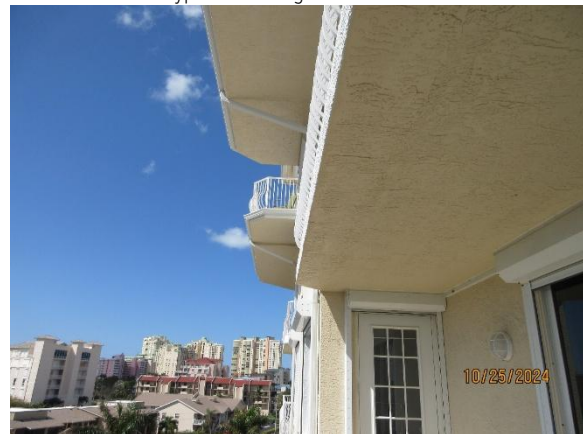
Front Balcony Ceiling and Slab

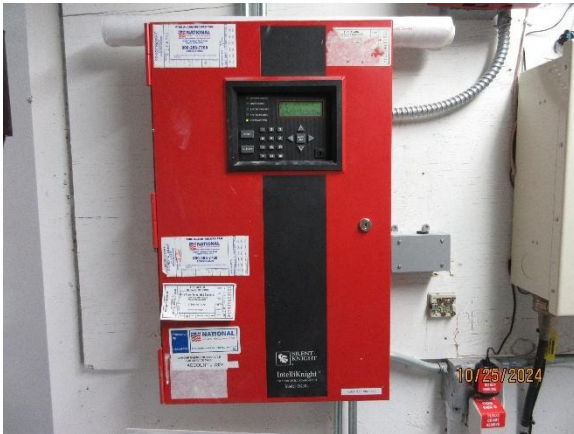
Addressable Fire Alarm Control Panel

As Expected Condition with Fire Protection Service Agreement and Age of Equipment

2. Based upon the age of the components and the typical useful life associated with electronic components, especially those systems such as the fire alarm and fire protection systems and their life safety function, are nearing the end of their intended useful service life. MSC recommends the association engage with a licensed service provider to develop a schedule for replacement within the next 5 years.

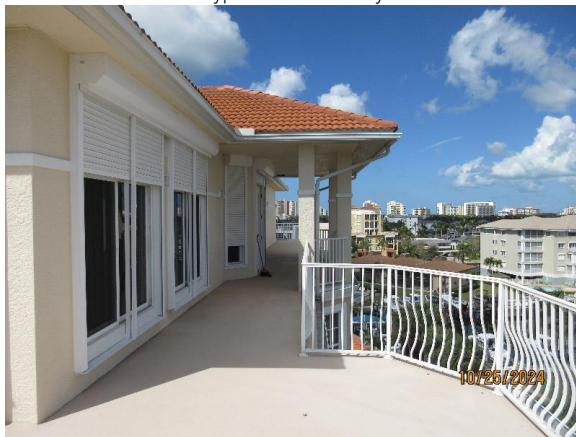
Penthouse Balcony Deck Over Occupied Space

4. Additionally, for all balcony locations over occupied spaces, including applicable second-level balconies and wrap-around penthouse balconies over living spaces, the waterproofing at these levels, serving as a roof system, should be scheduled for replacement in connection with the railing project for economies of scale, unless issues arise that necessitate an earlier replacement.

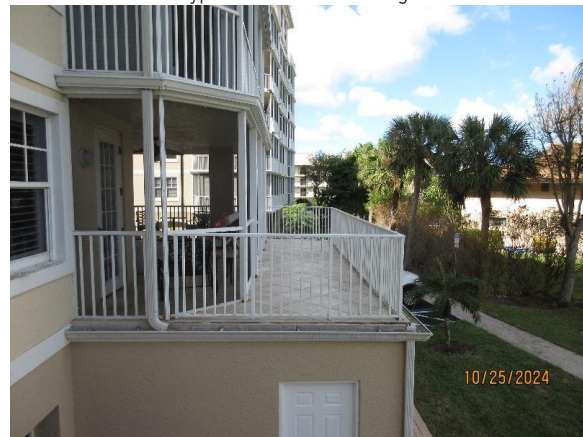
2<sup>nd</sup> Level Balcony Deck Over Occupied Space
