**DELA PARK PLACE CONDOMINIUM, INC.**

**Subject:** Report of Engineering Consulting Services  
**MILESTONE INSPECTION – PHASE I**  
Dela Park Place Condominium  
1020 South Collier Blvd.  
Marco Island, Collier County, Florida 34145  
SOCOTEC Project Number 6901-003.01P

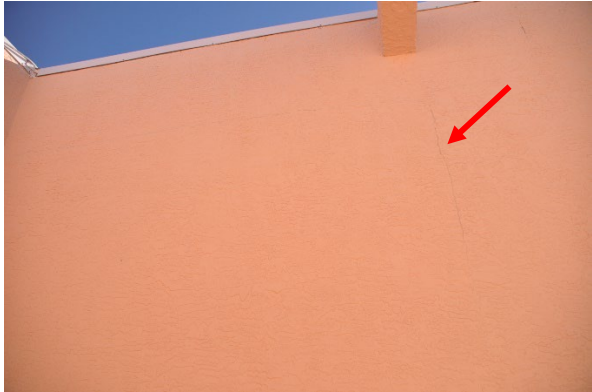
- Cracks or other similar type of concrete fractures indicated in figures 1, 4, 6, 7, 12, 13, 14, 18, 19, 20, & 23. These can lead to moisture absorption and lead to further deterioration that may cause issues to the reinforcement of the structure.

| <p>1. Minor crack on the roof of the building</p> | <p>2. Honeycombing on wall. Defect of negligible importance structurally at the given location.</p> |

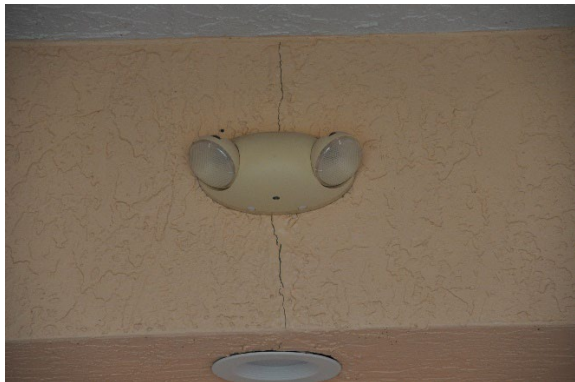
| <p>3. View inside the trash chute</p> | <p>4. Surface linear crack. Of no structural concern but repair is necessary to avoid moisture penetration.</p> |

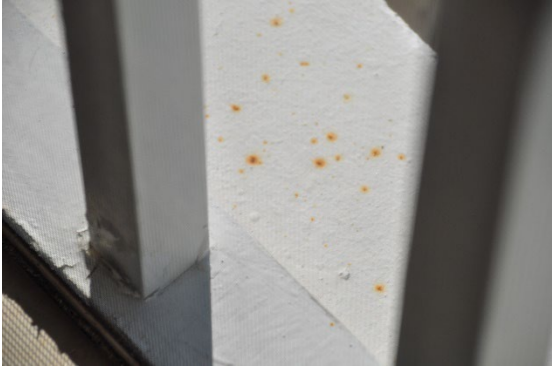
| <p>5. Random signs of corrosion on exterior surface of lanai balcony of Penthouse B</p> | <p>6. Crack on stucco next to a column. Action needs to take place to prevent moisture damages (Penthouse B)</p> |

- Conduct proper maintenance on paint by removing old layers, cleaning the surface from residue material and applying new layer of paint to protect surfaces. Such conditions can be traced in figures 5, 7, 10, 11, 17, 18.

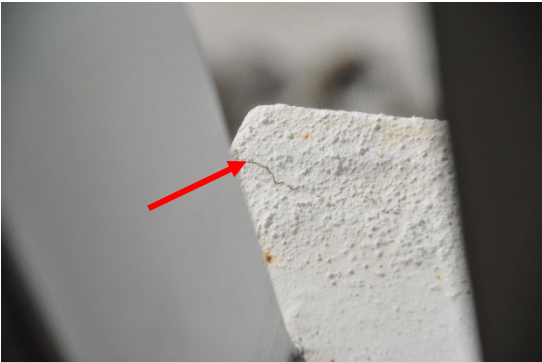
| <p>7. View of stucco/concrete distress outside balcony of Penthouse B</p> | <p>8. Severe fracture indicates a topical structural problem that needs to be addressed. (Penthouse A)</p> |

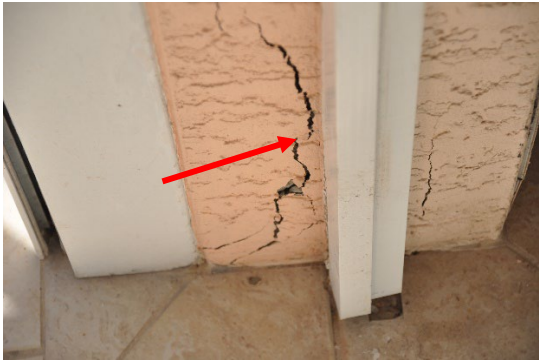
- One is a column that exhibits fracture at the lower end which will need a more in-depth investigation for probable spalling of the reinforced concrete, (fig. 8).
- The other is occurring at the edge of a PT slab, (fig. 9), which may lead to failure of a tendon.
- The signs of corrosion on figures 23 through 26 do not necessarily indicate an eminent danger but it will be recommended that clearing of the corrosion and tracing the cause to verify that there is no damage in a Post-Tensioning tendon or any other element that may compromise the topical integrity of the structure. In case any part of the Post-Tensioning components is compromised, that will constitute a structural issue that will need to be addressed immediately.

Neither of the above lead to a catastrophic failure yet, but the aforementioned is certainly possible and it is recommended that further and more thorough investigation of both cases takes place as soon as possible. If the investigation reveals substantial damage, reparative action will be recommended to minimize chances of accelerated damage that can escalate to the need of more extensive repairs.

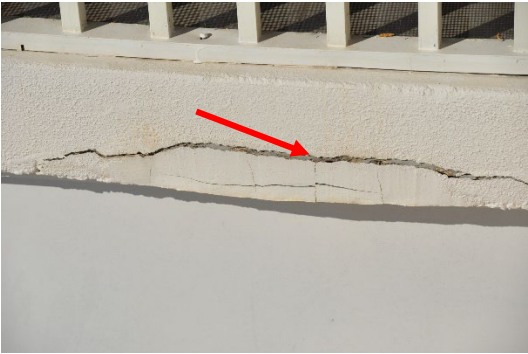
| <p>9. Covering of failure. It was evidently noticed at an earlier stage and some superficial work took place. Problem needs to be addressed. (Penthouse A)</p> | <p>10. Repeated case of signs of ferrous corrosion accompanied by surface crack on concrete. (Penthouse A)</p> |

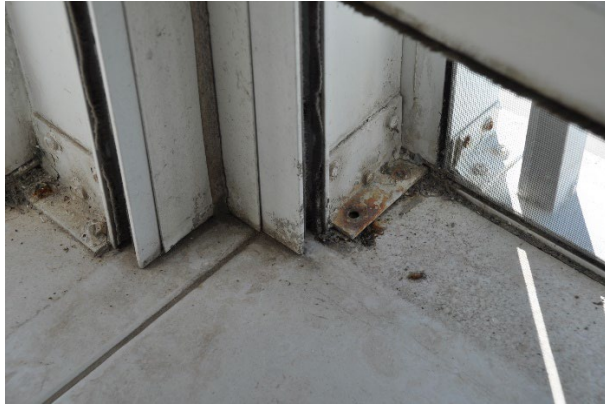
11. Typical maintenance issue of steel structural elements. (Unit 702)

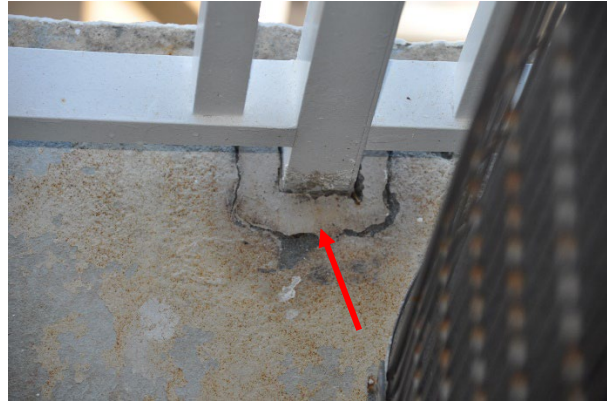
12. Minor maintenance issue that may lead to more important concerns if action does not take place promptly. Water will concentrate and percolate through to damage concrete reinforcement (Unit 702)

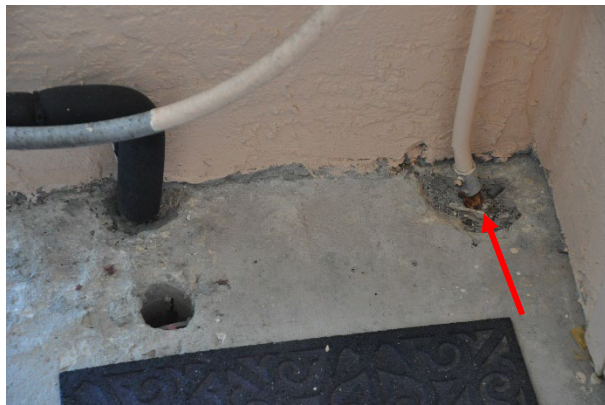
13. Water will concentrate and damage concrete. Prompt repair necessary. 7<sup>th</sup> Floor Service Area

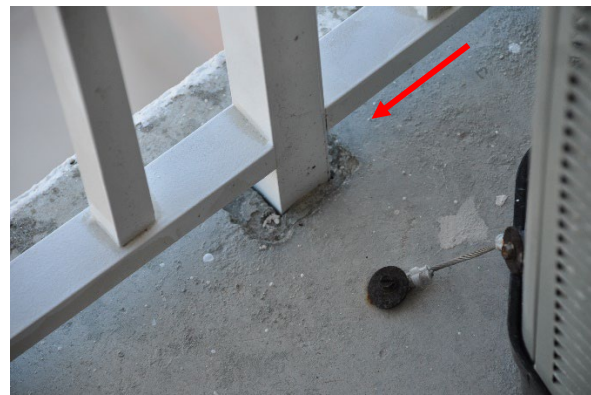
14. Same effect as previous photograph . . . 7<sup>th</sup> Floor Service Area

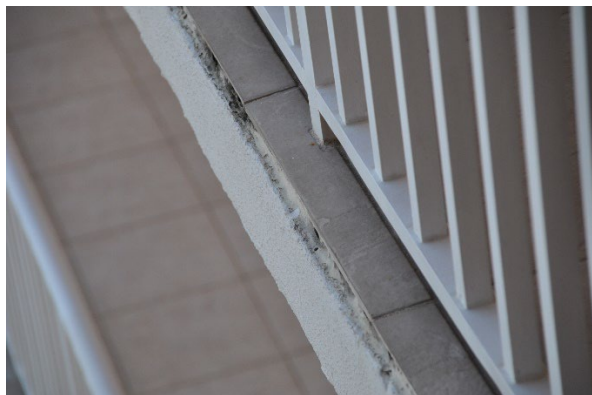
15. Poorly designed layering of construction materials. This is a continuous opening that will absorb and trap moisture inside the volume of the slab

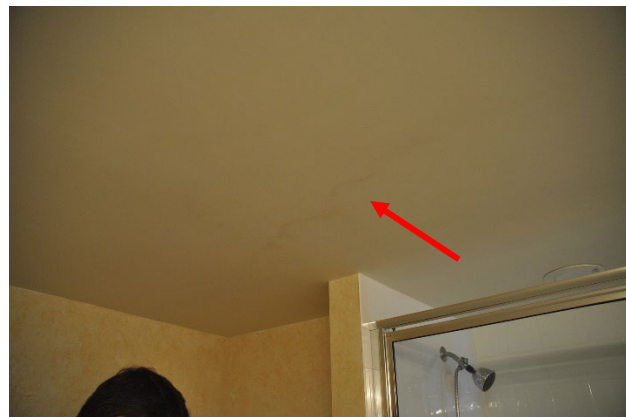
16. Watermark on ceiling in unit 605. Cause is only speculated but the damage cannot be precisely assessed by damage on surface.

- The watermark indicated in figure 16 should be addressed by plumbing specialists. Although plumbing is not a structural issue, water leaks and concentration of water can lead to corrosion of elements that are of structural significance.

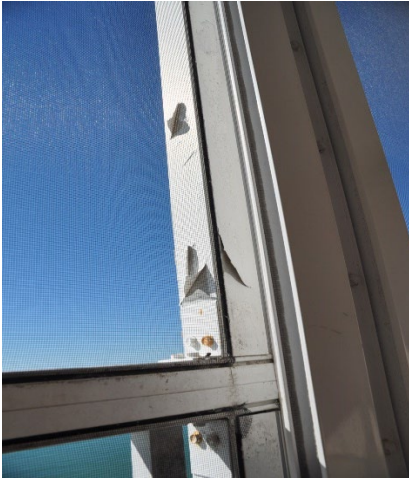
17. Improper use of materials and absence of maintenance – Unit 605. Structurally negligible.

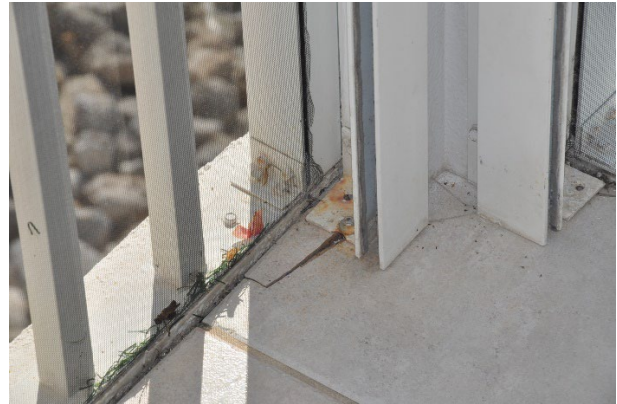
18. Unit 605 - Ceramic tile fracture – superficial damage - concentration of moisture & damage of steel angle

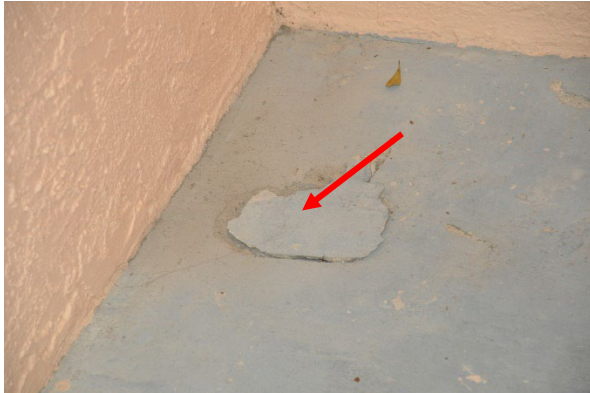
19. Concrete floor damage in service area 402

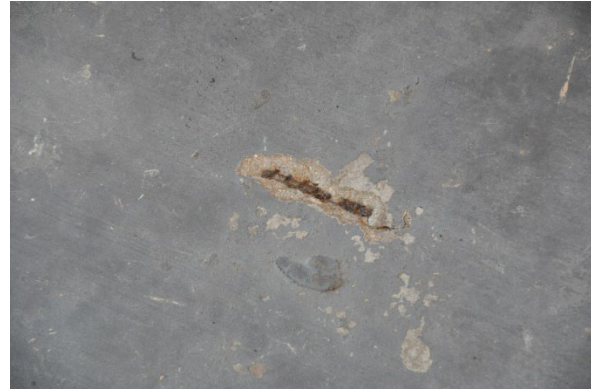
20. Exposed rogue piece of steel reinforcement. Too little coverage was provided during construction in service area 402

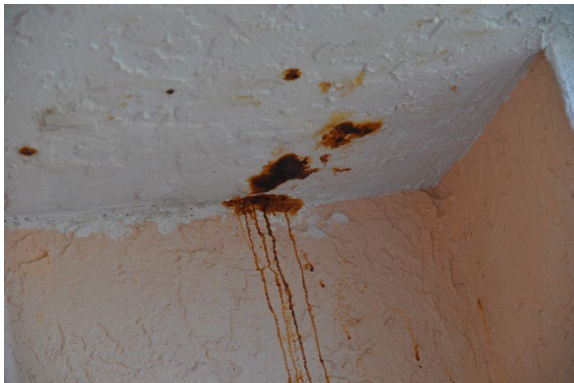
- The effect in figures 21 and 22 is an example of the aforementioned point. In this case, moisture reached a ferrous based metal and corrosion has leaked through the walls. That case needs to be addressed. Corrosion needs to be removed and before repairs and maintenance takes place, it is necessary to trace the origin of that moisture that lead to this result. Action is recommended asap to verify if there is any further hidden damage and prevent any possibility this damage becomes a structural issue.

21. Corrosion effect in ceiling area of service space 302

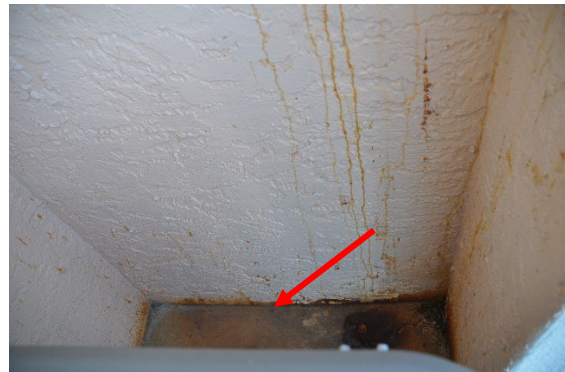
22. Corrosion effect in wall and the floor area of service space 302

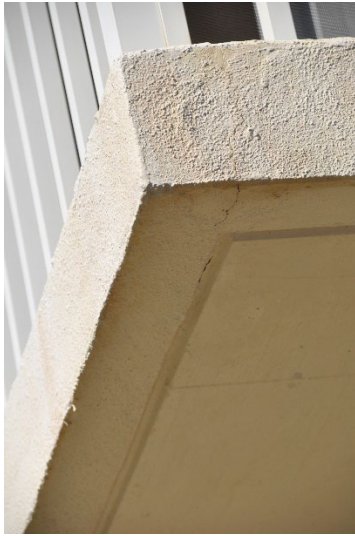
23. Maintenance will be required for such cracks. This can be injected with epoxy to prevent further expansion of the existing crack. See next figure.

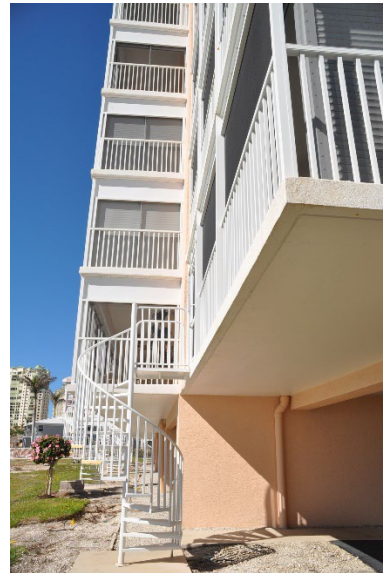
24. Larger general view of previous detail

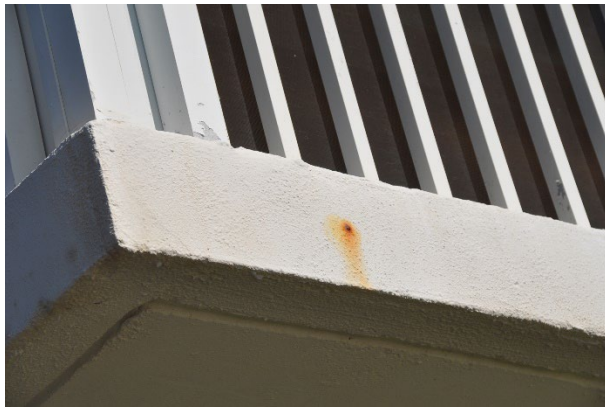
25. Corrosion of ferrous based element located very close to the concrete surface against ACI 318 codes. See next figure.

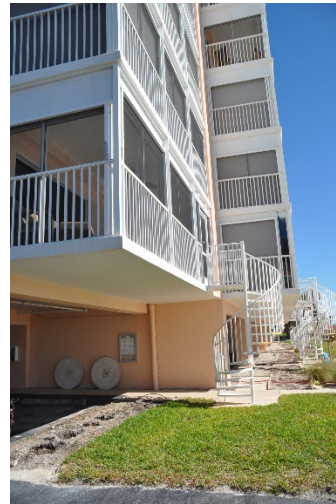
26. Larger general view of previous detail

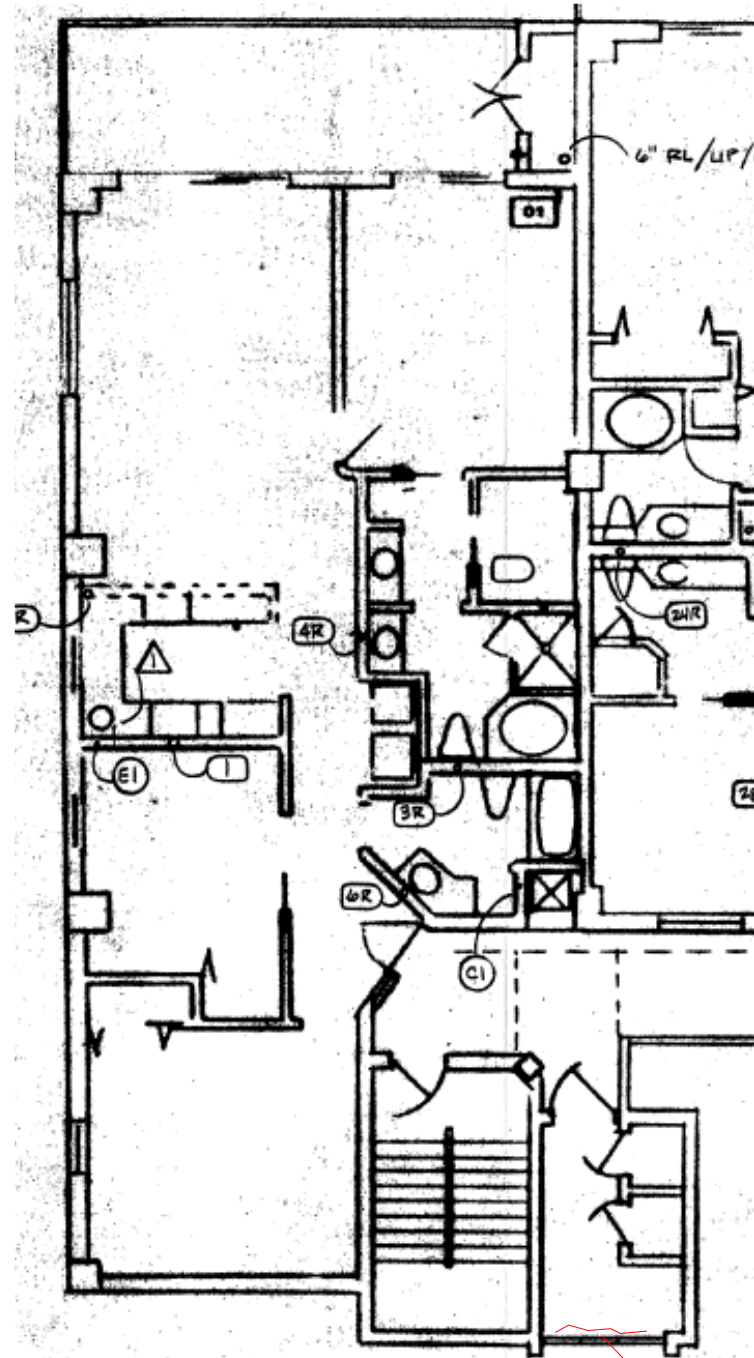
UNIT 101

Cracking in floor adjacent to AC unit

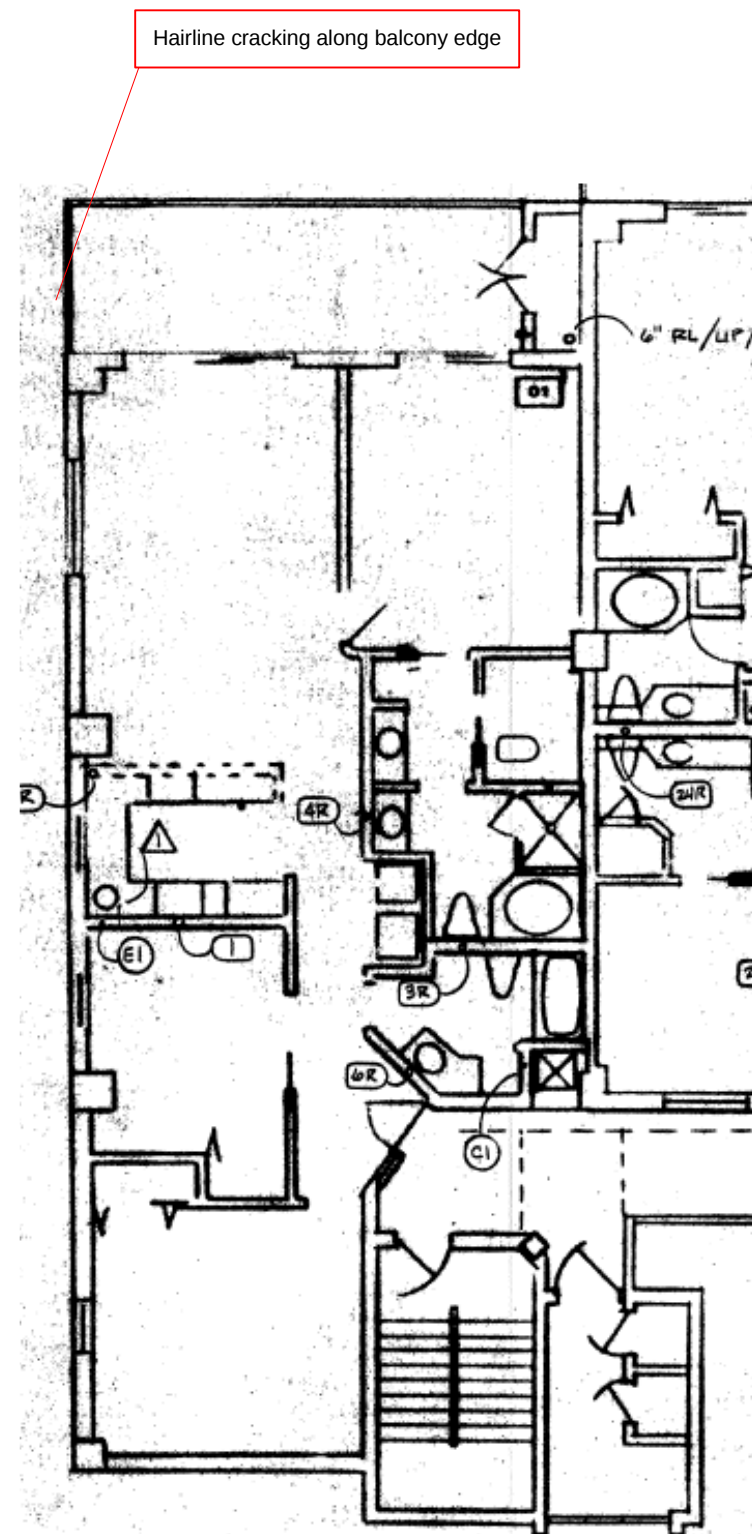
**UNIT 301**

Hairline cracking along balcony edge

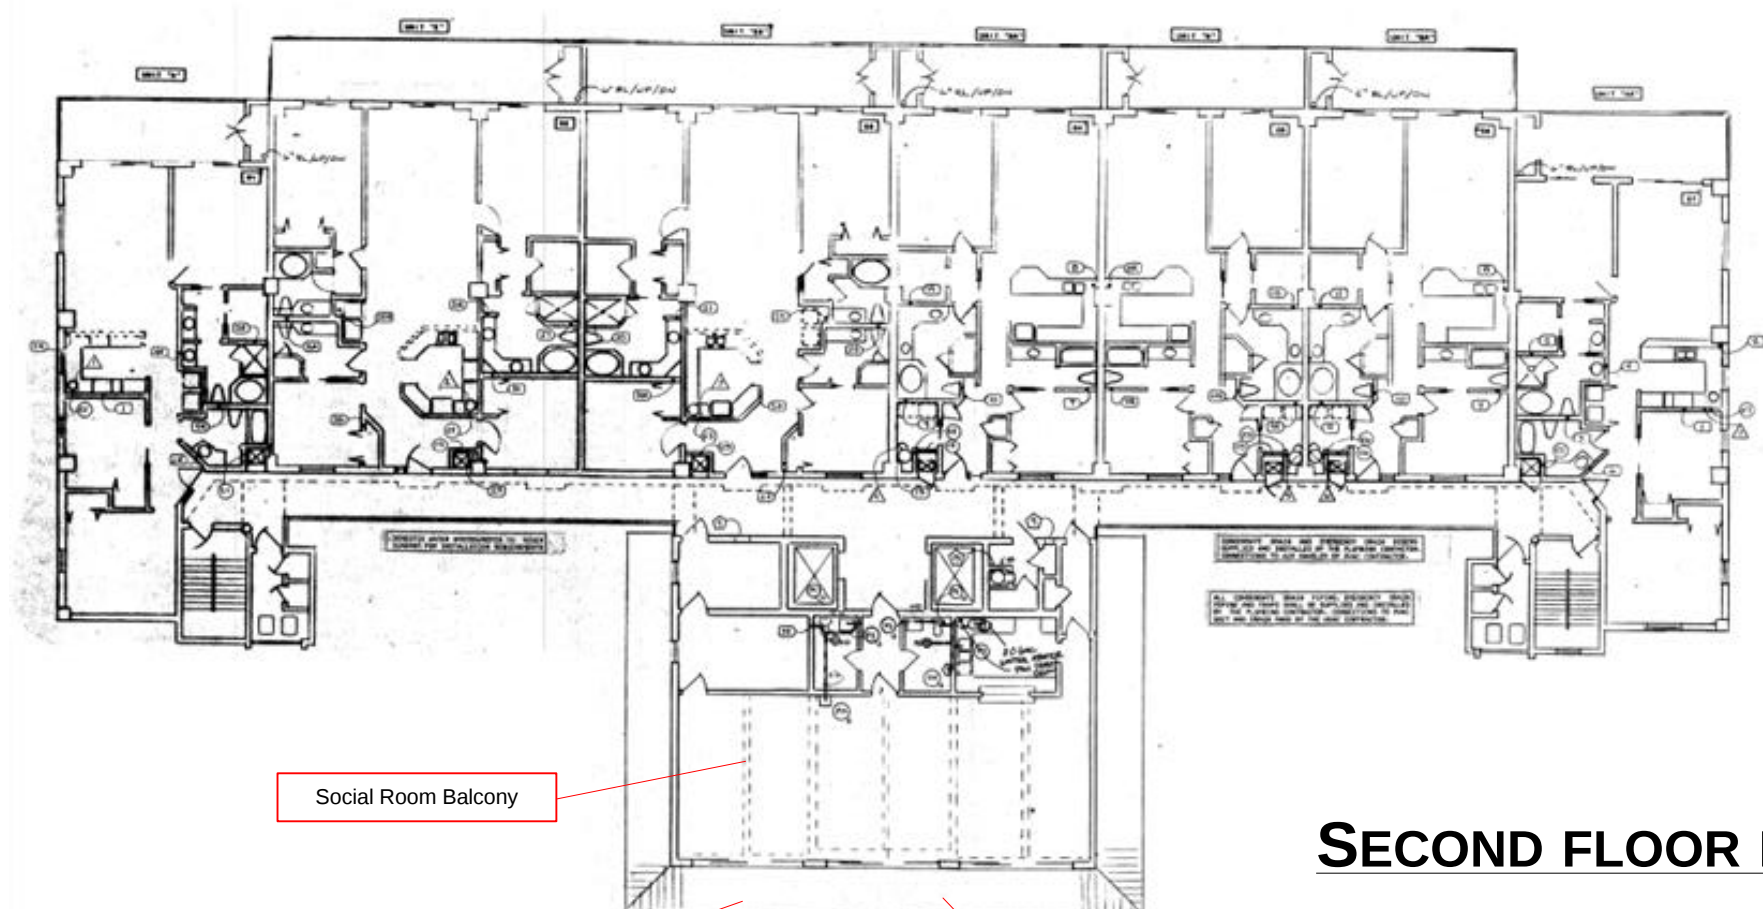
## SECOND FLOOR LIVING

Social Room Balcony

Distressed rail pockets along balcony edge

Cracking in the concrete scupper above

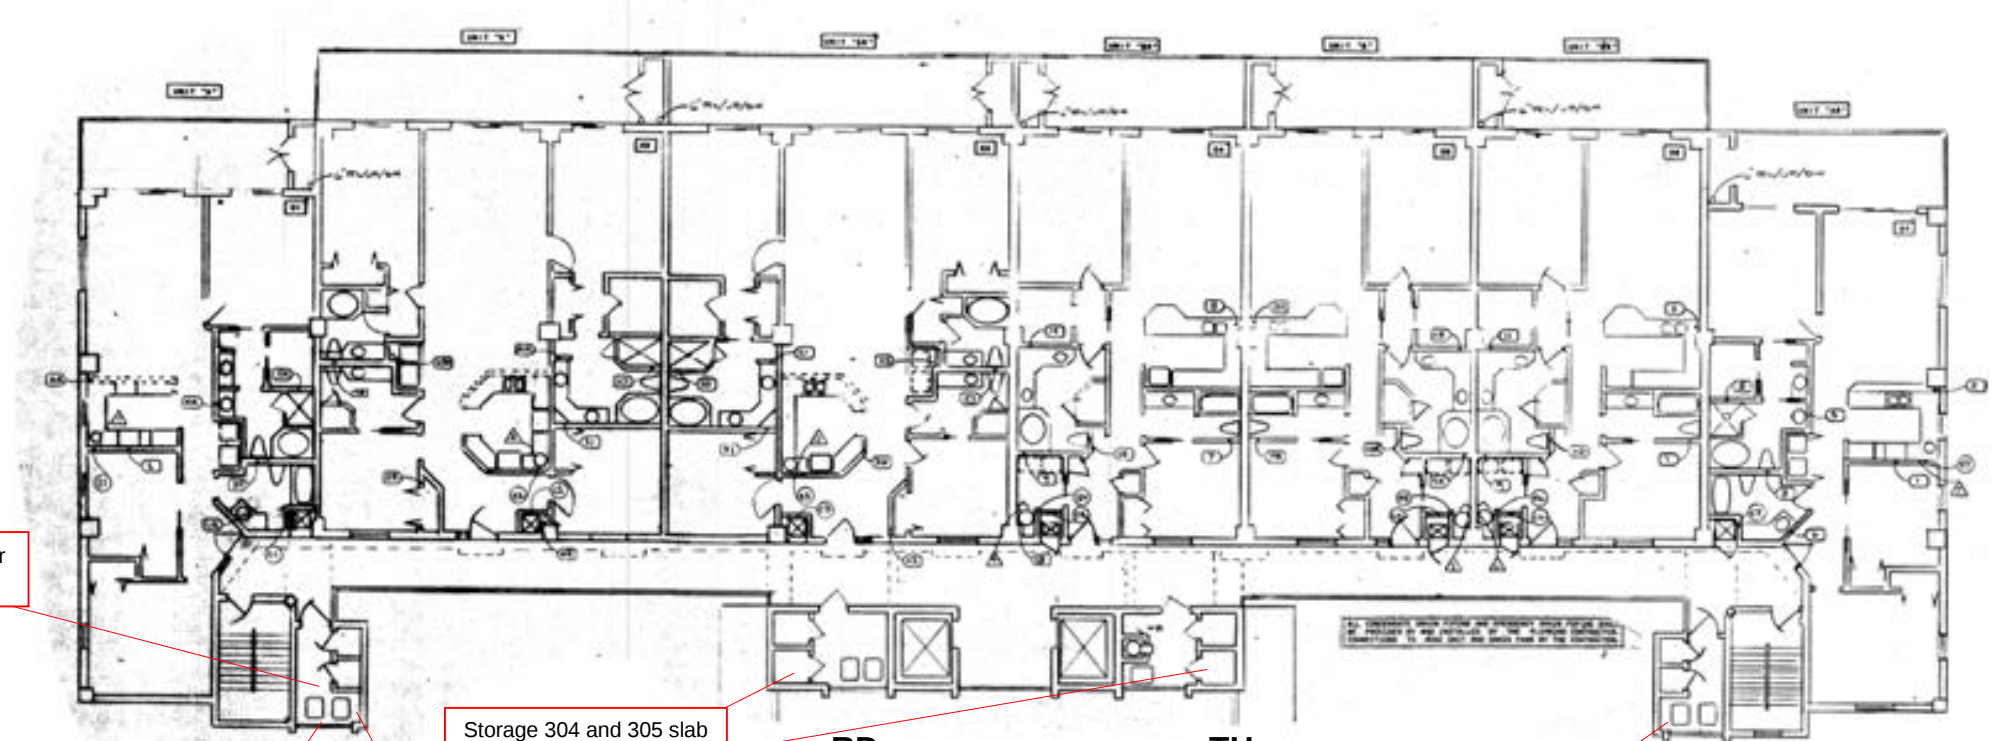
## 3<sup>RD</sup> THROUGH 7<sup>TH</sup> FLOOR LIVING

Concrete distress in floor next to 402 storage

Several handrail post pockets adjacent to the condensing units have concrete distress or allowing water to pond around posts

Corroded conduit in the 3<sup>rd</sup> floor deck and concrete distress in slab

Storage 304 and 305 slab penetration not fire sealed

Concrete distress in ceiling next to storage room 302

Corroded conduit at the 7<sup>th</sup> floor
