August 9, 2023

RE: *Dockside of Marco – Phase I Milestone Inspection Report*  
*KEG File# 22RN-0921*

Dockside of Marco is located at 848 W. Elkcarn Circle, Marco Island, FL 34145. Dockside of Marco is comprised of 1 three-story and 1 four-story building connected by a walkway with 28 residential units total.

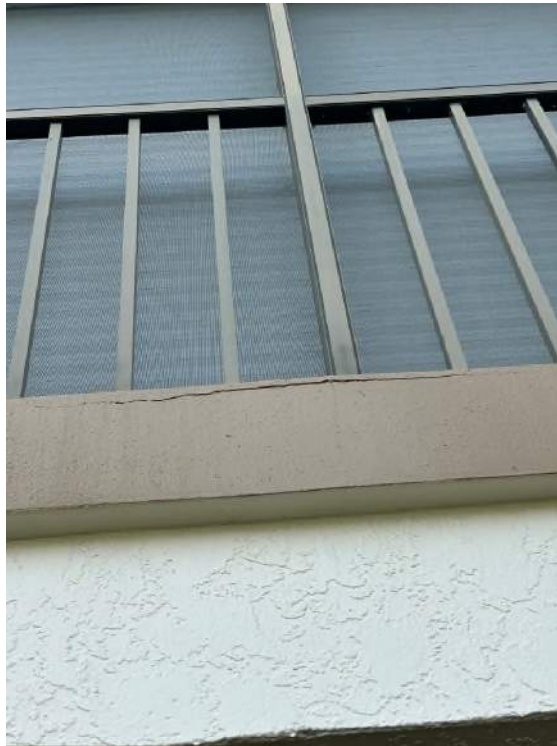
KE observed minor hairline cracks at concrete slabs and columns. These cracks should be repaired at the next painting/waterproofing project.

**Figure 2: Hairline crack at slab edge.**

KE would recommend addressing the isolated non-structural issues observed herein as soon as practical. Repair of existing concrete should be added to the restoration and painting project scope of work along with potential delaminated stucco and crack repairs.

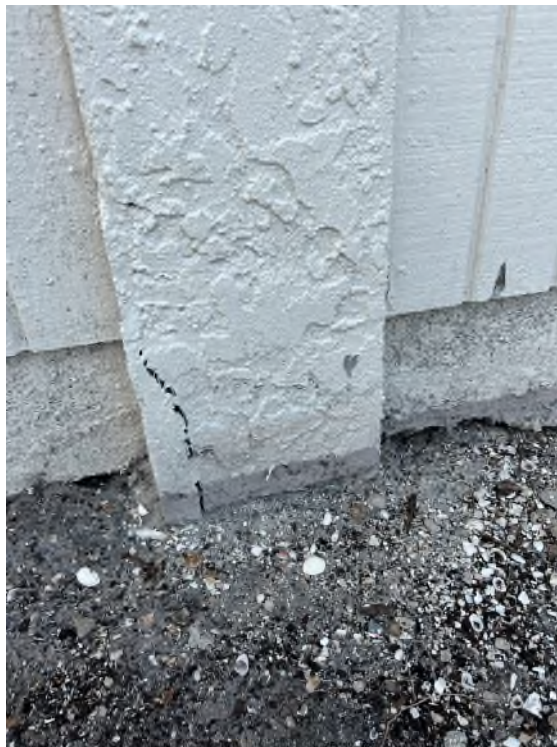
**Figure 3: Hairline crack at column base.**

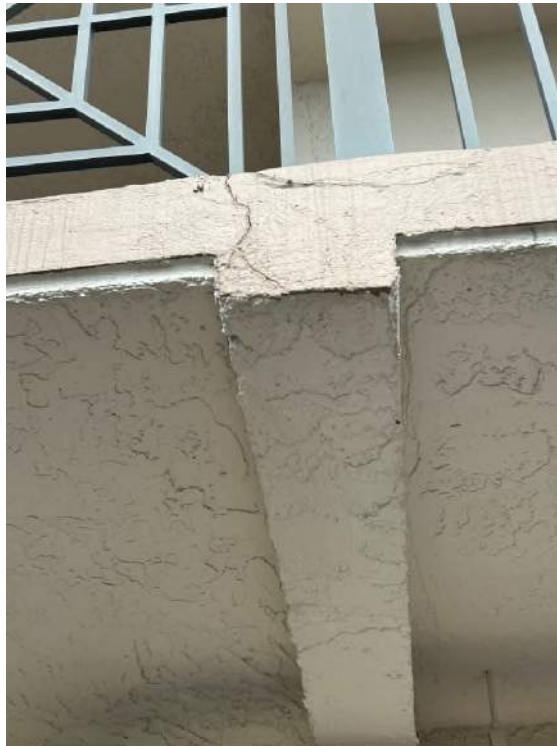
**Figure 4: Hairline crack at concrete beam.**

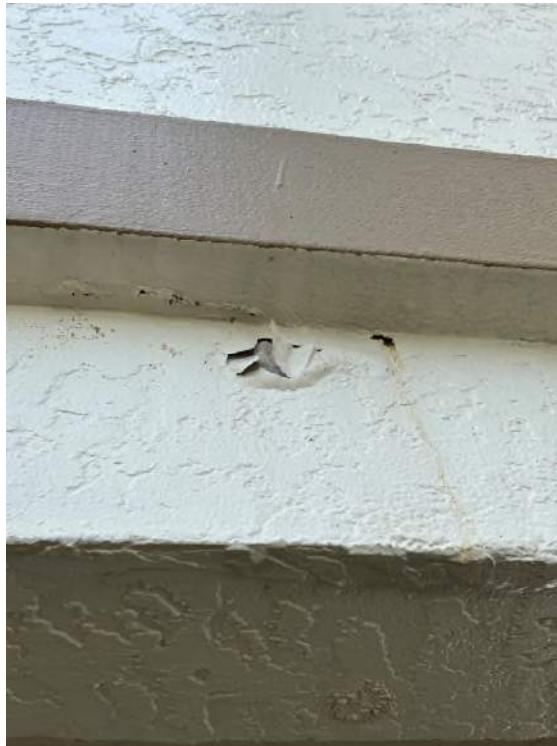
**Figure 5: Hairline crack at slab edge and paint blister.**
