## Report of Findings

### Structural Milestone Inspection *Phase I*

Duchess Condominium  
Owners Association, Inc.  
220 South Collier Boulevard  
Marco Island, FL

Rimkus Matter No: 100231470

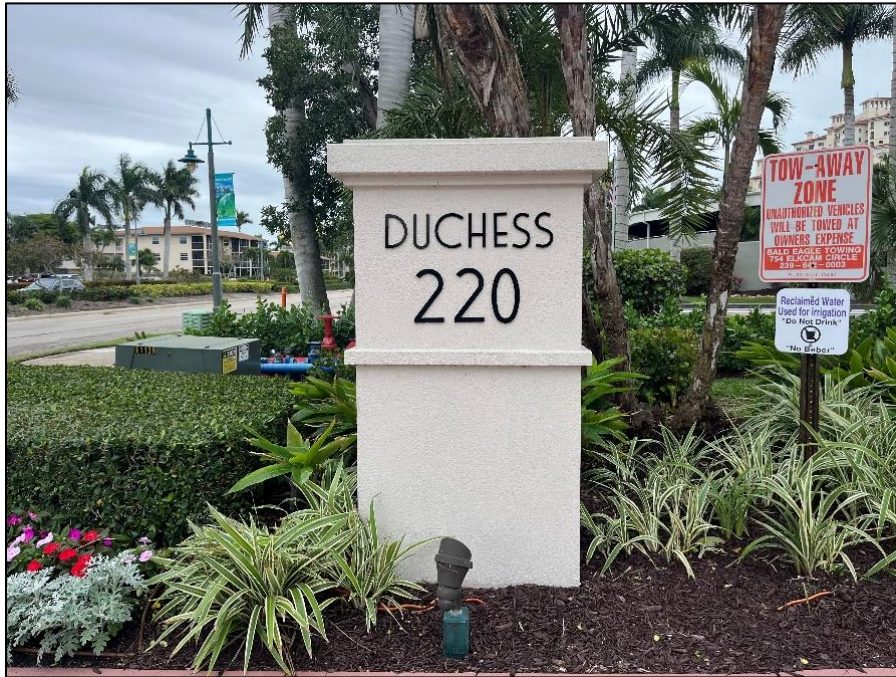
**Photograph 1**  
Duchess Condominium Association, Inc.

Duchess Condominium is a residential condominium located at 220 South Collier Boulevard in Marco Island, Florida. The subject building was designed by Gamble-Gilroy-Martin Architects P.A. in 1979. The subject building consists of a 14-story condominium of 79 residential units and a garage level on the ground floor. According to information provided by the Collier County Property Appraiser's Office, the subject property was originally constructed in 1981 (**Photograph #1, Table #1**).

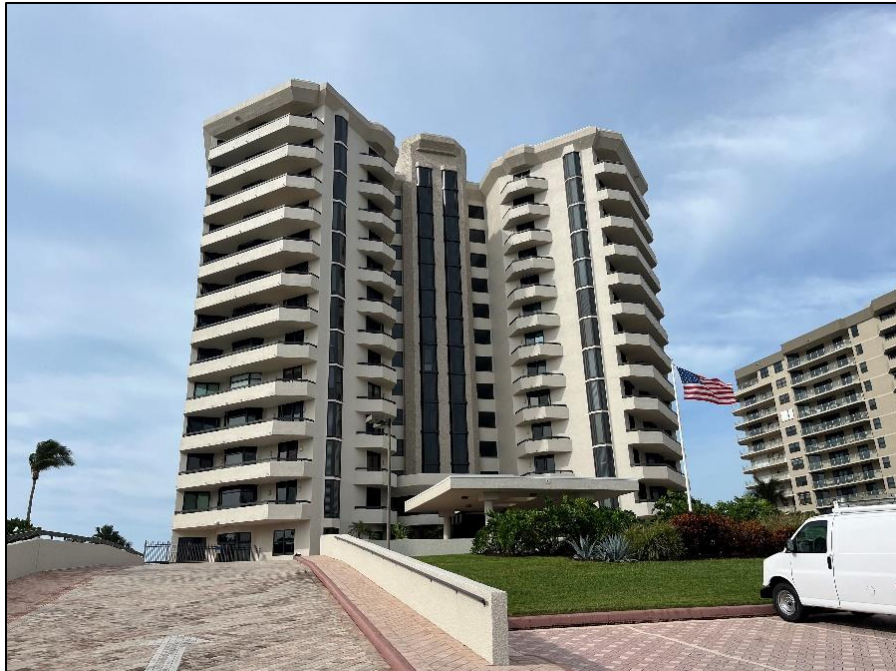
- The exterior walls were found to be in good condition and there were no indications of substantial structural deterioration present (**Photographs #1 through #6**).

**Photograph 2**  
Exterior walls – east elevation.

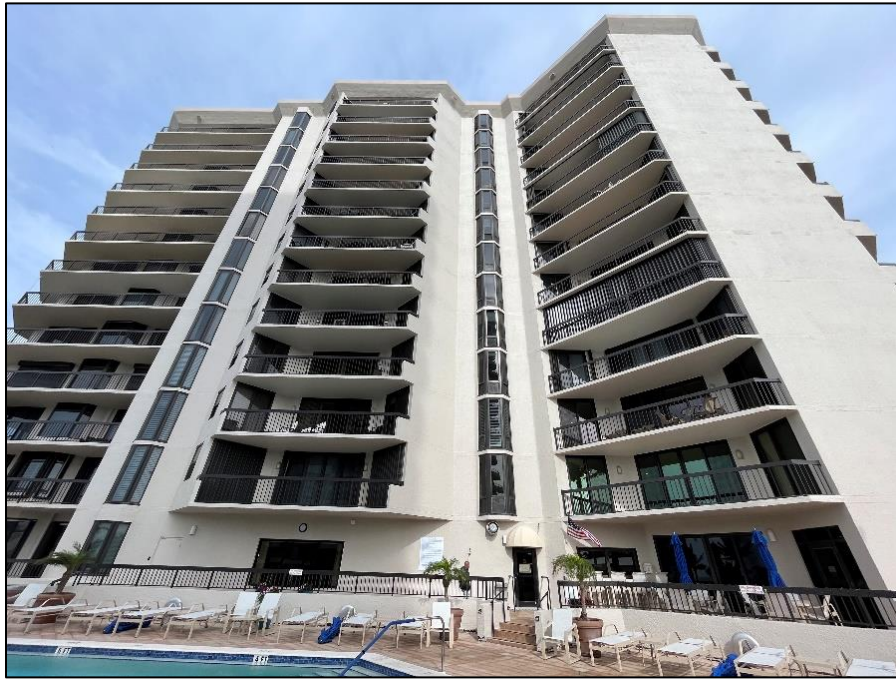
**Photograph 3**  
Exterior walls – south elevation.

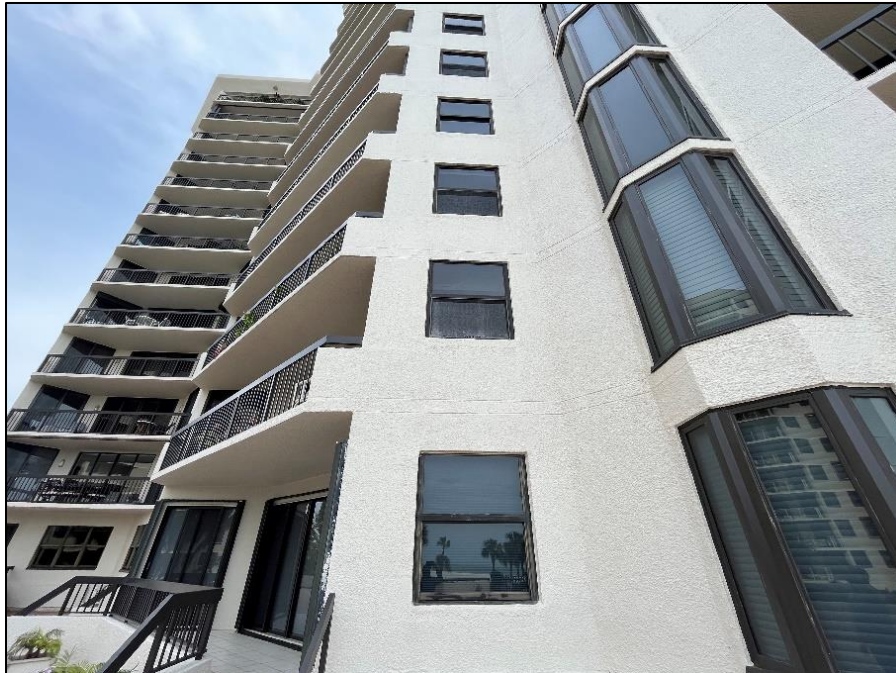
**Photograph 4**  
Exterior walls – south elevation.

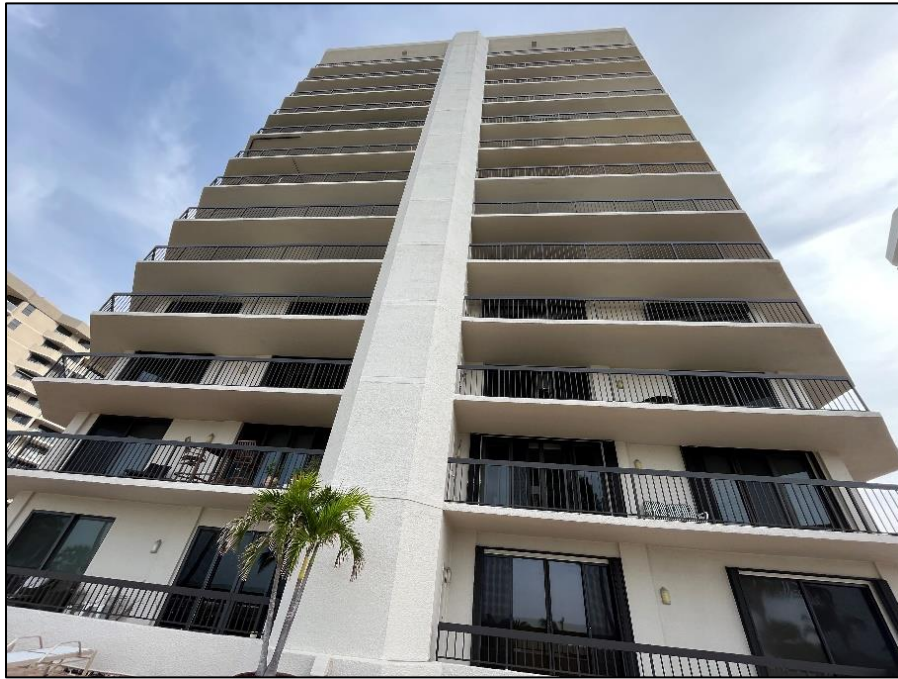
**Photograph 5**  
Exterior walls – west elevation.

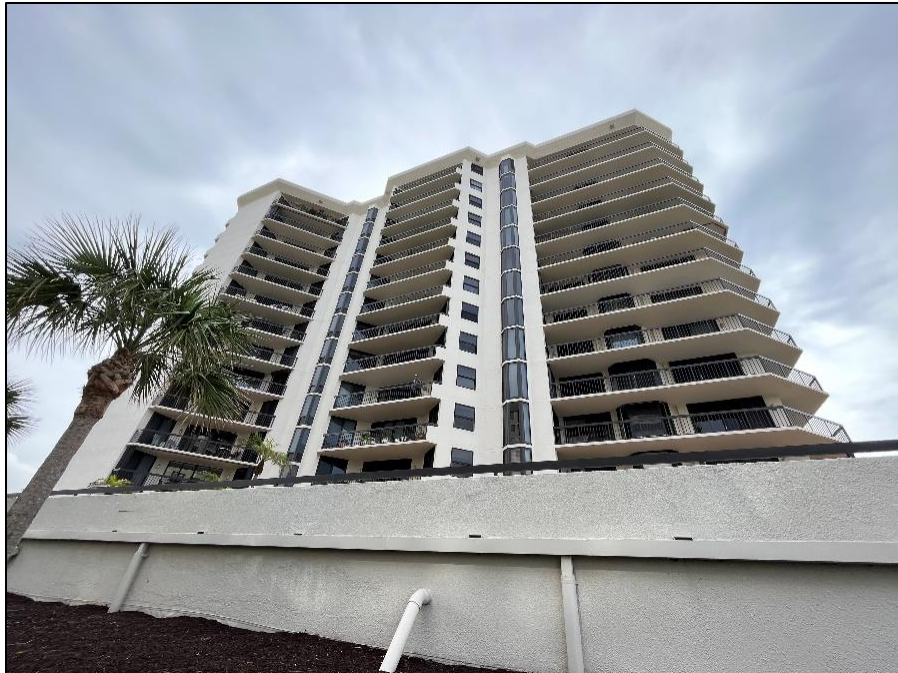
**Photograph 6**  
Exterior walls – north elevation.

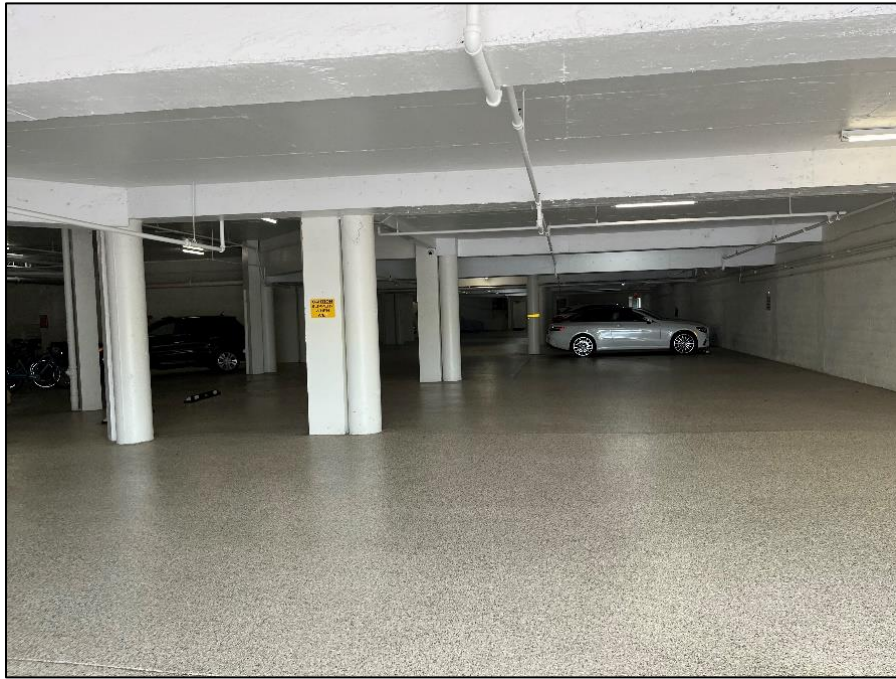
### **Photograph 7**

Columns and beams – garage level overview.

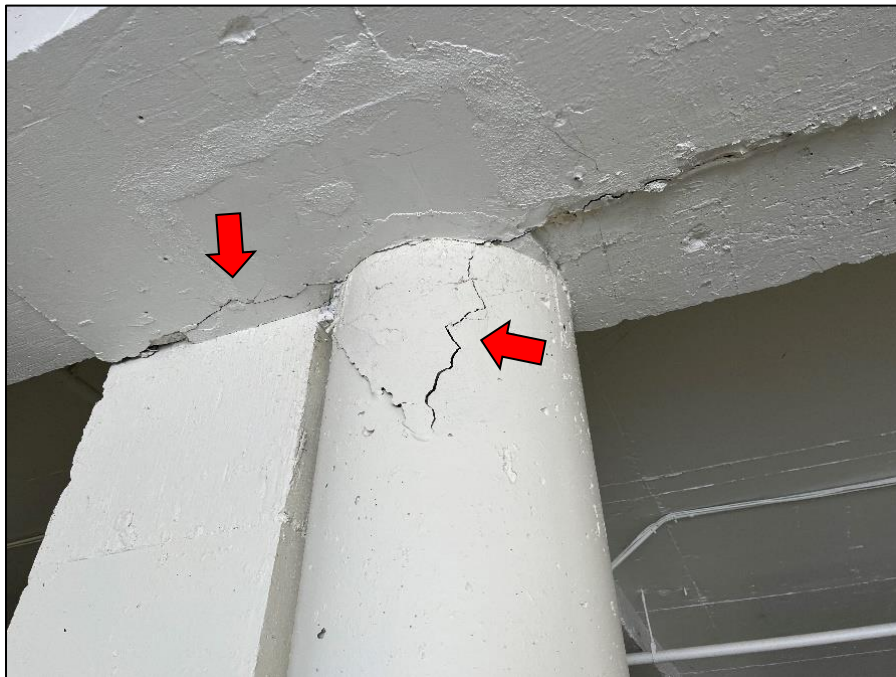
### **Photograph 8**

- A majority of columns and beams were not visible in the elevated floors due to enclosures and finishes. Columns and beams were primarily visible at the garage level (**Photograph #7**).
- Concrete column spalling and beam cracking were observed at one location in the garage level (**Photograph #8**). This condition requires further investigation to confirm the structural condition of members.

Columns and beams – garage level. Concrete column spalling and beam cracking were observed at one location. This condition requires further investigation to confirm structural condition of members.

Based on the scope and limitations of this SMI, **Further investigation is required** to confirm the structural condition of reinforced concrete at various cracks and spalls observed (**Photographs #8 through #11, #14, and #15**). **A Phase II Structural Milestone will be required.** The scope of this inspection shall include:

- **Destructive Investigation and Visual Assessment:** Partial demolition of select concrete exterior members; floor and balcony floor systems and visual assessment of the enclosed reinforcing steel.

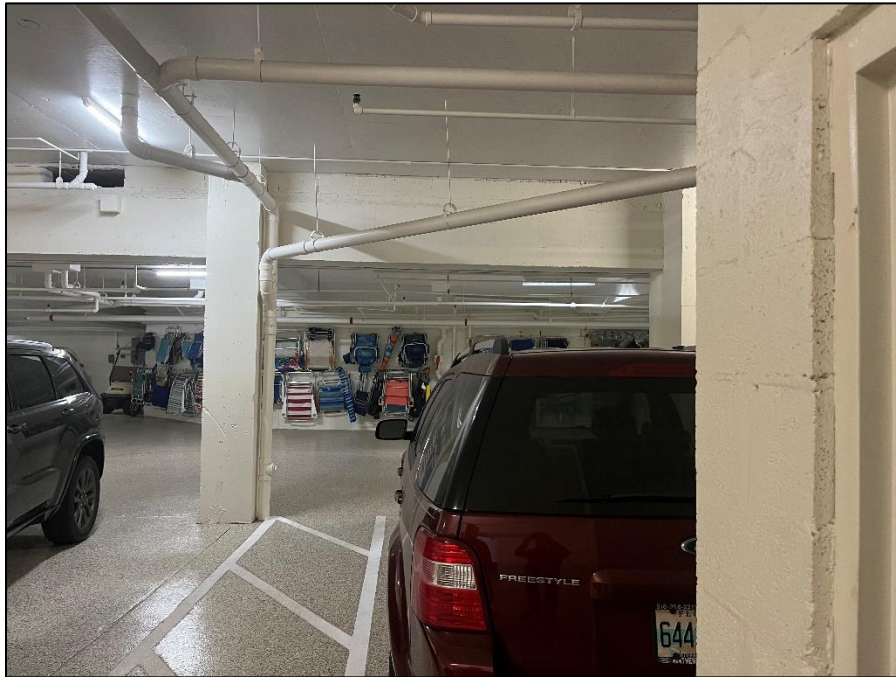
**Photograph 9**

- A majority of floor systems were not visible in the elevated floors due to enclosures and finishes. The floor system was primarily visible at the garage level. Concrete slab spalling and cracking were observed in one area of the garage. This condition requires further investigation to confirm structural condition. Further investigation is required to confirm structural condition. (**Photographs #9 through #11**).

Floor system – garage level. General area of visual distress shown.

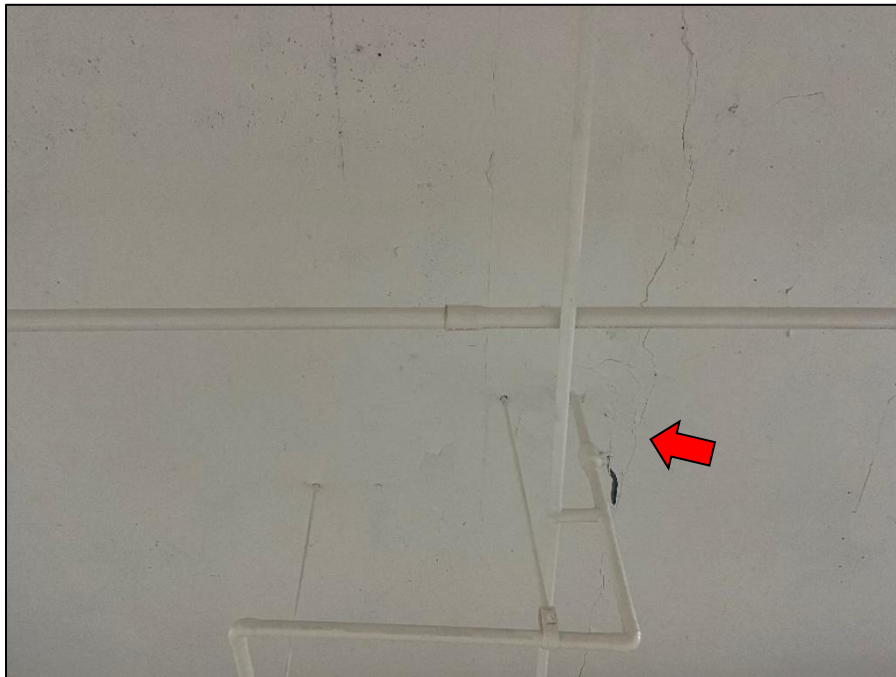
**Photograph 10**

Floor system – garage level. Concrete slab cracking was observed at one location. This condition requires further investigation to confirm structural condition.

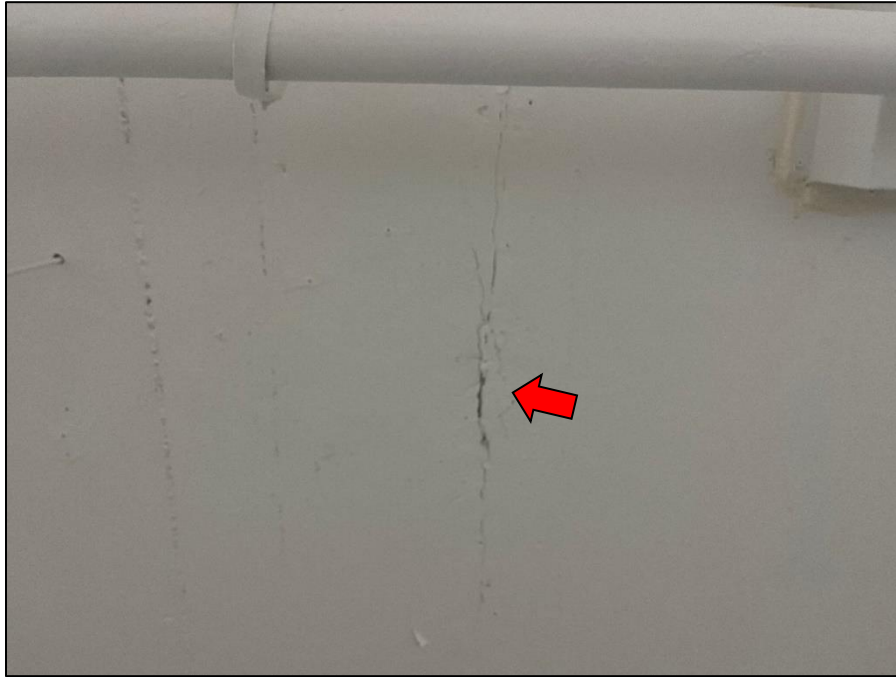
**Photograph 11**

Floor system – garage Level. Concrete slab spalling and cracking were observed at one location. This condition requires further investigation to confirm structural condition.

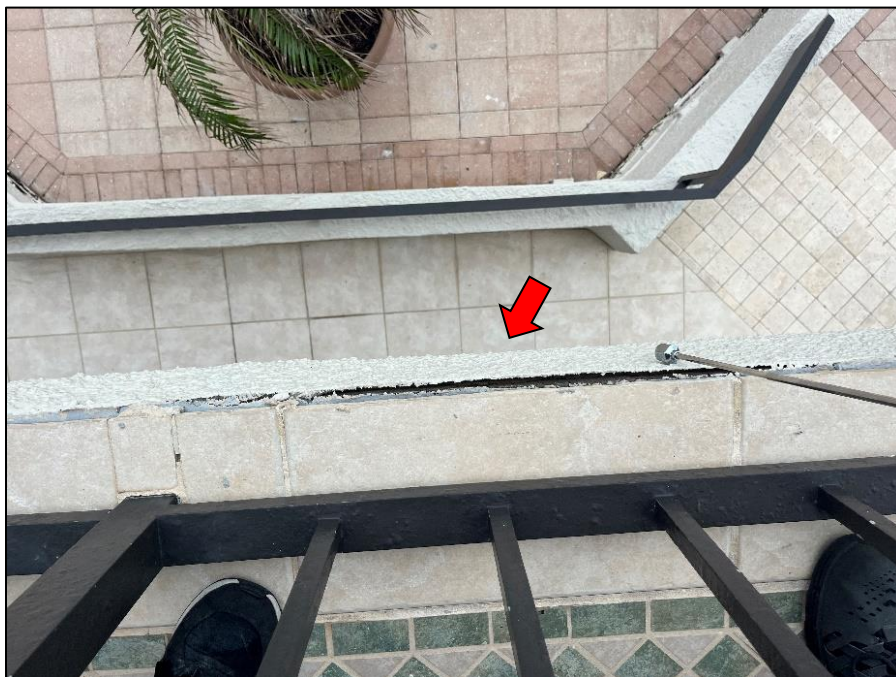
**Photograph 12**

- Stucco delamination was observed at the balcony slab edge. This condition does not represent substantial structural deterioration (**Photograph #12**).
- A handrail detached from the wall was observed at the balcony location. This condition does not represent substantial structural deterioration (**Photograph #13**)
- Concrete spalling and cracking were observed at the balcony floor topping slab. This condition requires further investigation (**Photographs #14 and #15**).

Unit 301 balcony – Damaged stucco void at detached; this condition does not represent substantial structural deterioration.

Additionally, Rimkus did not observe structural concerns that rise to the level of “unsafe” or “dangerous” conditions as defined by the Florida Building Code. For areas which did not rise to the level of substantial deterioration, Rimkus recommends routine building maintenance which includes but is not limited to repair of cracks, voids, and spalls in concrete and stucco, repair of interior finishes, repair of corroded door frames, and exterior painting and caulking of the building (**Photographs #12 and #13**). Forgoing repairs and routine maintenance may adversely affect the integrity of the structure.

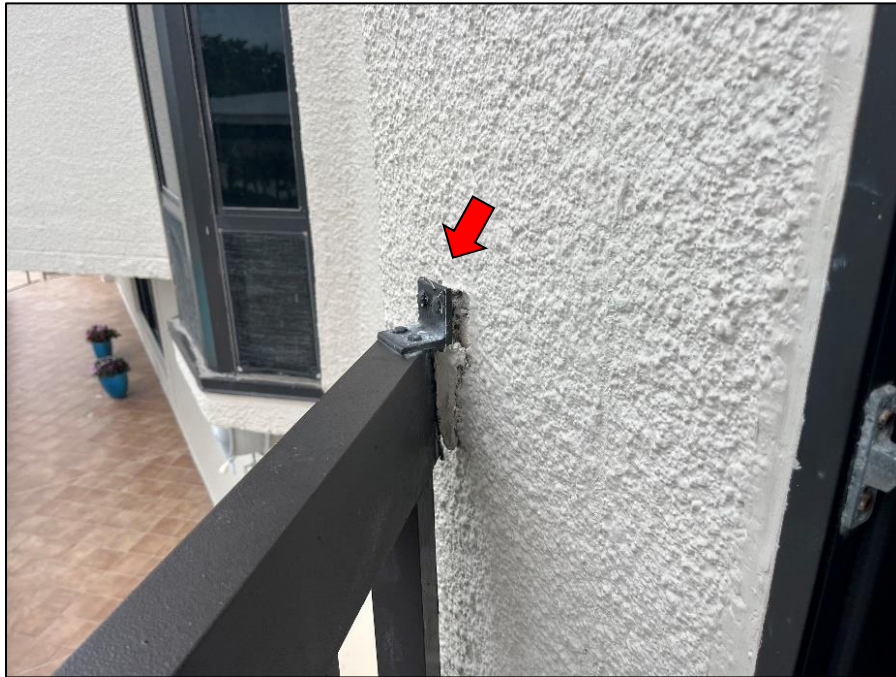
**Photograph 13**

Unit 305 balcony – Detached hand railing from wall.

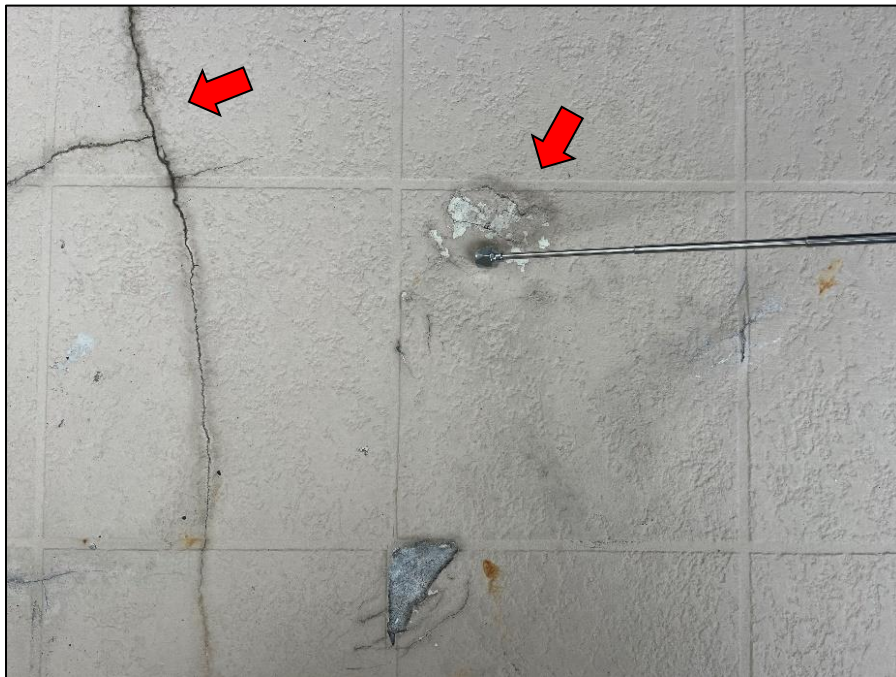
**Photograph 14**

Unit 406 balcony – Concrete spalling and cracking at balcony floor topping slab. This condition requires further investigation.

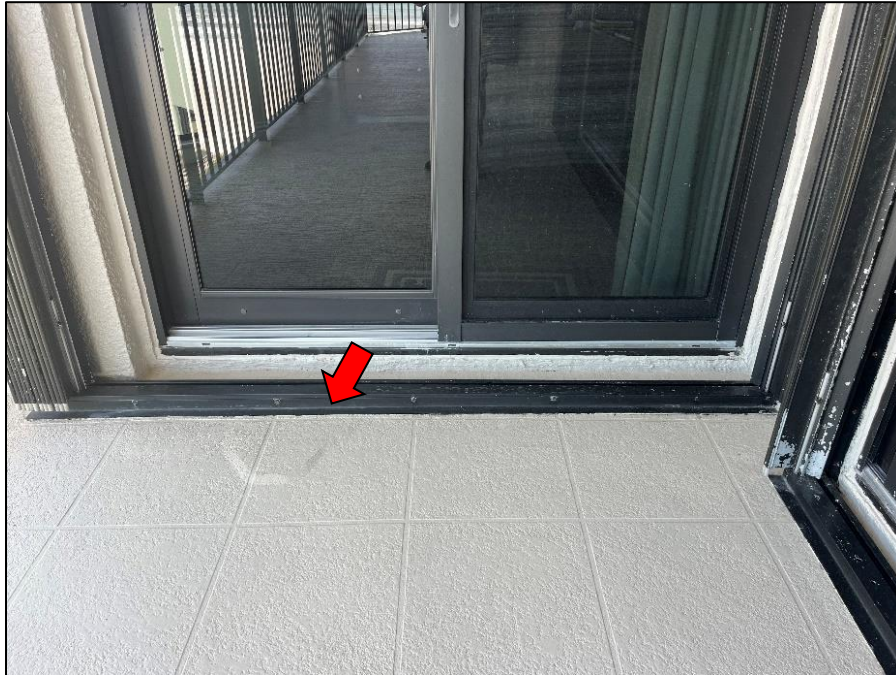
**Photograph 15**

Unit 802 balcony – Concrete spalling at balcony floor slab. This condition requires further investigation.

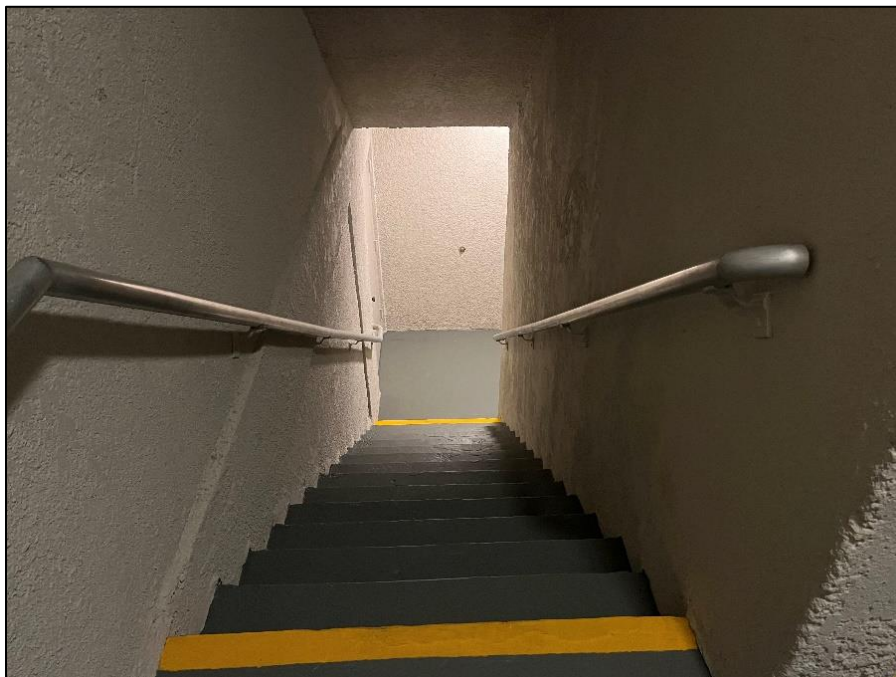
**Photograph 16**

- The interior stairs were found to be in good condition and there were no indications of substantial structural deterioration present (**Photograph #16**).

Stairs – 14<sup>th</sup> floor typical overview.

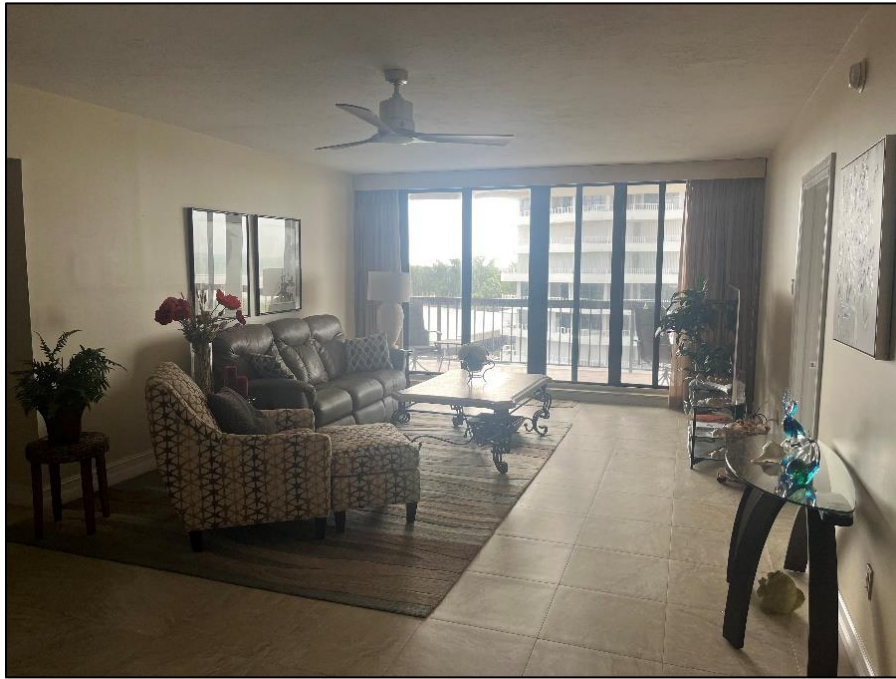
- Interior units were found to be in good condition and there was no indication of substantial structural deterioration present (**Photograph #17**).

**Photograph 17**  
Interior units – unit 503 overview.

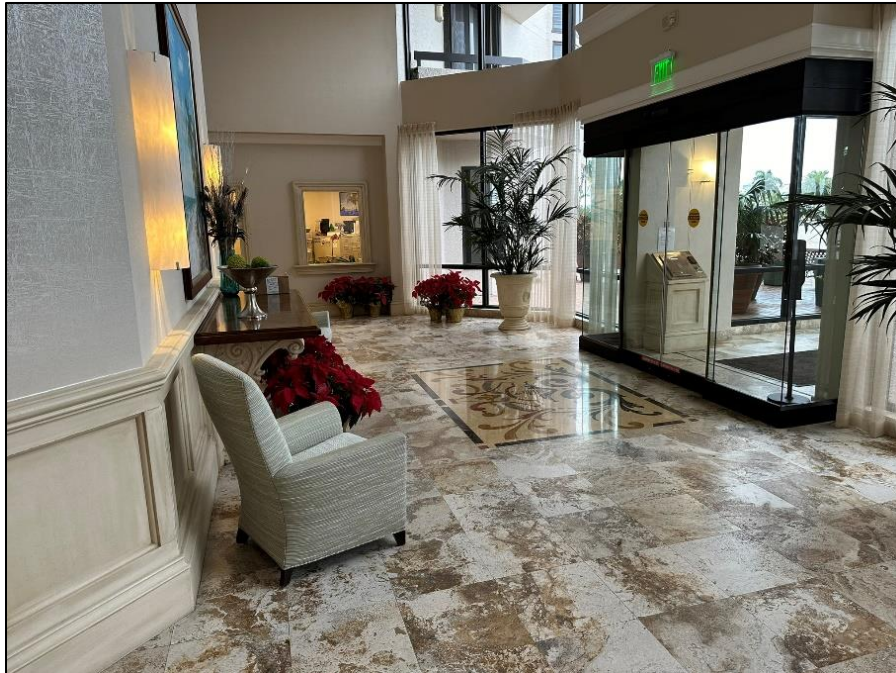
- Common areas were found to be in good condition and there was no indication of substantial structural deterioration present (**Photographs #18 and #19**).

**Photograph 18**  
Common area – 1<sup>st</sup> floor overview.

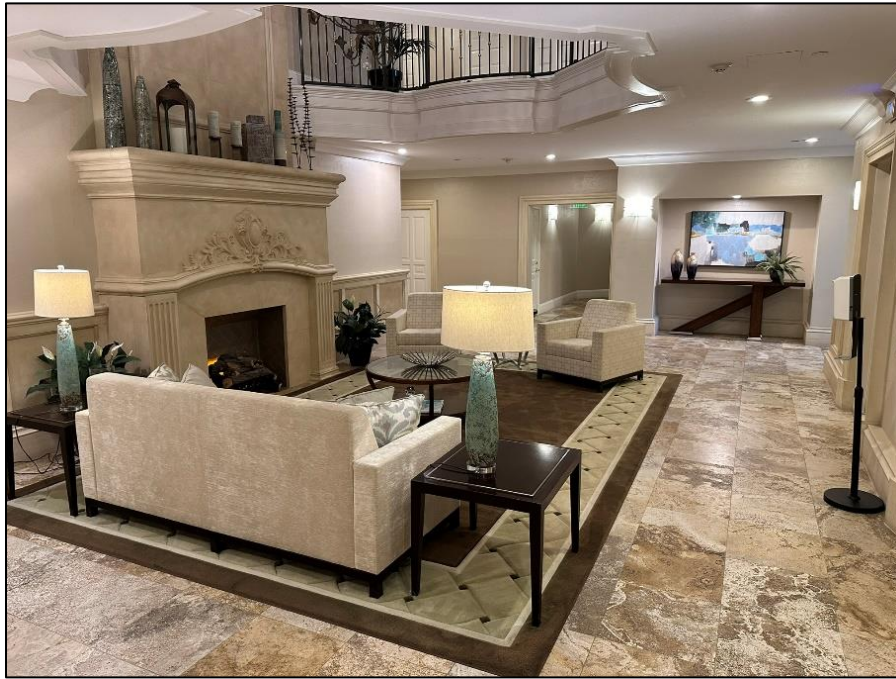
**Photograph 19**

Common area – 1<sup>st</sup> floor overview.
