## Report of Findings

### Structural Milestone Inspection *Phase II*

Duchess Condominium  
Owners Association, Inc.  
220 South Collier Boulevard  
Marco Island, FL

Rimkus Matter No: 100231470

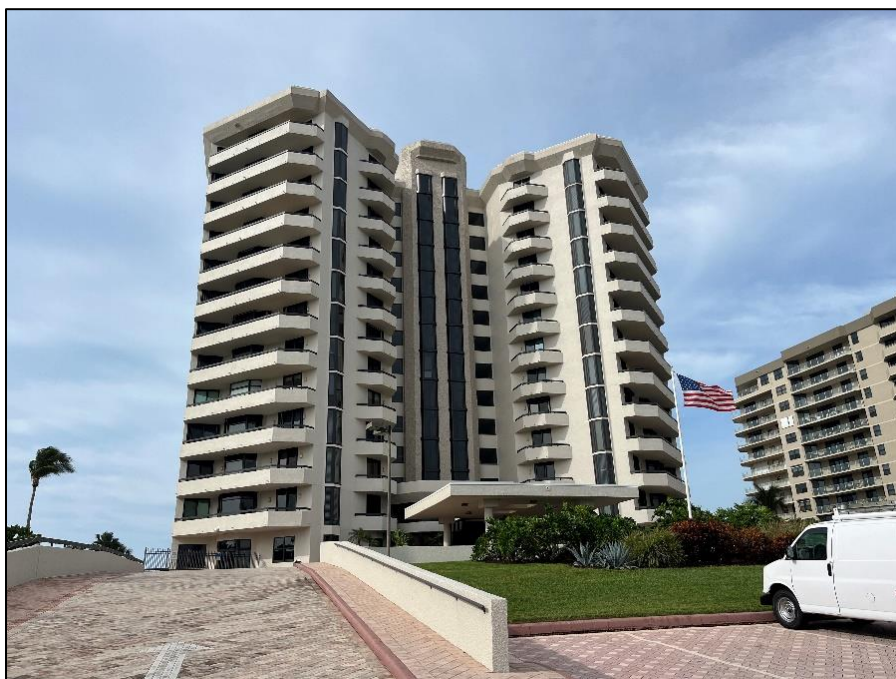
**Photograph 2**  
Exterior walls – east elevation.

- The exterior walls were found to be in good condition and there were no indications of substantial structural deterioration present (**Photographs #2 through #6**).

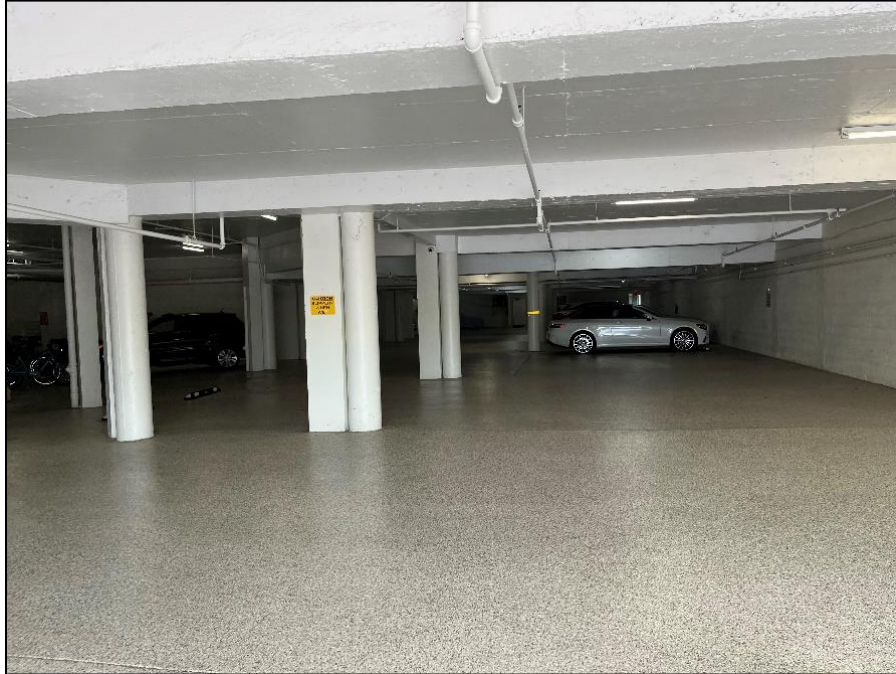
### Photograph 7

- A majority of columns and beams were not visible in the elevated floors due to enclosures and finishes. Columns and beams were primarily visible at the garage level (**Photographs #7 through #9**).
- Concrete column spalling and beam cracking were observed at one location in the garage level during Phase I and thus was identified as an area that required further investigation to confirm the structural condition of the members (**Photograph #8**).

Columns and beams – garage level overview.

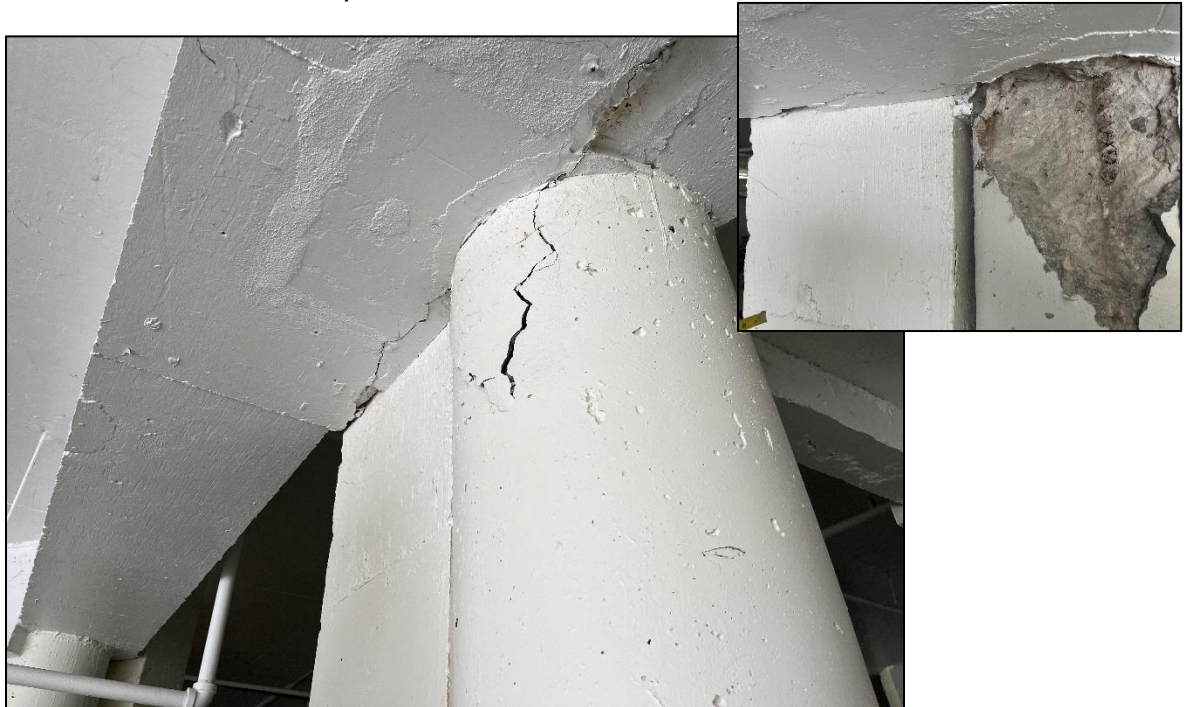
### Photograph 8

- During the Phase II inspection, we noted that a small portion of the concrete at the top corner of the circular column had cracked and debonded. After removing the debonded portion of the concrete we noted that the vertical, mild steel reinforcement was in fair condition with minimum corrosion. The subject circular column was designed to support the 12-inch-wide beam. However, there was a 20-inch-wide beam adjacent to it with an expansion joint between the two beams. The 20-inch beam was not designed to come in contact with the subject circular column. However, the expansion joint was terminated against the circular column causing the 20-inch-wide beam to come in contact with the column and apply stress. Due to the stress, the circular column's edge had cracked and debonded. The observed conditions at the column were consistent with substantial structural deterioration.

Column – garage level. The cracking on the column was observed during the Phase I inspection. During the Phase II inspection, after chipping the debonded concrete and close inspection we identified a construction deficiency that did not honor the expansion joint between the beams, which allowed the beam (left) to stress on the column causing the cracking and failure of the small portion of the concrete.

- Repairs should be made to the column such that the expansion joints between the beams are honored through the subject column and ensure that the 20-inch-wide beam does not come in contact with the column.

A preliminary repair scope includes the repair of spalled and delaminated concrete and corroded rebar. Concrete repairs shall entail excavating damaged concrete, providing sufficient (clear) cover, coating reinforcing steel with a corrosion-inhibiting coating, and re-casting with a compatible repair mortar, all repairs are to be in accordance with International Concrete Repair Institute standards. At the concrete column, the expansion joint must be honored such that the distressed column is isolated from the 20-inch-wide beam. The beam with flexural cracks and the ceiling slab below the pool deck should be further analyzed to determine the appropriate repair scope.

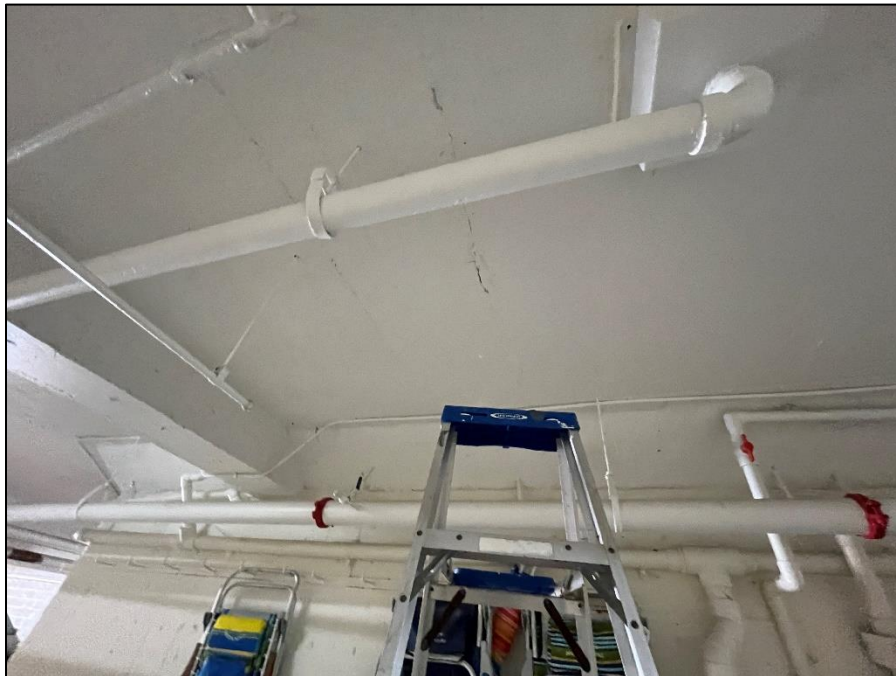
**Photograph 9**

- A majority of floor systems were not visible in the elevated floors due to enclosures and finishes. The floor system was primarily visible at the garage level. Concrete slab spalling and cracking were observed in one area of the garage and identified as an area that required additional investigation. During the Phase II inspection, we identified another similar cracking pattern on the adjacent slab area.
  - The areas of distress were sounded, chipped, and visually observed. The inspection revealed that concrete had cracked and spalled at these locations due to exposure to moisture and lack of sufficient (clear) cover for the reinforcement bars (**Photographs #9 through #11**). The observed conditions represented substantial structural deterioration.

Floor system – garage level. General area of visual distress shown.

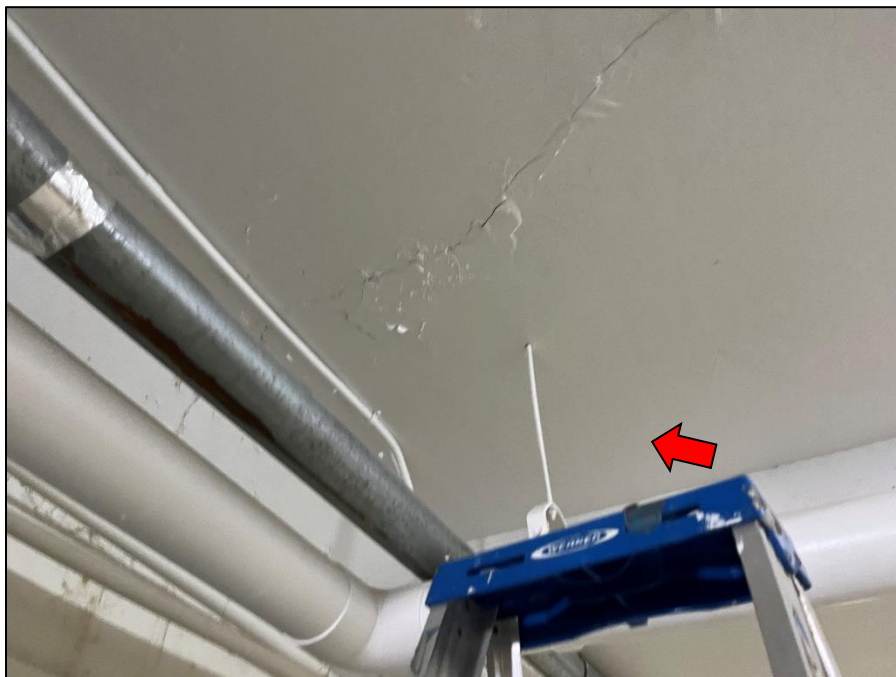
**Photograph 10**

Floor system – garage level. Concrete slab cracking was observed at one location.

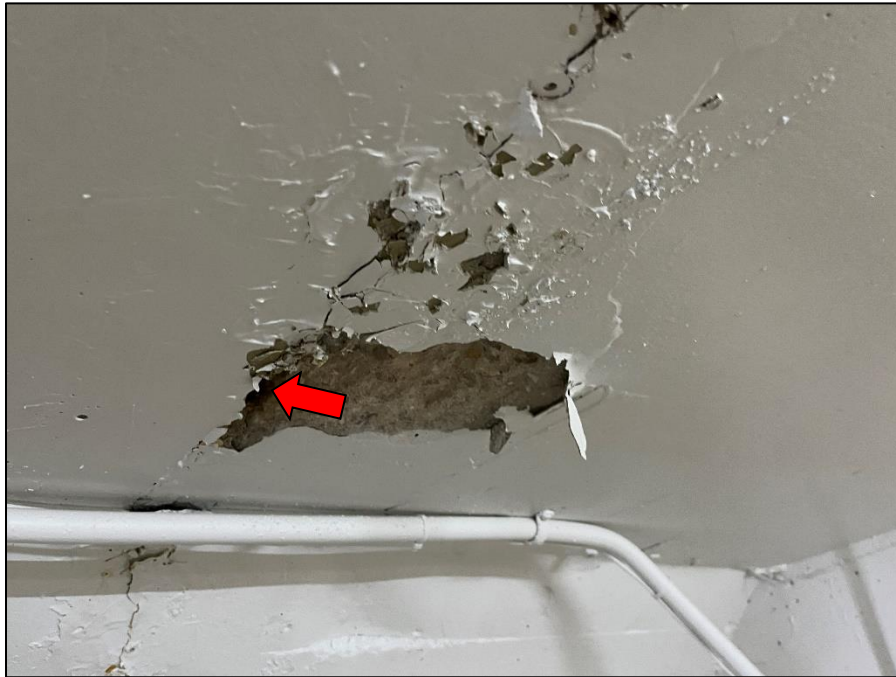
**Photograph 11**

Floor system – garage level. Concrete slab spalling and cracking were observed at one location. This condition requires further investigation to confirm structural condition.

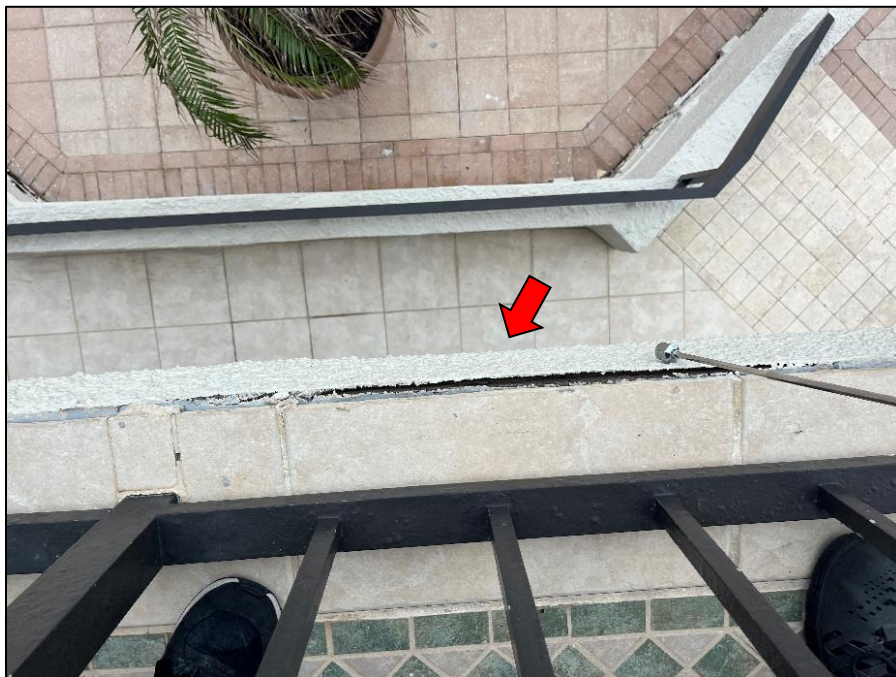
**Photograph 12**

- Stucco delamination was observed at the balcony slab edge. This condition does not represent substantial structural deterioration (**Photograph #12**).
- A handrail detached from the wall was observed at the balcony location. This condition does not represent substantial structural deterioration (**Photograph #13**).
- Cracking was observed at the balcony floor topping slab of units 406 and 802, during the Phase I inspection and was identified as an area that required additional investigation.
  - During the Phase II inspection, we chipped away the cracked topping and sounded the slab concrete. The investigation revealed that the cementitious

Unit 301 balcony – Damaged stucco void at detached; this condition does not represent substantial structural deterioration.

For areas that did not rise to the level of substantial structural deterioration, Rimkus recommends routine building maintenance which includes but is not limited to the replacement of unbonded stucco, sealing of exposed cracks in the exterior stucco finish, replacement of unbonded floor topping (at balconies) and waterproofing, and exterior painting and caulking of the building (**Photographs 12, 14, and 15**). Forgoing repairs and routine maintenance may adversely affect the integrity of the structure.

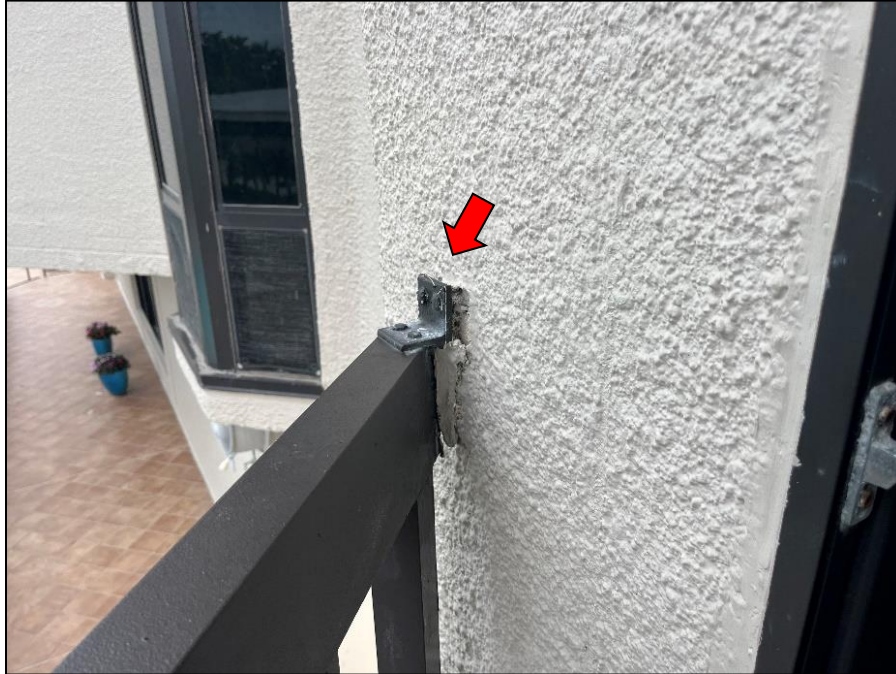
**Photograph 13**

Unit 305 balcony – Detached hand railing from wall.

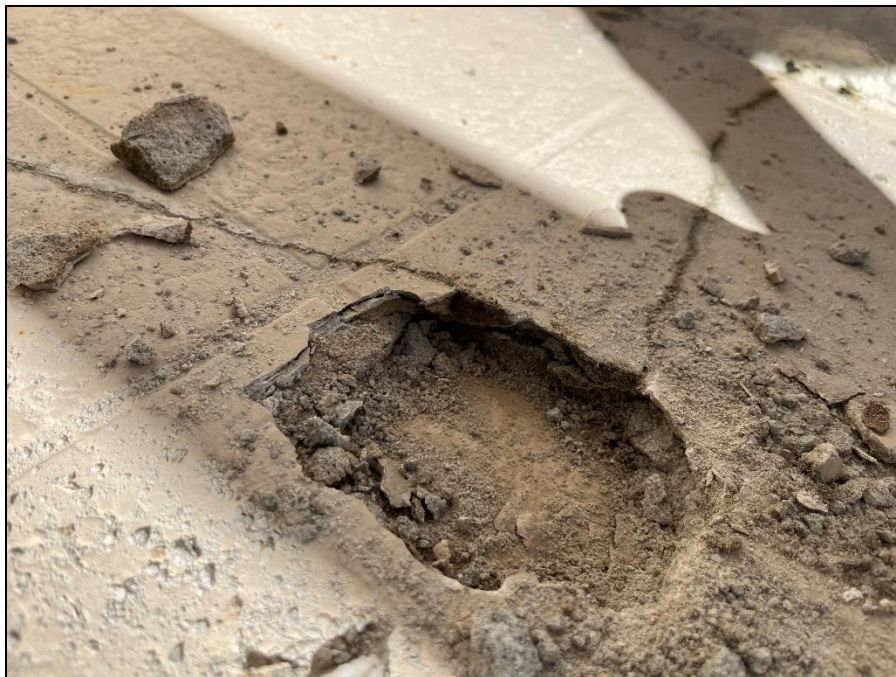
**Photograph 14**

finishes (topping) had failed and the concrete in the subject area was not damaged. The condition did not represent substantial structural deterioration. However, we recommend that the unbonded cementitious finish must be repaired and painted to avoid future damage to concrete (**Photographs #14 and #15**), **Unit 406 and 802**.

Unit 406 balcony – During the Phase II inspection, we chipped up the cracked topping and sounded the slab concrete. The investigation revealed that the cementitious finishes (topping) had failed and the concrete in the subject area was not damaged. The condition did not represent substantial structural deterioration. However, we recommend that the unbonded cementitious finish must be repaired and painted to avoid future damage to concrete.

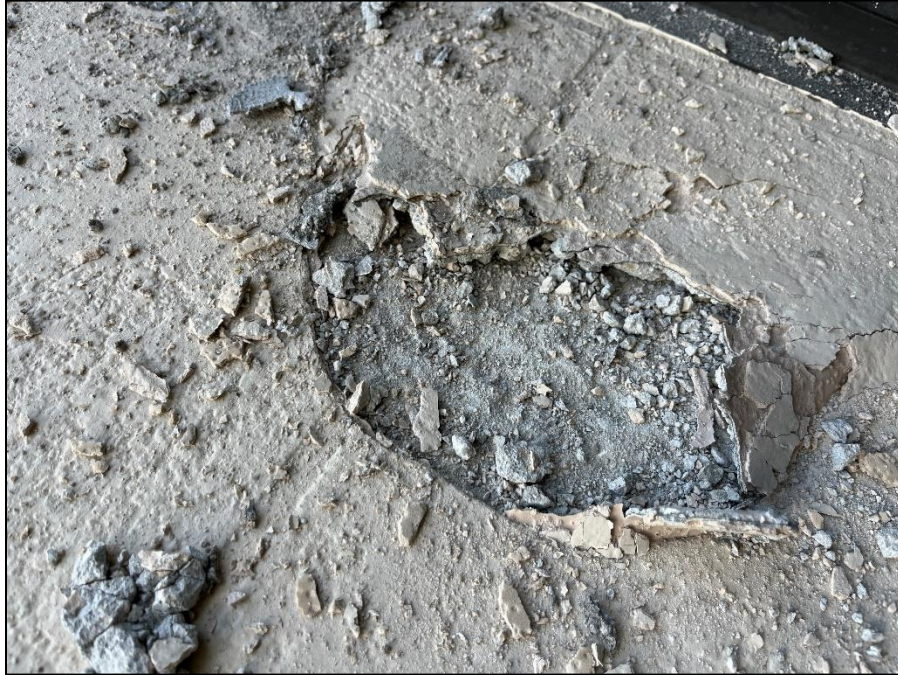
**Photograph 15**

Unit 802 balcony – During the Phase II inspection, we chipped up the cracked topping and sounded the slab concrete. The investigation revealed that the cementitious finishes (topping) had failed and the concrete in the subject area was not damaged. The condition did not represent substantial structural deterioration. However, we recommend that the unbonded cementitious finish must be repaired and painted to avoid future damage to concrete.

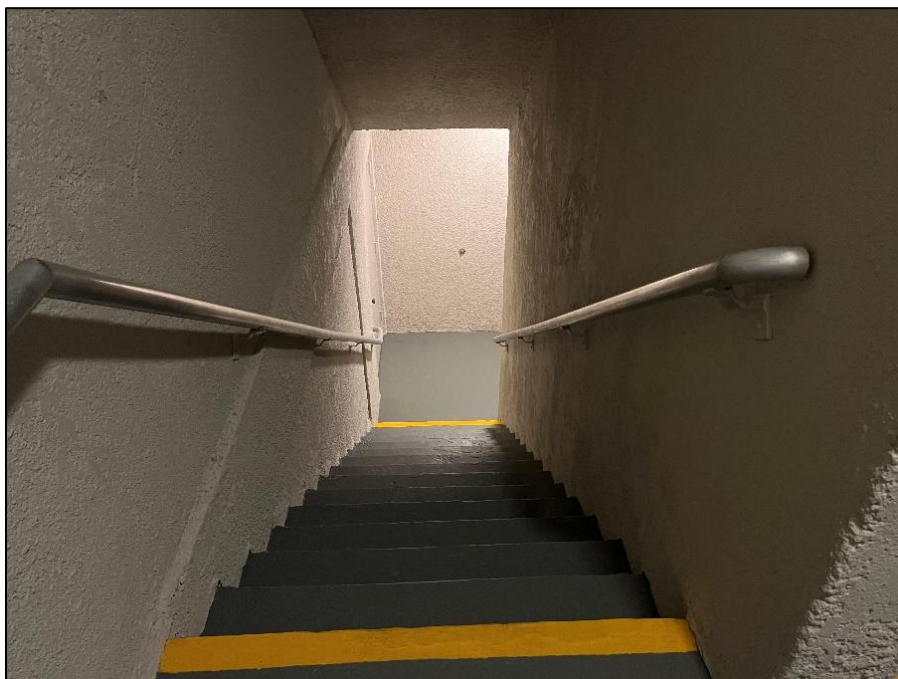
**Photograph 16**

- The interior stairs were found to be in good condition and there were no indications of substantial structural deterioration present (**Photograph #16**).

Stairs – 14<sup>th</sup> floor typical overview.

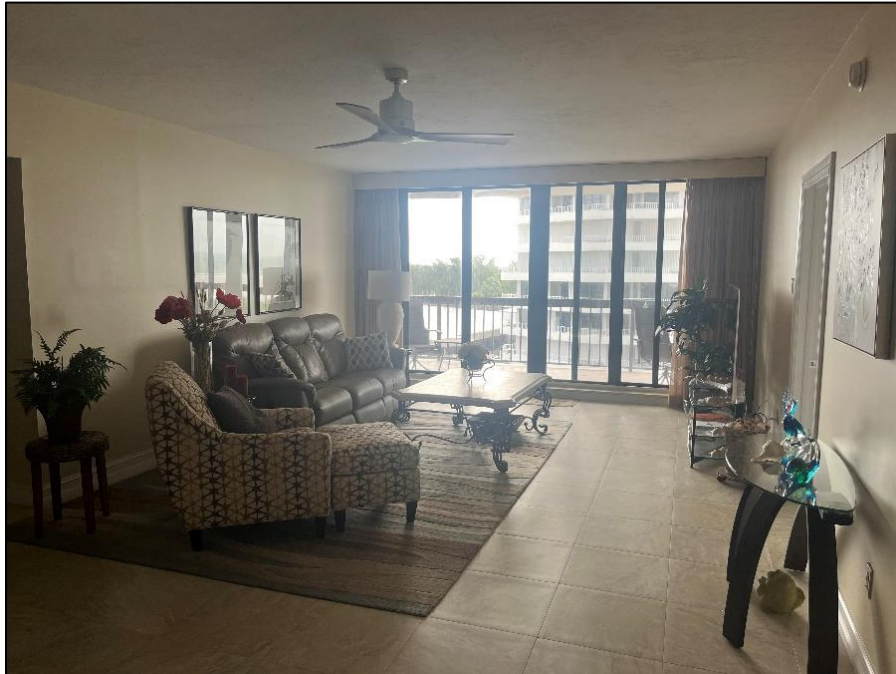
**Photograph 17**

- Interior units were found to be in good condition and there was no indication of substantial structural deterioration present (**Photograph #17**).

Interior units – unit 503 overview.

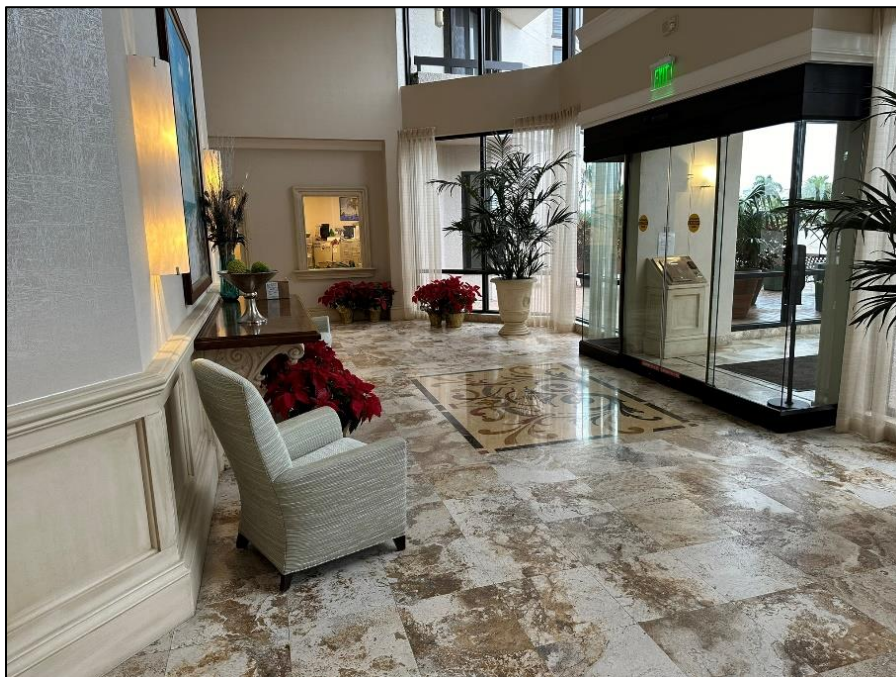
**Photograph 18**

- Common areas were found to be in good condition and there was no indication of substantial structural deterioration present (**Photographs #18 and #19**).

Common area – first-floor overview.

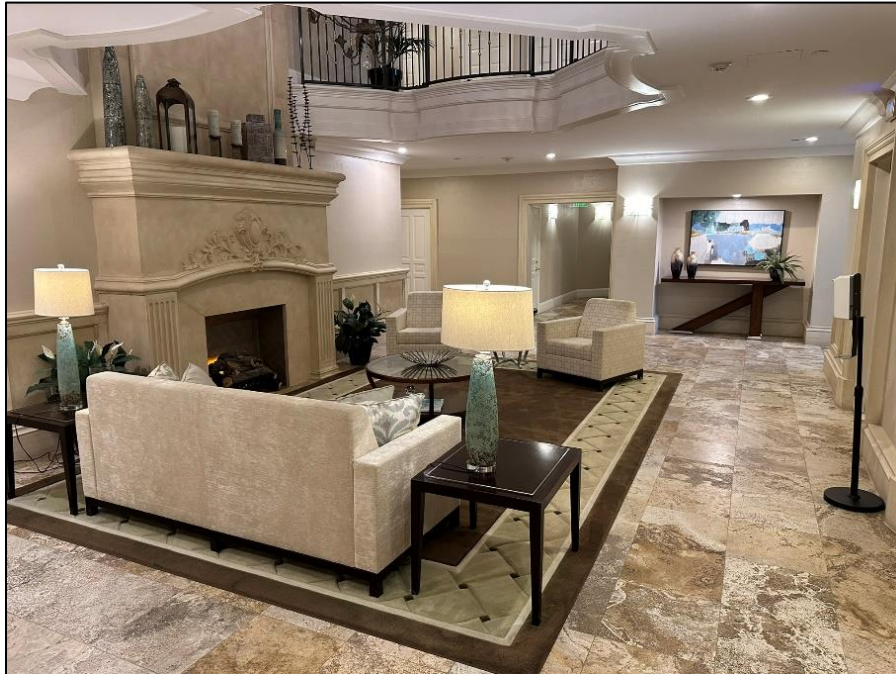
**Photograph 19**

Common area – first-floor overview.

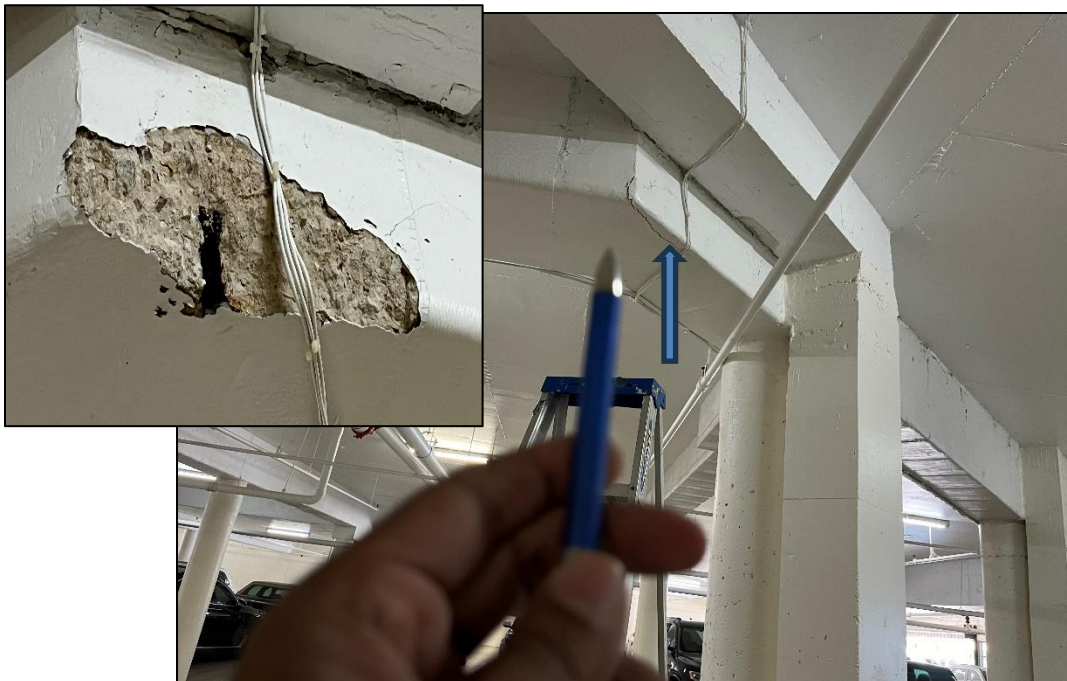
**Photograph 20**

- During the Phase II inspection, we noted an isolated area with spalls on a beam in the central-west portion of the garage area.
  - We sounded, chipped, and visually observed the subject area. The inspection revealed that the concrete spalled due to the lack of the required clear cover for the hooked reinforcement bars. The observed conditions represented substantial structural deterioration (**Photograph #20**).

View of the spalled concrete beam in the west-central portion of the garage. This condition represented substantial structural deterioration.

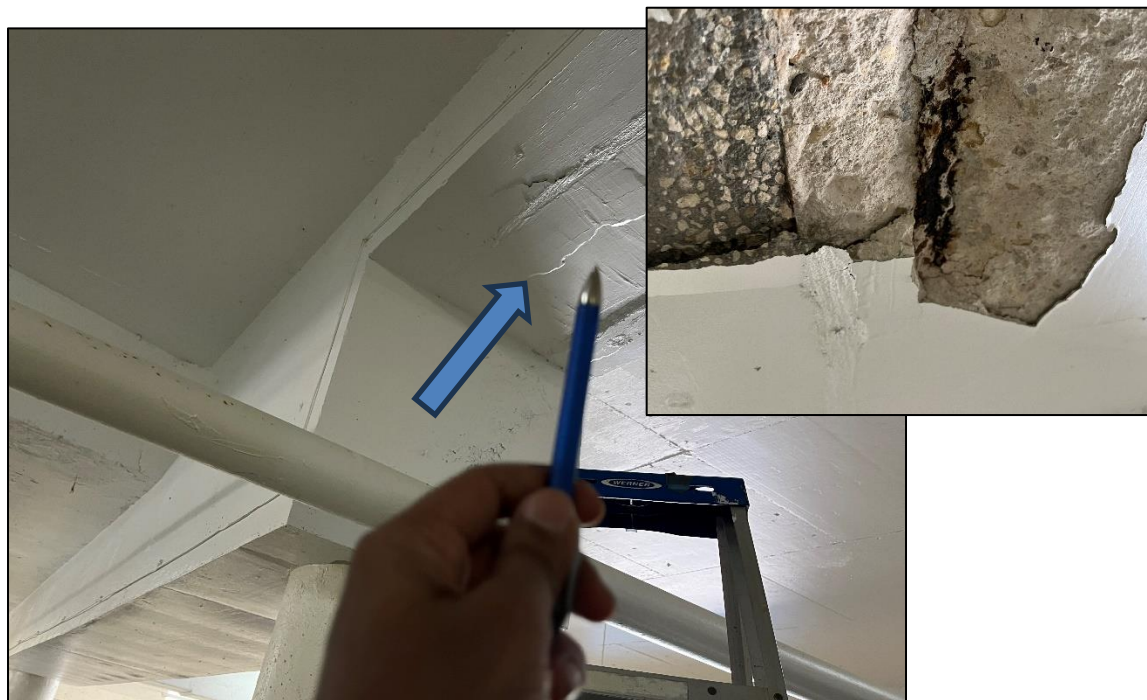
**Photograph 21**

- During the Phase II inspection, we noted an isolated area with spalls on a beam in the west portion of the garage area.
  - We sounded, chipped, and visually observed the subject area. The inspection revealed that the concrete spalled due to the lack of the required clear cover for the reinforcement bar. The observed conditions represented substantial structural deterioration (**Photograph #21**).

View of the spalled concrete beam in the west portion of the garage. This condition represented substantial structural deterioration.

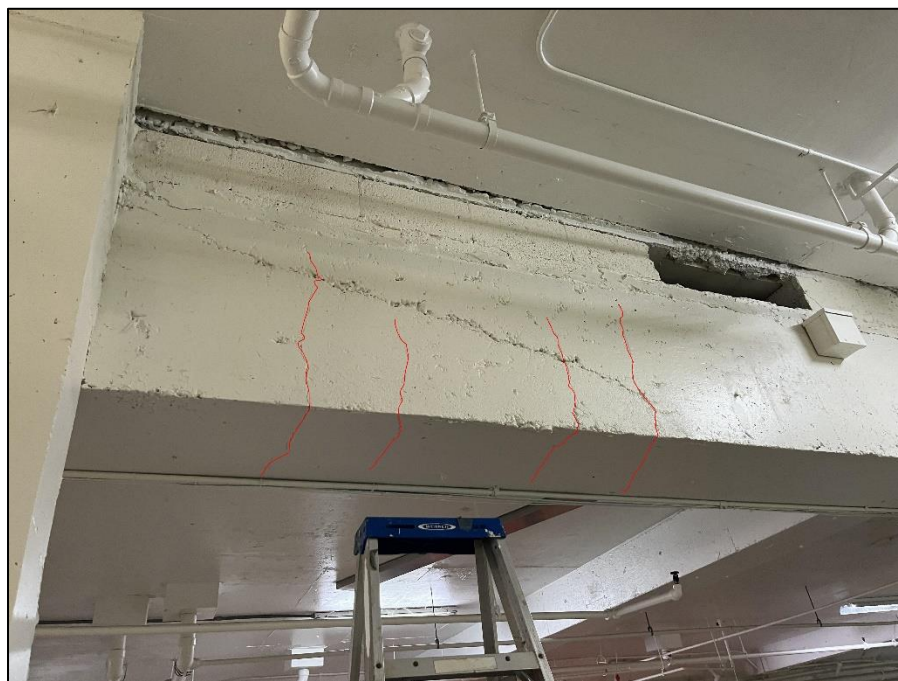
**Photograph 22**

- During the Phase II inspection, we noted several vertical cracks on a beam in the south-central portion of the garage. The beam was located below the pool deck.

The vertical cracking was consistent with flexural cracks. The condition represented substantial structural deterioration (**Photograph #22**).

Based on the information gathered from this inspection (Phase II), substantial structural deterioration and deficiencies were identified in isolated areas on the concrete columns, beams, and slabs. At the concrete beams and slabs, areas of distressed concrete were noted in the form of spalling concrete (unbonded concrete) as confirmed by the removal of unbonded concrete using masonry hammers and subsequent visual inspection of the exposed corroded steel reinforcement (**Photographs #9 through #11, #20, and #21**). At the concrete column (**Photographs #7 and #8**), the debonded concrete was caused by a construction deficiency that failed to honor the expansion joint between the beams and column. Additionally, we noted flexural cracks on a concrete beam located in the south-central portion of the garage below the pool deck. This condition also represented substantial structural deficiencies(**Photograph #22**).

View of the flexural cracks on a beam located in the south-central portion of the garage. This condition represented substantial structural deterioration.

- We recommend that appropriate repairs be determined with further analysis.
