**EAGLE CAY CONDOMINIUM, INC**

**Subject:** Report of Engineering Consulting Services  
**MILESTONE INSPECTION – PHASE I**  
Eagle Cay Condominium, Inc.  
889 to 901 Collier Court  
Marco Island, Florida 34145  
SOCOTEC Project Number VS230625

The subject is a 7-story residential building. It makes up 34 individual residential units and was developed circa 1988.

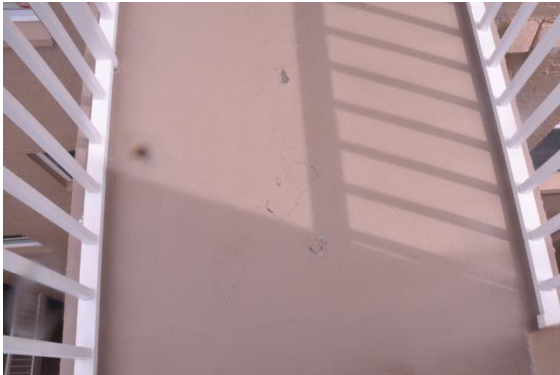
| <p>3. Surface damage on breezeway on top floor of Building 4.</p> | <p>4. 5<sup>th</sup> level Breezeway of building 4 paint peeling.</p> |

- Repair and reseal all horizontal surfaces that have been damaged by moisture and sealant has peeled off (figures 2-6).
- Repair and reseal all vertical surfaces that have been damaged by moisture and sealant has peeled off (figures 7-12). Poor craftsmanship on finishes was traced on some locations of exterior surfaces that encapsulated rainwater that will lead to degradation of the wall material, cementitious or other. Those points need to be promptly repaired before moisture affects ferrous based materials in the walls. It is recommended that during the next maintenance of the exterior walls, when the walls will be repainted, all of these instances are traced, scraped of all surface protection to produce a clear and smooth surface, infilled and painted appropriately.

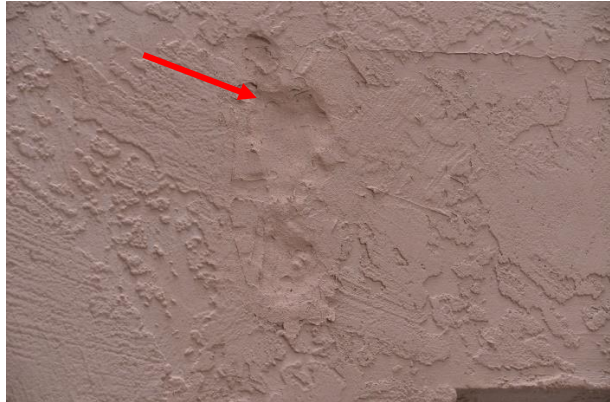
| <p>5. Substantial surface anomalies observed (concave). The presented photo is from 5<sup>th</sup> floor of Building 4.</p> | <p>6. Paint peeling on roof. Poor finishing and protection will inevitably produce structural issues.</p> |

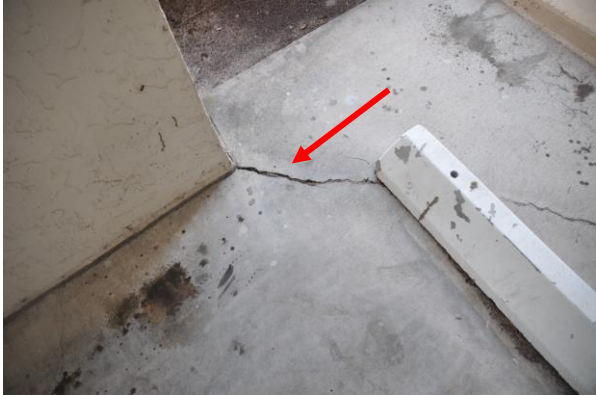
| <p>7. Slab on grade serves for the covered parking area. The level of reinforcement is not traced but cracks exceeding ¼" width were traced. These will lead to further deterioration if not repaired immediately.</p> | <p>8. Accumulation of dust, leaves, etc, allow decomposed substances to allow wild plants to grow in surfaces of roofs. Plant roots can generate substantial damages to the concrete.</p> |

- Cracks of minor width have been traced on the slabs on grade (figure 13). These can eventually lead to moisture absorption and deterioration of the reinforcement of the concrete. It is recommended that those cracks are filled with appropriate solutions. Such cracks were noticed at several random locations on the slabs. The instance indicated in the figure constitutes only an example.

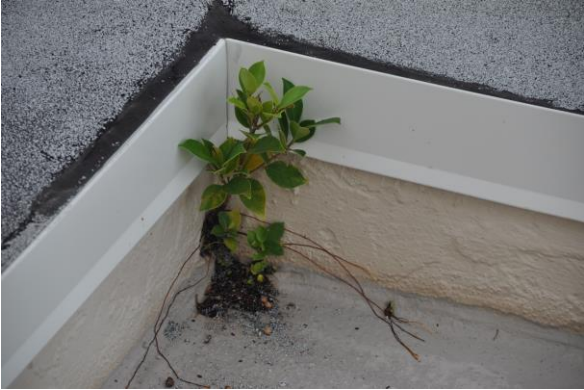
| <p>9. Accumulation of dust, leaves, etc, allow decomposed substances to allow wild plants to grow in surfaces of roofs. Plant roots can generate substantial damages to the concrete.</p> | <p>10. Dust particles allowed mold to form on staircase landings. This can easily be maintained through cleaning. Mold would not compromise the structural qualities of concrete.</p> |

- Remove and seal all locations of wild plant growth in open roof areas (figures 14-15). These plants may grow roots and expand the cracks on the roof that will lead to serious issues, infiltrating moisture in structure and in inhabited spaces.

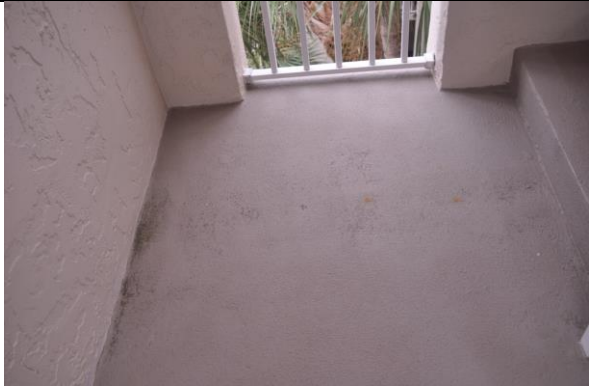
| <p>11. Dust particles allowed mold to form on staircase.</p> | <p>12. Accumulated moisture and dust produced mold on staircase landings.</p> |

- Perform the appropriate mold removal process for infected areas noted on staircase landings (figures 16-18).
- Conduct proper maintenance on paint by cleaning the surface from degradations such as corrosion or old paint peeling and applying new layer(s) of paint to protect surfaces. There were different types of surfaces that were affected.

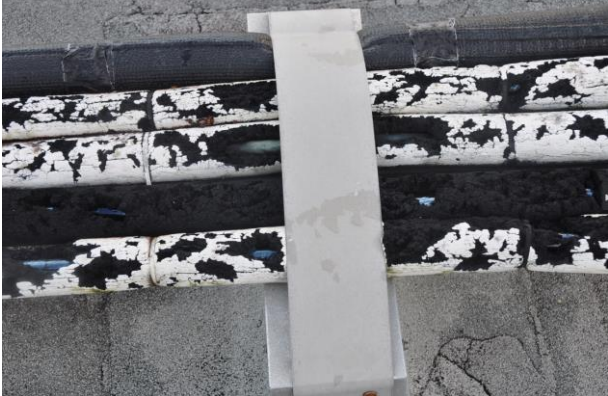
- The majority of pipes connected to AC units on roofs were noted to have compromised insulation covering (figure 21).

| <p>13. The deteriorated insulation on AC units dissipates energy that would otherwise be applied in units.</p> | <p>14. Inadequate inclination on rooftop surfaces allows puddling and inevitably damages the rooftop slab that is not designed to contain water.</p> |

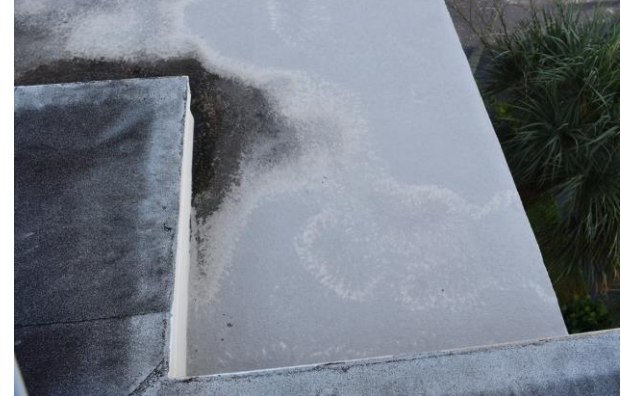
- Areas on rooftop or plain flat exterior areas of breezeways were noted to bear inadequate surface slope to shed rainwater, allowing puddles to be formed on concrete surfaces (figure 22).
- Linear cracks on floor/slab in exterior areas may not be of particular structural importance but need to be repaired with appropriate sealing substances (figures 23-24).

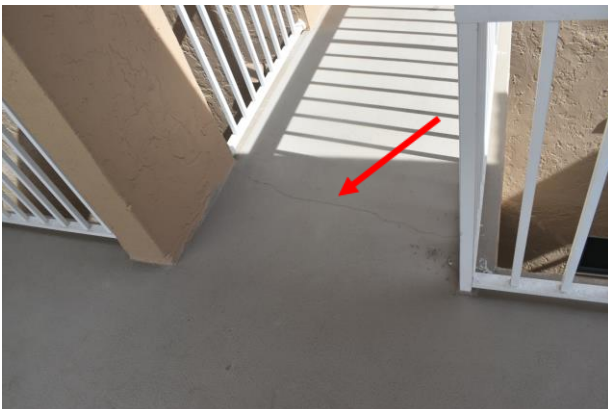
| <p>15. Linear crack on breezeway floor caused by tension over connection will not cause significant structural issue, but should be repaired with epoxy-based compound.</p> | <p>16. Linear crack on breezeway floor caused by tension over connection will not cause significant structural issue, but should be repaired with epoxy-based compound</p> |

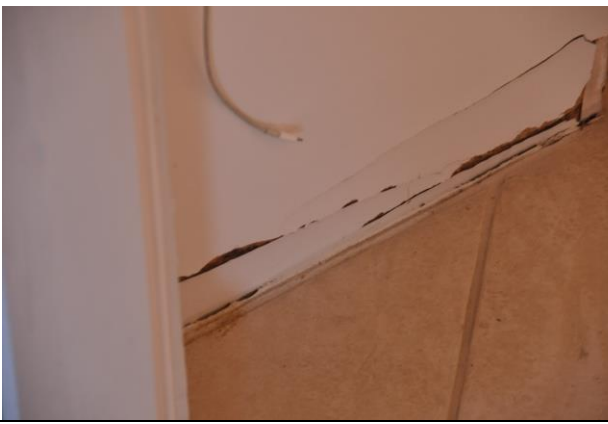
| <p>17. Unit 201, Building 4 – Moisture causes peeling on baseboards.</p> | <p>18. Unit 201, Building 4 – Excessive moisture damage on Lanai.</p> |

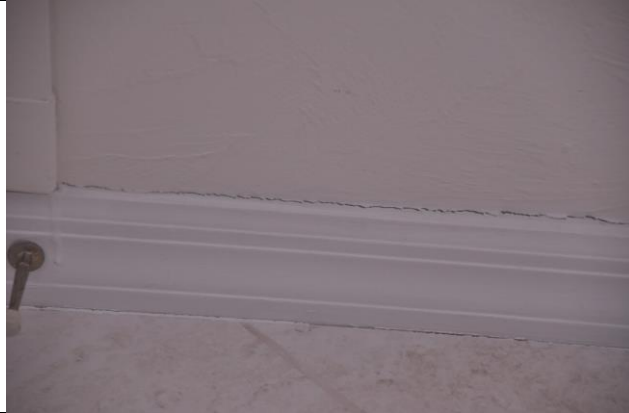
19. Unit 306, Building 4 – Cracks along baseboard.

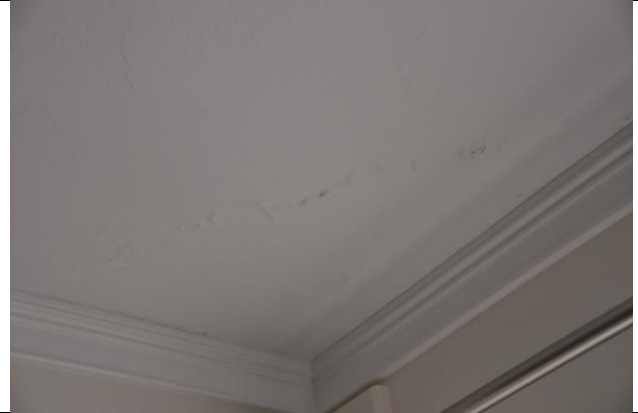
20. Unit 306, Building 4 – Cracks on ceiling.

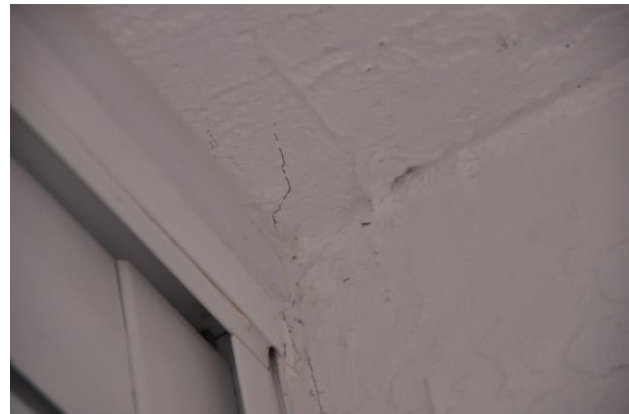
21. Unit 306, Building 4 – Cracks on Lanai ceiling.

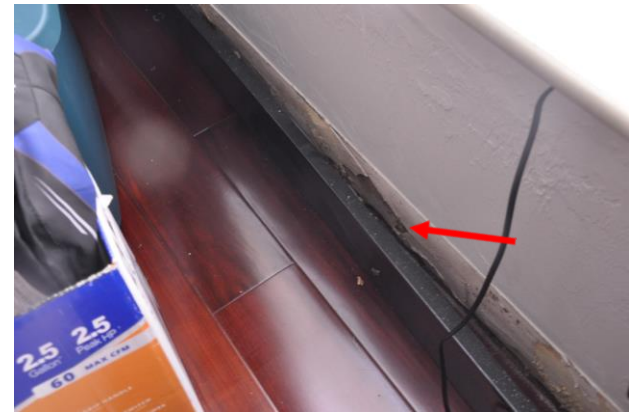
22. Unit 406, Building 4 – Moisture causes peeling on baseboards, elements disengaging from walls and ceiling.

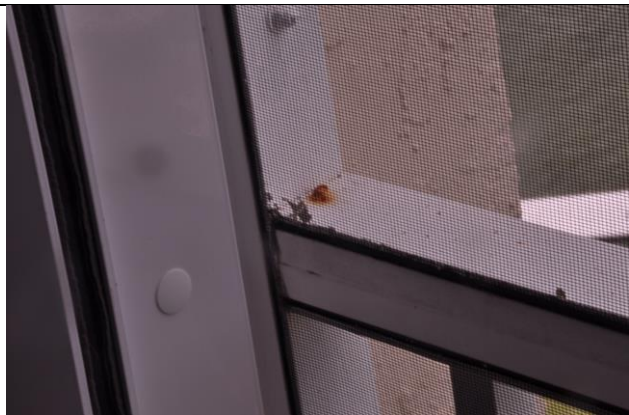
23. Unit 604, Building 4 – Rusty fasteners in Lanai area.

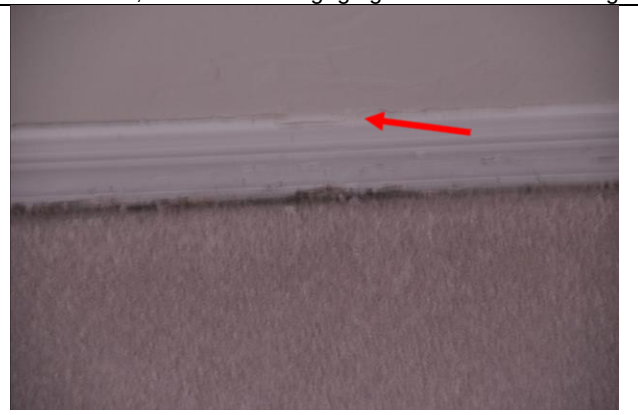
24. Unit 705, Building 4 – Moisture on floor and walls.

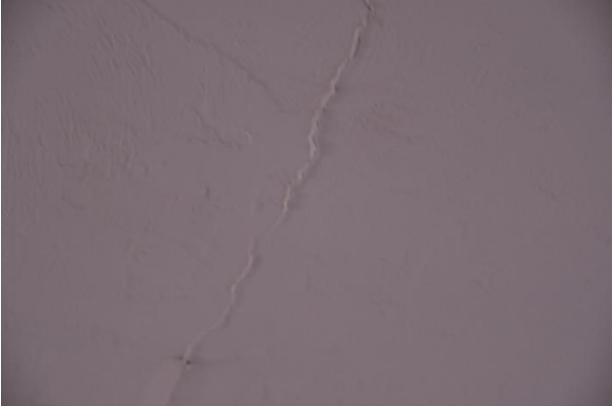
| 25. Unit 705, Building 4 – Cracks in ceiling. | 26. Unit 705, Building 4 – Wiring through doors allows moisture to enter the interior space. |
