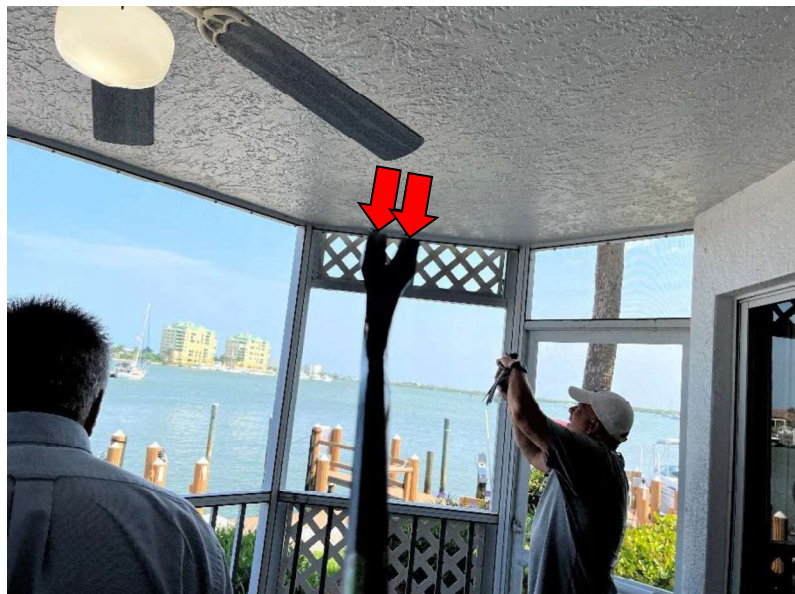
**PHOTOGRAPH #21**

**BALCONIES  
UNITS 109/209**

During Phase I, distress was observed at the concrete slab and was identified as an area that required further investigation. During Phase II inspection, the two locations with distress were sounded, chipped, and visually observed. The inspection revealed that concrete had spalled at these locations due to the lack of sufficient clear cover for the hooked reinforcement bars. The observed conditions represented substantial structural damage.

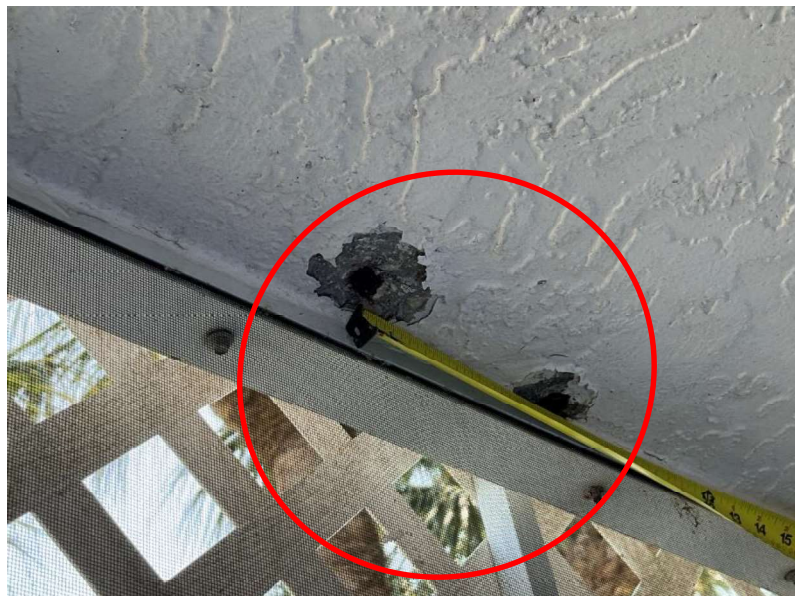
**PHOTOGRAPH #22**

**BALCONIES  
UNITS 109/209**

During Phase I, distress was observed at the concrete slab and was identified as an area that required further investigation. During Phase II inspection, the two locations with distress were sounded, chipped and visually observed. The inspection revealed that concrete had spalled at these locations due to the lack of sufficient clear cover for the hooked reinforcement bars. The observed conditions represented substantial structural damage.

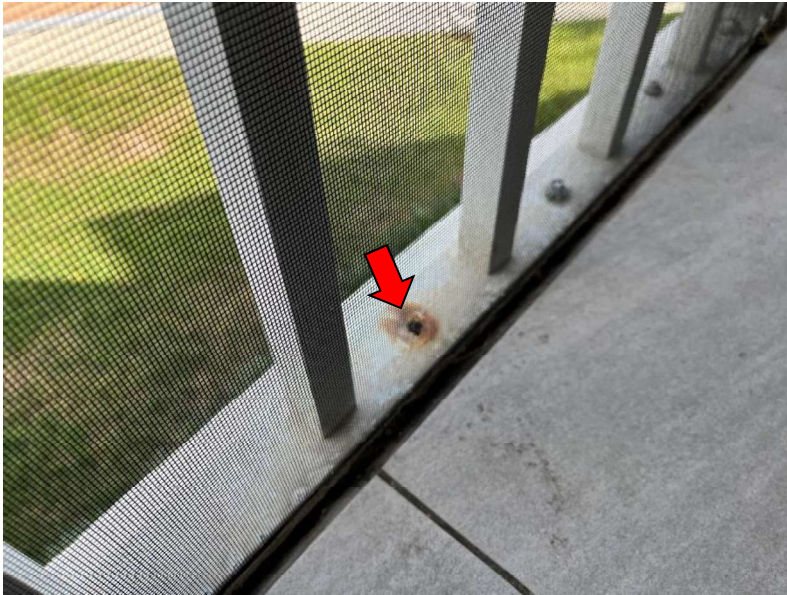
**PHOTOGRAPH #23**

**BALCONIES  
UNIT 202**

Corroded and open fastener hole at balcony edge screen enclosure bottom rail. This condition does not represent substantial structural deterioration. Note: typical condition throughout.

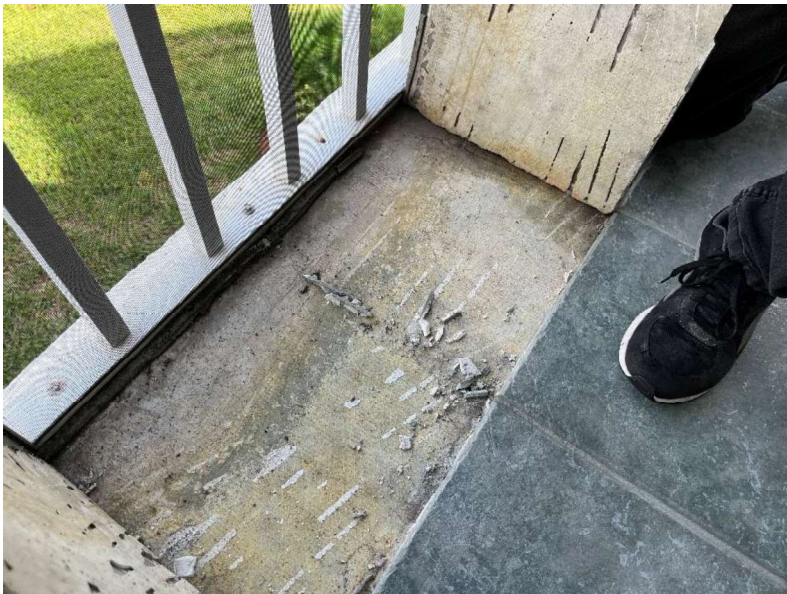
**PHOTOGRAPH #24**

**BALCONIES  
UNIT 206**

Delaminated tile at balcony. This condition does not represent substantial structural deterioration.

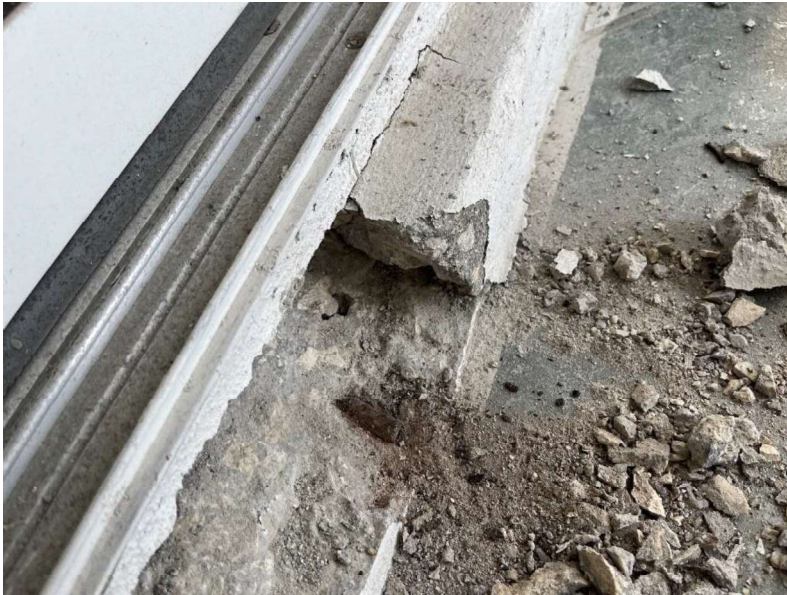
**PHOTOGRAPH #25**

**BALCONIES  
UNIT 206**

During Phase I inspection, cracks were observed at the concrete under the balcony sliding glass door and was identified as an area that required further investigation during. During Phase II inspection, the area with distress was sounded, chipped and visually observed. The inspection revealed that the concrete had spalled at these locations due to the lack of sufficient clear cover for the reinforcement bar. The observed conditions represented substantial structural damage.

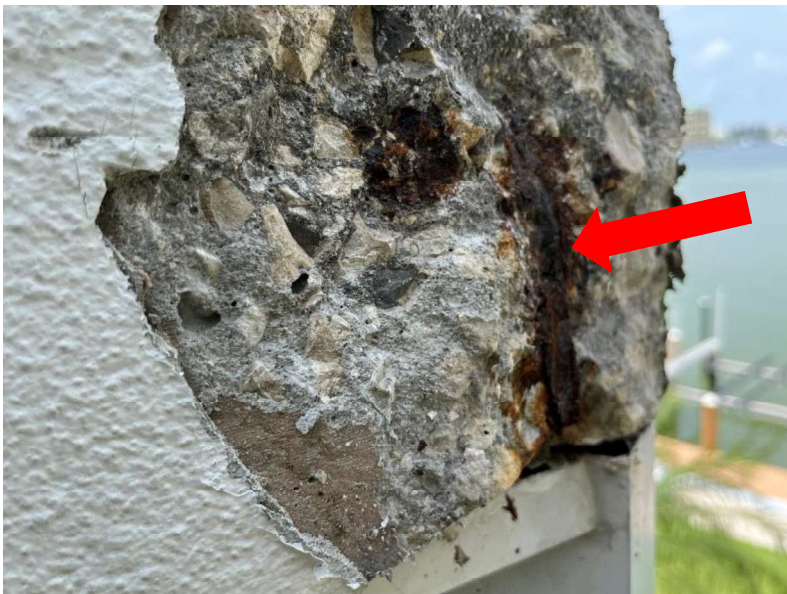
**PHOTOGRAPH #26**

**BALCONIES  
UNITS 208/308**

During Phase I inspection, multiple isolated distress locations at the slab edges of Unit 208/308 were observed and identified as areas that required further investigation. During Phase II inspection we sound, chipped and visually observed the subject area. The inspection revealed that at the northeast corner, concrete spalled due the lack of required clear cover for the hooked reinforcement bars. The observed conditions represented substantial structural damage.

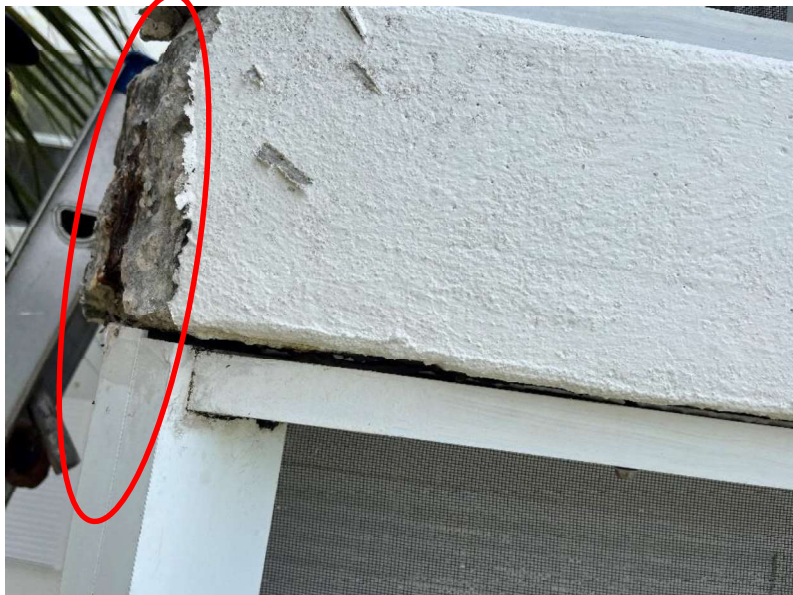
**PHOTOGRAPH #27**

**BALCONIES  
NORTH ELEVATION  
UNITS 208/308**

During Phase I inspection, multiple isolated distress locations at the slab edges of Unit 208/308 were observed and identified as areas that required further investigation. During Phase II inspection we sound, chipped and visually observed the subject area. The inspection revealed that at the northeast corner, concrete spalled due the lack of required clear cover for the hooked reinforcement bars. The observed conditions represented substantial structural damage.

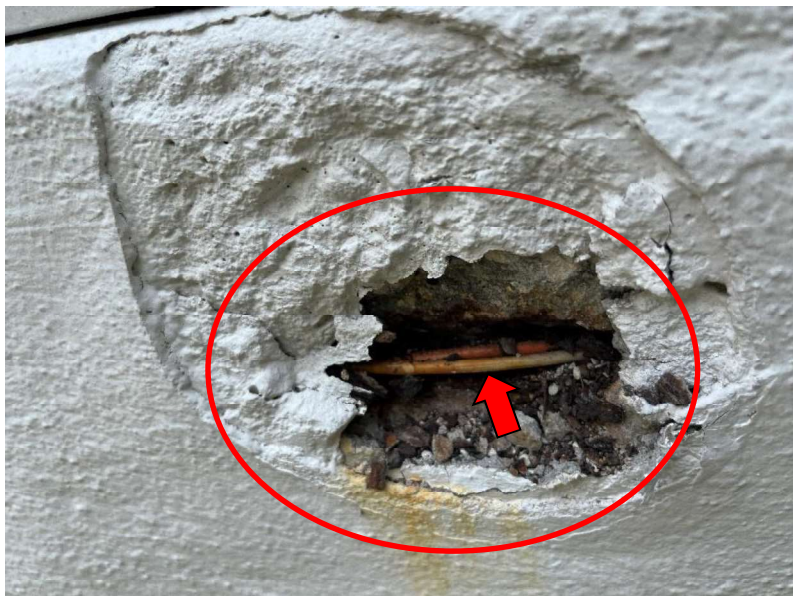
**PHOTOGRAPH #28**

**BALCONIES  
NORTH ELEVATION  
UNITS 208/308**

During Phase I inspection, multiple isolated distress locations at the slab edges of units 208/308 were observed and identified as areas that required further investigation. During Phase II inspection we sound, chipped and visually observed the subject area. The inspection revealed that along the west slab edge, concrete spalled due the corrosion of an electrical conduit. The observed conditions represented substantial structural damage.

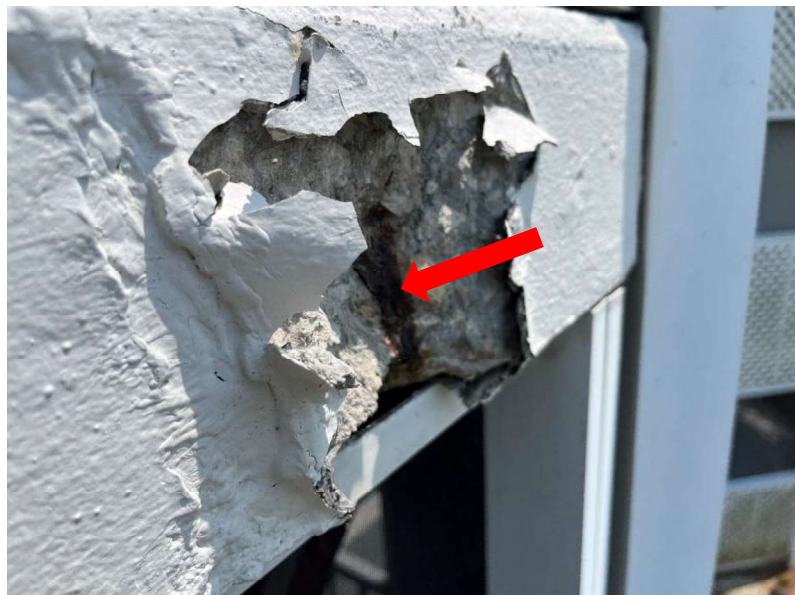
**PHOTOGRAPH #29**

**BALCONIES  
NORTH ELEVATION  
UNITS 214/314**

During Phase I inspection, distress at an isolated location along the slab edge was observed and identified as an area that required further investigation. During Phase II inspection we sounded, chipped, and visually observed the subject area. The investigation revealed that concrete spalled due the lack of required clear cover for the hooked reinforcement bars. The observed conditions represented substantial structural damage.

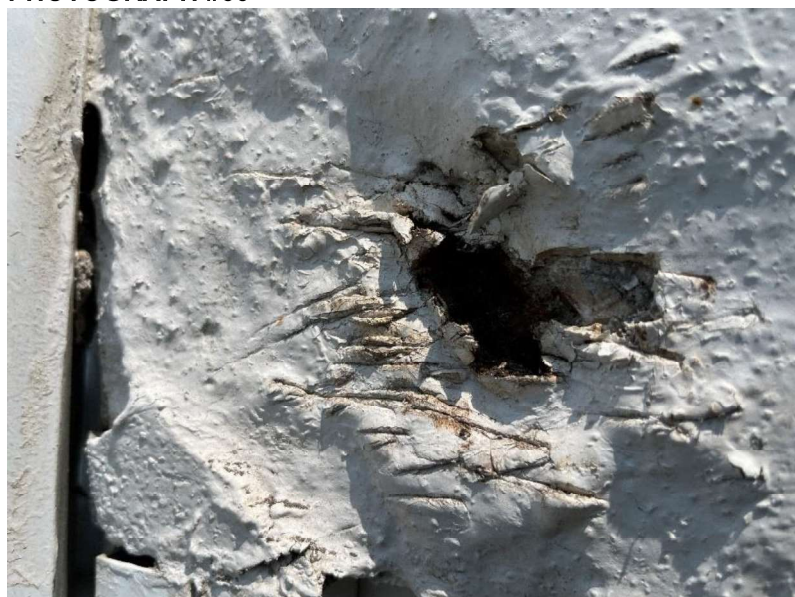
**PHOTOGRAPH #30**

**BALCONIES  
NORTH ELEVATION  
UNITS 215/315**

During Phase I inspection, distress at an isolated location of the slab edge was observed and identified as an area that required further investigation. During Phase II inspection we chipped and removed the existing surface finish at the subject area. The investigation revealed that the area had been finished and painted over a previous concrete spall with exposed steel, but concrete was sound. However, the current finishes are delaminated. The observed conditions did not represent substantial structural damage. However, we recommend patch repair concrete and refinish to avoid future structural damage.

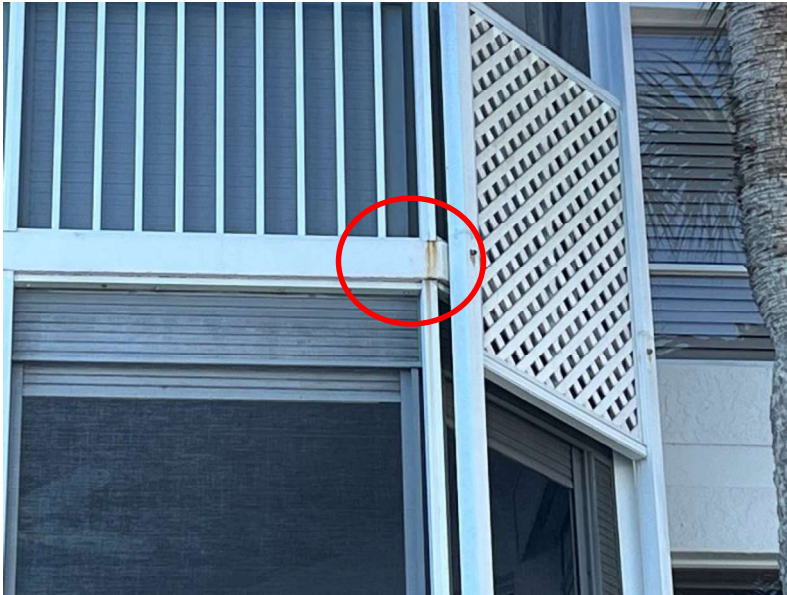
**PHOTOGRAPH #31**

**BALCONIES  
NORTH ELEVATION  
UNITS 215/315**

Rust stain at balcony slab edge. This condition does not represent substantial structural deterioration.

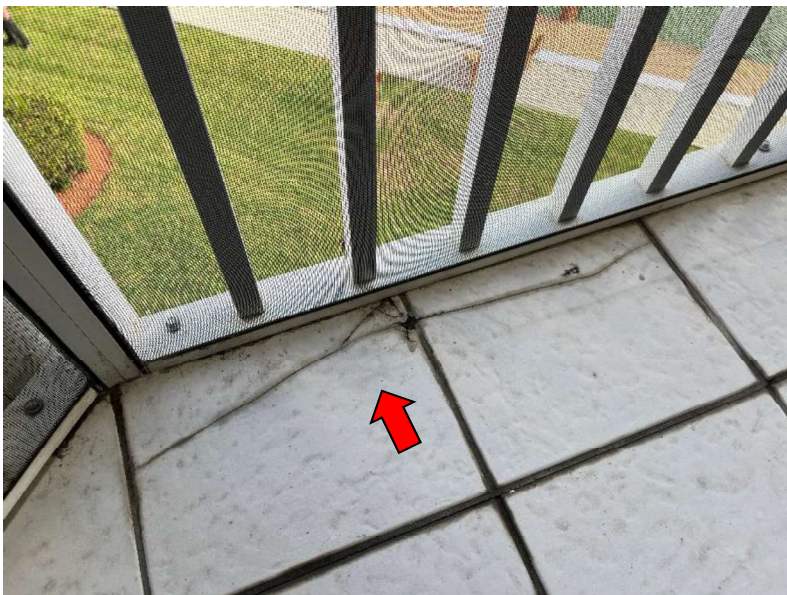
**PHOTOGRAPH #32**

**BALCONIES  
UNIT 303**

Tile crack at balcony floor slab. This condition does not represent substantial structural deterioration.

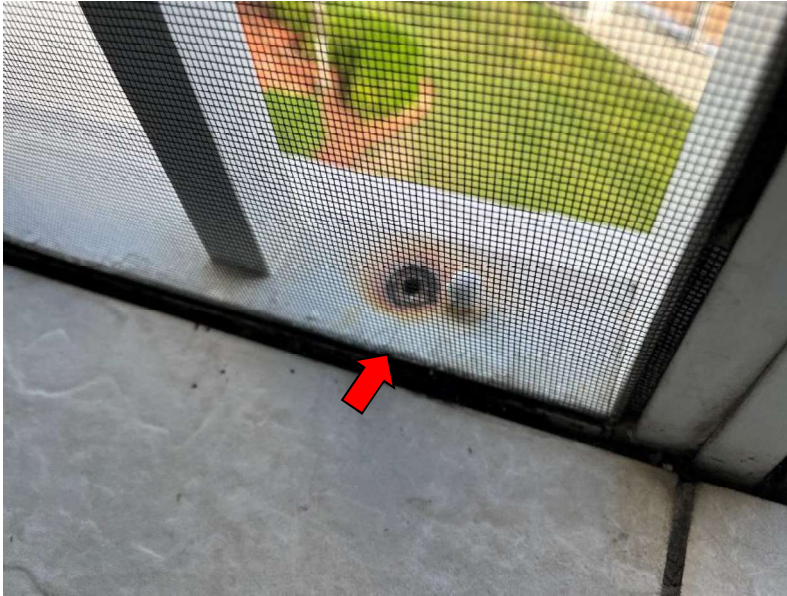
**PHOTOGRAPH #33**

**BALCONIES  
UNIT 306**

Corroded and open fastener hole at balcony edge screen enclosure bottom rail. This condition does not represent substantial structural deterioration. Note: typical condition throughout.

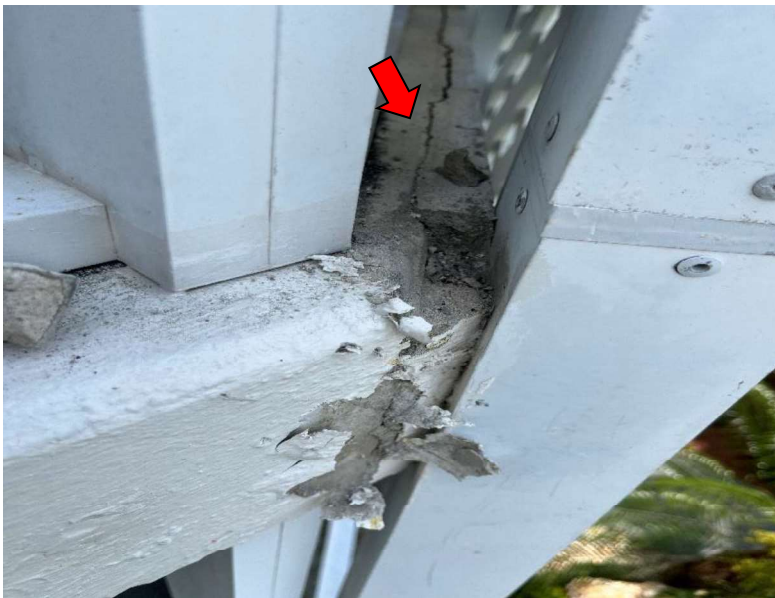
**PHOTOGRAPH #34**

**BALCONIES  
UNIT 307**

During Phase I inspection, cracks along the edge of the slab were observed and identified as an area that required further inspection. During Phase II inspection we sounded, chipped, and visually observed some of the cracked portion of the slab edge. The investigation revealed that the cracks were limited to the unbonded stucco, and the concrete was not damaged. The observed condition does not represent substantial structural damage; however, we recommend that the unbonded stucco along the edge of the slab be repaired and painted to avoid moisture intrusion and future structural damage.

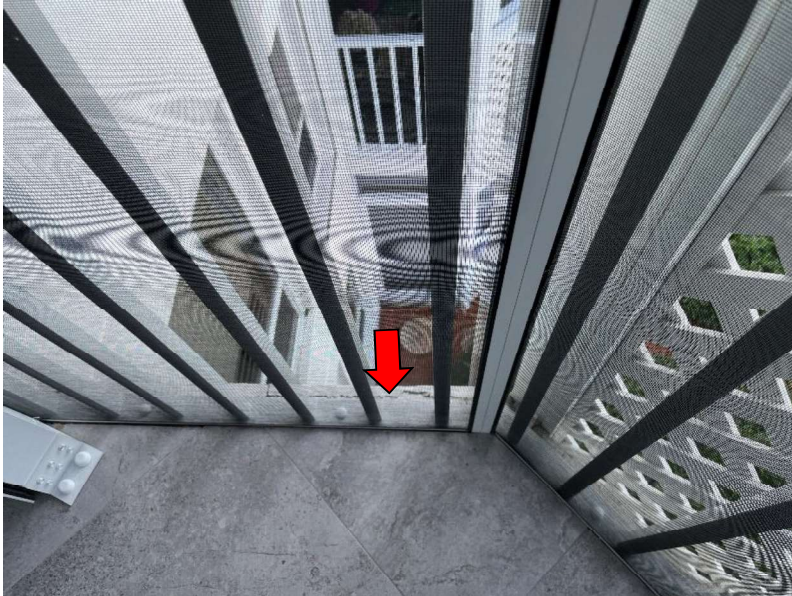
**PHOTOGRAPH #35**

**BALCONIES  
UNIT 307**

During Phase I inspection, cracks along the edge of the slab were observed and identified as an area that required further inspection. During Phase II inspection we sounded, chipped, and visually observed some of the cracked portion of the slab edge. The investigation revealed that the cracks were limited to the unbonded stucco, and the concrete was not damaged. The observed condition does not represent substantial structural damage; however, we recommend that the unbonded stucco along the edge of the slab be repaired and painted to avoid moisture intrusion and future structural damage.

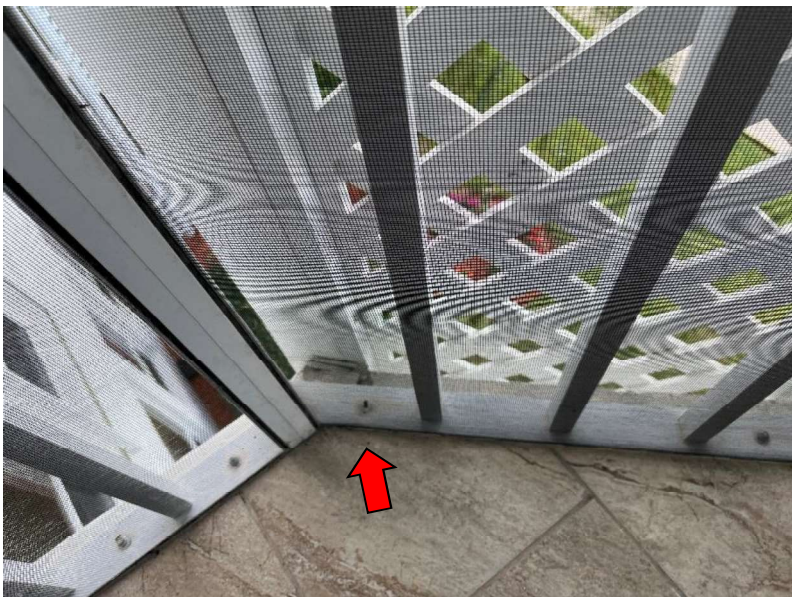
**PHOTOGRAPH #36**

**BALCONIES  
UNIT 312**

Corroded and open fastener hole at balcony edge screen enclosure bottom rail. This condition does not represent substantial structural deterioration. Note: typical condition throughout.

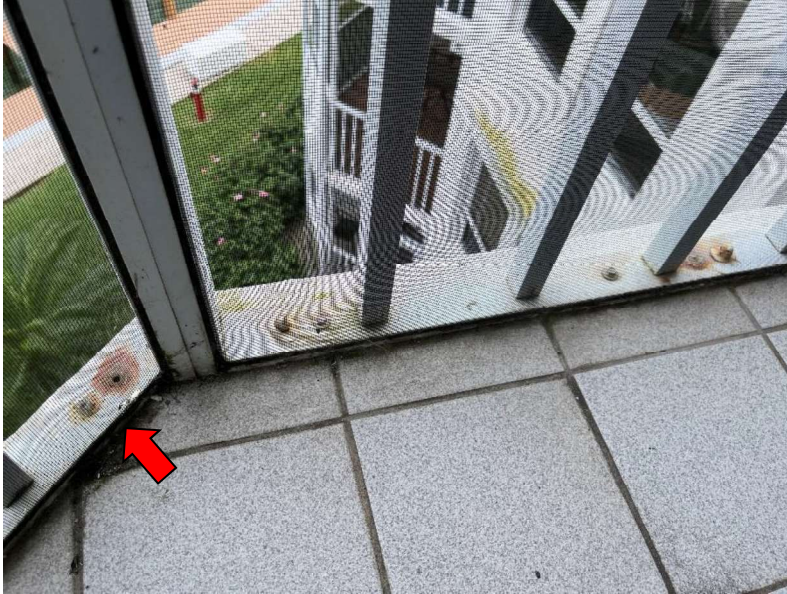
**PHOTOGRAPH #37**

**BALCONIES  
UNIT 408**

Corroded and open fastener hole at balcony edge screen enclosure bottom rail. This condition does not represent substantial structural deterioration. Note: typical condition throughout.

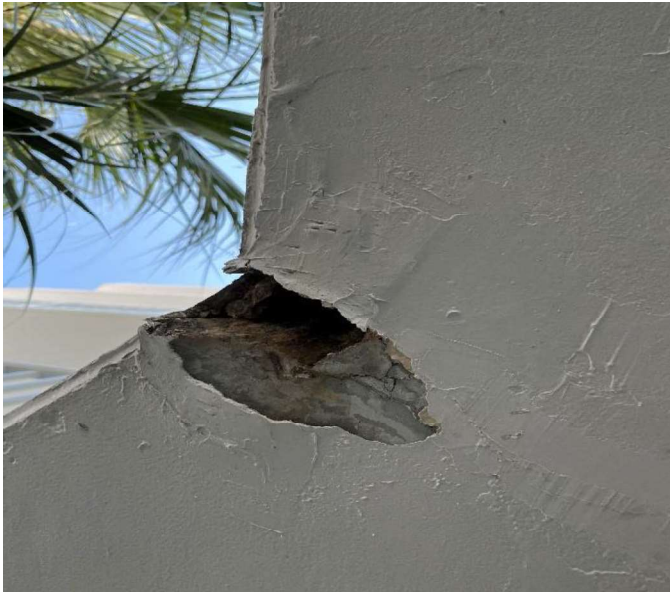
**PHOTOGRAPH #42**

**WALKWAYS  
1<sup>ST</sup> FLOOR  
ADJACENT UNIT 105/205**

During Phase I, at the underside of the walkway slab, cracks were observed and identified as a location that required further investigation. During Phase II, were removed the finishes and spalled concrete at the subject area. The investigation revealed that the concrete had spalled due to rusted rebar and poor post pocket installation. The condition represented substantial structural damage.

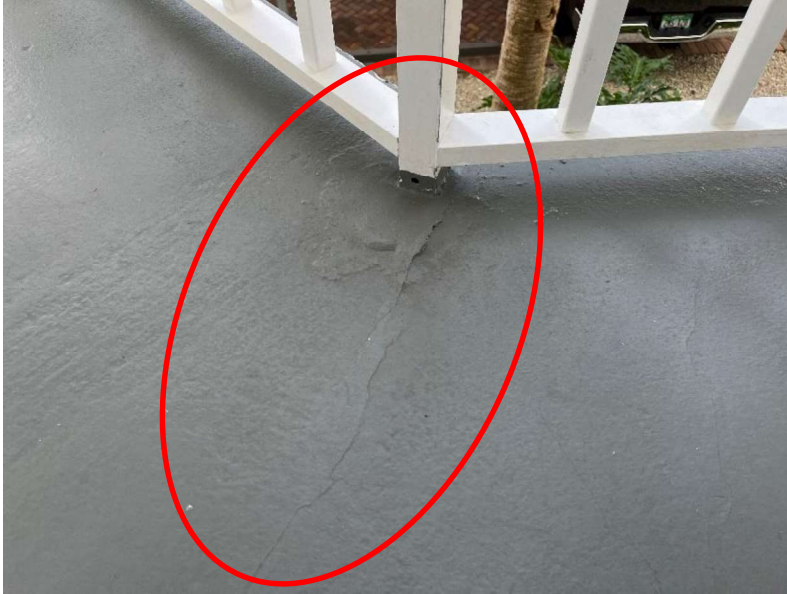
**PHOTOGRAPH #43**

**WALKWAYS  
2<sup>ND</sup> FLOOR  
ADJACENT UNITS 105/205**

During Phase I, at the underside of the walkway slab cracks were observed and identified as location that required further investigation. During Phase II, were removed the finishes and spalled concrete at the subject area. The investigation revealed that the concrete had spalled due to rusted rebar and poor post pocket installation. The condition represented substantial structural damage.

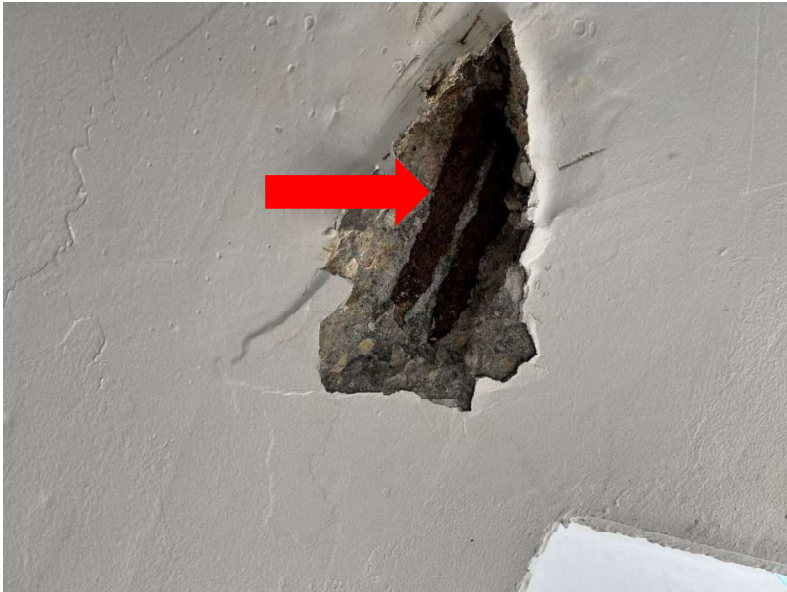
**PHOTOGRAPH #44**

**WALKWAYS  
1<sup>ST</sup> FLOOR  
ADJACENT UNIT 109**

During Phase I, at the underside of the walkway slab, cracks were observed and identified as an area that required further investigation. During Phase II inspection we sounded & chipped some of the concrete at the subject area. The investigation revealed that the concrete had spalled due to the corroded reinforcement steel. The condition represented substantial structural damage.

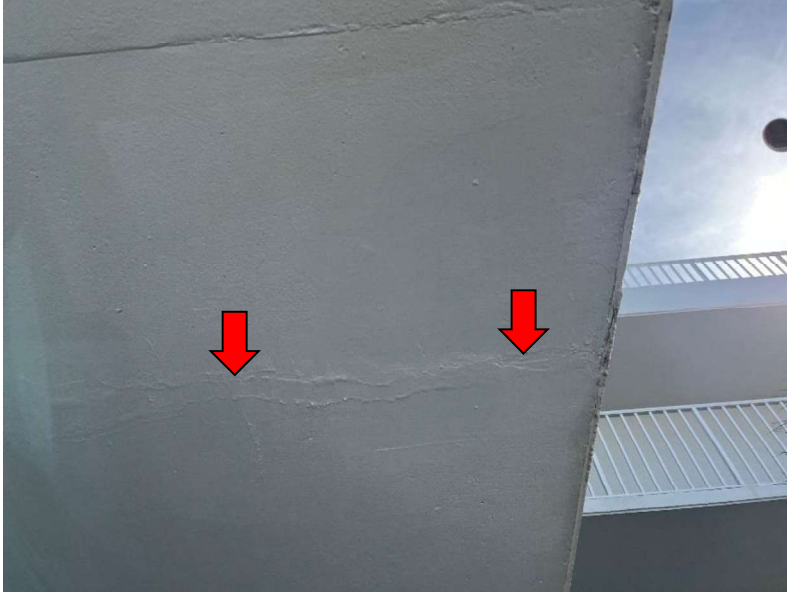
**PHOTOGRAPH #45**

**WALKWAYS  
2<sup>ND</sup> FLOOR  
ADJACENT UNIT 202**

Concrete crack at overhead walkway concrete cantilever slab. Note prior repair. This condition does not represent substantial structural deterioration but could lead to structural deterioration if not repaired.

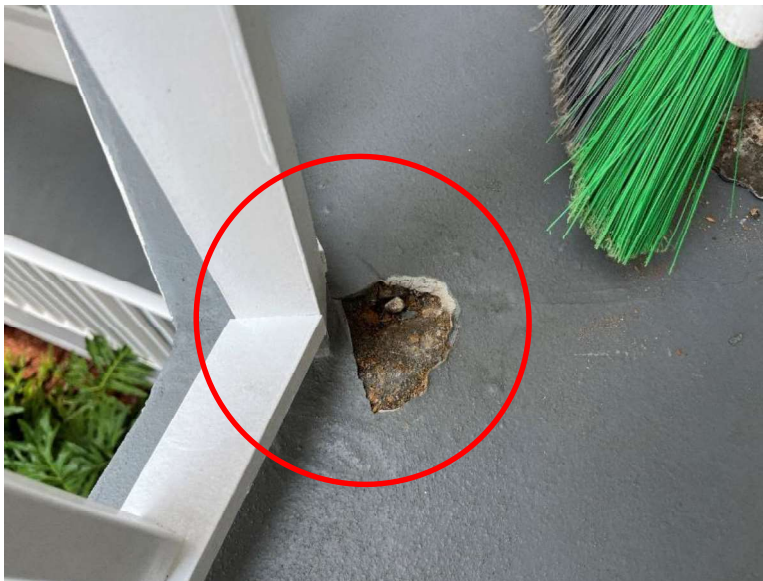
**PHOTOGRAPH #46**

**WALKWAYS  
2<sup>ND</sup> FLOOR  
ADJACENT UNIT 204**

During Phase I, on the walkway slab, cracks were observed adjacent to a post pocket and identified as location that required further investigation. During Phase II, we removed the finishes at the subject area. The investigation revealed that the damage was limited to the delaminated floor coating and the concrete was not damaged. The observed condition did not represent substantial structural damage; however, we recommend that new flexible coating to be applied after appropriate surface preparation at the subject area to avoid future structural damage.

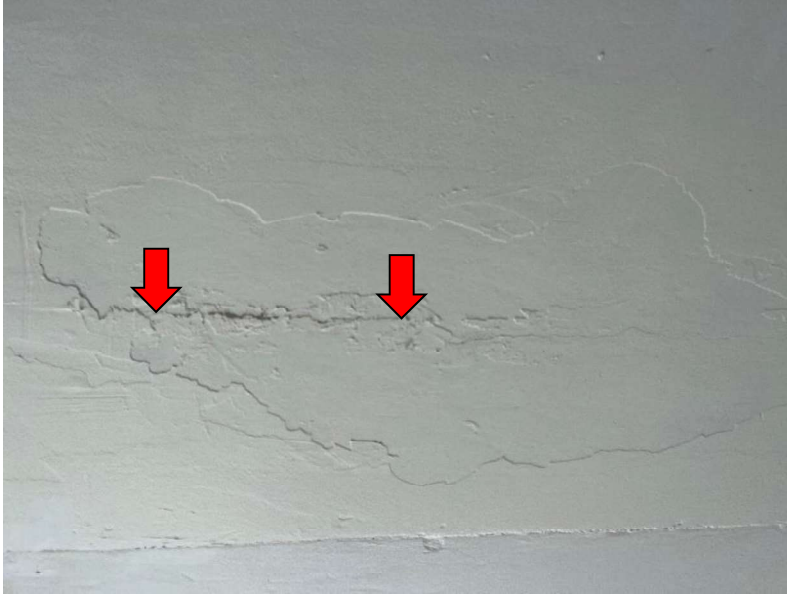
**PHOTOGRAPH #47**

**WALKWAYS  
2<sup>ND</sup> FLOOR  
ADJACENT UNIT 206**

Concrete crack and paint peeling at overhead walkway concrete cantilever slab. This condition does not represent substantial structural deterioration but could lead to structural deterioration if not repaired.

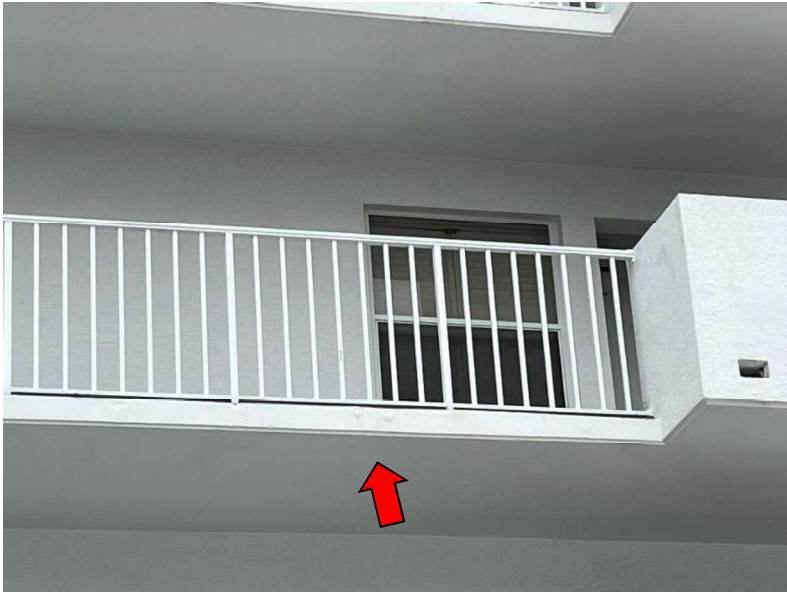
**PHOTOGRAPH #48**

**WALKWAYS  
3<sup>RD</sup> FLOOR**

Concrete crack and paint peeling at walkway concrete cantilever slab edge. This condition does not represent substantial structural deterioration but could lead to structural deterioration if not repaired.

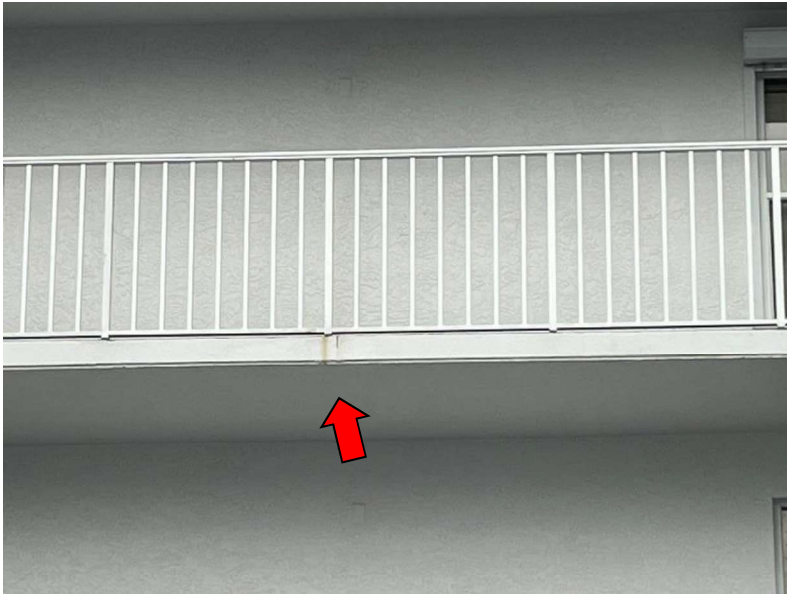
**PHOTOGRAPH #49**

**WALKWAYS  
3<sup>RD</sup> FLOOR**

Rust staining at walkway concrete cantilever slab edge. This condition does not represent substantial structural deterioration.

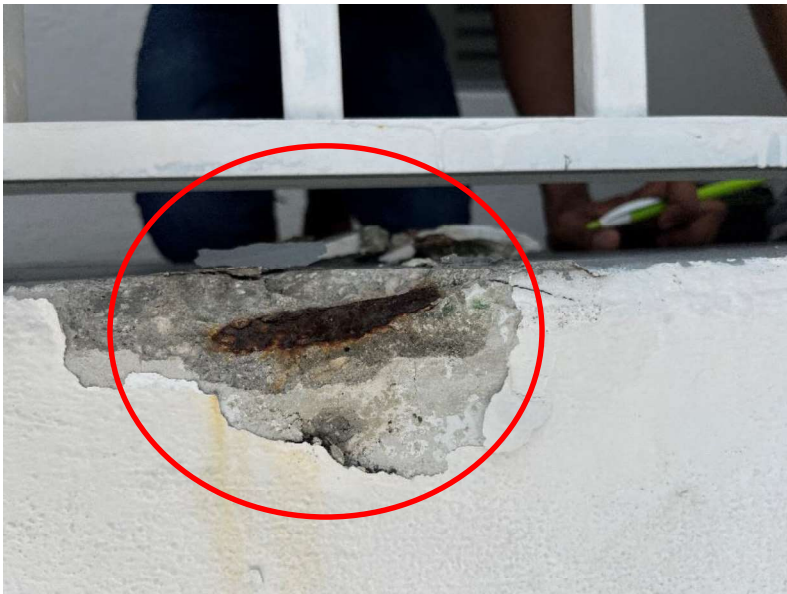
**PHOTOGRAPH #50**

**WALKWAYS  
3<sup>RD</sup> FLOOR  
ADJACENT UNIT 312**

During Phase I inspection, concrete crack and spall at walkway slab edge were observed and identified as area that required further investigations. During Phase II inspection we sounded and chipped the spalled concrete. The investigation revealed that the concrete at this location had spalled due to corroded reinforcement bars. The conditions represented substantial structural damage.

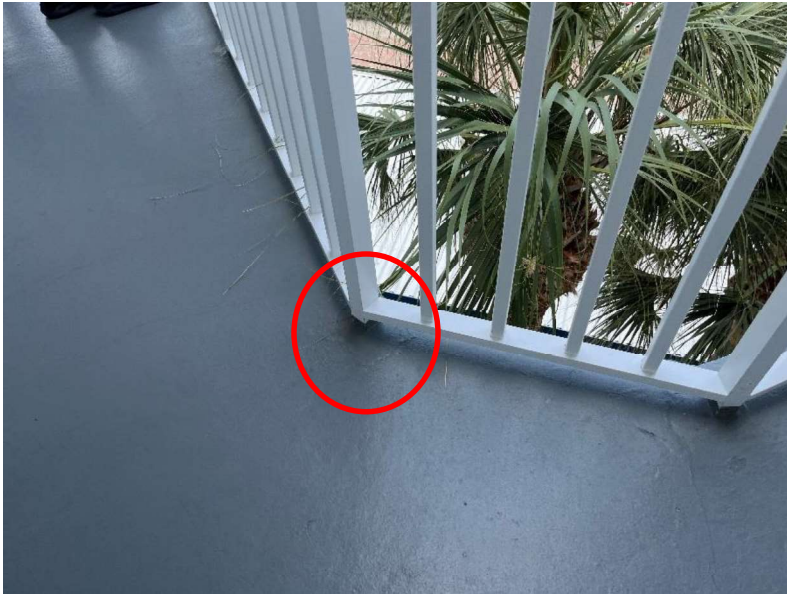
**PHOTOGRAPH #51**

**WALKWAYS  
4<sup>TH</sup> FLOOR  
ADJACENT UNIT 406**

During Phase I inspection, walkway surface distress (around post pocket) was observed and identified as an area that required further investigation. Investigations during phase II revealed that the condition did not represent substantial structural damage.

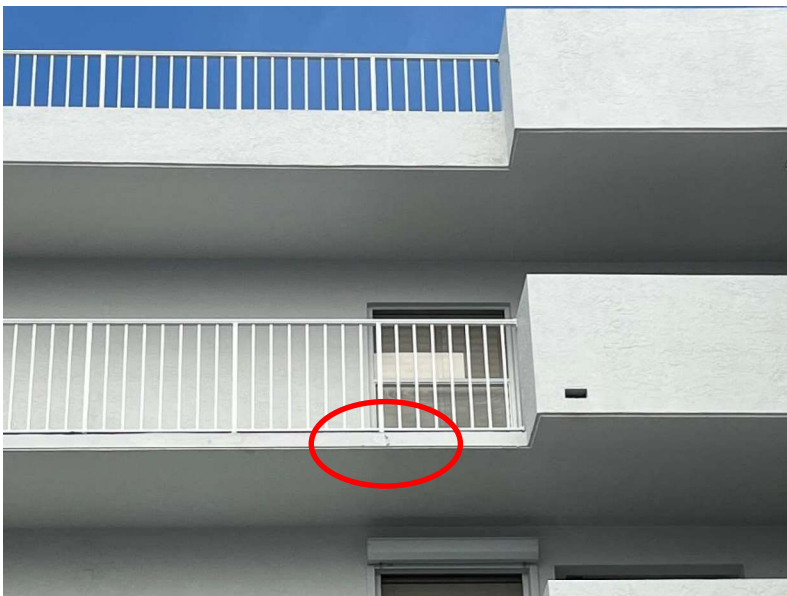
**PHOTOGRAPH #52**

**WALKWAYS  
4<sup>TH</sup> FLOOR**

Paint peeling at walkway concrete cantilever slab edge. This condition does not represent substantial structural deterioration.

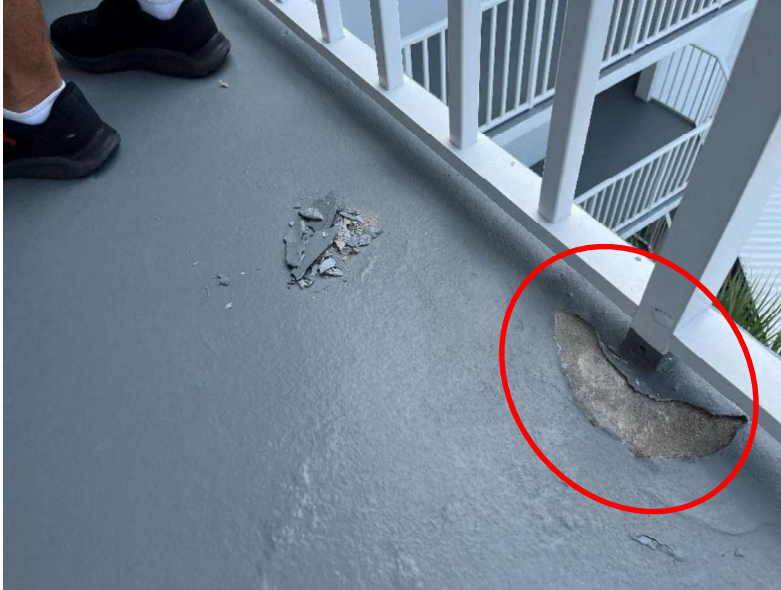
**PHOTOGRAPH #53**

**WALKWAYS  
4<sup>TH</sup> FLOOR  
ADJACENT UNIT 405**

During phase I inspection, walkway surface distress (around post pocket) was observed and identified as an area that required further investigation. During phase II inspection the surface finishes around the subject were removed. The investigation revealed that the concrete and post pocket was undamaged, and the distress was limited to the failed top coating at the subject area. The observed distress did not represent substantial structural damage; however, we recommend that new flexible coating to be applied after appropriate surface preparation at the subject area to avoid future structural damage.

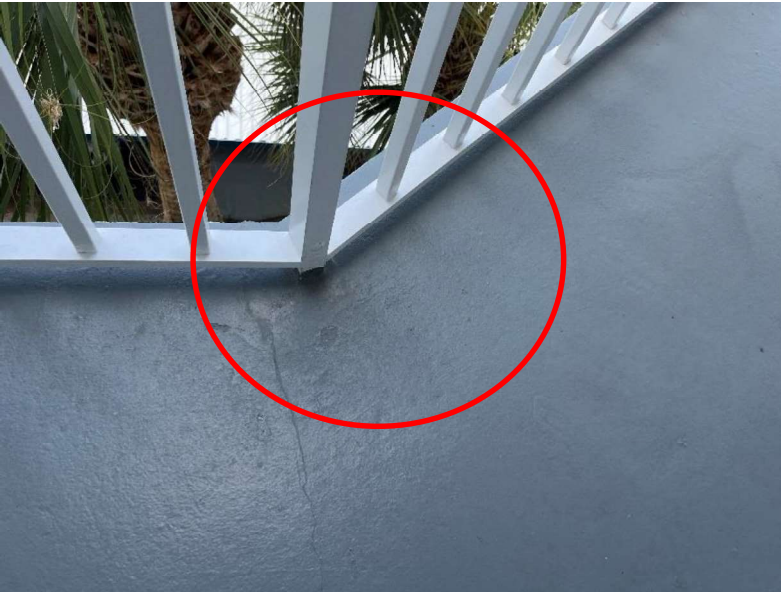
**PHOTOGRAPH #54**

**WALKWAYS  
4<sup>TH</sup> FLOOR  
ADJACENT UNIT 406**

During Phase I inspection, walkway surface distress (around post pocket) was observed and identified as an area that required further investigation. Investigations during phase II revealed that the condition did not represent substantial structural damage.

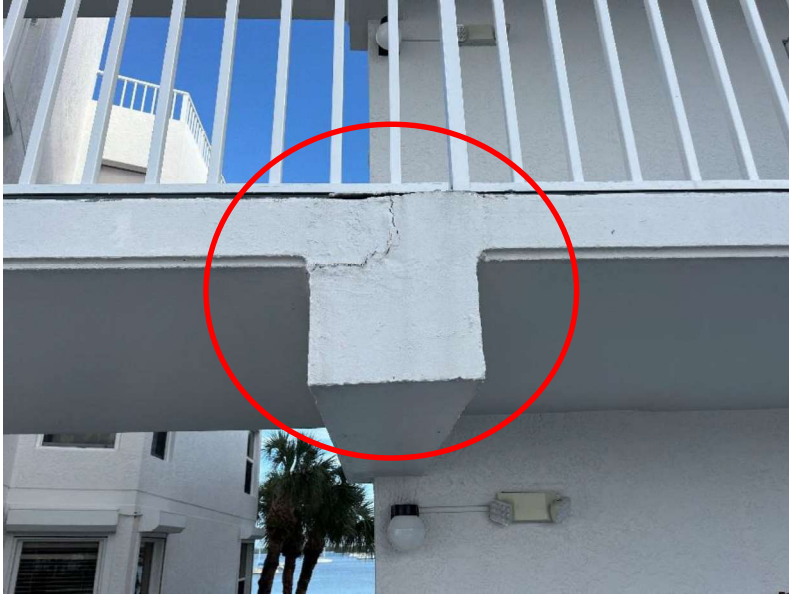
**PHOTOGRAPH #55**

**WALKWAYS  
4<sup>TH</sup> FLOOR WALKWAY  
EXPANSION JOINT  
ADJACENT UNITS 407/307**

Deteriorated sealant at expansion joint. This condition does not represent substantial structural deterioration but could lead to structural deterioration if not repaired (Typ. at all walkway expansion joints).

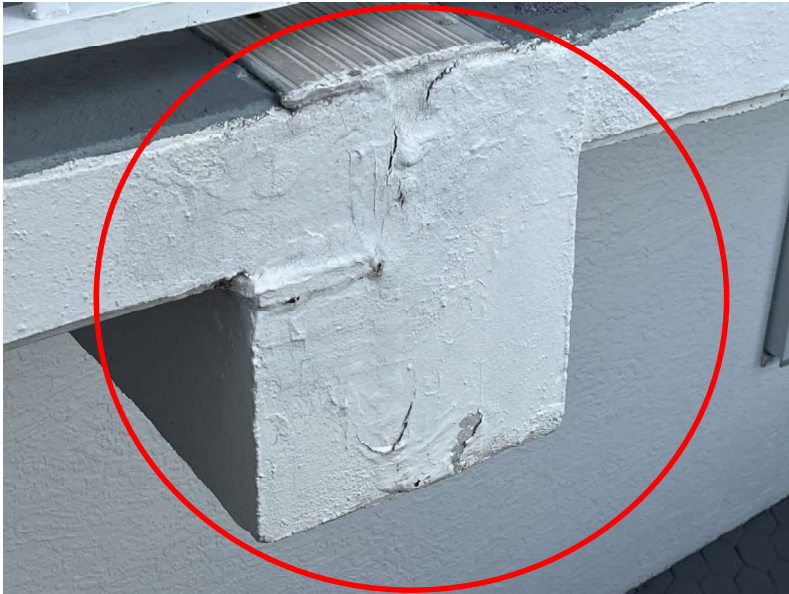
**PHOTOGRAPH #56**

**WALKWAYS  
4<sup>TH</sup> FLOOR WALKWAY  
EXPANSION JOINT  
ADJACENT UNITS 407/307**

Deteriorated sealant at expansion joint. This condition does not represent substantial structural deterioration but could lead to structural deterioration if not repaired (Typ. at all walkway expansion joints).

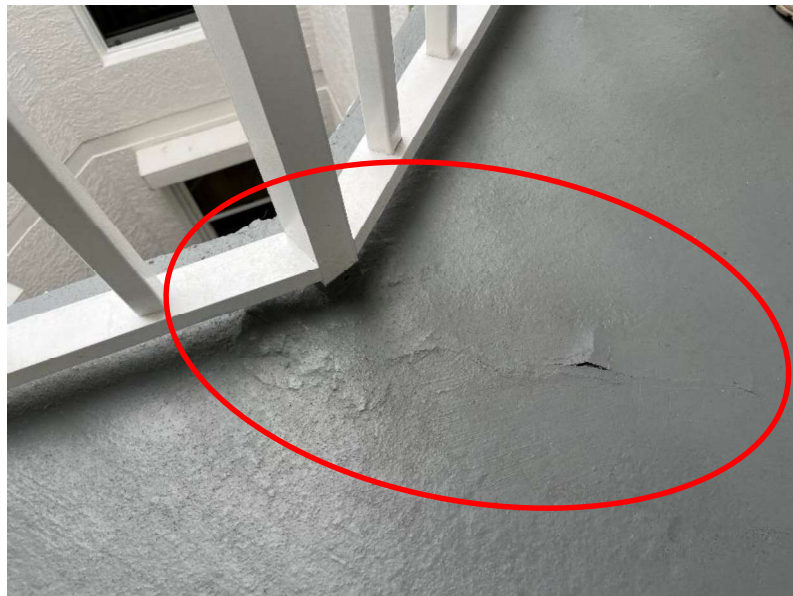
**PHOTOGRAPH #57**

**WALKWAYS  
4<sup>TH</sup> FLOOR  
ADJACENT UNIT 408**

During Phase I inspection, walkway surface distress (around post pocket) was observed and identified as an area that required further investigation. During Phase II inspection the surface finishes around the subject area were removed. The investigation revealed that the concrete and post pocket was undamaged, and the distress was limited to the failed top coating at the subject area. The observed distress did not represent substantial structural damage; however, we recommend that new flexible coating to be applied after appropriate surface preparation at the subject area to avoid future structural damage.

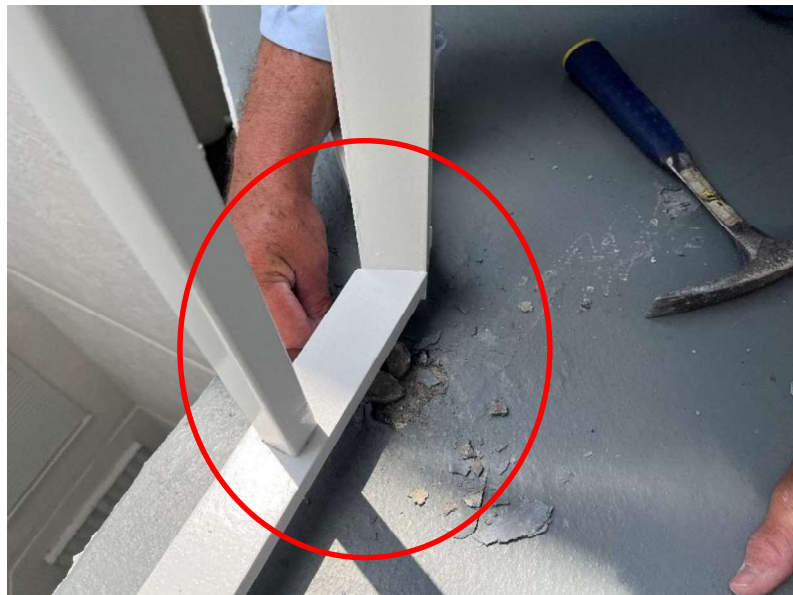
**PHOTOGRAPH #58**

**WALKWAYS  
4<sup>TH</sup> FLOOR  
ADJACENT UNIT 408**

During Phase I inspection, walkway surface distress (around post pocket) was observed and identified as an area that required further investigation. During Phase II inspection the surface finishes around the subject area were removed. The investigation revealed that the concrete and post pocket was undamaged, and the distress was limited to the failed top coating at the subject area. The observed distress did not represent substantial structural damage; however, we recommend that new flexible coating to be applied after appropriate surface preparation at the subject area to avoid future structural damage.

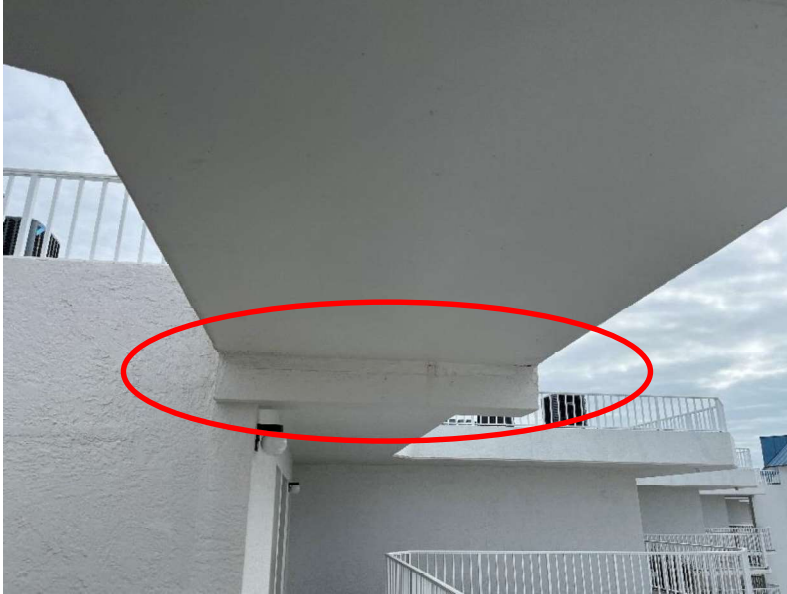
**PHOTOGRAPH #59**

**WALKWAYS  
4<sup>TH</sup> FLOOR WALKWAY  
EXPANSION JOINT  
ADJACENT UNIT 409**

Rust staining of steel angle at walkway dropped beam from failure of expansion joint sealant. This condition does not represent substantial structural deterioration but could lead to structural deterioration if not repaired.

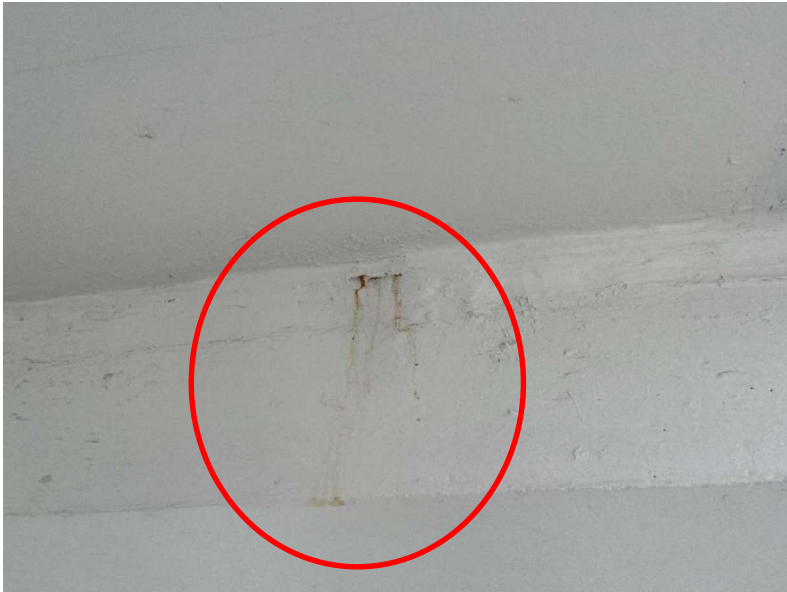
**PHOTOGRAPH #60**

**WALKWAYS  
4<sup>TH</sup> FLOOR WALKWAY  
EXPANSION JOINT  
ADJACENT UNIT 409**

Rust staining of steel angle at walkway dropped beam from failure of expansion joint sealant. This condition does not represent substantial structural deterioration but could lead to structural deterioration if not repaired.

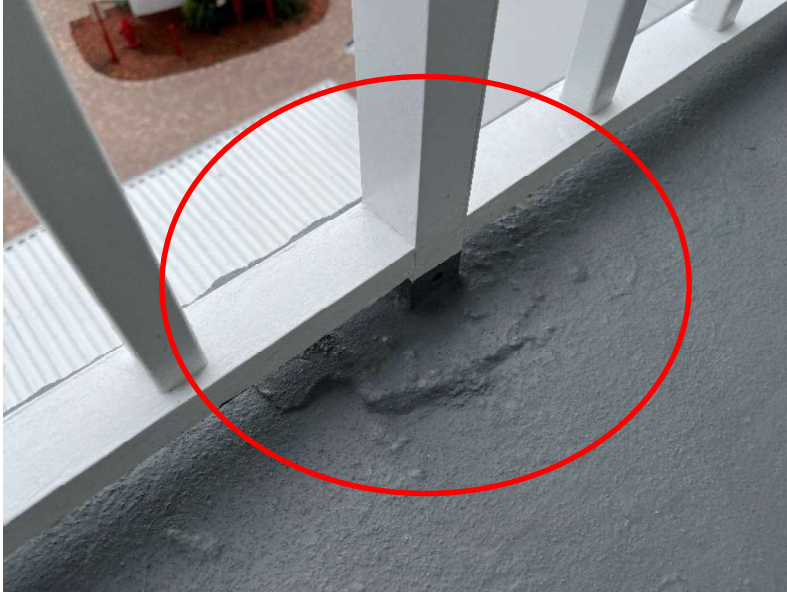
**PHOTOGRAPH #61**

**WALKWAYS  
4<sup>TH</sup> FLOOR  
ADJACENT UNIT 409**

During Phase I inspection, walkway surface distress (around post pocket) was observed and identified as an area that required further investigation. During Phase II inspection the surface finishes around the subject area were removed. The investigation revealed that the Portland cement grout around the post pocket had failed, however the concrete slab was undamaged. Although the condition did not represent substantial structural damage, the post pocket issue must be addressed in order to avoid future damage to structural components.

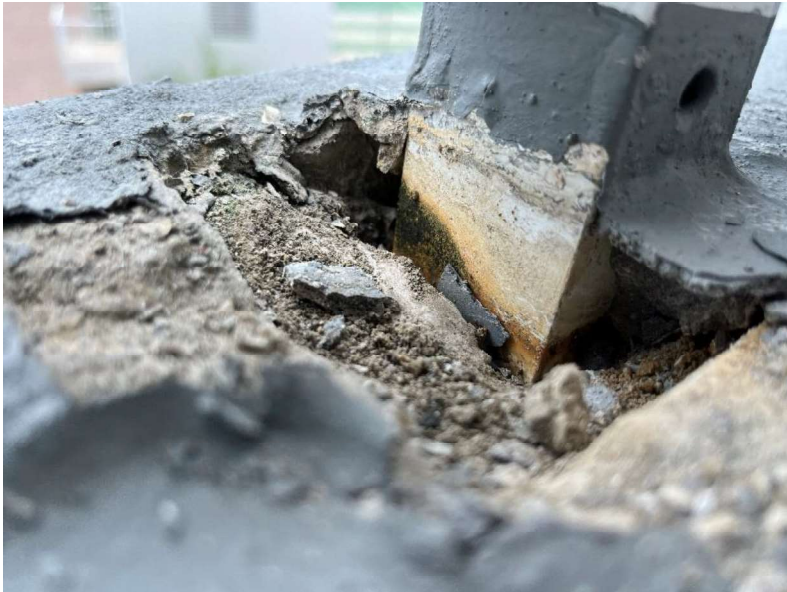
**PHOTOGRAPH #62**

**WALKWAYS  
4<sup>TH</sup> FLOOR  
ADJACENT UNIT 409**

During Phase I inspection, walkway surface distress (around post pocket) was observed and identified as an area that required further investigation. During Phase II inspection the surface finishes around the subject area were removed. The investigation revealed that the Portland cement grout around the post pocket had failed; however, the concrete slab was undamaged. Although the condition did not represent substantial structural damage, the post pocket issue must be addressed in order to avoid future damage to structural components.

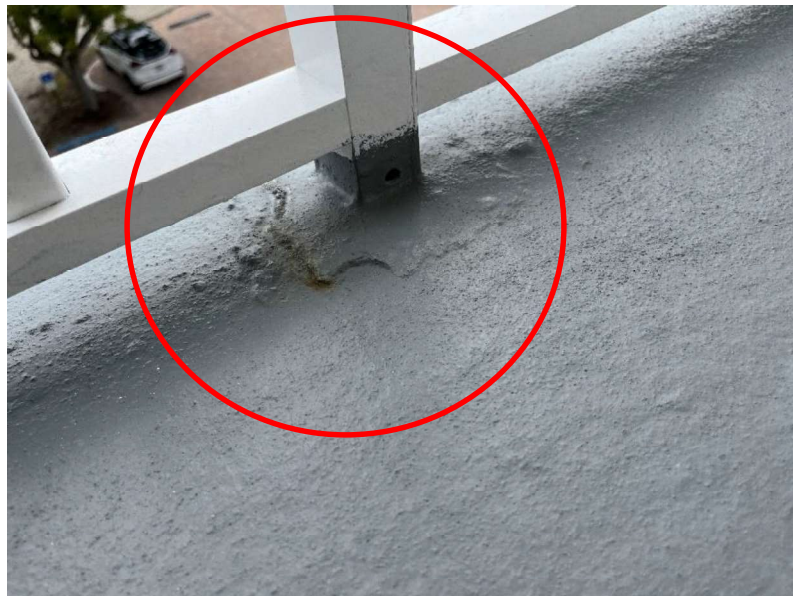
**PHOTOGRAPH #63**

**WALKWAYS  
4<sup>TH</sup> FLOOR  
ADJACENT UNIT 409**

During Phase I inspection, walkway surface distress (around post pocket) was observed and identified as an area that required further investigation. During Phase II inspection the surface finishes around the subject area were removed. The investigation revealed that the Portland cement grout around the post pocket had failed; however, the concrete slab was undamaged. Although the condition did not represent substantial structural damage, the post pocket issue must be addressed in order to avoid future damage to structural components.
