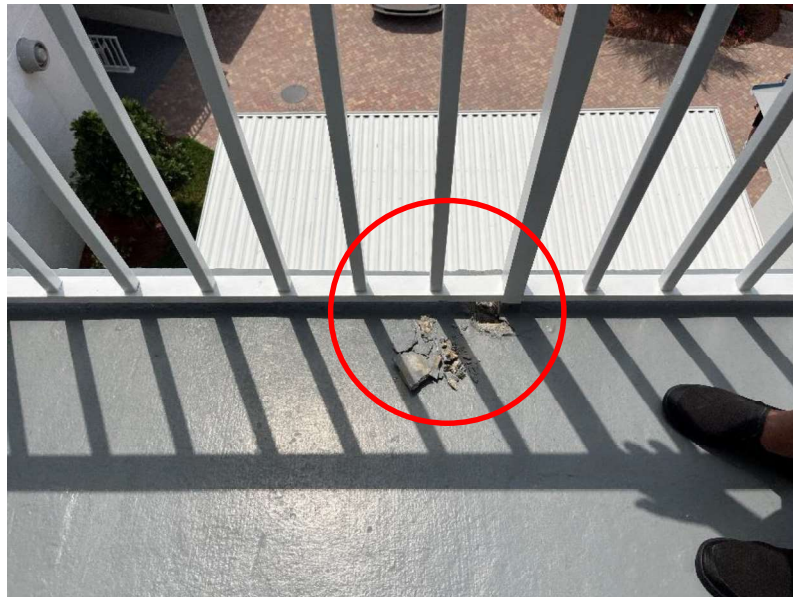
**PHOTOGRAPH #64**

**WALKWAYS  
4<sup>TH</sup> FLOOR  
ADJACENT UNIT 409**

During Phase I inspection, walkway surface distress (around post pocket) was observed and identified as an area that required further investigation. During Phase II inspection the surface finishes around the subject area were removed. The investigation revealed that the Portland cement grout around the post pocket had failed; however, the concrete slab was undamaged. Although the condition did not represent substantial structural damage, the post pocket issue must be addressed in order to avoid future damage to structural components.

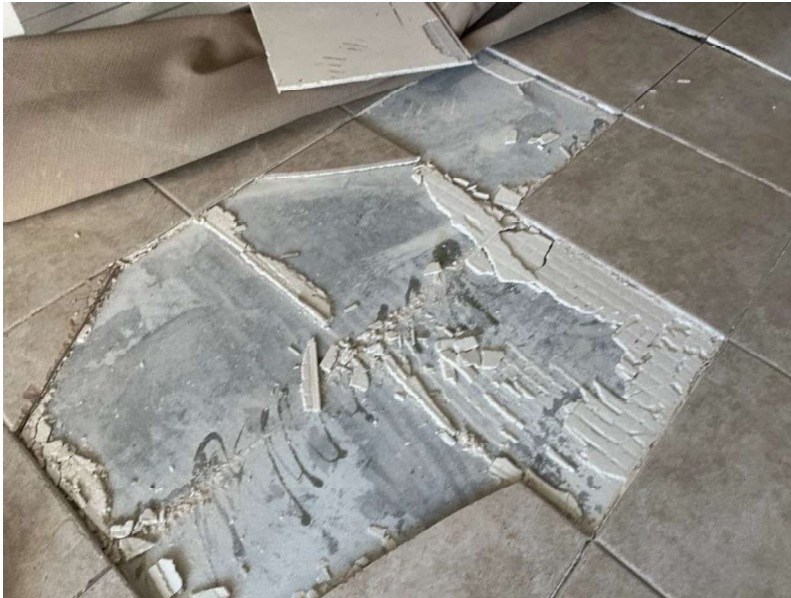
**PHOTOGRAPH #69**

**INTERIOR UNITS  
UNIT 104**

During Phase I inspection, delaminated ceramic floor tile was observed. Further investigation during Phase II, including partial removal of the delaminated tiles and sounding of the floor concrete below, indicated that the concrete floor slab was not damaged. The delaminated tiles were attributable to the expansion of the tiles due to temperature changes and the lack provision to allow tiles to expand. The observed conditions did not represent substantial structural damage.

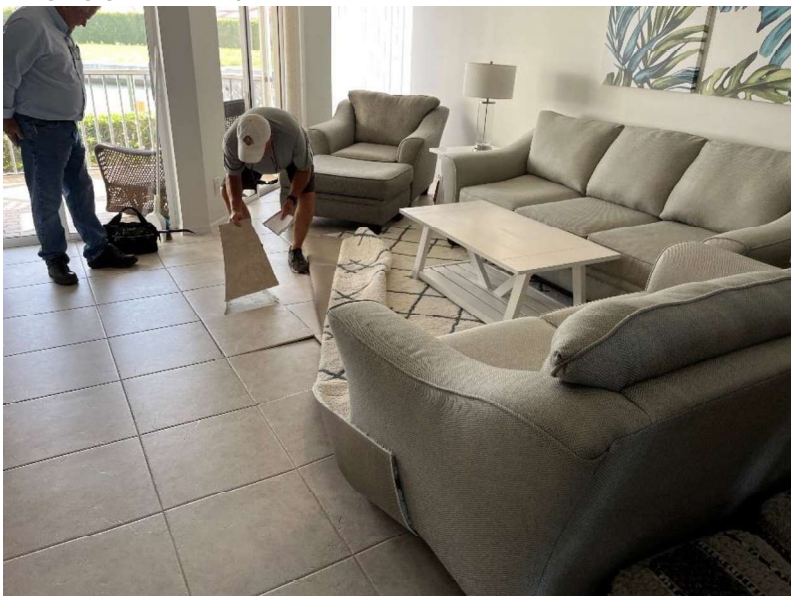
**PHOTOGRAPH #70**

**INTERIOR UNITS  
UNIT 104**

During Phase I inspection, delaminated ceramic floor tile was observed. Further investigation during Phase II, including partial removal of the delaminated tiles and sounding of the floor concrete below, indicated that the concrete floor slab was not damaged. The delaminated tiles were attributable to the expansion of the tiles due to temperature changes and the lack provision to allow tiles to expand. The observed conditions did not represent substantial structural damage.

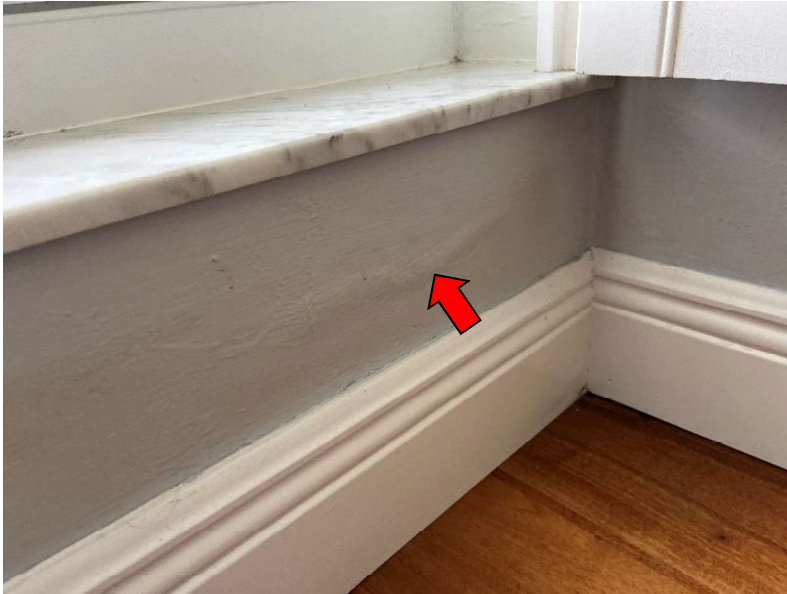
**PHOTOGRAPH #71**

**INTERIOR UNITS  
UNIT 206**

Paint bubbling at drywall.

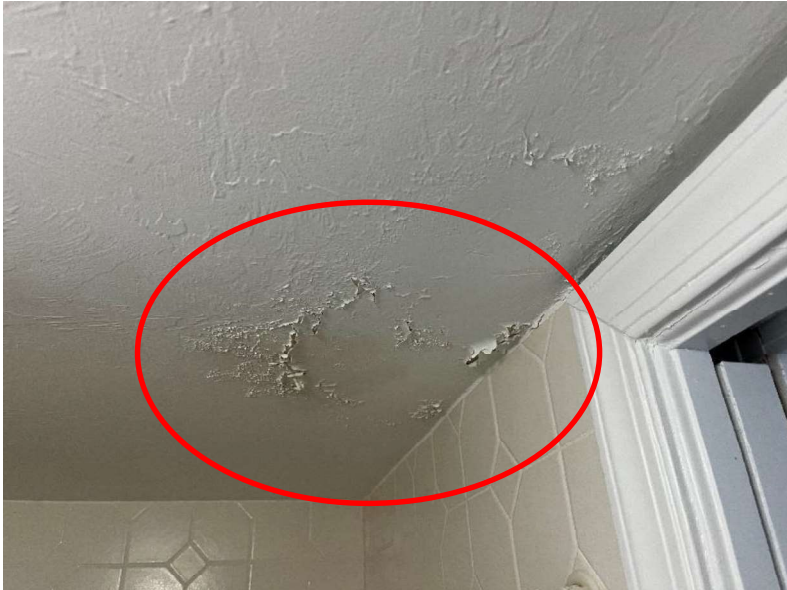
**PHOTOGRAPH #72**

**INTERIOR UNITS  
UNIT 209**

Paint peeling at bathroom ceiling drywall.

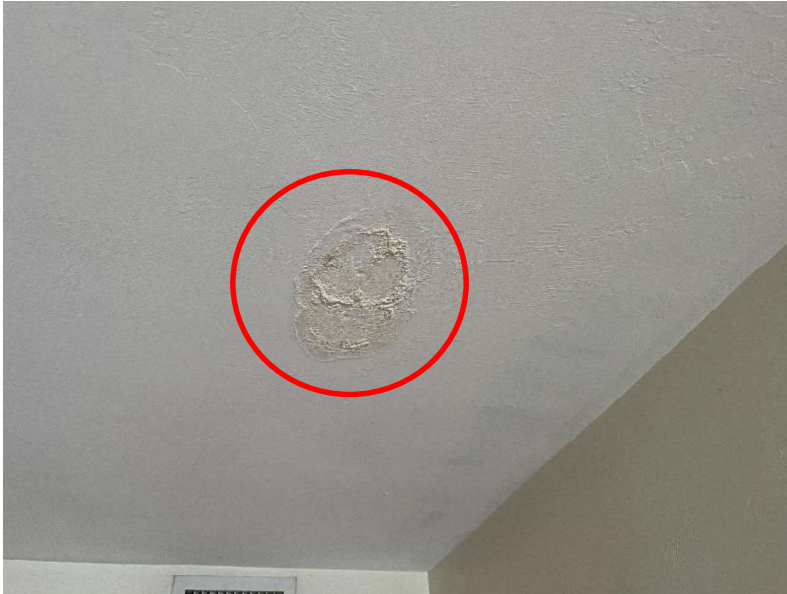
**PHOTOGRAPH #73**

**INTERIOR UNITS  
UNIT 404**

Water stain at ceiling drywall.

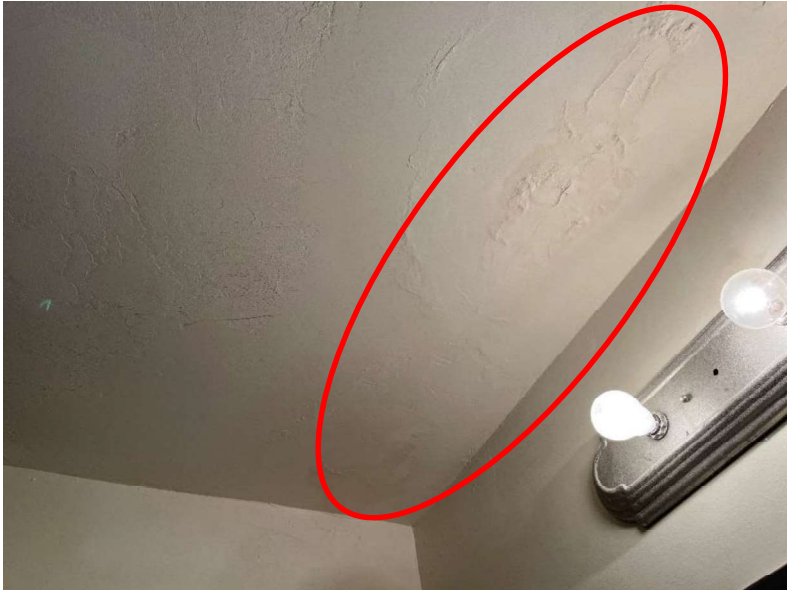
**PHOTOGRAPH #74**

**INTERIOR UNITS  
UNIT 404**

Water stain at ceiling drywall.

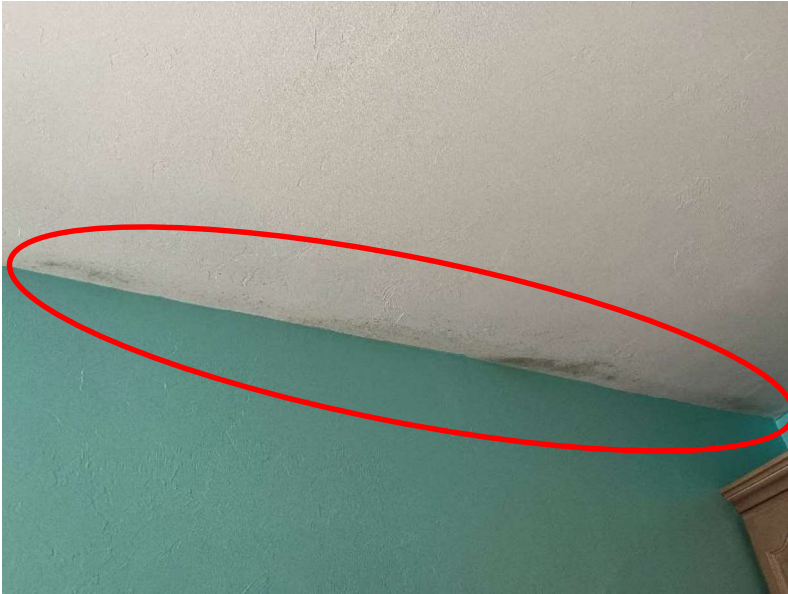
**PHOTOGRAPH #75**

**INTERIOR UNITS  
UNIT 408**

Organic growth and staining at ceiling drywall.

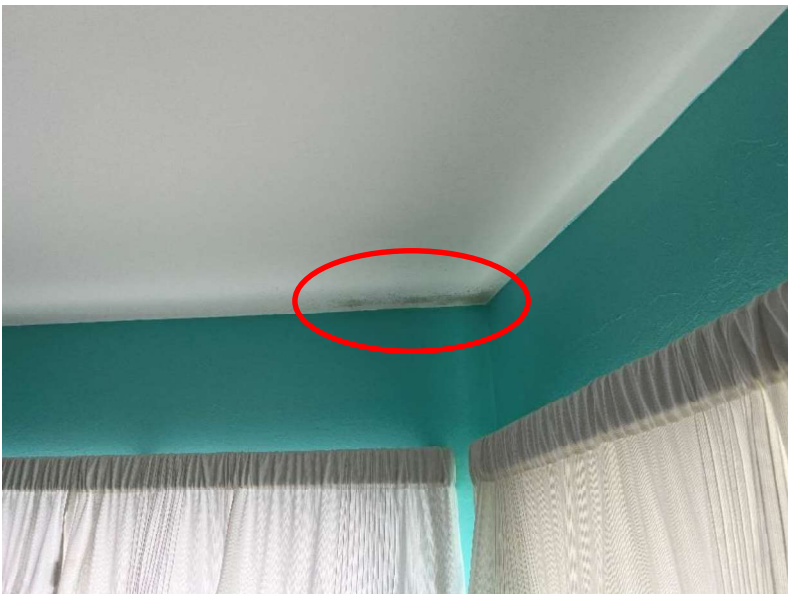
**PHOTOGRAPH #76**

**INTERIOR UNITS  
UNIT 408**

Organic growth and staining at ceiling drywall.

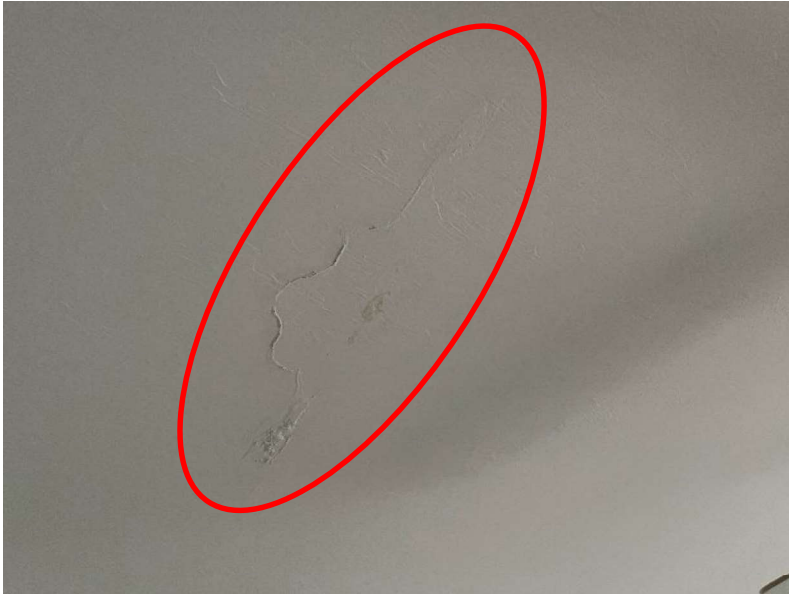
**PHOTOGRAPH #77**

**INTERIOR UNITS  
UNIT 411**

Water stain and cracking at ceiling drywall.

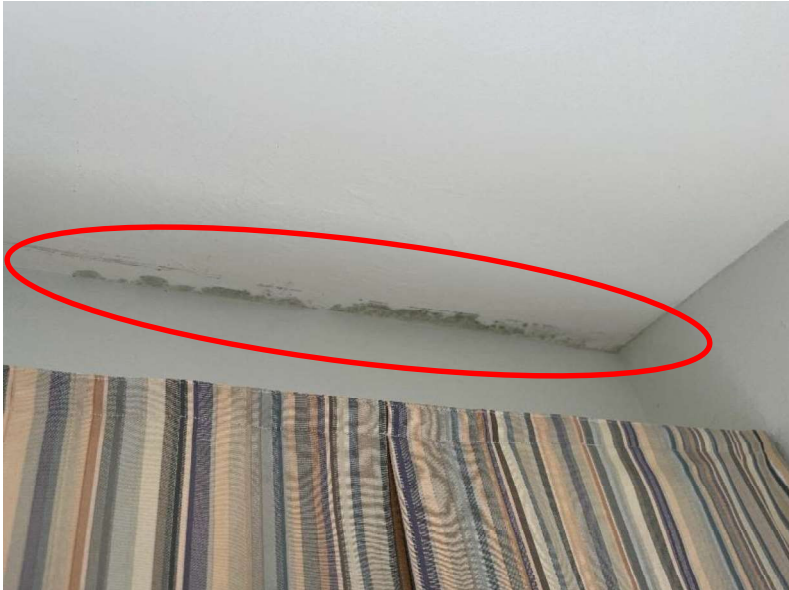
**PHOTOGRAPH #78**

**INTERIOR UNITS  
UNIT 411**

Organic growth and staining at ceiling drywall.
