**BONDURANT**  
ARCHITECTURE

### HURON COVE CONDOMINIUMS 911 HURON COURT

**Site-Visit Date:**  
August 27, 2024

**Report Date:**  
August 29, 2024

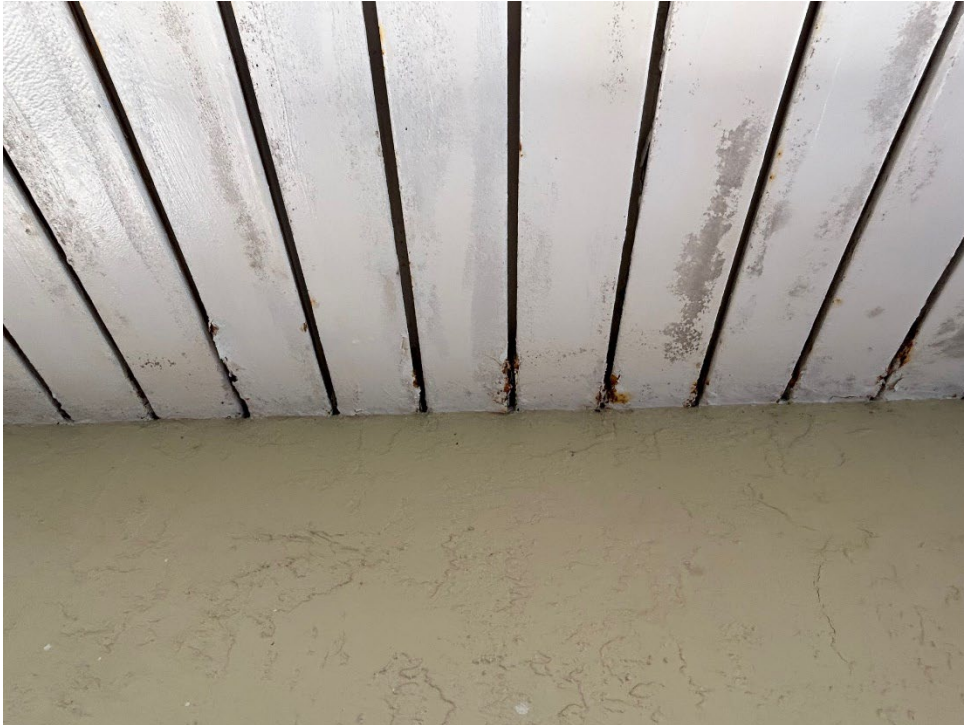
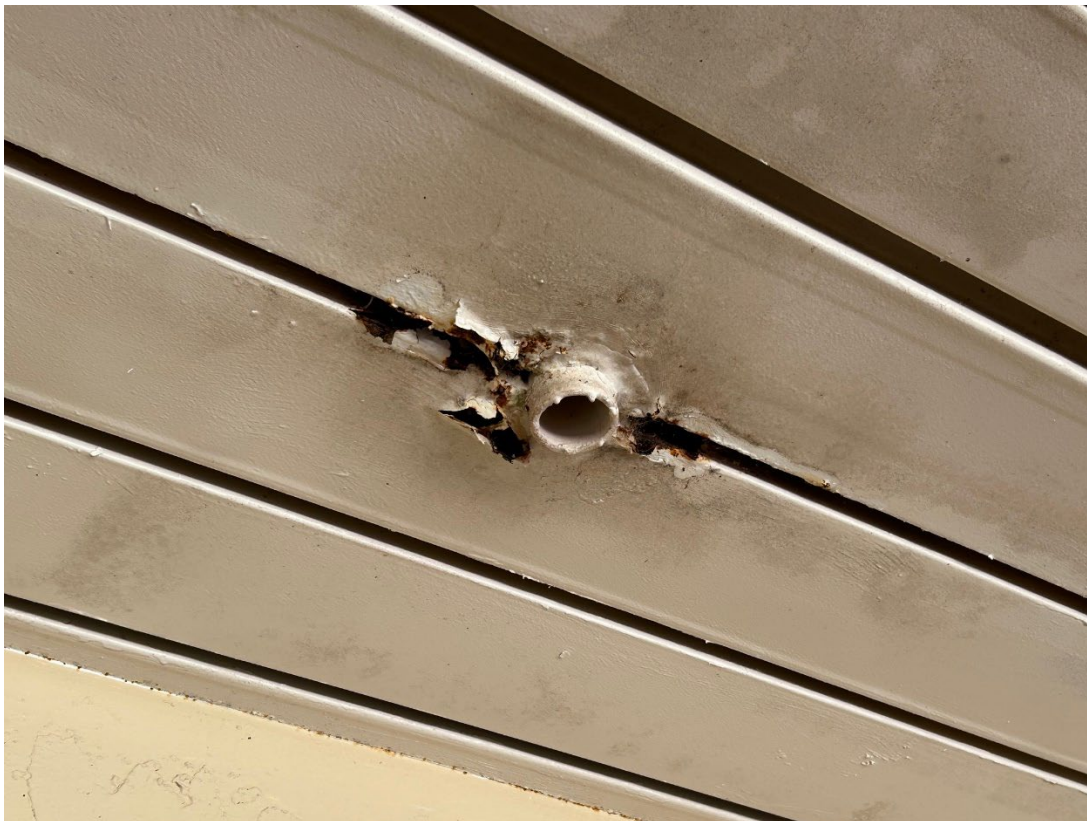
## **Rust and Corrosion on Metal Deck**

Above the parking carport is a grooved metal deck. This deck has some rust on it and one area around a floor drain was particularly corroded. Inspector suggests removing the rust and coating the metal with a high grade rust proofer (ie Rust-Oleum 7000) prior to painting. Repair any water damage prior to painting.

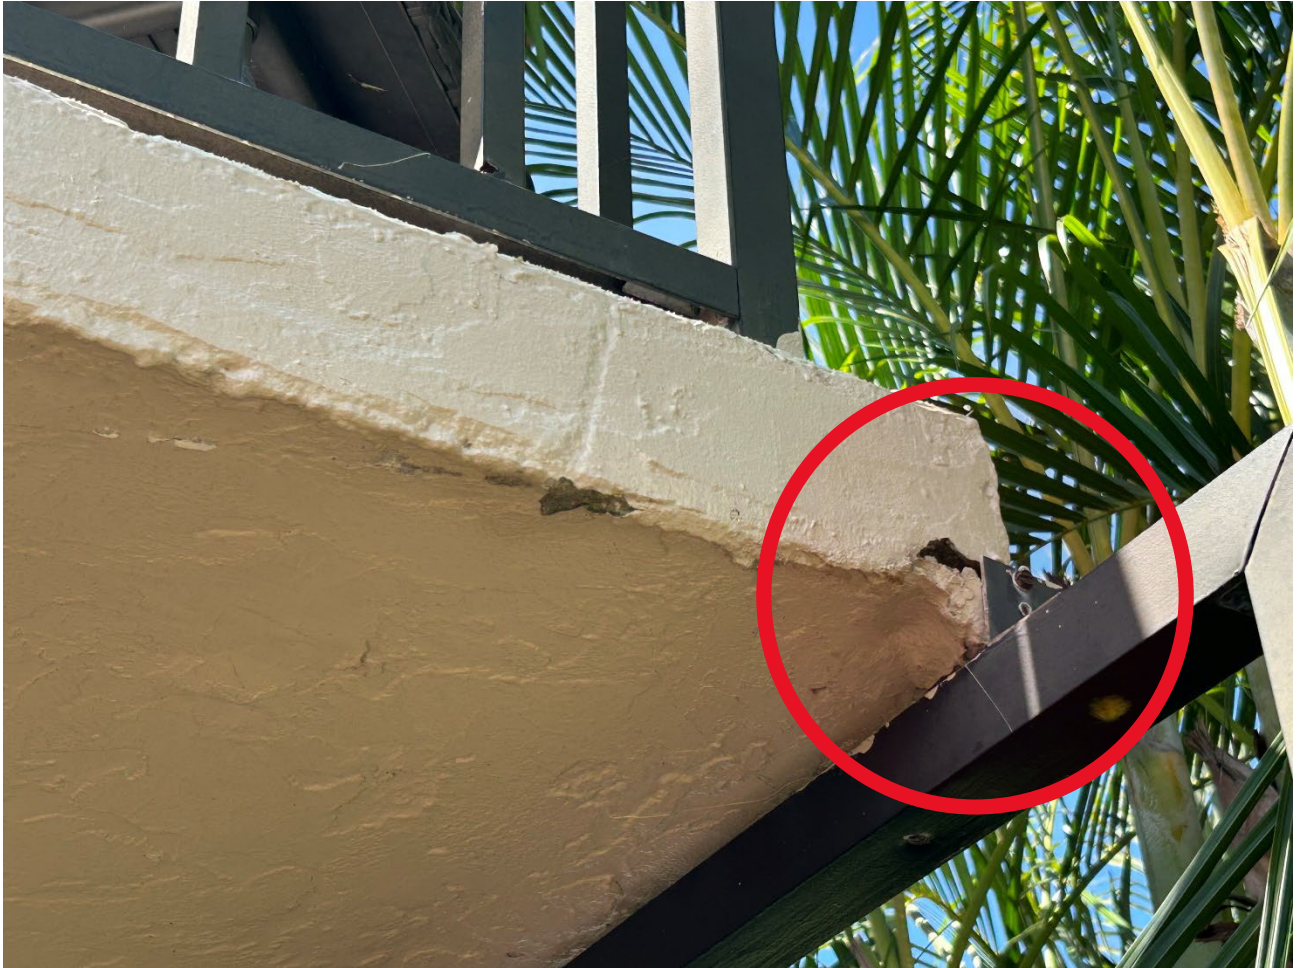
### Corner of Balcony Slab

This balcony is on the front left corner of the building. Gaps in the concrete like this can allow salty water to get into slab and corrode embedded steel re-bars. Suggest having this repaired prior to painting which is scheduled in the near future.

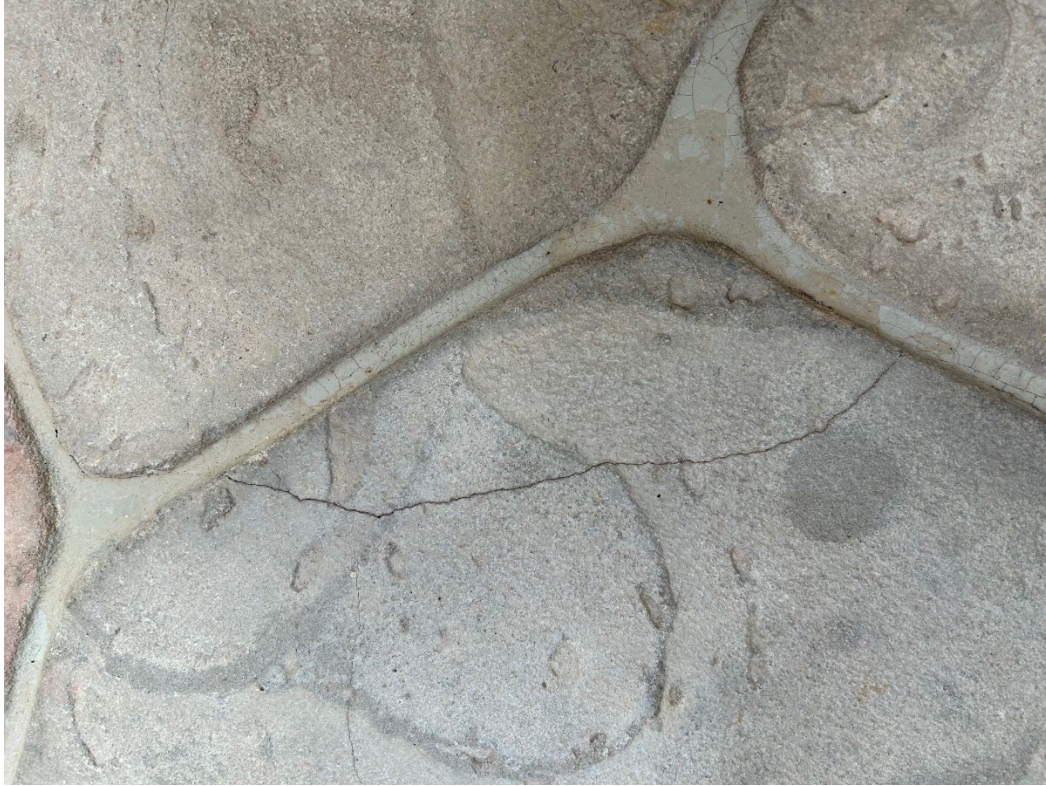
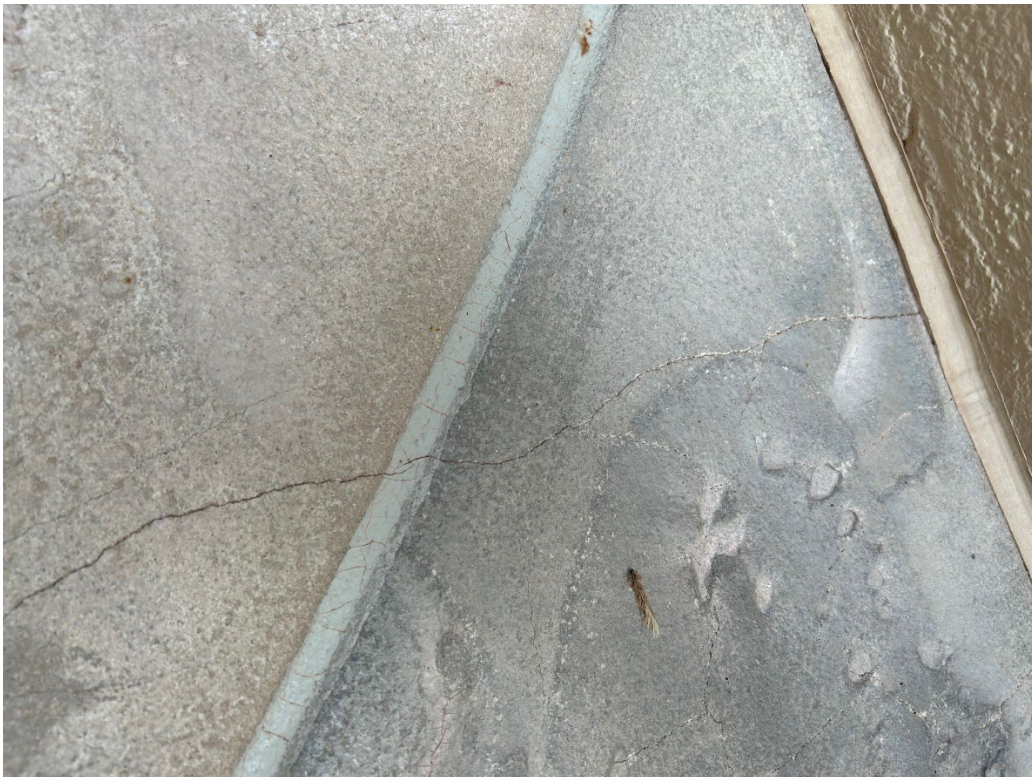
### **Hairline Cracks in Suspended Walkway**

There was observed several hairline cracks in the suspended walkway between buildings. These can allow moisture to get below the surface and corrode the structural slab beneath over time. Suggest having a qualified waterproofing technician apply a high grade sealant to the surface to help fill in cracks and seal them from moisture penetration.

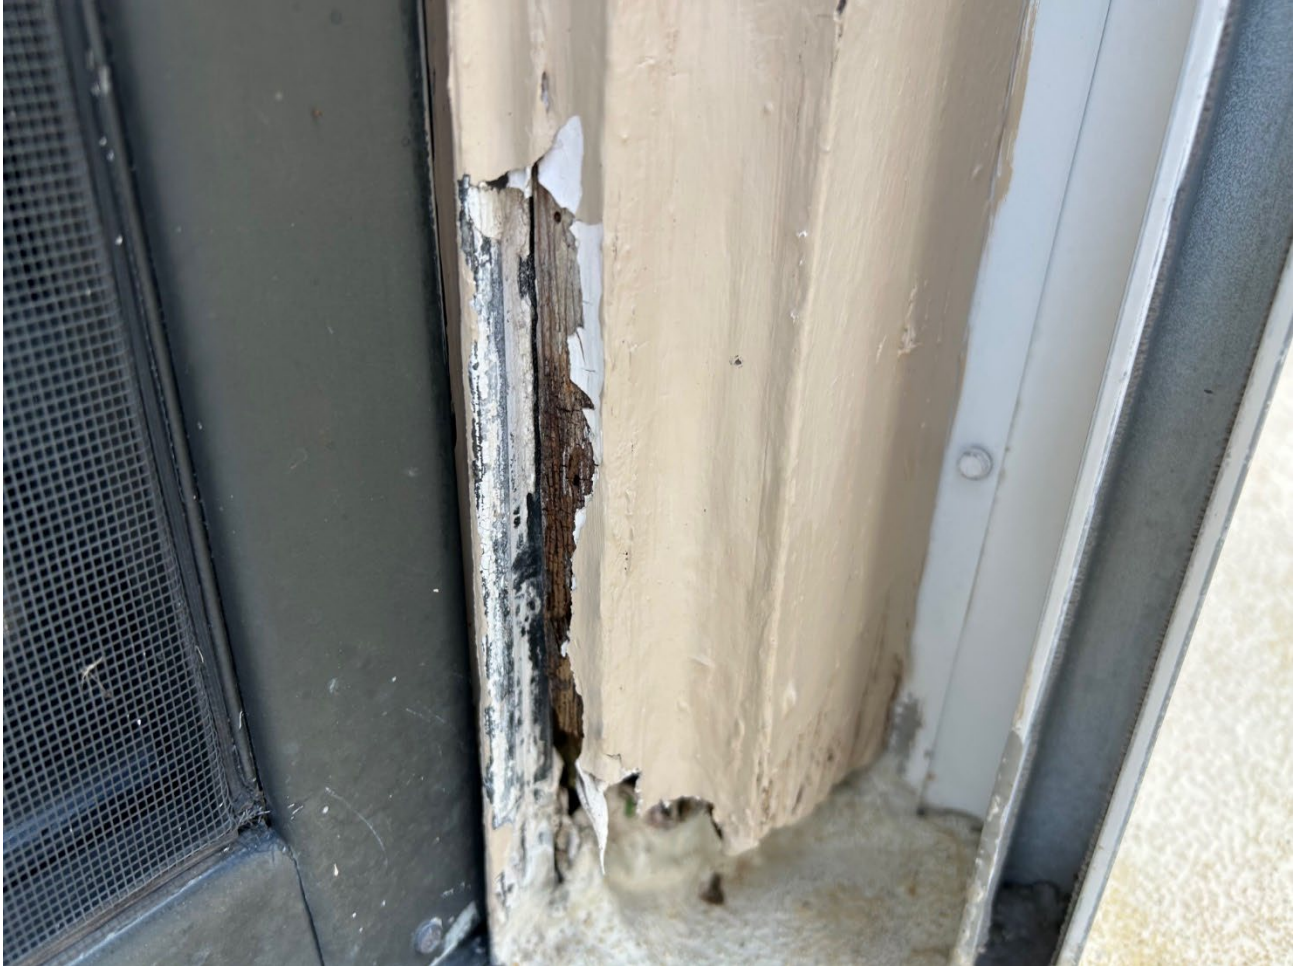
### **Water Damaged Wood Trim**

On the balcony of Unit #7, severely water damaged wood trim was observed. This wood trim is cosmetic but the wet wood against the building surface can lead to deterioration of underlying substrate structural materials. Inspector suggests all such wood trim around the building be further evaluated and replaced as needed.

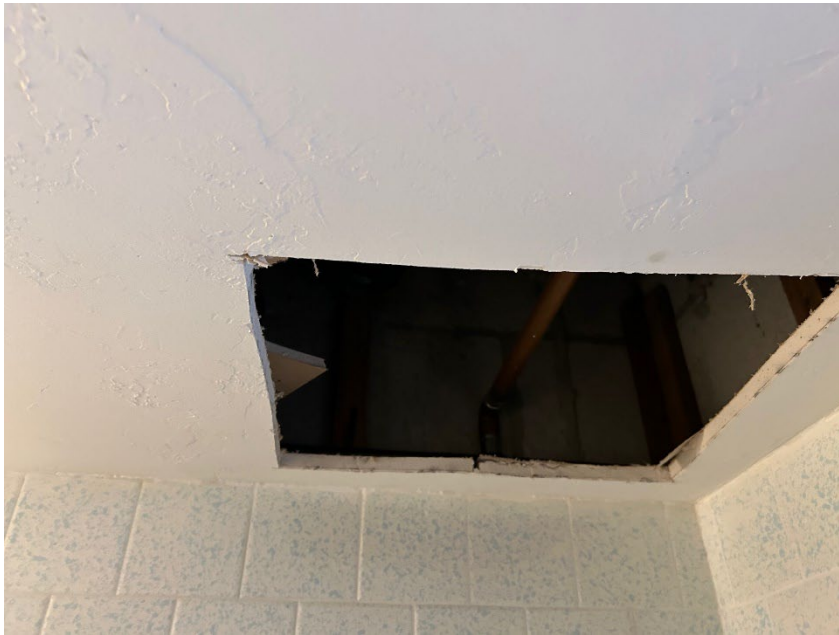
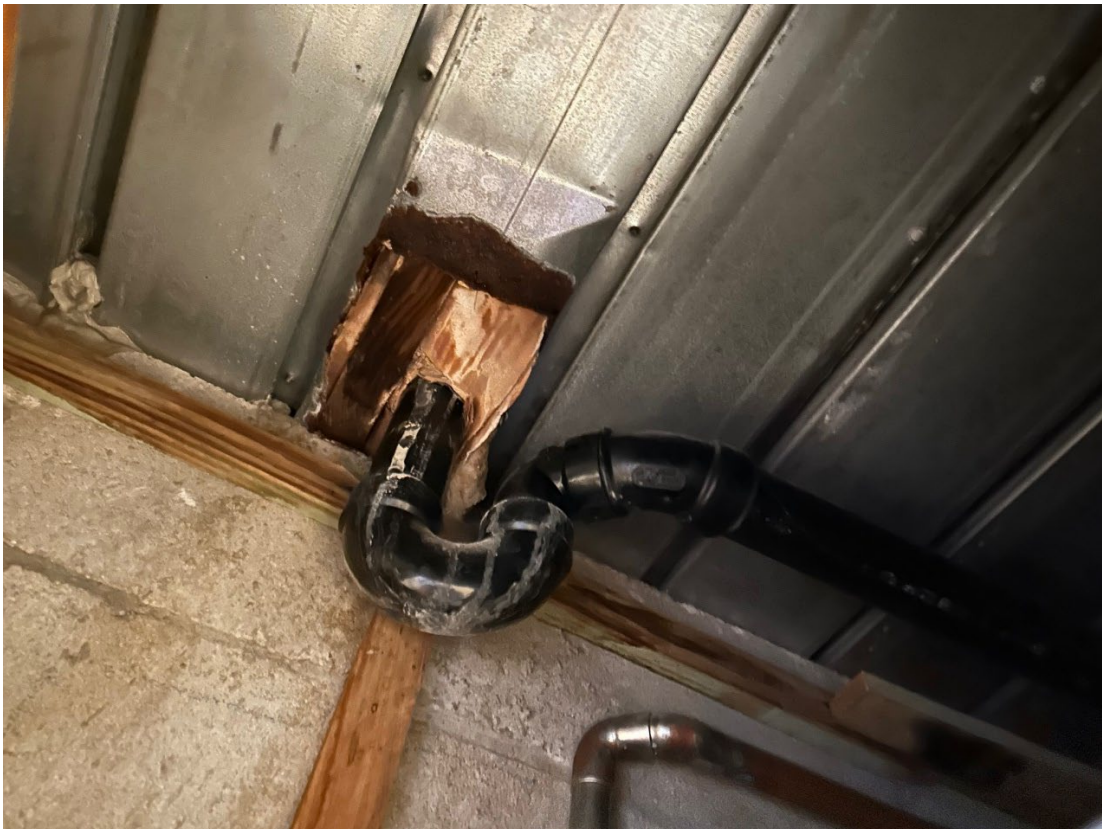
### Unit 2

This Unit 2 had part of the ceiling cut out in the guest bathroom. Probably required to repair a leak as there was a plumbing trap directly above this hole. Chronic water leaks can cause slow deterioration of structural components. Suggest being sure the water leak is fixed before repairing the drywall below it.

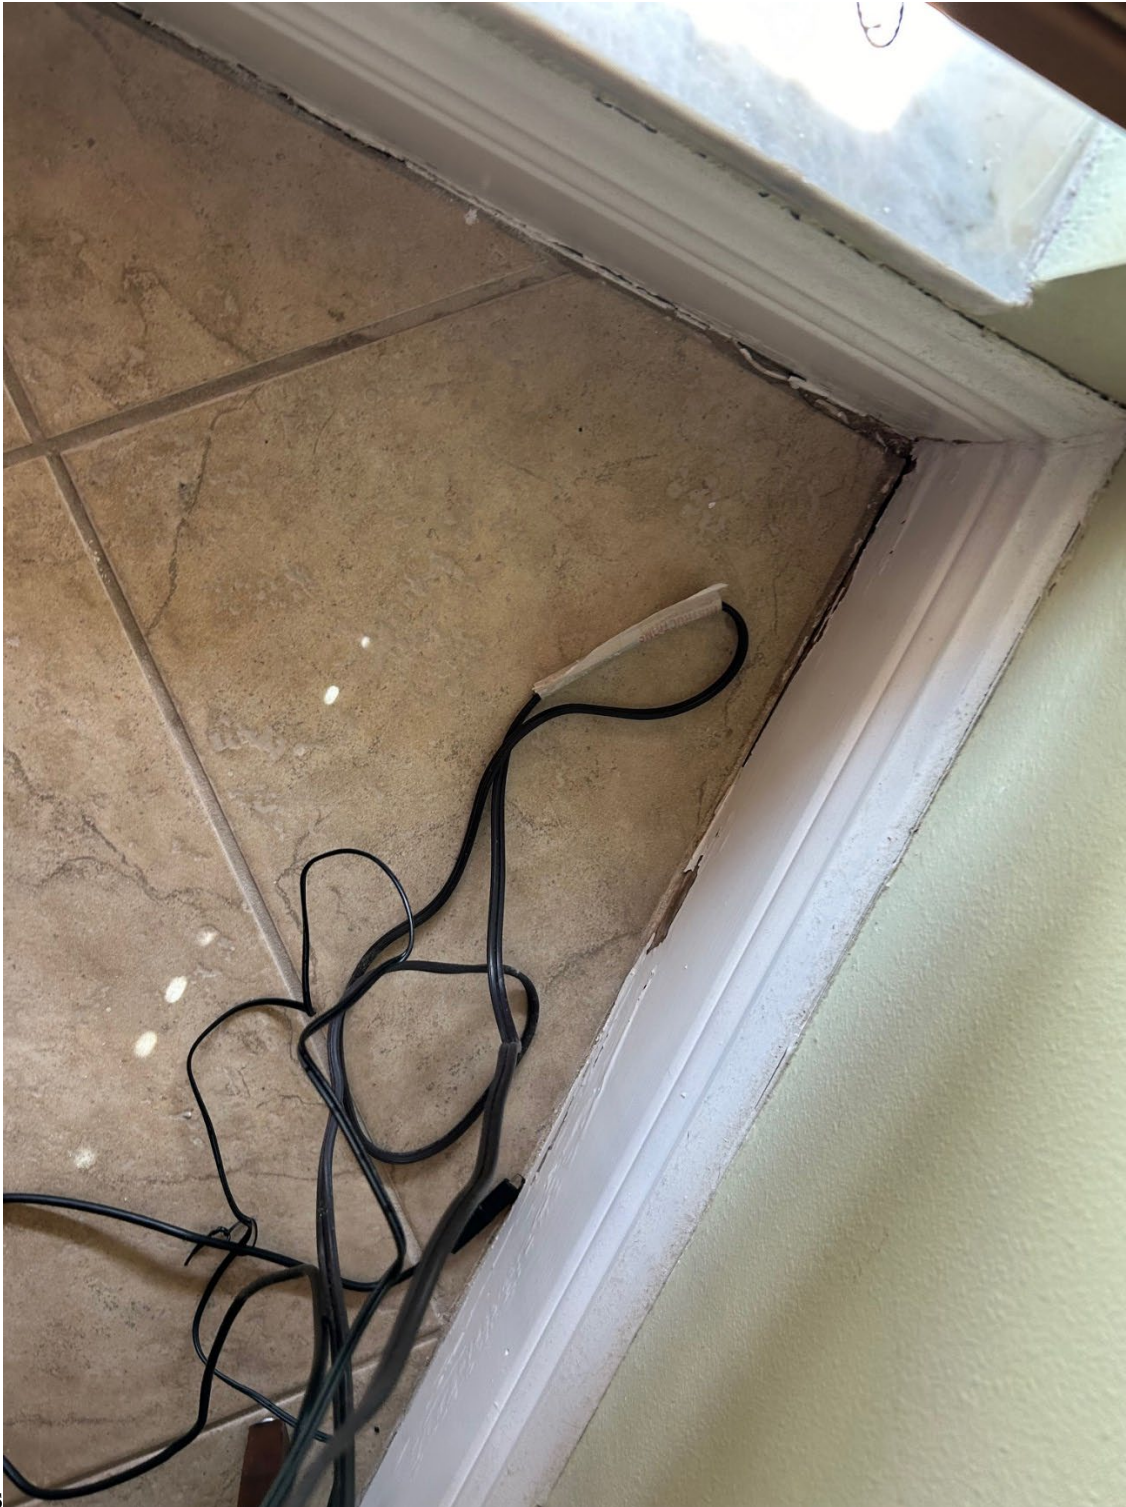
### Unit 3

This unit had some water damaged baseboards in the kitchen underneath the window. Suggest having this baseboard repaired after the source of the water was determined and corrected.

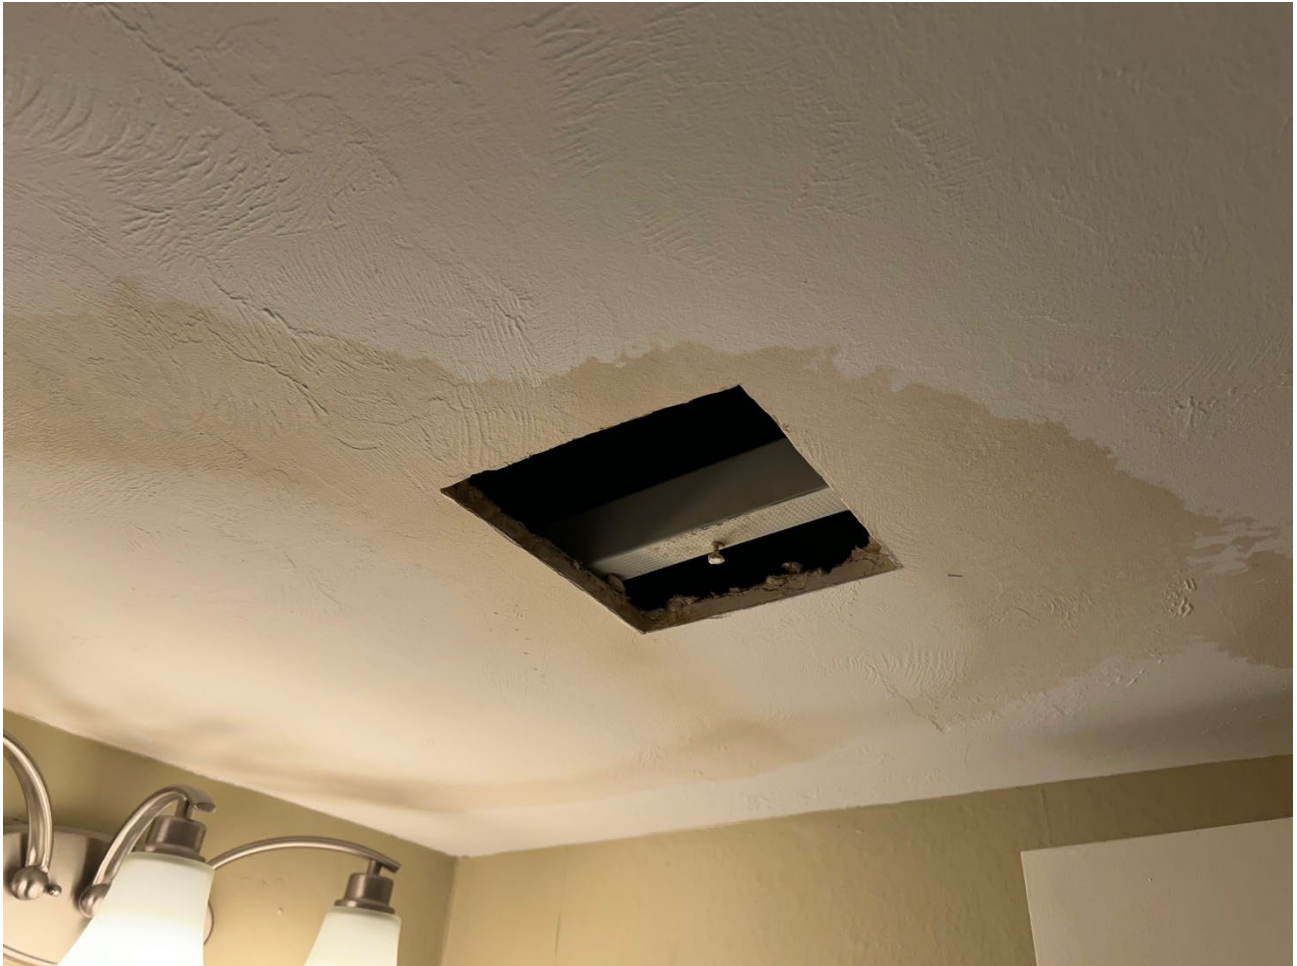
## Unit 7

This unit also had some evidence of a water leak on the ceiling of the guest bath. Appeared that repairs were underway so the source of the water leak must have been repaired.

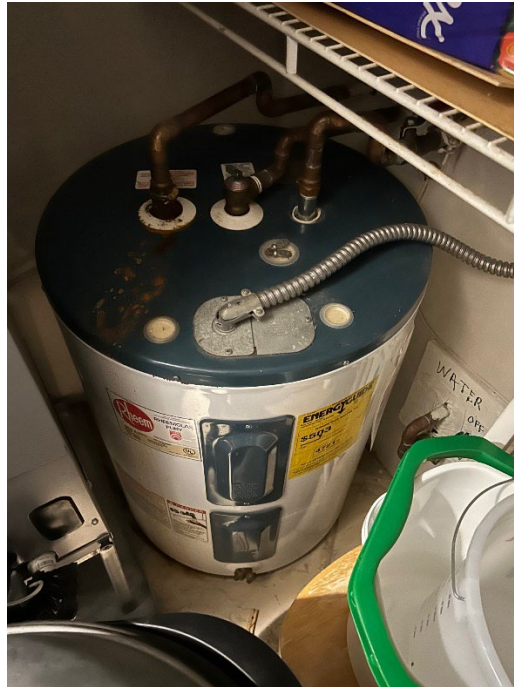
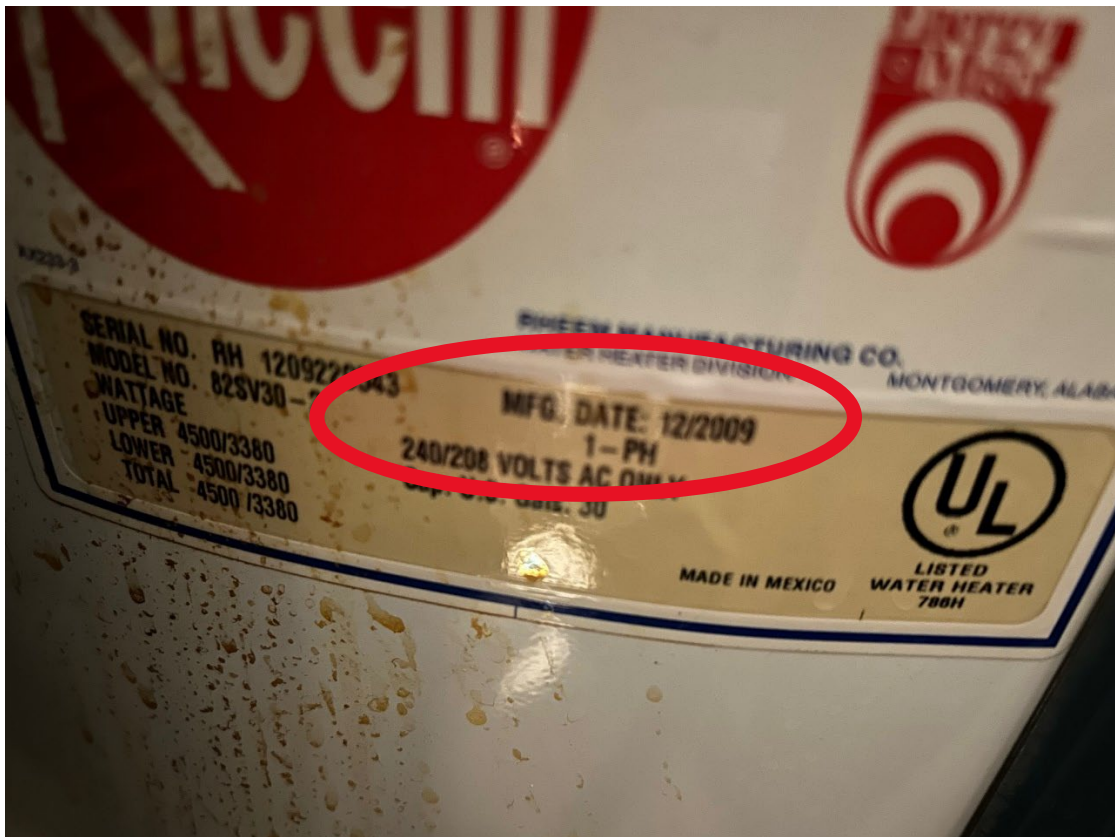
## Unit 8

This unit had a water heater that was 15 years old. The general rule is for water heaters in multi-unit buildings to be changed out every 12-15 years. This unit had rust on the top and around the bottom, which can be early signs of an impending tank failure. Suggest having this water heater replaced as soon as possible, and have all residents check the age of their water heaters and change any that are 15 years old or older.

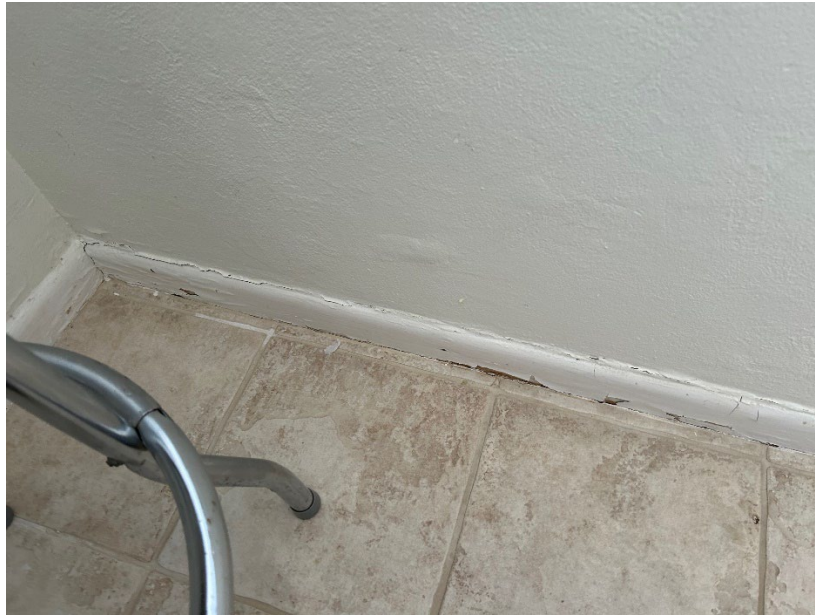
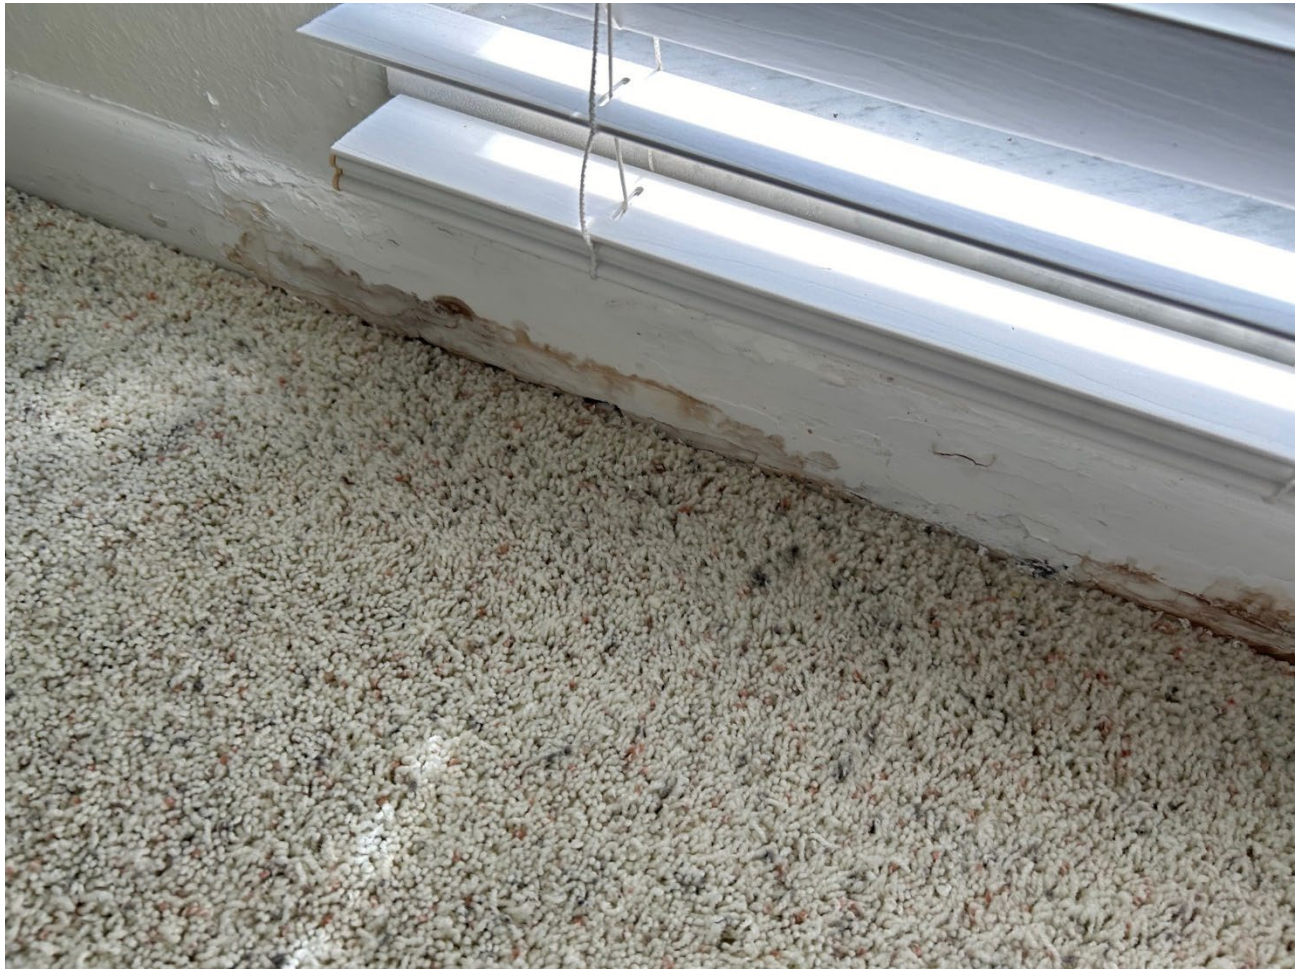
## Unit 10

This unit had evidence of water damage in the kitchen and living room near the window. Suggest having the source of this water determined and corrected. Then have the water damaged repaired and monitored over time to see if any dampness returns to this area.

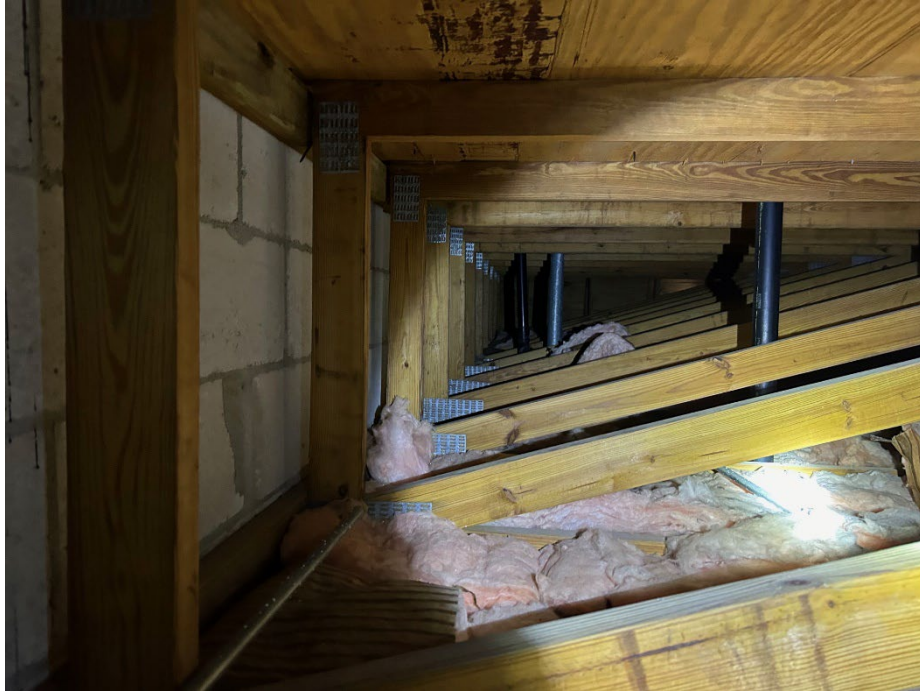
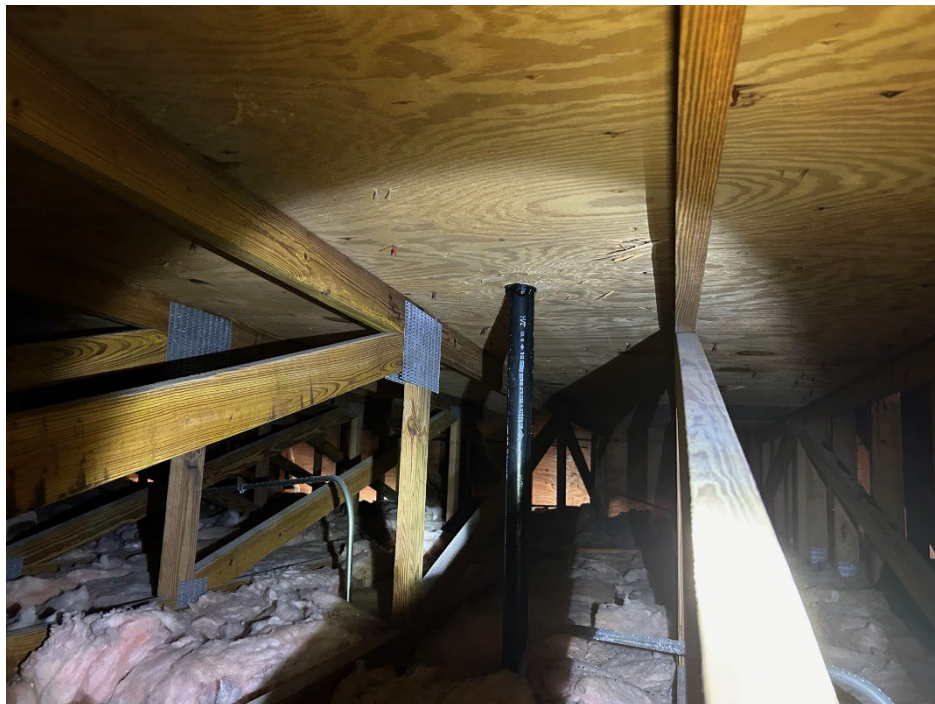
#### Typical Wood Trusses

The roofs of these buildings are framed with pre-engineered wood trusses. The attic was accessed to assess the condition of these trusses. All trusses observed were in good condition with appropriately size gusset plates at intersections. Double straps and hurricane clips were also noted in place as required by current codes. No checking or splitting of wood members were seen, and plywood roof decking showed no signs of deterioration.

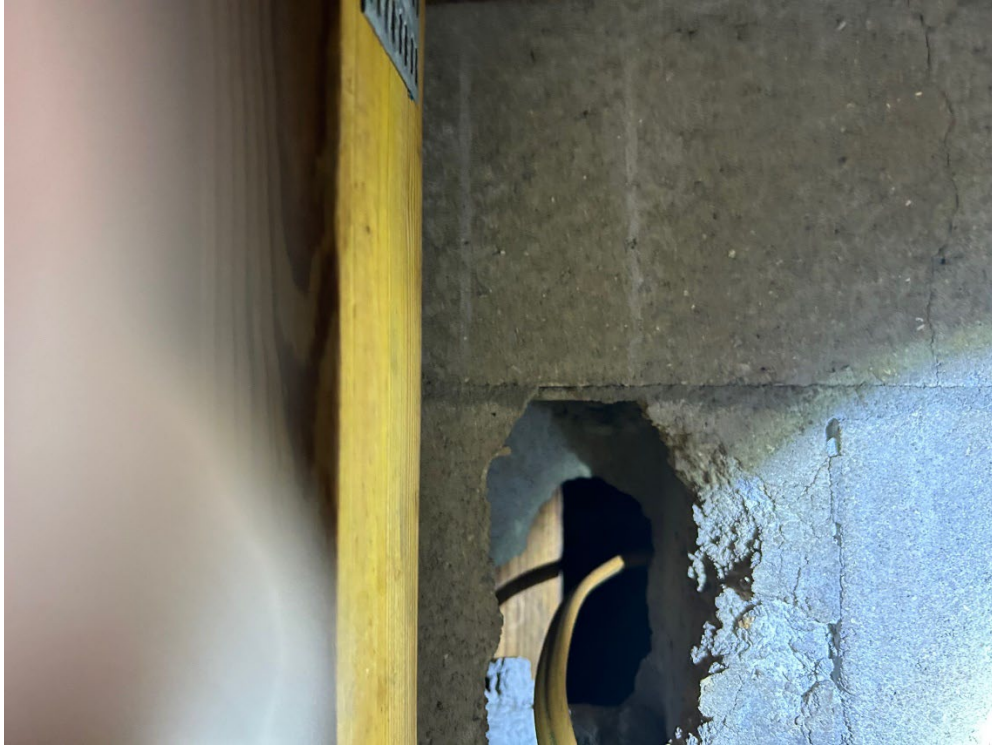
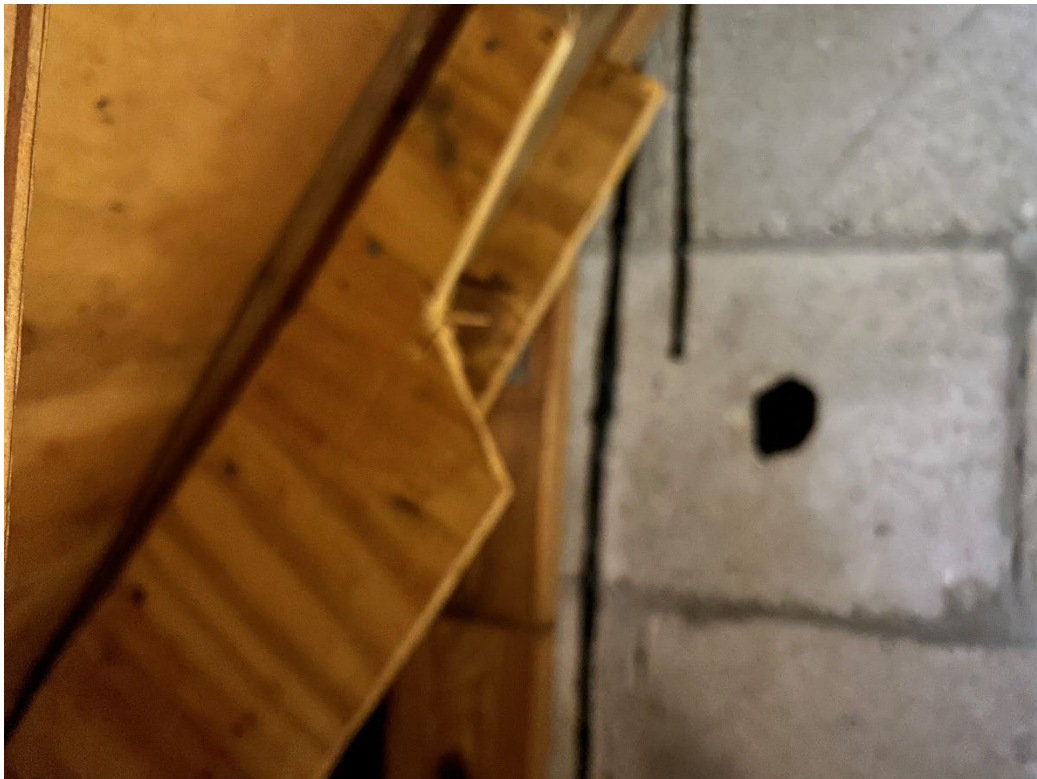
### One Condition in Attic to Address

There appeared to be several holes in the party wall between units that acts as a smoke barrier (draft stop). It is important that any holes in this wall be filled with a fire resistant material to maintain the smoke separation in the event of a fire. Suggest having any such holes filled and sealed by a qualified fire proofing technician.

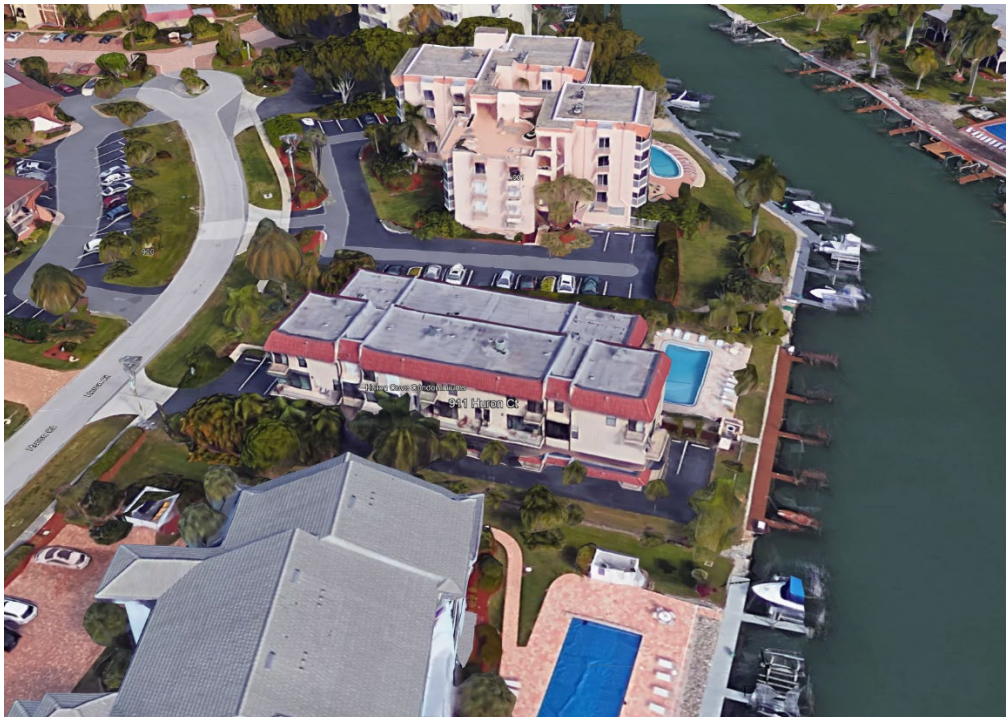
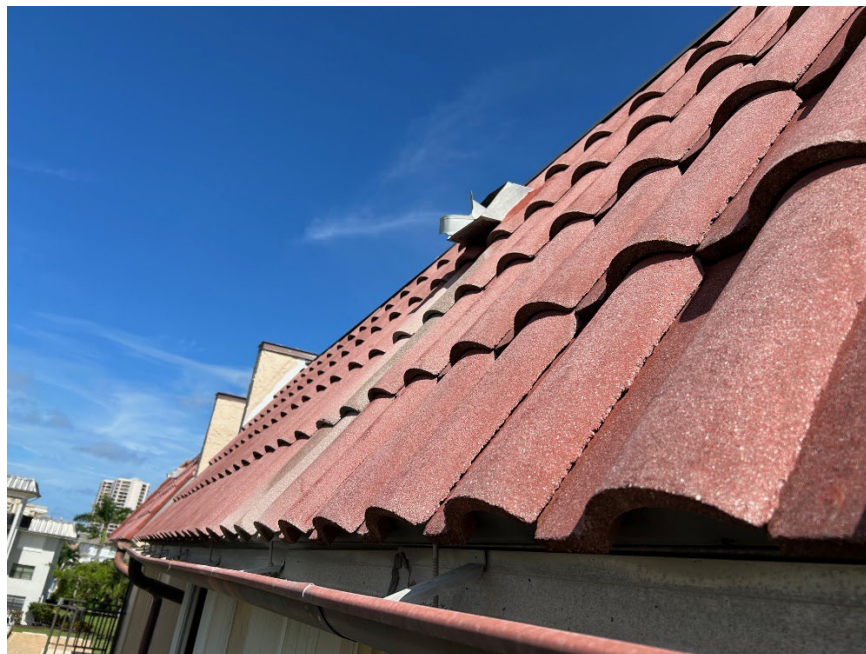
## 3.2 ROOF ASSESSMENT

Roofing on these buildings is a combination of a cement coated metal tile mansard and a modified bitumen membrane over the low slope areas. Roofing was installed in 2021 and appeared to be in good condition with no roof leaks on any ceilings. This type of roofing system is known to have a useable service life of 30-35 years if properly maintained so remaining service life exceeds 30 years. Access to the roof could not be obtained due to the need for multiple ladders and unsafe conditions.
