**Huron Cove Condominium**  
**SIRS Components**  
***Marco Island, FL***

Report #: 53605-0  
Beginning: January 1, 2025  
Expires: December 31, 2025

**RESERVE STUDY**  
**"Full"**

December 3, 2024

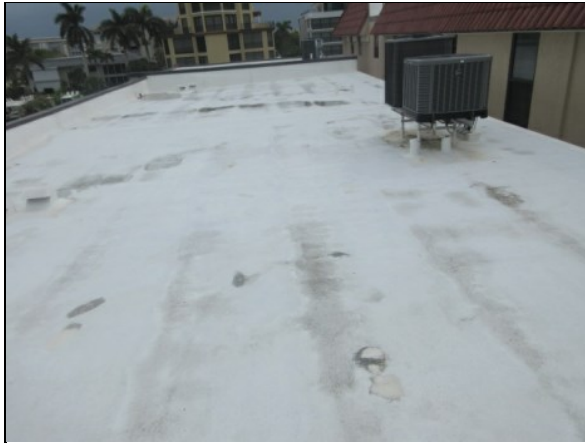
Useful Life:  
20 years

Remaining Life:  
15 years

Best Case: \$ 117,000

Worst Case: \$ 147,000

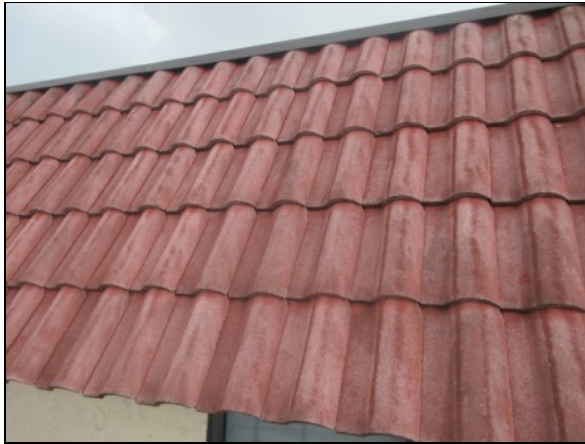
Remaining Life:

5 years

Best Case: \$ 79,000

Worst Case: \$ 97,000

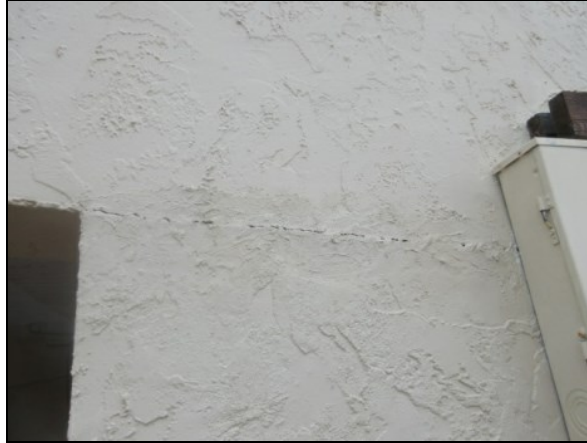
Useful Life:  
8 years

Remaining Life:  
0 years

Best Case: \$ 8,000

Worst Case: \$ 12,000

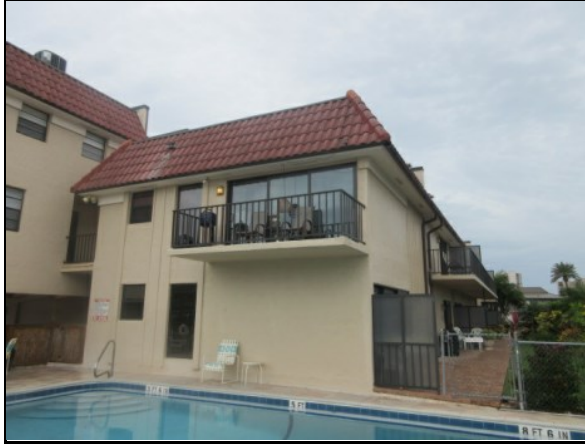
Remaining Life:

5 years

Best Case: \$ 10,000

Worst Case: \$ 15,000

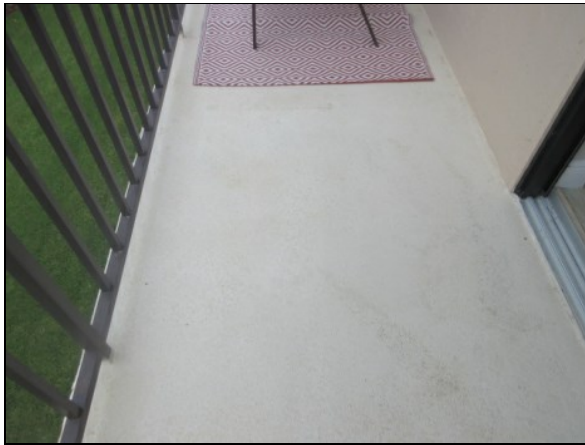
Useful Life:  
24 years

Remaining Life:  
22 years

Best Case: \$ 15,600

Worst Case: \$ 19,700

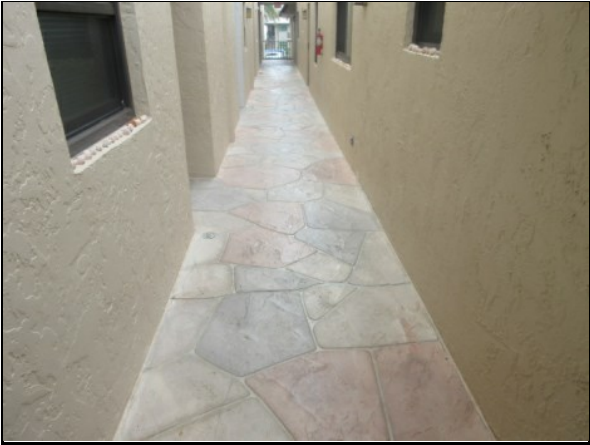
Useful Life:  
24 years

Remaining Life:  
8 years

Best Case: \$ 21,700

Worst Case: \$ 27,800

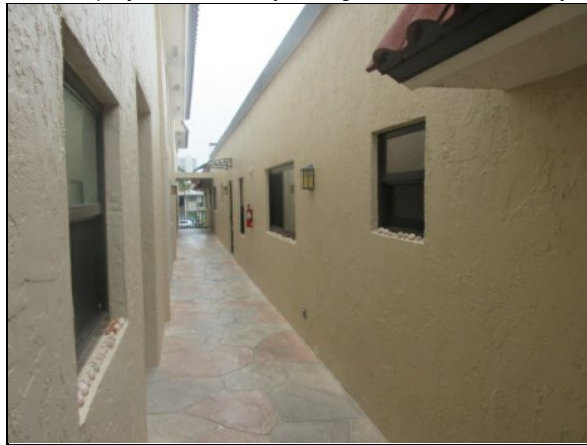
Useful Life:  
8 years

Remaining Life:  
0 years

Best Case: \$ 63,000

Worst Case: \$ 77,000

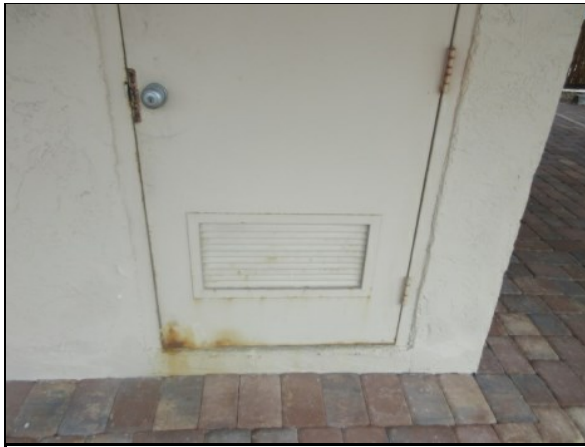
Useful Life:  
40 years

Remaining Life:  
0 years

Best Case: \$ 8,500

Worst Case: \$ 12,500

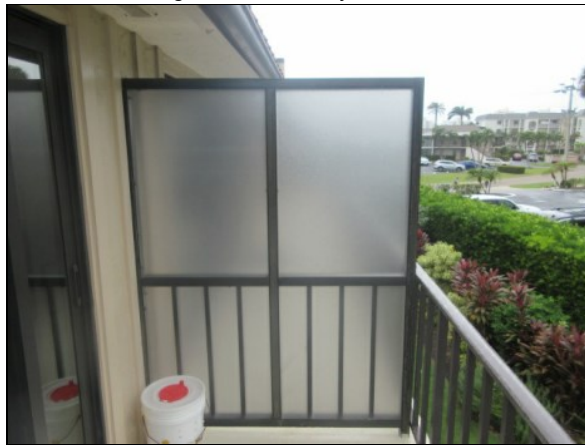
Useful Life:  
32 years

Remaining Life:  
8 years

Best Case: \$ 43,800

Worst Case: \$ 53,900
