April 12, 2023

Les Falls Condominium Association  
c/o John Zimmerman, Vice President  
870 S Collier Blvd  
Marco Island, FL 34145

## **Phase 1 Milestone Inspection Report at Les Falls Condominium in Marco Island, FL**

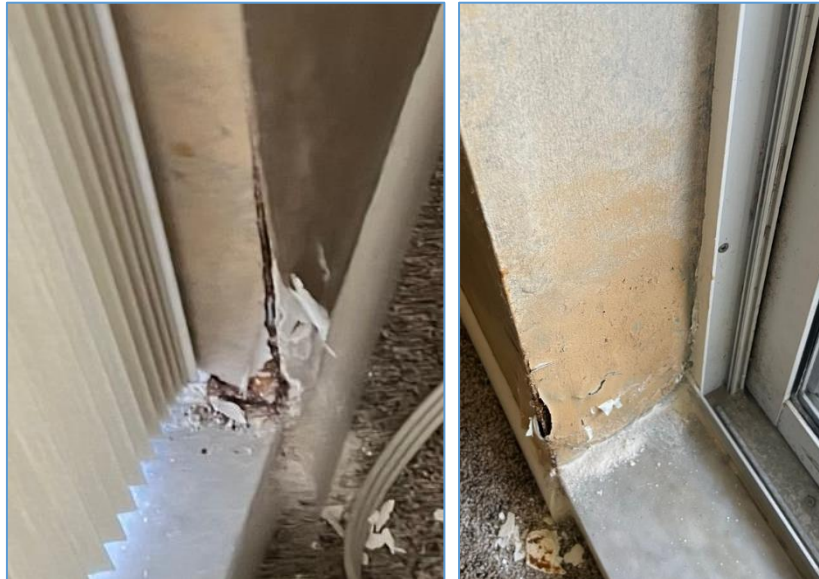
**Interiors:** The residential unit interiors were all finished in drywall, as such visual examination of the concealed structural elements was not observable. Corrosion of drywall corner bead adjacent to sliding glass doors was observed at several units (202 and 306) with older sliding glass doors.

*Figure 1: Cornerbead corrosion adjacent to original sliding glass doors at unit 306*

**Interiors:** As these areas are renovated, concealed structural elements should be inspected for spalls and deterioration. Since this area is concealed from the elements, no deterioration is expected. Original sliding glass doors should be replaced when feasible and masonry openings properly waterproofed as part of the replacement.

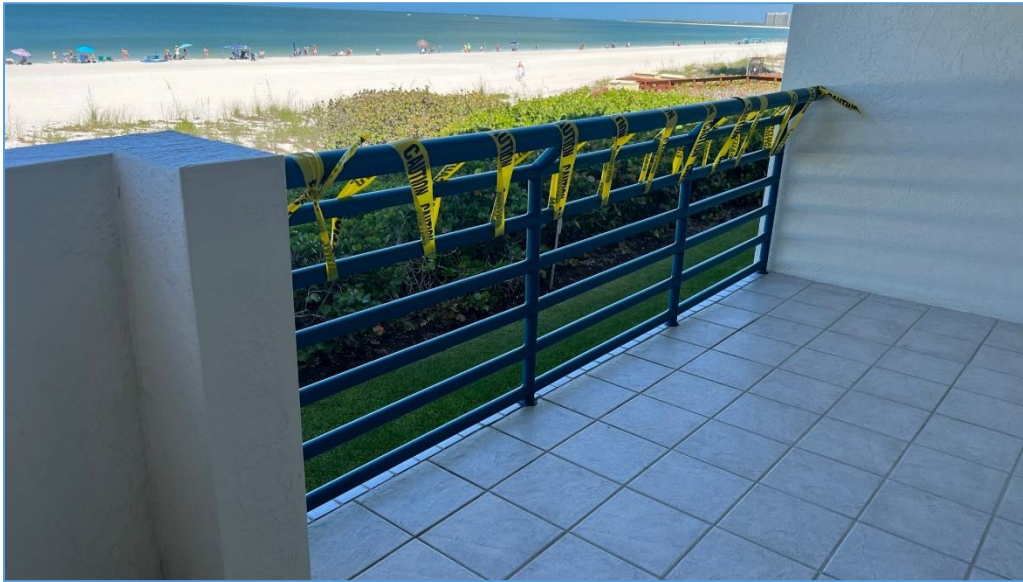
The balcony guards at all large balconies were a combination of aluminum railing and concrete knee walls. The guards at all small balconies (Juliet) were concrete knee walls only. No deficiencies were observed at the concrete knee walls. The aluminum railings had varying degrees of deterioration. A section of aluminum railing at each of units 103 and 104, had significant deflections when a load was applied to the top horizontal railing, **building management immediately placed caution tape at these railings**. The balance of the aluminum railings at balconies varied in condition. All aluminum railings appear to meet the 42" height requirement of current code but do not meet the 4" sphere requirement.

*Figure 2: Balcony railing significantly deflecting when loaded at unit 103*

**Balconies:** The balance of the units not inspected by SSEC, should be inspected for significant deflected rail conditions as identified in units 103 and 104. **Any rails with significant rail deflections should be remedied in the next 180 days. Balconies with significant rail deflections should not be accessed by residents until the condition is corrected.** This will require a structural engineer to prepare repair details to correct the corroded rail base connections and repair associated concrete edges. The engineer will need to confirm with the local municipality that this will be sufficient for their requirements as some municipalities require replacement railings instead, which would change the aesthetic of the building due to the 4" sphere requirement.

All railings should be assessed and a scope of work prepared for the same repair in the next 2 years to specific rail sections requiring repair.

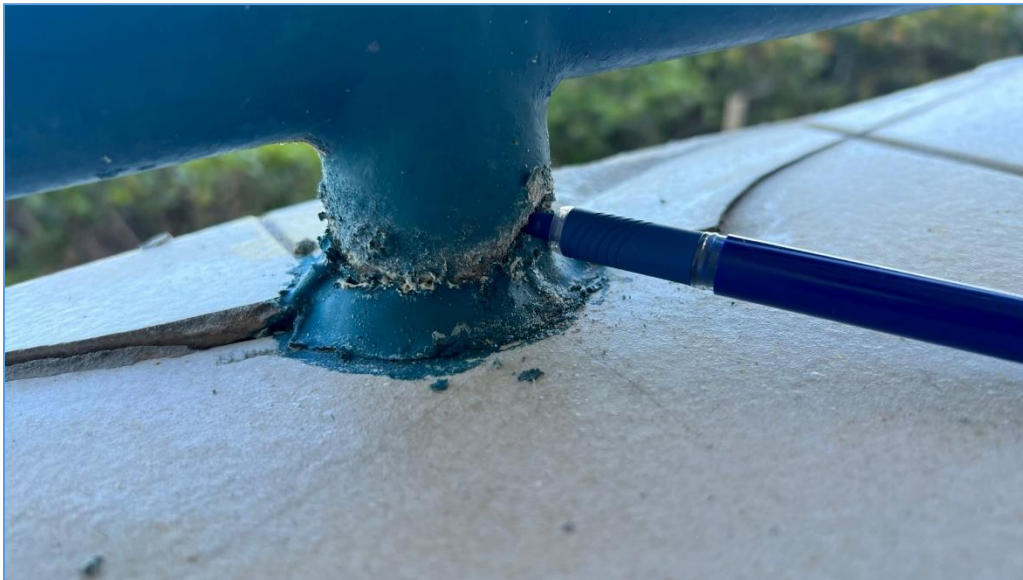
*Figure 3: Balcony railing post corrosion at unit 104*

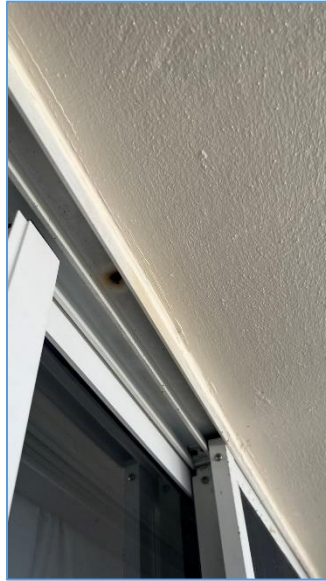
Units had varying configurations of original sliding glass doors, newer sliding glass doors, impact resistant sliding glass doors, accordion shutters attached to the building walls, accordion shutters installed at the balcony edges, and electric shutters. The stucco to metal sealants at windows was recently replaced. Older doors and shutters show signs of corroded fasteners.

*Figure 4: Typical corroded sliding glass door fastener (unit 202)*

It is SSEC understanding that individual unit owners are responsible for maintaining and replacement of windows, doors, and shutters. SSEC recommends that these elements be continued to be maintained including semi annual cleaning and replacement of deteriorating sealants, gaskets, and fasteners.

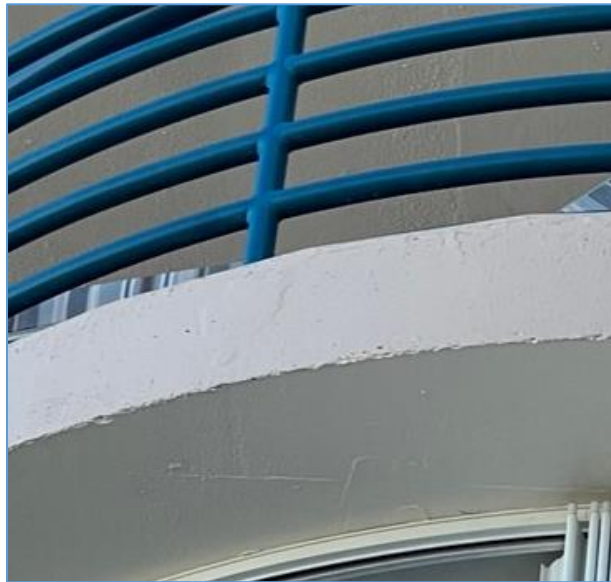
In addition, the balconies were visually inspected from the ground level with minor edge spalling noted.

*Figure 5: 203 concrete spall at slab edge coinciding with post pocket (typical)*

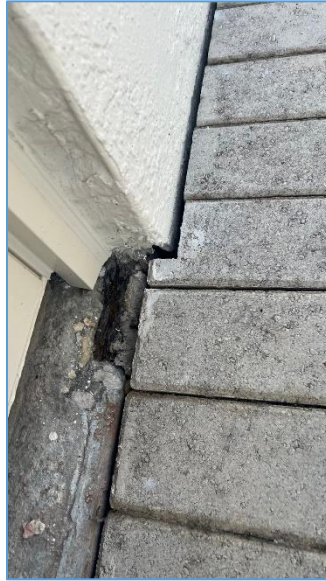
SSEC inspected a limited number of cabanas. Corroding reinforcing bar was identified at the entrance of unit 9 (Figure 1 following page). The interior of the cabanas was not finished in drywall, as such visible and limited acoustic inspection of the structural elements was available with no deficiencies noted.

*Figure 6: Reinforced concrete repair at entrance of Cabana 9*

Corroding reinforcement identified at the entrance of cabana unit 9 should be remediated in the next 180 days.

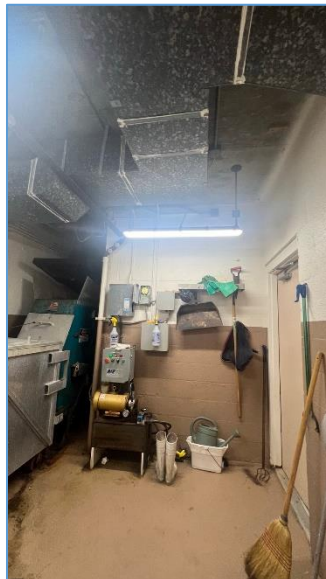
**Mechanical Rooms:** Ground floor mechanical rooms (maintenance area, north trash room, north meter room) were accessed. The interior of these areas was not finished in drywall, as such visible an limited acoustic inspection of the structural elements was available with no deficiencies noted.

*Figure 7: Typical unfinished mechanical room (North trash room)*

**Mechanical Rooms:** No recommendations at this time.

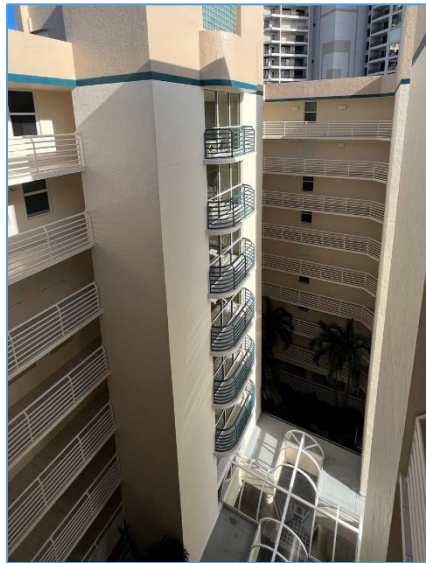
**Catwalks:** Exterior catwalks allow access to the individual units. The catwalks are constructed of elevated concrete decks using mild steel reinforcement. The exterior catwalks primarily use aluminum gaurds of the same type as noted on the balconies. The exterior catwalk gaurds appeared to be in good condition. The exterior catwalks were visually inspected by SSEC and no structural deficiencies were noted. A single Juliet balcony is located at each floor to the east of the elevators. These balconies are not accessible. No visual deficiencies were noted at these Juliet balconies.

*Figure 8: Exterior catwalks and Non-Accessible Juliet Balconies*

**Catwalks:** No recommendations at this time.

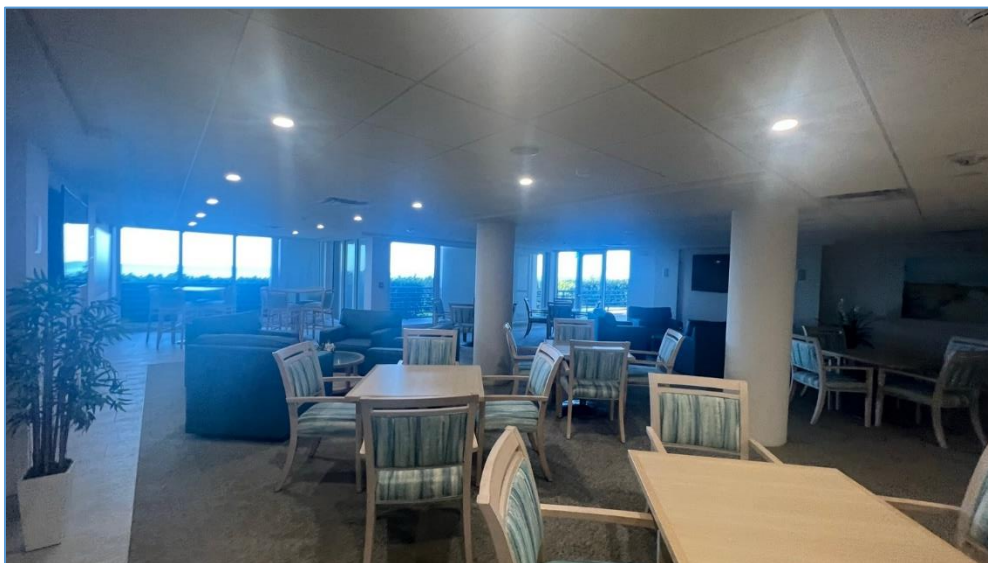
**Card/Gym Rooms:** The card/gym room interiors were all finished in drywall, as such visual examination of the concealed structural elements was not observable.

*Figure 9: Card room interior finishes preventing visual examination of structural elements*

**Card/Gym Rooms:** As these areas are renovated, concealed structural elements should be inspected for spalls and deterioration. Since this area is concealed from the elements, no deterioration is expected.

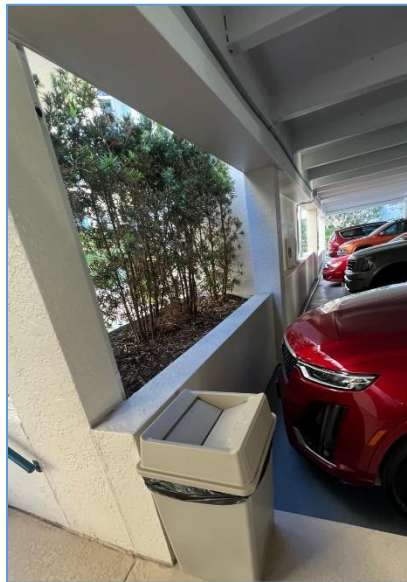
**Garage:** The garage is not attached to the main structure, as such this element is not directly related to the intent of the Phase 1 Milestone, however, SSEC performed a limited acoustic and visual survey of the garage structure. The garage is single story covered structure, with asphalt on grade, reinforced circular columns, precast joists spanning and bearing on precast beams. Minor structural deficiencies were noted throughout the garage with respect to cracks in beams and spalling at columns (acoustic only, not bulging). The west circular columns appear to be clad in a wire lath stucco to aesthetically match the abutting planters. The stucco is delaminating and a visual examination of the structural column within was not observable. Planter waterproofing condition was not observable due to plant infill material.

*Figure 10: Planter and square column cover to be investigated at west side of garage*

**Garage:** SSEC recommends an investigation of the existing waterproofing at the planters and condition of the concealed structural columns adjoining the planters. This will require removal of plant infill and wire lathe stucco cladding the columns to inspect. A single planter should be sufficient for this investigation and a scope of work for all planters can be prepared by a structural engineer and implemented by a general contractor experienced in waterproofing and concrete restoration. SSEC would recommend remediating column spalls noted throughout the garage as part of this work. SSEC recommends that this investigation take place in the next 180 days to properly evaluate the conditions and determine a timeline for garage restoration which would include spalling columns noted in the remaining portion of the structure.

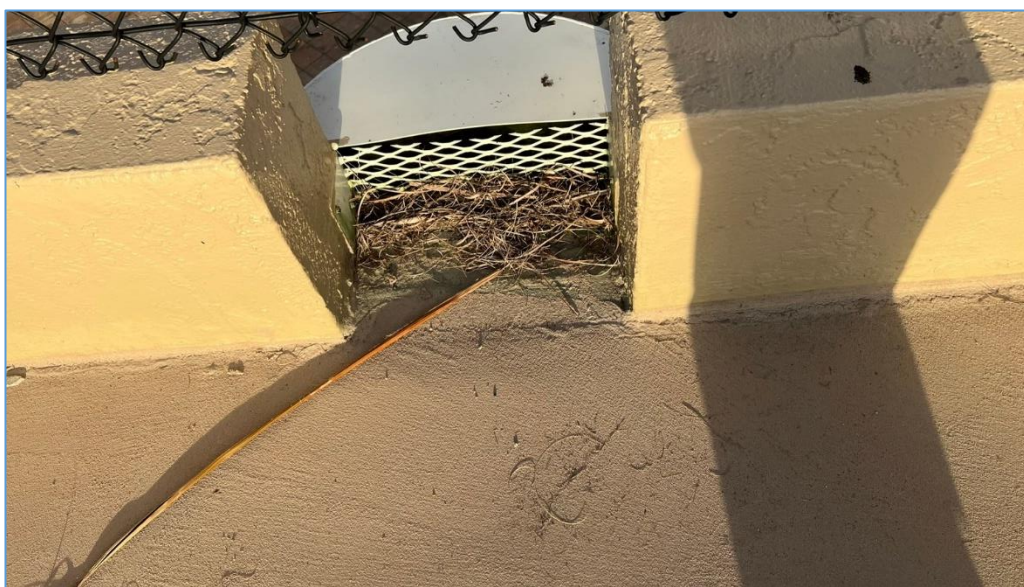
**Tennis Court:** The tennis court is located on top of the garage and therefore acts as the roof of the garage. The tennis court has perimeter scuppers to allow draining of water. The perimeter scuppers appear to be functioning due to no evidence of ponding water (stains). Some perimeter scuppers are blocked with debris. The perimeter chain link fence acts as the guard for the structure. The connection of the chain link fence posts with the concrete knee wall was exhibiting corrosion throughout. Two sets of stairs at the north and south of the porte-cochere allow access to the tennis court from the grade level. Both sets of stairs were acoustically sounded and deterioration of concrete was noted through this sounding. Expansion joints separate the stairs from the tennis court and are concealed by aluminum cover plates attached to both the tennis court and top stair landing, with one side in a slotted hole to allow for movement.

*Figure 12: Tennis court scupper blocked debris*

**Tennis Court:** SSEC recommends that the perimeter chain link fence post bases be properly repaired in the next 180 days since they act as guards for the structure. Scuppers at the perimeter should be cleared of debris on a monthly basis (to be adjusted once maintenance, is familiar with seasonal frequency requirements). The spalling at the associated stairs can be incorporated into a garage restoration referenced above.

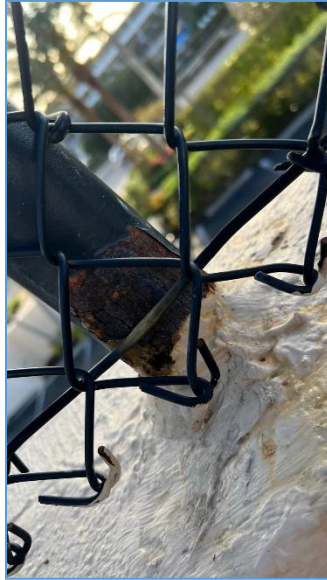
*Figure 13: Tennis court chainlink post typical corrosion*

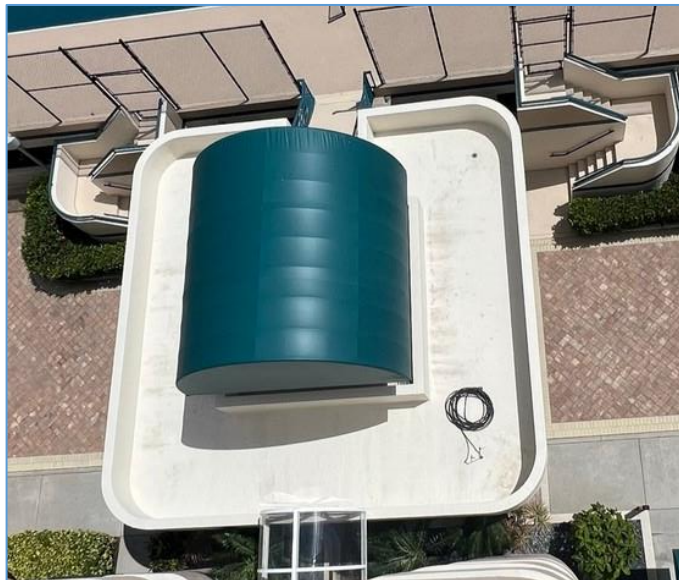
**Porte-cochere:** The porte-cochere is not attached to the main structure, as such this element is not directly related to the intent of the Phase 1 Milestone, however, SSEC performed a limited acoustic and visual survey of the porte-cochere structure. The porte-cochere was originally intended to be a planter. At some point in the buildings life, ownership decide to remove the plant material, waterproof the planters, and leave them open (without infill). Minor structural deficiencies were noted throughout the porte-cochere slab with respect spalling of the deck (acoustic only, not visual). A large awning with steel framing is attached at the center of the porte-cochere and was visually observed with no structural deficiencies noted.

*Figure 14: Porte-cochere*

**Porte-cochere:** SSEC recommends performing a water test of the planters (plug drains to hold 2" of water for 24 hours) to make sure no leaks are occurring. If the water level is diminishing, then the waterproofing at the planter should be replaced as part of the garage restoration referenced above.

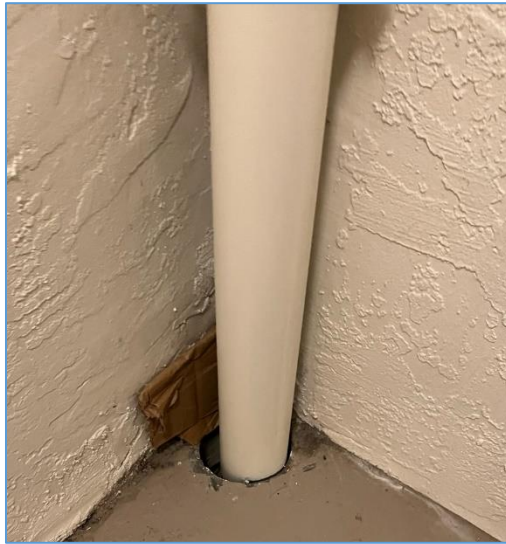
**South Egress Stairs:** The south egress stair was accessed through all floors. No structural deficiencies were noted in this stairwell. Minor non-structural deficiencies were noted such as missing pipe floor clamps and a light out at floor 6 landing.

*Figure 15: Pipe stand clamp missing (typical condition)*

**South Egress Stairs:** Replace missing pipe floor clamps and burnt out bulbs.

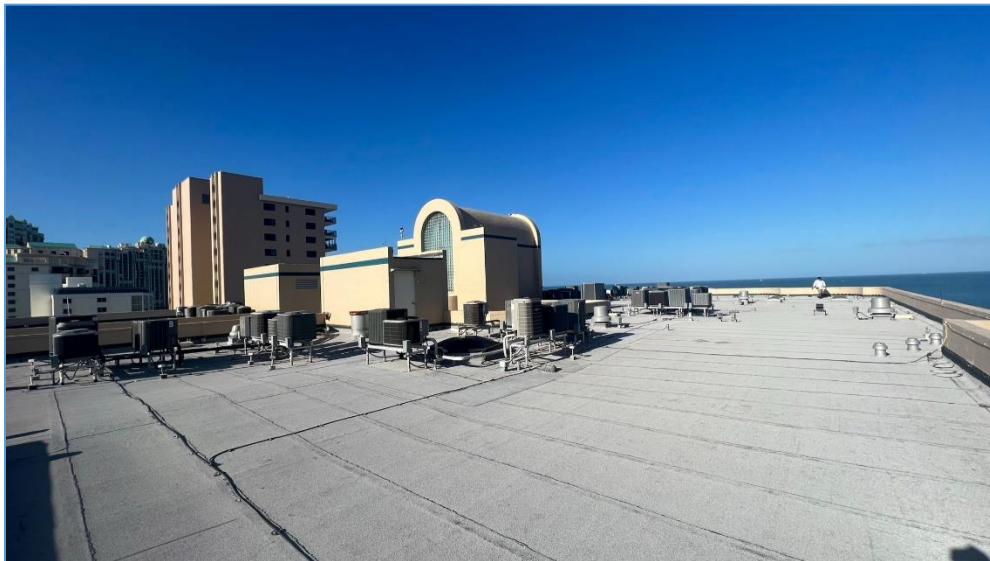
**Main building roof:** The main building roof was accessed. The building roof appears to be in good condition with no ponding water or soft spots noted. The drains and scuppers appear to be functioning to allow water to drain from the roof. The perimeter counter flashing at the kneewalls is continuous and not corroded. The stucco above the flashing at the parapet appeared to be delaminating through acoustic sounding. Lightning protection was noted at the perimeter parapet. Window washing hook bases (appear to accept a plate with a D-ring) were observed at the roof level but no anchor load testing chart was on-site. Individual unit air conditioners were located on the roof, airconditioner bases appear to be in good condition. Penetrations throughout the roof appear to be in good condition (skylights, disconnect conduit, and vents). According to the building, no leaks are observed in the penthouse units below.

*Figure 16: Main building roof*

**Main building roof:** Perform a roof moisture survey when the building becomes 10 years of age to determine if it has exceed 25% roof moisture levels permissible by the Florida Building Code. When the roof is replaced, parapet stucco replacement and counterflashing should be incorporated into the scope of work. Test the anchors to ensure they meet the OSHA 1910.27 5,000 pound anchor requirement at 10 year intervals.

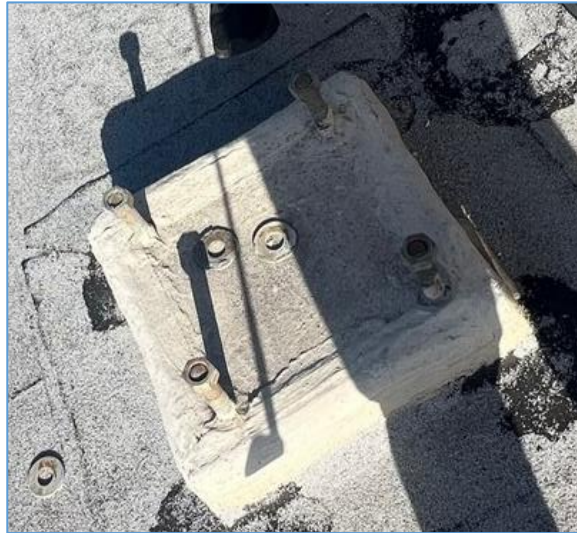
*Figure 17: Typical roof anchor system*

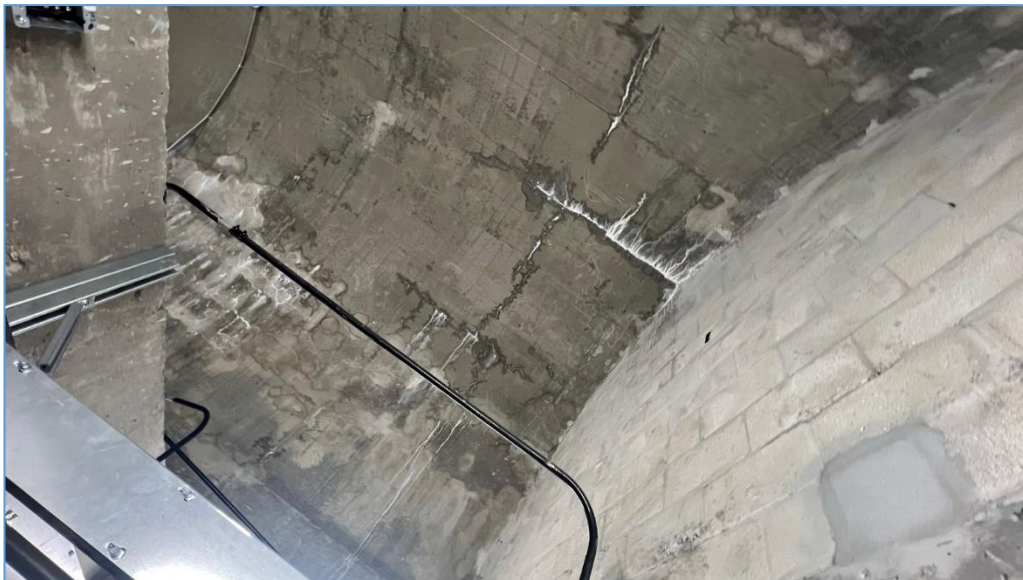
**Rooftop Elevator Room:** The roof top elevator room was accessed. The interior of this area was not finished in drywall, as such visible and limited acoustic inspection of the structural elements was available. Efflorescence through cracks at the ceiling was noted. The ceiling is the concrete underside of the barrel shaped concrete roof deck above. The topside of this roof is finished in stucco and paint. Upon visual examination, from the main roof below, the paint at the top side appears to be fully adhered. The elevator equipment was all replaced within the last year.

*Figure 18: Rooftop elevator ceiling efflorescence to be removed and monitored*

**Rooftop Elevator Room:** The efflorescence noted at the ceiling may be prior to the recent paint restoration. SSEC recommends removing the efflorescence at the underside and monitoring to see if it returns. In the event the efflorescence returns, the cracks should be properly repaired, an appropriate highbuild paint applied to the top side of the structure.

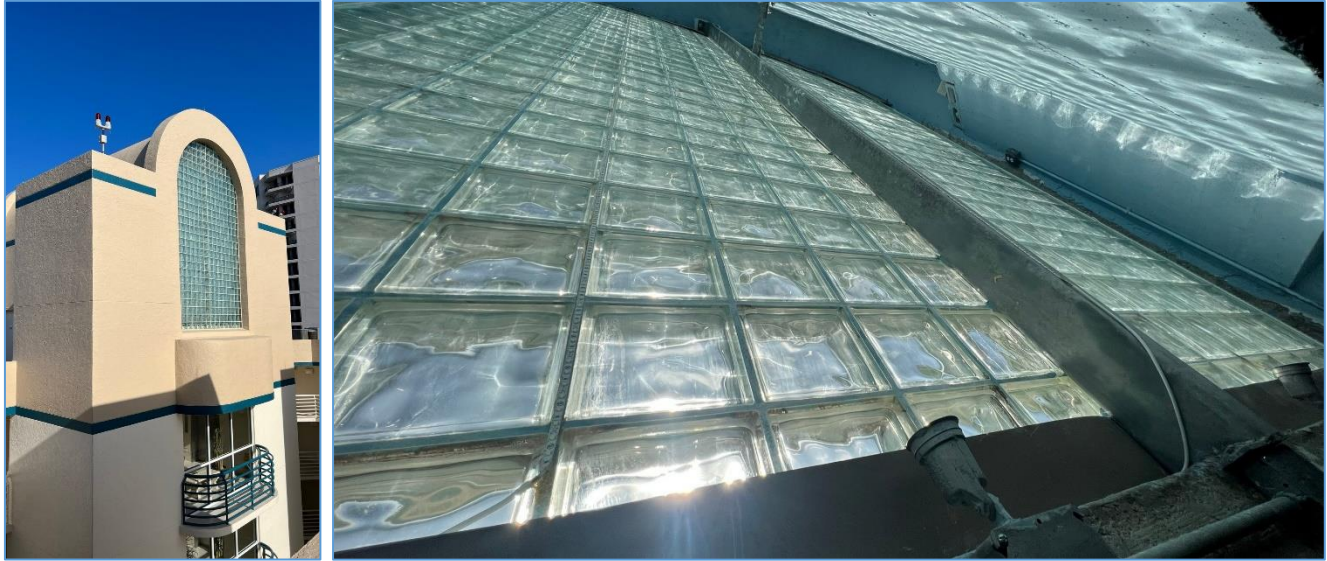
**Rooftop space behind glass enclosure:** The space behind the glass enclosure was accessed. The interior of this area was not finished in drywall, as such visible an limited acoustic inspection of the structural elements was available with no deficiencies noted. No moisture intrusion was observed in this area.

*Figure 19: Rooftop glass enclosure*

**Rooftop space behind glass enclosure:** No recommendations at this time.
