# **G. BATISTA**

Marbelle Club of Marco Island Condominium Association, Inc.  
c/o Kimberly Ouimet – Property Manager  
840 S Collier Boulevard  
Marco Island, FL 34145  
Phone: 239-394-7668  
Email: manager@themarbelclub.net

RE: Structural Visual Inspection  
**Inspection performed at 840 S Collier Blvd., Marco Island, FL 34145**

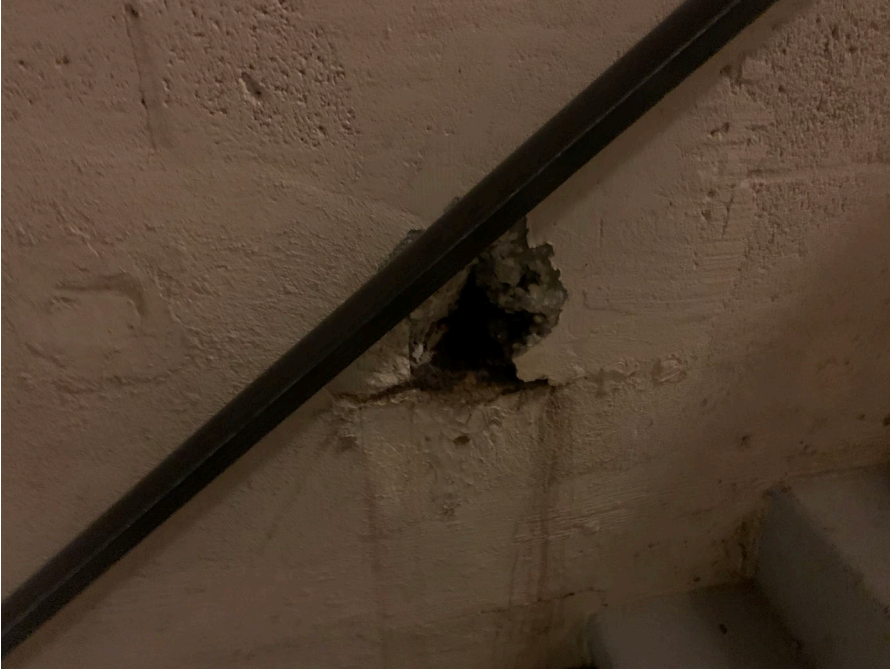
Column “spalling” at the staircase between the 18<sup>th</sup>-floor and roof level.

1. Repair the concrete “spalling”. The work must be performed by an experienced, licensed, and insured contractor. Keep in mind, this work involves a structural component of the house, and a permit will be required. The city will request a set of plans and specification to do this work.

- Properly shore (or support) the surrounding areas with “Jacks” while the repairs are performed. Proper shoring of the existing the affected areas is critical to avoid over-stressing the surrounding structural element and causing a local collapse. This must be repaired and supervised by a licensed contractor with vast experience in concrete restoration.

- Remove all damaged or unsound concrete. Preparation of concrete surface shall be in accordance with ACI 546 R-96 Chapter 2 entitled “Concrete Removal, Preparation and Repair Techniques”.

- Saw cut the perimeter of the repair area; a minimum of 0.5-inch deep all around forming a shoulder perpendicular to the substrate.
  - Chip out the concrete to expose the entire circumference of the rebar. Removal shall continue along the length of the reinforcing steel until at least 6 inches of un-corroded rebar is observed.

- Sandblast the concrete and exposed rebar. All scale shall be removed from rebar, restoring bars to their original "white metal" condition. Surface and existing rebar shall be prepared as per “Guide for Surface Preparation for the Repair of Deteriorated Concrete Resulting from Reinforcing Steel Corrosion” ICRI Guideline No.03730. Insert new bars of equal diameter next to those that have deteriorated by more than 10%. All new steel shall be ASTM A- 615 Grade 60. Lap splices shall be in accordance with ACI 318-14.

- Coat all new and existing rebar with an anti-corrosive coating.
  - Repair mortar shall be approved by the ACI & ICRI standards.
  - Bonding agent shall meet ACI & ICRI standards.

- Cure and finish as required by the mortar manufacturer.
2. Repair damaged picket on the unit #1101’s balcony railing.

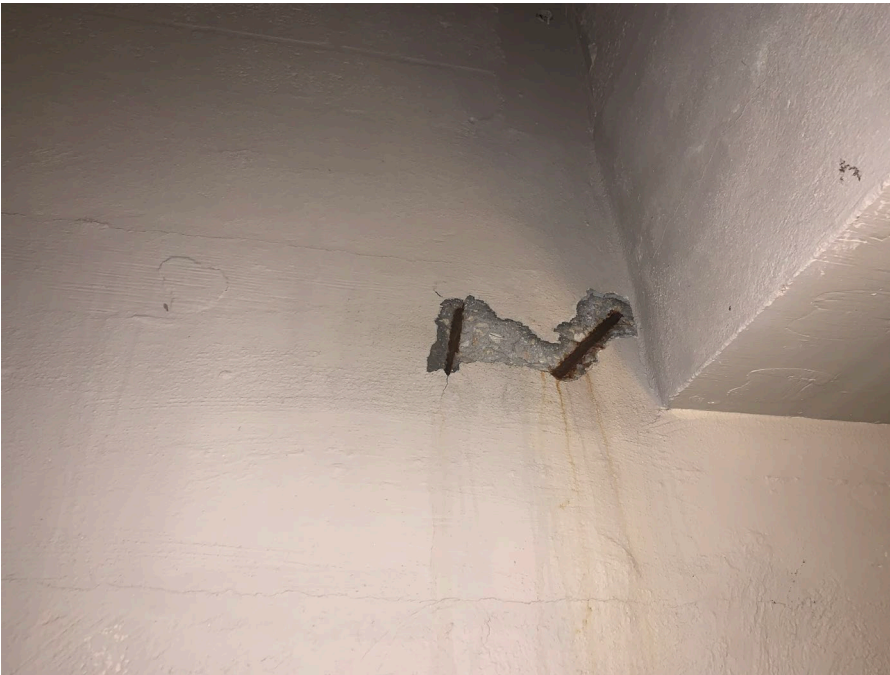
Column “spalling” at the staircase landing of the 18<sup>th</sup>-floor. (Stair #1)

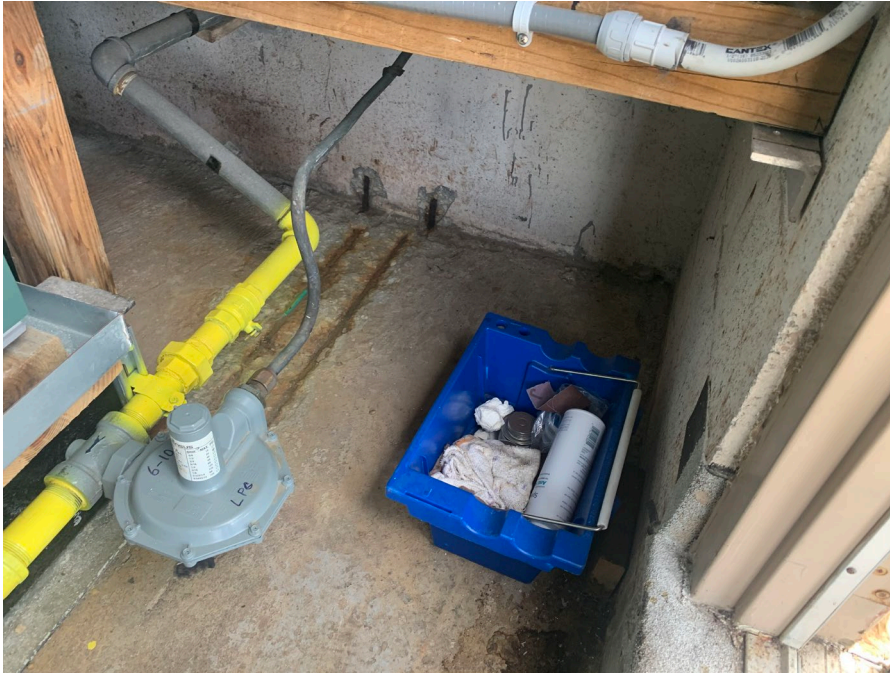
Floor “spalling” at the boiler room. (Roof)

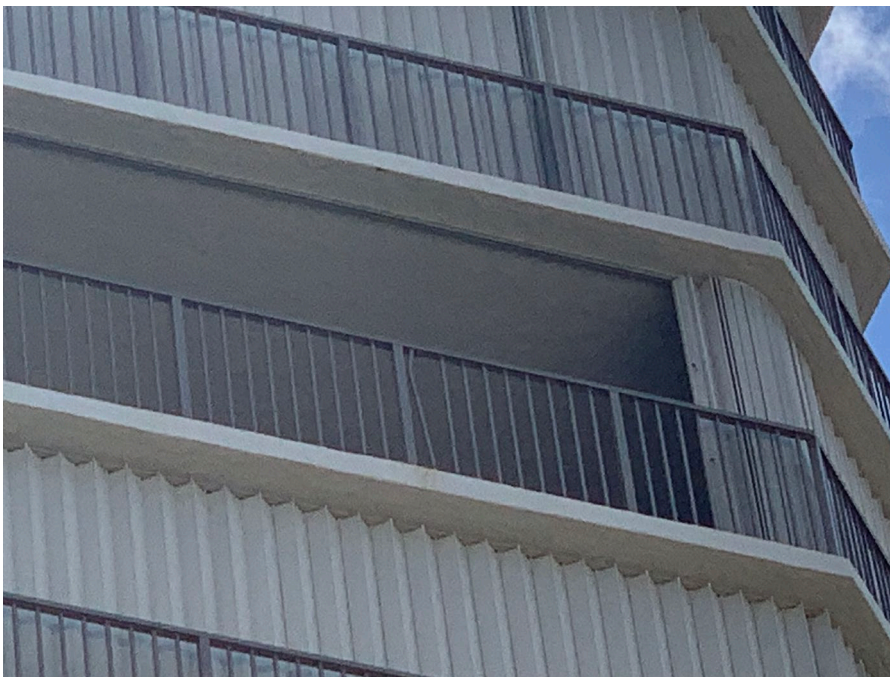
On the exterior of the building no sign of distress, excessive deflection, concerning cracks, or any other deficiency was seen during this inspection, except for a damaged picket on unit #1101's balcony railing.

Damage picket at the unit #1101 balcony railing.
