## STRUCTURAL INTEGRITY RESERVE STUDY

Maxime Club of Marco Island  
Condominium Association, Inc.

907 Panama Court  
Marco Island, Florida 34145

Project Number: 2425776

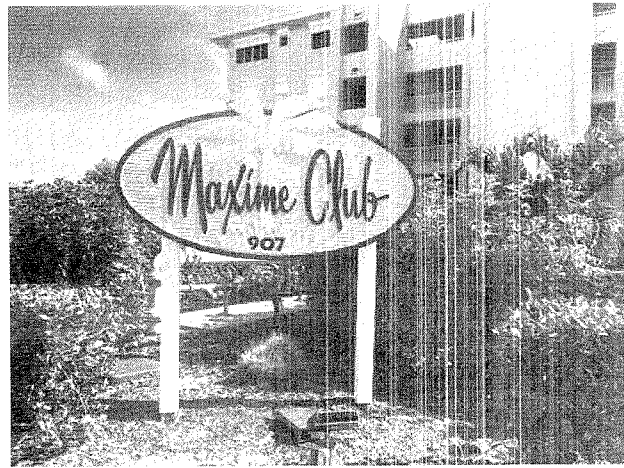
GENERAL VIEW OF PROPERTY

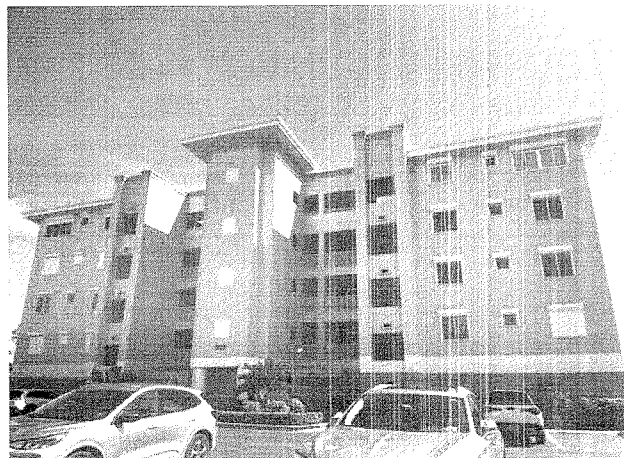
PHOTO 2

GENERAL VIEW OF PROPERTY

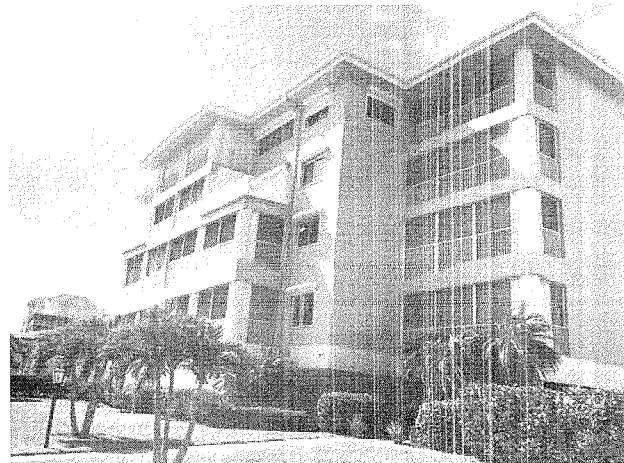
PHOTO 3

GENERAL VIEW OF PROPERTY

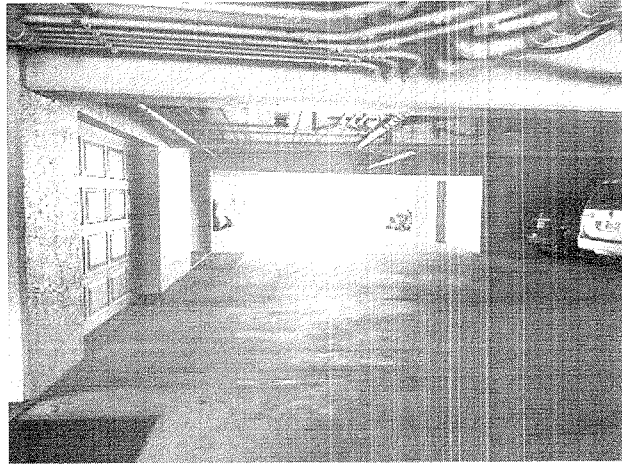
PHOTO 4

GENERAL VIEW OF PROPERTY

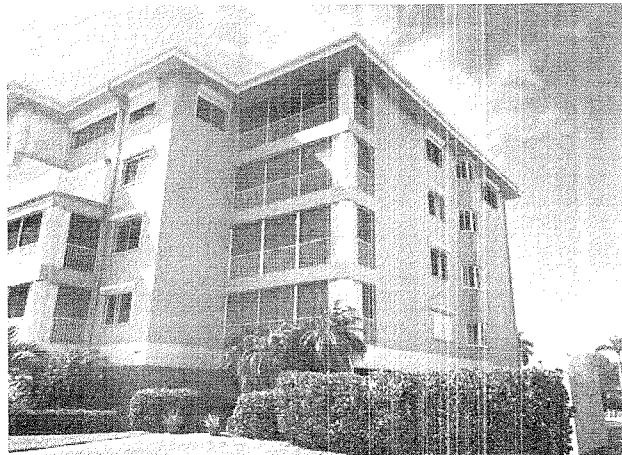
PHOTO 5

GENERAL VIEW OF PROPERTY

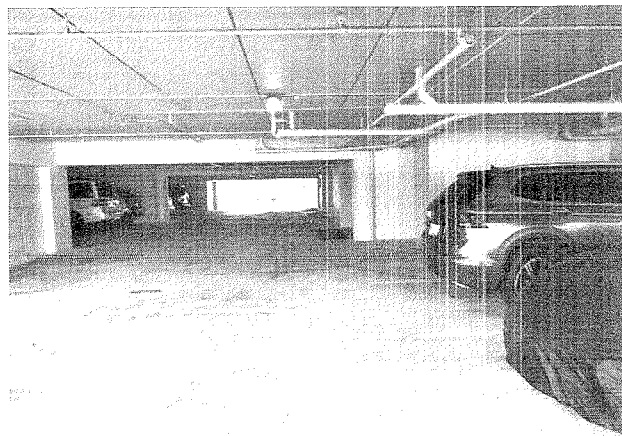
PHOTO 6

GENERAL VIEW OF PARKING

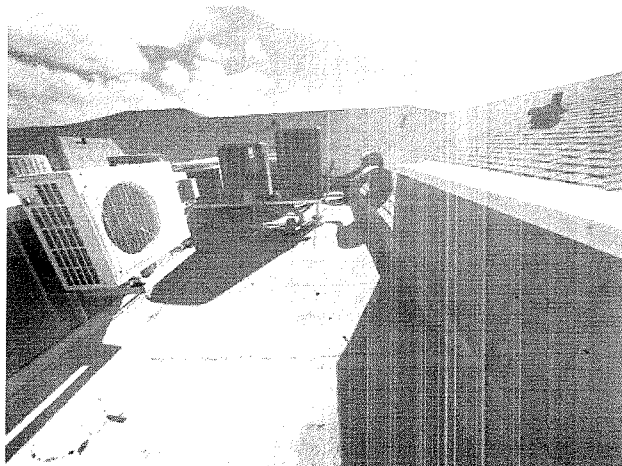
PHOTO 7

The roof was observed to be in good condition.

GENERAL VIEW OF TYPICAL ROOF

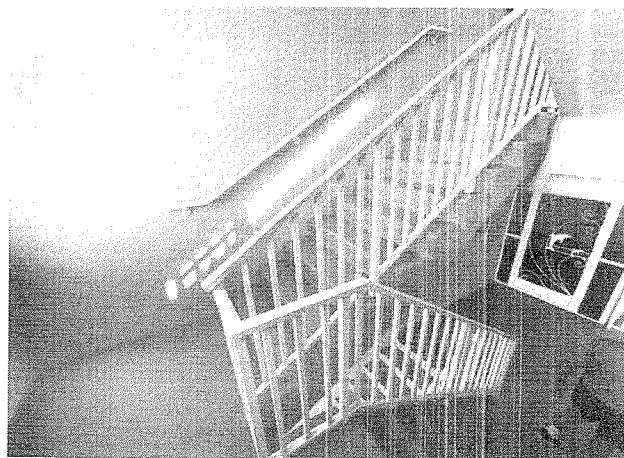
PHOTO 8

| Item | Description/Observations/Comments |
|---|---|
| Stairs | <p>The buildings each have (2) sets of concrete stairs with aluminum handrails, located at the front and on the side of the building.</p> <p>The stairs were observed to be in good condition.</p> <p>In addition, periodic repainting and waterproofing of the stairs, including any anticipated repairs, are addressed as part of the Structural recommendations discussed above.</p> |

GENERAL VIEW OF TYPICAL STAIRWAY

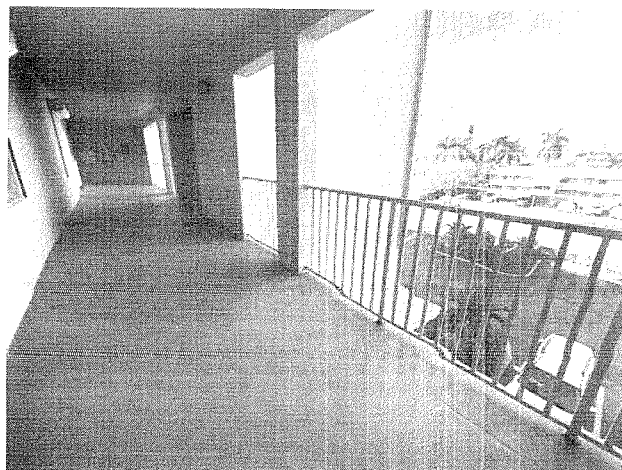
PHOTO 9

| <b>Item</b> | <b>Description/Observations/Comments</b> |
|---|---|
| <b>Exterior Walkways</b> | <p>The exterior walkways are concrete and supported by the structural systems of the building.</p> <p>All exterior elevated walkways were observed to be in good condition.</p> |

GENERAL VIEW OF TYPICAL ELEVATED WALKWAY

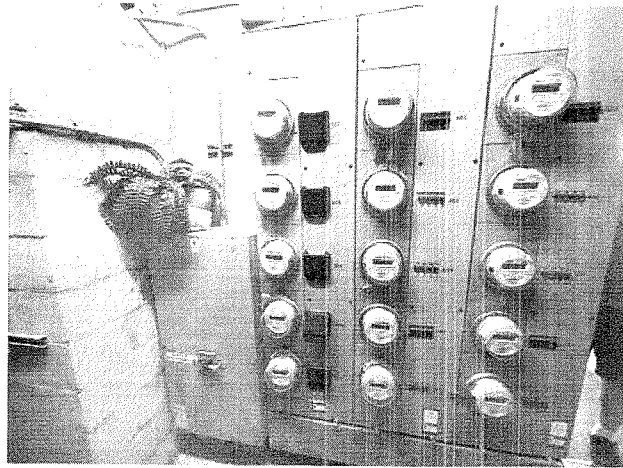
PHOTO 10

**The electrical system components were observed to be in good condition. In general, the electrical systems for the Property, including main switchboards, transformers, distribution circuit breaker panels, contactors, lighting, and wiring system were noted to be adequately sized for the intended use of the facility. With proper maintenance, no significant expenditures are anticipated. We have allocated some funds in the Reserve Table.**

GENERAL VIEW OF ELECTRICAL EQUIPMENT

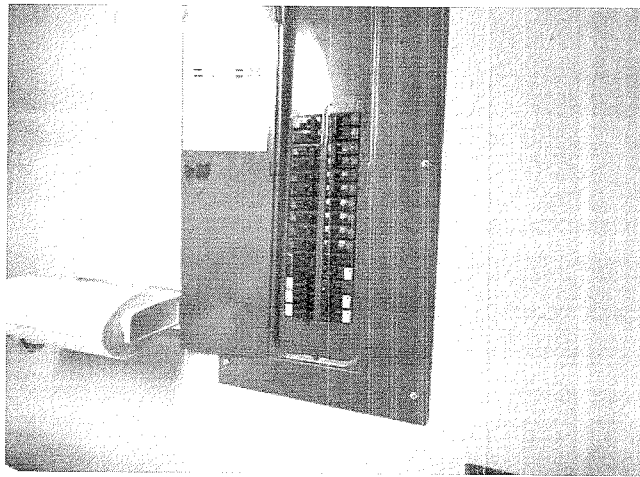
PHOTO 11

GENERAL VIEW OF ELECTRICAL EQUIPMENT

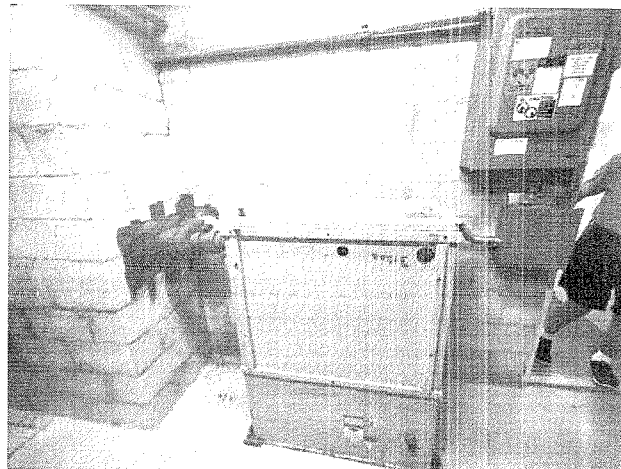
PHOTO 12

| Item | Description/Observations/Comments |
|---|---|
| Elevators | <p>The buildings are equipped with 1 hydraulic, passenger elevator, each, with a load capacity of 2,500 pounds, providing access to all levels of the building.</p> <p>The elevators were noted to be in generally good operating condition and reportedly serviced regularly by an elevator service contractor.</p> <p>We don't anticipate any work needed at this time for the elevator that is in excess of \$10,000 that would impact the structural integrity of the Building. As such it is not considered part of the Reserve Table.</p> |

GENERAL VIEW OF ELEVATOR EQUIPMENT

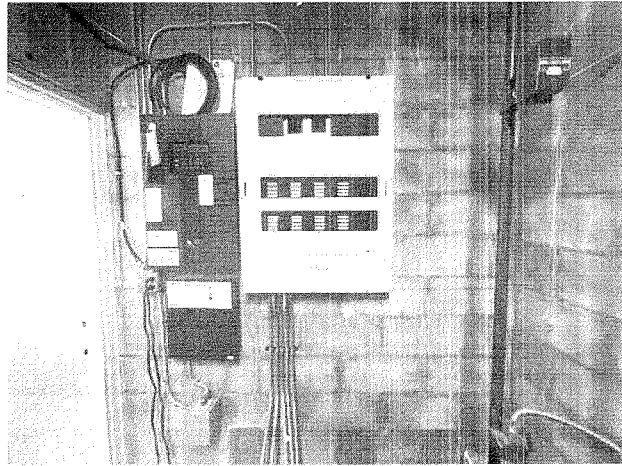
PHOTO 13

| Item | Description/Observations/Comments |
|---|---|
| Fire Protection | <p>The building is equipped with portable fire extinguishers in common areas.</p> <p>The Property's fire alarm systems utilize central panels for monitoring manual pull stations.</p> <p>The fire alarm panel was locked at the time of this inspection, we assume that the panel is original to the building and should be replaced in 2025.</p> <p>The fire extinguishers were noted to be in general condition requiring routine maintenance over the evaluation period.</p> <p>The central alarm panels are in good condition. Central fire alarm panels typically have an EUL of 25 years. Funds have been spread throughout the Replacement Reserves Cost Estimate Table, adopting the straight-line accounting method to ensure the availability of funds at the end of the replaced element's EUL, beyond the evaluation period of this assessment.</p> <p>Fire protection and life safety systems within the dwelling units are reported to be the responsibility of the respective condominium unit owner to maintain and replace.</p> |

GENERAL VIEW OF FIRE ALARM PANEL

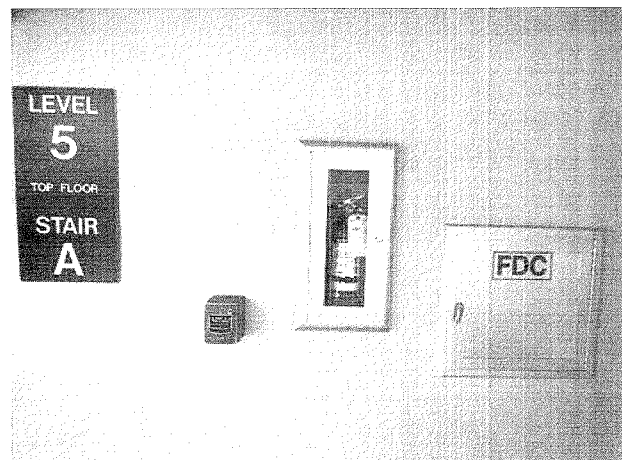
PHOTO 14

GENERAL VIEW OF FIRE EXTINGUISHER

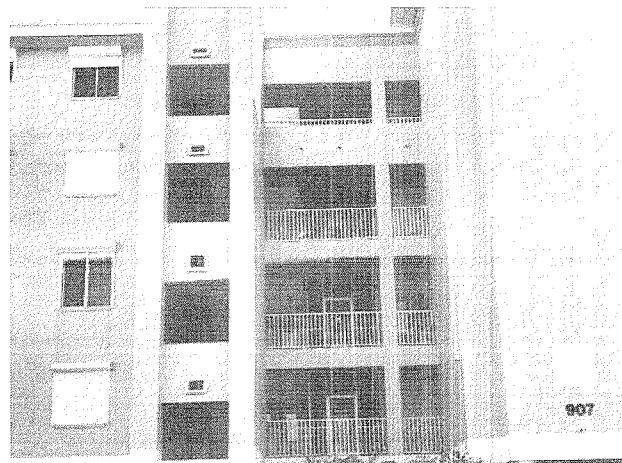
PHOTO 15

GENERAL VIEW OF GUARDRAILS

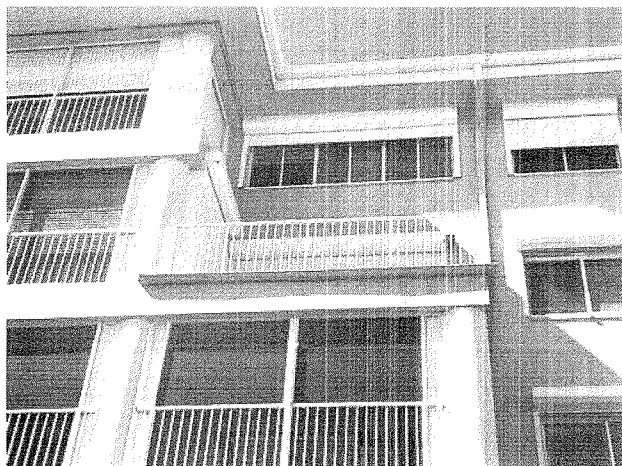
PHOTO 16

| Item | Description/Observations/Comments |
|---|---|
| Exterior Walls | <p>The exterior walls typically consist of concrete masonry units (CMU) construction finished with painted stucco.</p> <p>The walls were reported to have been repainted in 2023.</p> <p>The exterior walls appeared to be in good condition, with no signs of deterioration or stucco damage.</p> <p>The exterior façades were reportedly repainted and waterproofed as part of regular maintenance in 2023. Based on the EUL of seven years, periodic repainting and waterproofing of the exterior wall surfaces, including any required repairs, should be anticipated during the evaluation period. Funds have been spread throughout the Replacement Reserves Cost Estimate Table, adopting the straight-line accounting method to ensure the availability of funds at the end of the replaced element's Expected useful Life (EUL), beyond the evaluation period of this assessment.</p> |

GENERAL VIEW OF BUILDING'S FINISH

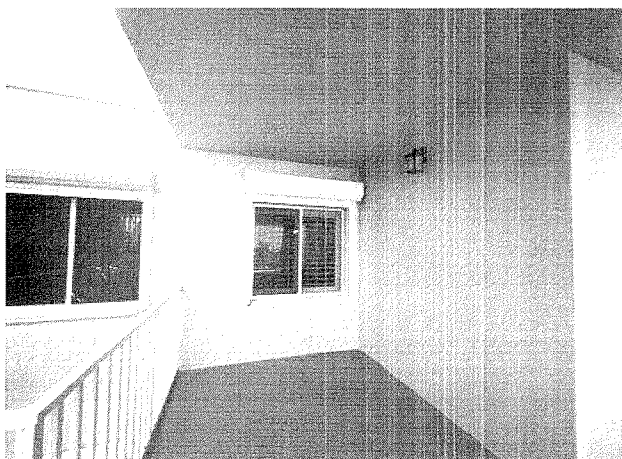
PHOTO 17

GENERAL VIEW OF BUILDING'S FINISH

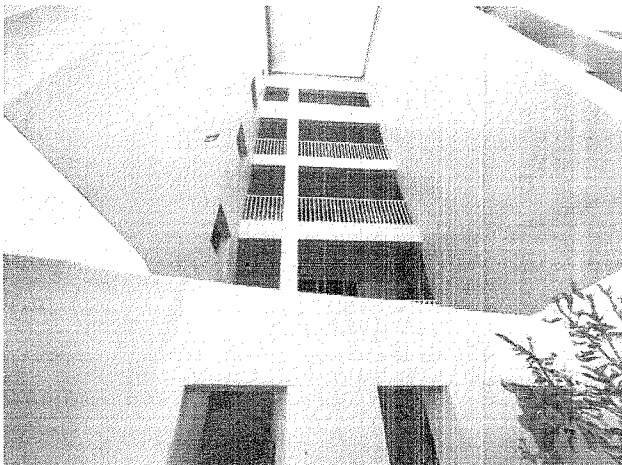
PHOTO 18

GENERAL VIEW OF BUILDING'S FINISH

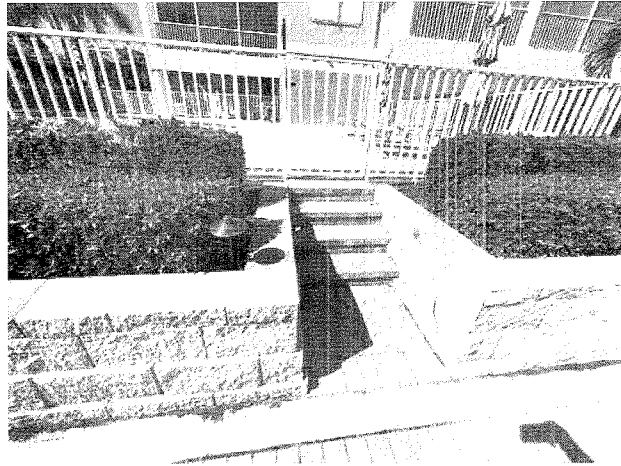
PHOTO 19

GENERAL VIEW OF LANDSCAPING

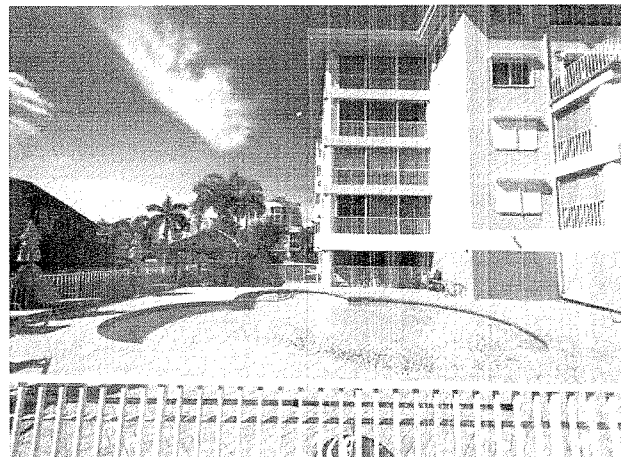
PHOTO 20

GENERAL VIEW OF SWIMMING POOL

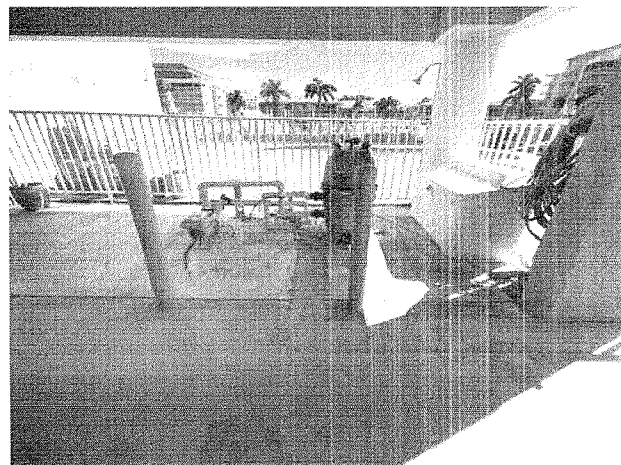
PHOTO 21

GENERAL VIEW OF SWIMMING POOL EQUIPMENT
