January 20, 2025

**MONTERREY CONDOMINIUM ASSOCIATION**

**Subject:** Report of Engineering Consulting Services  
**MILESTONE INSPECTION – PHASE I**  
Monterrey Condominium  
980 Cape Marco Drive  
Marco Island, Florida  
SOCOTEC Project Number VS242430

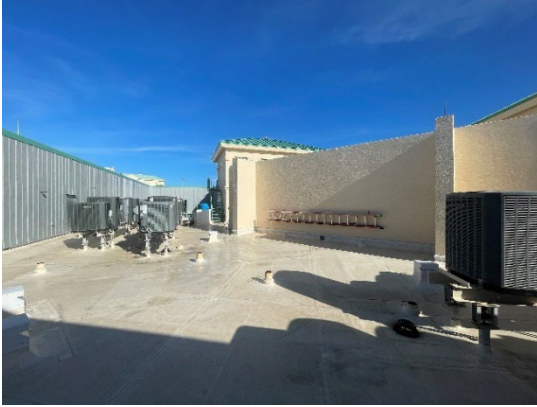
View on top of roof.

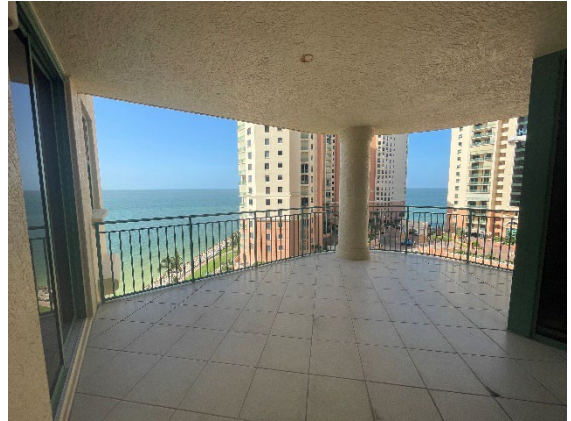
View of terrace. (Unit 1007)

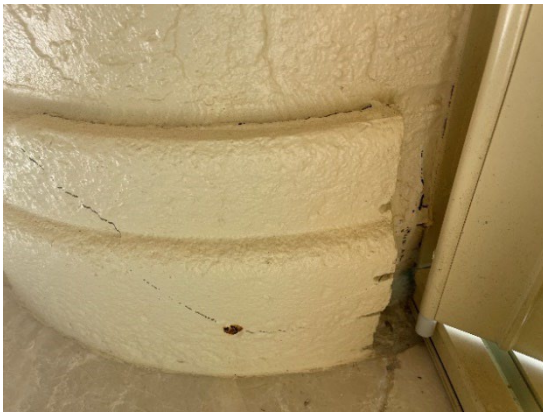
Cracked arch accent at column base. (Unit 1401)

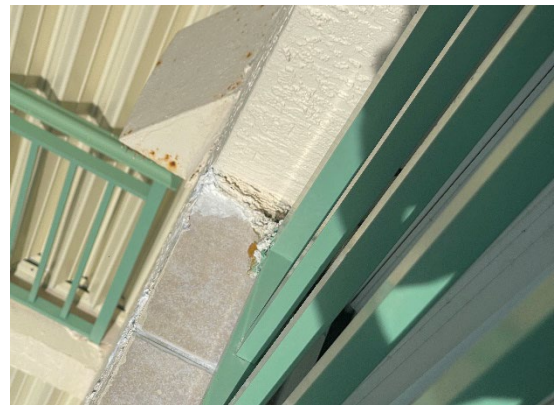
Efflorescence from terrace post pockets. (Unit 1701)

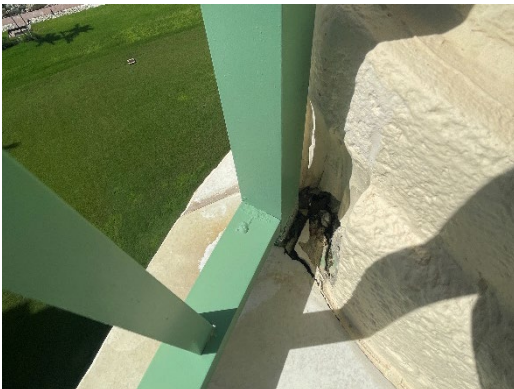
Staining between rail and column (Unit 701)

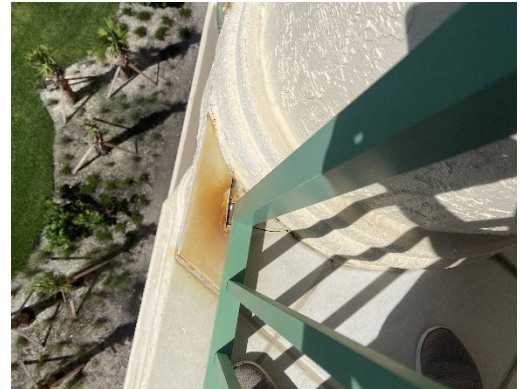
Stain on deck at post pocket. (Unit 701)

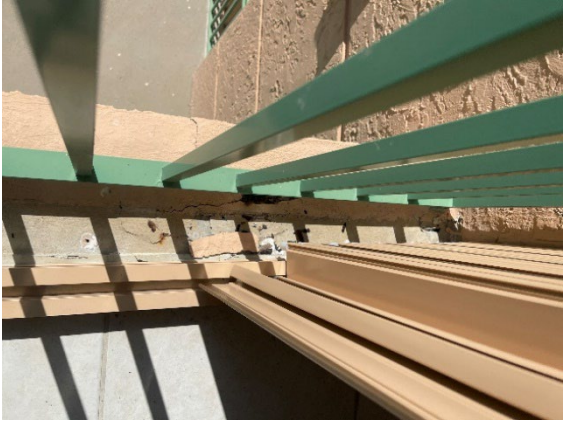
| Concrete cracks at corroded fasteners (Unit 402) | Vertical crack on stucco under windowsill (Unit PH5) |

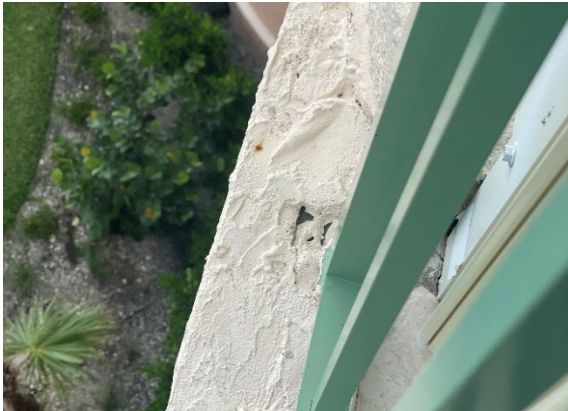
| Opening in stucco near post pocket (Unit 604) | Sliding Glass Door Corrosion (Unit 1606) |

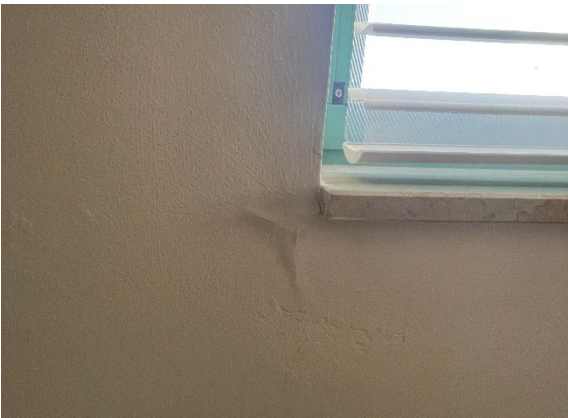
| Water intrusion. (Unit 806) | Staining at post pocket (Unit 305) |

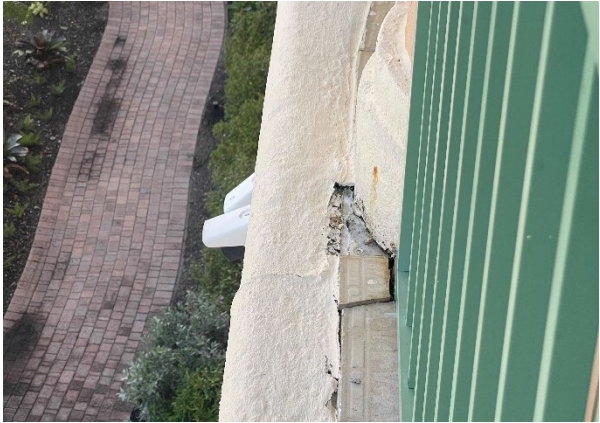
| <p>Loose tile &amp; exposed deck (Unit 305)</p> | <p>Column arc. accent base crack (Unit 1608)</p> |

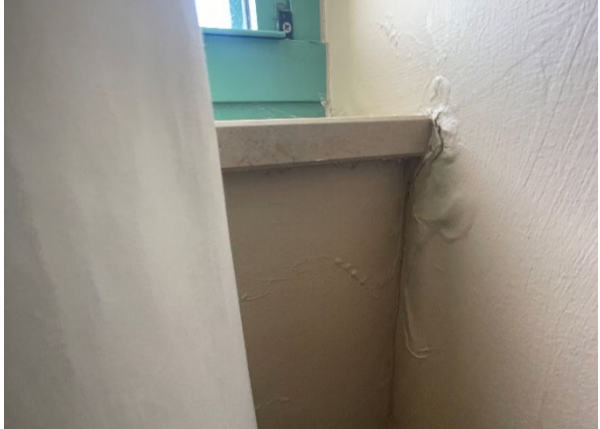
| <p>Water intrusion. (Unit 1007)</p> | <p>Sliding Glass Door's Screen Door Corrosion (Unit 908)</p> |

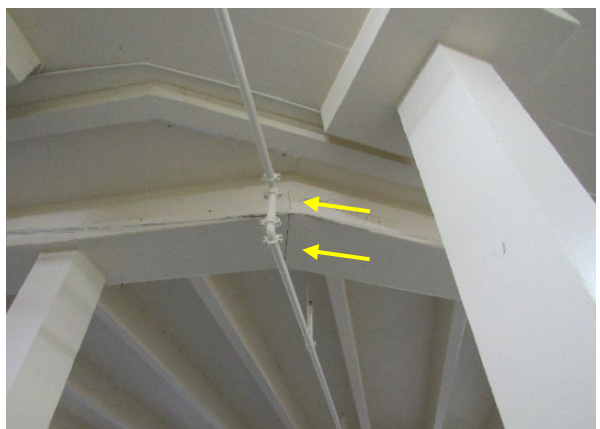
| <p>Crack in beam – garage</p> | <p>View of exterior elevation.</p> |

The building components that warrant additional attention are two structural beams located in the garage that each have a crack at what appears to be a cold joint in the concrete. Our recommendation is to install multiple crack gauges at each location and perform monthly monitoring for at least six months. In addition, these cracks should be sealed with a structural epoxy to protect the underlying structural elements.
