## RESIDENTIAL REPORT

Nautilus Condominium Association

848 Collier Ct.

## Phase One Milestone Inspection

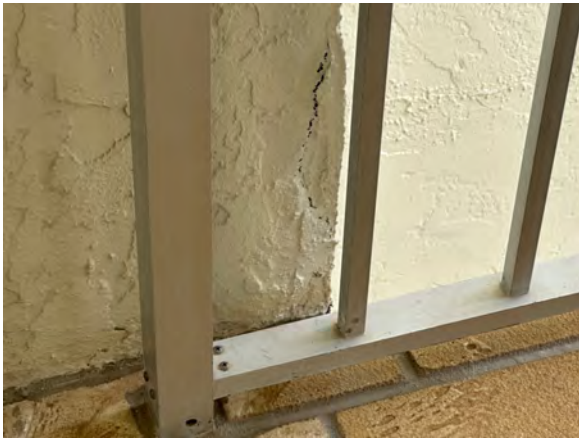
1.p.1

1. Minor cracking in concrete column between Units 301-401.
2. Minor cracking in concrete column between Units 206-306.

All cracks observed were HAIRLINE to FINE in width.
