June 14, 2024

Fred Arce  
Manager  
***The Prince Condominium***  
176 S Collier Blvd  
Marco Island, FL 34145

**RE:    *The Prince Condominium***  
          ***ASCE File No. 241792***  
          ***Milestone Inspection***

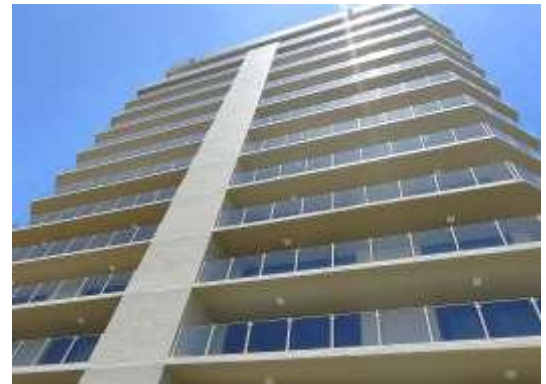
***Exterior of the structure.***

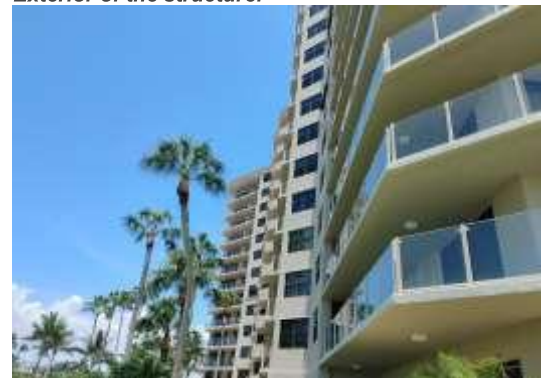
***Exterior of the structure***

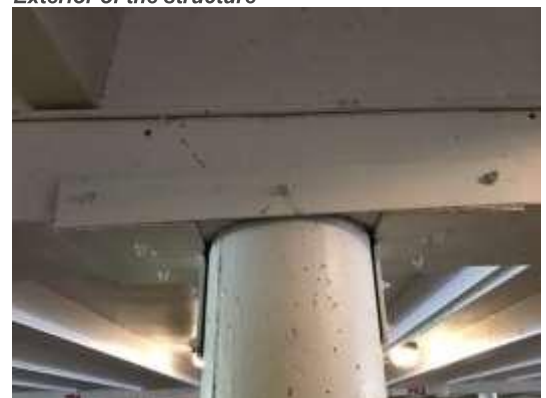
***Garage Supplemental Support***

Representatives of ASCE performed visual observations of the structure's exterior and some of the interior elements on the ground floor. Visual Examinations were conducted from the ground and from inside the structure. We did not observe any surface imperfections such as cracks, distortion, sagging, excessive deflections, significant misalignment, signs of leakage, or peeling of finishes. We observed several locations where the top of the columns was altered with drop panels. In discussions with your manager, these were added after other engineers completed the structure. These appeared to be performing as intended.

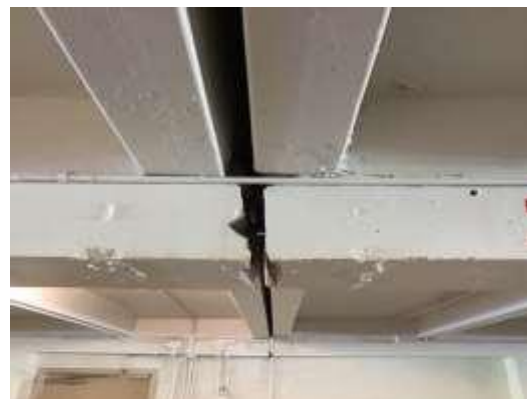
*Expansion Joint.*

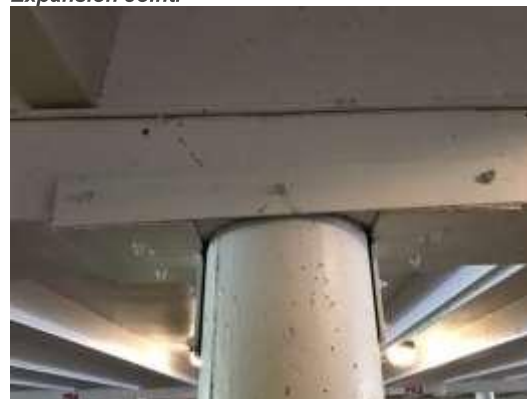
*Garage Supplemental Support*

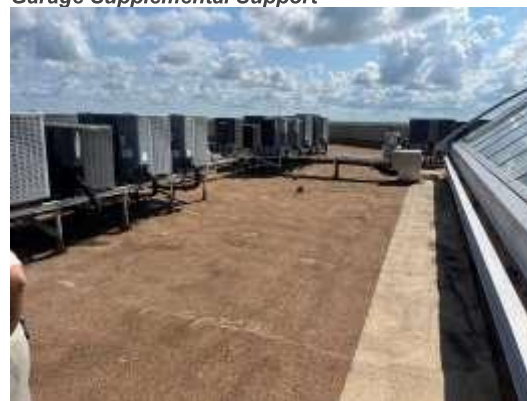
*Roof overall condition.*

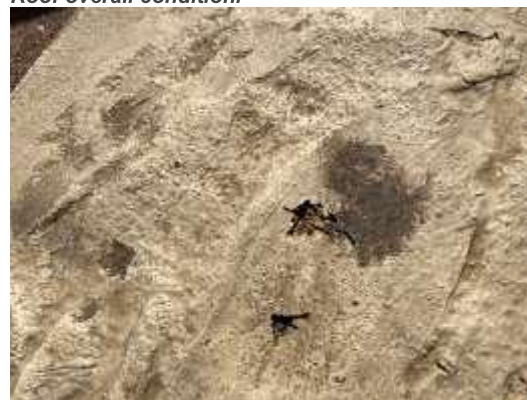
*Peeling on the waterproofing.*

ASCE has observed minor damage, such as peeling and cuts in the roof's waterproofing layer. These must be corrected under the existing warranty to avoid future water intrusion into the roof structure.

After inspecting the structure, ASCE recommends that corrective work be performed on the damages found in the roof waterproofing system; these repairs are included in the maintenance program agreed upon with the roofing company that conducted the roof waterproofing project to prevent water intrusion into the structure and maintain the structural integrity of the building. This minor damage does not constitute a current danger to the structure. However, they must be corrected to avoid future significant implications. This minor damage does not constitute a current danger to the structure. However, they must be corrected to prevent substantial future consequences.

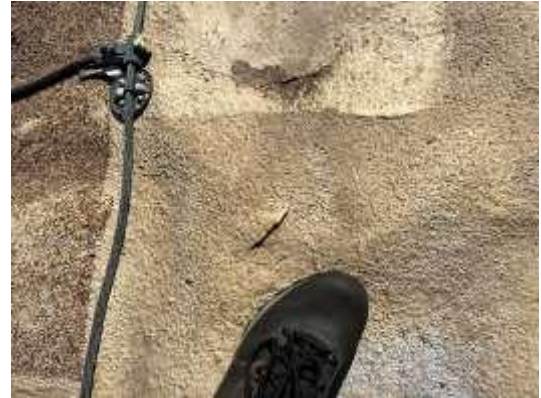
*Cuts on the waterproofing.*

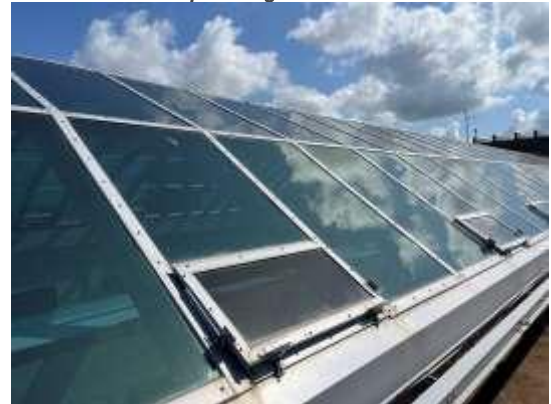
After Hurricane Wilma in 2006, the roof and supporting structure were replaced with impact-rated glass panels. This structure appears to be in good condition; no appreciable deterioration was found during the observation.

*Glass roof.*
