**MILESTONE INSPECTION –PHASE I  
REPORT**

Princess Del Mar Condominium  
174 South Collier Boulevard.  
Marco Island, Florida 34145

SOCOTEC Project Number VS240425

June 2024

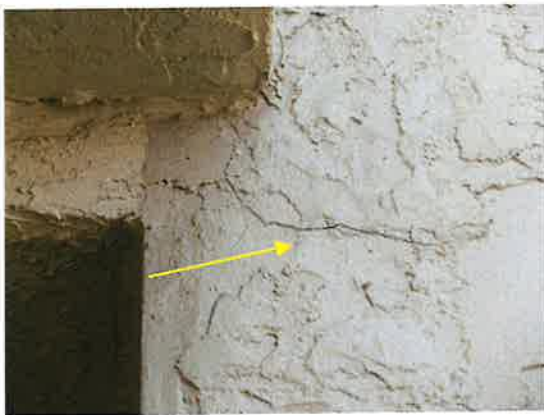
View of concrete distress along a wall.

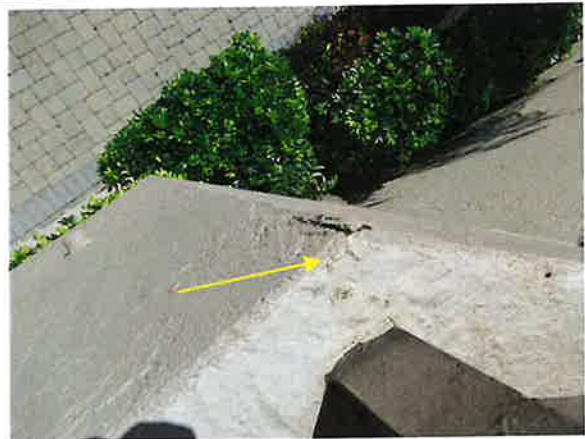
View of typical delaminated stucco.

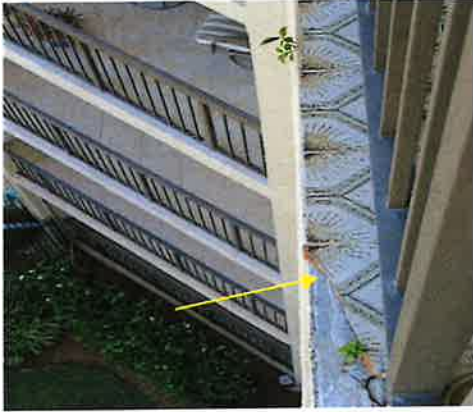
View of delaminated tile with vegetation growth along unit balcony deck edge.

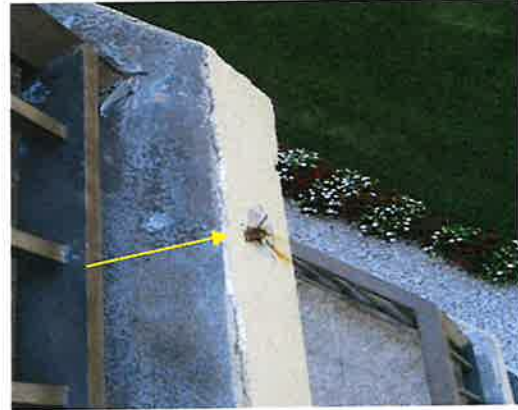
View of exposed and corroded steel reinforcement along deck edge.

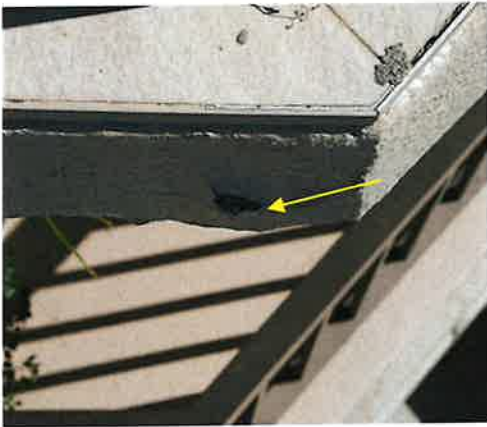
View of distressed concrete along unit balcony deck edge.

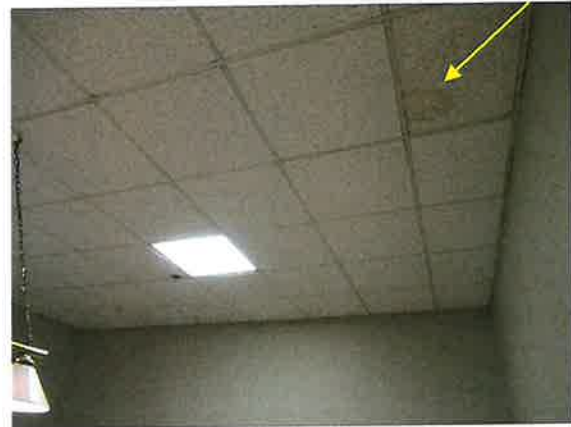
View sign of potential water intrusion.

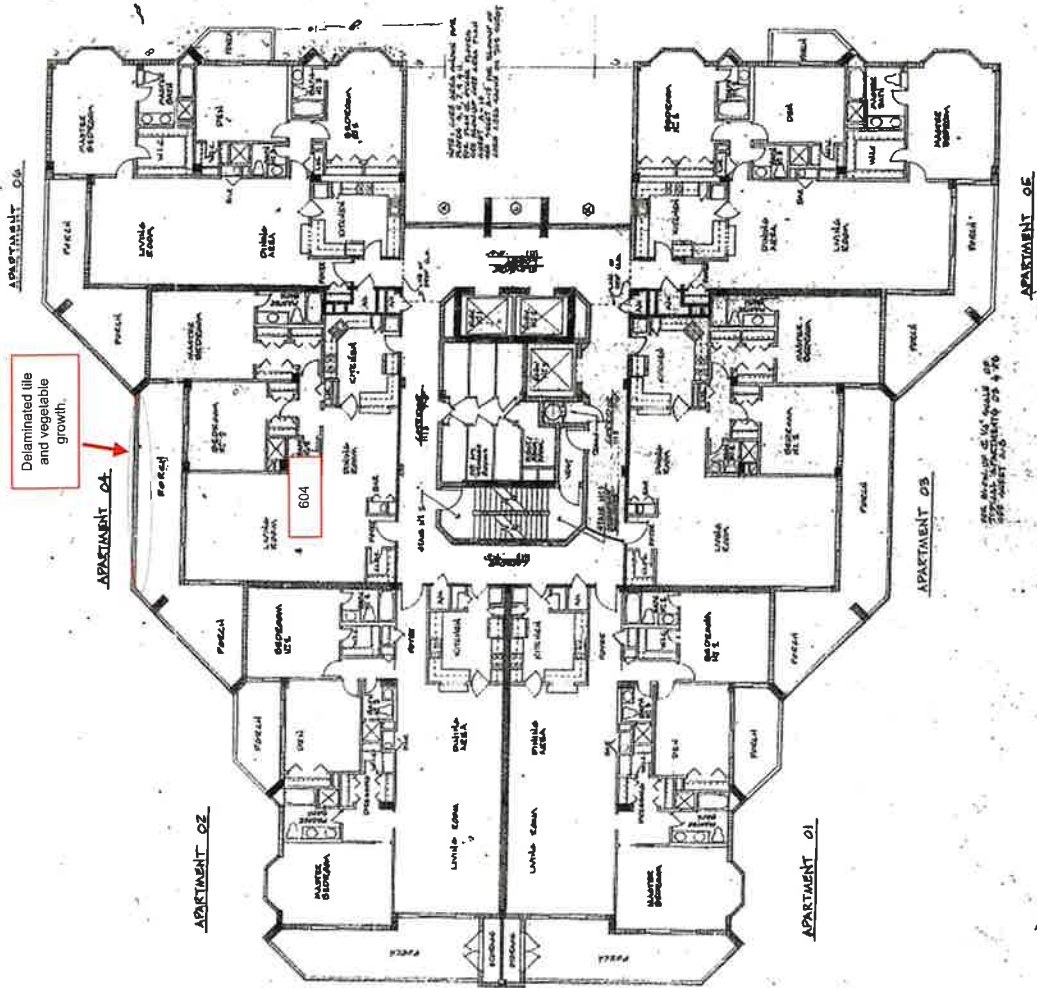
# UNIT 604

**Delaminated tile  
and vegetable  
growth.**

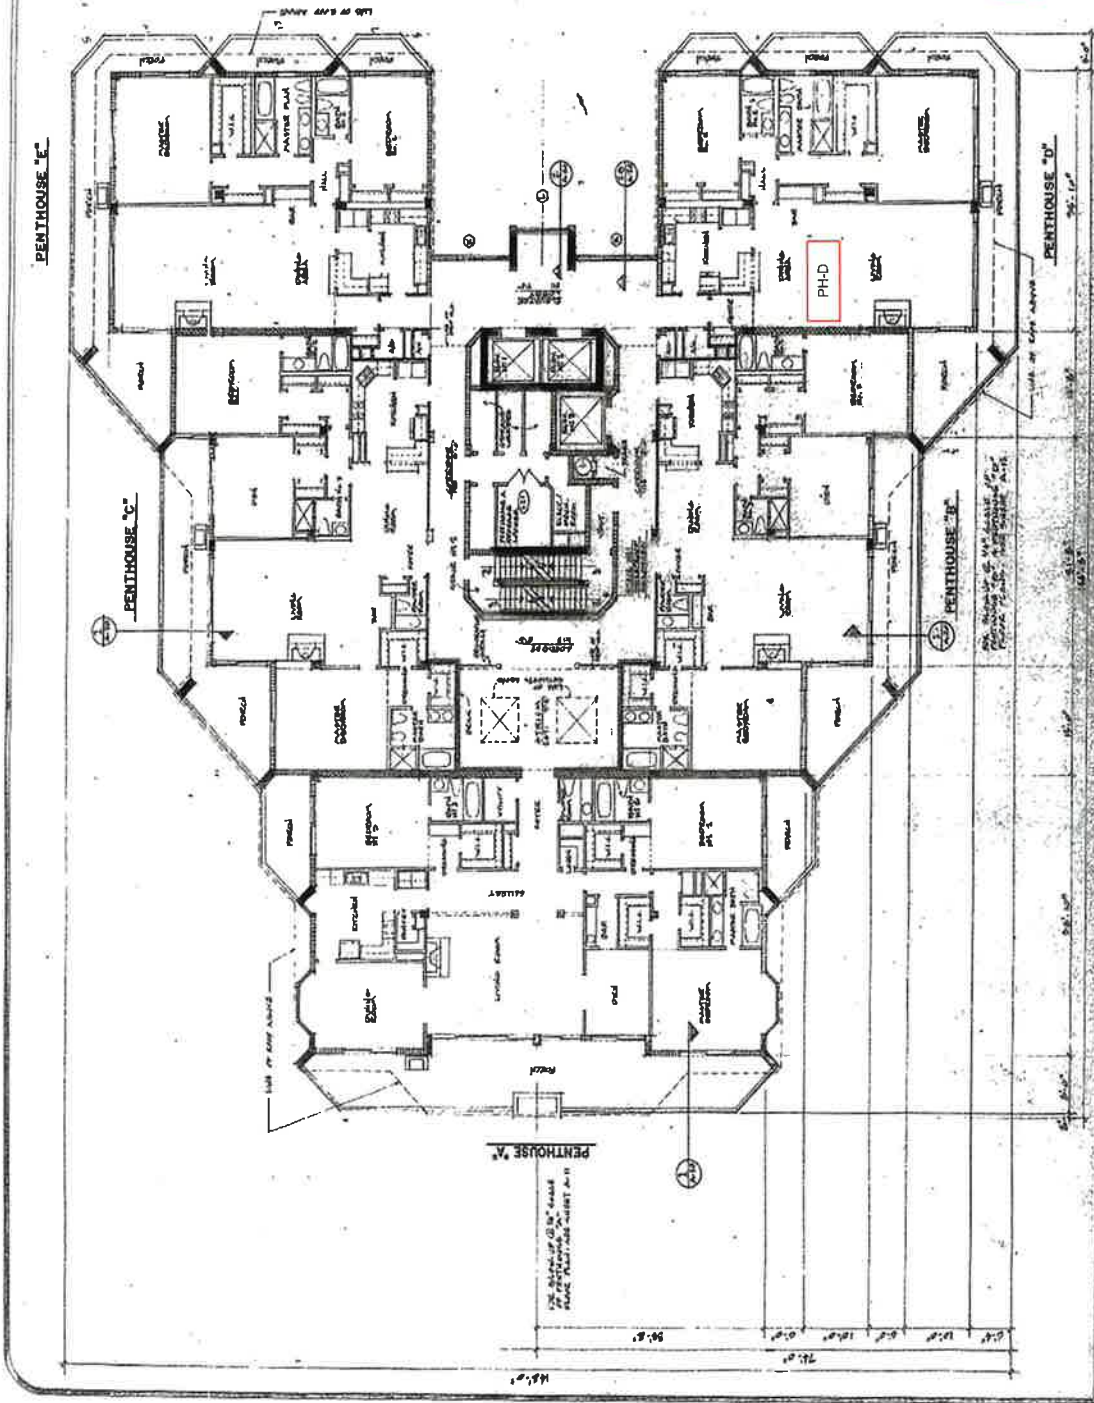
PH-D

No structural distress noted  
across the unit

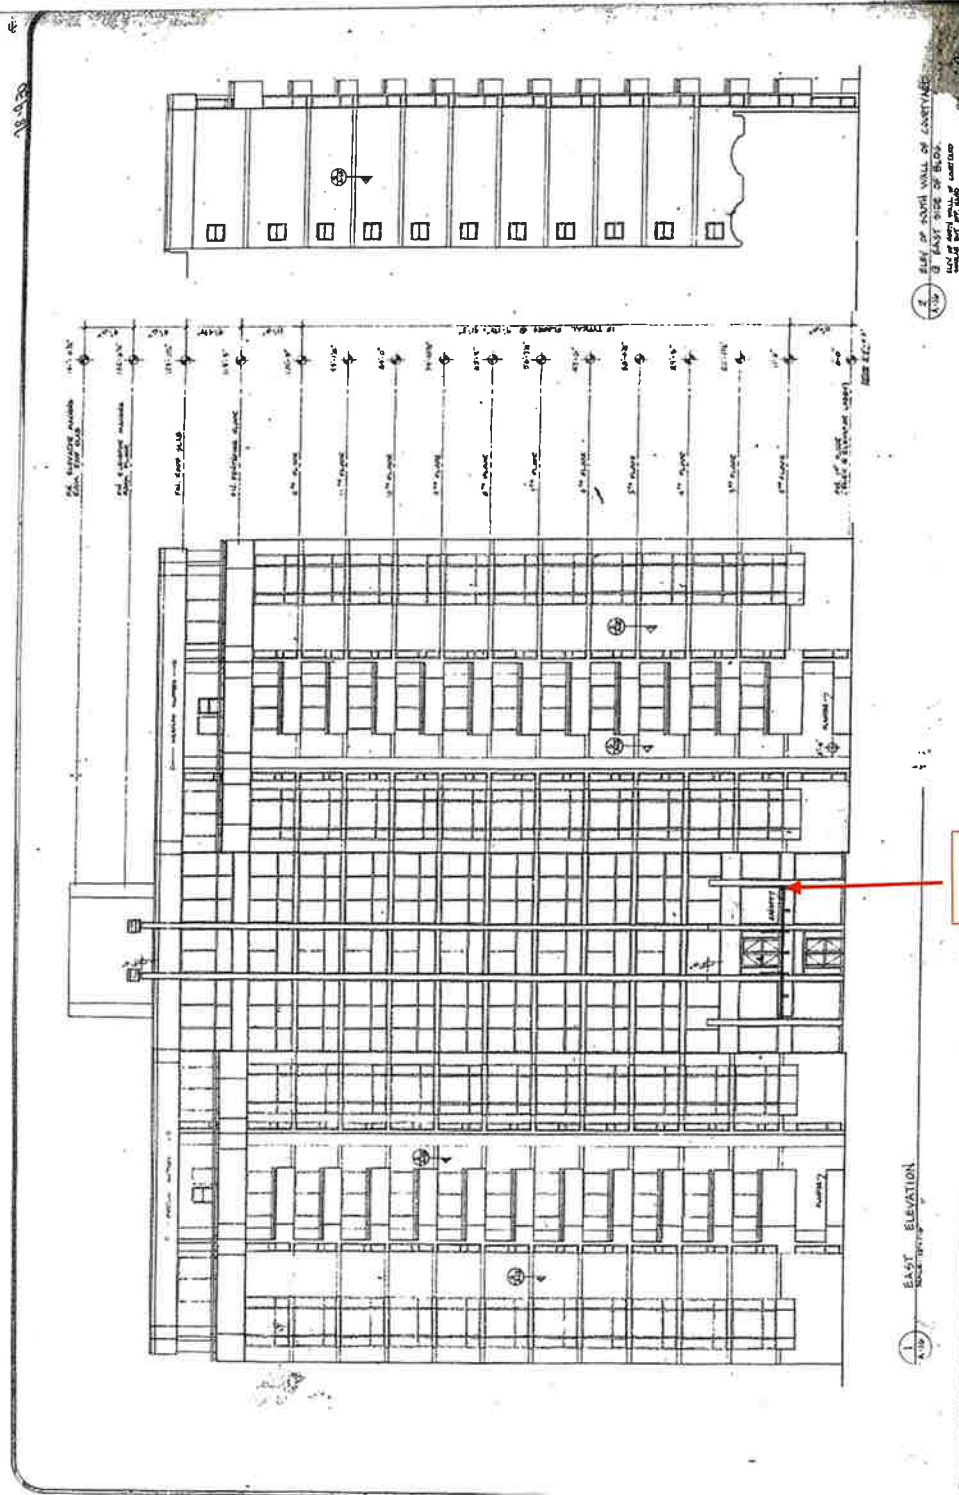
## EAST ELEVATION

### Fail repair

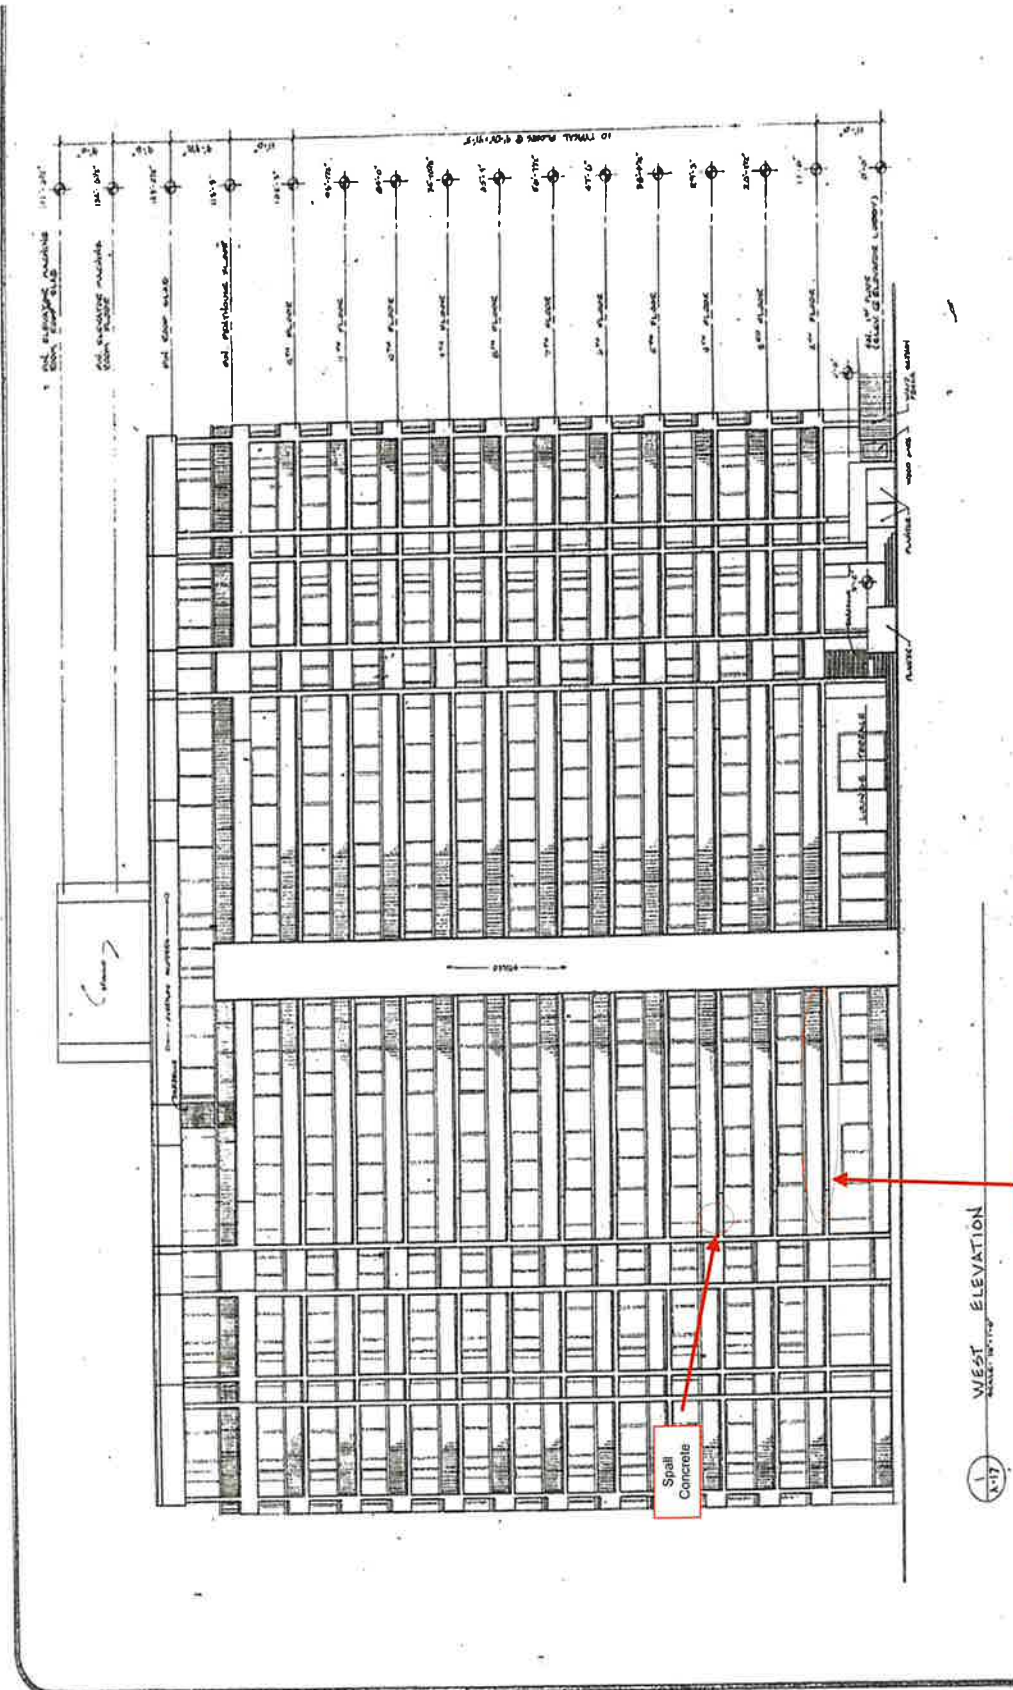
WEST ELEVATION

Spall  
Concrete

Minor  
cracks
