**Contract # 45630**

## **Milestone Inspection – Phase 1**

### **Riverside Club Condominium Association**

1085 Bald Eagle Dr. B Building, Marco Island, FL 34145

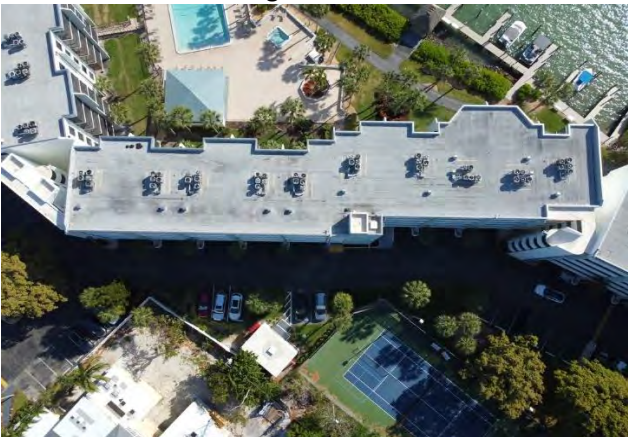
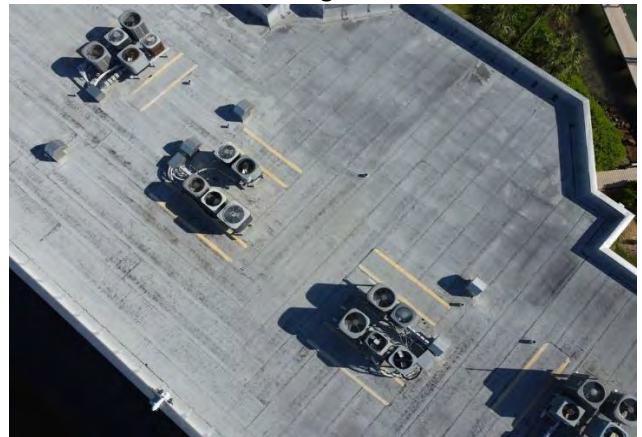
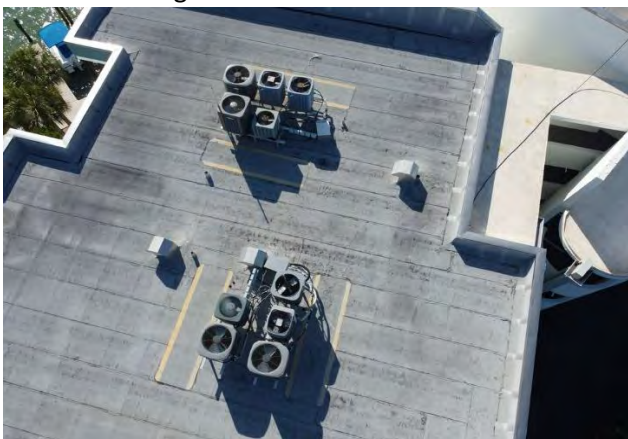
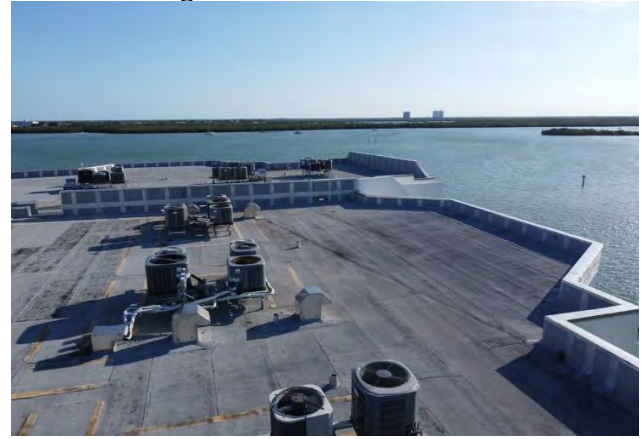
- Building #B
  - No concerns of note

5 Building B Roof Overview

6 Building B Roof Overview

7 Building B Roof Overview

8 Building B Roof Overview

For the flat roof, we do not recommend that the roof have a Phase 2 thermal inspection performed at this time. However, Annual roof inspections, as well as post-storm roof inspections, should be performed to allow for quick remediation of issues that can prevent structural impact on the framing.

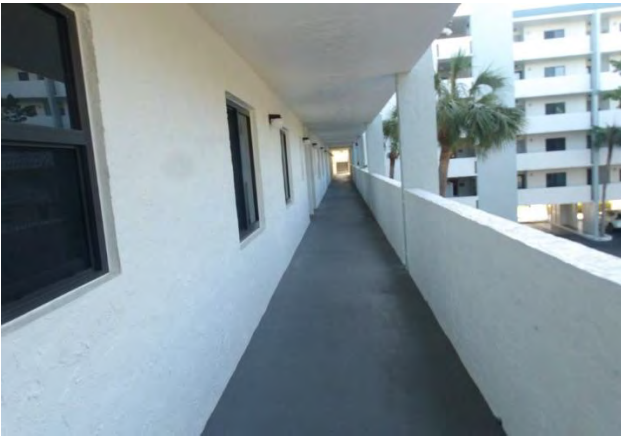
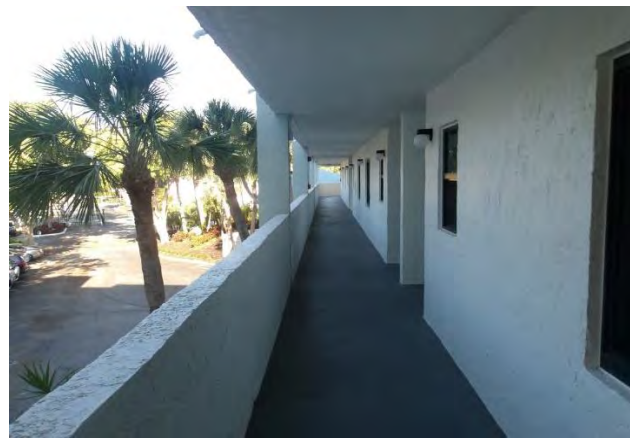
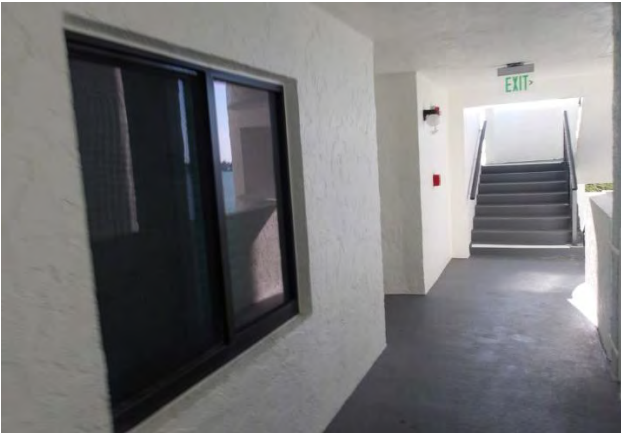
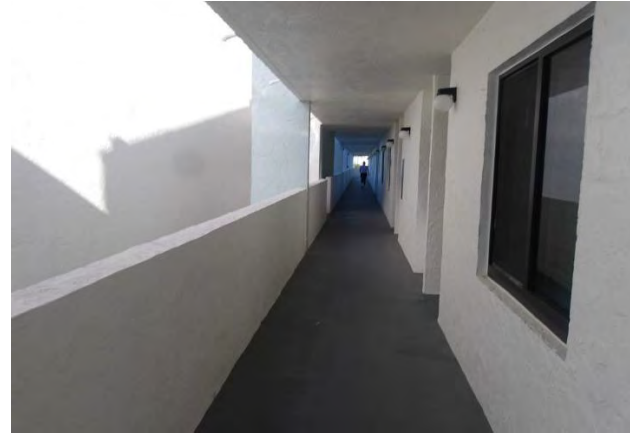
- Building B, Level 2
  - No concerns of note
- Building B, Level 3
  - No concerns of note
- Building B, Level 4
  - No concerns of note
- Building B, Level 5
  - No concerns of note
- Building B, Level 6
  - No concerns of note

9 Building B Exterior Walls and Breezeways

10 Building B Exterior Walls and Breezeways

11 Building B Exterior Walls and Breezeways

12 Building B Exterior Walls and Breezeways

For the Exterior Walls/Breezeways, we do not recommend that the breezeways and walls have a Phase 2 destructive testing preformed. We recommend that the painting/waterproofing schedule is strictly adhered to. As part of a yearly inspection, we recommend that any surficial cracks developing are sealed with elastomeric sealer between formal painting cycles.

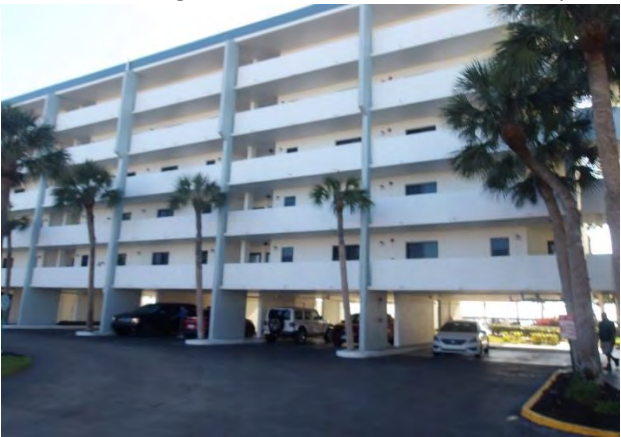
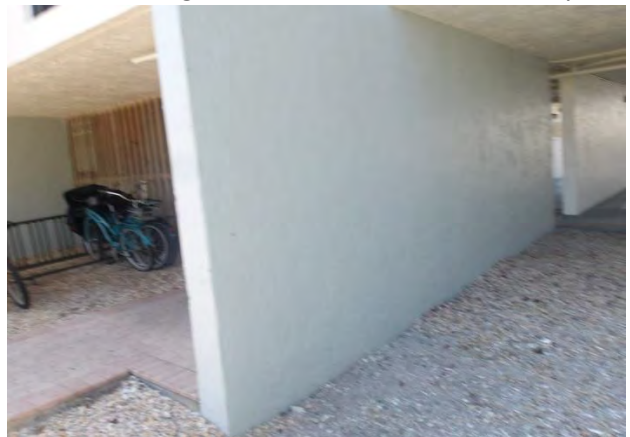
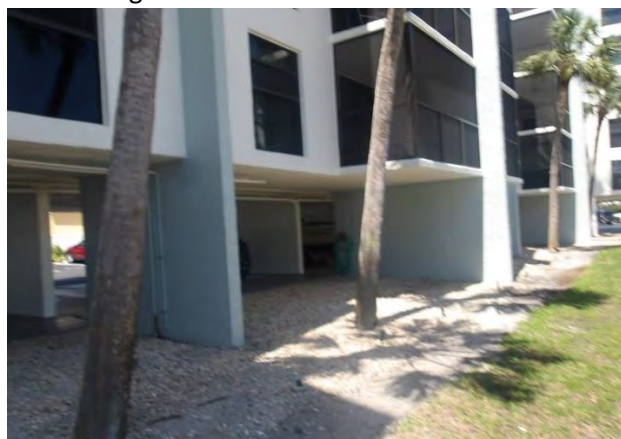
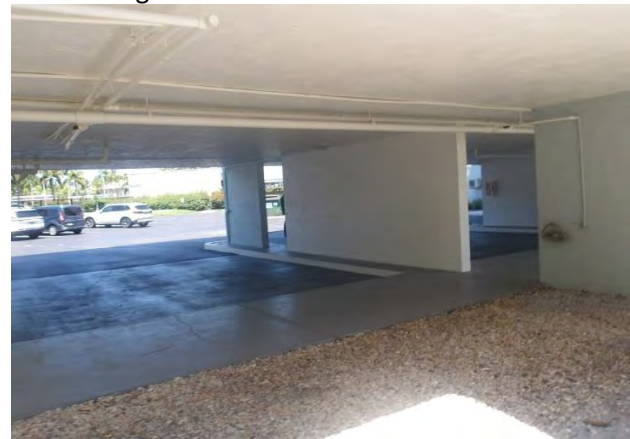
- Building B,
  - No concerns of note

13 Bldg B Pier and Beam Foundation Overview

14 Bldg B Pier and Beam Foundation Overview

15 Bldg B Pier and Beam Foundation Overview

16 Bldg B Pier and Beam Foundation Overview

For the foundation, we do not recommend that the foundation have a Phase 2 destructive testing performed. When the breezeways/walkways are sealed, we recommend that any slab-on-grade cracks are repaired with epoxy. Differential settlement may require high-strength concrete injection as part of a preventative maintenance plan. We further recommend removing any large shrubs or trees within 5 feet of the structure.

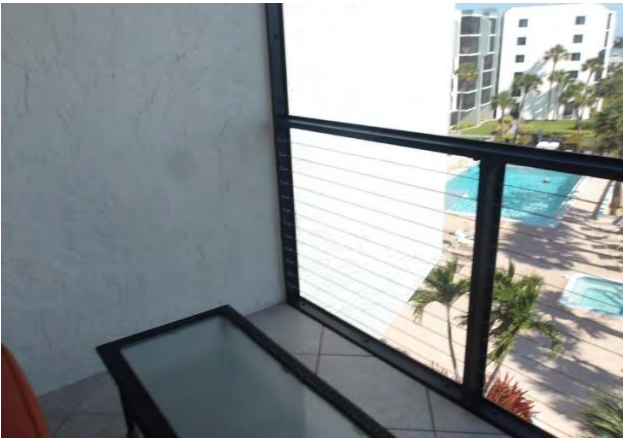
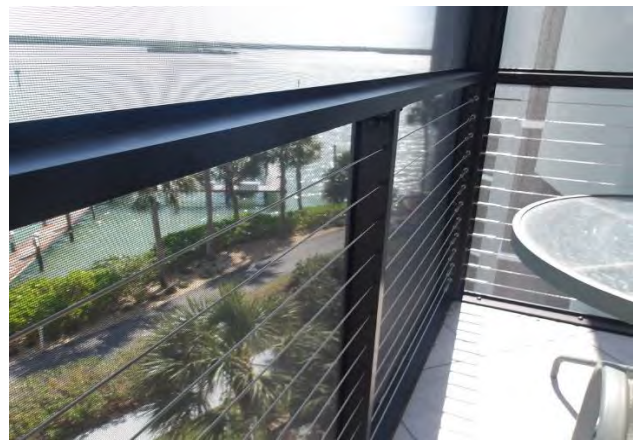
- Building B, Unit #207
  - No concerns of note
- Building B, Unit #308
  - No concerns of note
- Building B, Unit #402
  - No concerns of note
- Building B, Unit #406
  - No concerns of note
- Building B, Unit #505
  - No concerns of note

17 Bldg B Balcony Overview Unit #B505

18 Bldg B Balcony Overview Unit #B505

For the Balconies, we do not recommend that the balconies have a Phase 2 destructive testing preformed. We recommend that the painting/waterproofing schedule is strictly adhered to. As part of a yearly inspection, we recommend that any surficial cracks developing are sealed with elastomeric sealer between formal painting cycles. No modifications to the balconies such as tile or carpet should be allowed by the COA without approval of the Board or Architectural Review Committee along with receiving plans on how the waterproofing both under the tiles and at the end walls are achieved.

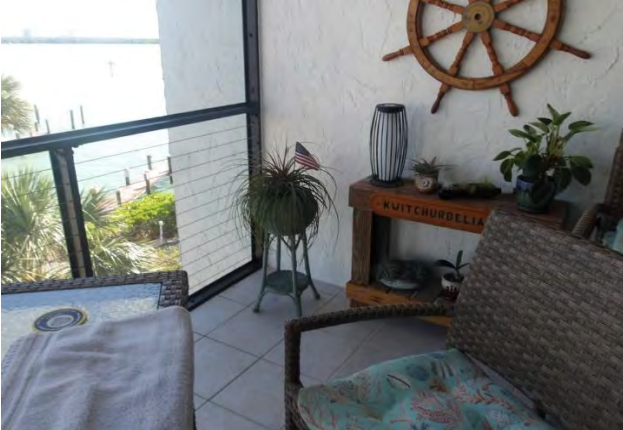
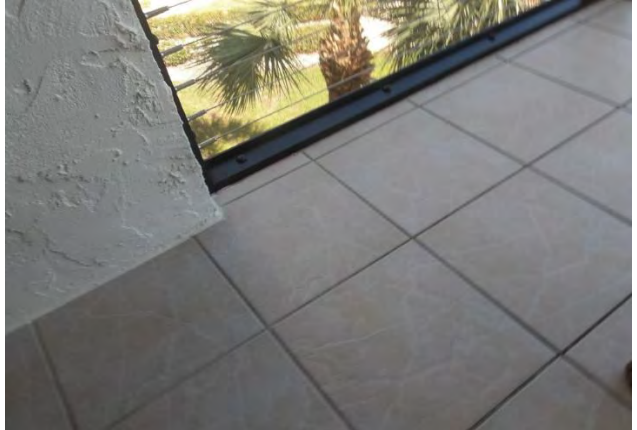
19 Bldg B Balcony Overview Unit #B406

20 Bldg B Balcony Overview Unit #B406

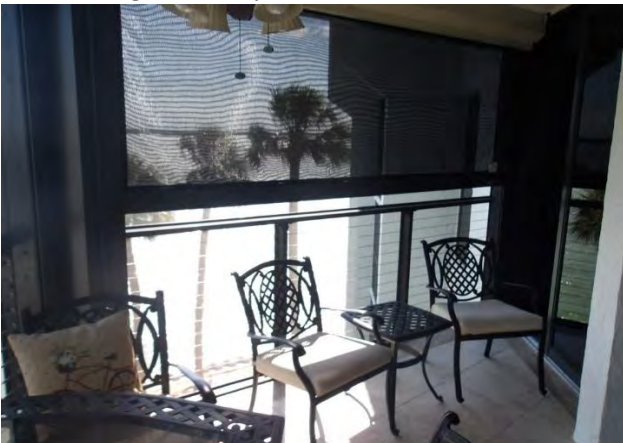
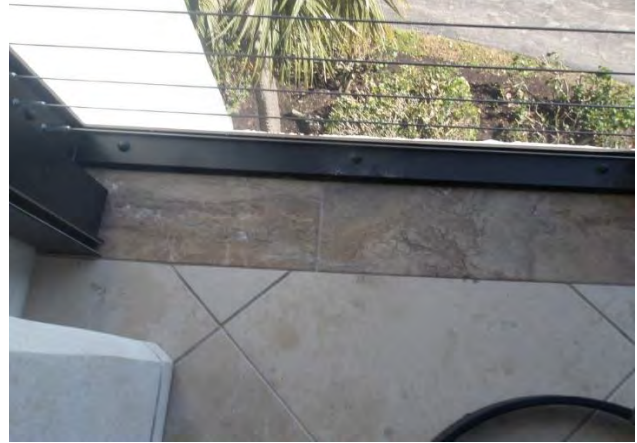
21 Bldg B Balcony Overview Unit #B402

22 Bldg B Balcony Overview Unit #B402

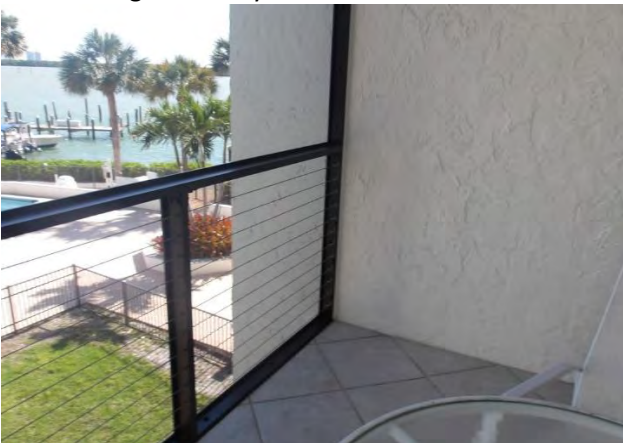
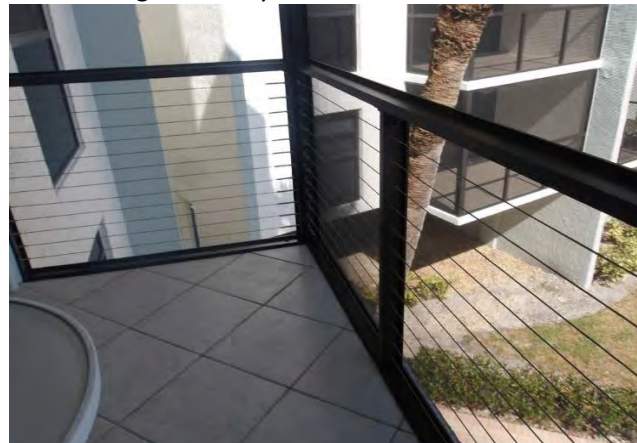
23 Bldg B Balcony Overview Unit #B308

24 Bldg B Balcony Overview Unit #B308

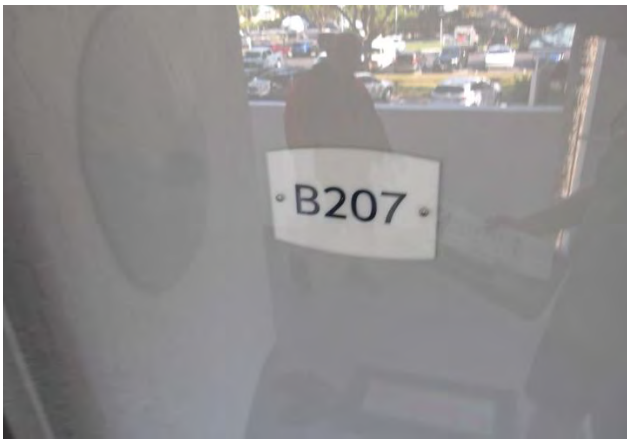
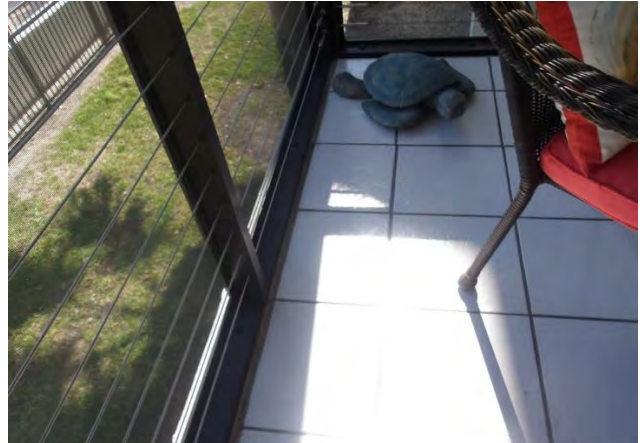
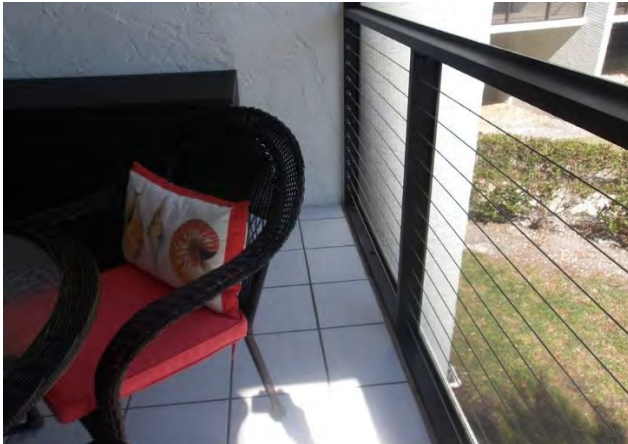
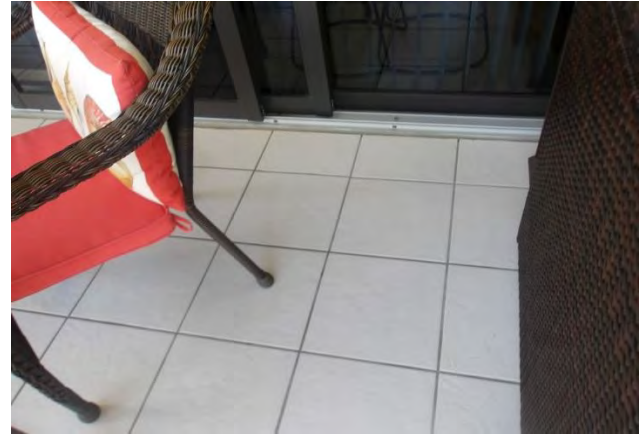
25 Bldg B Balcony Overview Unit #B207

26 Bldg B Balcony Overview Unit #B207

27 Bldg B Balcony Overview Unit #B207

28 Bldg B Balcony Overview Unit #B207

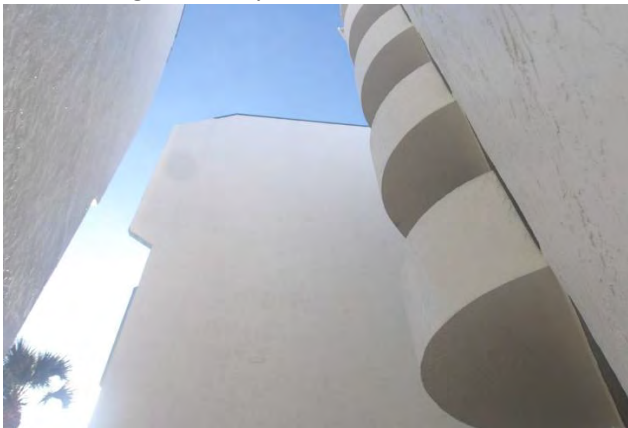
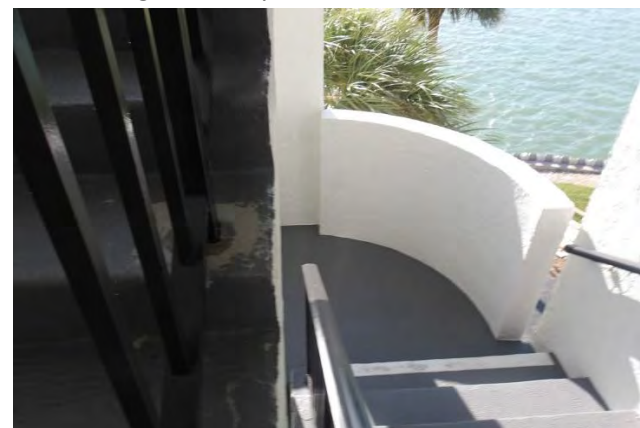
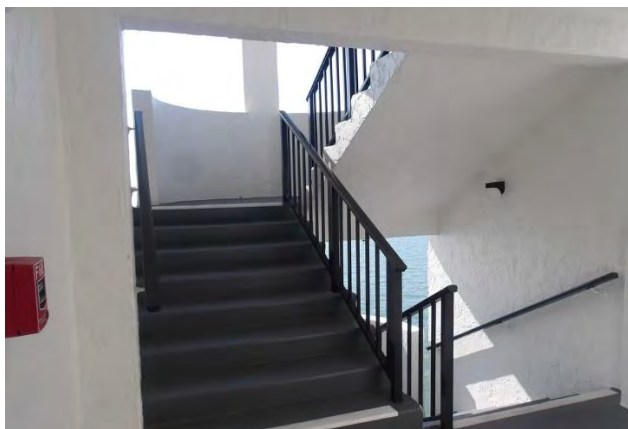
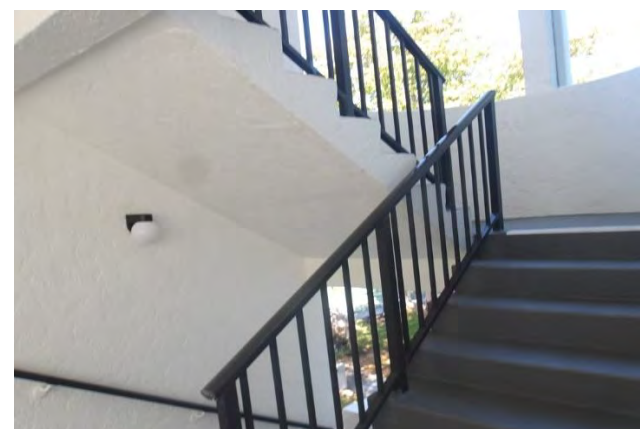
- Stairs at the East side of Building #B
  - No concerns of note

29 Bldg. B Stairway Overview

30 Bldg. B Stairway Overview

31 Bldg. B Stairway Overview

32 Bldg. B Stairway Overview

For the stairs, we do not recommend that the stairs have a Phase 2 destructive testing performed as there was no concern with structural compromising at the time of inspection. When the breezeways/walkways are sealed, we recommend that the stairs are included to help prevent future structural issues caused by water infiltration as part of a preventative maintenance plan.

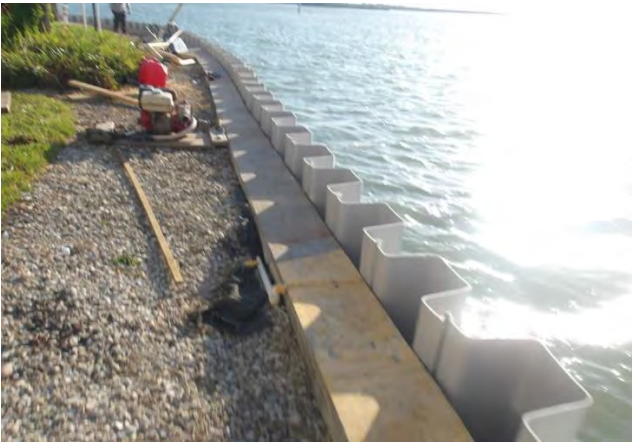
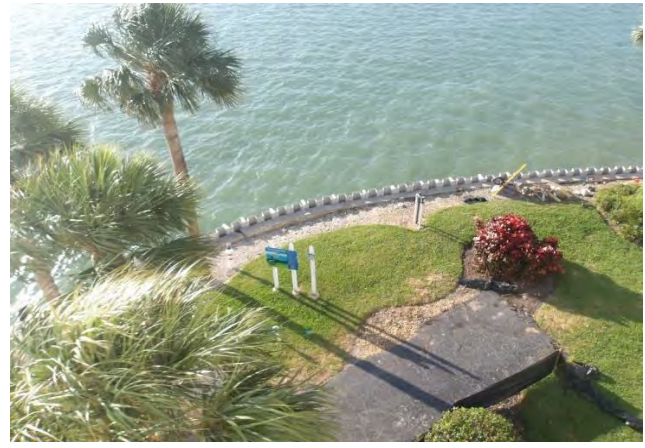
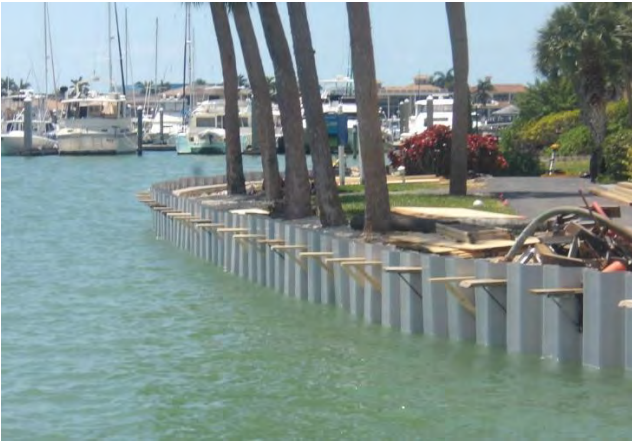
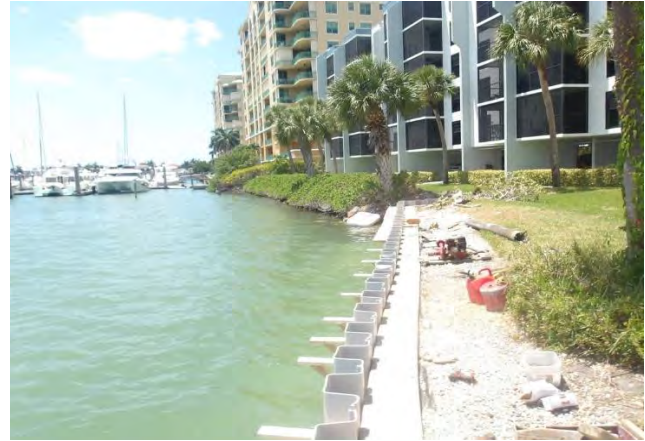
- At the time of Beryl's site visit, a new Seawall was being built in front of the original one. The previous Seawall was replaced due to damage at the cap and bulkhead.

33 Seawall Overview

34 Seawall Overview

35 Seawall Overview

36 Seawall Overview

For the retaining wall, we do not recommend a Phase 2 destructive testing performed. We recommend a yearly inspection protocol of the retaining wall to look for the defects described above. Any defects noted such as cracks should be elastomerically sealed as part of a preventative maintenance program.
