# Milestone Inspection Report Phase 1

## Royal Marco Point I Condominium Association, Inc.

2000 Royal Marco Way  
Marco Island, FL 34145

Prepared on:  
1/8/2025

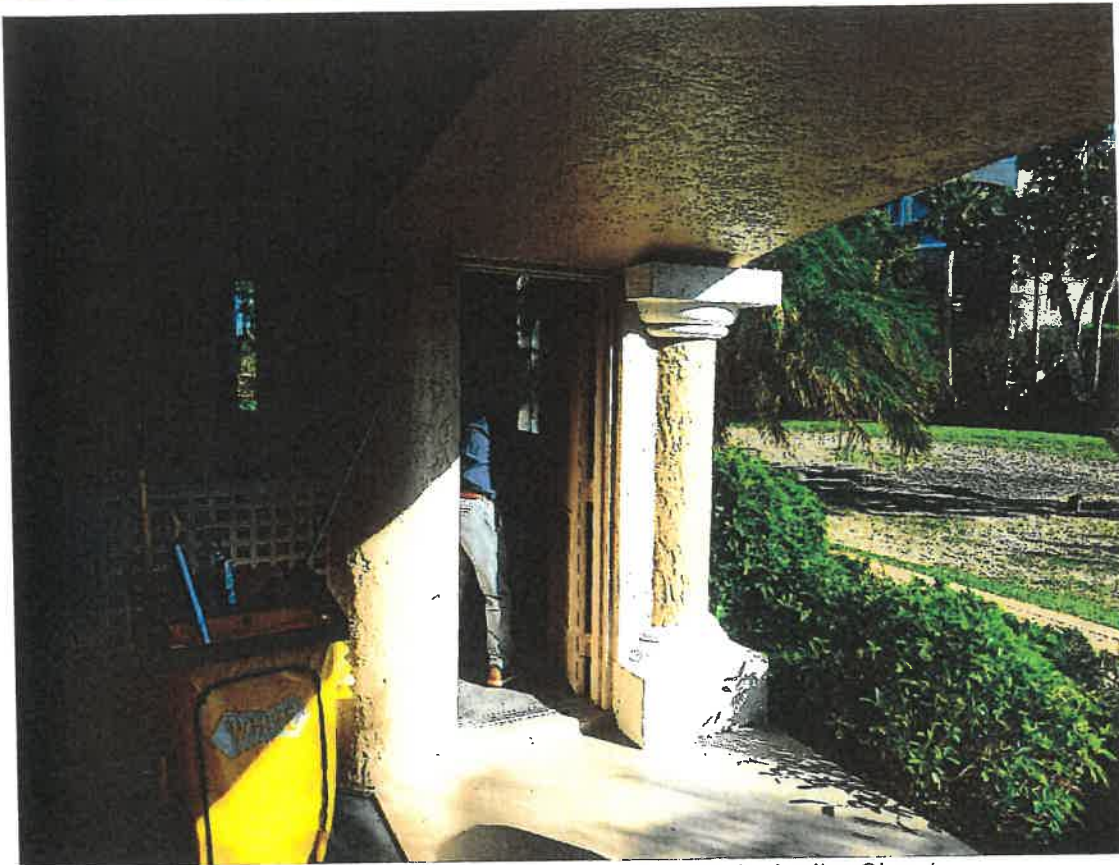
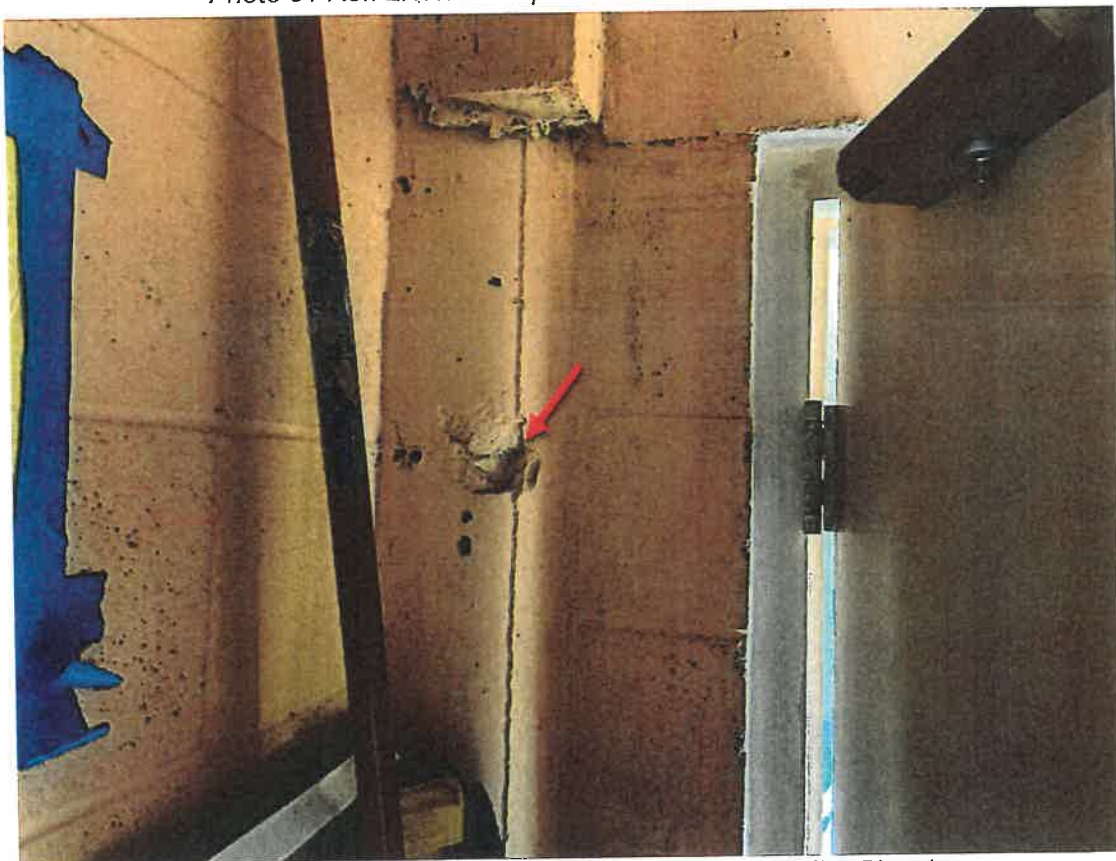
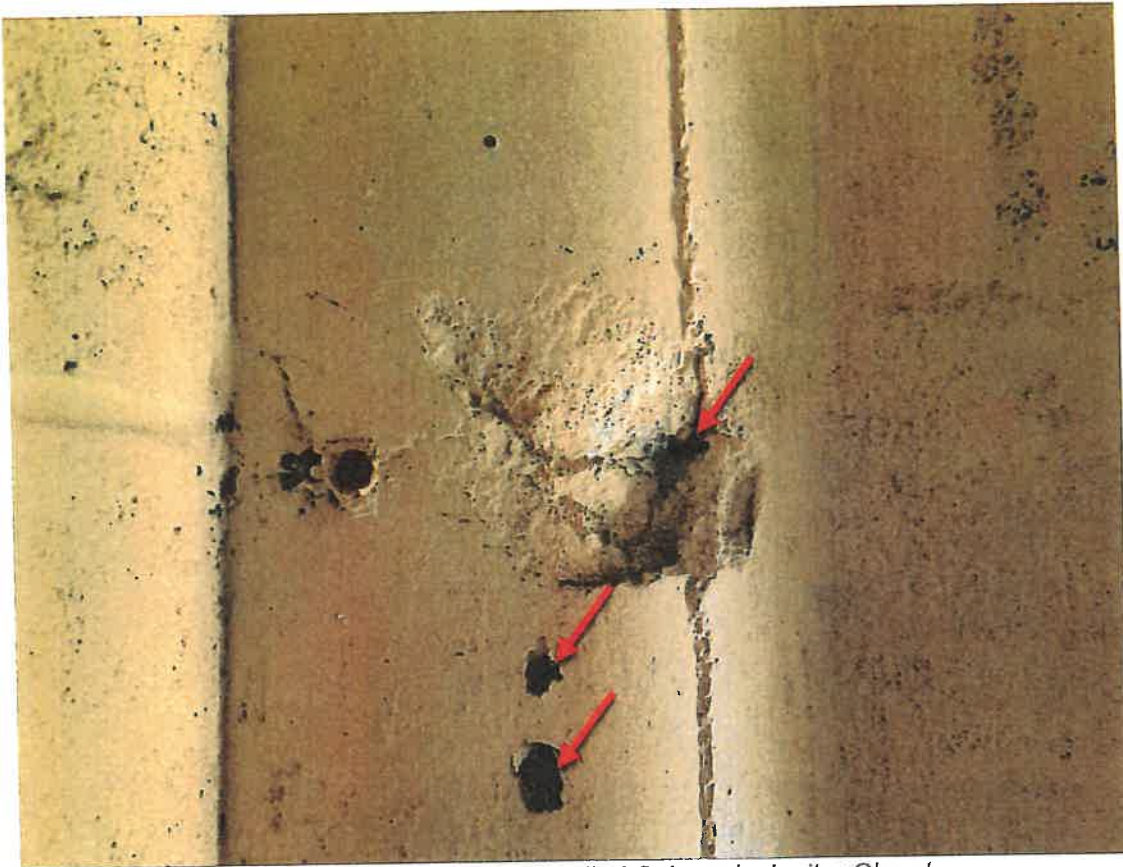
- 2.1.1.1 There is a large spall on a cylindrical support column inside a janitor's closet (Photos 01, 02, 03). Even if there was an attempt to coat the spall with paint, there is still exposed concrete evident which will react with the moist, salty, coastal air, resulting in more spalling of the concrete. The Carbonation process will progress rapidly inside the penetrations in the painted surfaces. See *Carbonation & the Concrete Spalling / Degradation Process* (pg. 2)

*Photo 01 Ref: 2.1.1.1 – Spalled Column in Janitor Closet*

*Photo 02 Ref: 2.1.1.1 – Spalled Column in Janitor Closet*

*Photo 03 Ref: 2.1.1.1 – Spalled Column in Janitor Closet*

3.1.1.1 Perform a Phase Two Milestone Inspection of the items identified in Section 2.1 of this report in accordance with FS 553.899(7)(b). The engineer performing the Phase Two Milestone Inspection should provide recommended repairs to address the items identified in both reports.

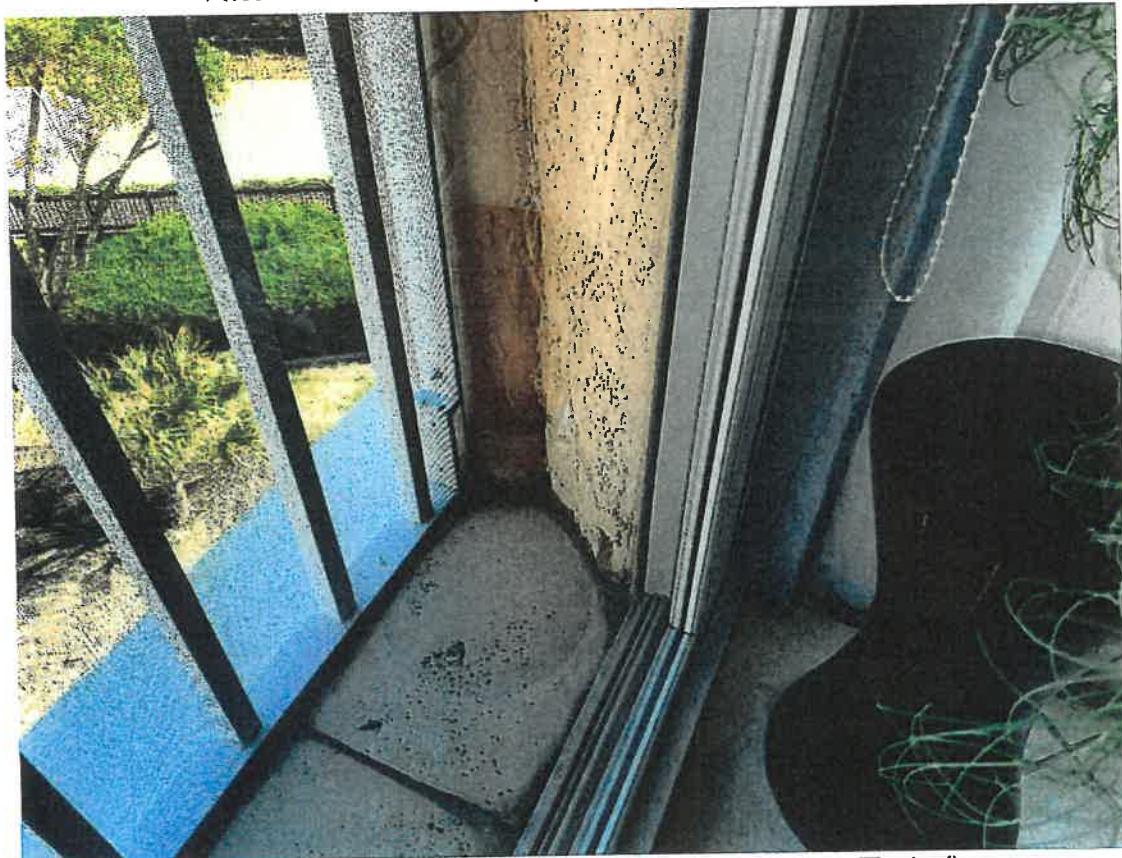
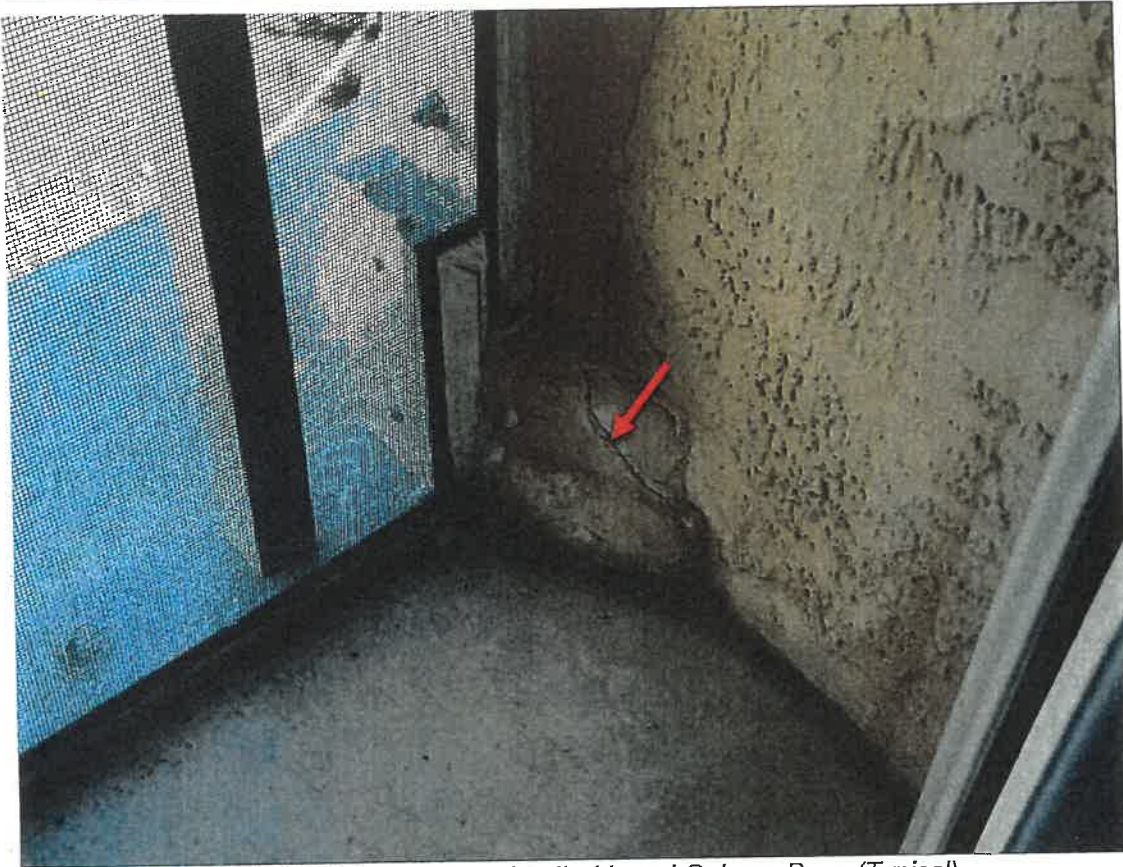
- 2.1.2.1 Some columns, located on the slab edges of lanais; were spalled (Photos 04, 05 typical). The Carbonation process will progress rapidly inside of these spalls. See *Carbonation & the Concrete Spalling / Degradation Process* (pg. 2)

*Photo 04 Ref: 2.1.2.1 – Spalled Lanai Column Base (Typical)*

*Photo 05 Ref: 2.1.2.1 – Spalled Lanai Column Base (Typical)*

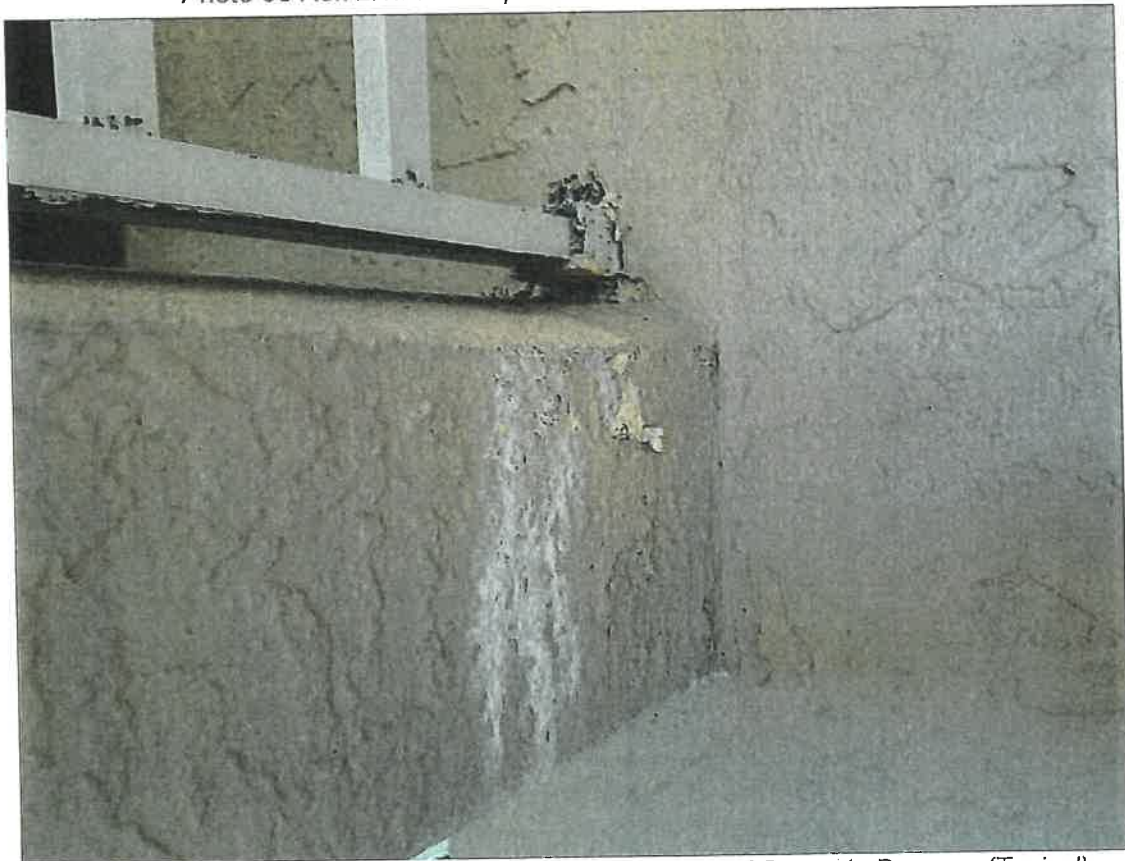
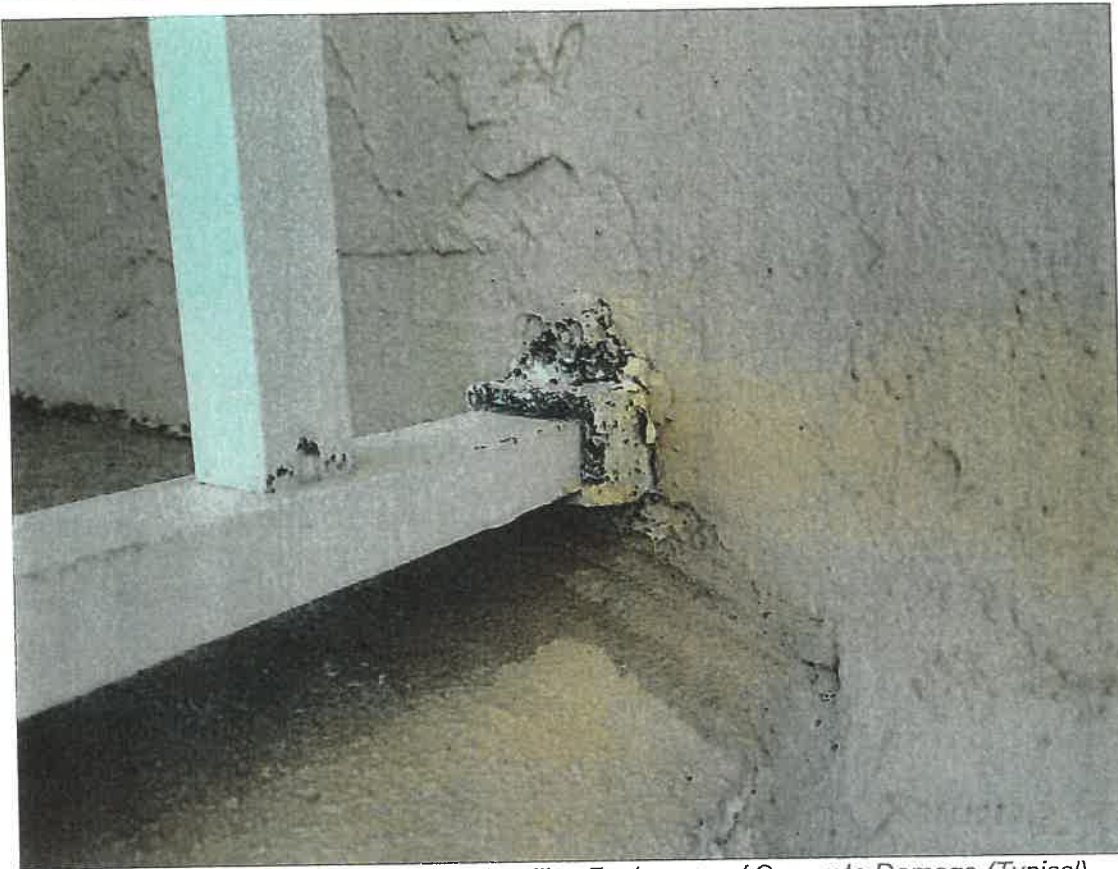
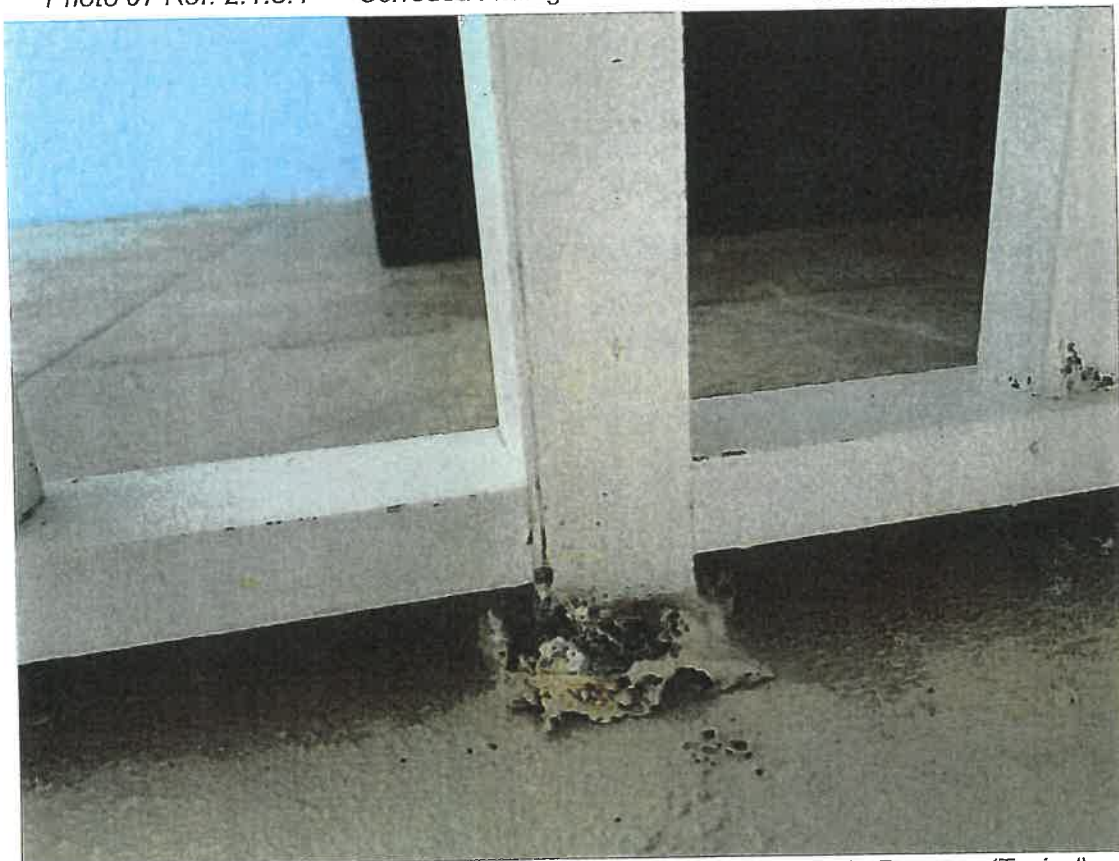
- 2.1.3.1 Multiple brackets at locations where the railings are fastened to the wall, are severely corroded and beginning to affect the adjacent concrete walls (Photos 06, 07, 08 typical). As the aluminum fasteners corrode away, they leave space for moisture to enter the stucco and therefore to be trapped against the concrete. The Carbonation process will progress rapidly inside of this new small voids against the concrete. See *Carbonation & the Concrete Spalling / Degradation Process* (pg. 2)

*Photo 06 Ref: 2.1.3.1 – Corroded Railing Fasteners w/ Concrete Damage (Typical)*

*Photo 07 Ref: 2.1.3.1 – Corroded Railing Fasteners w/ Concrete Damage (Typical)*

*Photo 08 Ref: 2.1.3.1 – Corroded Railing Fasteners w/ Concrete Damage (Typical)*

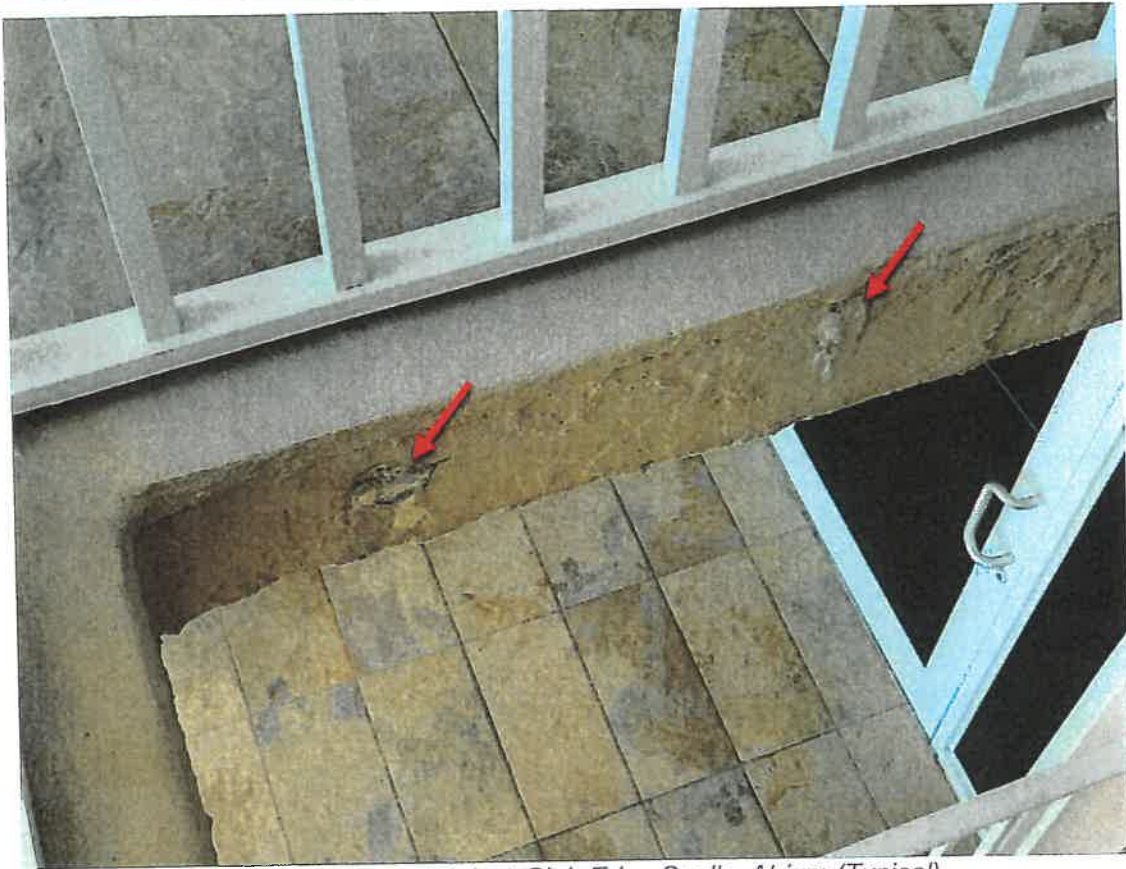
- 2.1.4.1 Locations along the slab edges of the atriums are spalled. (Photo 09 typical). The Carbonation process will progress rapidly wherever there is chronic moisture in contact with the concrete. Spalls allow this moisture into the concrete and spalls tend to continue becoming worse because the rebar corrosion continues. See *Carbonation & the Concrete Spalling / Degradation Process* (pg. 2)

*Photo 09 Ref: 2.1.4.1 – Slab Edge Spalls, Atrium (Typical)*

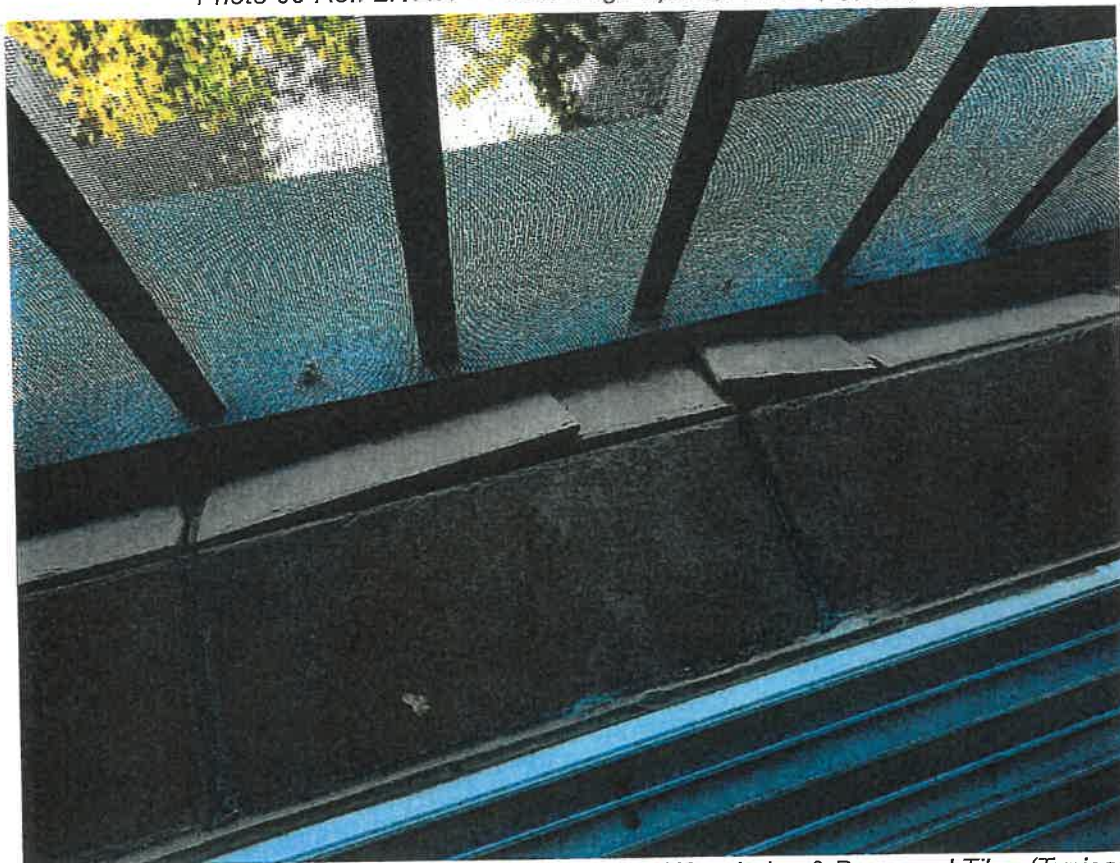
- 2.2.1.1 The tile on some portions of the lanais is damaged between the slab edge and the screen enclosure (Photos 10,11 typical). The tile is damaged from the screen enclosures blocking the proper runoff of rainwater. Tile has been installed too close to the weepholes in the bottom of the screen enclosures and / or the weepholes have sometimes been clogged. Lingering rainwater on any masonry or tile surface, degrades the grout and concrete. Damaged tile lets water penetrate to the waterproofing layer (if present) underneath and shortens it's life. If there is no waterproofing layer under the tile, the concrete structure below will be affected directly and more rapidly. See *Carbonation & the Concrete Spalling / Degradation Process* (pg. 2)

*Photo 10 Ref: 2.2.1.1 – Blocked Screen Enclosure Weepholes & Damaged Tiles (Typical)*

3.1.2.2 All screen enclosures should be inspected for their ability to drain rainwater through their weepholes. If tile is blocking the weepholes, a portion should be removed next to the screen enclosure. Any other obstructions or clogs should be removed.

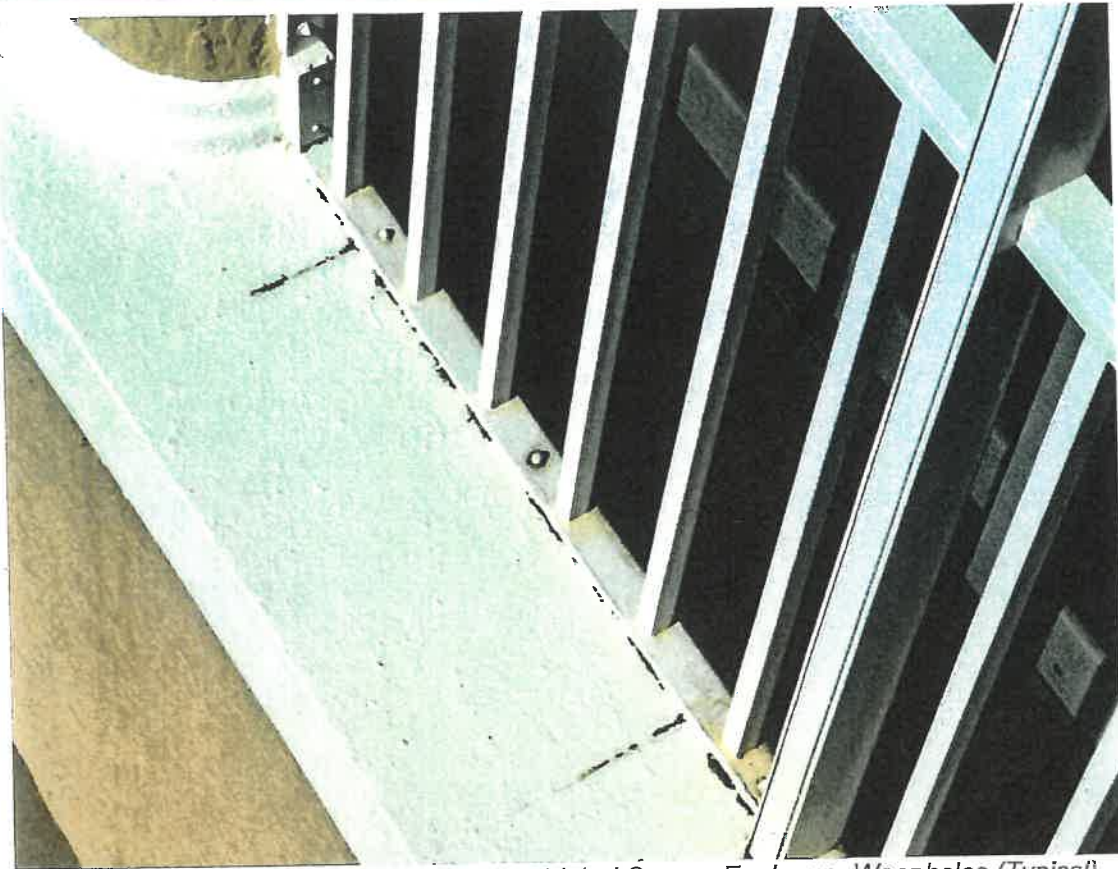
*Photo 11 Ref: 2.2.1.1 – Blocked or Restricted Screen Enclosure Weepholes (Typical)*

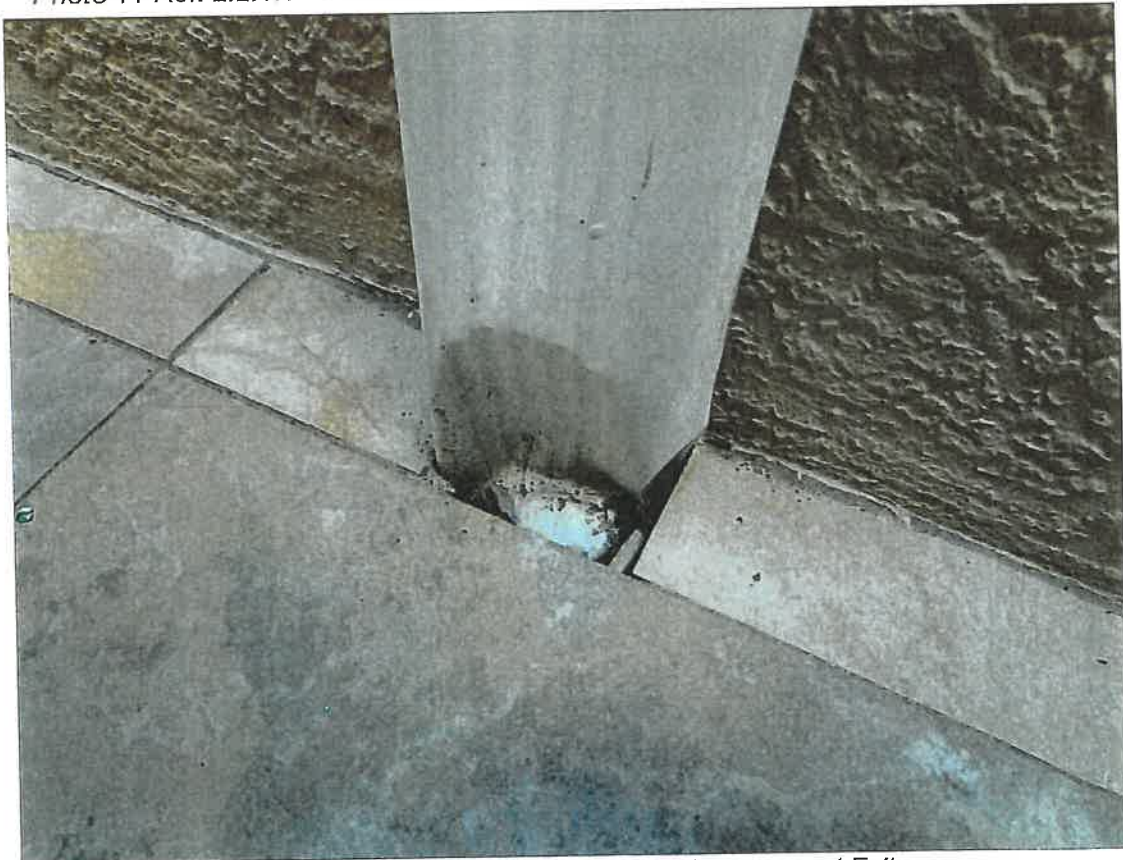
- 2.2.2.1 A downspout exit was crumpled at it's exhaust end (Photo 12 typical). The rainwater exiting this downspout looks as though it could be scattered around the adjacent tile and concrete surfaces or between floors. This situation increases the chronic exposure to moisture which accelerates the carbonation process of concrete. See *Carbonation & the Concrete Spalling / Degradation Process* (pg. 2)

*Photo 12 Ref: 2.2.2.1 – Crumpled Downspout Exit*

3.1.2.1 All downspouts should be routed to smoothly exit at least 4 feet away from the building and any downspout junctions upstream of the exit should be assembled properly with no damage.

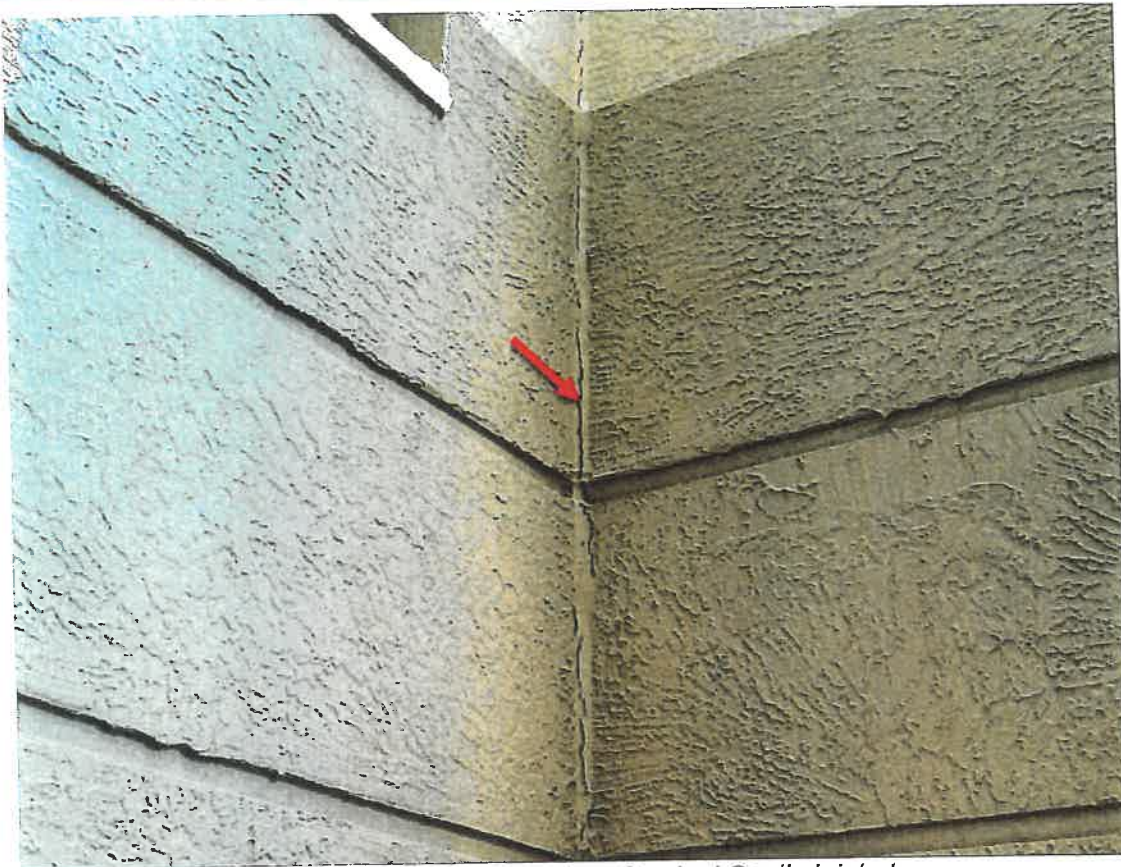
- 2.2.3.1 A vertical cold joint between a stair tower and main building appears to require a substantial width of sealant. This sealant is cracked (Photo 13 typical). Any penetration of moisture into this cold joint will quickly degrade the concrete within. Holding moisture in this joint will soon be detrimental to the concrete via the Carbonation process. It is very important to maintain the sealant at the entrance to a cold joint. See *Carbonation & the Concrete Spalling / Degradation Process* (pg. 2)

*Photo 13 Ref: 2.2.3.1 – Cracked Caulk Joint at*

3.1.2.3 Re-seal all compromised exterior vertical cold joints and replace.

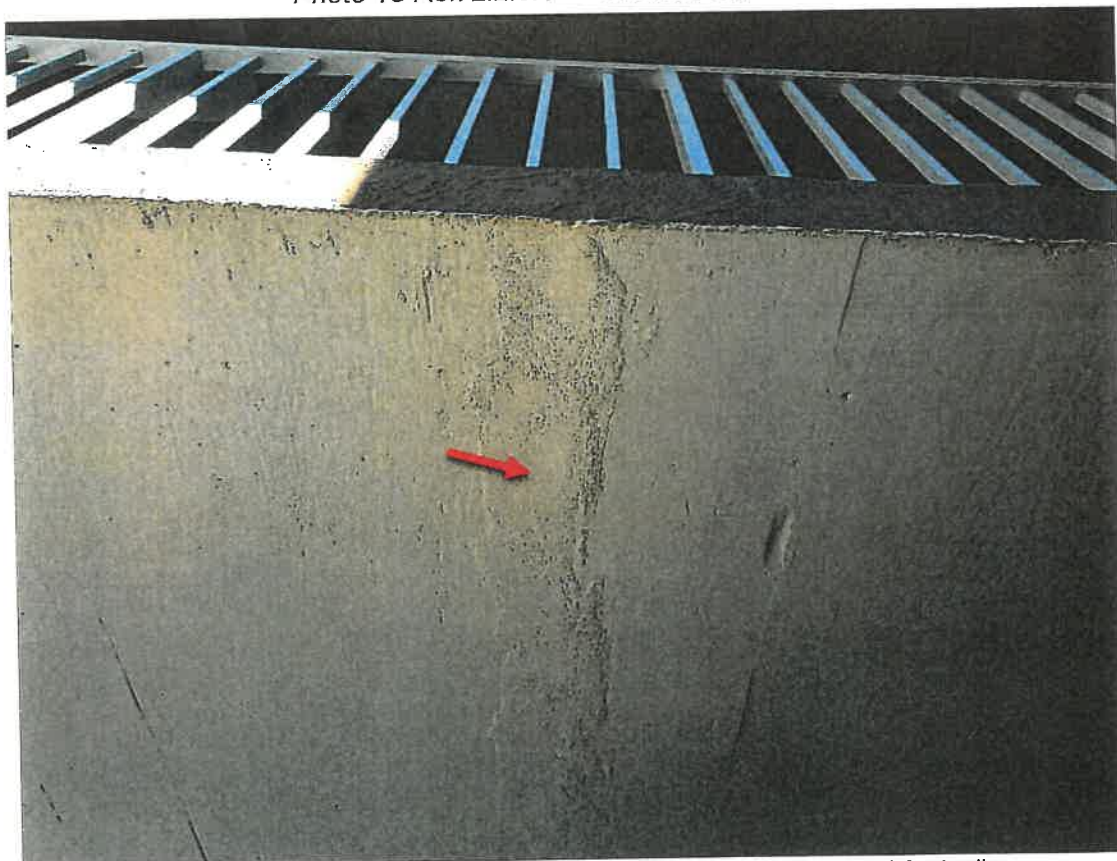
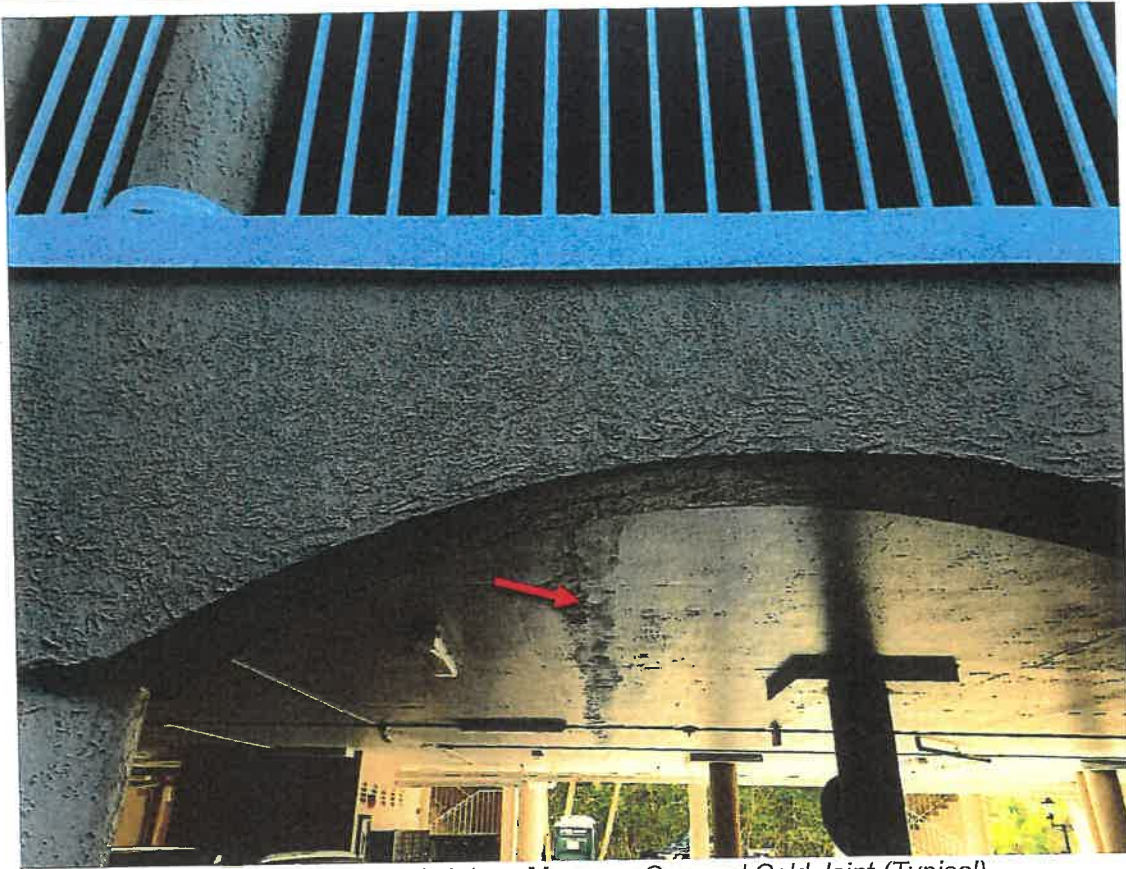
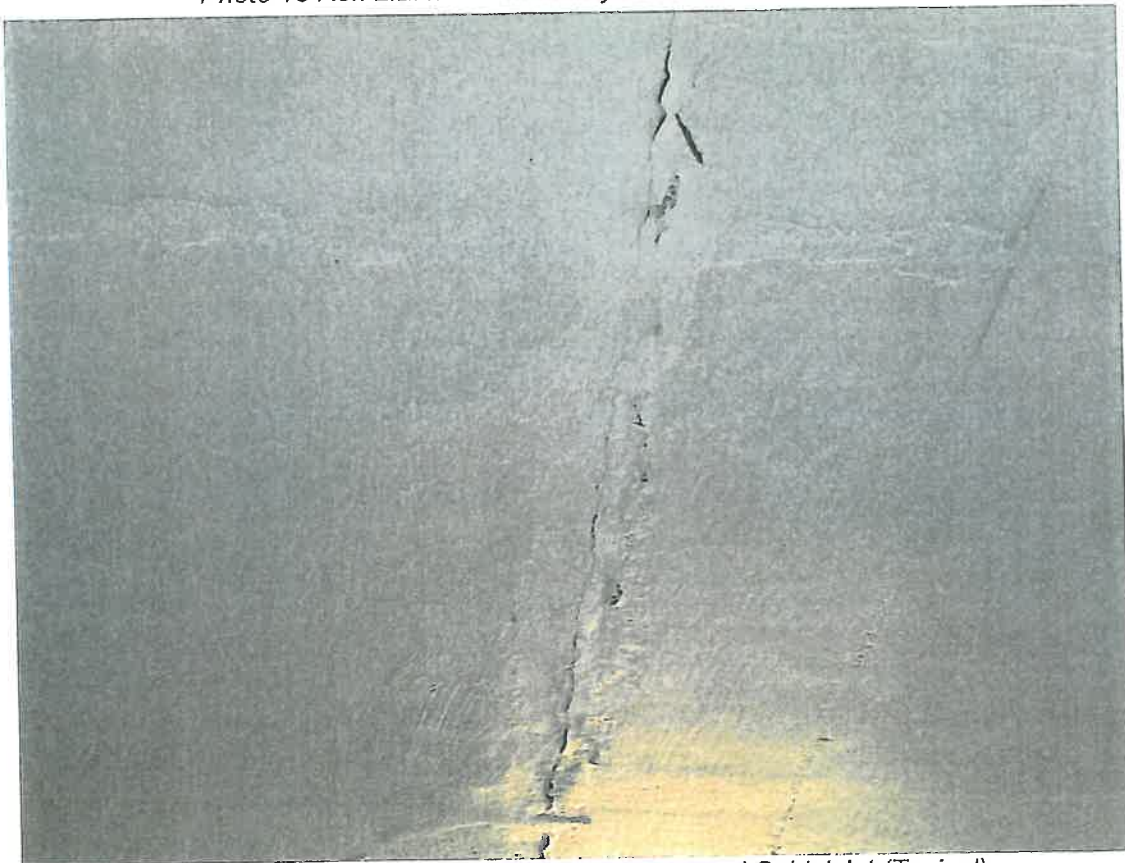
- 2.2.4.1 The multiple cold joints between parking garage slabs are patched with rigid masonry from above and below the slab. This patching is cracked on the top surface, therefore allowing water to enter the cold joint and become trapped there, degrading the cold joint and patching from below. (Photos 14, 15, 16 typical). Any penetration of moisture into this cold joint will quickly degrade the concrete within. Holding moisture in this joint will soon be detrimental to the concrete via the Carbonation process. It is very important to maintain flexible sealant at the entrance to a cold joint while leaving the bottom of the joint open to drain if any moisture does enter from above. See *Carbonation & the Concrete Spalling / Degradation Process* (pg. 2)

*Photo 14 Ref: 2.2.4.1 – Masonry-Covered Cold Joint (Typical)*

*Photo 15 Ref: 2.2.4.1 -- Masonry-Covered Cold Joint (Typical)*

*Photo 16 Ref: 2.2.4.1 -- Masonry-Covered Cold Joint (Typical)*

3.1.2.4 Cut through and clear masonry patching from above and below the garage floor cold joints and install flexible sealant along the top side of the joints.

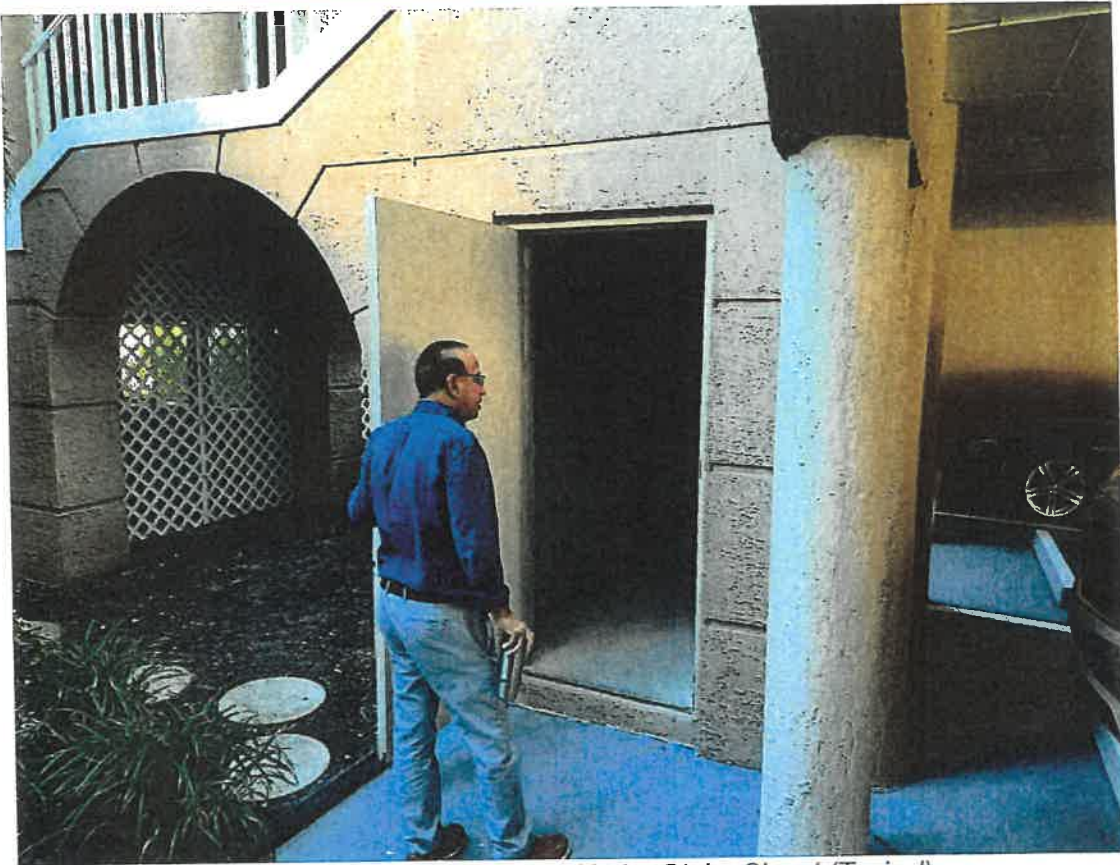
- 2.2.5.1 Some of the ground floor storage closets which are located under the upper stair landings which lead to the 2-story buildings show signs of water intrusion on the surfaces of their inner walls and cracks above their door headers (Photos 17, 18, 19 typical). These closets are located next to the expansion joints between the main building and the 2-story buildings, and on the main-building side of the expansion joint. A ground floor mechanical room showed signs of water intrusion on the surfaces of their inner walls and efflorescing cracks in the ceiling. (Photos 20, 21, 22 typical). This mechanical room is located adjacent to the expansion joint in the center of the main building. The Carbonation process will progress rapidly inside these cracks and the moist areas. See *Carbonation & the Concrete Spalling / Degradation Process* (pg. 2)

*Photo 17 Ref: 2.2.5.1 – Under-Stairs Closet (Typical)*

3.1.2.5 Excavate and repair all stucco and or concrete cracks above the ground floor closet doorways.

- 3.1.2.6 Determine the source of moisture intrusion into the equipment room and ground floor closets and at the locations of peeling paint on garage ceilings. Repair the issues at their source.
- 3.1.2.7 Re-seal all vertical compromised settling cracks at the stair towers, usually found on the lowest two floors.
- 3.1.2.8 Repair all stucco and or concrete cracks, spalling, peeling paint, and efflorescence anywhere in the stair towers.

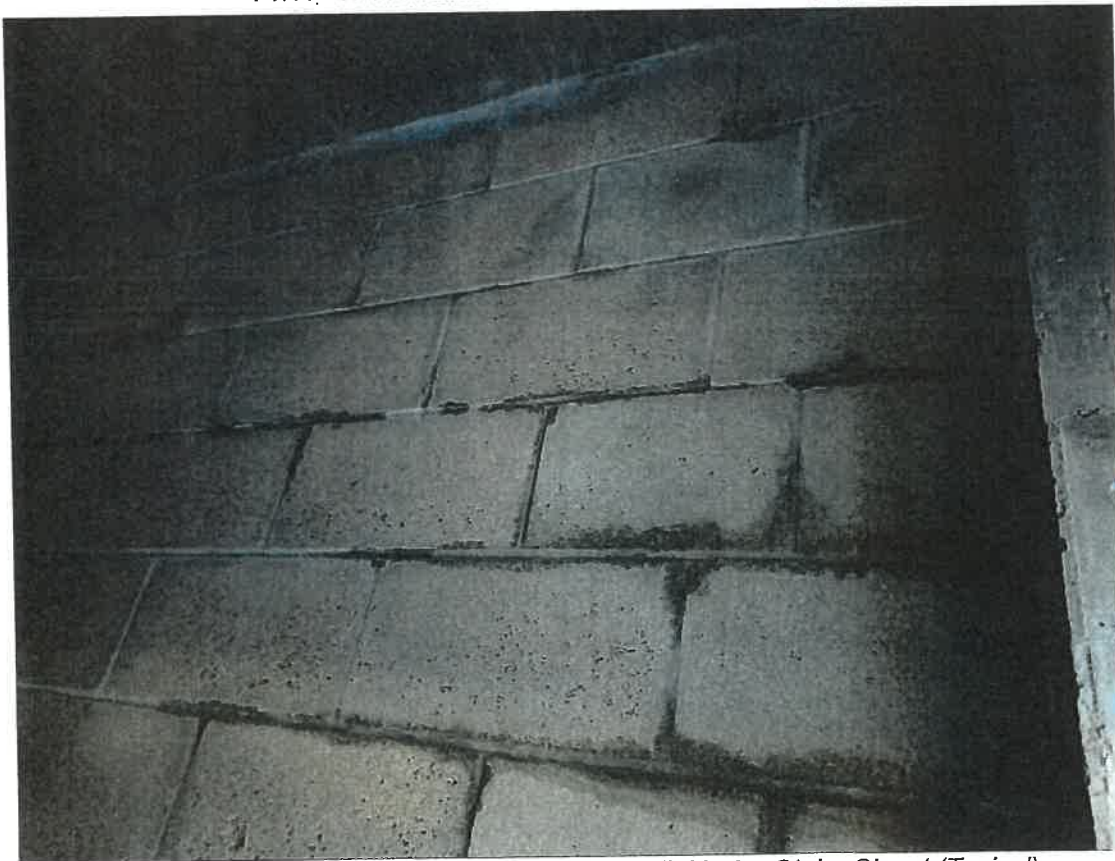
*Photo 18 Ref: 2.2.5.1 – Moisture on Wall, Under-Stairs Closet (Typical)*

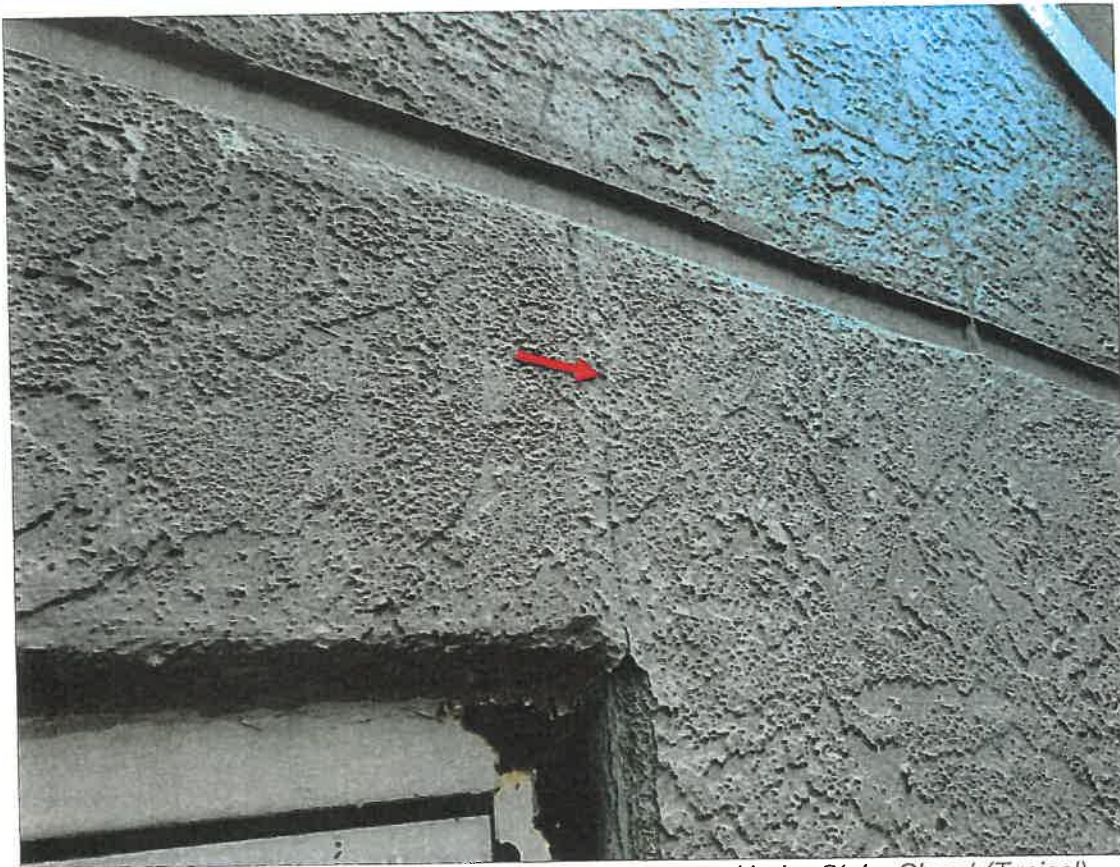
*Photo 19 Ref: 2.2.5.1 – Cracks in Door Header Area, Under-Stairs Closet (Typical)*

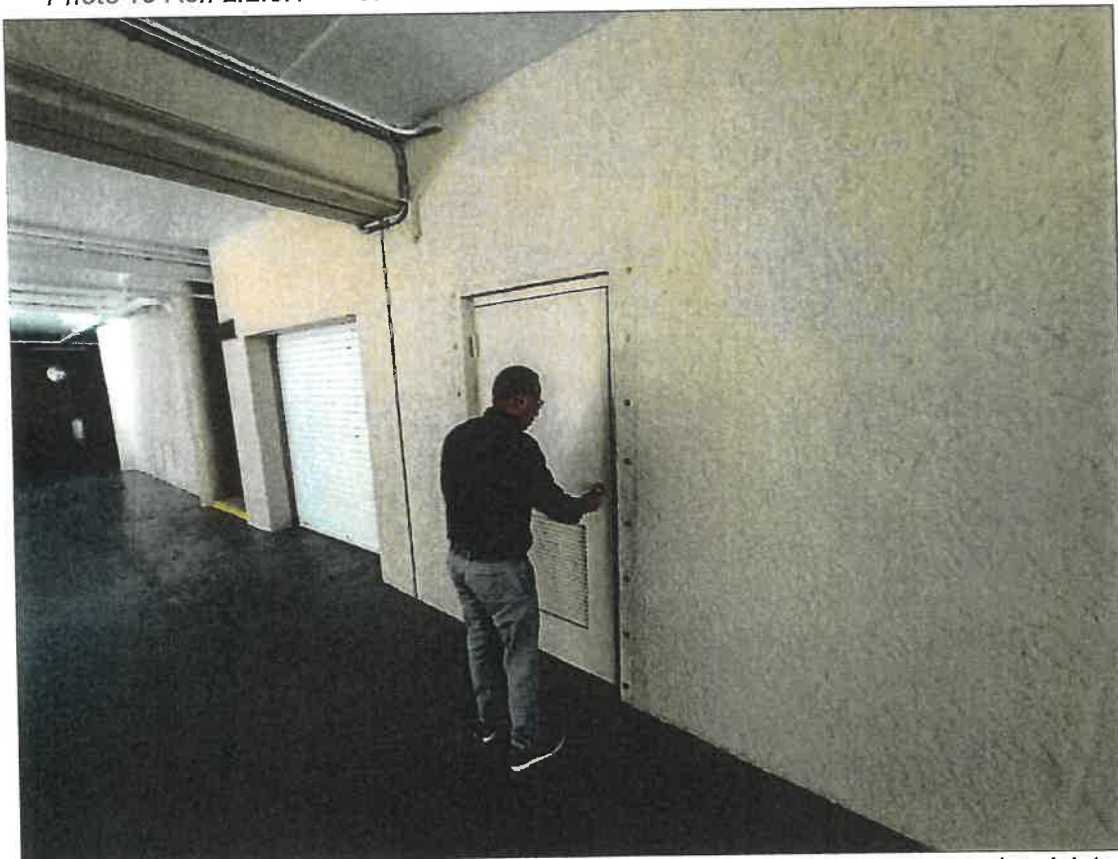
*Photo 20 Ref: 2.2.5.1 – Ground Floor Mechanical Room Adjacent to Expansion Joint*

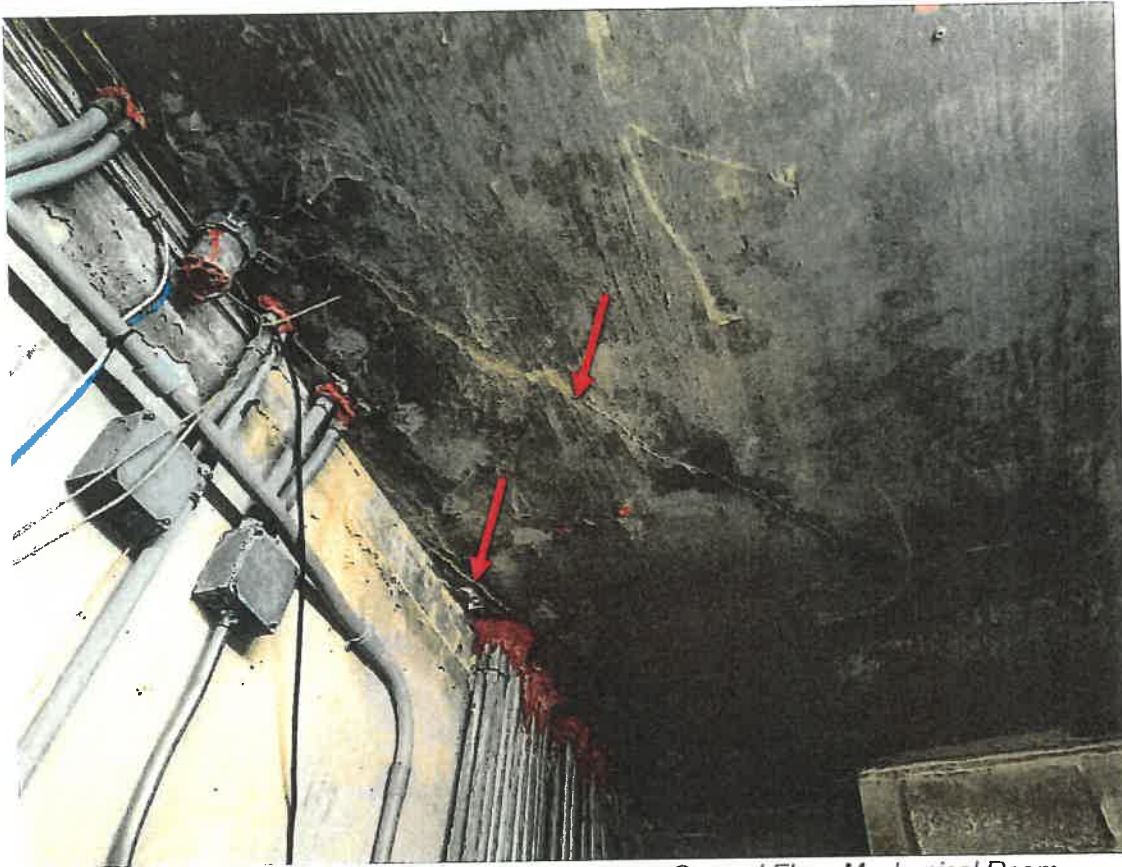
*Photo 21 Ref: 2.2.5.1 – Crack Efflorescence, Ground Floor Mechanical Room*
