# Milestone Inspection Report Phase 1

## Royal Marco Point I Condominium Association, Inc.

2000 Royal Marco Way  
Marco Island, FL 34145

Prepared on:  
1/8/2025

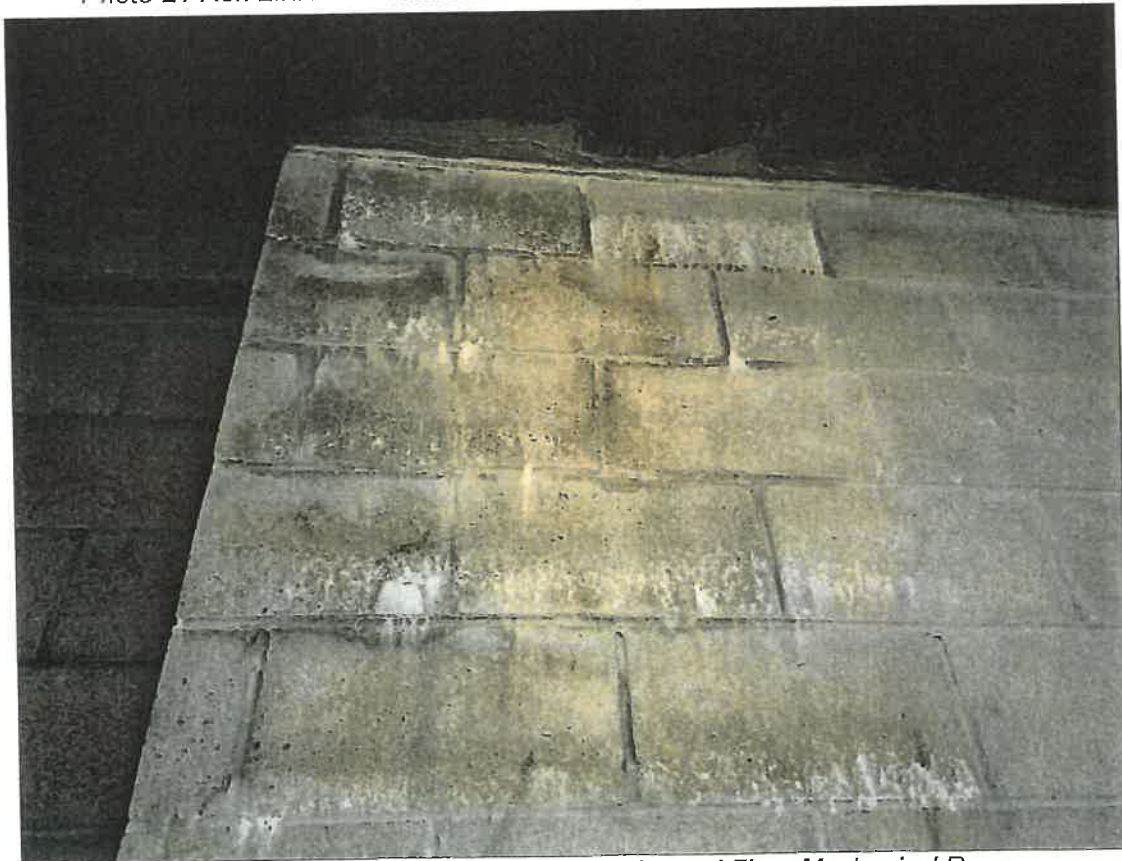
*Photo 22 Ref: 2.2.5.1 – Wall Moisture, Ground Floor Mechanical Room*

- 3.1.2.6 Determine the source of moisture intrusion into the equipment room and ground floor closets and at the locations of peeling paint on garage ceilings. Repair the issues at their source.
- 3.1.2.7 Re-seal all vertical compromised settling cracks at the stair towers, usually found on the lowest two floors.
- 3.1.2.8 Repair all stucco and or concrete cracks, spalling, peeling paint, and efflorescence anywhere in the stair towers.

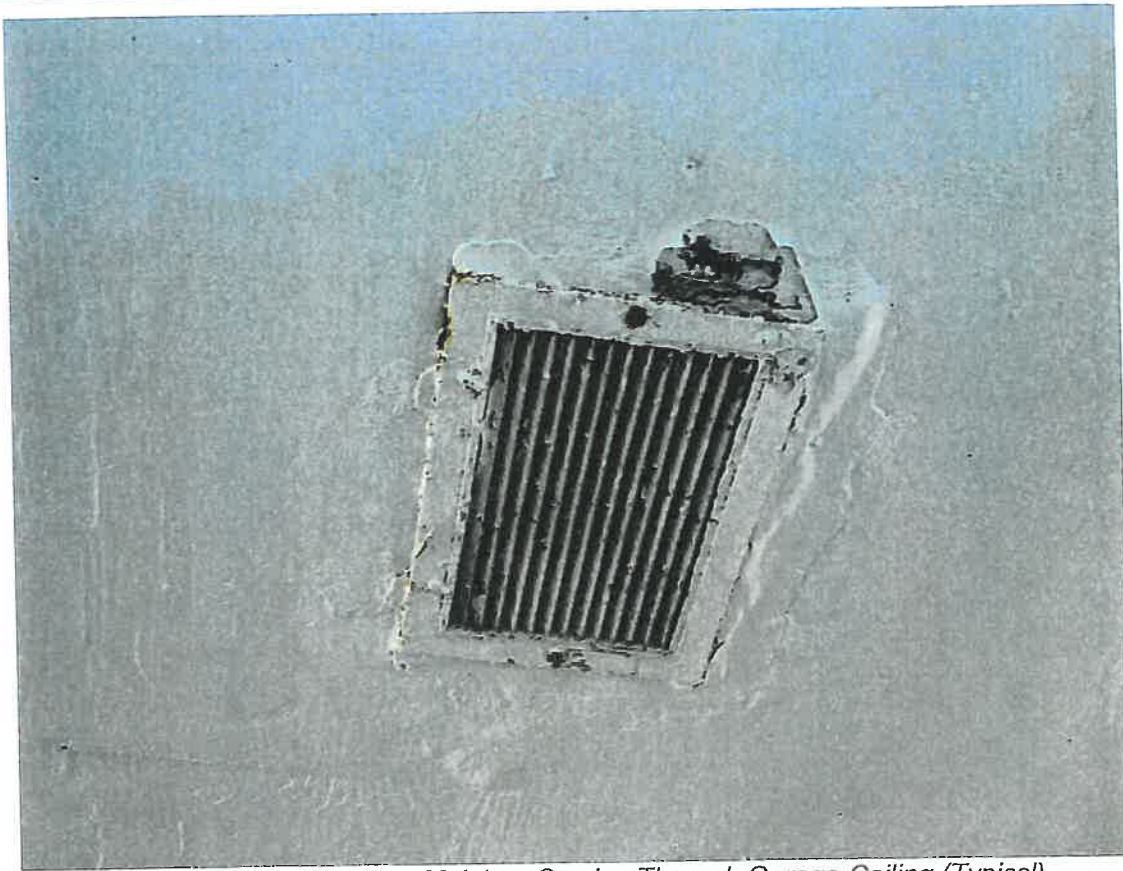
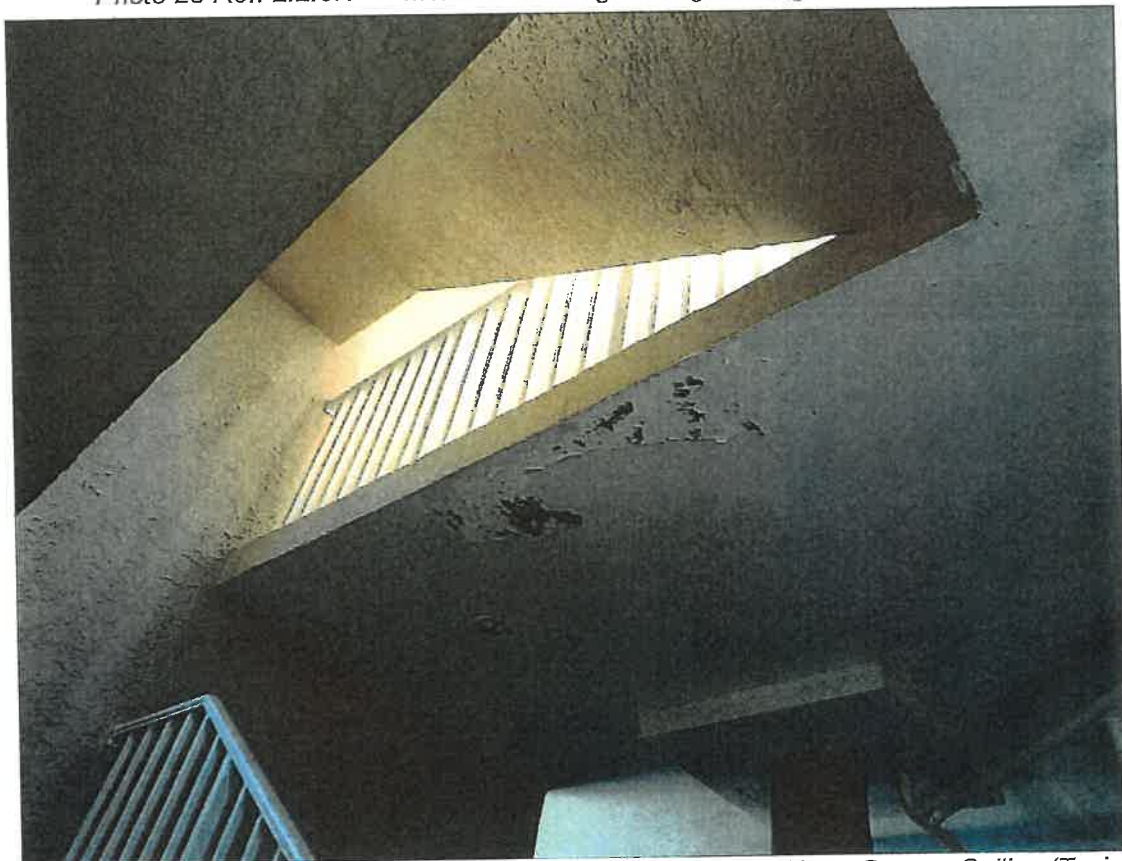
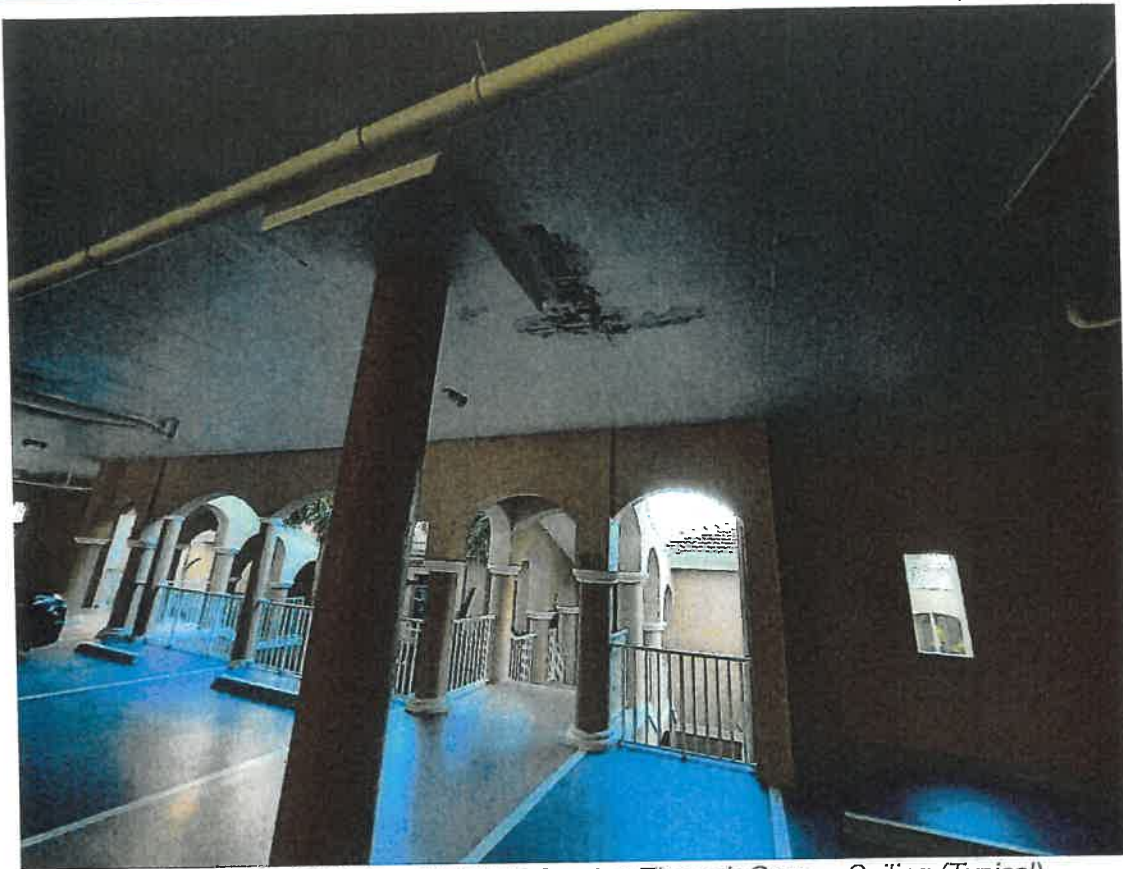
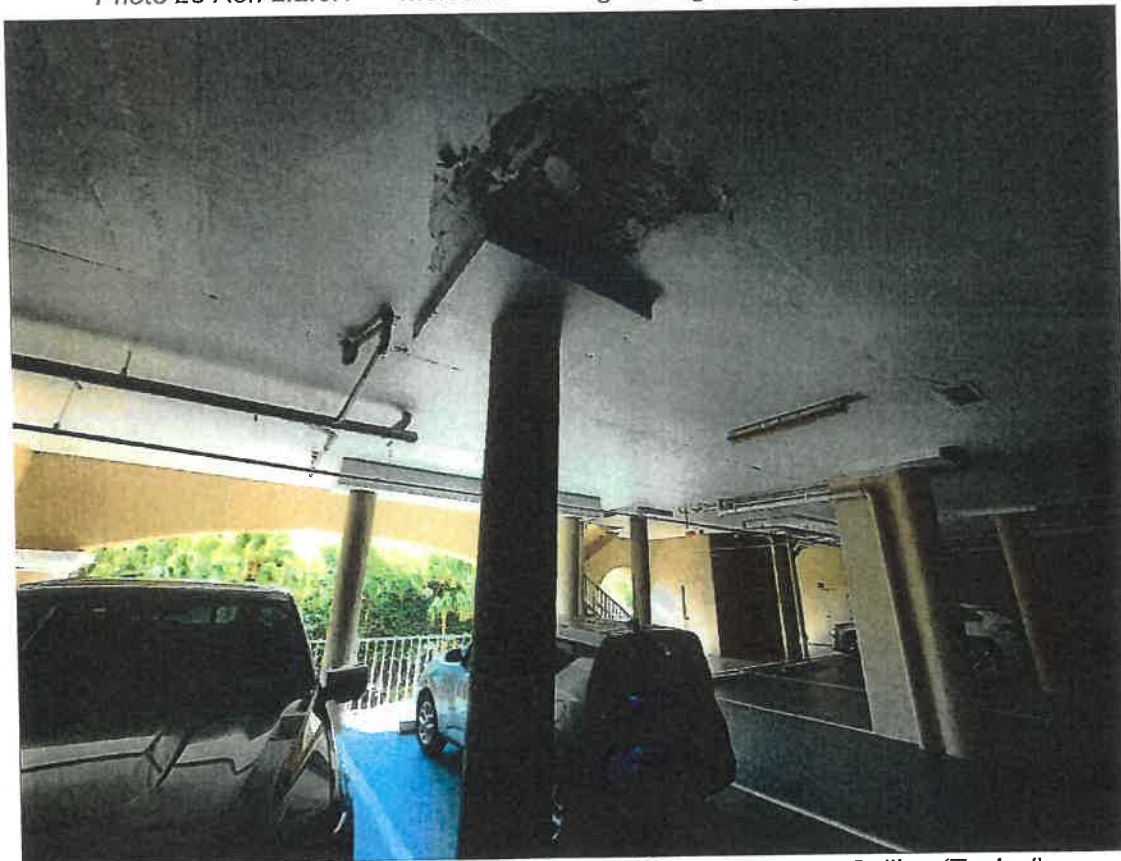
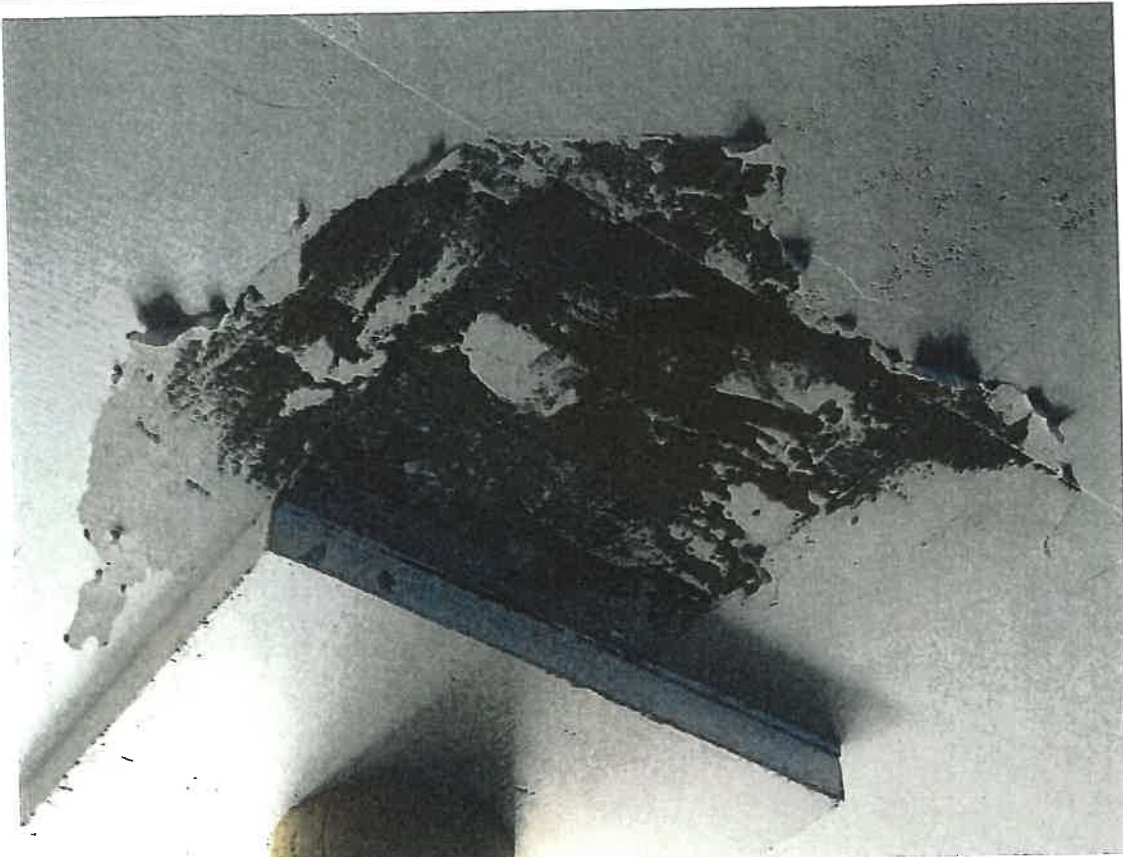
- 2.2.6.1 Specific locations on the ceiling of the garages have paint peeling prematurely. This is a sign of water exposure, possibly from above. (Photos 23, 24, 25, 26, 27 typical). The Carbonation process will progress rapidly wherever there is chronic moisture in contact with the concrete. It should be determined where the moisture is coming from and it should be stopped. See *Carbonation & the Concrete Spalling / Degradation Process* (pg. 2)

*Photo 23 Ref: 2.2.6.1 – Moisture Coming Through Garage Ceiling (Typical)*

*Photo 24 Ref: 2.2.6.1 – Moisture Coming Through or Dripping Along Garage Ceiling (Typical)*

*Photo 25 Ref: 2.2.6.1 – Moisture Coming Through Garage Ceiling (Typical)*

*Photo 26 Ref: 2.2.6.1 – Moisture Coming Through Garage Ceiling (Typical)*

*Photo 27 Ref: 2.2.6.1 – Moisture Coming Through Garage Ceiling (Typical)*

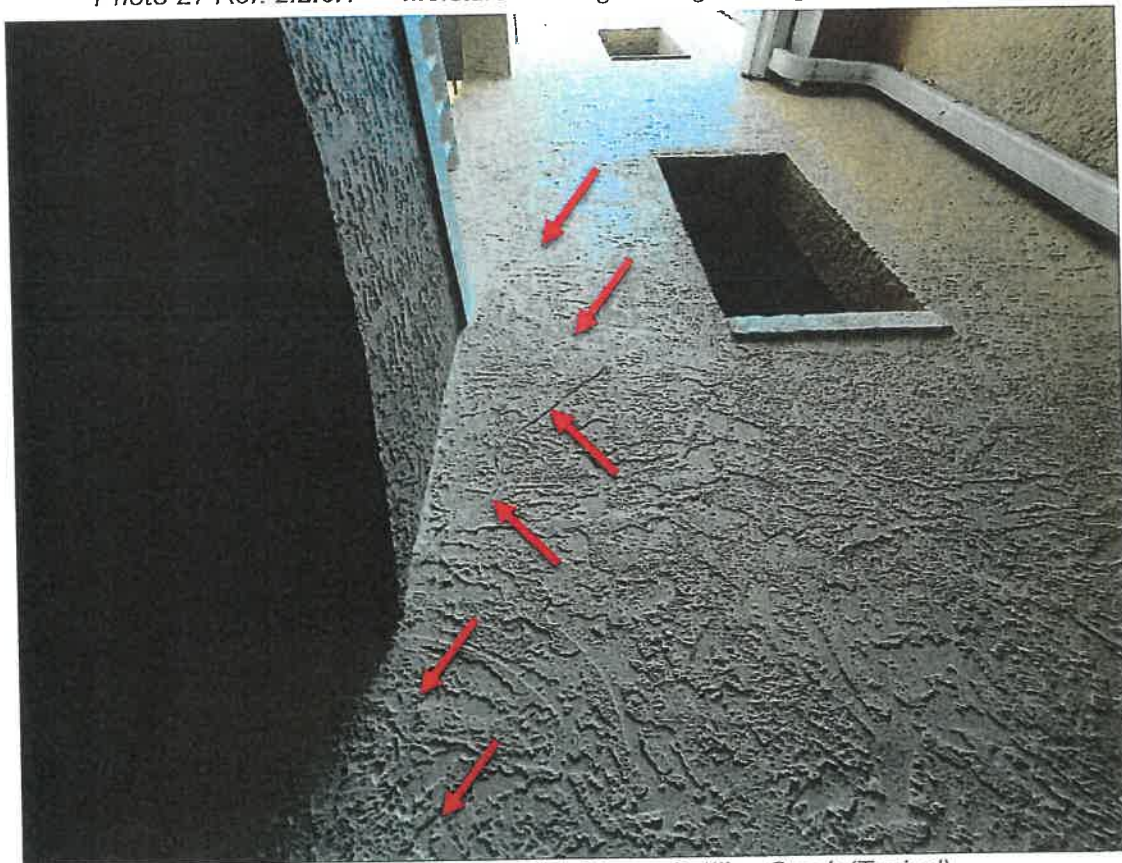
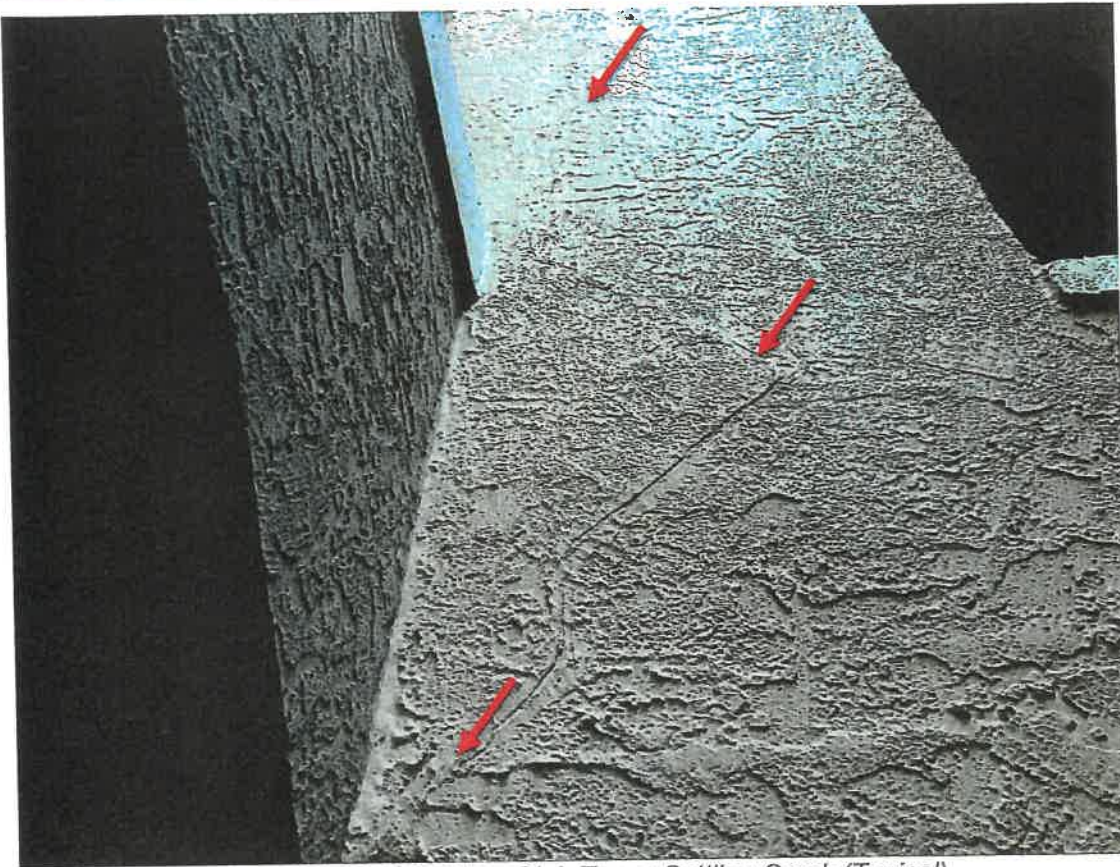
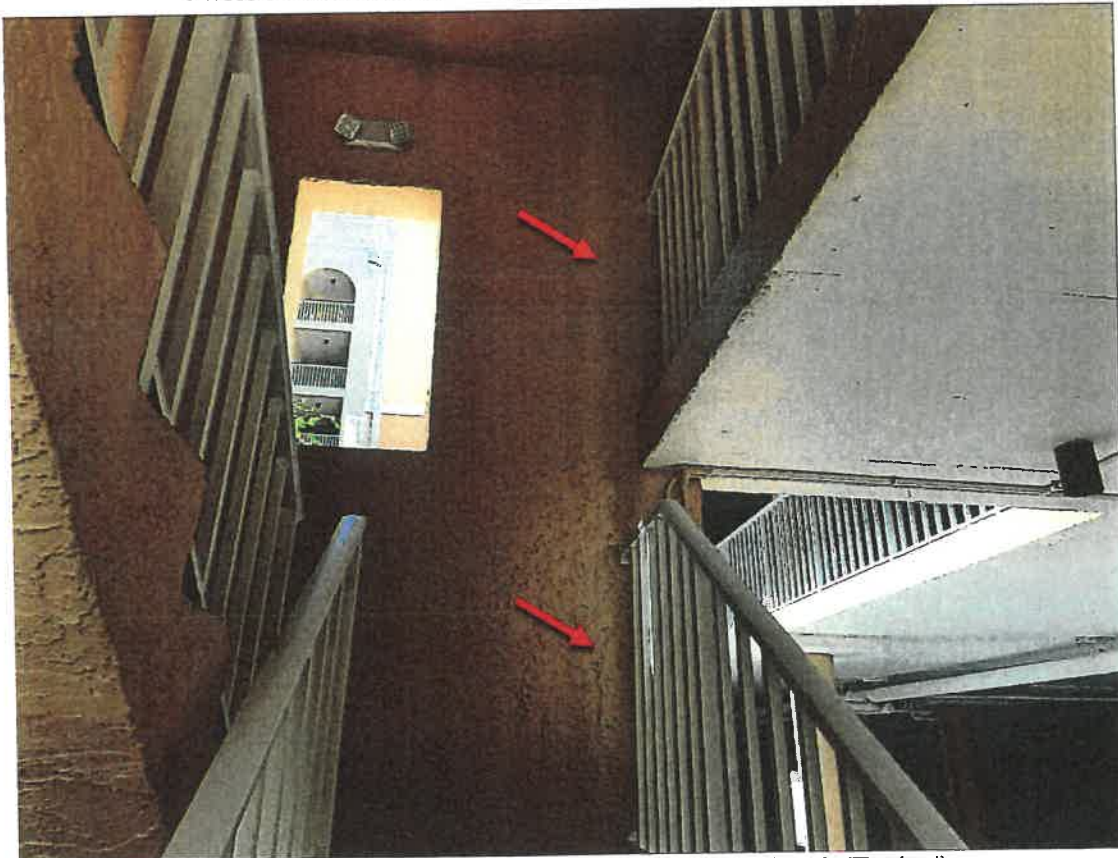
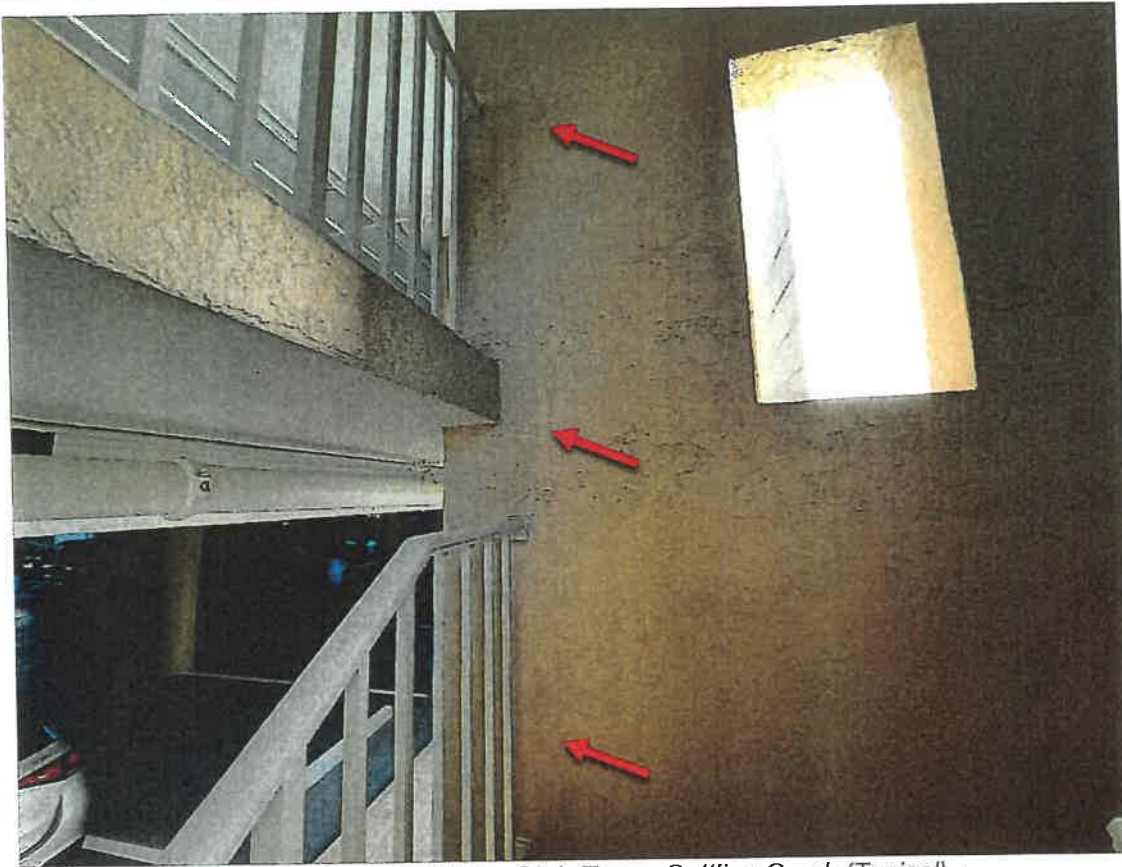
2.2.7.1 Consistent vertical settling cracks are observed in the stair towers where the tower walls join the tower columns adjacent to the main structure. (Photos 28, 29, 30, 31 typical). These cracks have been caulked multiple times and some look as if they need additional repair or re-caulking. The Carbonation process will progress rapidly wherever there is chronic moisture in contact with the concrete. It should be determined why and how fast the settling is progressing. See *Carbonation & the Concrete Spalling / Degradation Process* (pg. 2)

*Photo 28 Ref: 2.2.7.1 – Stair Tower Settling Crack (Typical)*

*Photo 29 Ref: 2.2.7.1 – Stair Tower Settling Crack (Typical)*

*Photo 30 Ref: 2.2.7.1 – Stair Tower Settling Crack (Typical)*

Photo 31 Ref: 2.2.7.1 – Stair Tower Settling Crack (Typical)

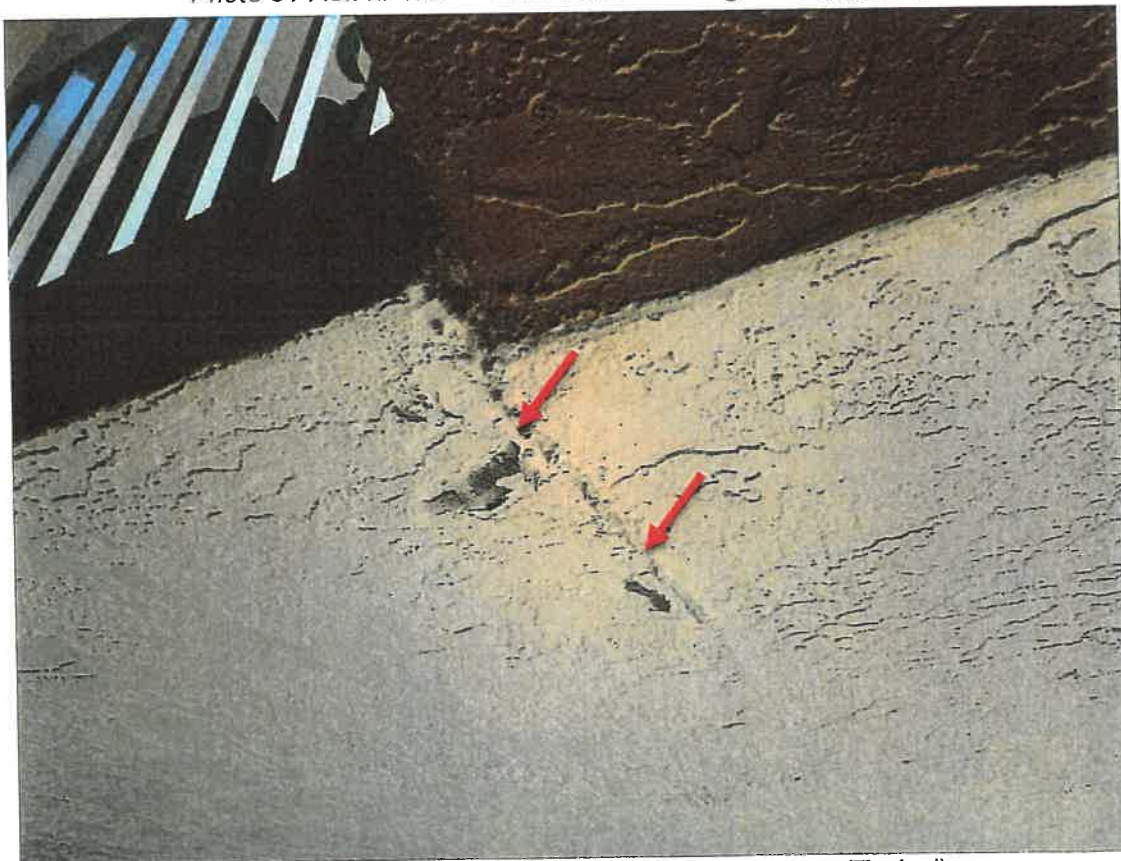
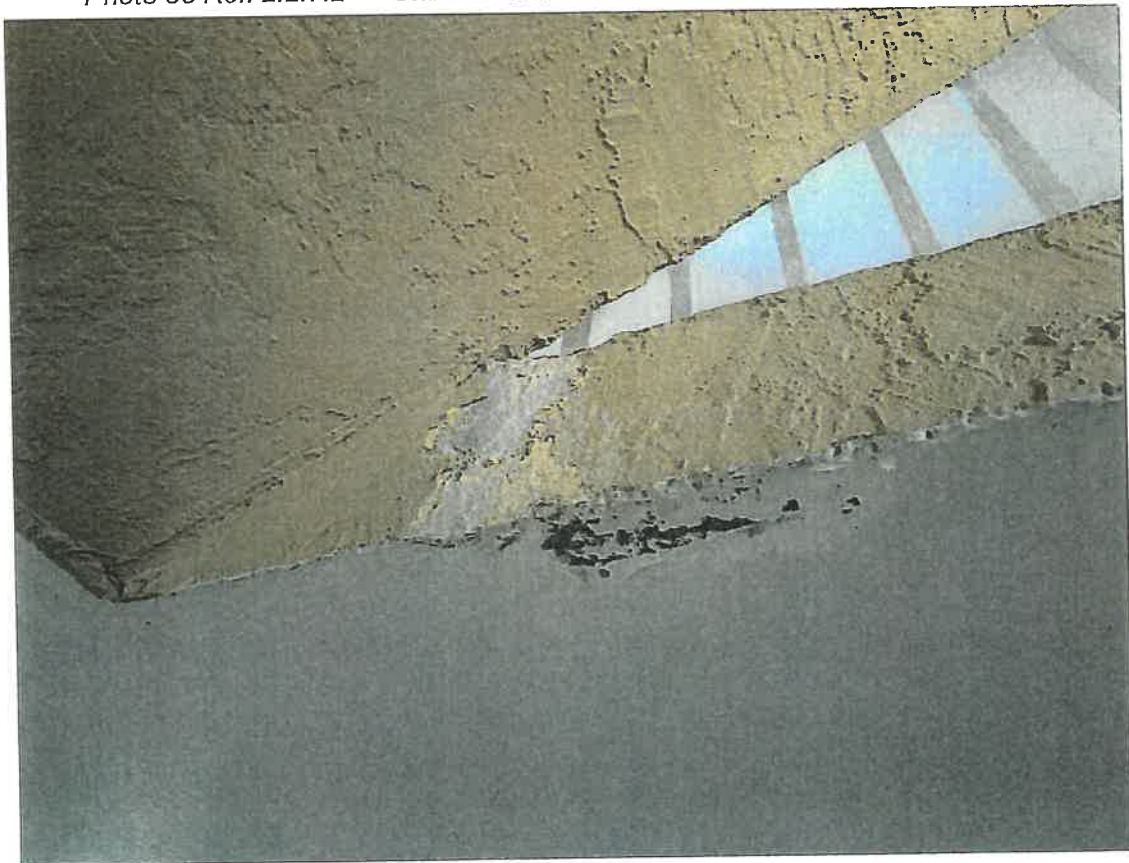
2.2.7.2 Concrete efflorescence and peeling paint with exposed cracks is present in various locations within the stair tower (Photos 32, 33, 34, 35, 36 typical).

Photo 32 Ref: 2.2.7.2 – Stair Tower Efflorescence (Typical)

*Photo 36 Ref: 2.2.7.2 – Stair Tower Efflorescence (Typical)*

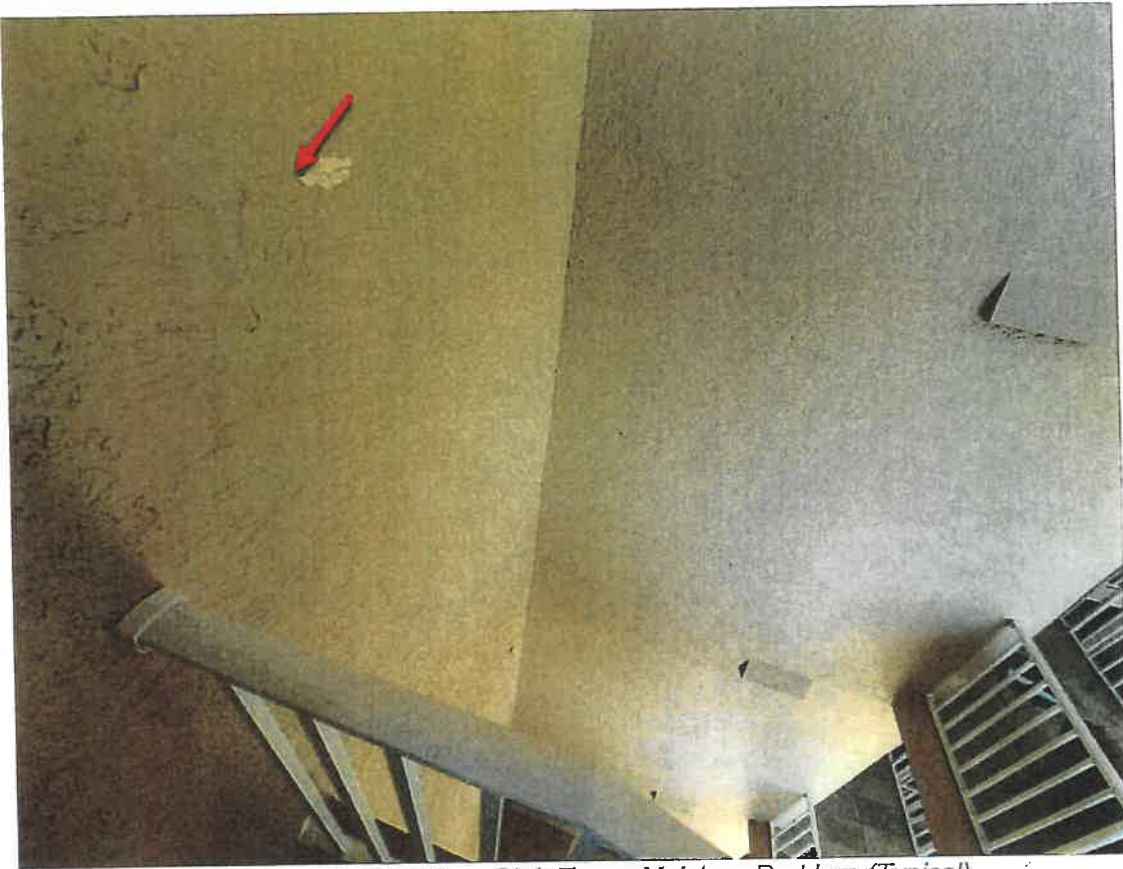
*Photo 33 Ref: 2.2.7.2 – Stair Tower Moisture Problem (Typical)*

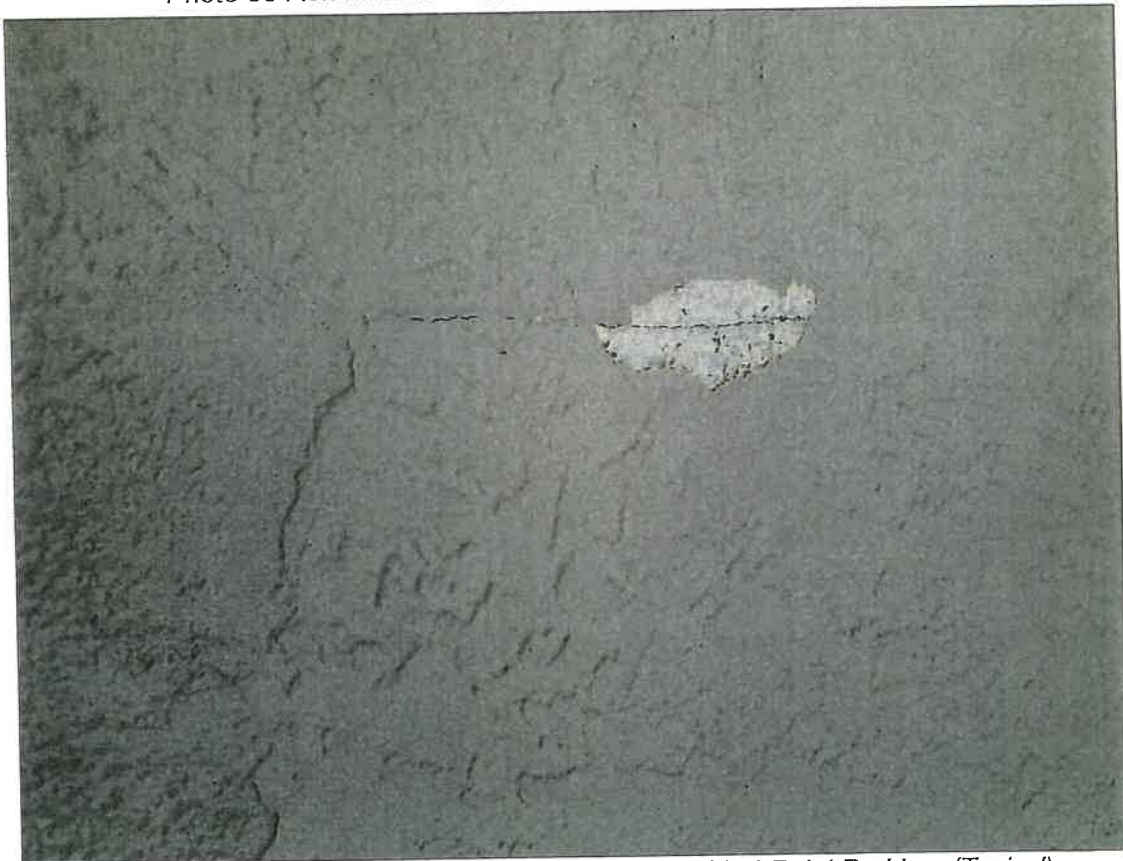
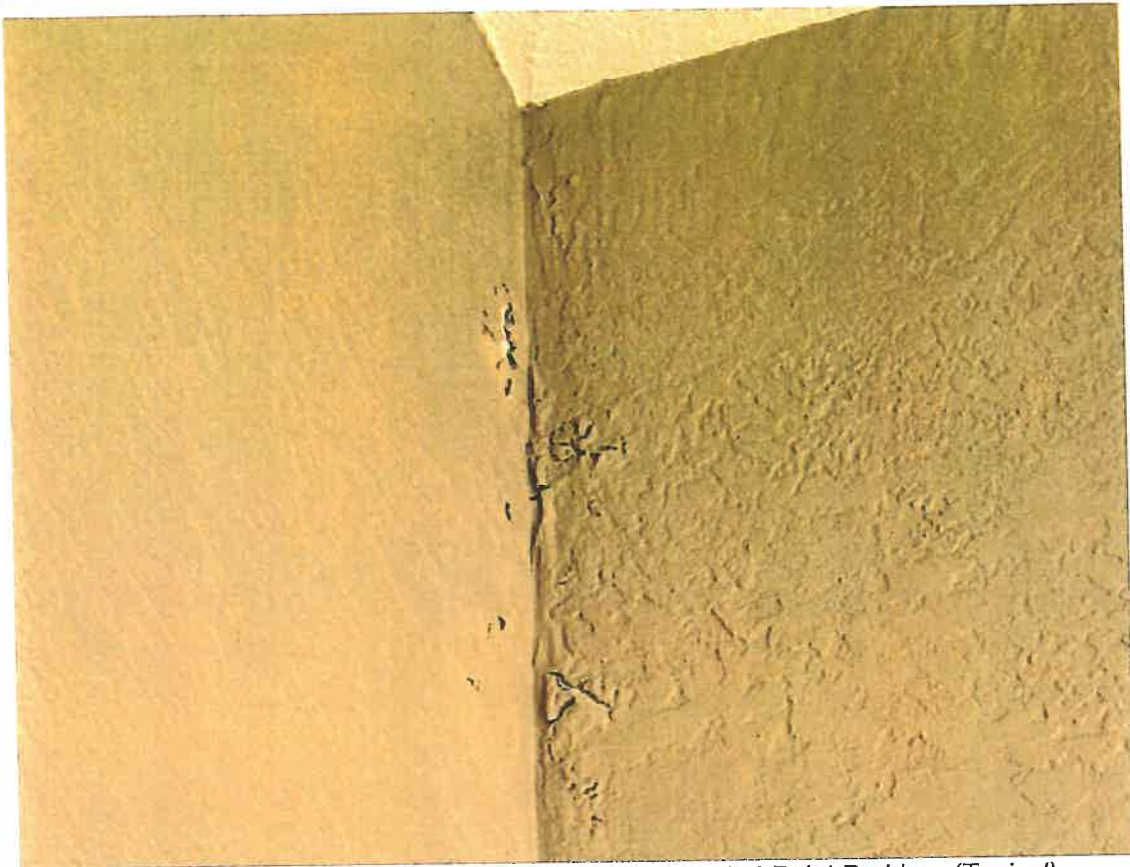
*Photo 34 Ref: 2.2.7.2 – Stair Tower Moisture-Behind-Paint Problem (Typical)*

*Photo 35 Ref: 2.2.7.2 – Stair Tower Moisture-Behind-Paint Problem (Typical)*
