# ***W.J. JOHNSON & ASSOCIATES***

September 28, 2022

Subject: **Limited Structural Review and Wind Mitigation Report  
Sandcastle I Condominium  
Project #: 05128.07**

Subject:     **HB-4D Phase I Structural Inspection**  
              **Sandcastle I Condominium**  
              **730 south Collier Boulevard**  
              **Marco Island, FL**  
              **Project #: 05128.09**

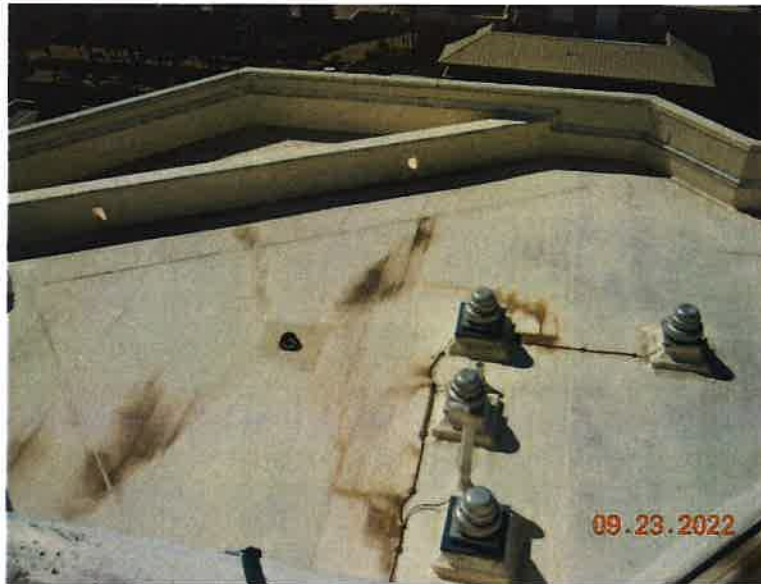
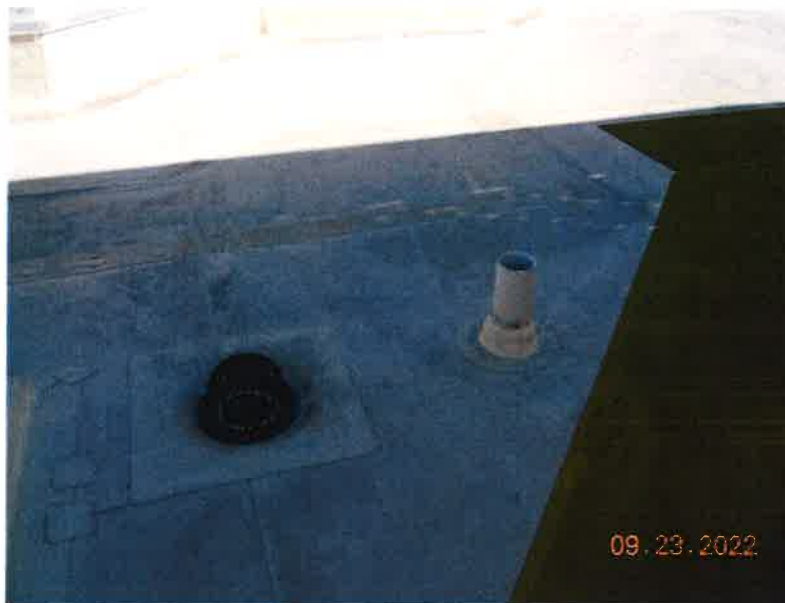
**Roof Drain with Overflow**

The roof system is a Fiber Tight membrane system installed in 2006. This type of system should produce a 30-year life cycle. The roof was recently inspected by Sutter Roofing who will be doing repairs. Roof inspections are done on an as-needed basis. The roof is in good condition and should provide an additional 10 years of service. It is recommended that the roof be inspected by a qualified roofing company annually at a minimum.

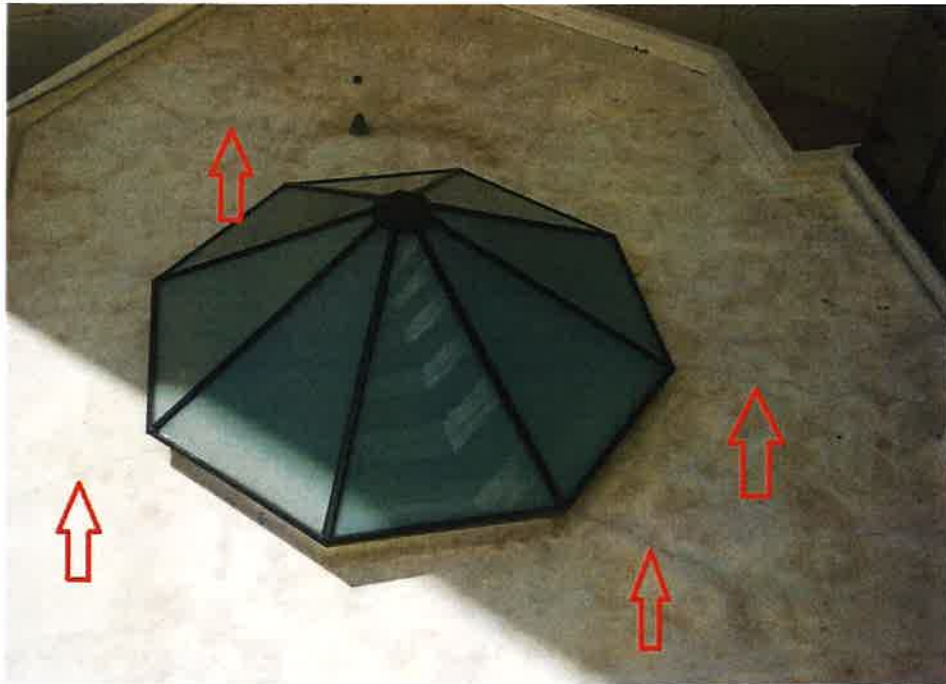
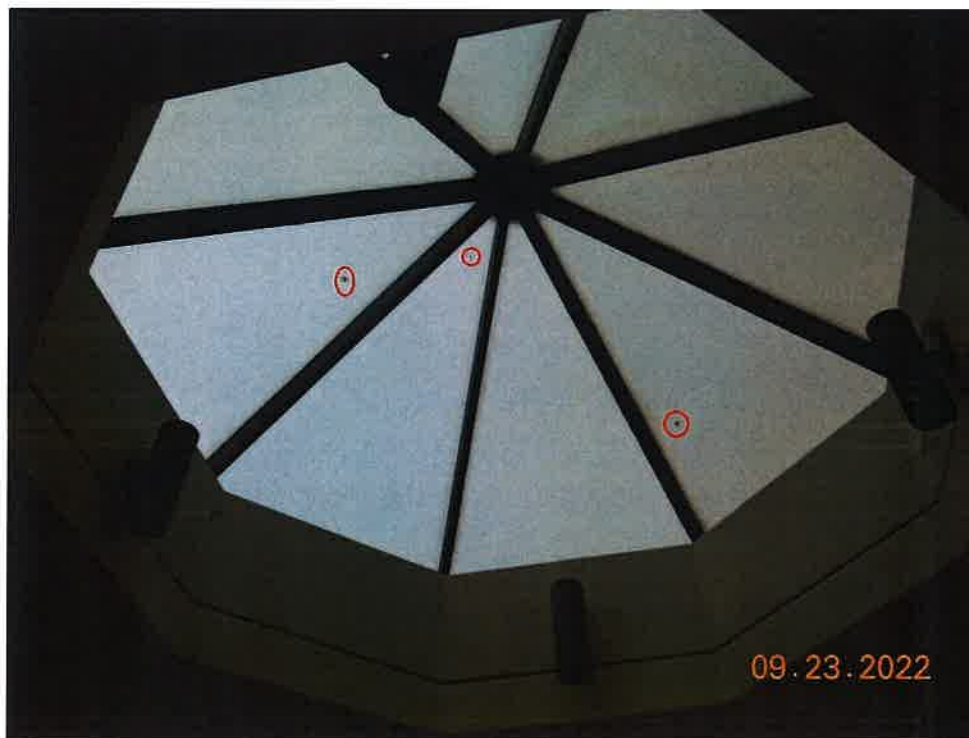
The roof at the membrane roof system at the first-floor carport is in poor condition with several cracks in the light weight concrete finish.

**Damaged Skylight**

- The Upper roof be inspected on a scheduled yearly basis.
- The structural damage at the roof areas should be repaired within one year.
- The stairwell moisture problem should be repaired within one year.
- The stairwell pass doors should be replaced.
- The skylight should be replaced to meet the current impact and wind loads.
- The exterior areas of concern should be addressed at the next painting cycle.
- The lower carport/vestibule roof should be repaired and or replaced within one year.
- The parking structure roof /athletic surface should be repaired or replaced within two years.
- The rusted storm drain pans and pipe hangers at the parking garage should be replaced within two years.

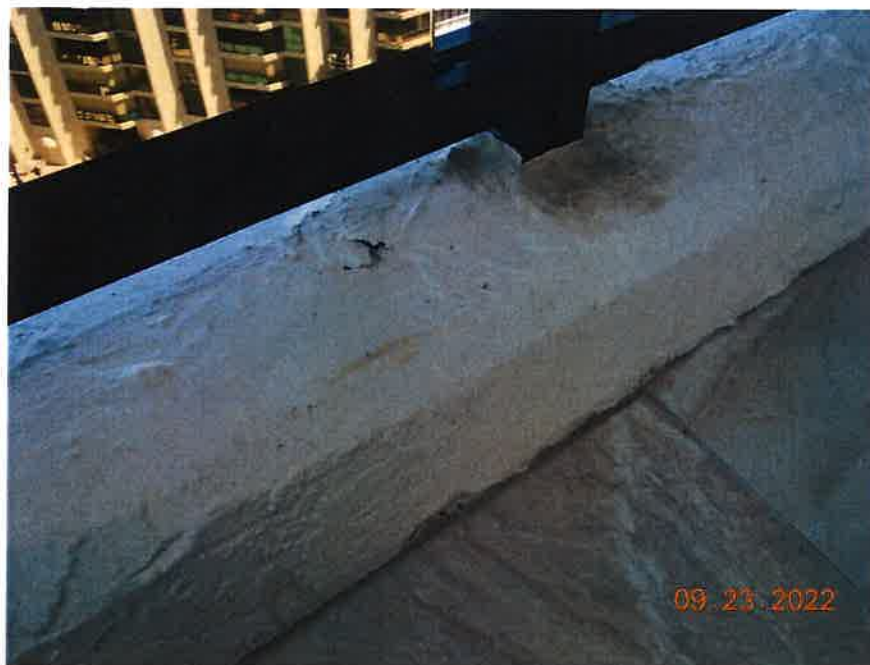
There is evidence of paint blistering. This should be addressed at the next painting cycle.

**Paint Blistering**

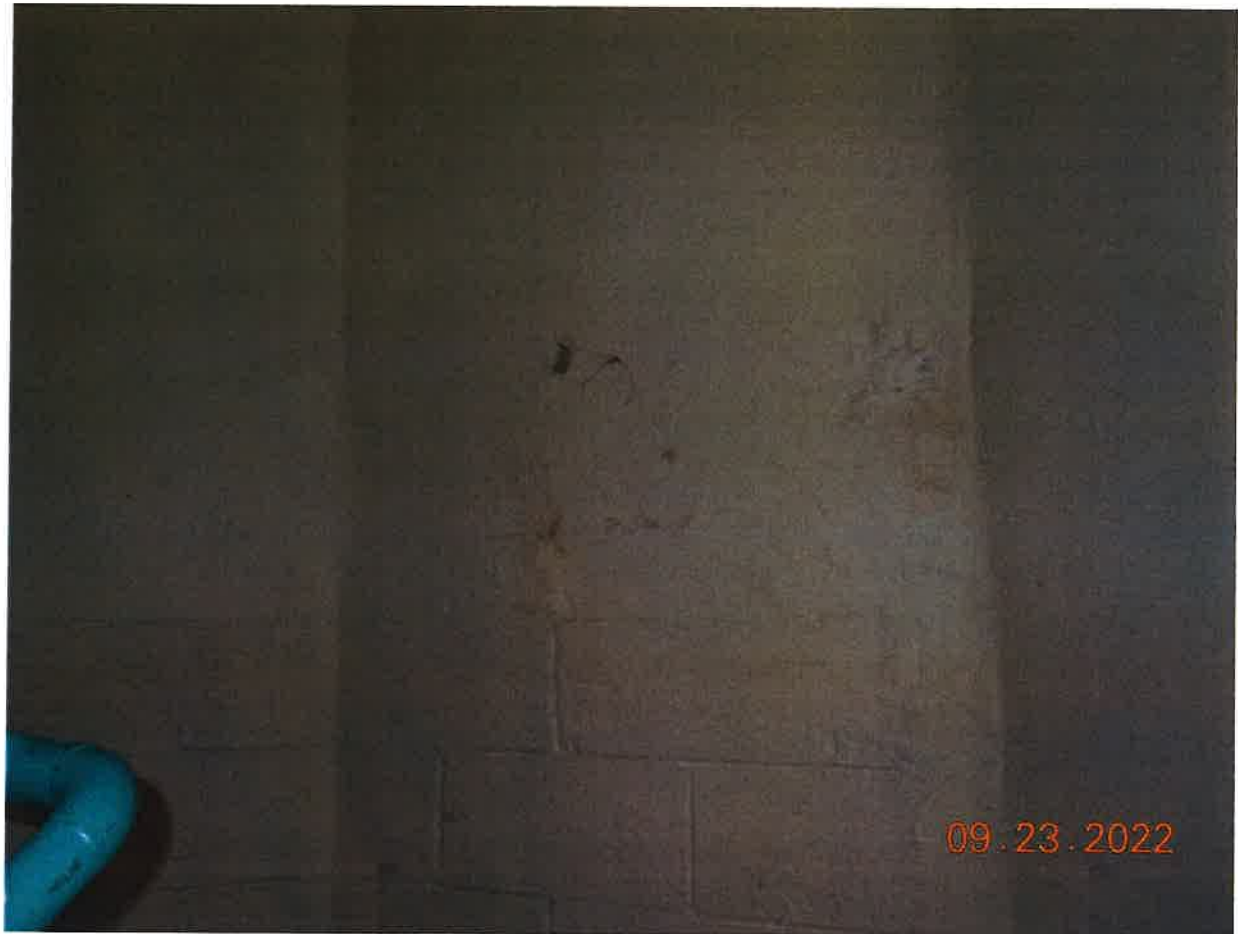
The common areas are serviced by two fire rated stairwells that discharge directly to the exterior. There are two areas within the stairwells that display evidence of moisture infiltration. This could be a flashing detail at the adjacent penthouse decks. These issues should be addressed within the next year.

**Moisture Infiltration Between Floors 12 and 13 both Stairwells**

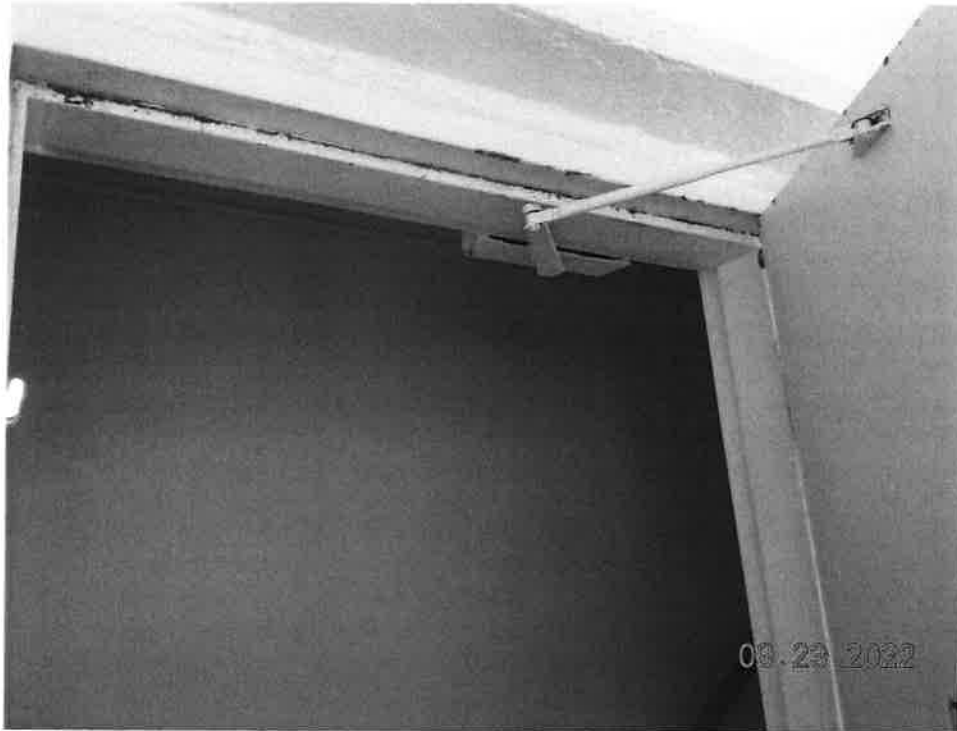
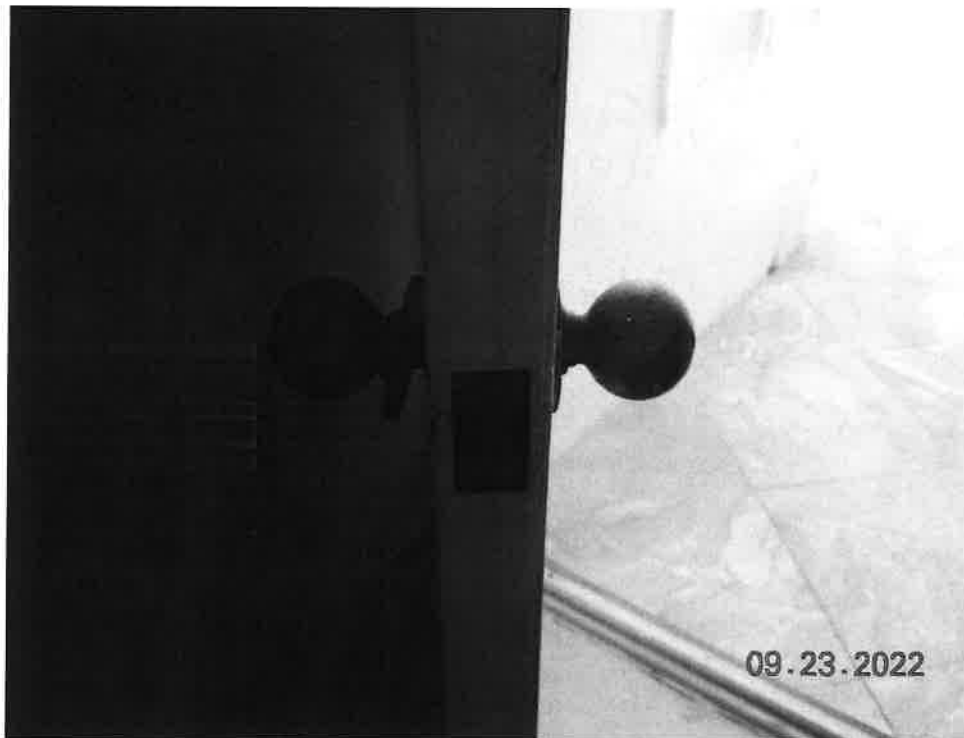
The stairwell pass doors are in poor condition, however, they are scheduled for replacement this year.

**Stairwell Exit Doors**

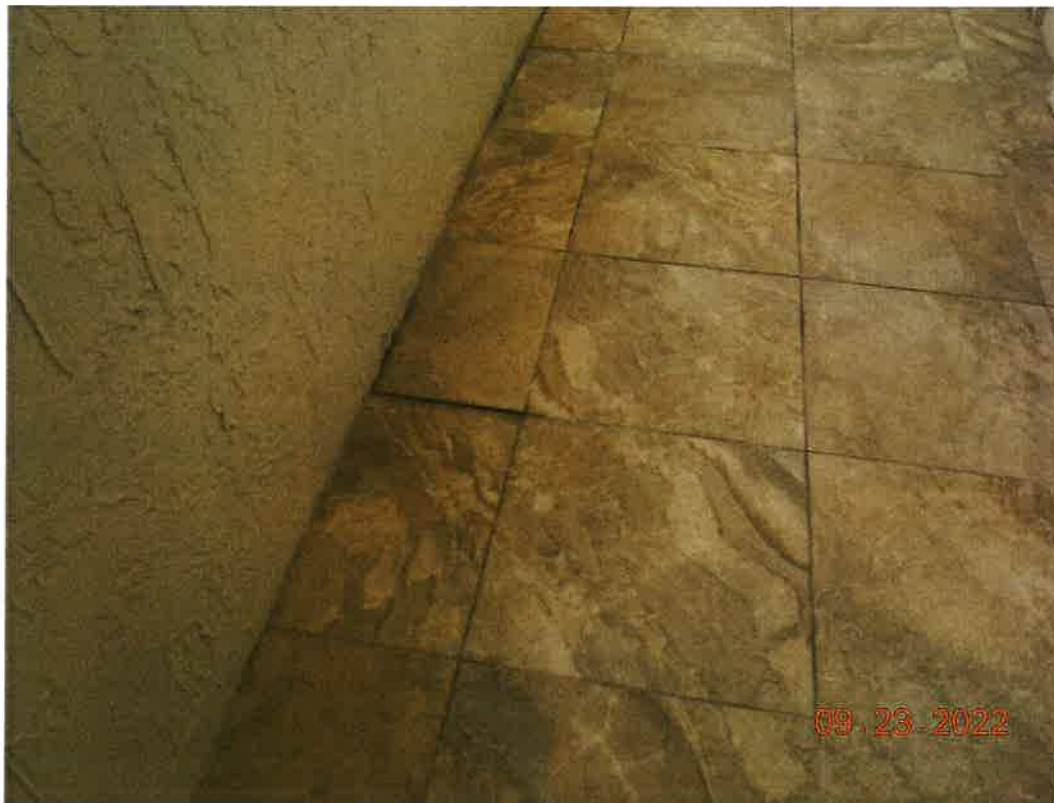
**Delaminating Tile, 4<sup>th</sup> Floor South**

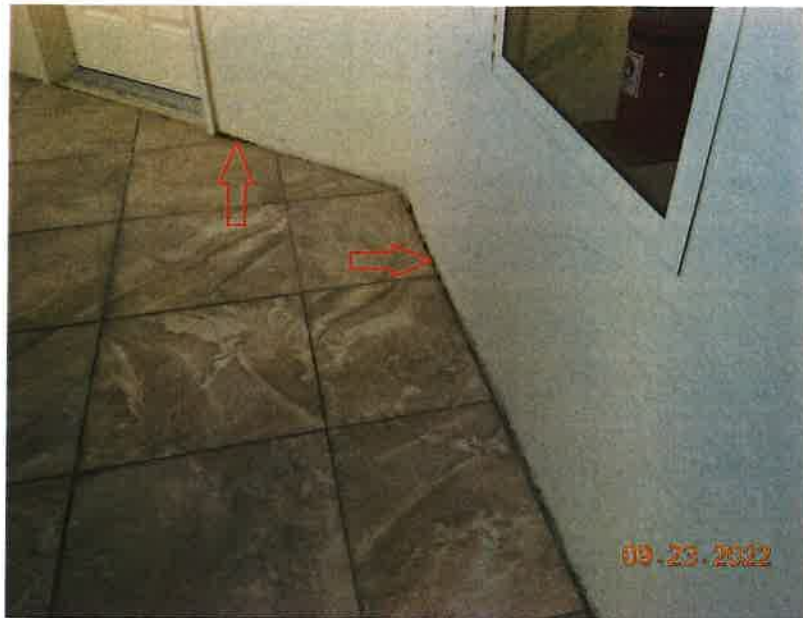
Each level of the East side of the building is serviced by an exterior walkway. These areas are susceptible to moisture damage during a tropical rain event. These areas are now being protected by hurricane curtains manually attached to the structure. The first-floor level displays evidence of moisture infiltration from previous events.

**First Floor Moisture Damage**

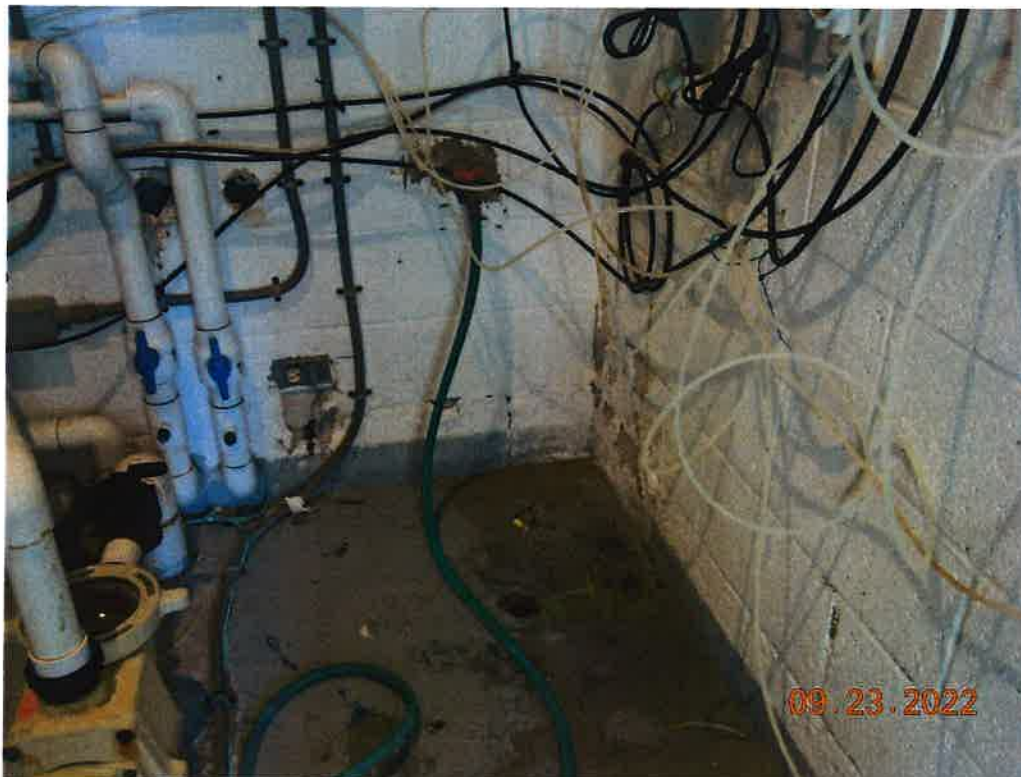
Masonry deterioration due to pool chemicals was observed. This should be repaired as part of the next painting cycle. The area should be coated with a chemical resistant epoxy coating once repaired.

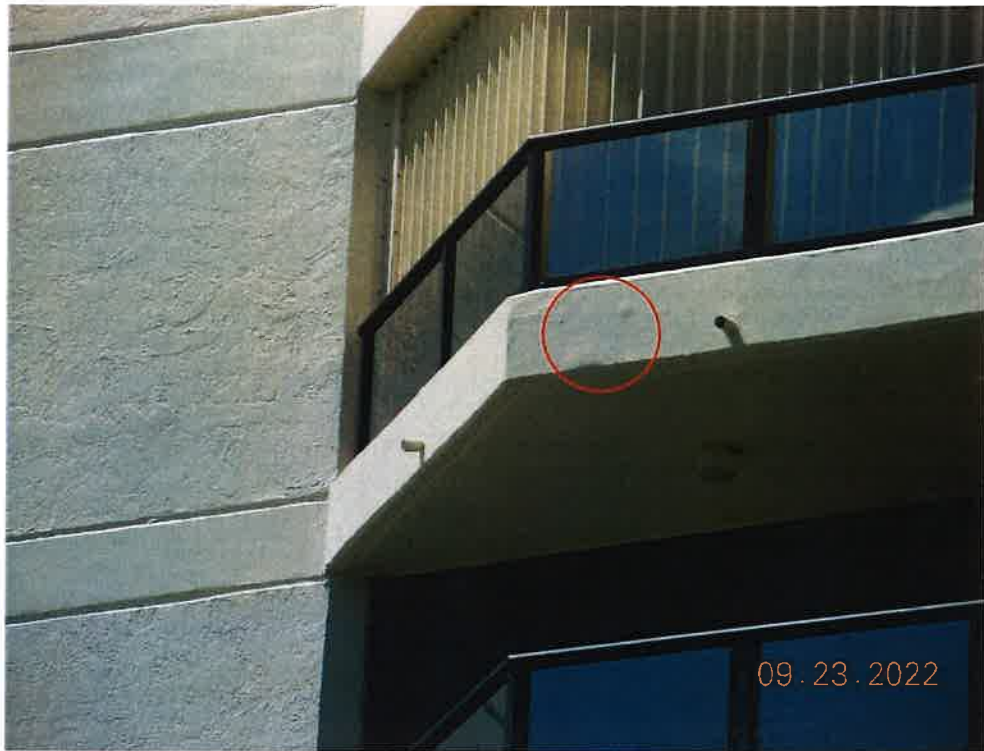
#1 Paint Blistering

The exterior of the building is constructed using reinforced concrete columns and beams with masonry wall and a stucco finish. The building is in good condition with the following area of concern: These issues should be addressed during the next painting cycle.

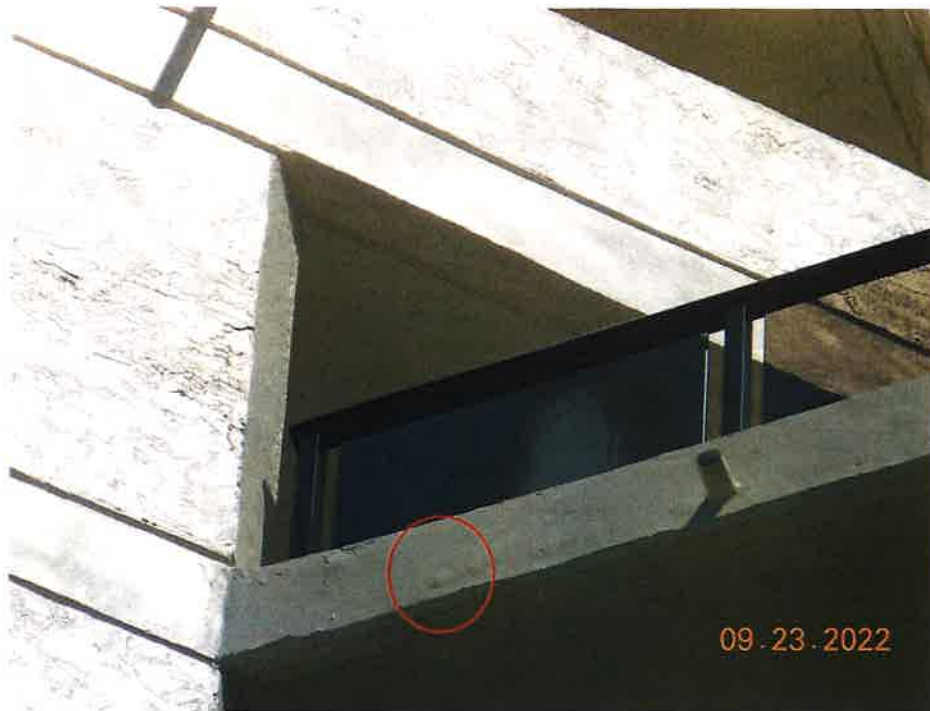
**#3 Paint Blistering**

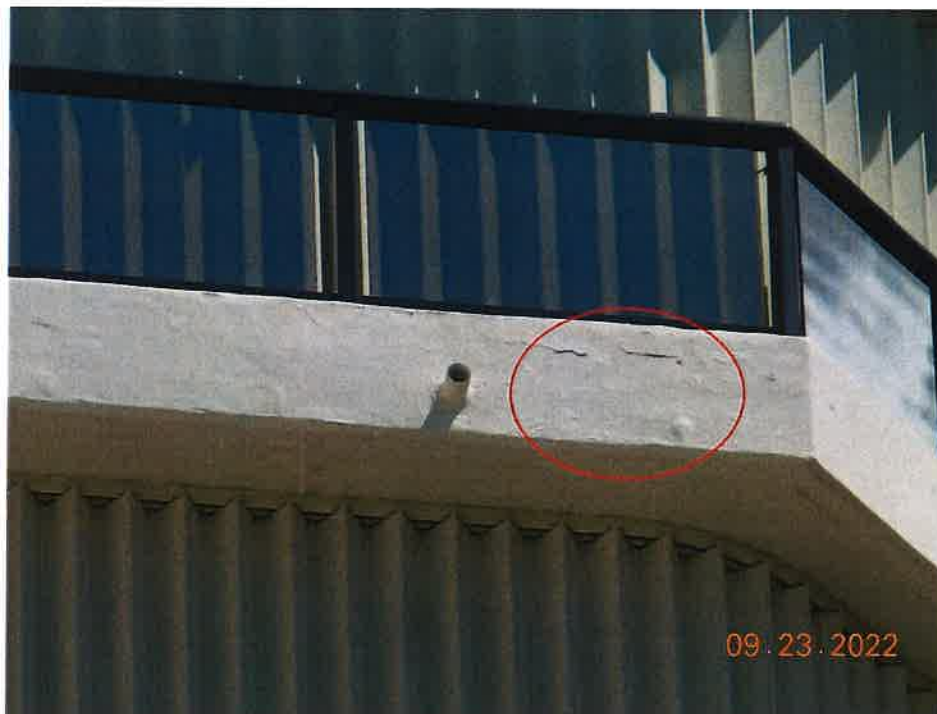
**#4 Paint Blistering / Cracking**

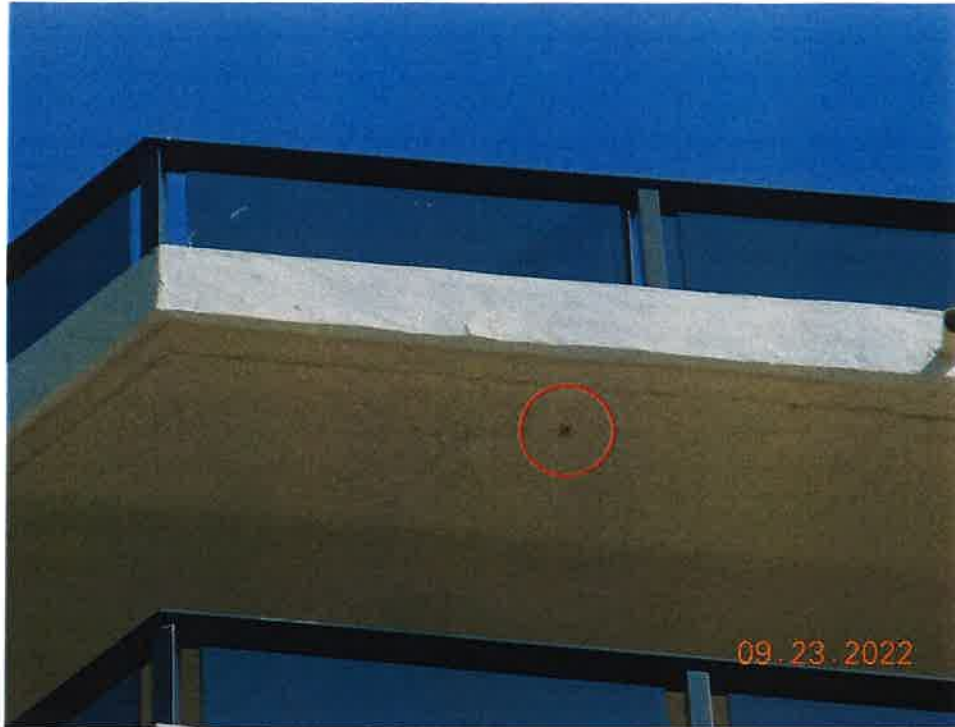
**#5 Rust Spot**

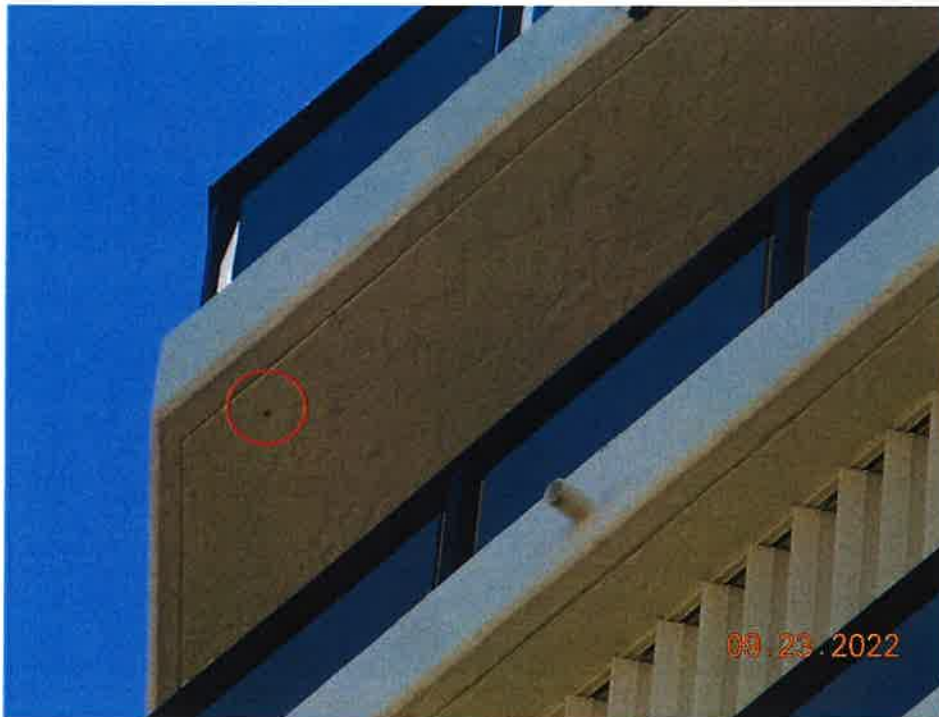
**#6 Rust spot**

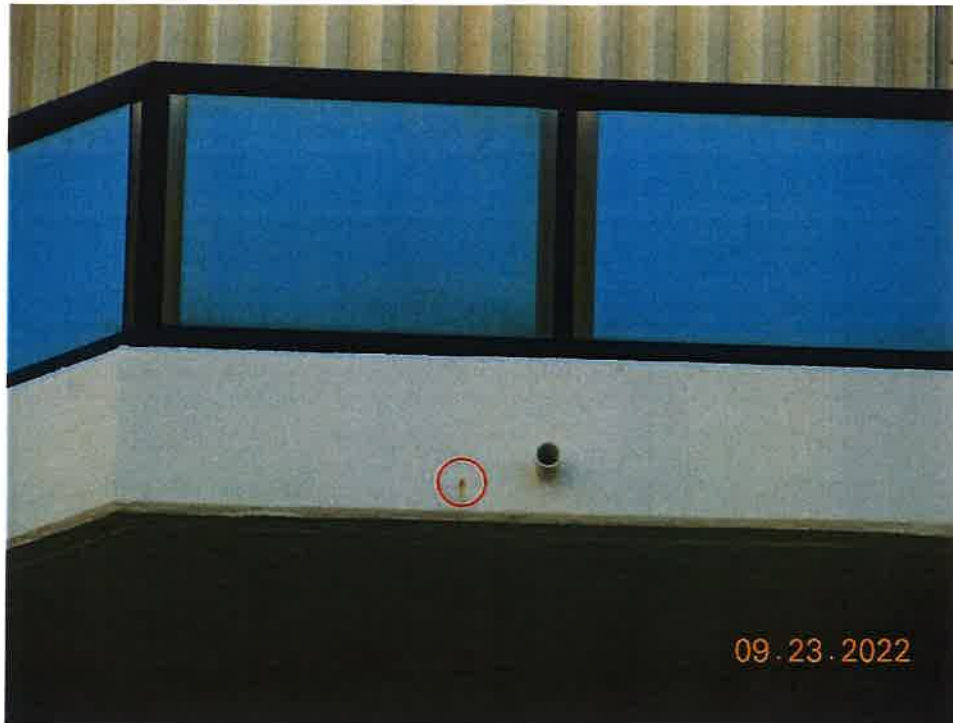
**#7 Rust Spot**

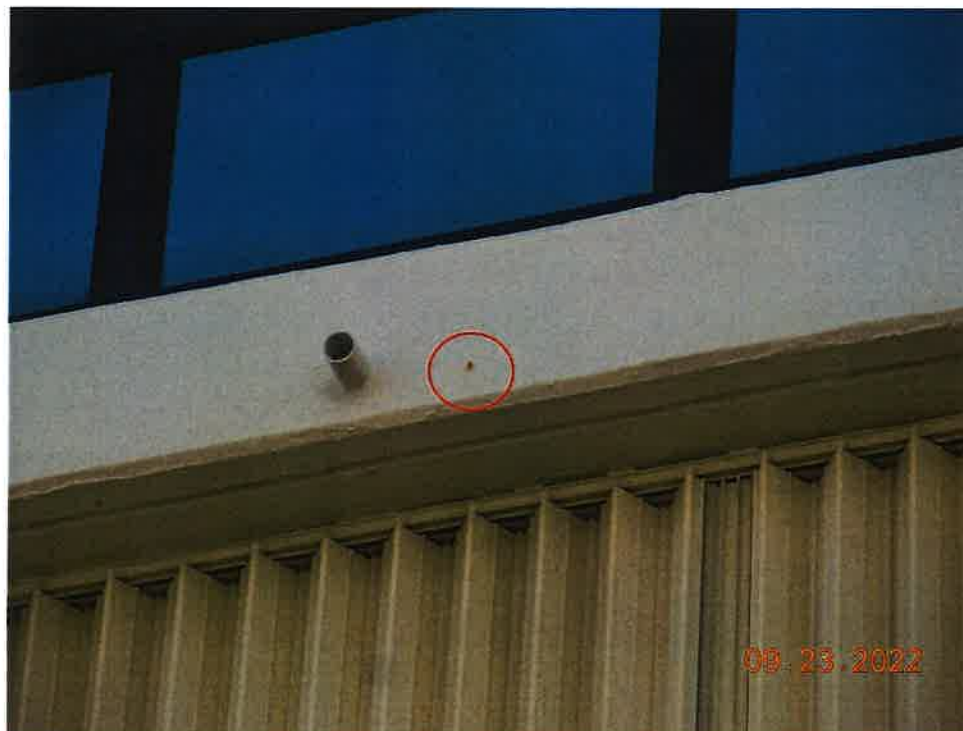
**#8 Rust Spot**

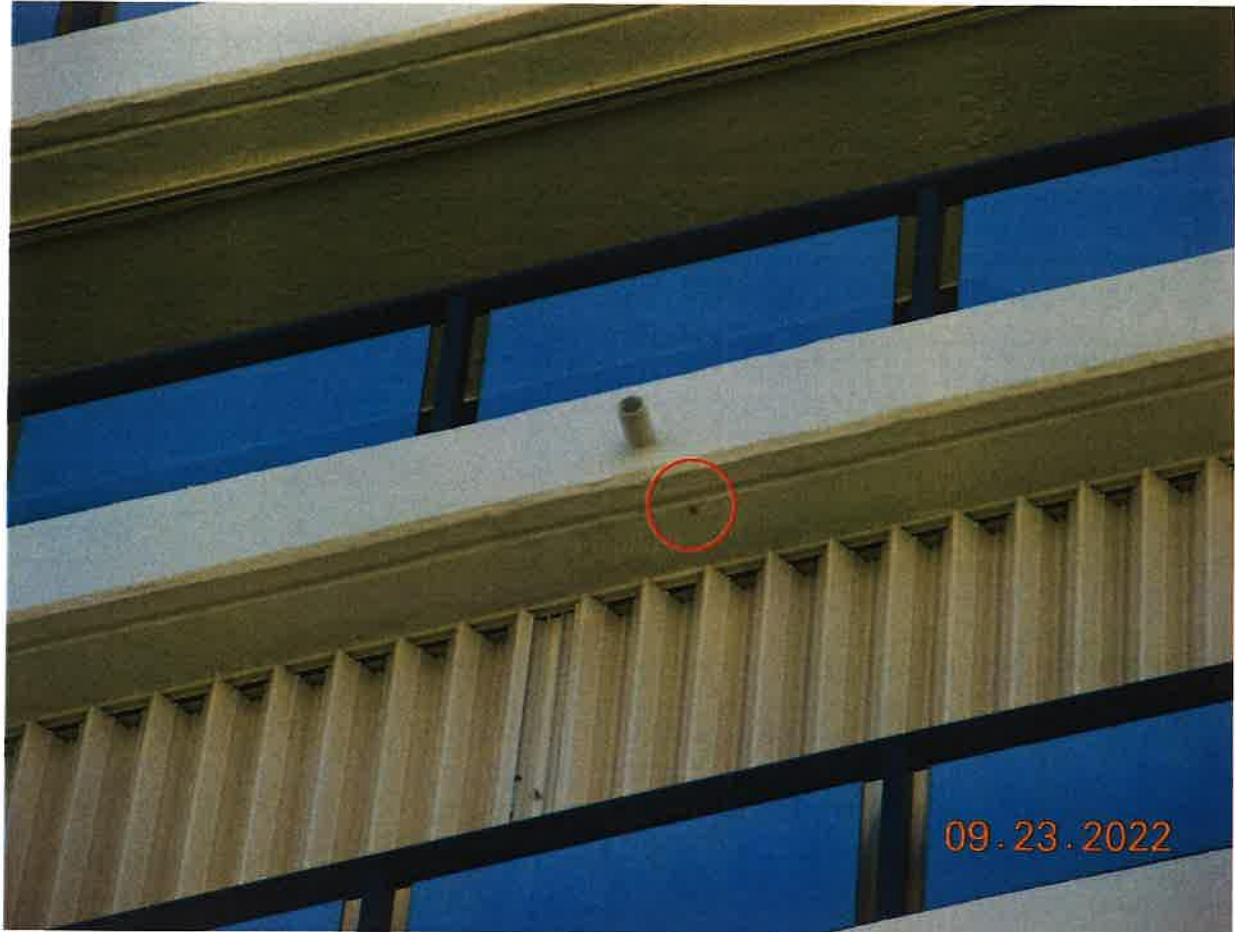
**#9 Rust Spot**

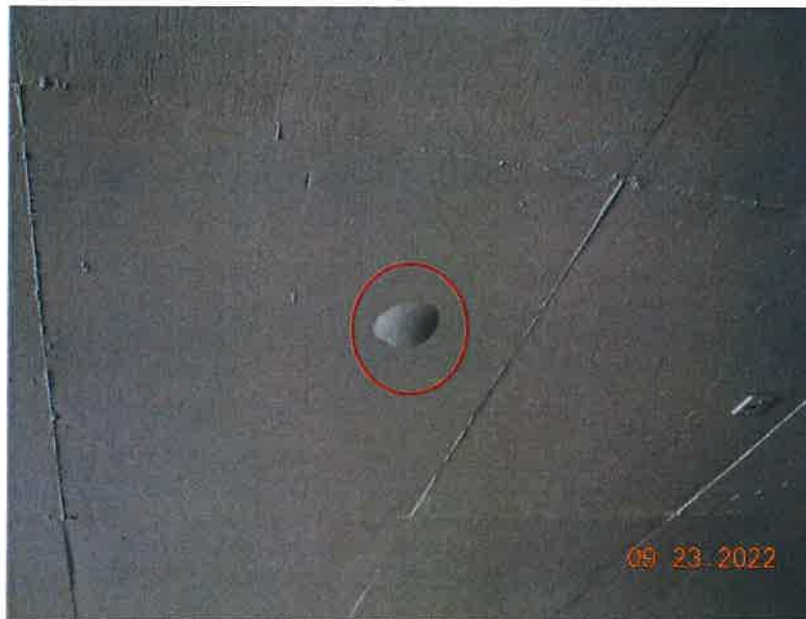
The parking garage is a single story reinforced concrete parking garage with a recreational area on the roof. The structure is in very good condition. The athletic surface above shows signs of wear and there are areas of paint blistering at the ceiling deck indicating potential moisture infiltration.

**Paint Blistering**

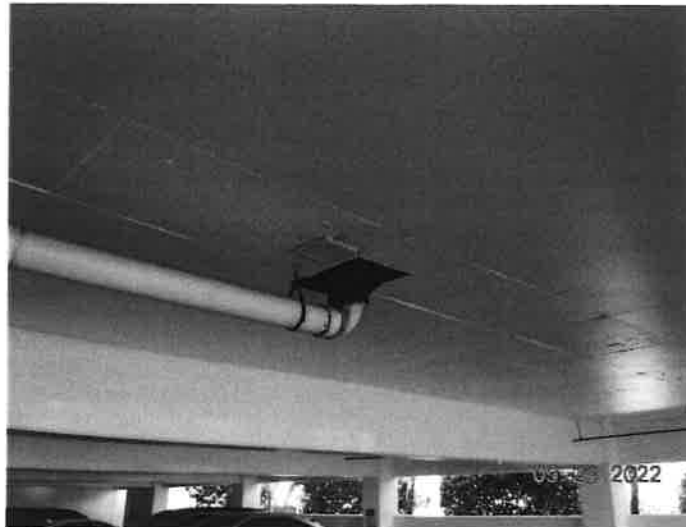
**Rusted Rood Drains and Hangers**
