# **Structural Integrity Reserve Study**

**SANDPIPER CONDOMINIUM ASSOCIATION of MARCO ISLAND,  
INC.**

**Date: May 15, 2024**

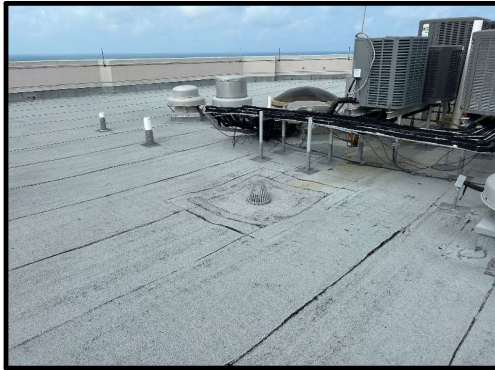
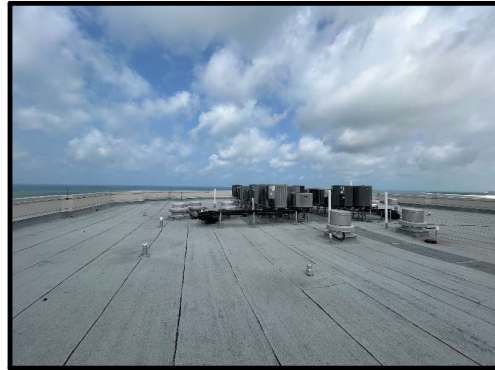
### Roof - Modified-Bit - 2031

The roof is a modified bitumin membrane installed in 2011. It is in good condition. The roof is inspected and repaired quarterly. The roof area is approximately 16,000 SqFt.

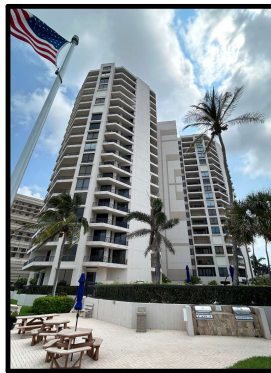
### Exterior Painting - 2028

The building was last painted in 2018 and is on a 10 year painting cycle. The exterior surface area is approximately 200,000 SF. This is for painting the building, not the railings.

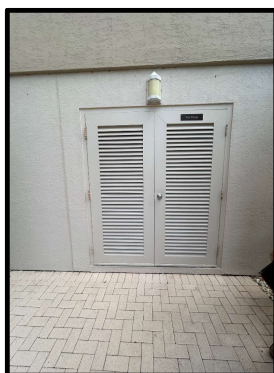
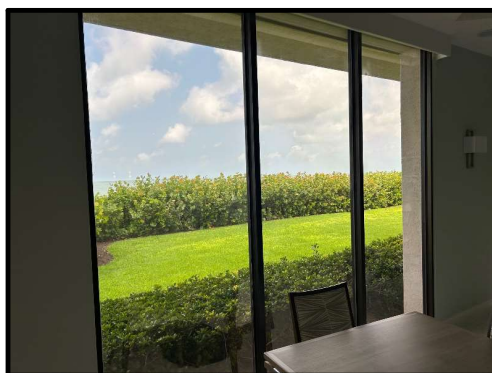
**Windows & Doors - 2029**

Unit Owners are required to have impact glass or shutters on all windows and sliders. 75% of the common glass has been replaced post Wilma with impact glass. The remaining common windows were replaced with tempored glass post Wilma due to the lack of impact glass at the time as these windows were broken. All floor common areas are conditioned and all interior doors are in good condition. The interior hardware on all interior doors was changed in 2023. There are 6 exterior hollow metal doors that may require replacing in the next 5 years.

This is a one-time allowance to replace the 6 exterior doors by 2029.

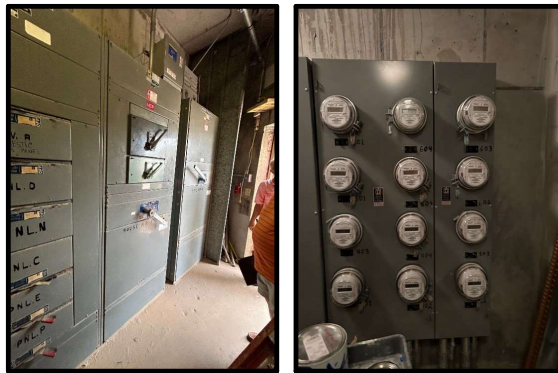
### Electrical Switchgear - 2025

Original switch gear and distribution centers from 1984.

Every third floor is fed with an 800 Amp sub panel.

The Electrical equipment is all by Square D.

This type of system has a life expectancy of 50 years. This equipment is not obsolete and parts are in stock. It is currently in good condition.

This is an allowance to have an electrician conduct a thermal video inspection inside the switchgear and panels every 5 years, looking for hot spots.

The replacement cost is estimated at \$350,000.

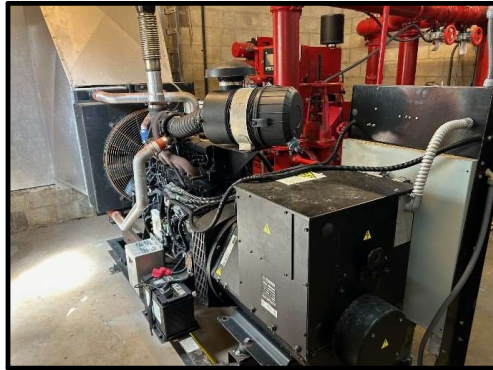
**Backup Generator - 2060**

The building has a diesel emergency generator to operate the base building electric in times of power outages.

This is a Gillette generator with an auto transfer switch installed in 2020.

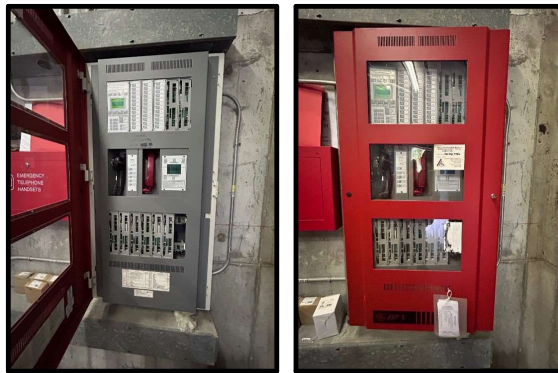
### Fire Safety - Fire Panel - 2046

The fire alarm system is an EST system. This system was updated 8 years ago. This is an excellent, fully monitored system, with all required devices throughout the building.

This system has a life cycle of 30 years.

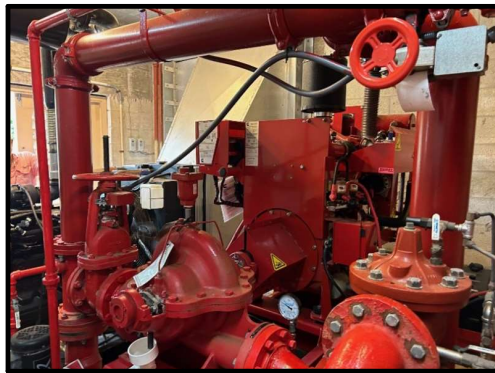
### Fire Safety - Sprinkler System - 2055

The fire safety system begins with a sprinkler system serving the interior of the main building with a single sprinkler head in each entry to all residences.

The fire pump is a diesel system installed in 2016. This should have a life cycle of 35 years.

Sprinkler heads are replaced as needed.

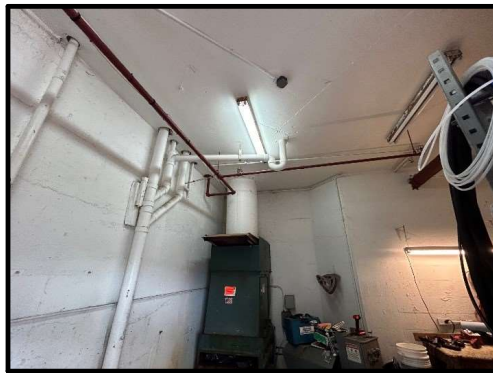
### Plumbing - 2026

Plumbing pipe consists of copper supply and PVC waste pipe.

The HOA had the stacks scoped in the last 5 years and found no issues.

The sanitary waste piping is PVC and this is a solid choice of pipe for sanitary waste in South Florida.

This is an allowance for jet cleaning these pipes every 7 years. This will maintain this system for many years.

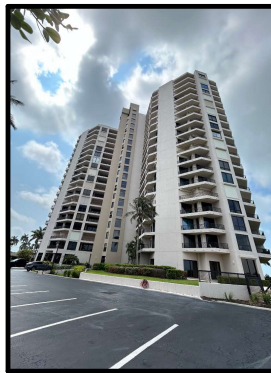
### Structure - 2028

The building was constructed in 1984 consisting of reinforced concrete, masonry and post tension floor slabs. The exterior stucco was replaced in 2008 / 2009 as a result of damage from Hurricane Wilma. The building was painted in 2018 and stucco repairs were completed again at that time. There were only minor concrete repairs in 2018.

This is an allowance for \$100,000 in structural repairs with the next paint cycle in 2028.
