**Structural Milestone Inspection  
Phase II Summary**

**Property Address:** Building "C," 129 South Collier Boulevard, Marco Island, FL 34145

# **Structural Milestone Inspection Phase II**

**Property Located at:  
The Sands of Marco - Building "C"  
129 South Collier Boulevard  
Marco Island, Florida 34145**

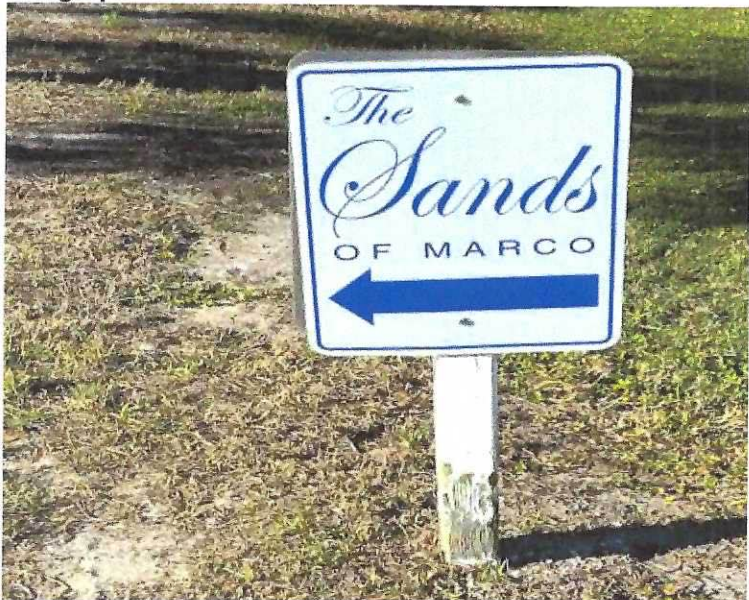
Photograph #1

The subject building on the property, The Sands of Marco Condominium, is a residential condominium located at 129 S. Collier Blvd, Marco Island, FL 34145. The Sands of Marco Condominium was designed by Dekonshin & Associates Inc., Architect in 1988 under the 1982 Standard Building Code with 1985 Amendments. The property consists of two 3-story buildings, two 4-story buildings, two 5-story buildings, and one 6-story building (128 units). According to information provided by the Collier County Property Appraiser's Office, the subject property was originally constructed in 1989 (**Photographs #1, #2, #3, and #4**).

THE SANDS OF MARCO

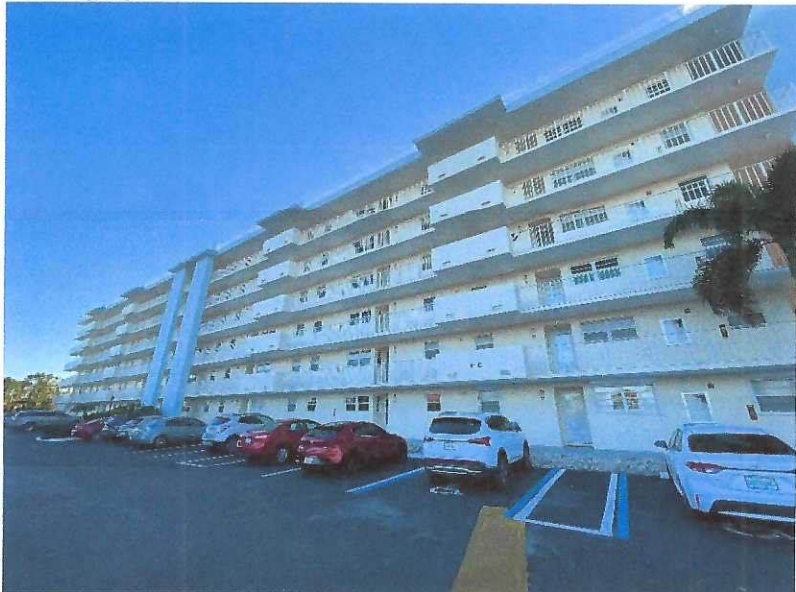
Photograph #2

THE SANDS OF MARCO  
BUILDING “C”

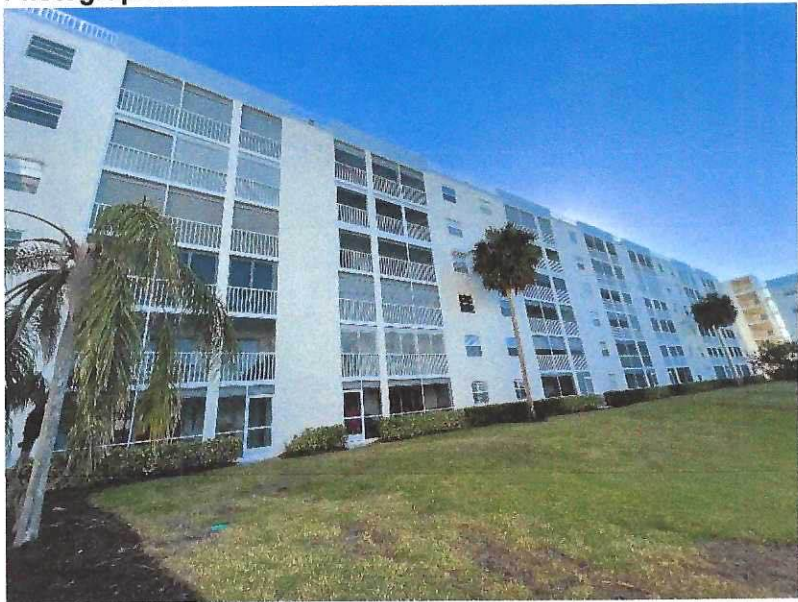
Photograph #3

THE SANDS OF MARCO  
BUILDING “C”

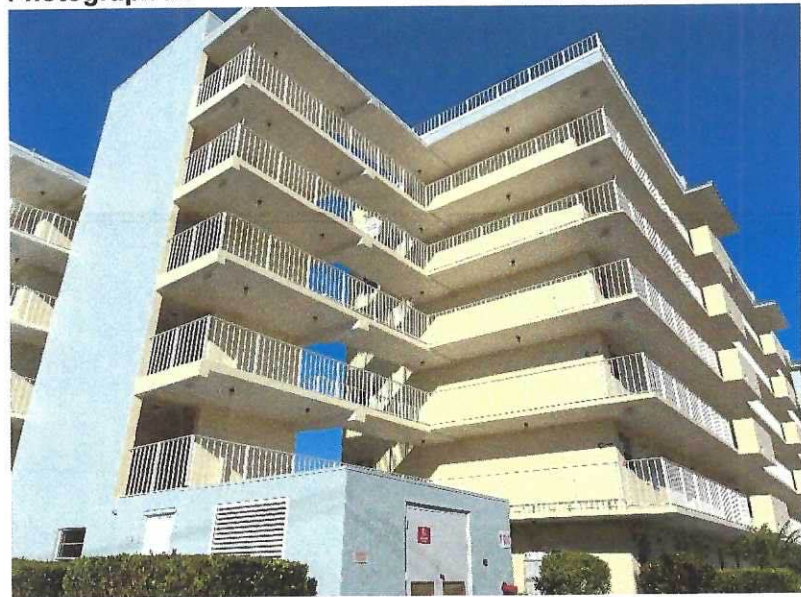
Photograph #4

THE SANDS OF MARCO  
BUILDING “C”

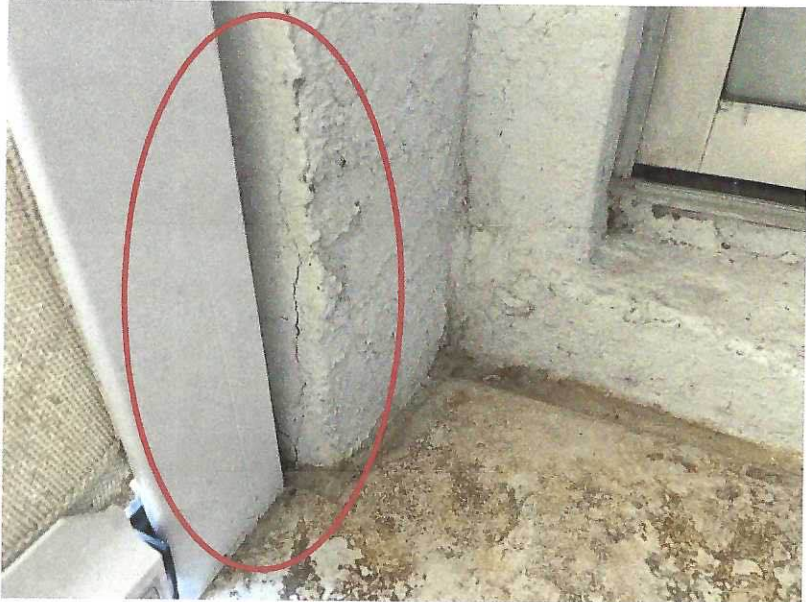
Photograph #5

- 3.2.1 Stucco cracking and spalling were observed at the enclosure of the steel balcony columns. Further investigation was conducted at select locations, including the removal of stucco and concrete enclosure of the steel columns. Subsequently, the steel columns were visually inspected, and minor surface corrosion was observed. This condition does not represent substantial structural deterioration (**Photographs #5, #6, #7, and #8**).

**COLUMNS AND BEAMS  
UNIT C401**

Stucco cracking and spalling were observed at the enclosure of the steel balcony columns. These conditions do not represent substantial structural deterioration.

For areas that did not rise to the level of substantial deterioration, Delta recommends routine building maintenance, which includes but is not limited to mechanically cleaning and coating steel columns; sealing exposed cracks in the exterior stucco finish; replacing damaged stucco; repairing exposed cracks in the balcony concrete slabs; and repairing concrete spalling, damaged coatings, and waterproofing at the exterior walkway deck (**Photographs #5 through #10, #12, #16, #17, #21 and #24**). Forgoing repairs and routine maintenance may adversely affect the integrity of the structure.

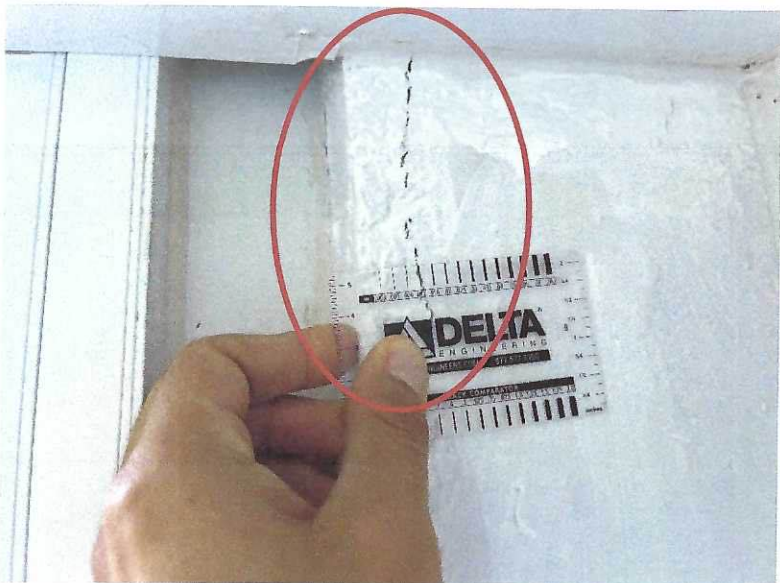
Photograph #6

**COLUMNS AND BEAMS  
UNIT C406**

Stucco cracking and spalling were observed at the enclosure of the steel balcony columns. These conditions do not represent substantial structural deterioration.

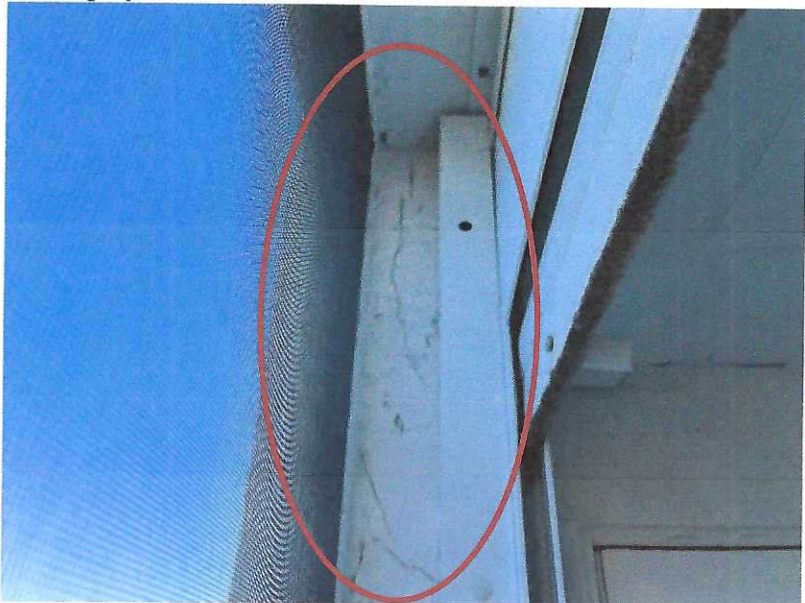
Photograph #7

**COLUMNS AND BEAMS  
UNIT C407**

Stucco cracking and spalling were observed at the enclosure of the steel balcony columns. These conditions do not represent substantial structural deterioration.

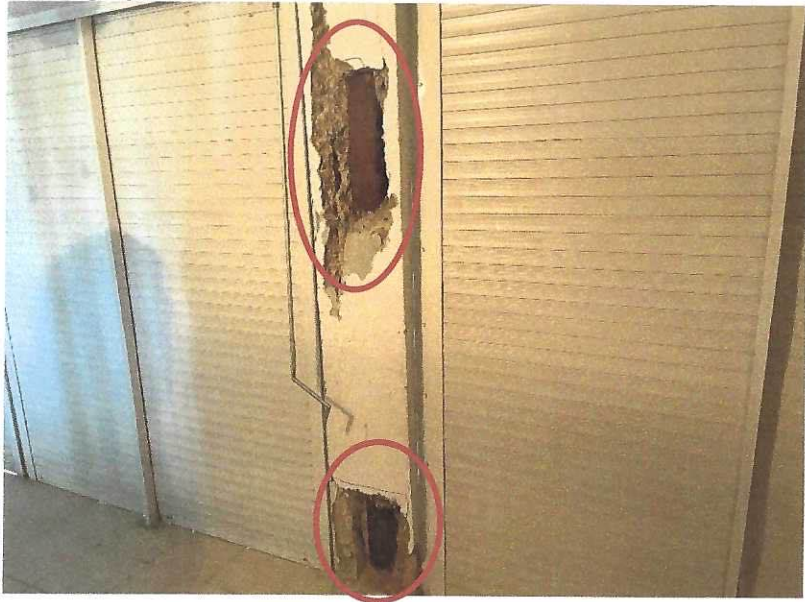
Photograph #8

**COLUMNS AND BEAMS  
UNIT C202**

Minor surface corrosion was observed at a steel column. This condition does not represent substantial structural deterioration.

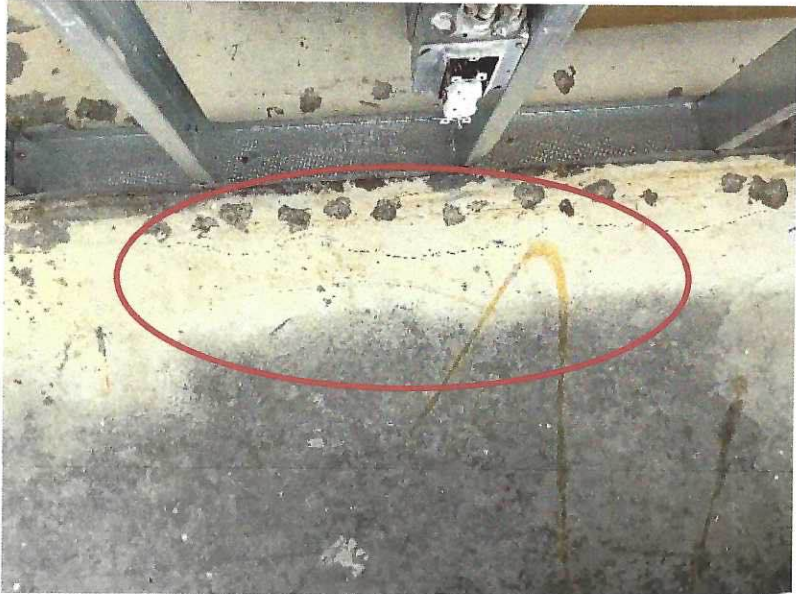
Photograph #9

- 4.3.1 Cracking was observed at the interior unit floor system during the Phase I inspection. This condition does not represent substantial structural deterioration (**Photograph #9**).

**FLOOR SYSTEM  
UNIT C501**

Cracking was observed at the unit's interior floor slab. This condition does not represent substantial structural deterioration.

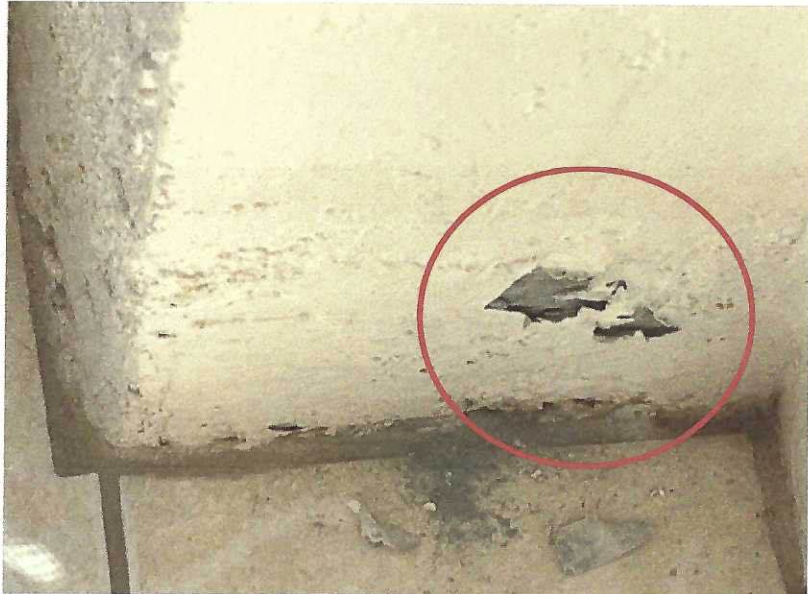
Photograph #10

- 4.4.1 Stucco damage was observed at the exterior balcony column during the Phase I inspection. This condition does not represent substantial structural deterioration but could eventually lead to structural deterioration if not repaired (**Photograph #10**).

**EXTERIOR BALCONIES  
UNIT C104**

Stucco damage was observed at the exterior balcony column. This condition does not represent substantial structural deterioration.

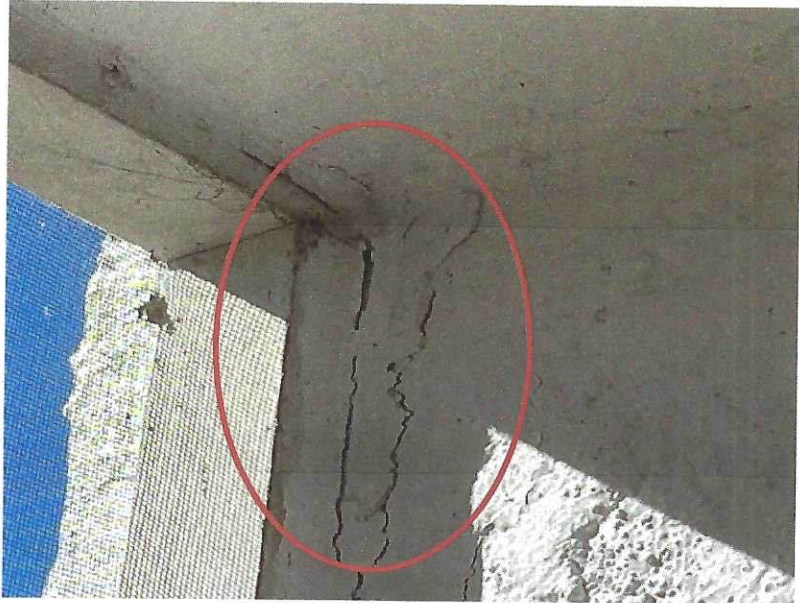
Photograph #11

4.4.2 Concrete spalling and cracking were observed at balcony overhead slabs and walls during the Phase I inspection. This condition represents substantial structural deterioration and requires immediate repair (**Photographs #11, #13, #14, #15, #18, #19, and #20**).

Based on the scope and limitations of this SMI, ***Substantial Structural Deterioration*** was observed at the fifth-floor walkway slab drop beam (**Photographs #22 and #23**) and unit balconies (**Photographs #11, #13, #14, #15, #18, #19, and #20**) which requires immediate repair.

**EXTERIOR BALCONIES  
UNIT C105**

Cracking was observed at the exterior balcony wall. This condition represents substantial structural deterioration and requires immediate repair.

A preliminary repair scope includes repair of spalled and delaminated concrete and exposed rebar at the columns by excavating damaged concrete, coating reinforcing steel with a corrosion-inhibiting coating, and re-casting with a compatible repair mortar, all in accordance with ICRI standards.

Engineering specifications and details will be required to correct the structural deficiencies cited within this report and provide preventative repair procedures. Due to the structural nature of the damage, the design of the repair should be prepared by a licensed Florida Professional Engineer. If the repairs are not performed to correct these deficiencies, these conditions will worsen, thereby further compromising the capacity and integrity of the structural elements, resulting in a greater expense for the Association to repair and if left unmitigated could result in unsafe conditions. Delta did not observe structural concerns that rise to the level of “unsafe” or “dangerous” conditions as defined by the Florida Building Code.

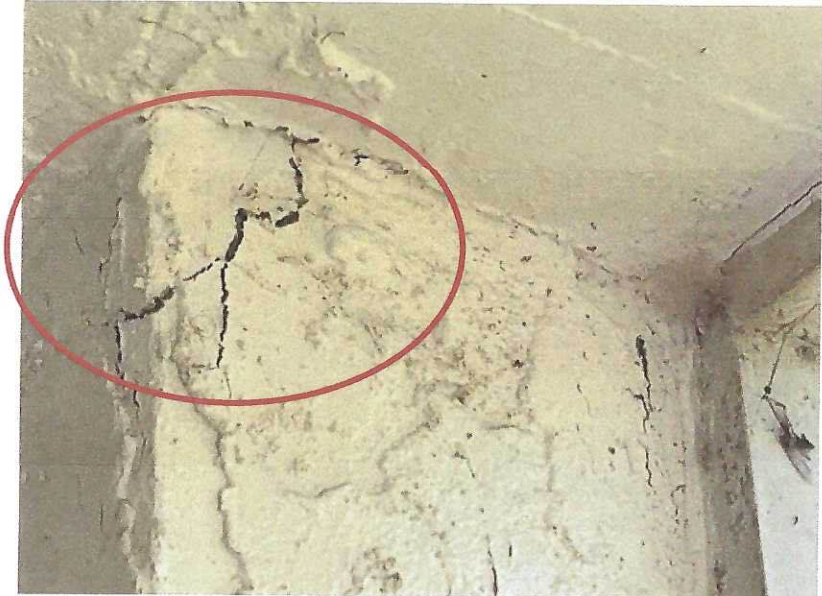
Photograph #12

4.4.3 Stucco cracking and spalling were observed at the enclosure of the steel balcony columns. Further investigation was conducted, including the removal of stucco and concrete enclosure of the steel columns. Subsequently, the steel columns were visually inspected, and minor surface corrosion was observed. This condition does not represent substantial structural deterioration (**Photographs #12, #16, #17, and #21**).

**EXTERIOR BALCONIES  
UNIT C105**

Stucco cracking and spalling were observed at the enclosure of the steel balcony columns. These conditions do not represent substantial structural deterioration.

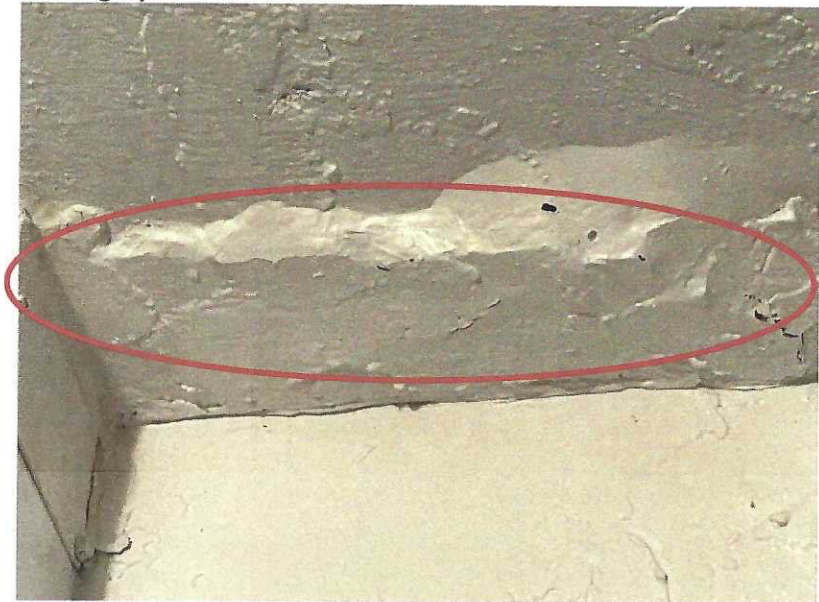
Photograph #13

**EXTERIOR BALCONIES  
UNIT C107**

Concrete spalling was observed at the exterior balcony overhead slab. This condition represents substantial structural deterioration and requires immediate repair.

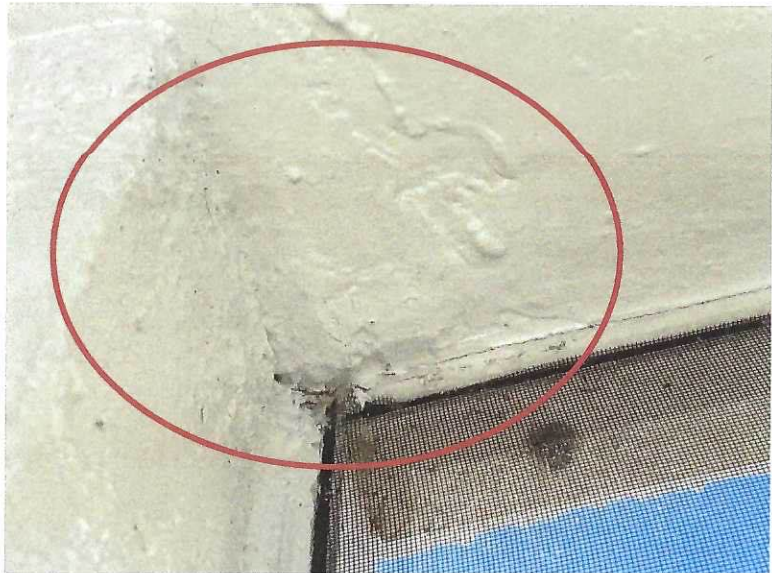
Photograph #14

**EXTERIOR BALCONIES  
UNIT C201**

Concrete spalling was observed at the exterior balcony overhead slab near the column. This condition does not represent substantial structural deterioration.

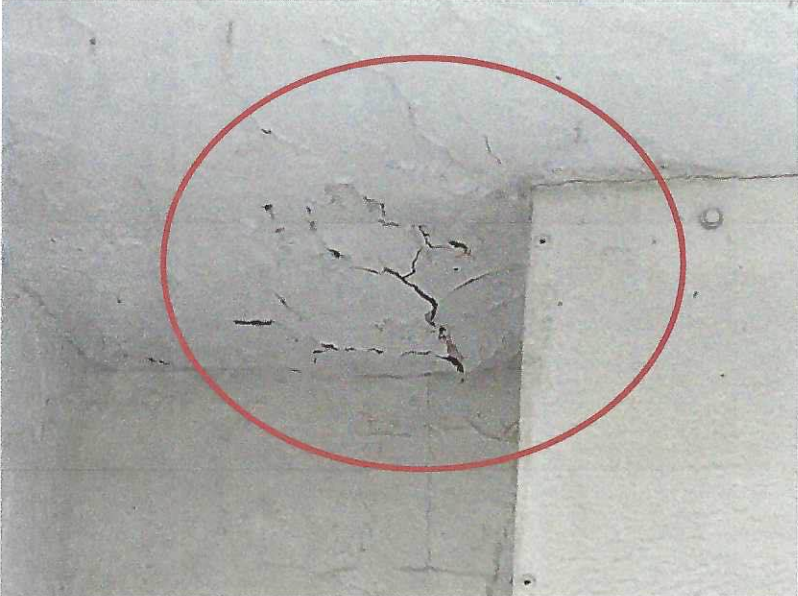
Photograph #15

**EXTERIOR BALCONIES  
UNIT C202**

Concrete spalling was observed at the exterior balcony overhead slab. This condition represents substantial structural deterioration and requires immediate repair.

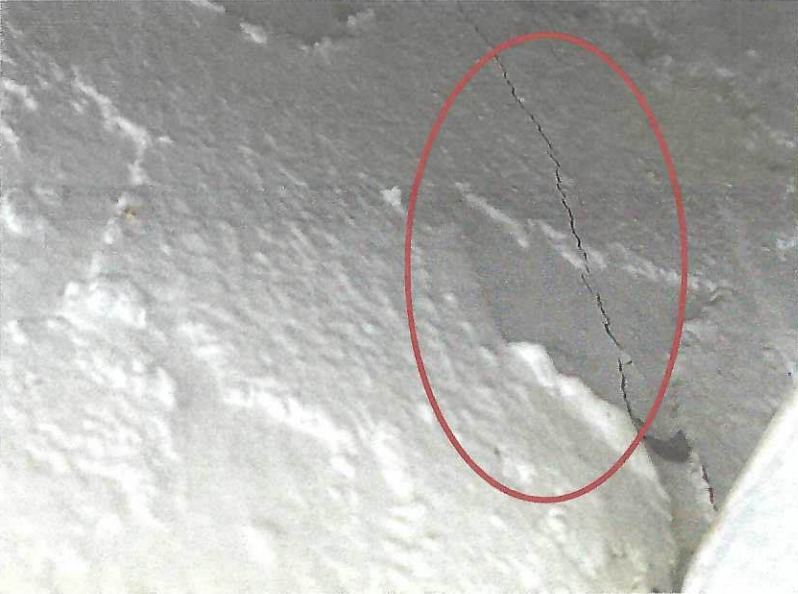
Photograph #16

**EXTERIOR BALCONIES  
UNIT C204**

Stucco cracking was observed at the enclosure of the steel balcony columns. This condition does not represent substantial structural deterioration.

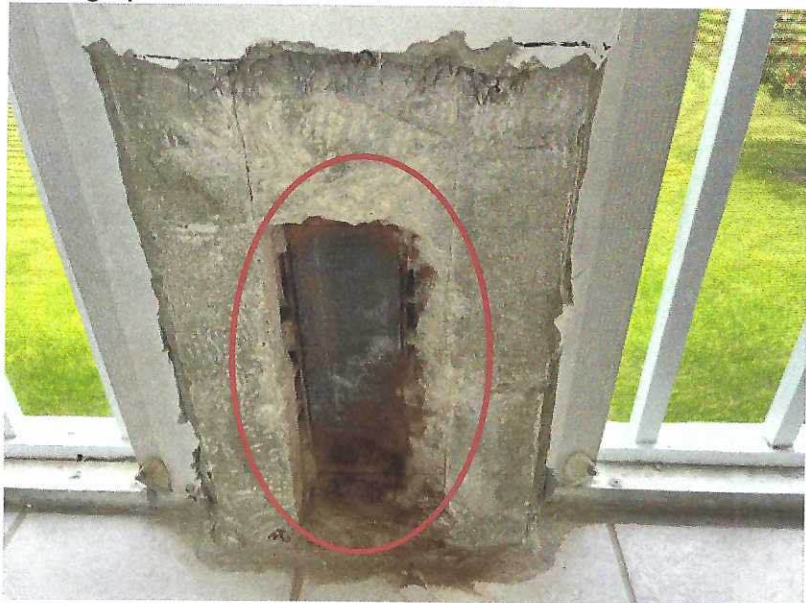
Photograph #17

**EXTERIOR BALCONIES  
UNIT C204**

Minor surface corrosion was observed at a steel column. This condition does not represent substantial structural deterioration.

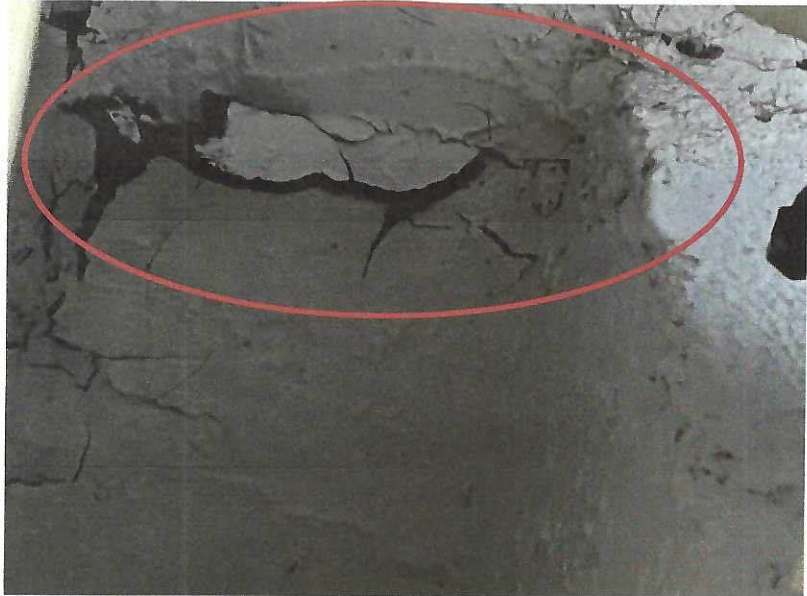
Photograph #18

**EXTERIOR BALCONIES  
UNIT C205**

Concrete spalling was observed at the exterior balcony overhead slab. This condition represents substantial structural deterioration and requires immediate repair.

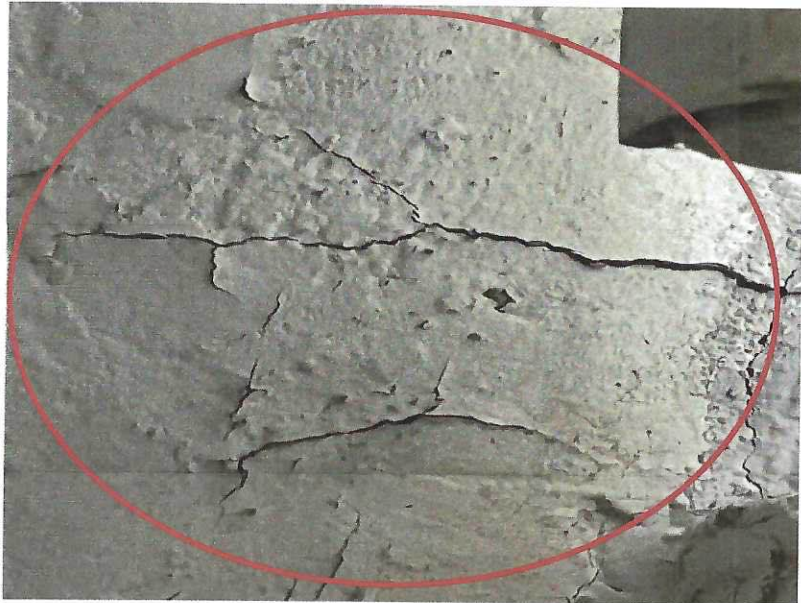
Photograph #19

**EXTERIOR BALCONIES  
UNIT C205**

Concrete spalling was observed at the exterior balcony overhead slab. This condition represents substantial structural deterioration and requires immediate repair.

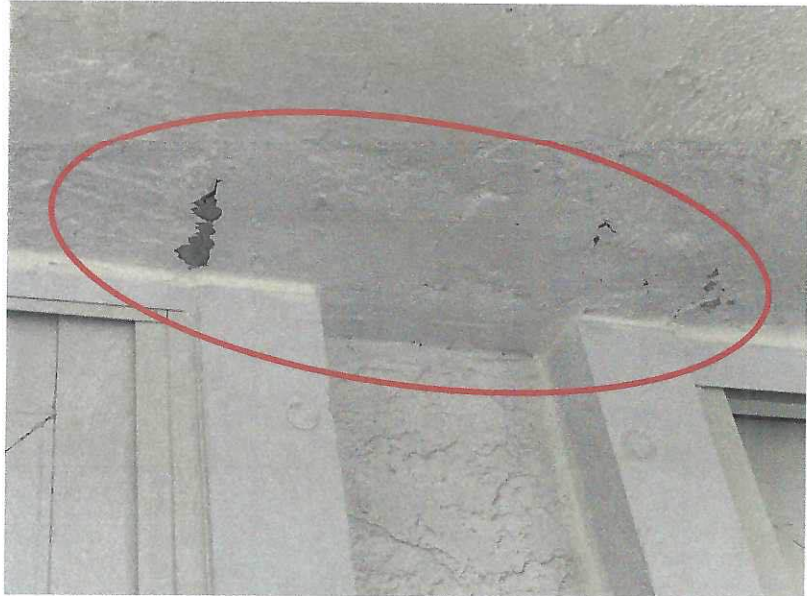
Photograph #20

**EXTERIOR BALCONIES  
UNIT C301**

Concrete spalling was observed at the exterior balcony overhead slab. This condition represents substantial structural deterioration and requires immediate repair.

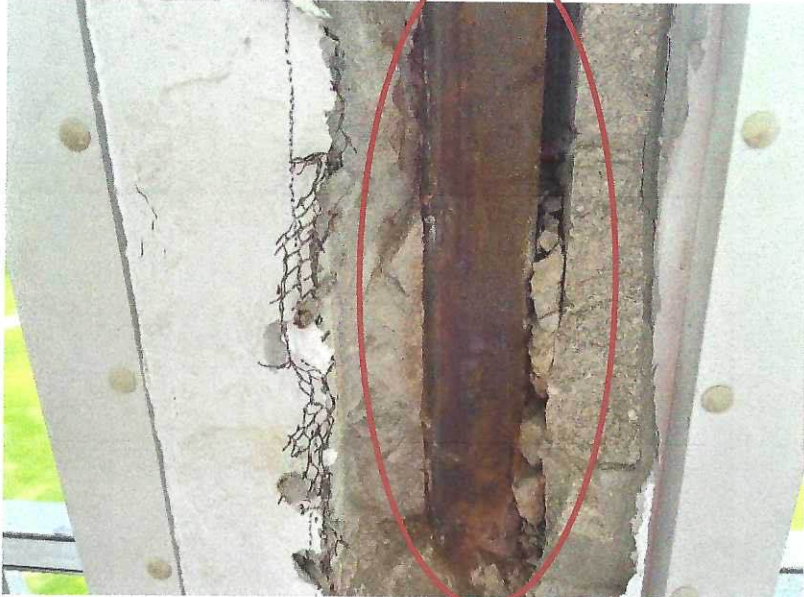
Photograph #21

**EXTERIOR BALCONIES  
UNIT C305**

Minor surface corrosion was observed at a steel column. This condition does not represent substantial structural deterioration.

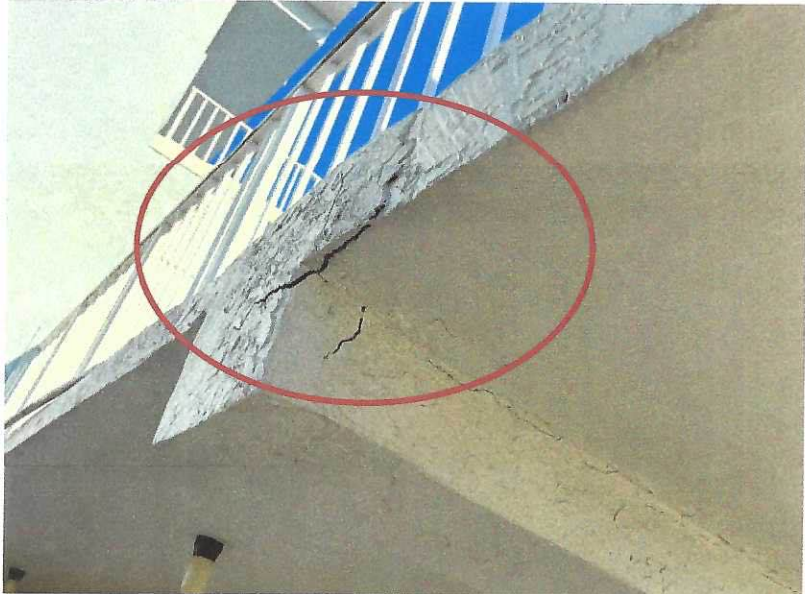
Photograph #22

4.5.1 Stucco and concrete cracking were observed at the fifth-floor walkway slab edge and drop beam during the Phase I inspection. The drop beam is part of the Building C walkway where it meets the Building B East walkway under the expansion joint. This condition represents substantial structural deterioration and requires immediate repair (**Photographs #22 and #23**).

**EXTERIOR WALKWAY – FIFTH  
FLOOR**

Stucco and concrete cracking were observed at the fifth-floor walkway slab edge and drop beam. These conditions represent substantial structural deterioration and require immediate repair.

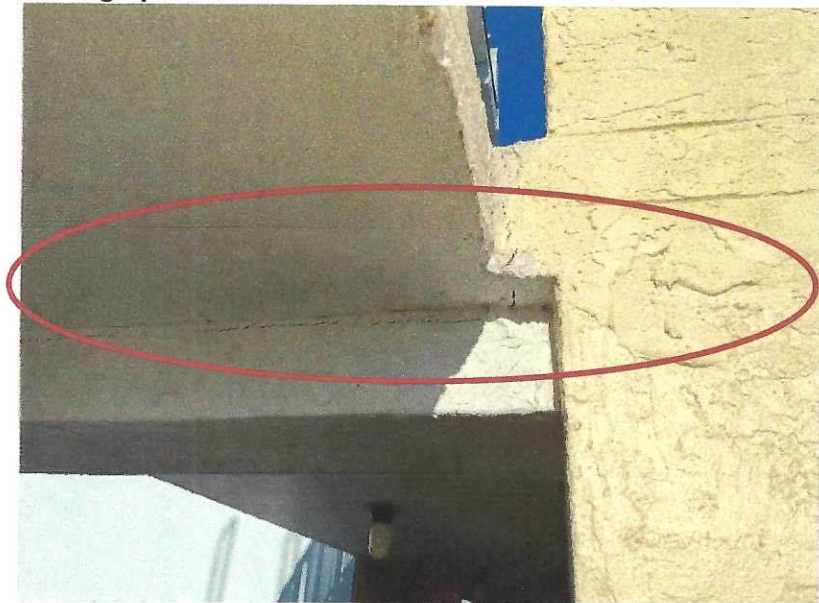
Photograph #23

**EXTERIOR WALKWAY – FIFTH FLOOR**

Stucco and concrete cracking were observed at the fifth-floor walkway slab edge and drop beam. These conditions represent substantial structural deterioration and require immediate repair.

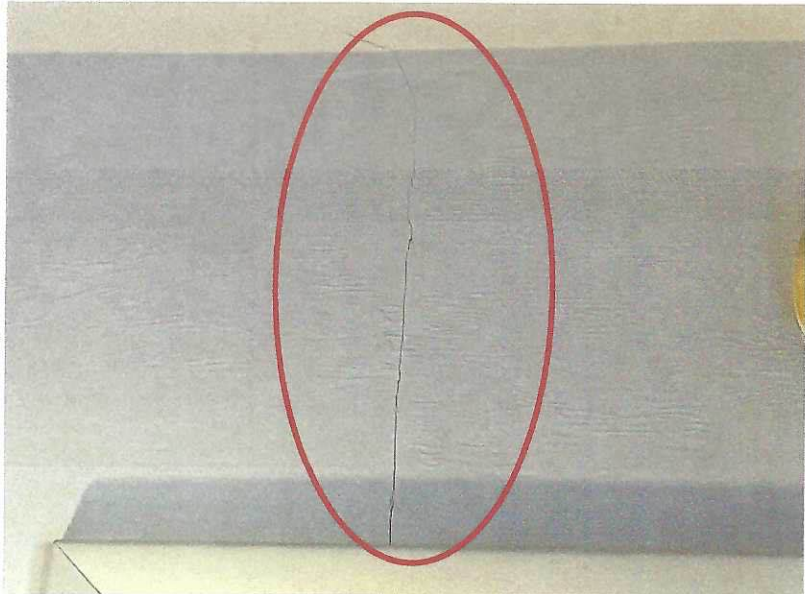
Photograph #24

4.8.1 Cracking on the overhead slab and walls was observed during the Phase I inspection. This condition does not represent substantial structural deterioration but could eventually lead to structural deterioration if not repaired (**Photograph #24**).

**INTERIOR UNITS  
UNIT C207**

Cracking was observed inside the unit. This condition does not represent substantial structural deterioration.
