RE: *Shipp's Landing – Phase I Milestone Inspection Report*  
1100 S Collier Boulevard  
KEG File# 21RN-0972

**Karins Engineering (KE)** is providing this report based on our Phase I Milestone Inspection in accordance with Florida Statutes 553.899 at **Shipp's Landing Condominium (SLC)**. KE performed a visual inspection of the building, including the major structural components to provide a qualitative assessment of the overall structural conditions of the building(s).

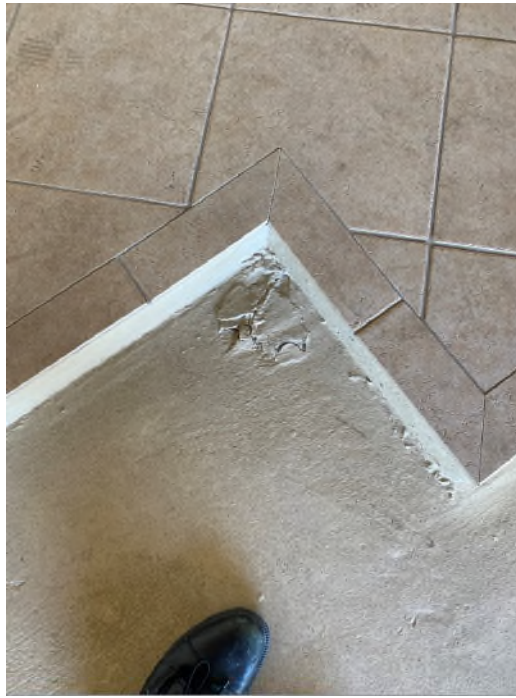
Exposed concrete columns and beams did not present any potential structural issues at the time of our visit. A few cracks at slab edges and minor spalls at precast planks were observed. These isolated issues are part of the ongoing maintenance program.

**Figure 2: Concrete spall at slab. Common area.**

KE would recommend addressing the isolated non-structural issues observed herein during the next painting project. Repair of existing concrete should be added to the restoration and painting project scope of work along with crack and potential delaminated stucco repairs.

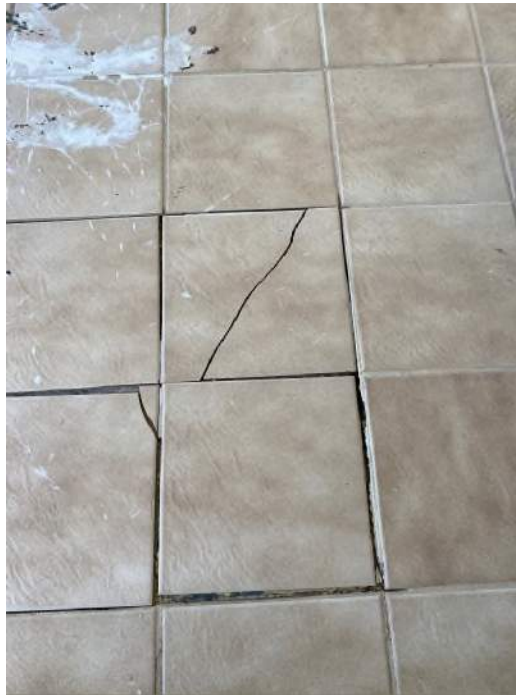
**Figure 3: Cracked and delaminated tile at unit 622.**

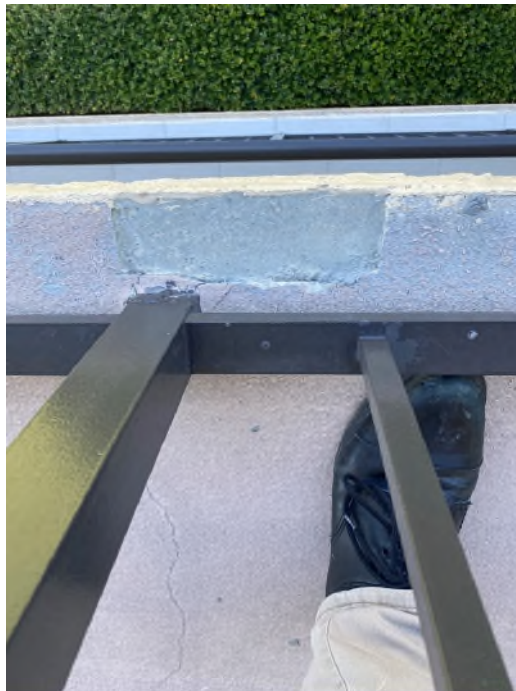
**Figure 4: Stucco delamination and hairline crack. Unit 425.**
