## **MILESTONE INSPECTION – PHASE I REPORT**

The Somerset of Marco Island  
780 South Collier Boulevard  
Marco Island, Florida 34145

SOCOTEC Project Number 6178-002.01

December 2024

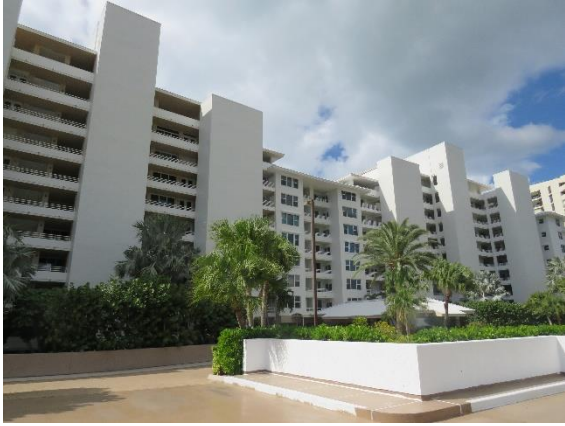
| <p>View of the east side of the building.</p> | <p>View of the west side of the building.</p> |

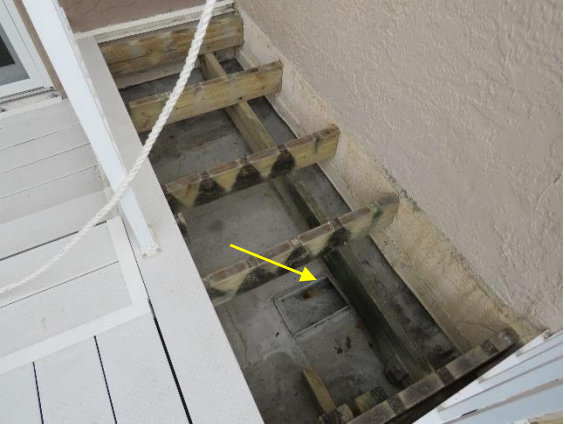
| <p>View of water intrusion through a penthouse terrace scupper, currently undergoing remedial repairs.</p> | <p>View of metal roofing system.</p> |

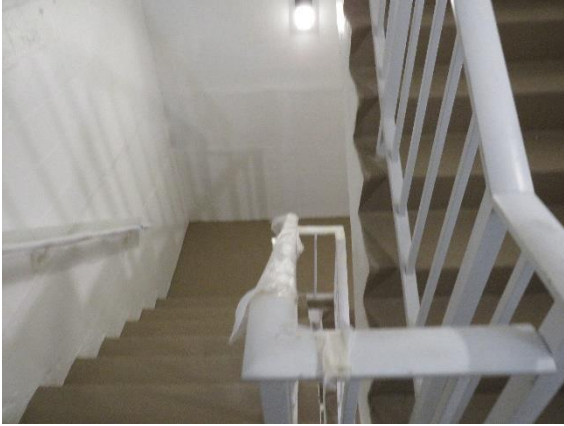
| View within the stairwells. | View of typical entry walkway deck waterproofing failure. |

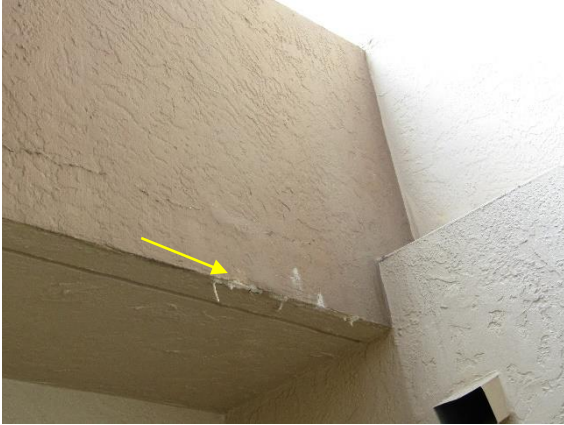
| Indications of water intrusion through walkway waterproofing. | Indications of slab movement at the rear entrance to the building lobby. |

- Replace waterproofing across common area entry walkways.

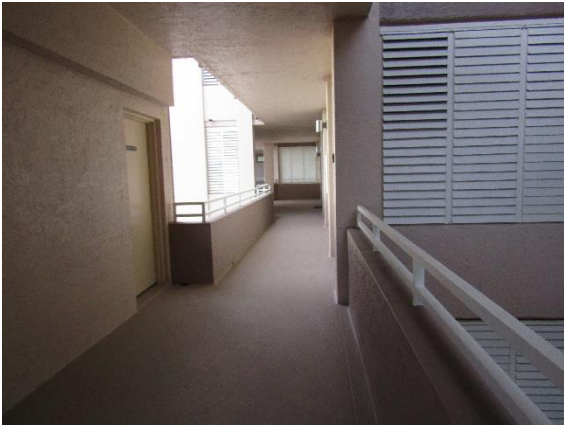
| Typical entrance walkway | View within the ground floor storage room. |

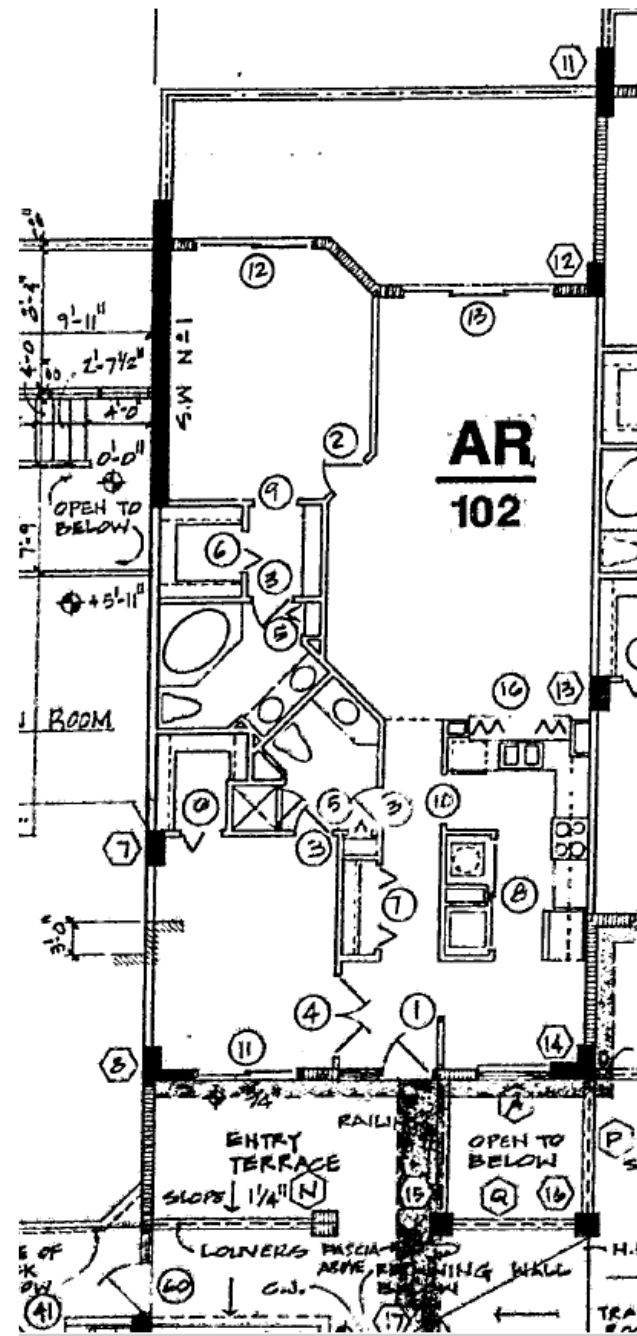
**UNIT 102**

No Structural Distress  
Observed

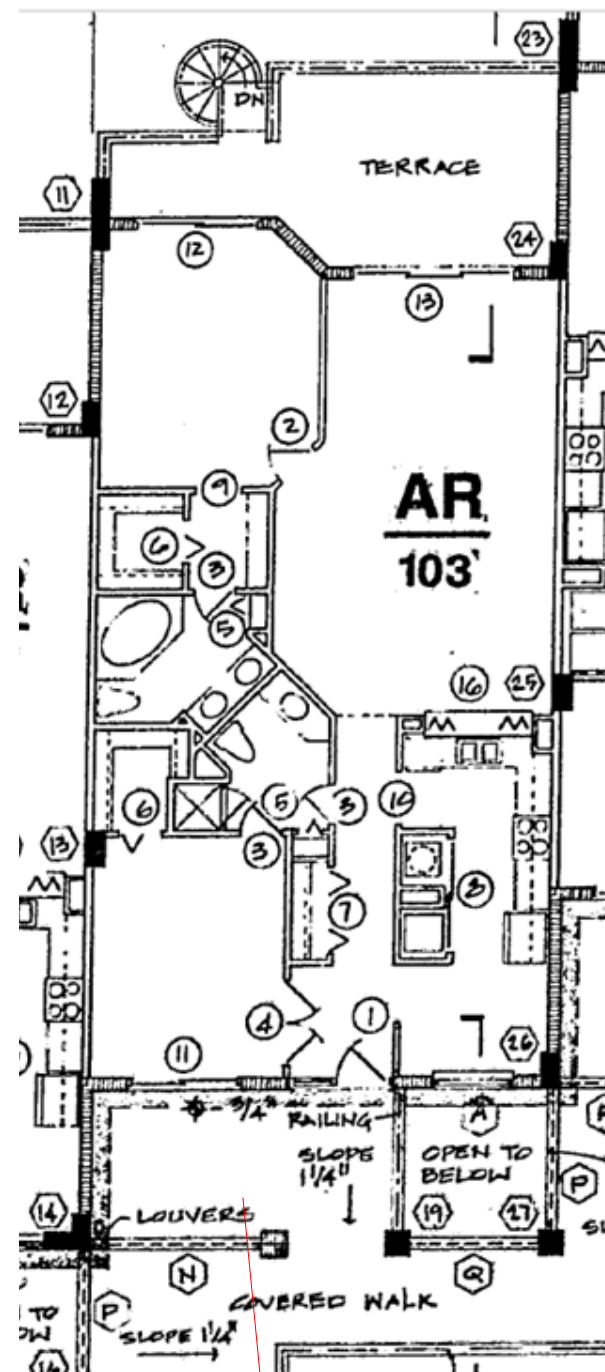
**UNIT 103**

No Structural Distress  
Observed

Enclosed in to living  
space

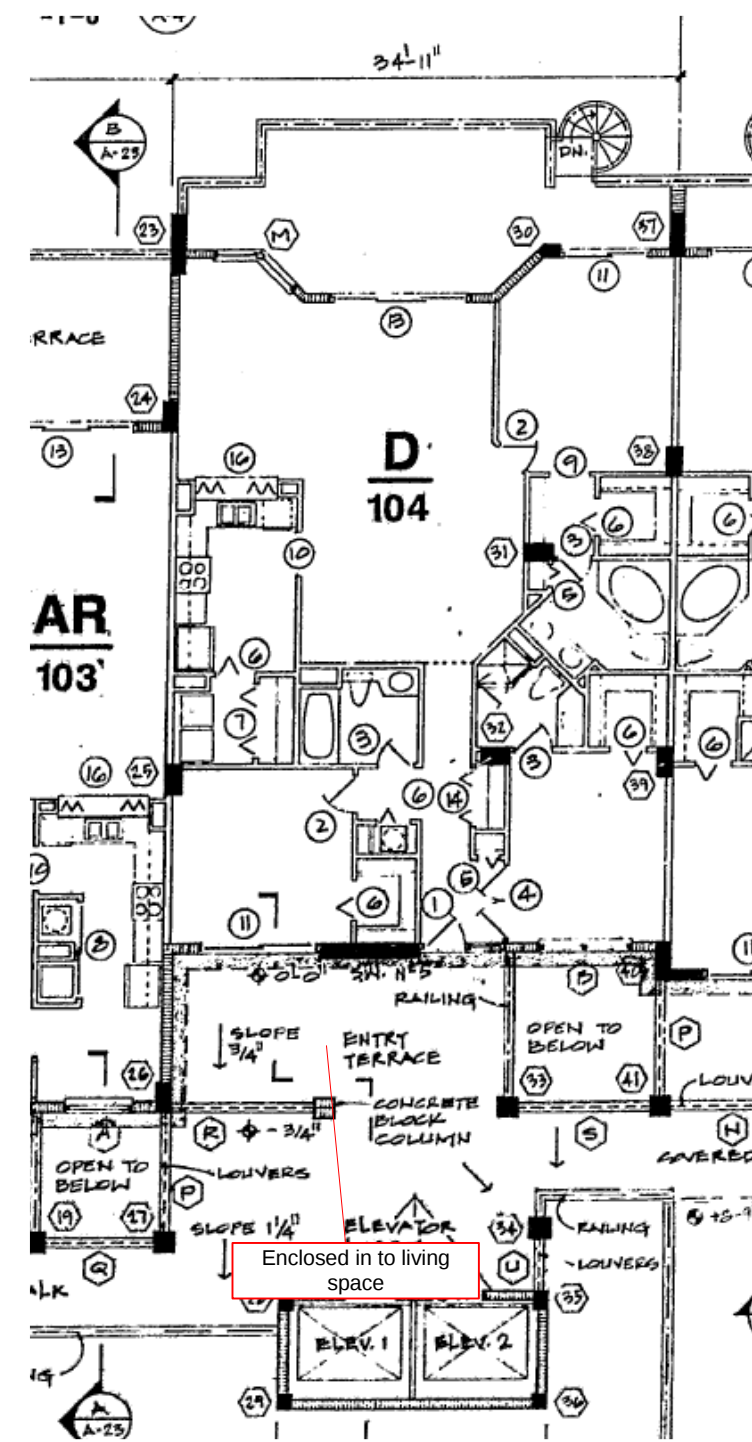
**UNIT 104**

No Structural Distress  
Observed

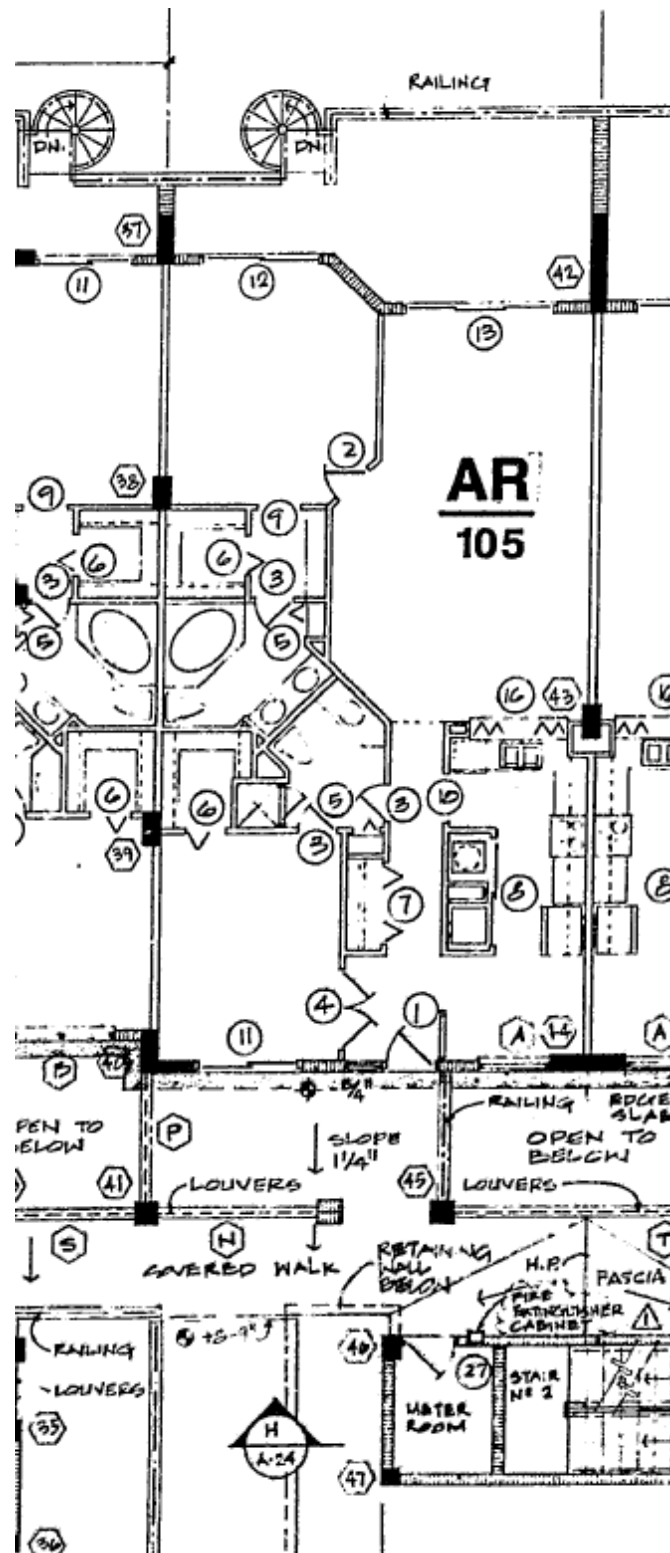
**UNIT 105**

No Structural Distress  
Observed

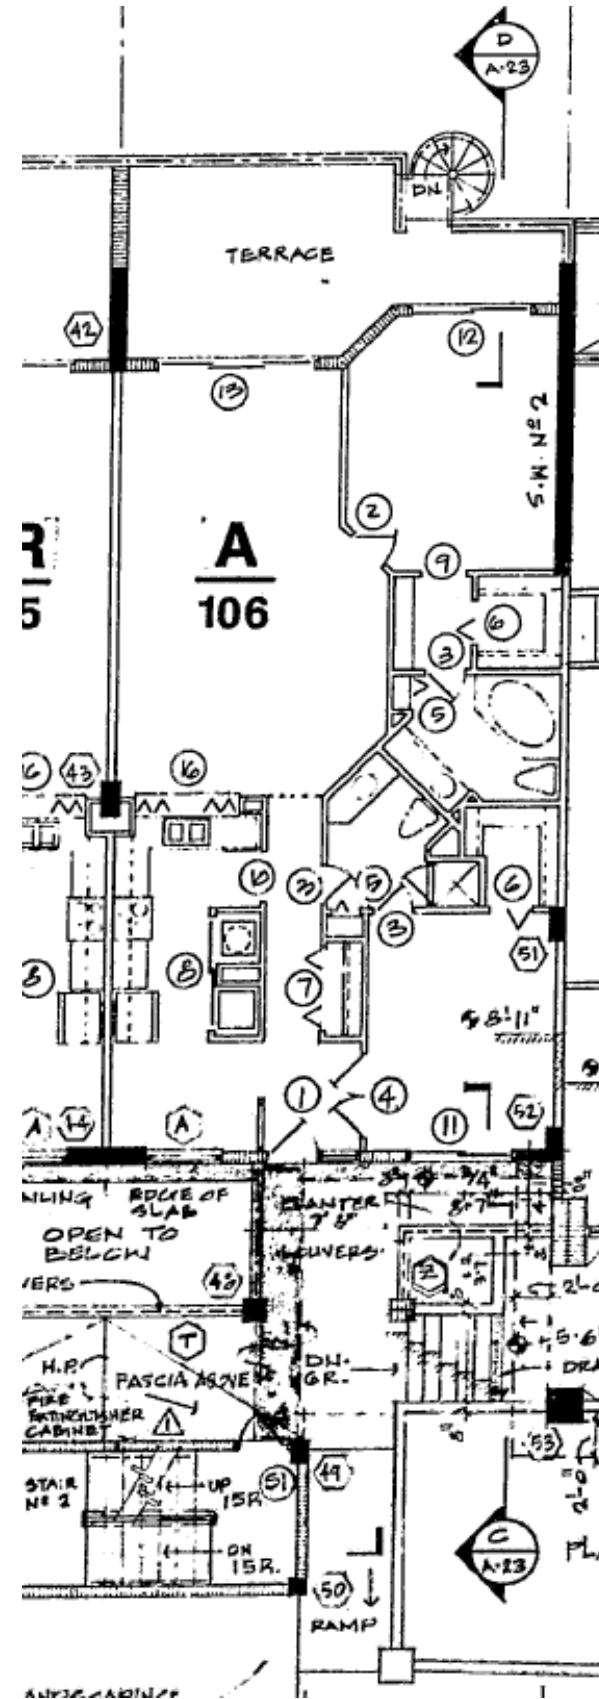
**UNIT 106**

No Structural Distress  
Observed

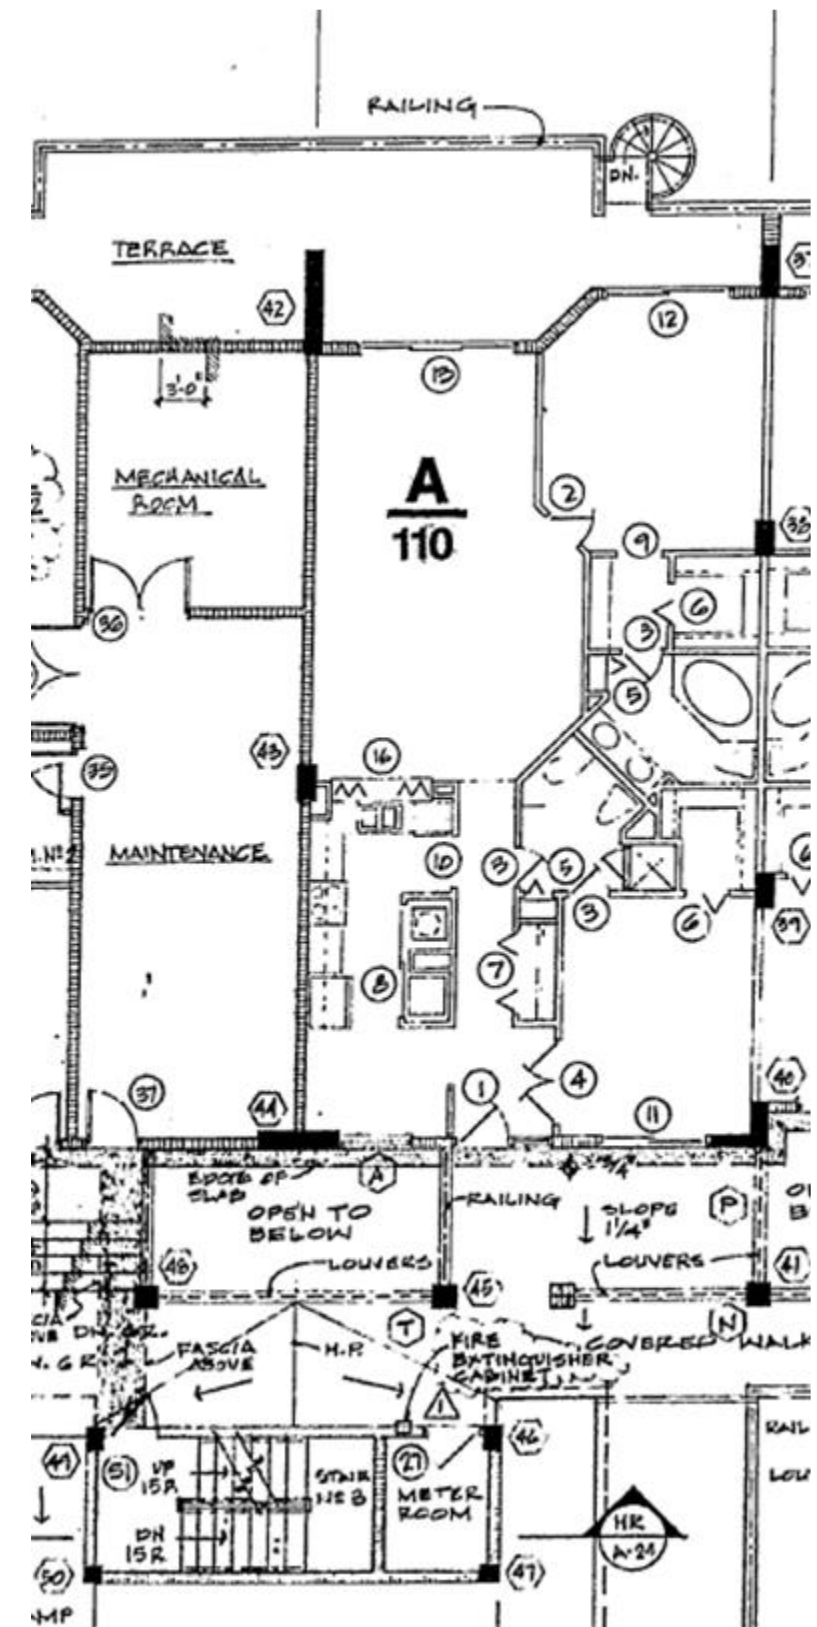
**UNIT 110**

No Structural Distress  
Observed

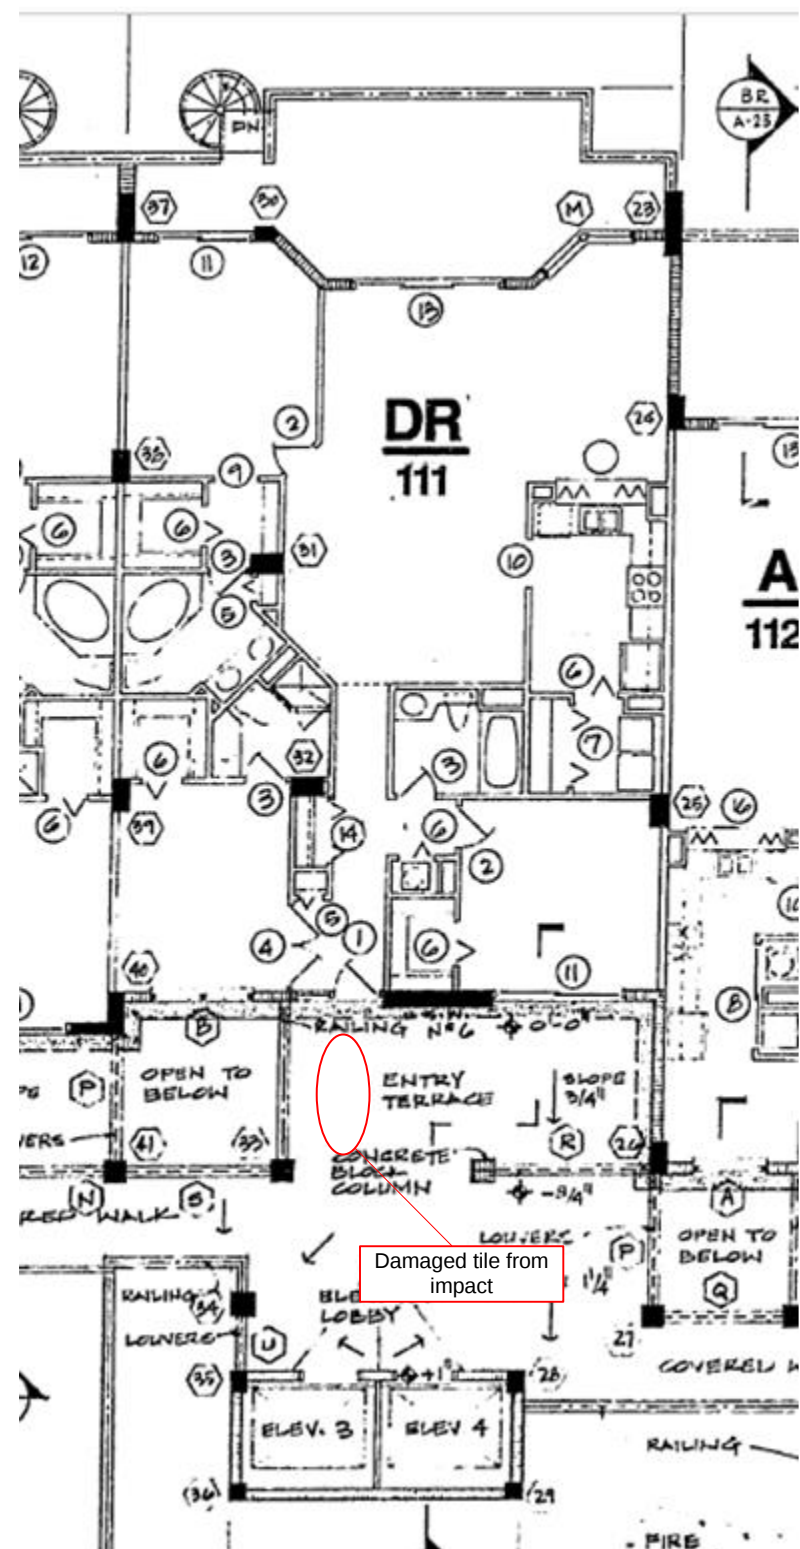
**UNIT 111**

No Structural Distress  
Observed

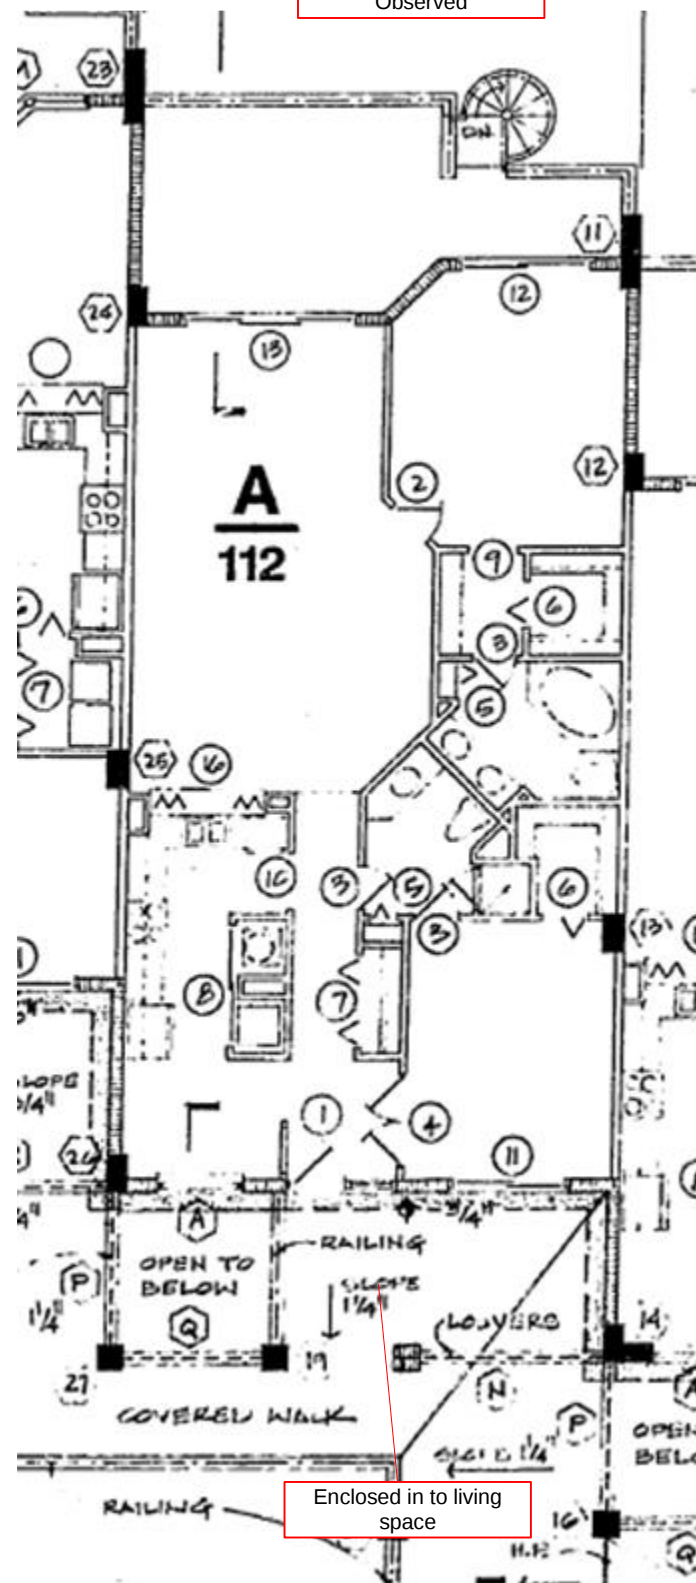
**UNIT 112**

No Structural Distress  
Observed

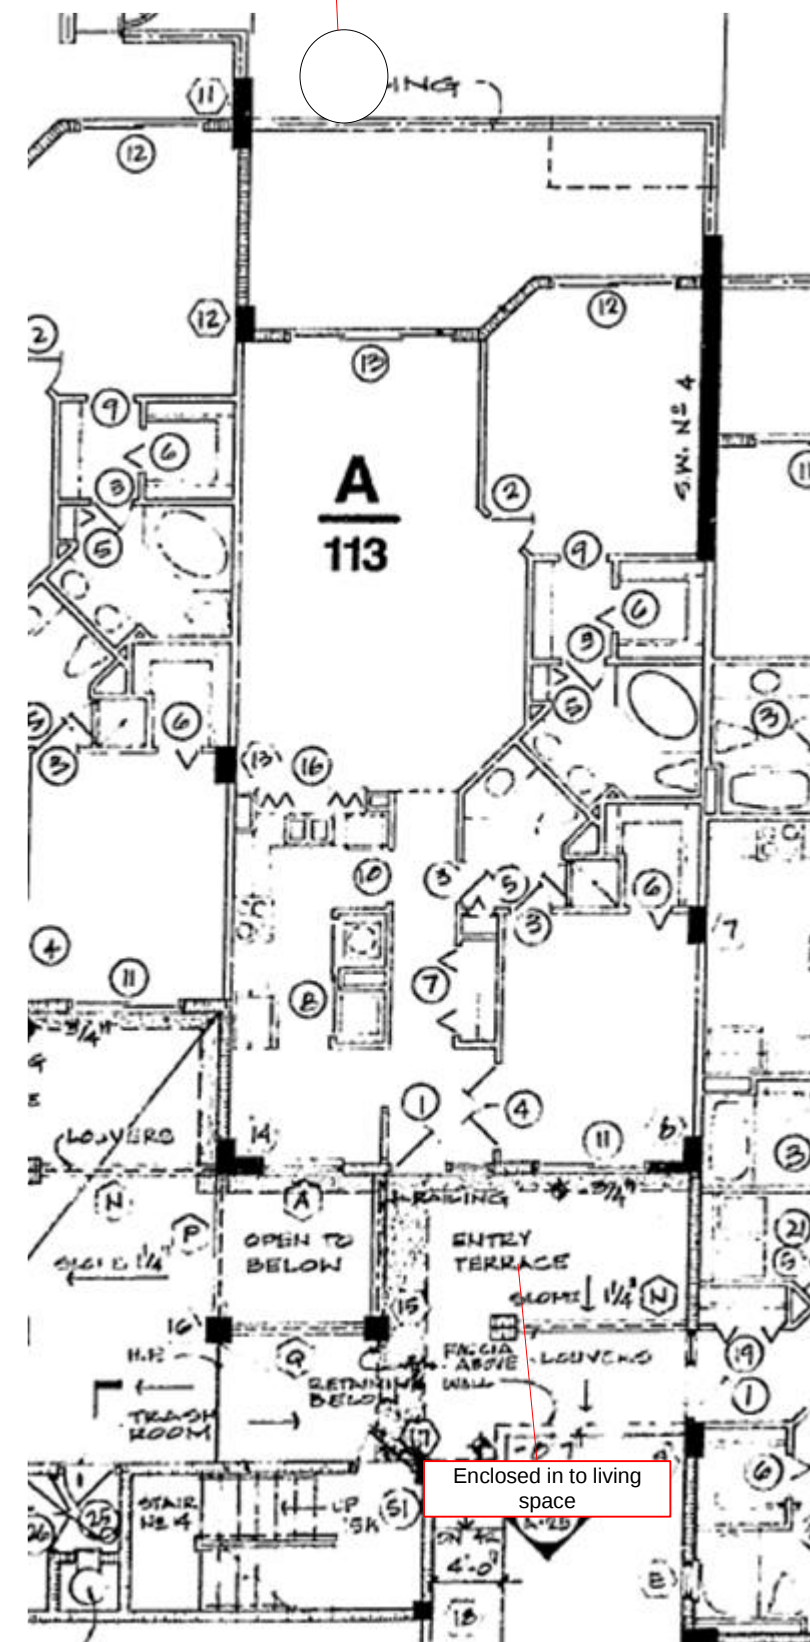
**UNIT 113**

Spiral stairs starting to pull  
away from the building

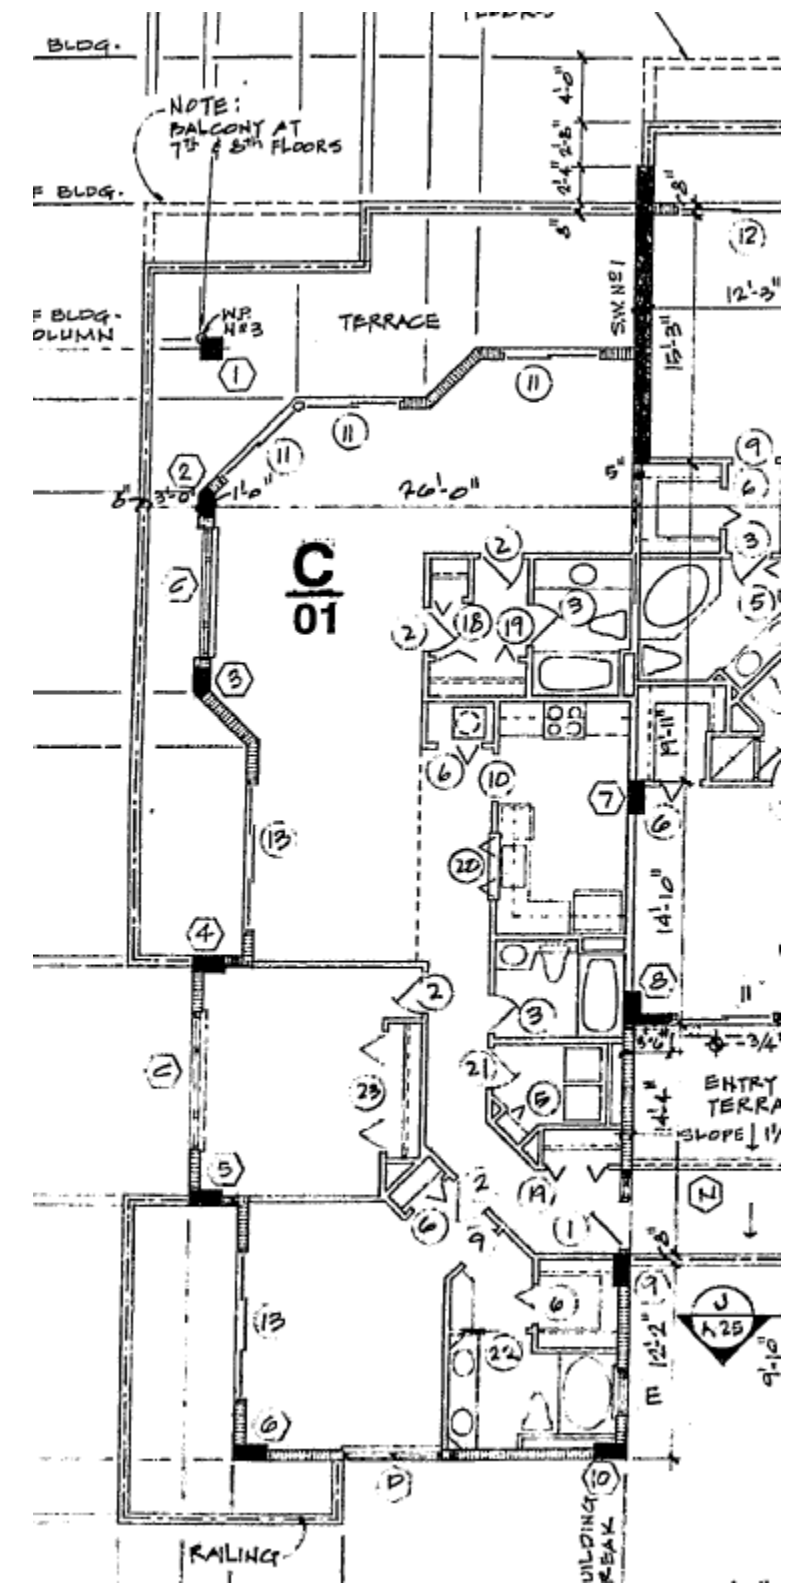
**UNIT 701**

No Structural Distress  
Observed

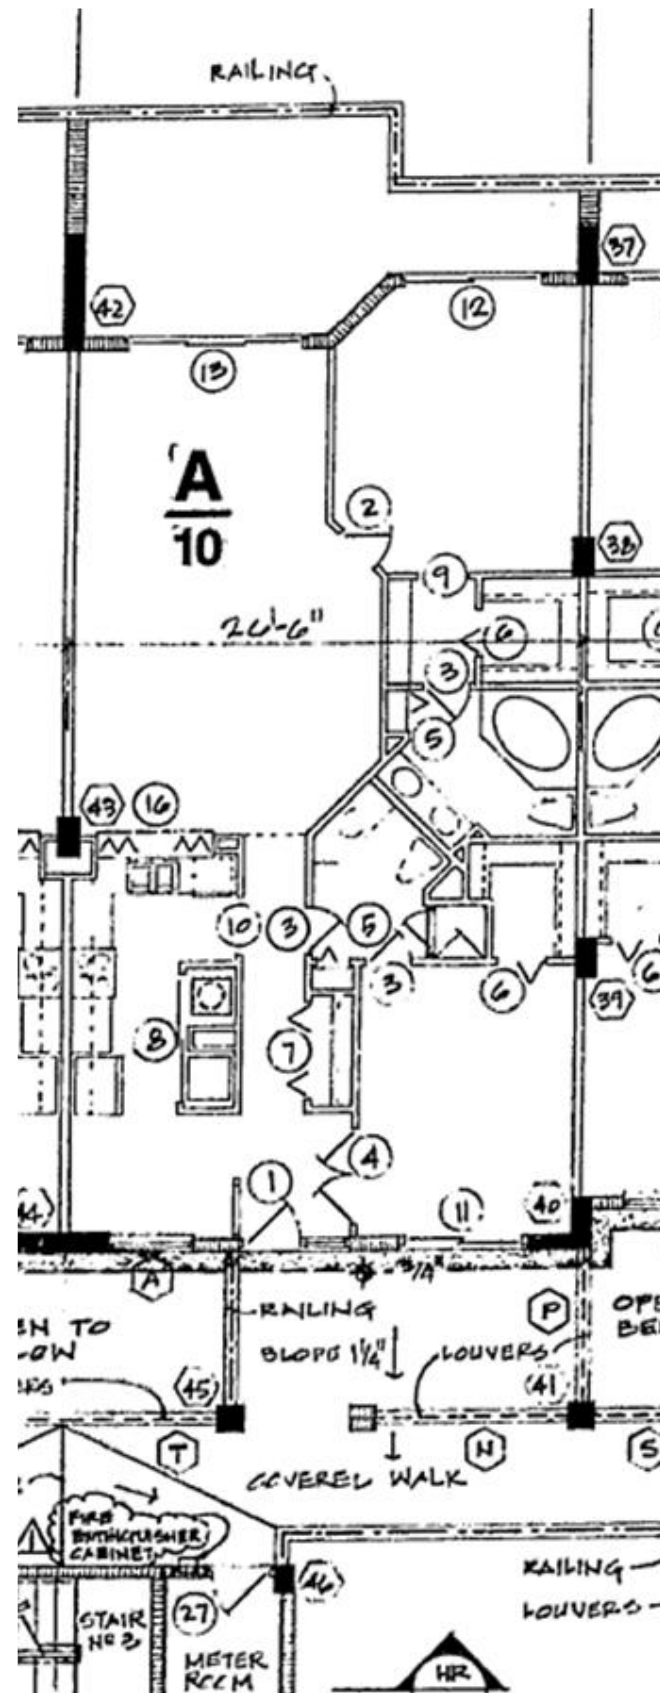
**UNIT 410**

No Structural Distress  
Observed

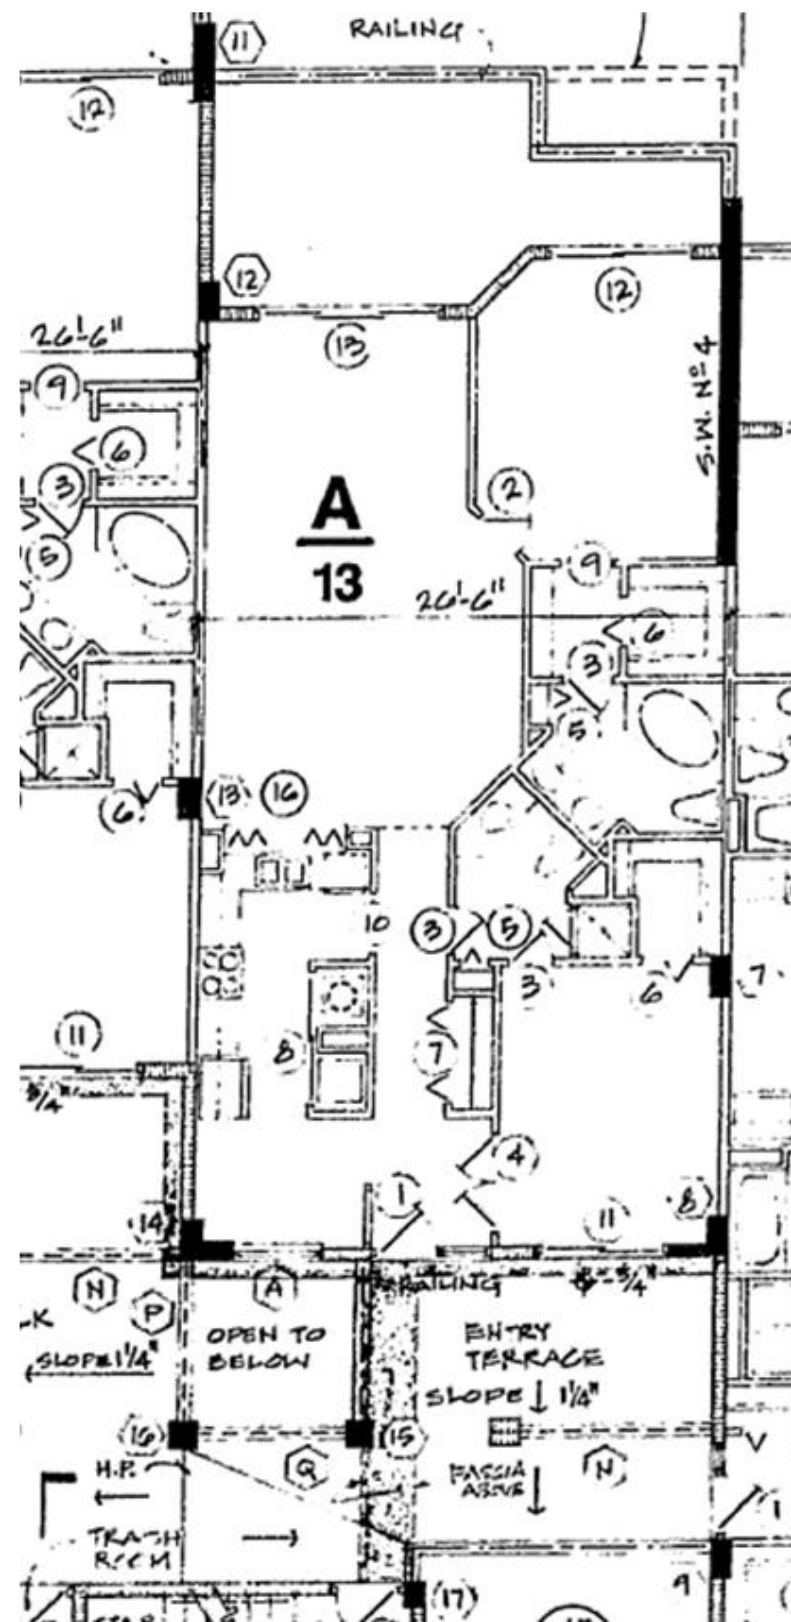
**UNIT 413**

No Structural Distress  
Observed

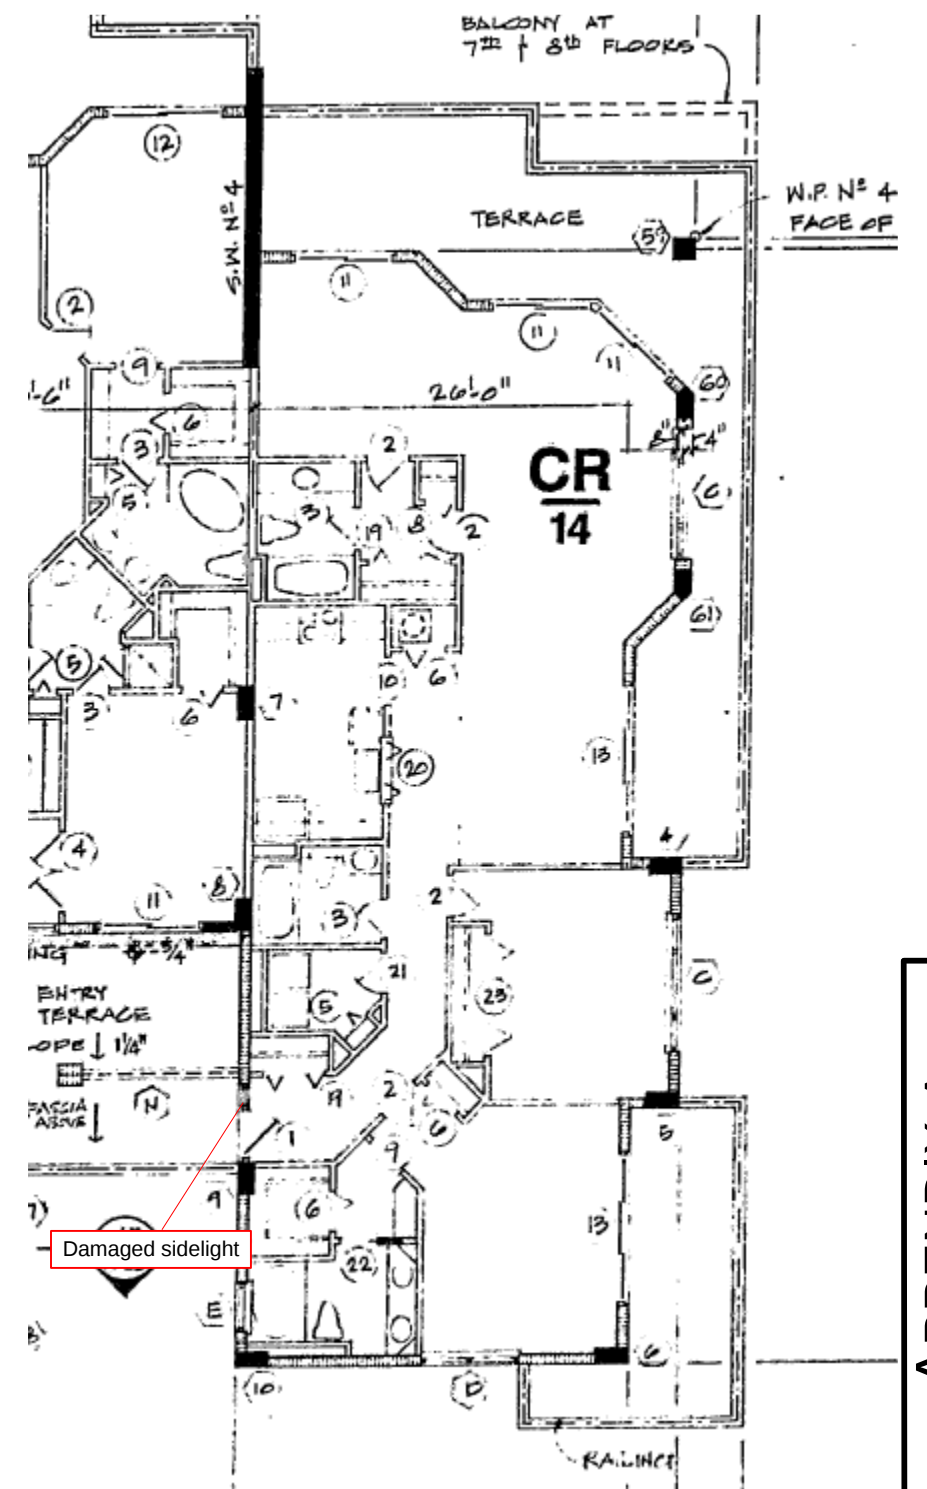
**UNIT 414**

No Structural Distress  
Observed

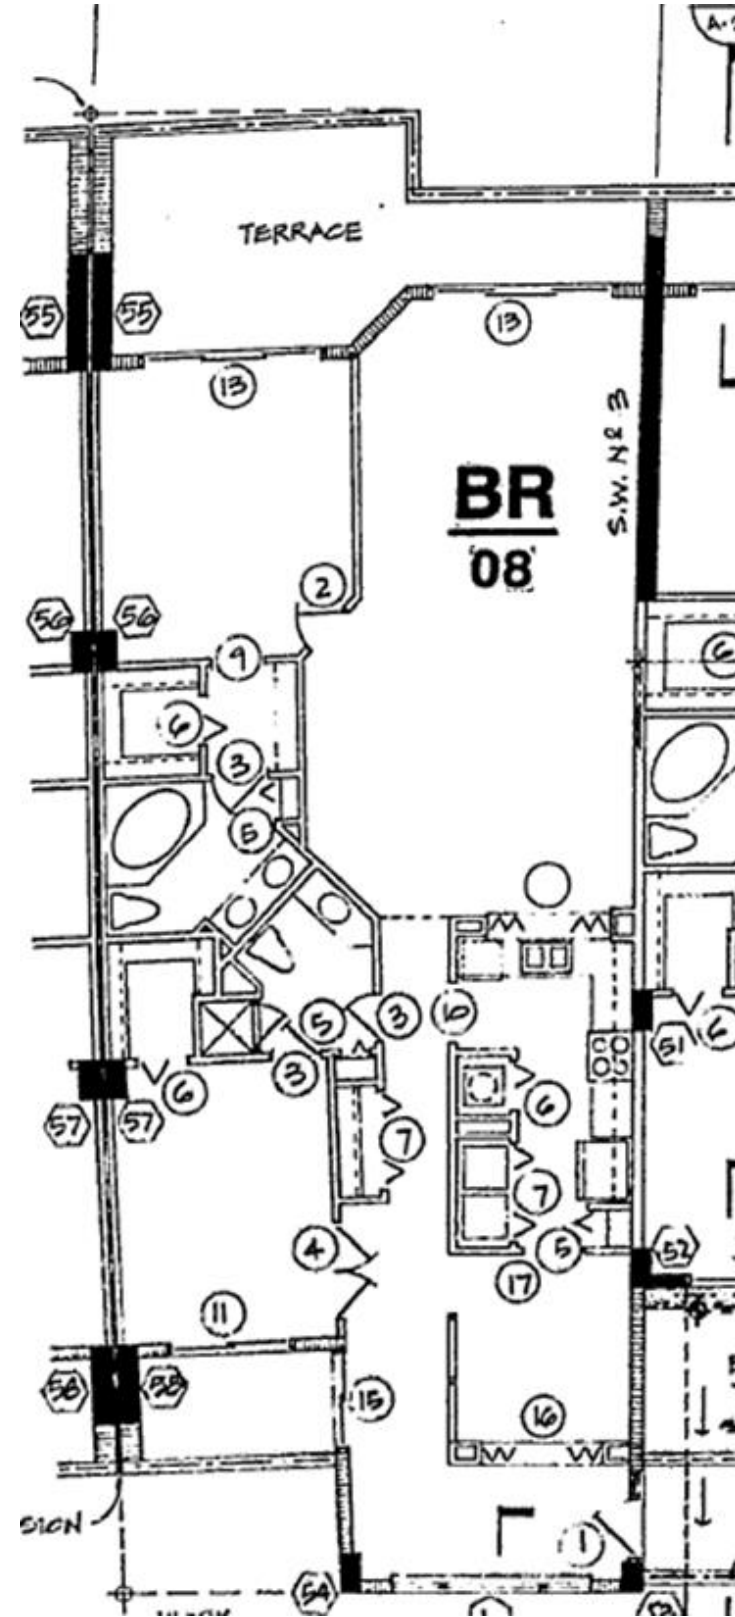
**UNIT 308**

No Structural Distress  
Observed

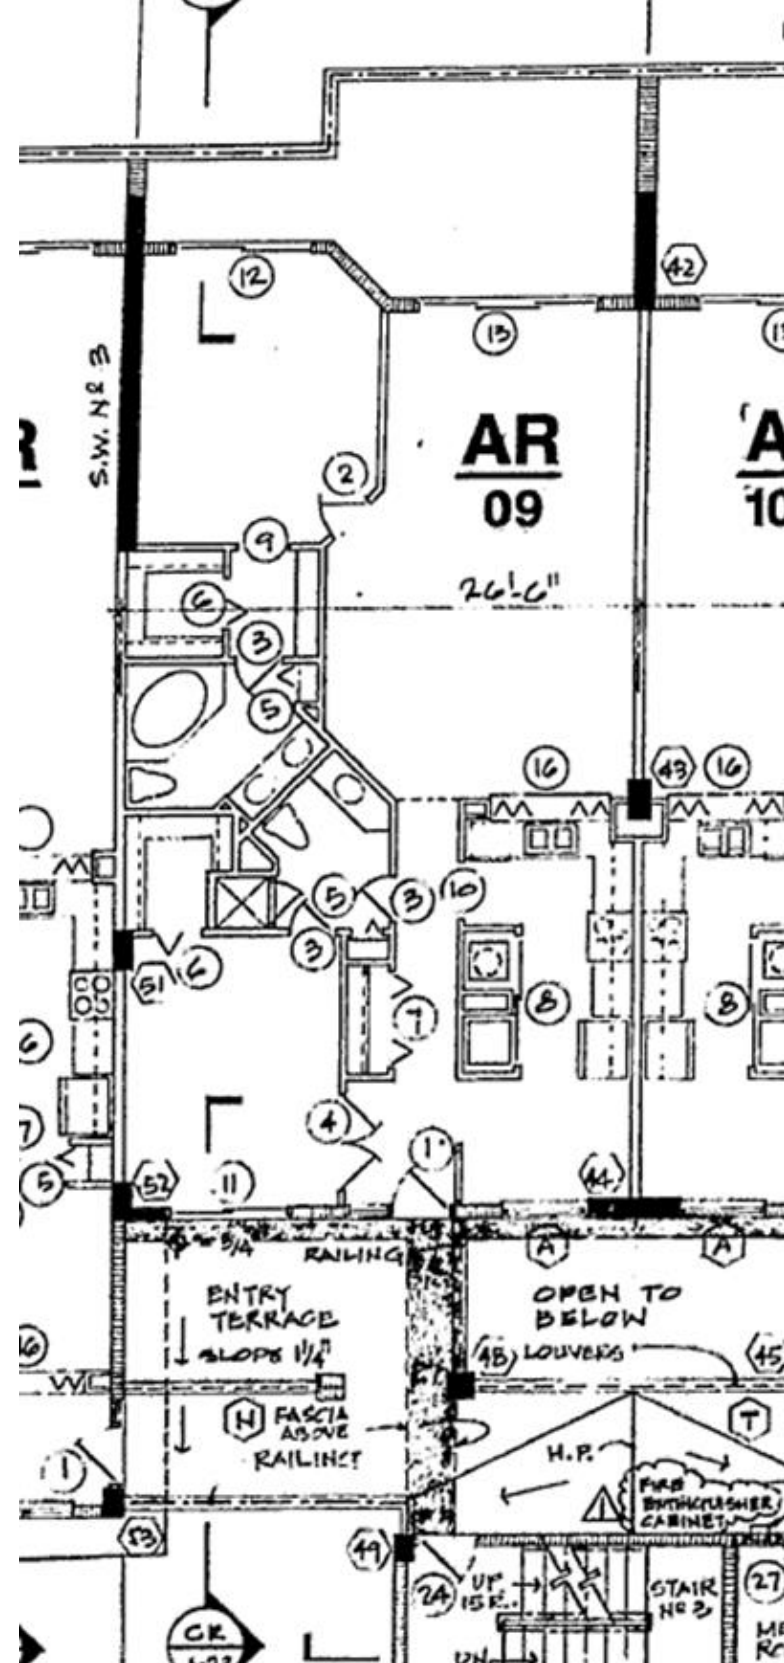
**UNIT 209**

No Structural Distress  
Observed

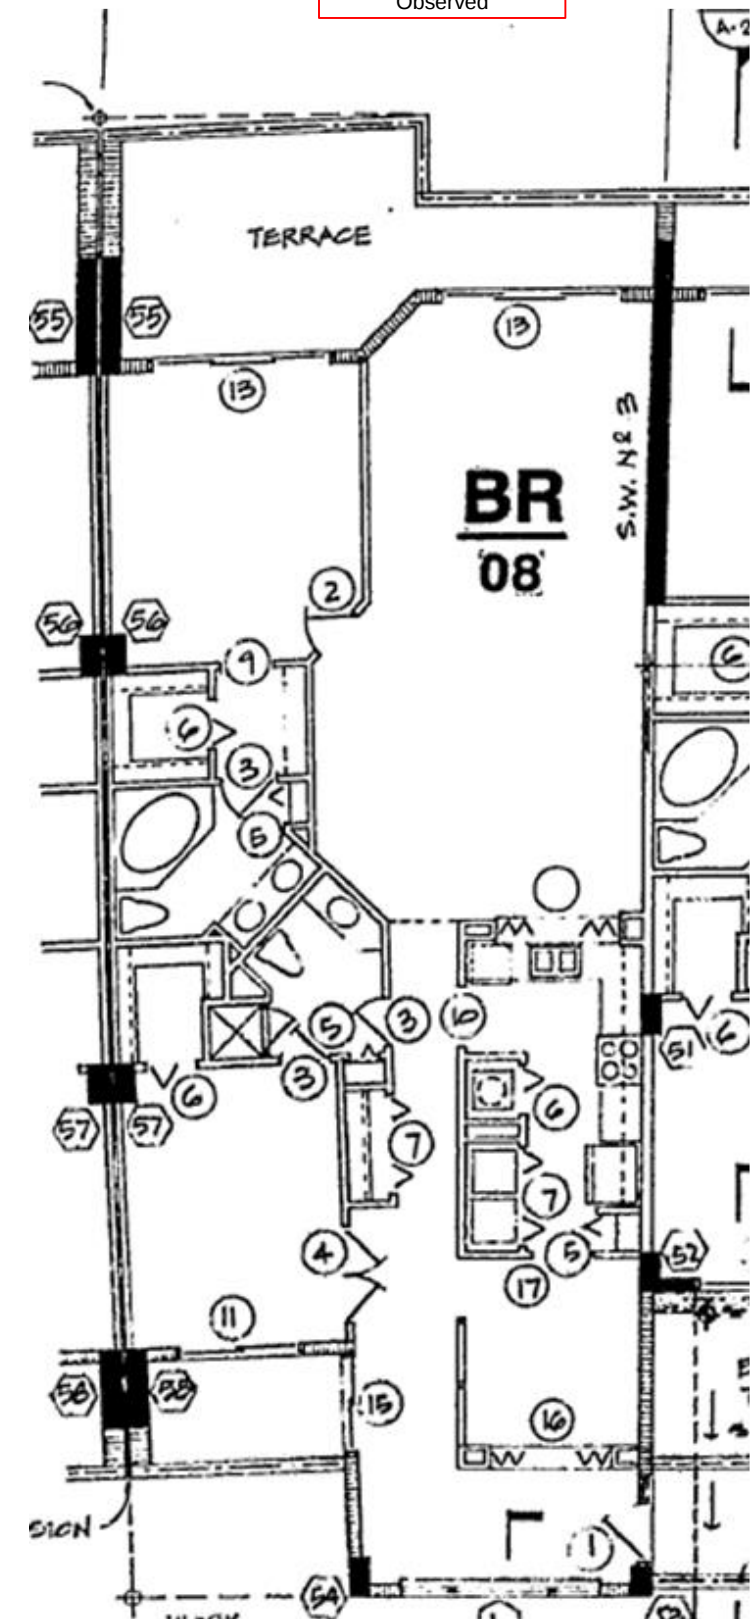
**UNIT 808**

No Structural Distress  
Observed

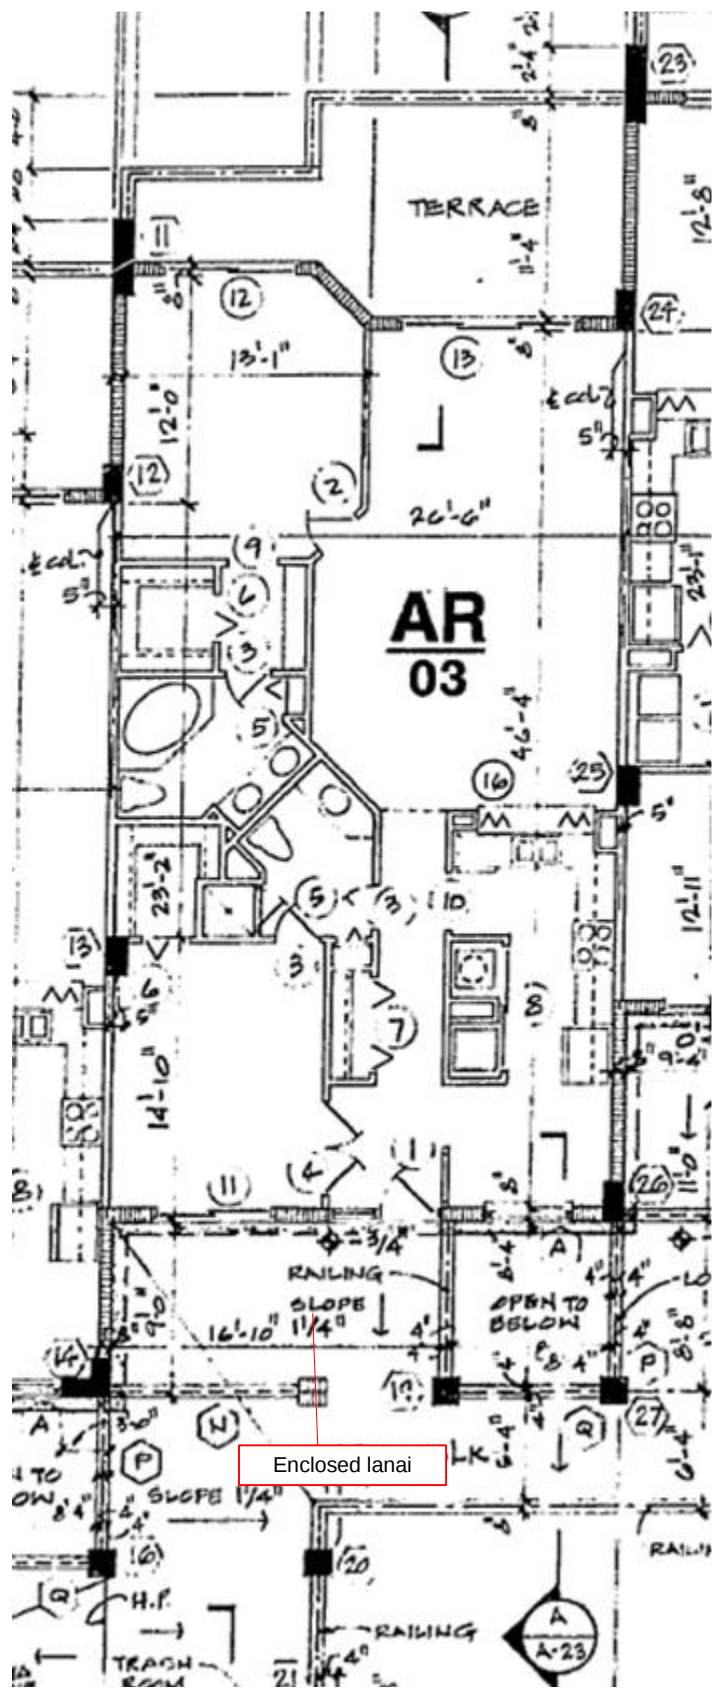
**UNIT 203**

No Structural Distress  
Observed

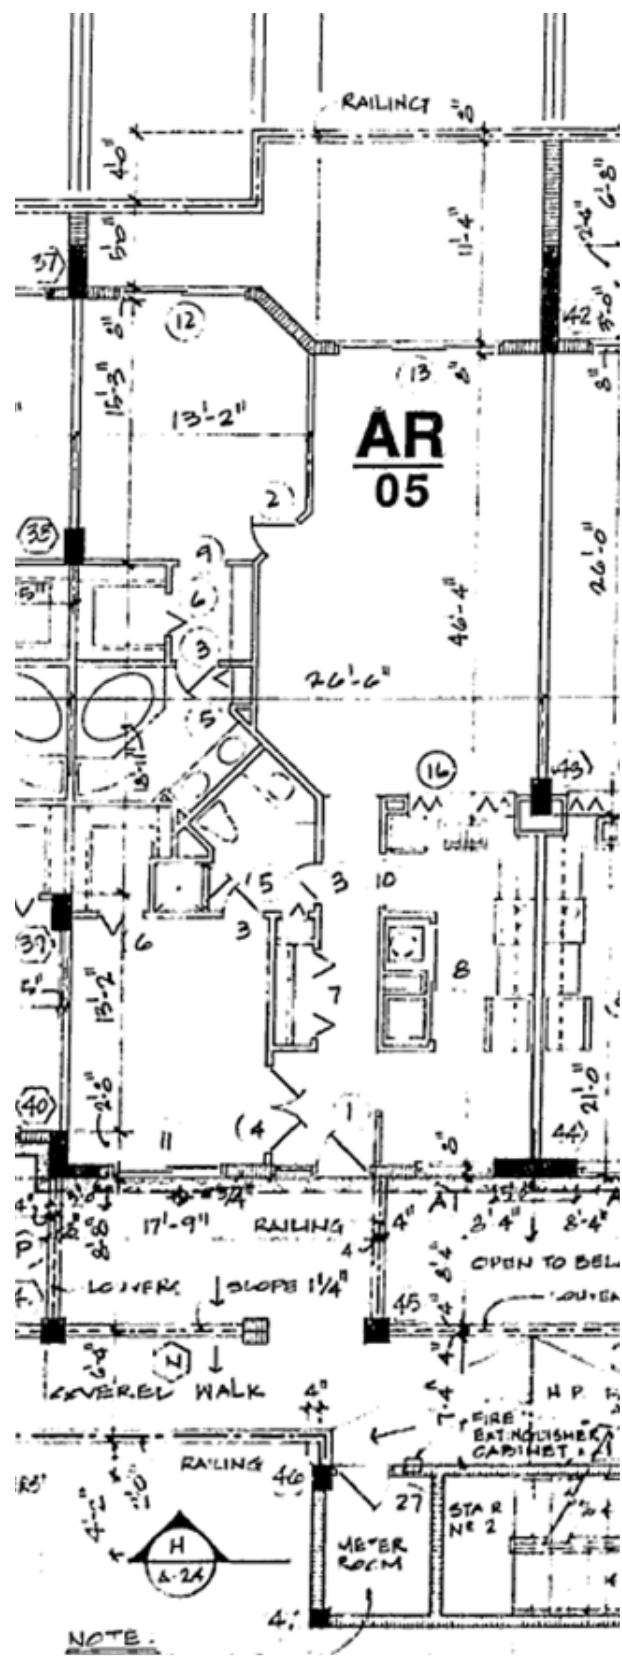
**UNIT 205**

Enclosed lanai
