## **MILESTONE INSPECTION – PHASE I REPORT**

The Somerset of Marco Island  
780 South Collier Boulevard  
Marco Island, Florida 34145

SOCOTEC Project Number 6178-002.01

December 2024

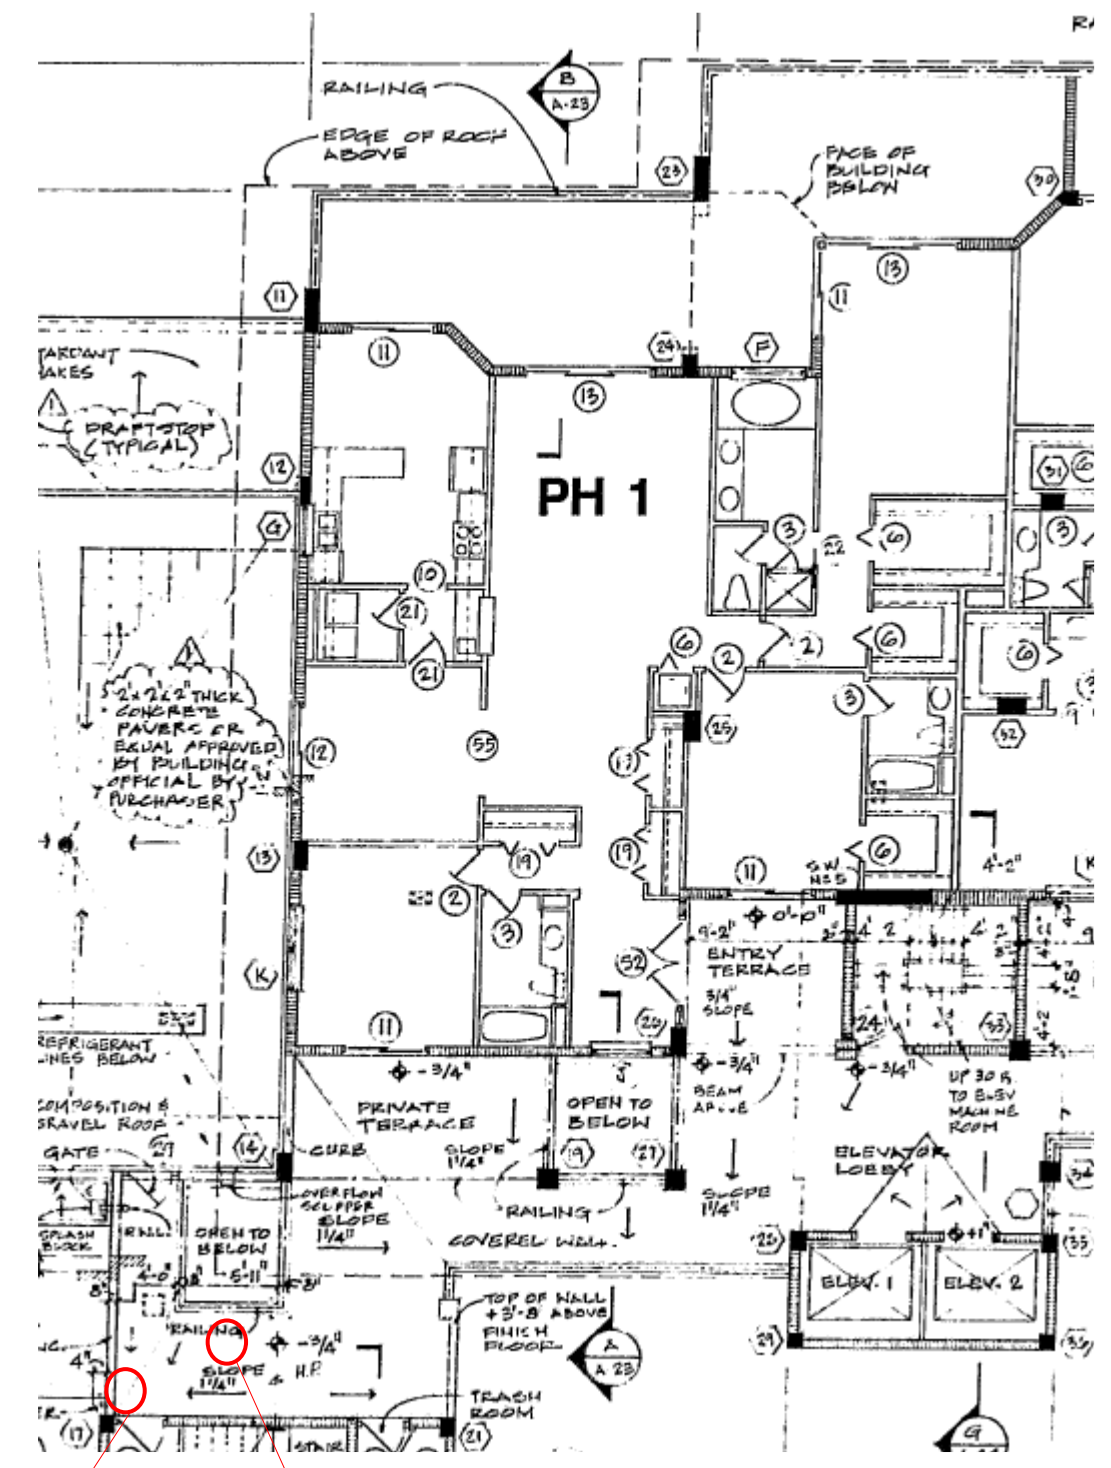
**BREEZEWAY IN FRONT  
OF PENTHOUSE 1**

Distress to stucco  
and floor sealant

Distressed  
walkway coating

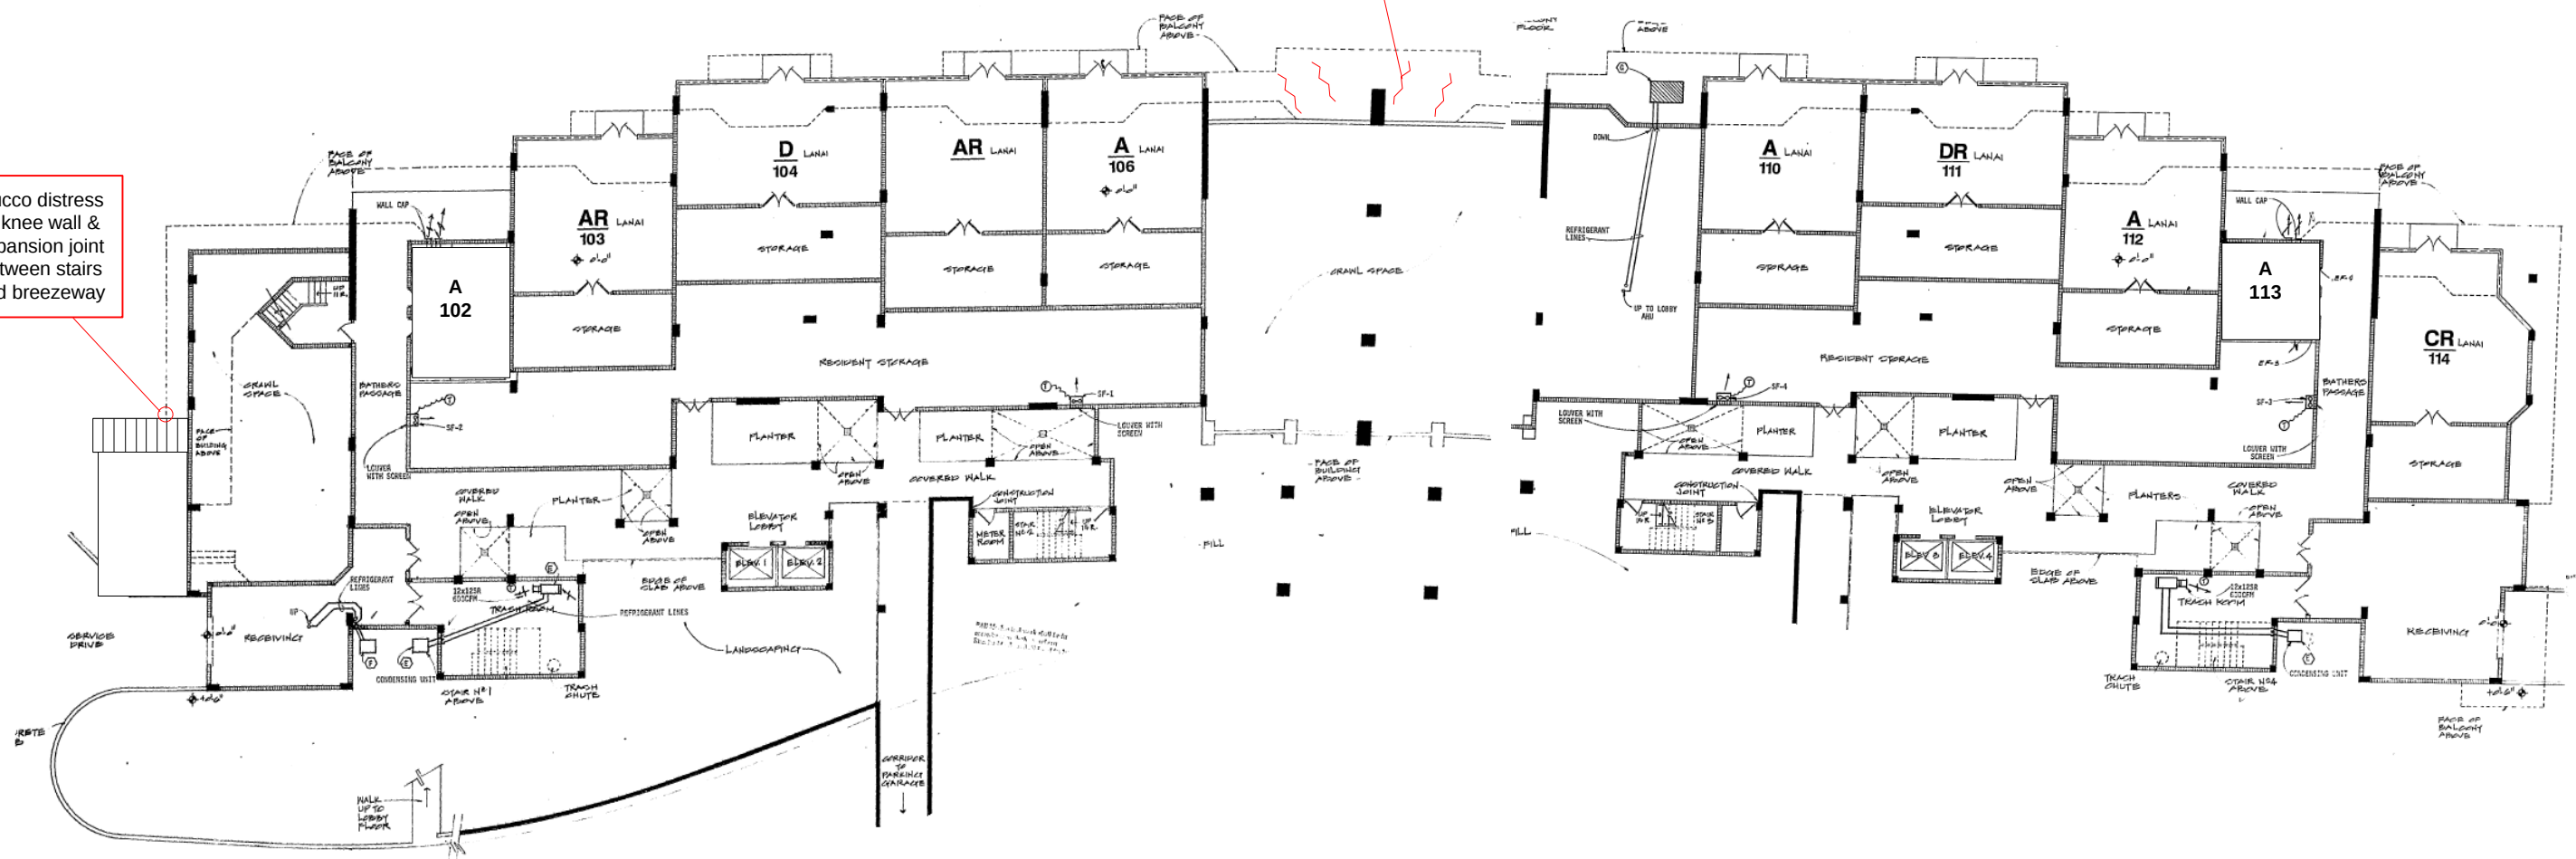
## GROUND FLOOR LAYOUT

stucco distress  
at knee wall &  
expansion joint  
between stairs  
and breezeway

Numerous observed cracks and  
possible settlement along deck off of  
lobby level. Further investigation be  
need to determine source of problem

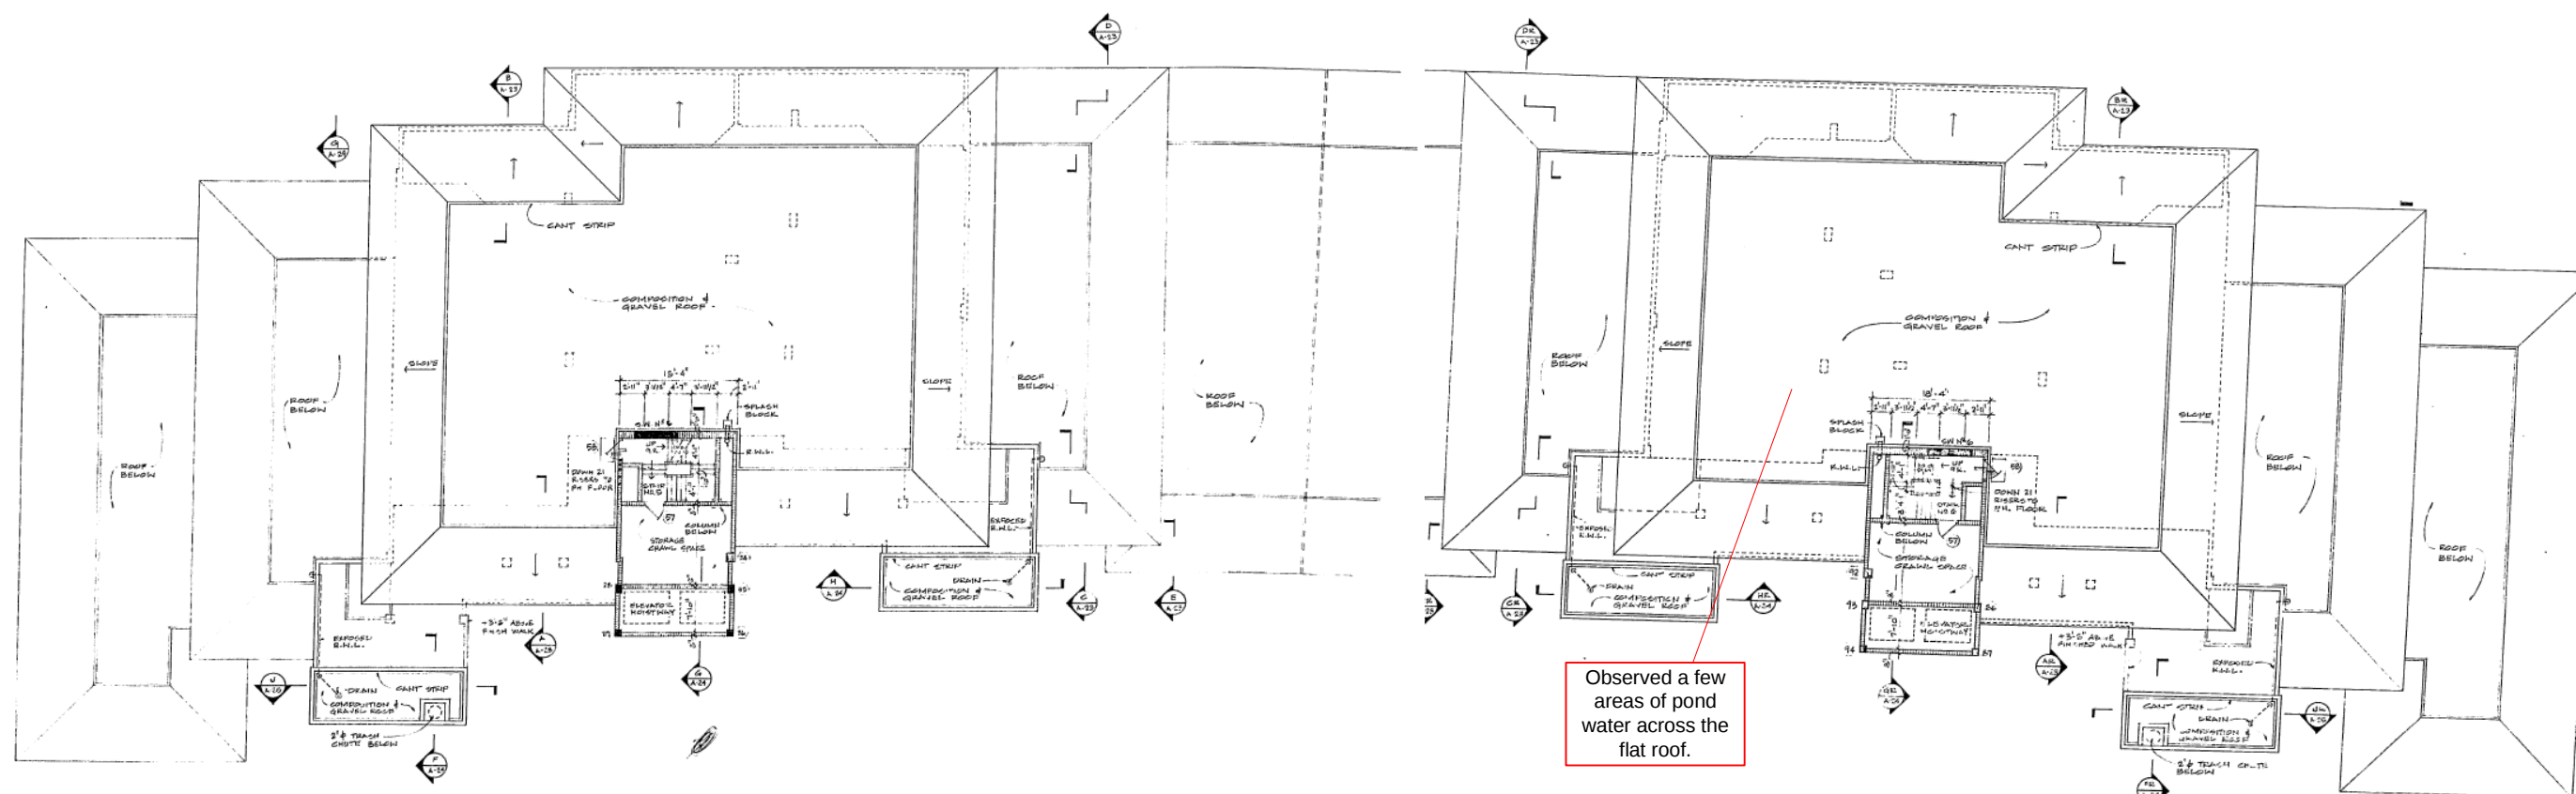
# ROOF LAYOUT

Observed a few areas of pond water across the flat roof.

We observed several sections of roof flashing and roof panels that are experiencing severe corrosion.

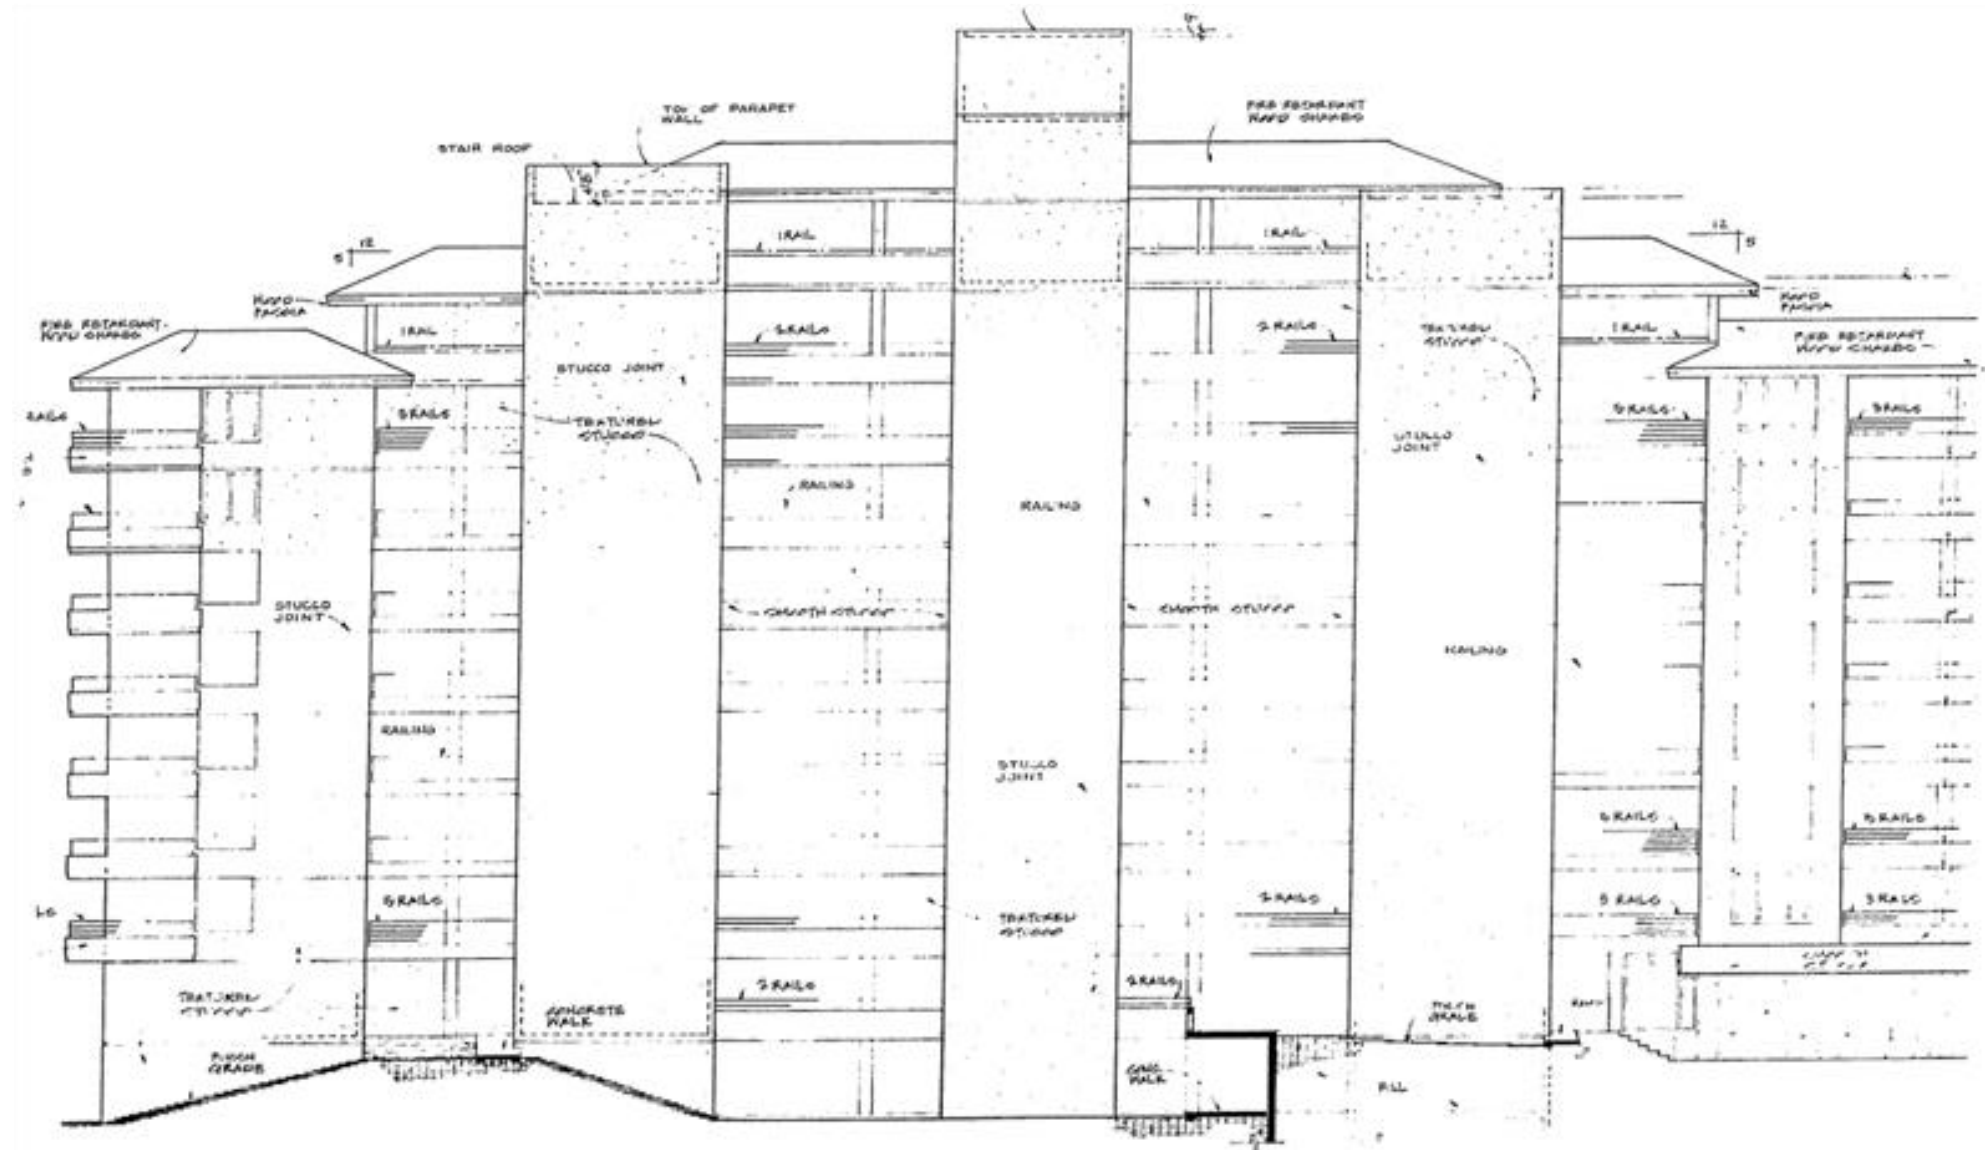
**EAST ELEVATION**  
**SOUTH TOWER**

Distressed flooring system through entryway walkway

- Replace waterproofing across common area entry walkways.

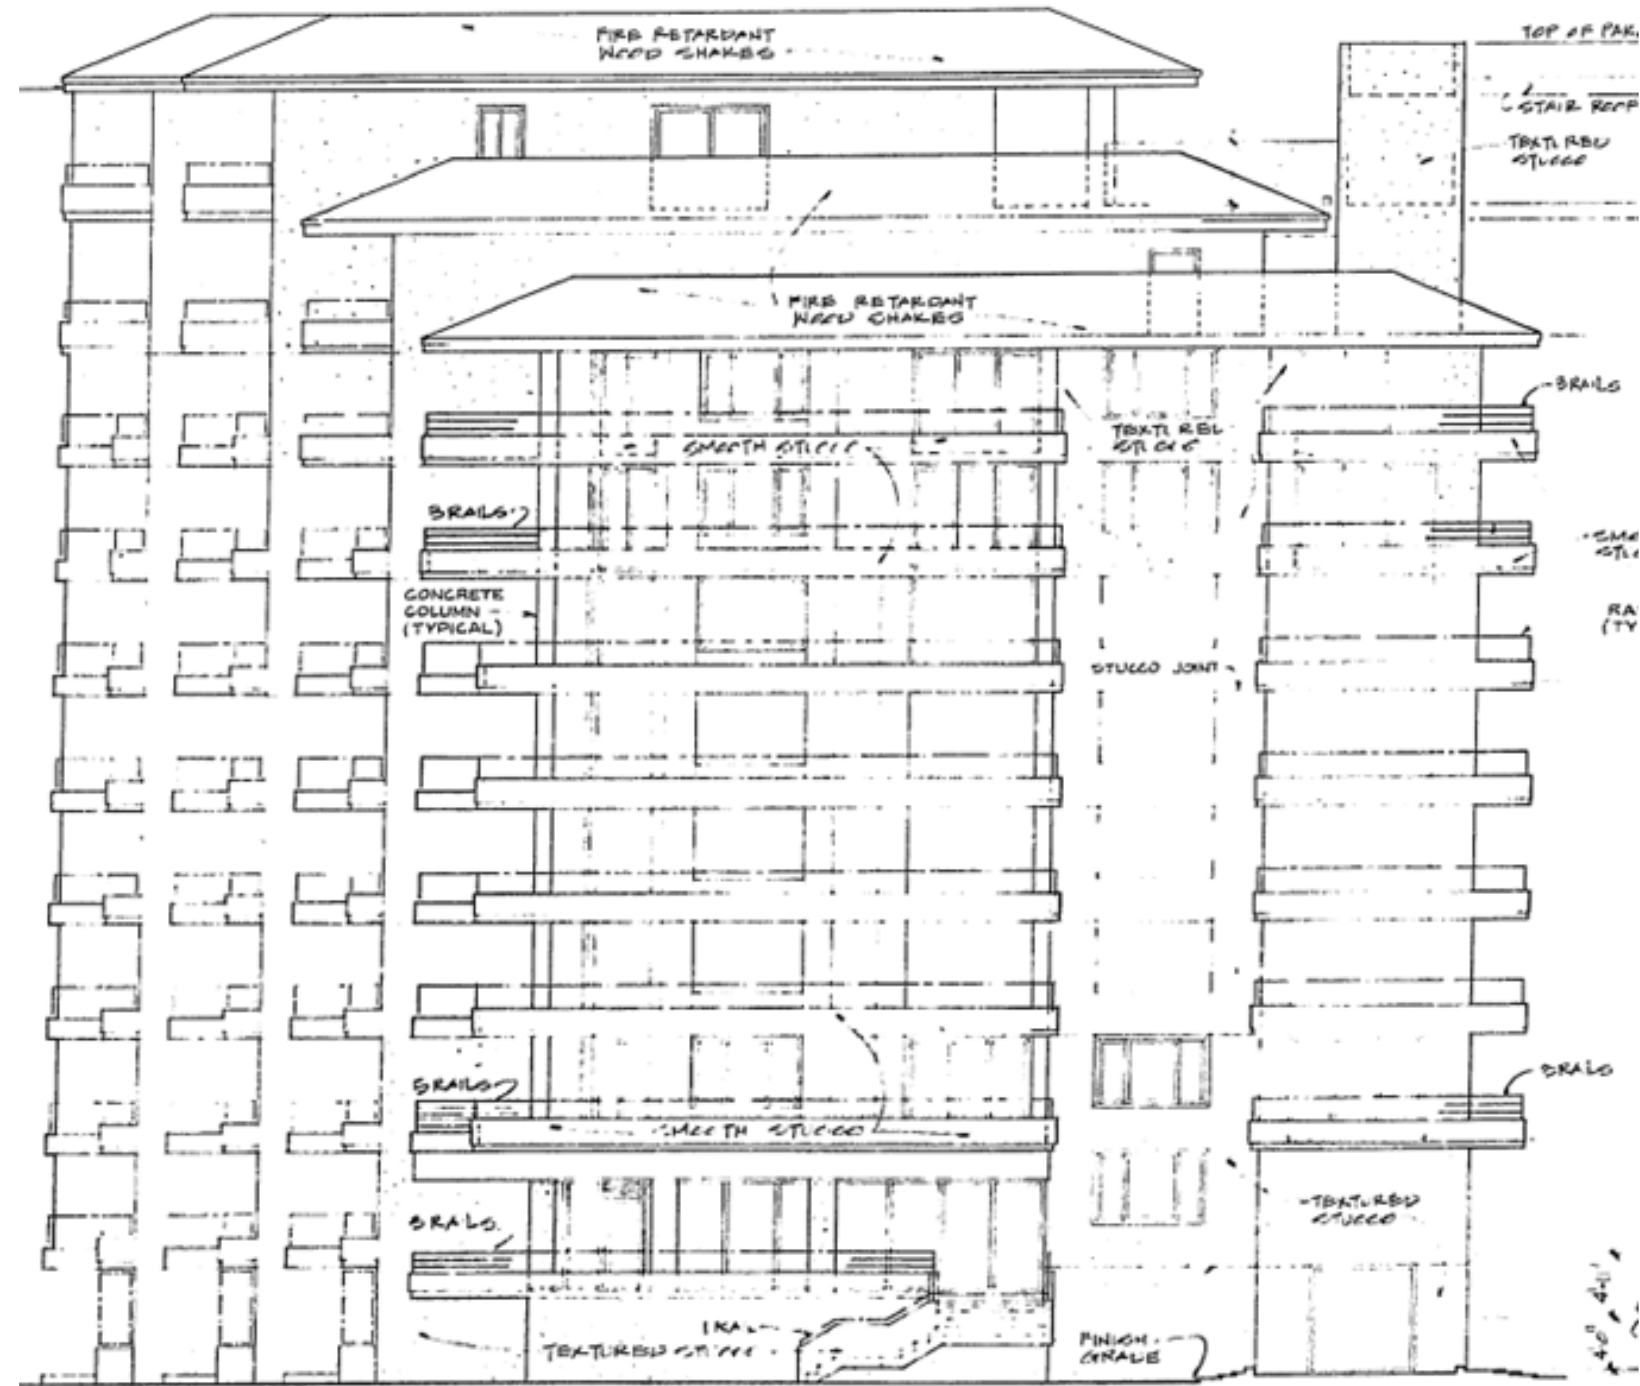
**SOUTH ELEVATION**

No Structural Distress  
to note

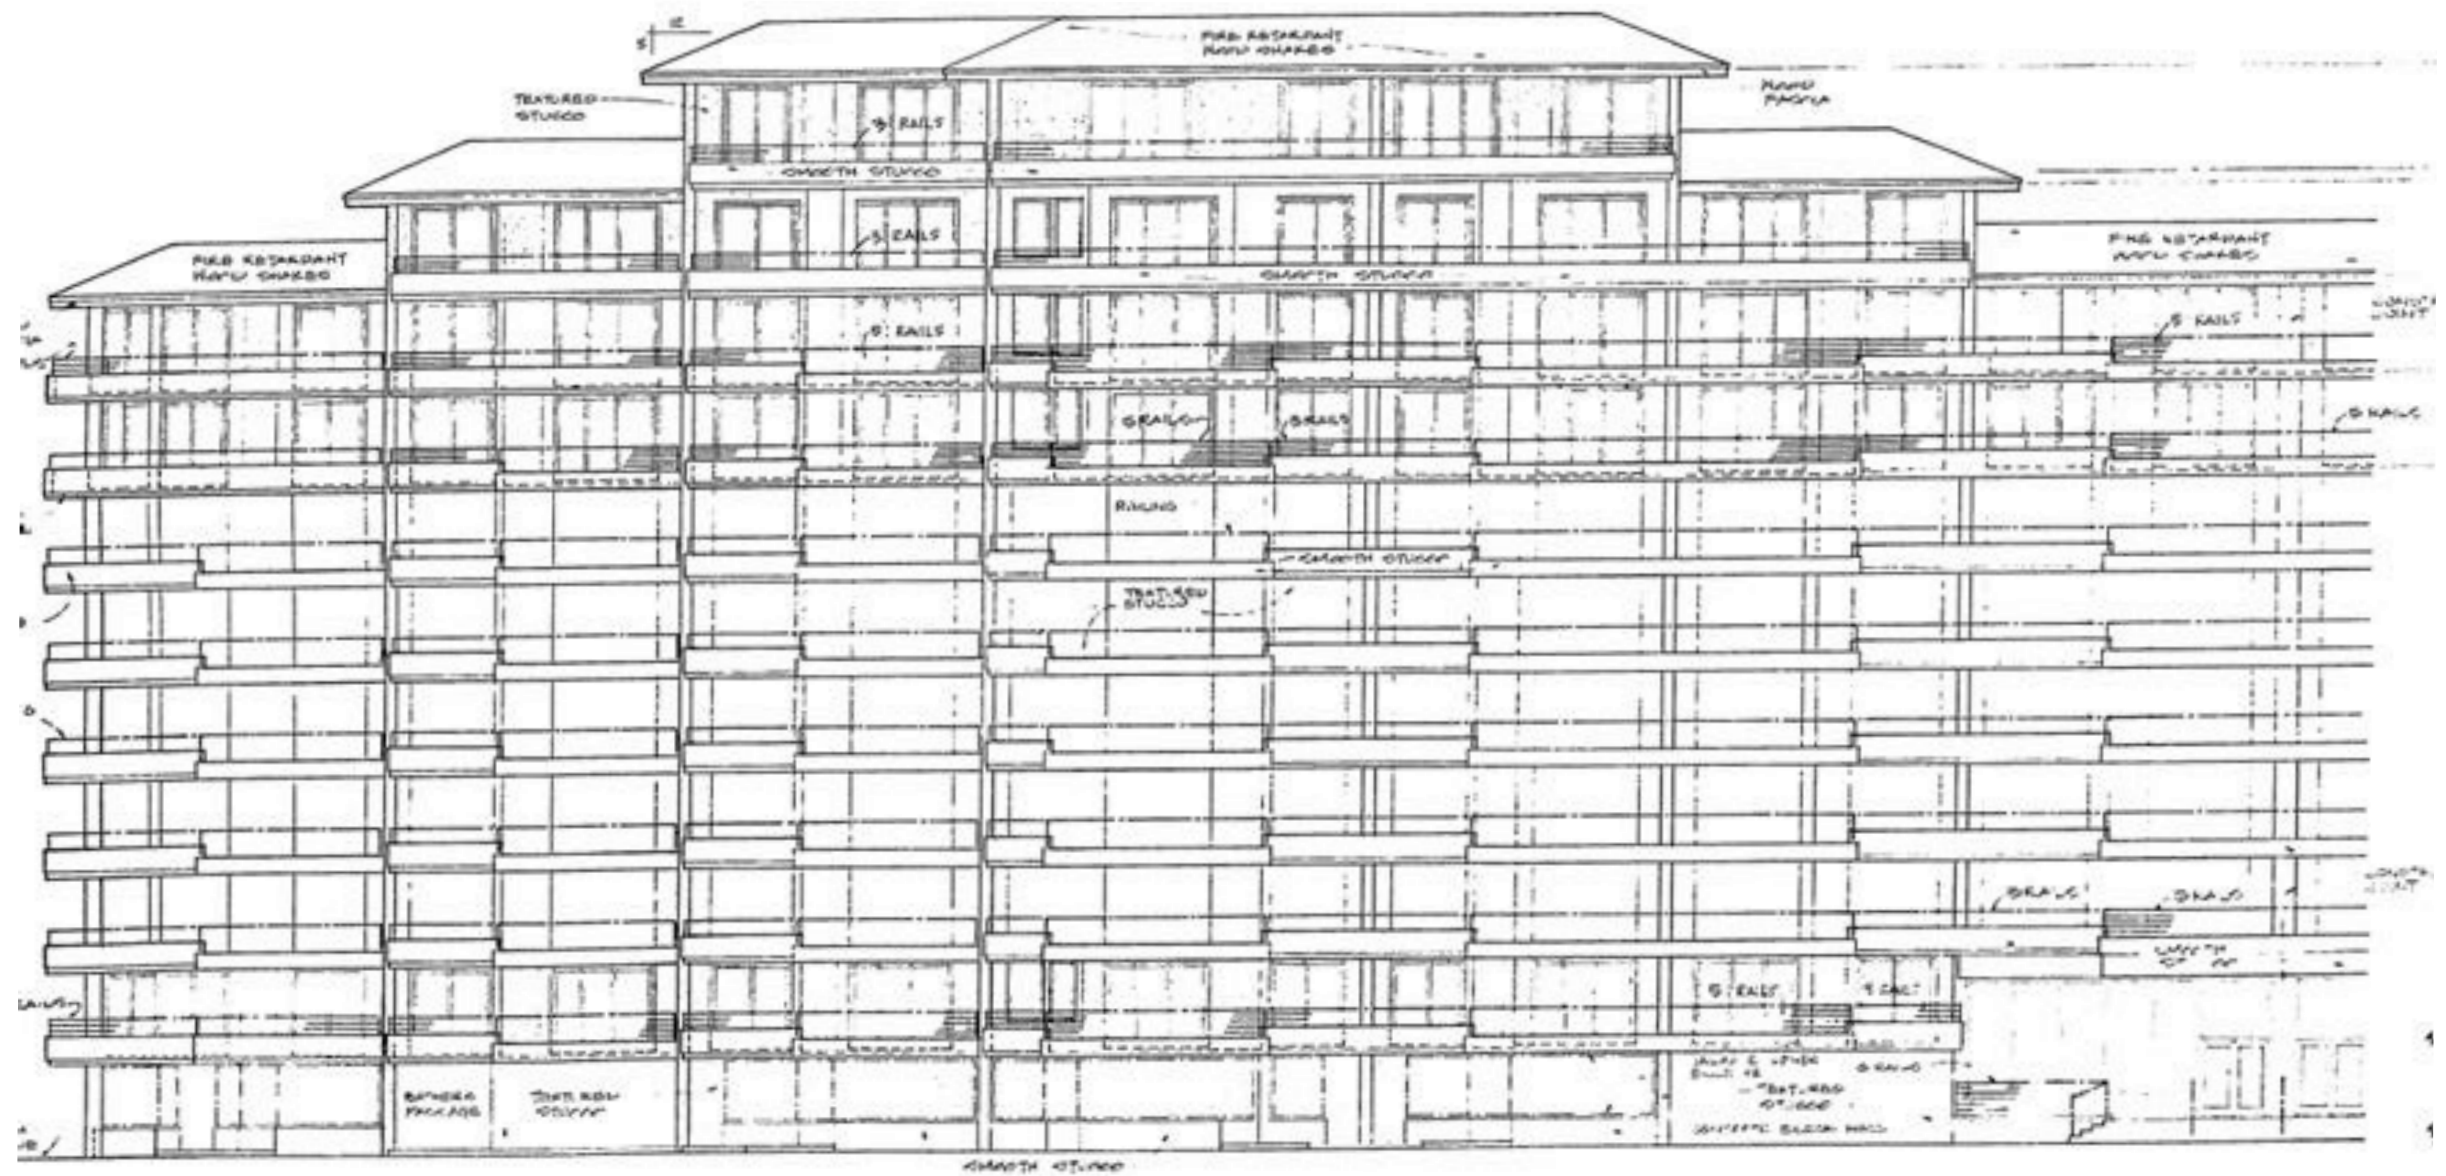
**WEST ELEVATION**  
**NORTH TOWER**

No Structural Distress  
to note

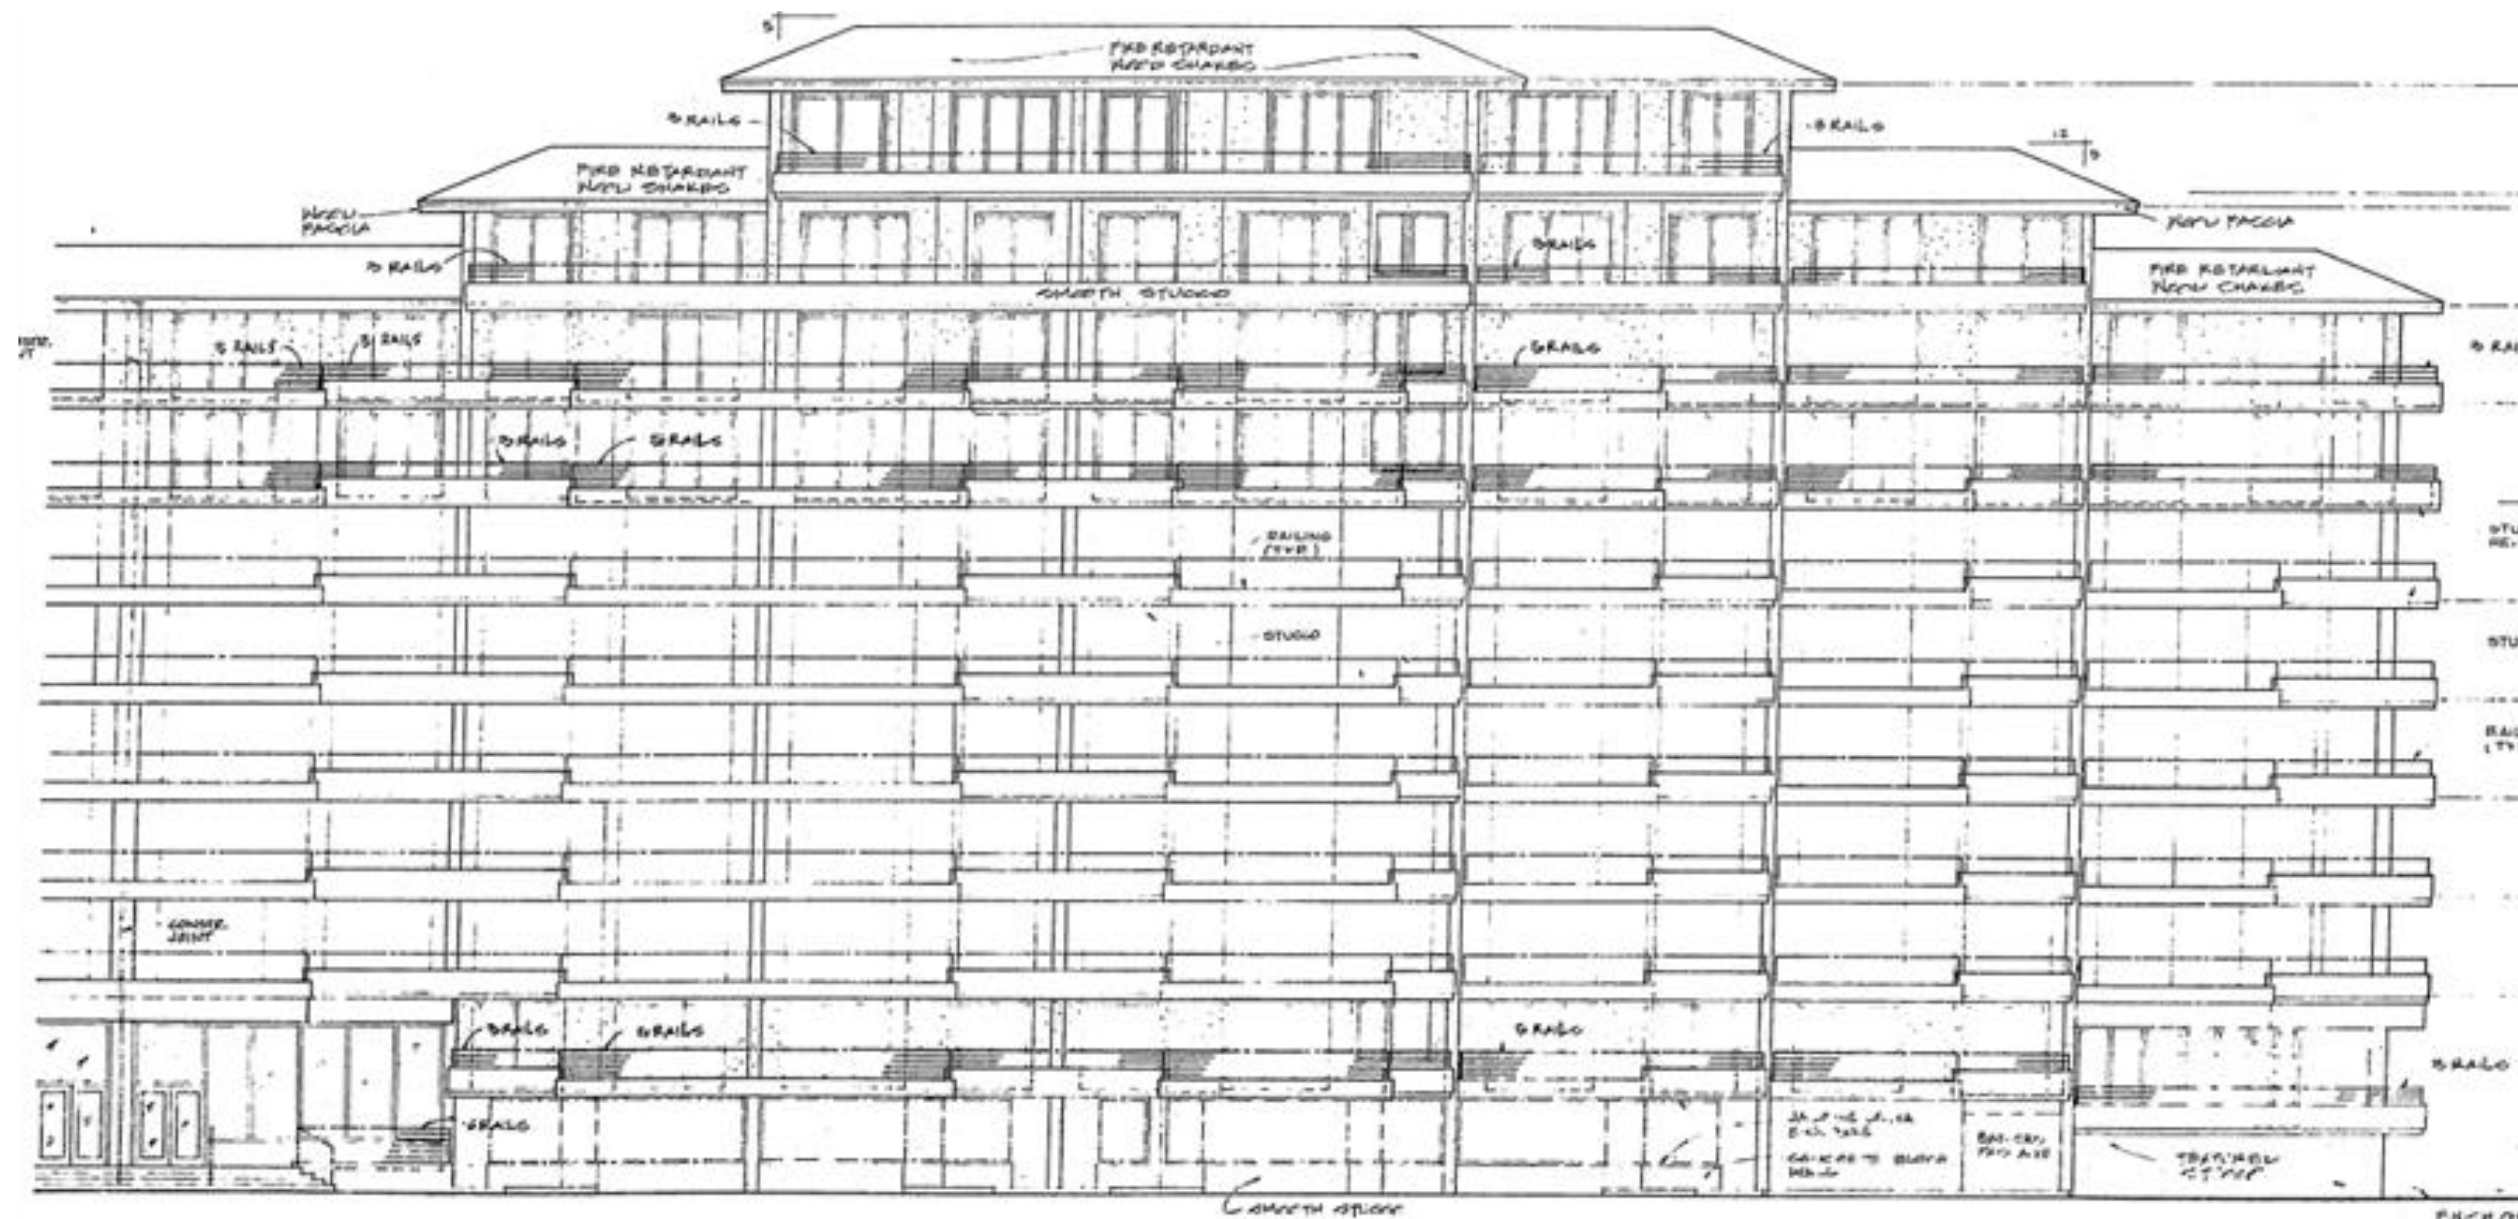
**WEST ELEVATION**  
**SOUTH TOWER**

No Structural Distress  
to note
