# **W.J. JOHNSON & ASSOCIATES**

Subject: **HB-4D Phase One Structural Inspection**  
**South Seas East Condominium Apartments of Marco Island, Inc.**  
**651 Seaview Ct. Building B**  
**Marco Island, FL**  
**Project #: 22069.04**

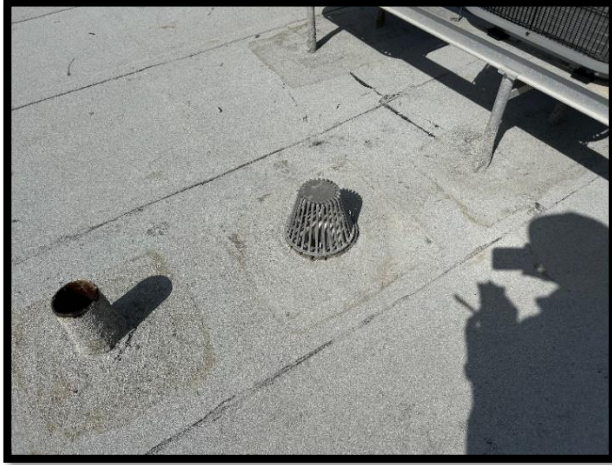
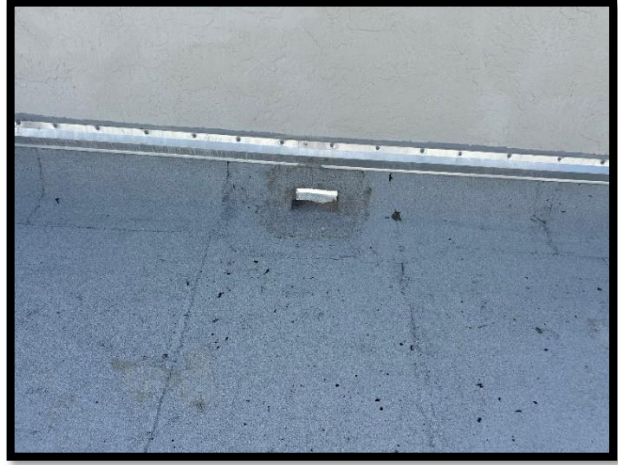
**Roof Drains and Scuppers**

The roof system is a modified bitumen system installed at all areas in 2023 under permit #ROOF-22-07867. This permit is listed as expired. This includes the flat roof and the pitched concrete tile mansard sections. The roof is in good condition. The HVAC condensers are supported by structural aluminum stands in good condition.

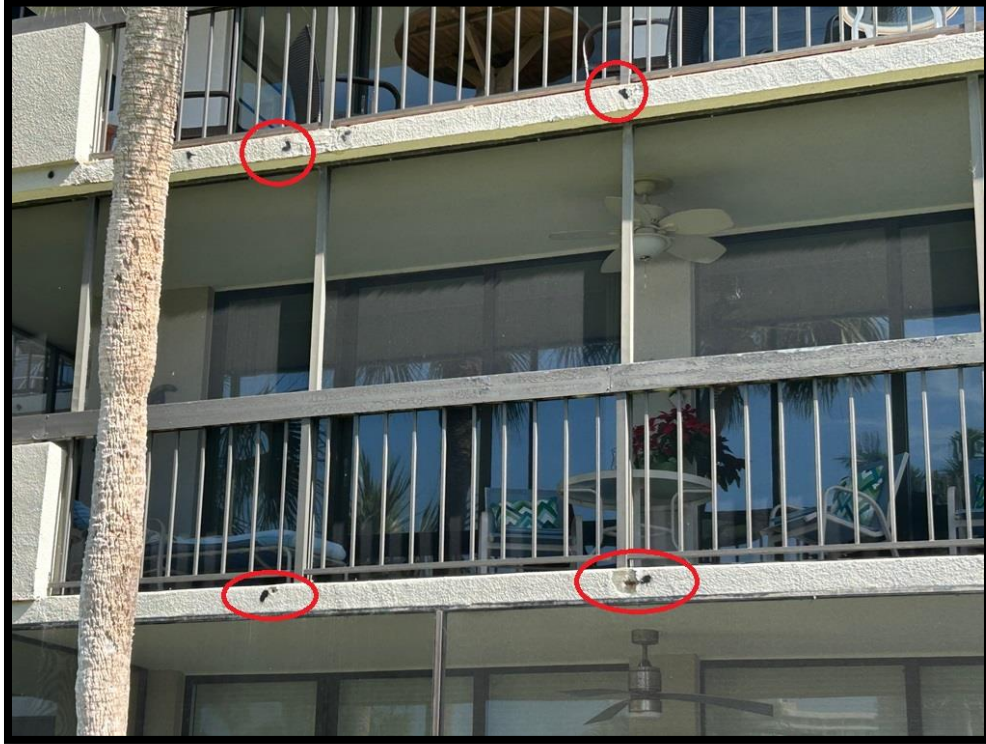
The exterior of the building is constructed using reinforced concrete columns and beams with masonry wall and a stucco finish. The building is currently undergoing concrete and stucco repair and scheduled for painting within the next two years.

**Areas Identified for Repair**

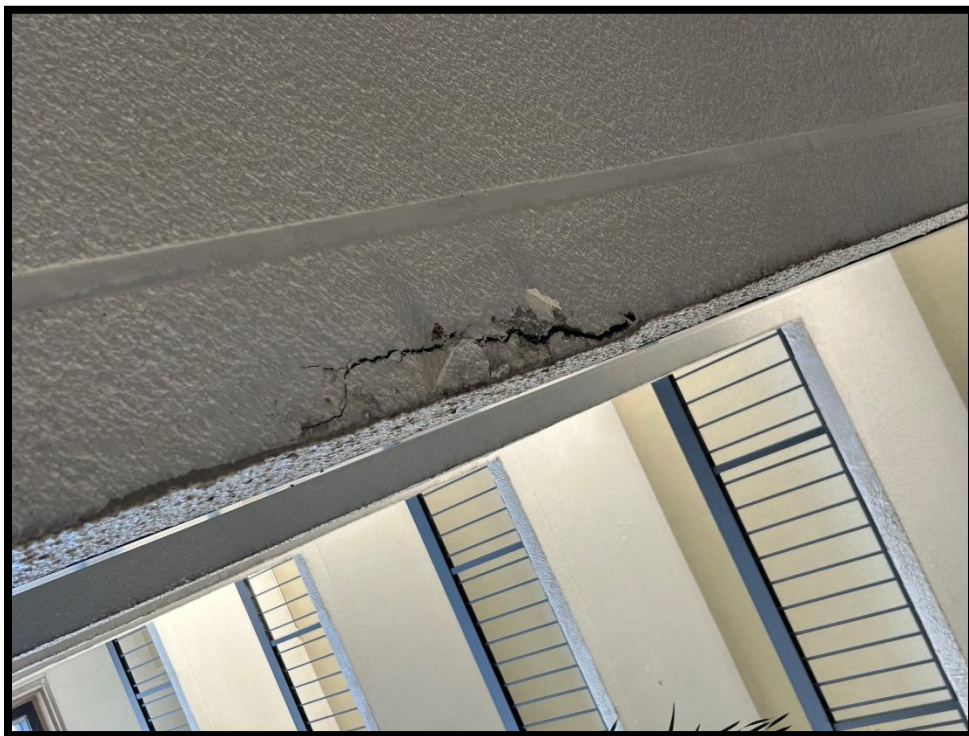
**Interior Courtyard Second Floor West**

**Additional Areas of Concern:**
