# **W.J. JOHNSON & ASSOCIATES**

July 18, 2024

Subject: **Phase One Structural Inspection  
South Seas North Condominium Apartments  
Marco Island, FL  
Project #: 24024.04**

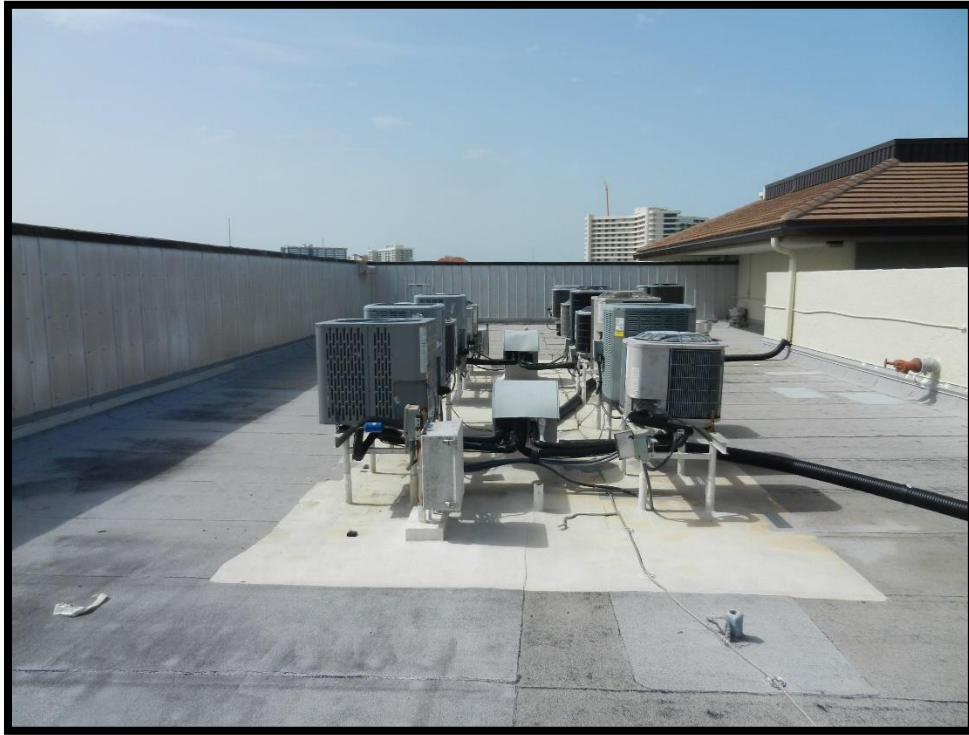
**East Wing Roof**

The roof system is a modified bitumen system installed at all areas in 2021 except for the East wing, which is in good condition. The façade tile was replaced in in 2023. The façade roof is supported by a wood truss system in good condition. The wood truss system is double strapped to the structural system.

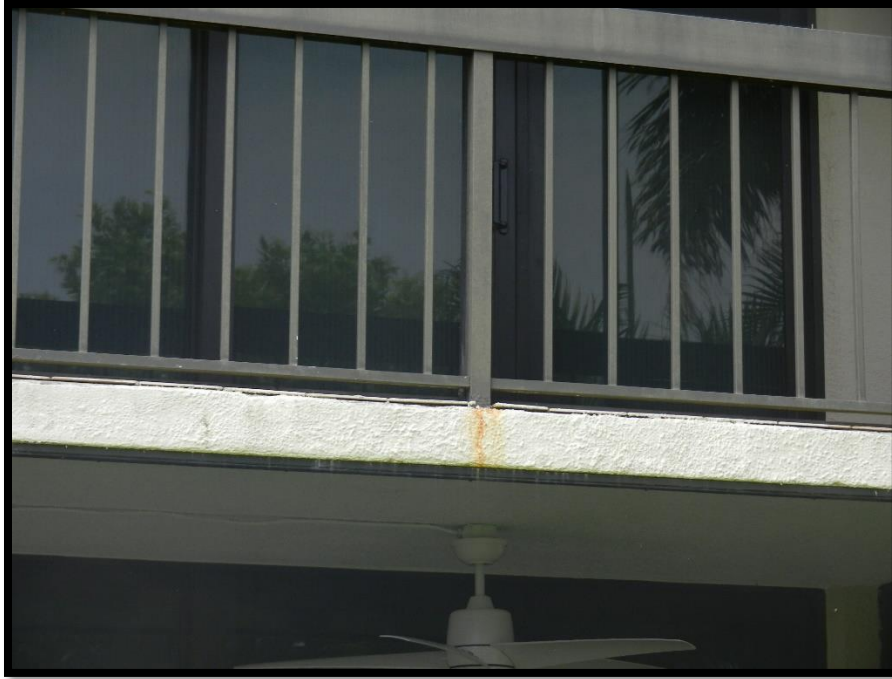
**North Elevation Rust Streaking**

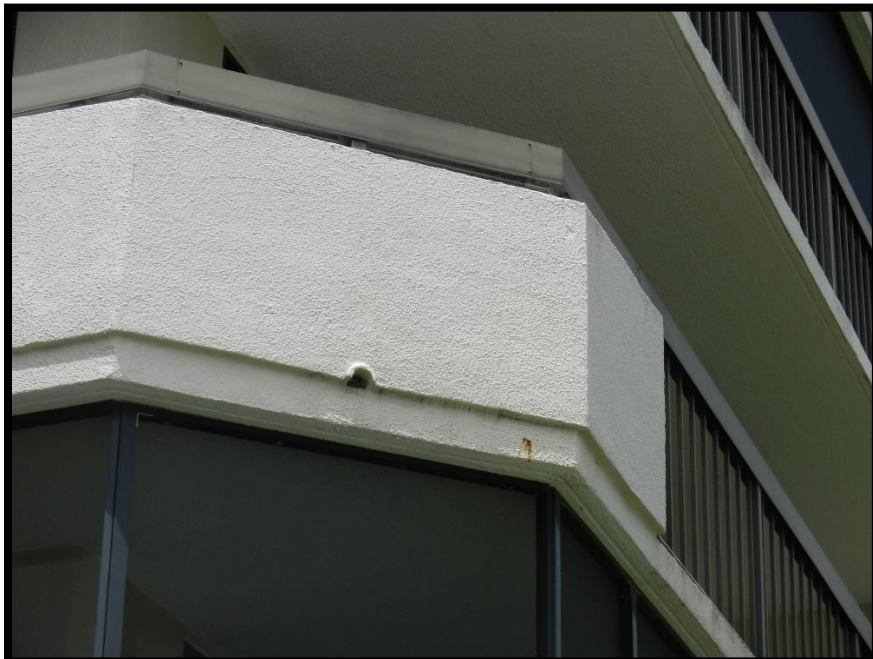
**North Elevation Rust Streaking**

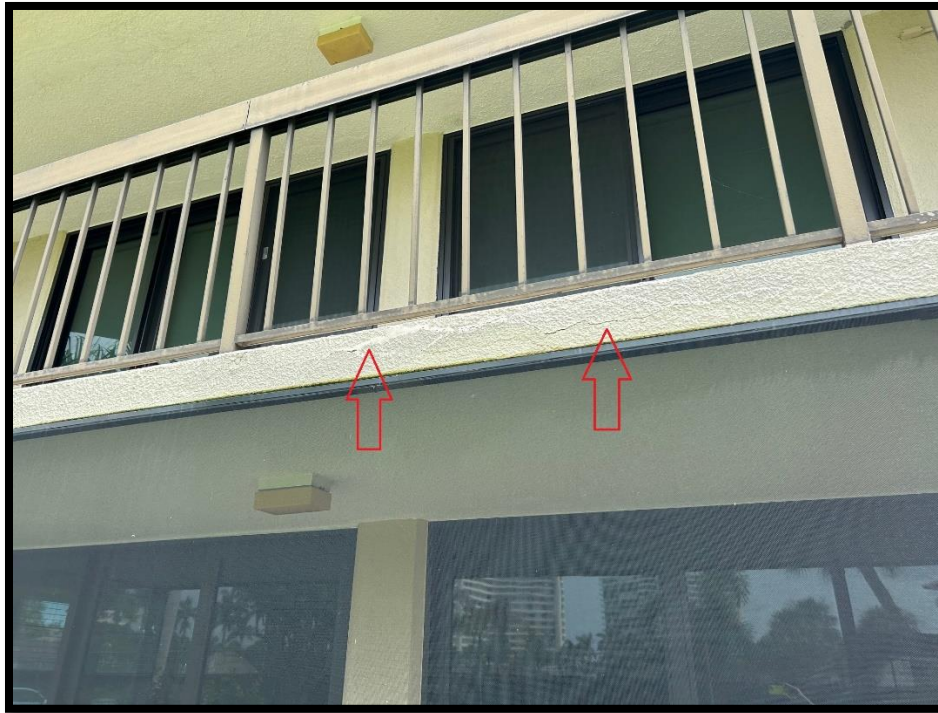
**South Elevation Lanai Spauling**

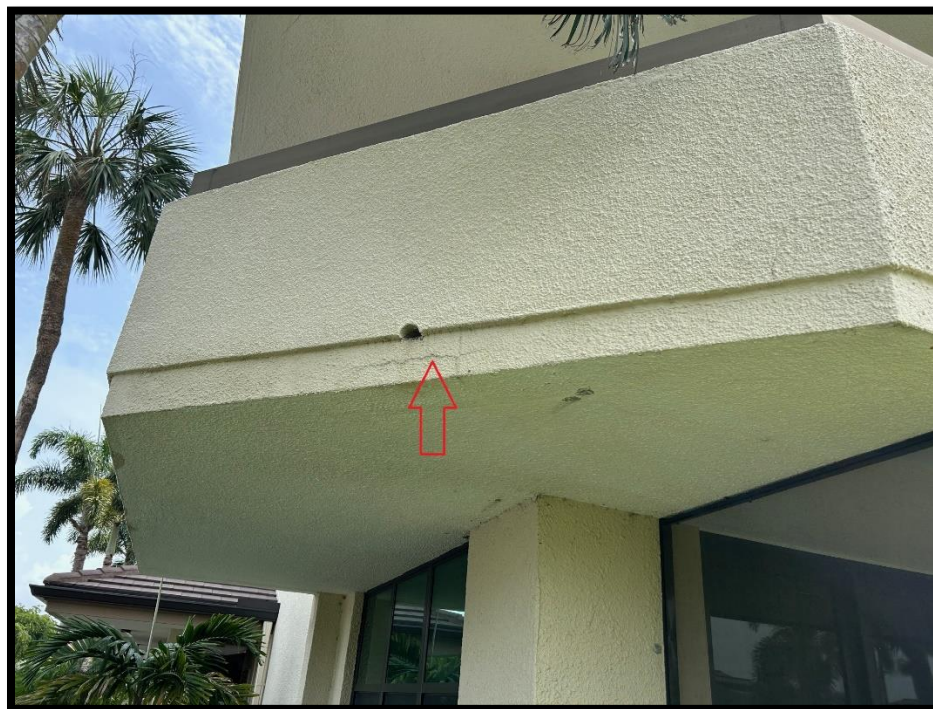
**South Elevation Lanai Concrete Spauling**
