# **Structural Integrity Reserve Study**

South Seas North Condominium Apartments of Marco Island, Inc.

Account 24024.03 - Version

**Date: July 29, 2024**

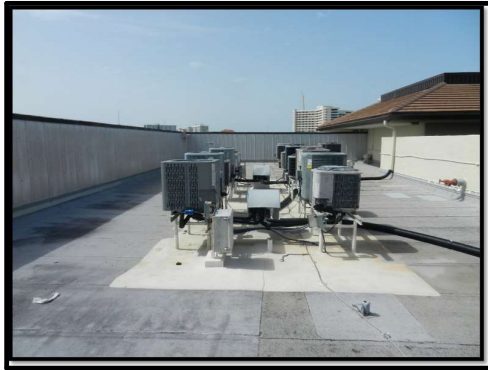
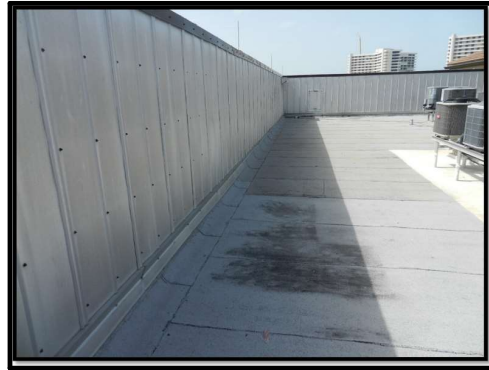
**Roof - 2021 - 2040**

The roof system is a modified bitumen system installed at all areas in 2021 except for the East wing, which is in good condition. The façade tile was replaced in 2023. The façade roof is supported by a wood truss system in good condition. The wood truss system is double strapped to the structural system.

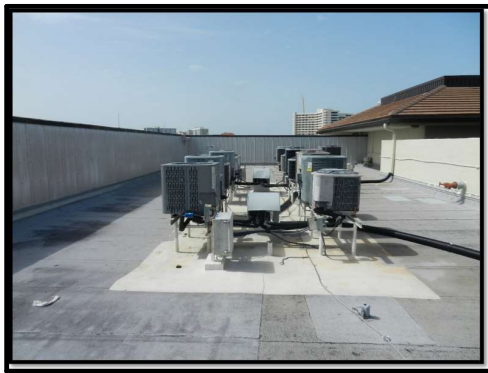
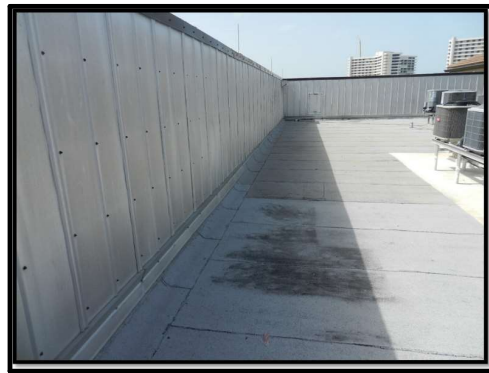
**Roof - East Wing - 2032**

The roof system is a modified bitumen system installed at all areas in 2021 except for the East wing, which is in good condition. The façade tile was replaced in in 2023. The façade roof is supported by a wood truss system in good condition. The wood truss system is double strapped to the structural system.

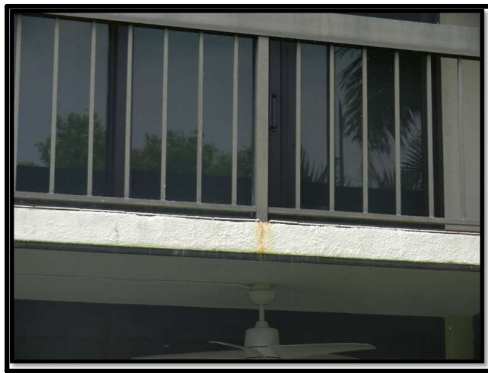
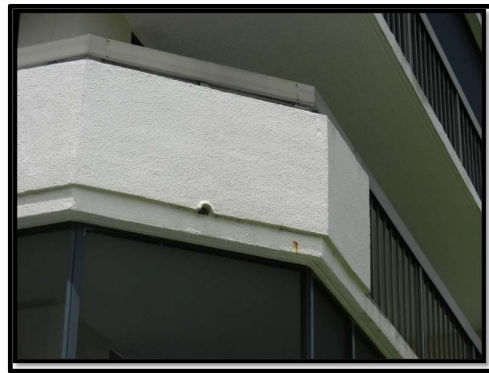
**Exterior Painting - 2025**

The last Painting of the building was completed in 2015.  
 It is showing streaking in places. Repainting should be scheduled for 2025.  
 Pricing is based on the 2015 repainting updated for inflation.

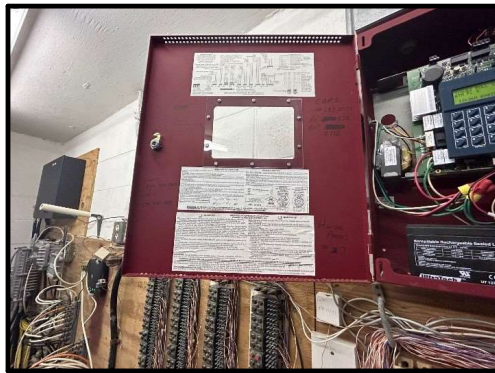
**Fire Protection - 2010 Panel System - 2044**

The fire alarm system is a Honeywell Fire Lite System. There are two systems. One is from 2010 and another is newer and appears to be from 2023. Both are in good condition and each has a life cycle of 35 years.

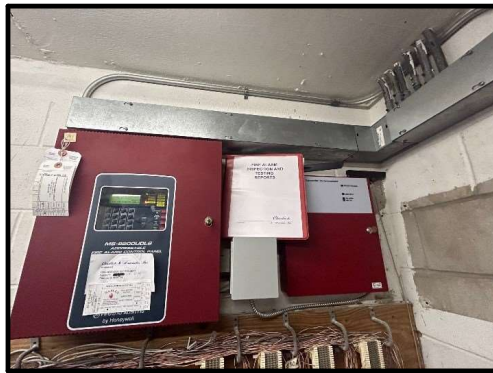
**Fire Protection - 2023 Panel System - 2057**

The fire alarm system is a Honeywell Fire Lite System. There are two systems. One is from 2010 and another is newer and appears to be from 2023. Both are in good condition and each has a life cycle of 35 years.

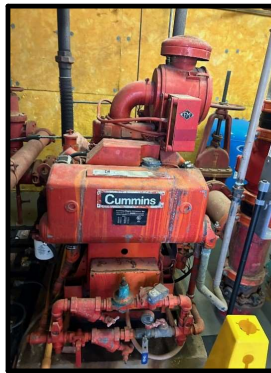
**Fire Protection - Fire Pump & Piping - 2025**

The fire pump is a Cummins diesel pump and is overdue to be replaced. A newer pump of the same type would have a cost of \$60,000 with \$12,000 installation added.

The fire piping is standpipes only in the stairwells. The pipe is in good condition.

There is an emergency generator on site that may be able to support an electric fire pump. An electric pump would reduce the cost. However, the generator must be able to support the fire pump as well as the other backup loads.

The Association should require that after any changes to the fire pump system, that the contractor prove the new system will meet the code required flow rate at the roof of the building.

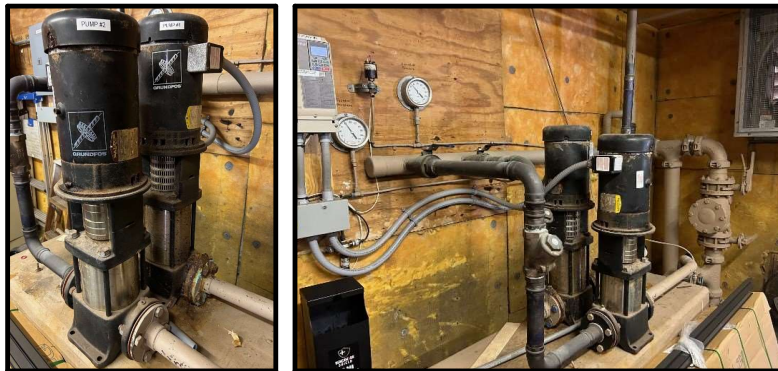
**Plumbing - Domestic water jockey pumps - 2025**

The Domestic jockey pumps are in poor condition and will need replacement in the near future. These will have a cost of about \$8,500 each. The copper pipe to the pumps is showing severe electrolysis. This is due to copper being installed against black or cast iron pipe without the use of dielectric fittings.

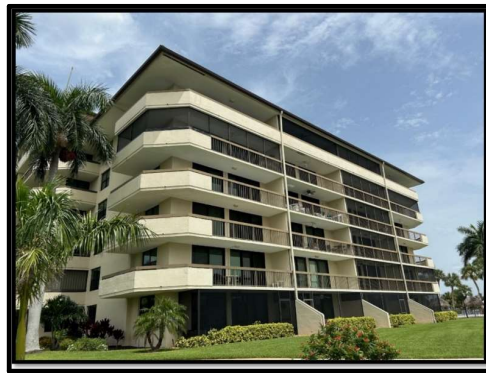
**Structure - 10-Year Reserve - 2033**

Minor concrete restoration repairs were completed in 2023 based on recommendations by De Stefano Engineering Group. Based on our observations and this history a structural reserve of \$50,000 is appropriate, to be scheduled with the 2034 paint cycle.

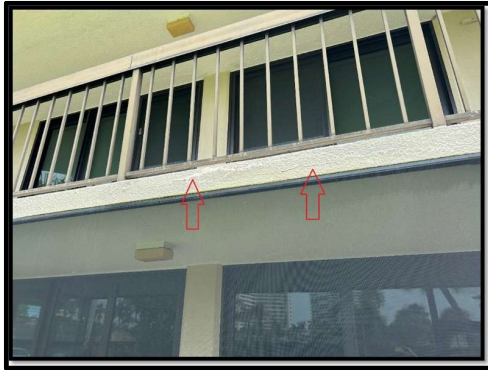
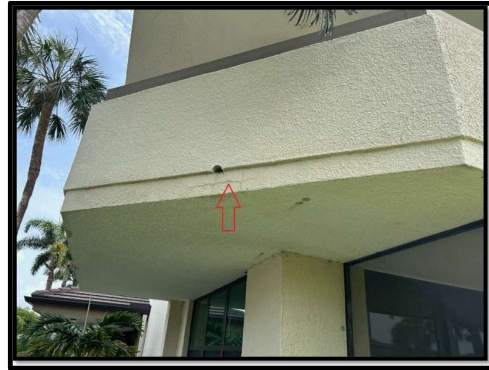
**Structure - 2025 Repairs - 2025**

The South elevation cracking / spalling should be repaired in the next 6 months (by January 2025) at an estimated cost of \$20,000. Please note that this repair will require a building permit from the City of Marco Island.

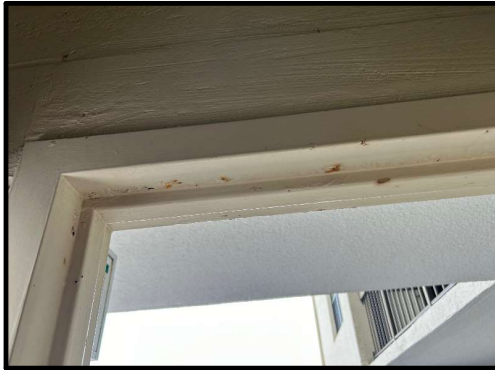
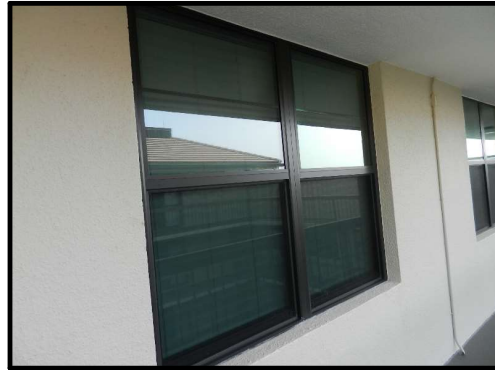
**Windows & Doors - 2025**

New hurricane rated doors and windows were installed in 2022 and 2023.  
 Stairwell fire doors are rusting and are not properly closing, total of 14 doors.  
 This is a \$10,000 allowance to repair the Stairwell fire doors by January 2025.

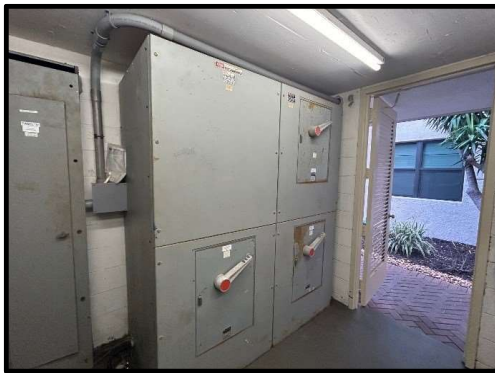
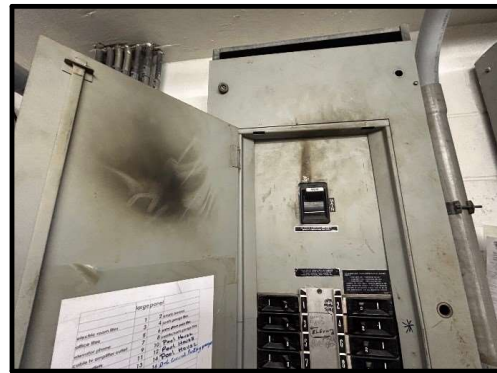
**Electrical - Panel 1 - 2054**

The original Electrical service equipment is all by Federal Pacific. Federal Pacific Circuit Breakers and Breaker Panels are noted to be a problematic fire hazard. In the photo on the right, note what appears to be soot on the door opposite the large main breaker.

We recommend the Federal Pacific breaker panel be replaced, not the switch gear, only the circuit breaker panels.

Specifically - The House main *Panel 1* has been quoted replacement at a cost of \$13,000 and should be replaced ASAP.

We also recommended an electrician conduct a video thermal inspection of all the electrical equipment and address any problems found.

Parts are available to address any problems with the switchgear if needed. And, be aware the replacement of all the main switchgear breakers would be approximately \$130,000.
