## **Phase 1 Milestone Structural Integrity Assessment**

### **South Seas West**

**260 Seaview Court, Marco Island, FL 34145**

K21146.00

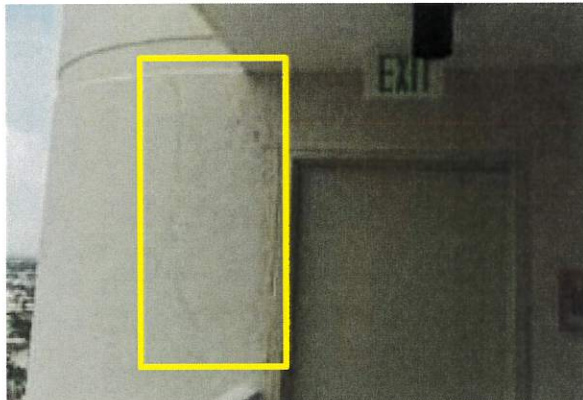
- Miscellaneous concrete spalling was observed in the exterior building walkways. (**Photo 5 – Photo 6**)
- There was corrosion of the metal deck, risers, and steel connections typical throughout most of the buildings metal staircases. (**Photo 7 – Photo 10**)

**Photo 5:** Tower 2 – Spalled concrete observed from the breezeway.

- Perform a concrete restoration to repair all concrete deterioration in accordance with the International Concrete Repair Institutes (ICRI) guidelines and Florida Building Code.
- Perform steel staircase repairs including welding of new steel as required removal of corrosion and application of a protective coating.

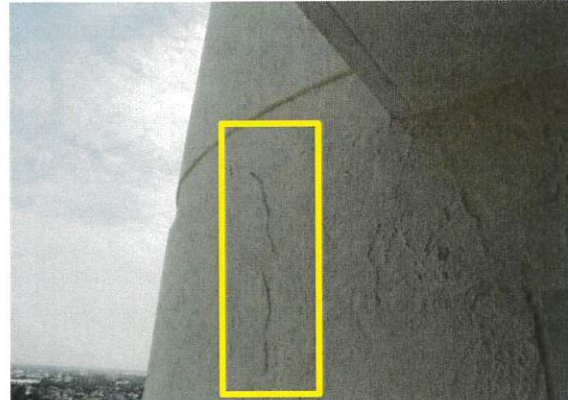
**Photo 6:** Tower 2 – Spalled concrete observed from the breezeway

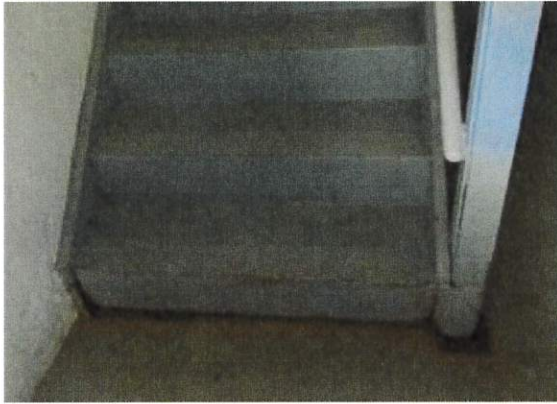
**Photo 7:** Corrosion of Steel Staircase

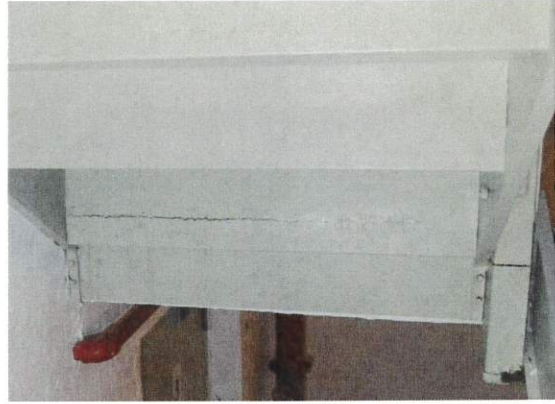
**Photo 8:** Corrosion of Steel Staircase

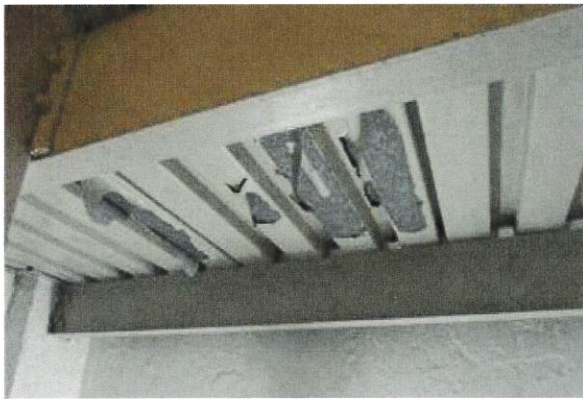
**Photo 9:** Corrosion of Steel Staircase

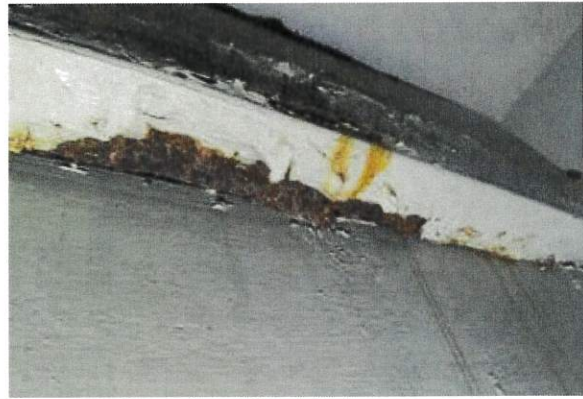
**Photo 10:** Corrosion of Steel Staircase

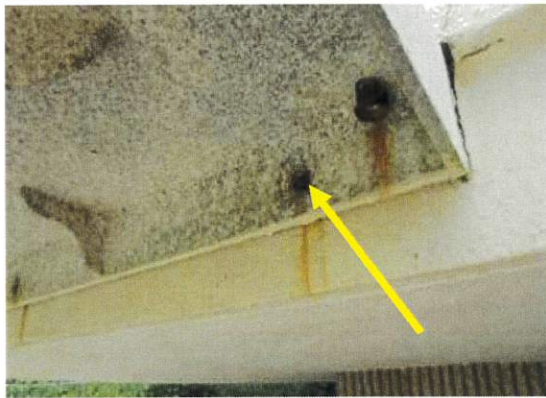
- Corroded / missing anchor and cracked concrete pads (**Photo 13 – Photo 16**)
- Spalled concrete with exposed / corroded steel reinforcement at HVAC closet ceiling. (**Photo 17 – Photo 18**)

**Photo 13:** Missing anchor.

- Perform a concrete restoration to repair all concrete deterioration in accordance with the International Concrete Repair Institutes (ICRI) guidelines and Florida Building Code.

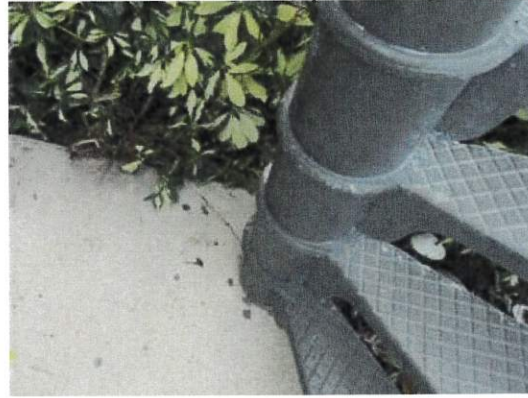
**Photo 14:** Cracked concrete pad at base of spiral stairs.

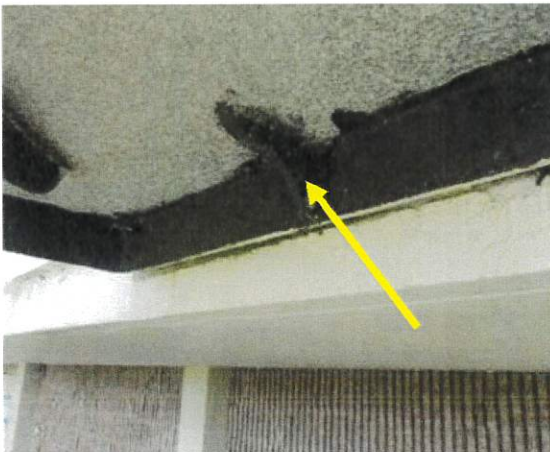
**Photo 15:** Corroded anchor.

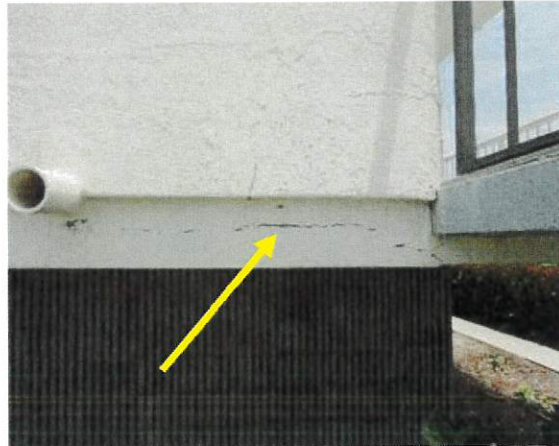
**Photo 16:** Cracked concrete pad.

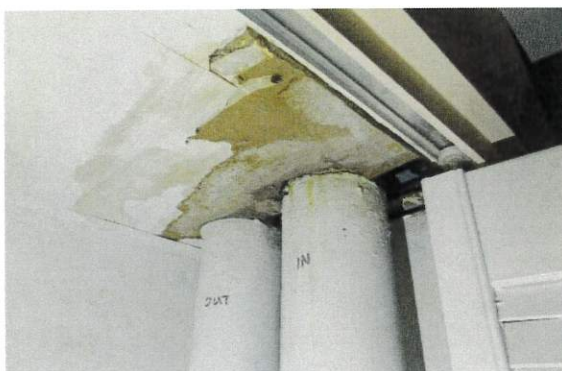
**Photo 17:** Spalled corrosion / corroded reinforcement to the slab in the HVAC Closet

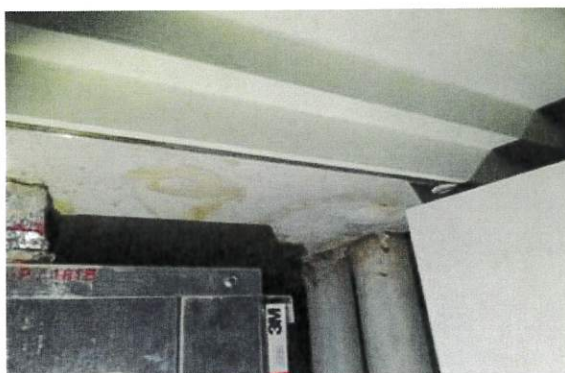
**Photo 18:** Spalled concrete to the slab in the HVAC Closet

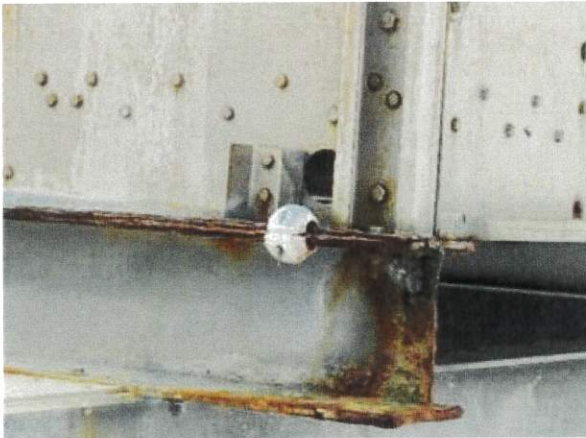
- Long-term corrosion / sectional loss observed to the steel members for the cooling tower skid. (Photo 19 – Photo 22)

**Photo 19:** Server corrosion on steel beam.

- Perform steel cooling tower skid repairs including welding of new steel as required removal of corrosion and application of a protective coating.

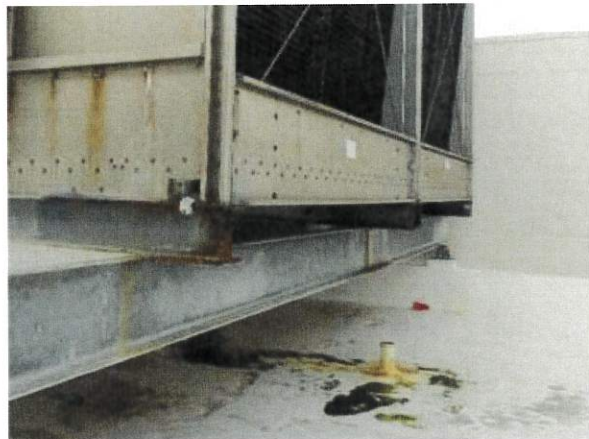
**Photo 20:** Server corrosion on multiple steel beam.

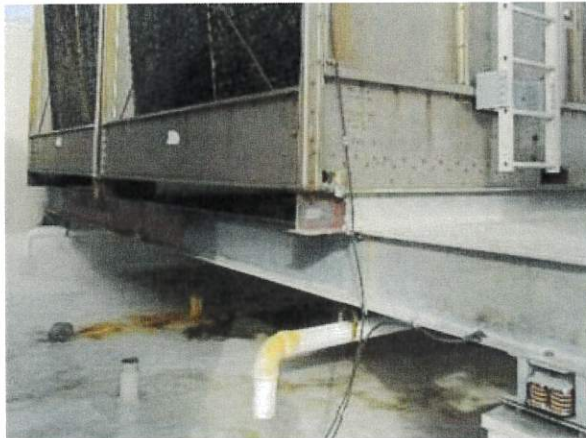
**Photo 21:** Server corrosion on multiple steel beam.

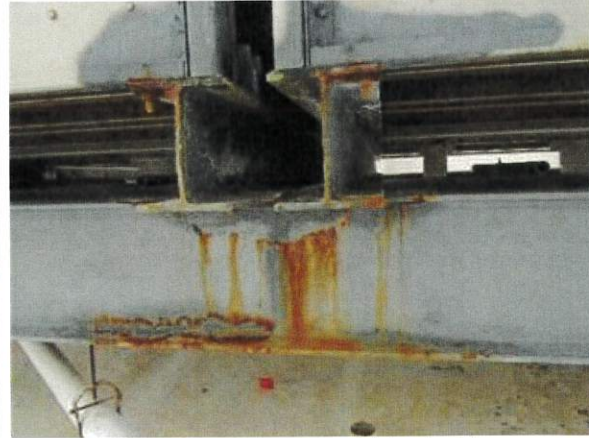
**Photo 22:** Server corrosion on multiple steel beam.

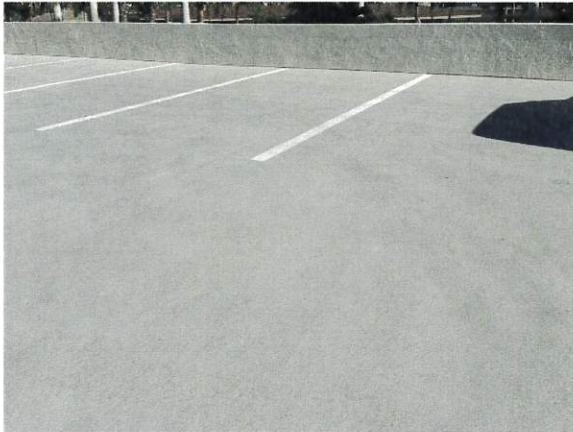
- The upper floor surface of the parking garage has been repaired, waterproofed, and sealed (**Photo 23 – 24**).
- New expansion joints have been installed (**Photo 25 – 26**).
- Exposed steel stirrups have been covered (**Photo 27**).
- Concrete spalling has been repaired (**Photo 28**).

**Photo 23:** New sealant and waterproofing to the garage.

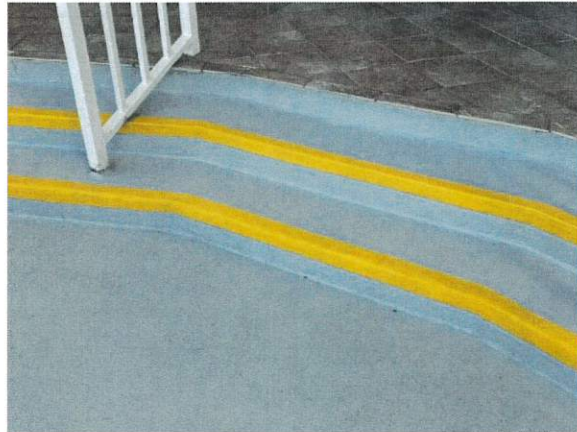
**Photo 24:** Newly sealed and waterproofed steps to the garage.

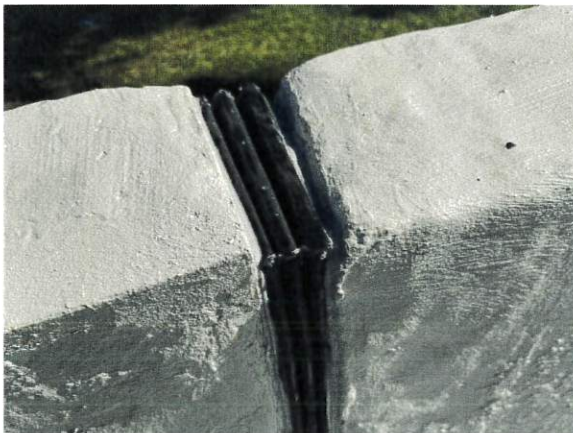
**Photo 25:** Newly installed expansion joint.

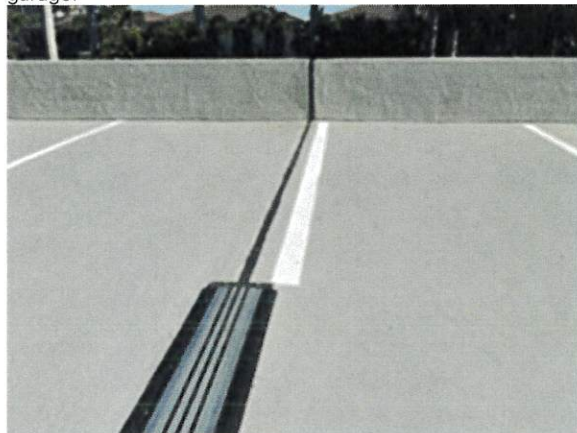
**Photo 26:** Newly installed expansion joint.

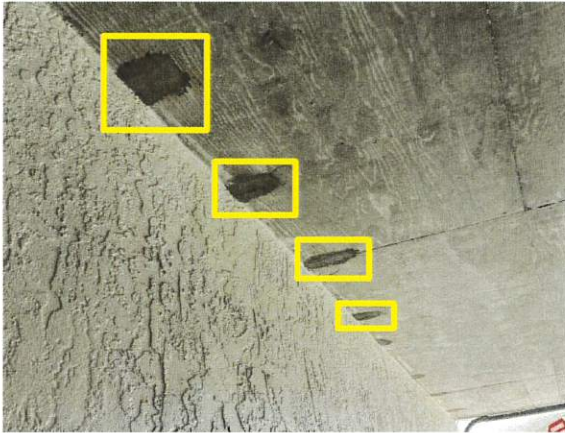
**Photo 27:** Exposed steel stirrups have been covered

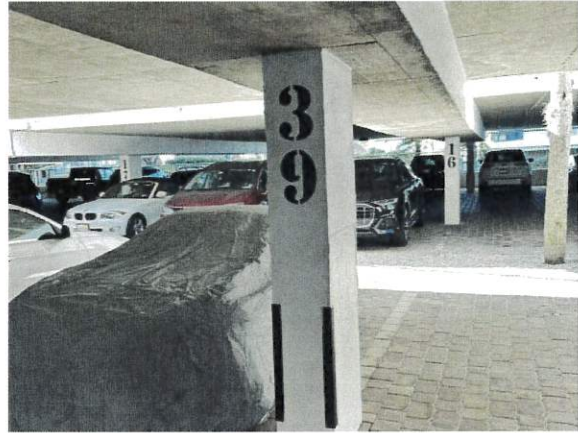
**Photo 28:** Concrete spalling on column has been repaired.
