# Structural Milestone Inspection - Phase I & II -

Property Located at:  
South Seas Northwest  
440 Seaview Court, Tower IV  
Marco Island, FL 34145

Prepared for:  
South Seas Northwest Condo Apts.  
of Marco Island Inc.  
c/o Resort Management Group

August 8, 2023

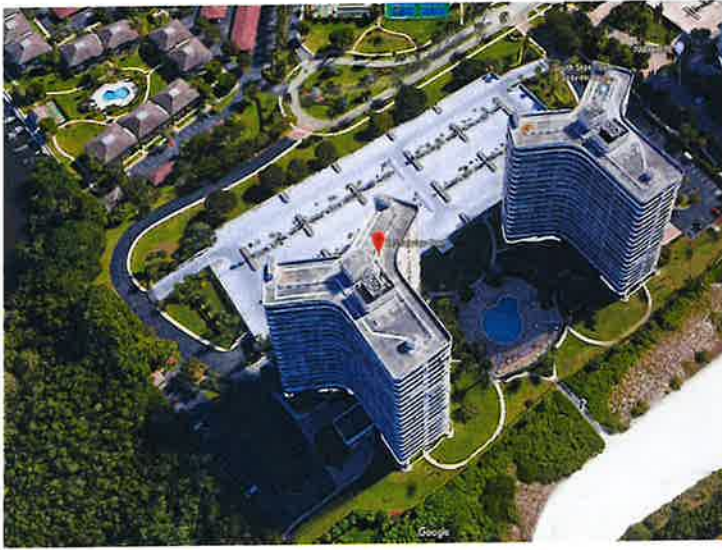
**PHOTOGRAPH #1**

**SOUTH SEAS NORTHWEST  
CONDOMINIUMS**

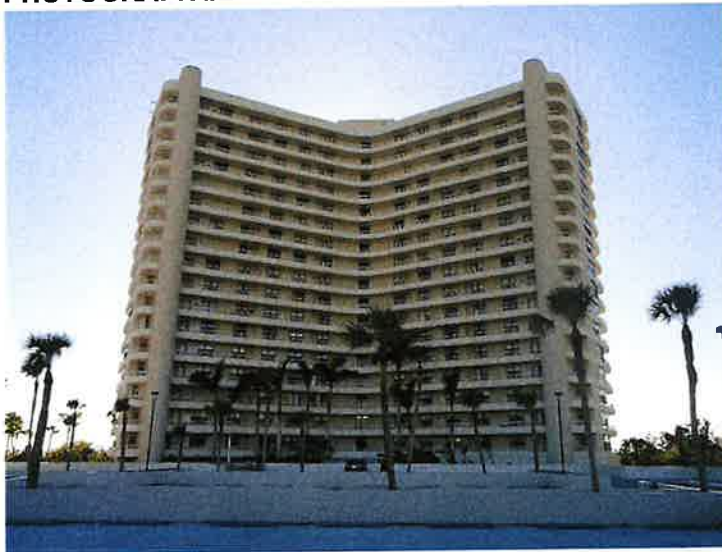
**PHOTOGRAPH #2**

**SOUTH SEAS NORTHWEST  
CONDOMINIUMS  
TOWER 4**

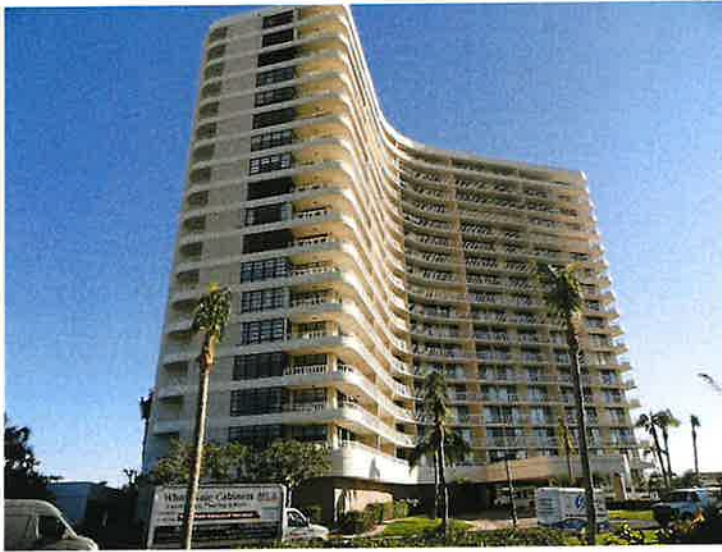
**PHOTOGRAPH #3**

**SOUTH SEAS NORTHWEST  
CONDOMINIUMS  
TOWER 4**

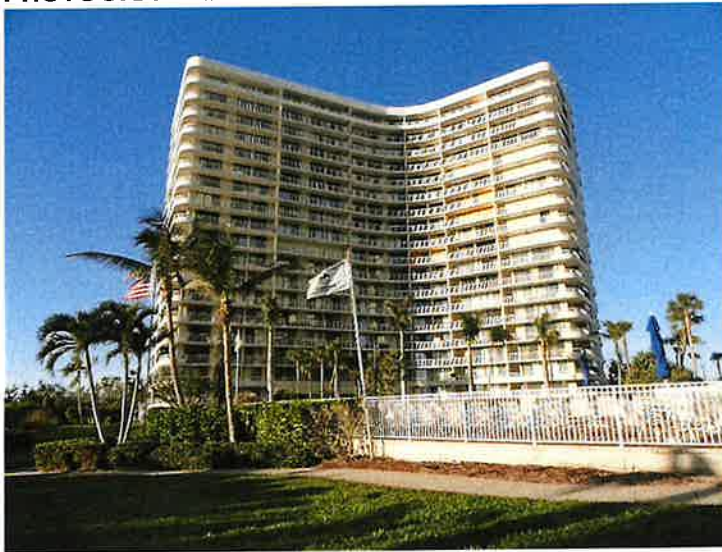
**PHOTOGRAPH #4**

**SOUTH SEAS NORTHWEST  
CONDOMINIUMS  
TOWER 4**

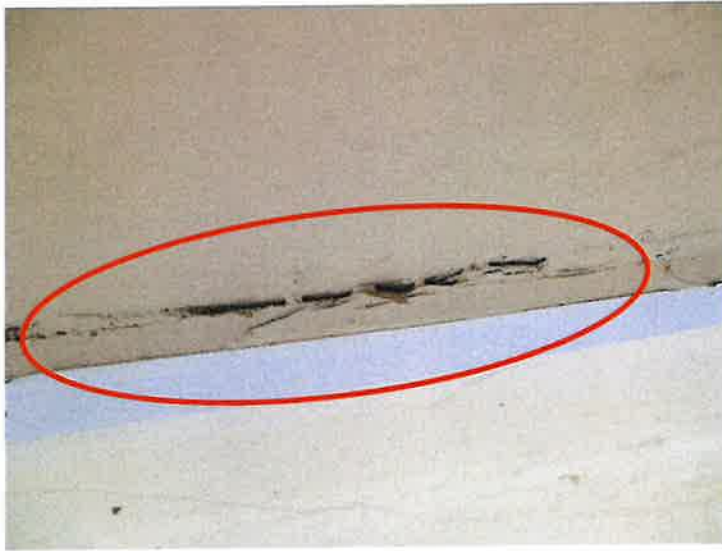
**PHOTOGRAPH #5**

**EXTERIOR  
VOIDS IN STUCCO**

Voids in the stucco finishes were observed at several areas throughout the roof parapet wall.

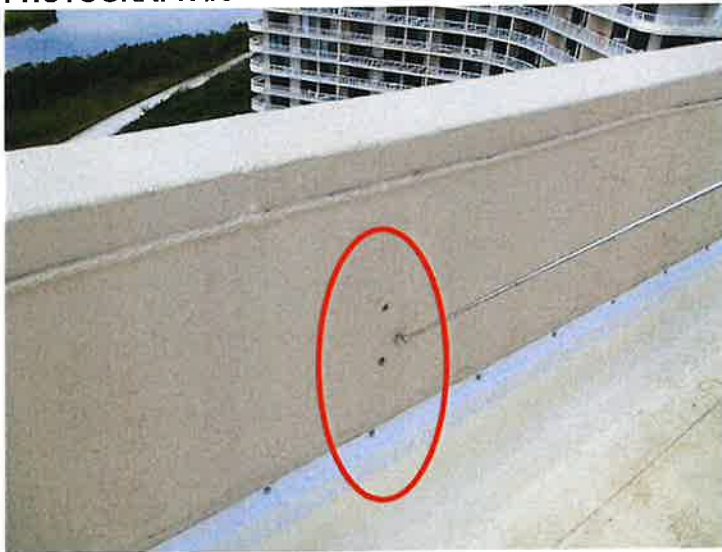
**PHOTOGRAPH #6**

**EXTERIOR  
UNSEALED PENETRATIONS**

Unsealed penetrations were observed at several areas throughout the roof parapet wall.

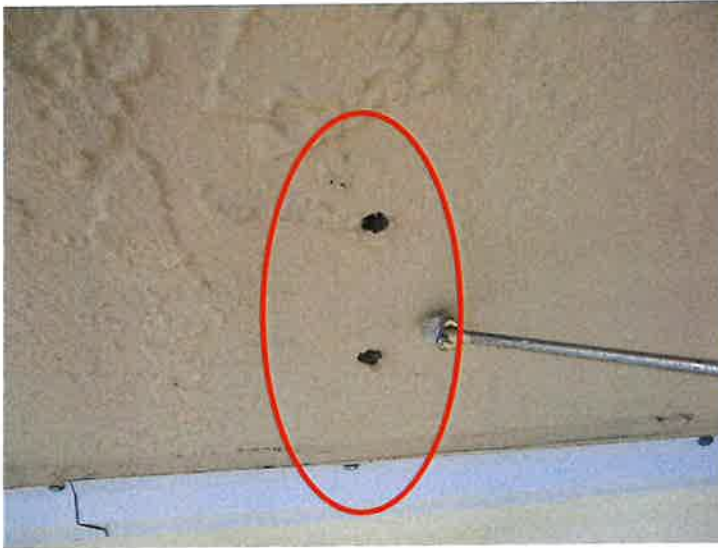
**PHOTOGRAPH #7**

**EXTERIOR  
UNSEALED PENETRATIONS**

Unsealed penetrations were observed at several areas throughout the roof parapet wall.

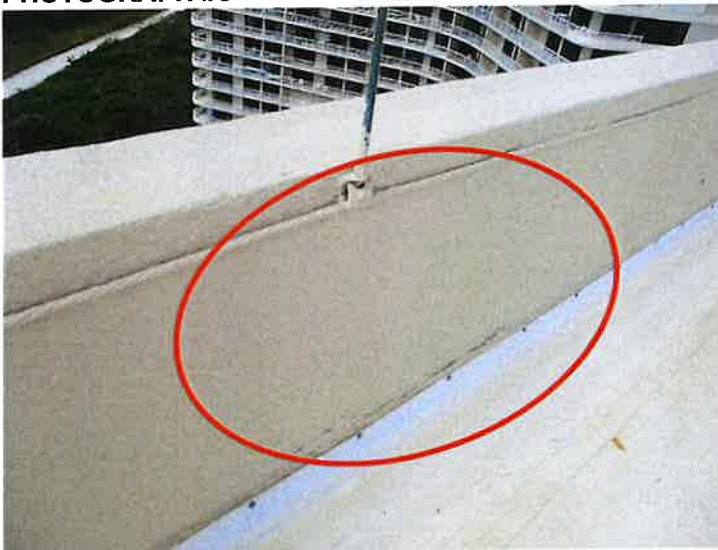
**PHOTOGRAPH #8**

**EXTERIOR  
UNBONDED STUCCO**

Unbonded stucco was observed throughout areas of the roof parapet walls.

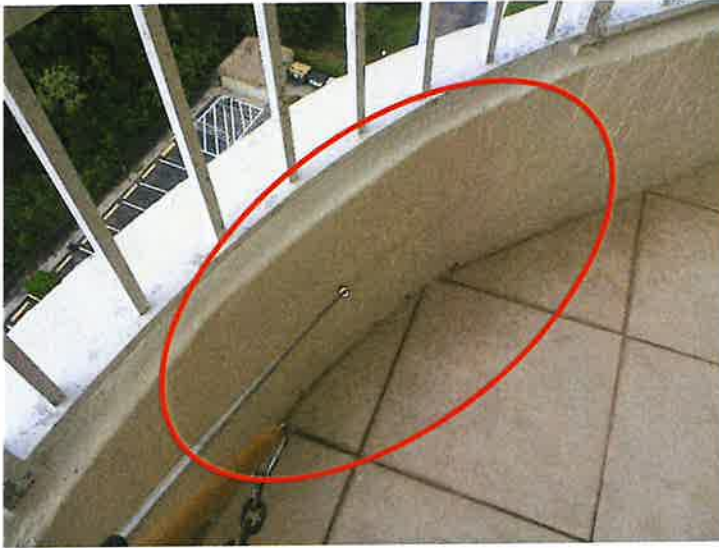
**PHOTOGRAPH #9**

**EXTERIOR  
UNBONDED STUCCO  
TOWER 4  
UNIT 1603**

Hollow sounding stucco was observed throughout several areas of the building exterior.

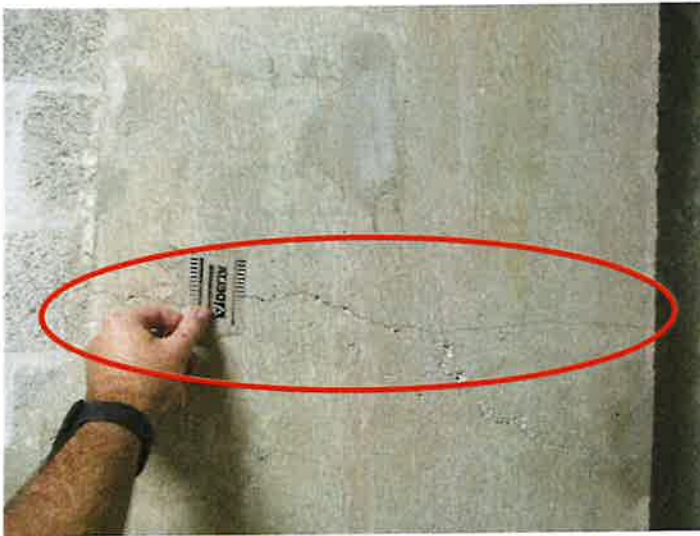
**PHOTOGRAPH #10**

- 3.2.1 The columns and beams were found to be in good condition. There is isolated cracking, and wood embedded in one column. (**Photographs #10, #11**) Although the majority of these structural elements were not visible, there were no indications of substantial structural damage present.

**BUILDING  
CONCRETE CRACKING  
TOWER 4  
3<sup>RD</sup> FLOOR ELECTRICAL ROOM**

Concrete cracks were observed at the column in the electrical room.

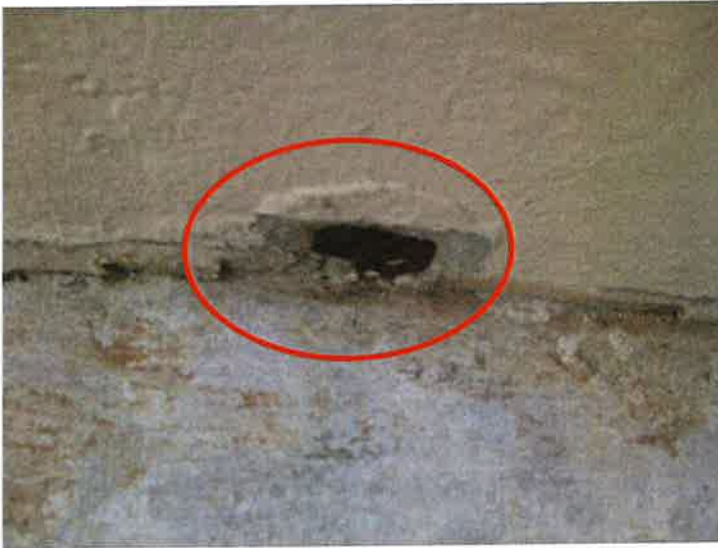
**PHOTOGRAPH #11**

**EXTERIOR  
RUST SPOT & EXPOSED REBARS  
TOWER 4  
UNIT 1903**

Rust spots and exposed rebars were observed at several areas throughout the building exterior.

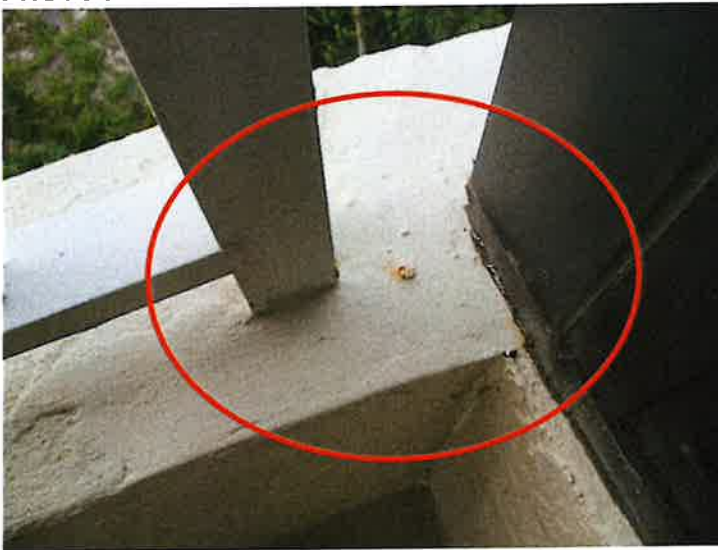
**PHOTOGRAPH #12**

**EXTERIOR  
RUST SPOT & EXPOSED REBARS  
TOWER 4**

Rust spots and exposed rebars were observed at several areas throughout the building exterior.

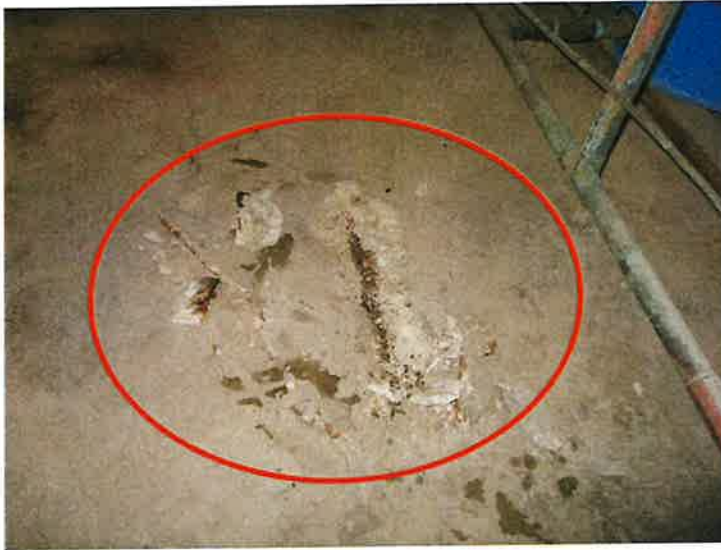
**PHOTOGRAPH #13**

- 3.3.1 The floor system was found to be in good condition and although the majority of the floor system was not visible. Spalls with exposed rebars were found in the rooftop mechanical room floor. There was also some spalling in the 15<sup>th</sup> floor owner’s storage room. (**Photograph #13, #14, #15, #16, #17**) There were no indications of substantial structural damage present.

**BUILDING  
EXPOSED REBARS  
TOWER 4  
ROOF MECHANICAL ROOM**

Exposed rebars were observed at several areas throughout the mechanical room.

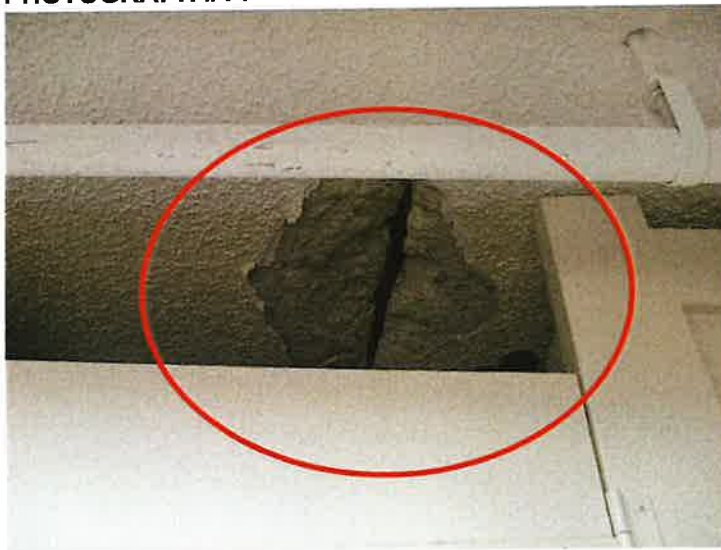
**PHOTOGRAPH #14**

**BUILDING  
EXPOSED REBARS  
TOWER 4  
19<sup>TH</sup> FLOOR OWNER STORAGE  
ROOM**

Exposed rebars was observed at the owner storage room

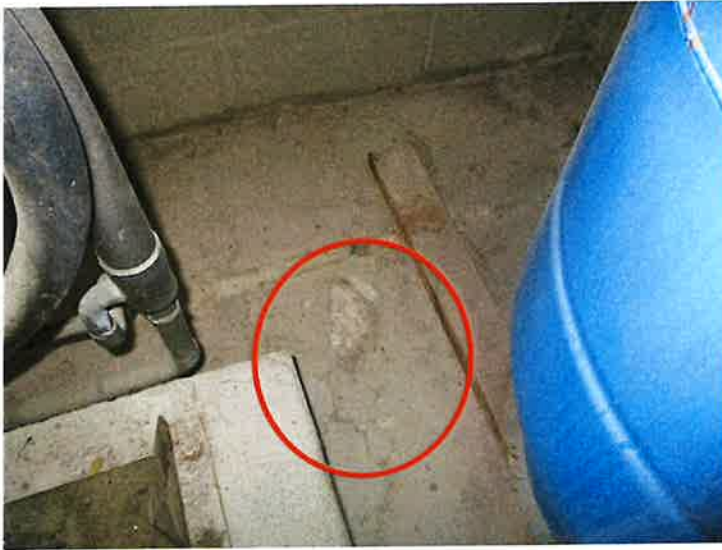
**PHOTOGRAPH #15**

**BUILDING  
CONCRETE SPALLING  
TOWER 4  
ROOF MECHANICAL ROOM**

Concrete spalling was observed at several areas throughout the roof mechanical room.

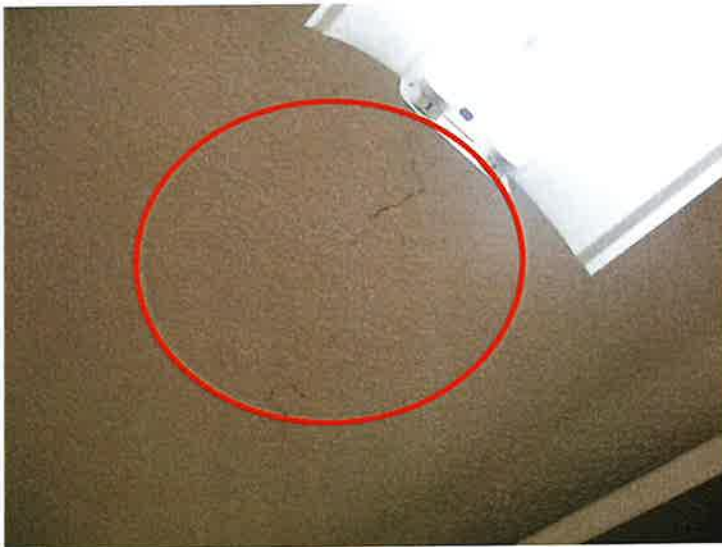
**PHOTOGRAPH #16**

**BUILDING  
CONCRETE SPALLING  
TOWER 4  
19<sup>TH</sup> FLOOR OWNER STORAGE  
ROOM**

Concrete spalling was observed at several areas throughout the owner storage room.

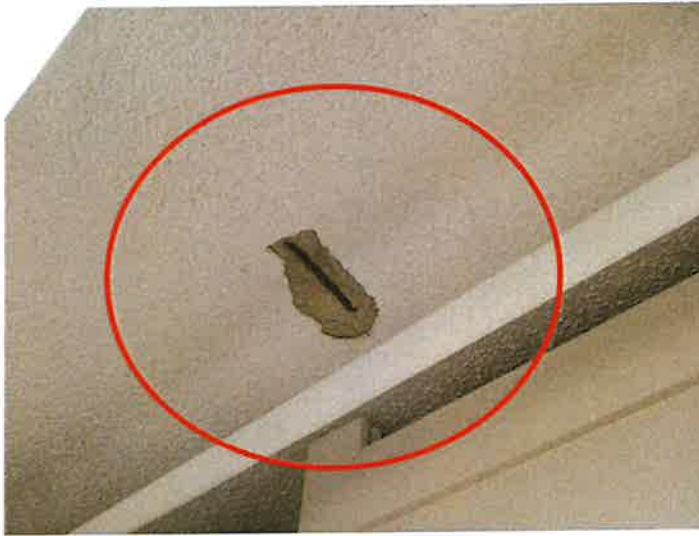
**PHOTOGRAPH #17**

**BUILDING  
CONCRETE SPALLING  
TOWER 4  
15<sup>TH</sup> FLOOR OWNER STORAGE  
ROOM**

Concrete spalling was observed at several areas throughout the owner storage room.

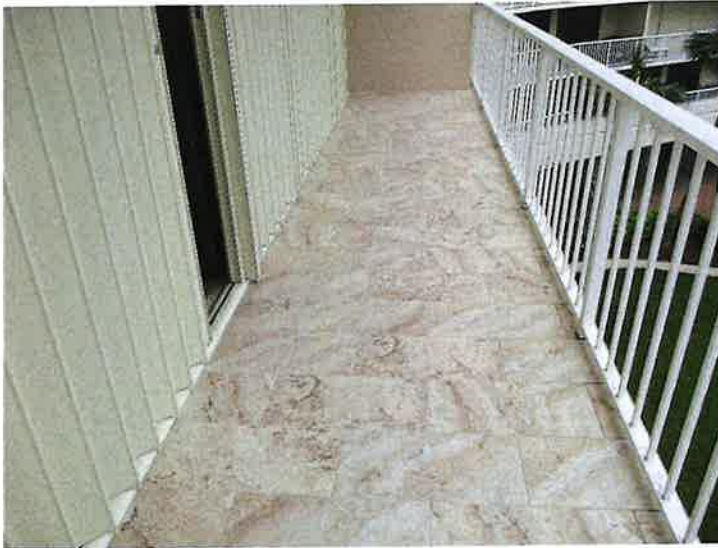
**PHOTOGRAPH #18**

- 3.4.1 The acoustical emission testing (sounding) detected several hollow sounding areas throughout the balconies' decks (**Photograph #18**). This condition is indicative of either concrete spall and delamination or poor tile thin-set adhesion. Selected balcony tile was removed revealing spalling of the balcony slab. A survey of the concrete decks should be performed at the time of removal of the balance of the existing tiles to determine the extent of unbonded concrete. Once the extent of the damage been identified, removal of all unbonded areas and re-casting will be required to be performed. This is structurally significant damage.

**ELEVATED BALCONIES**

Hollow sounding area detected, indicating spalls.

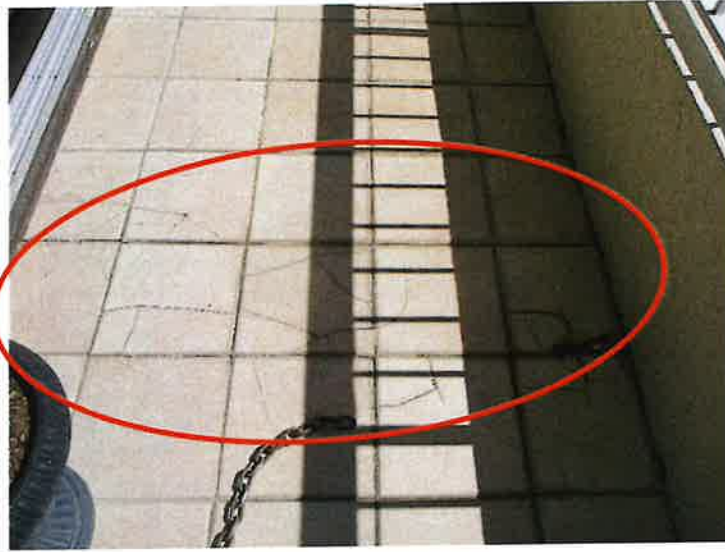
**PHOTOGRAPH #19**

**ELEVATED BALCONIES  
DAMAGED TILES  
TOWER 4  
UNIT 1909**

Buckling, broken and dislodged tiles were observed throughout the balconies' decks.

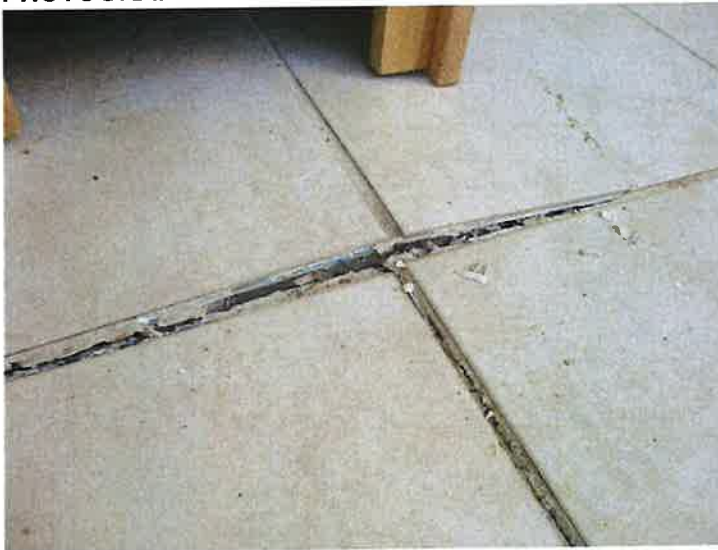
**PHOTOGRAPH #20**

**ELEVATED BALCONIES  
DAMAGED TILES  
TOWER 4  
UNIT 1910**

Buckling, broken and dislodged tiles were observed throughout the balconies' decks.

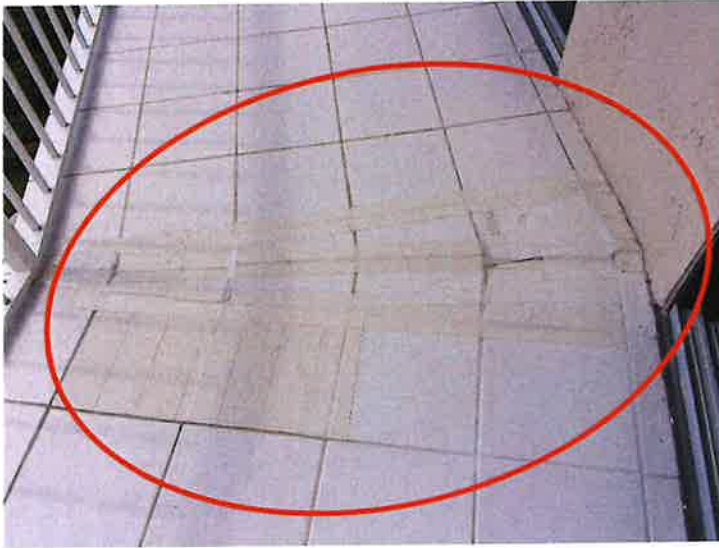
**PHOTOGRAPH #21**

**ELEVATED BALCONIES  
DAMAGED TILES  
TOWER 4  
UNIT 1407**

Buckling, broken and dislodged tiles were observed throughout the balconies' decks.

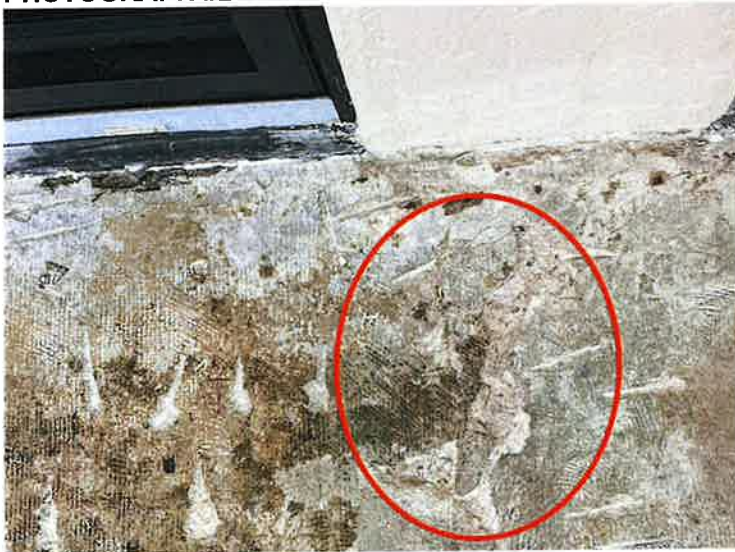
**PHOTOGRAPH #22**

- 3.4.2 Buckling, broken, and dislodged tiles were observed throughout the balconies' decks (**Photographs #5, #6, #7, #22**). Selected demolition showed spalled concrete due to inadequate cover on the steel. This is potentially structurally significant damage.

**ELEVATED BALCONIES  
DAMAGED TILES  
TOWER 4  
UNIT 1005**

Removal of tile revealed spalled concrete.

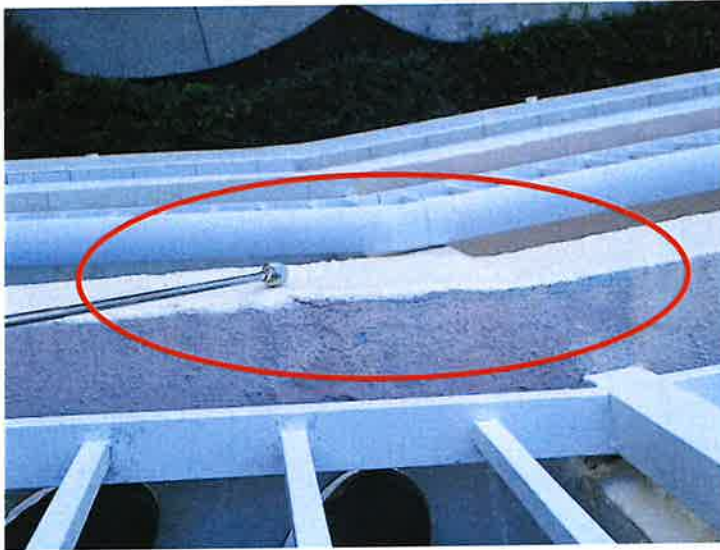
**PHOTOGRAPH #23**

- 3.4.4 Cracks varying in width were observed at the deck surface and slab edges of the elevated balconies (**Photographs #23, #24**). This condition does not comply with the American Concrete Institute Guideline for (ACI) 224R Committee's Tolerable Crack Widths which indicates a maximum crack width of 0.012 inch when exposed to humidity and moist air. Cracks compromise the integrity of the concrete deck and walls and provide a direct pathway for water intrusion (leaking and leaching) resulting in accelerated concrete deterioration and corrosion of the reinforcing steel. Cracks are required to be repaired in accordance with ACI/ICRI standards. This is structurally significant damage.

**ELEVATED BALCONIES  
STUCCO CRACKS  
TOWER 4  
UNIT 501**

Cracks in the stucco finishes were observed at throughout several areas of the elevated balconies.

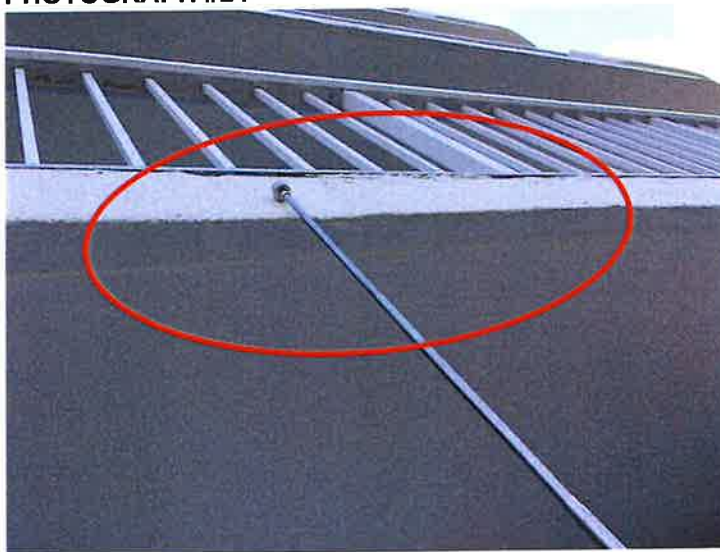
**PHOTOGRAPH #24**

**ELEVATED BALCONIES  
UNBONDED STUCCO  
TOWER 4  
UNIT 1412**

Hollow sounding stucco was observed throughout several areas of the elevated balconies.

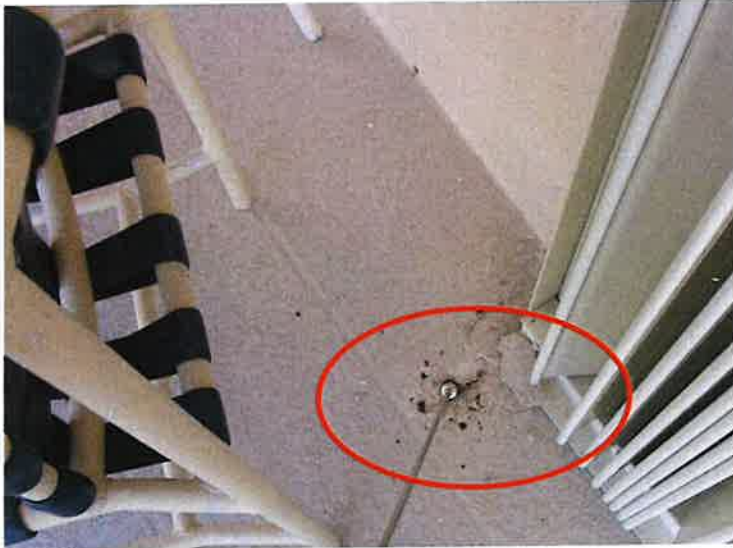
**PHOTOGRAPH #25**

**ELEVATED BALCONIES  
CONCRETE SPALLING  
TOWER 4  
UNIT 612**

Concrete spalling was observed at several areas throughout the elevated balconies.

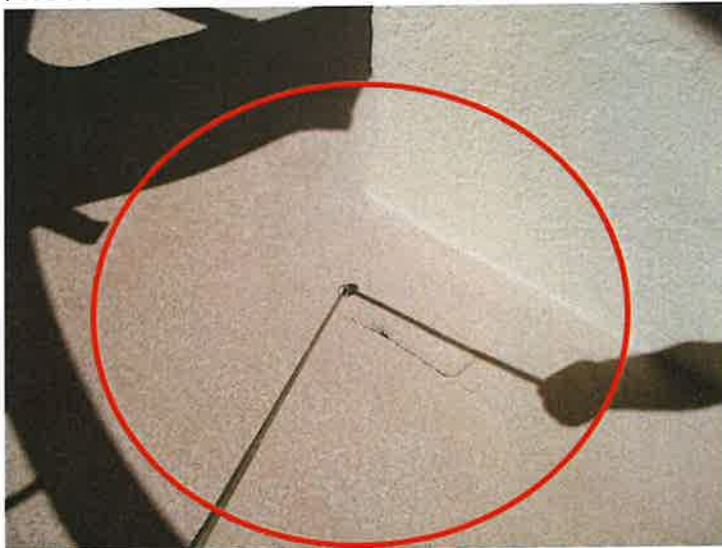
**PHOTOGRAPH #26**

**ELEVATED BALCONIES  
CONCRETE SPALLING  
TOWER 4  
UNIT 206**

Concrete spalling was observed at several areas throughout the elevated balconies.

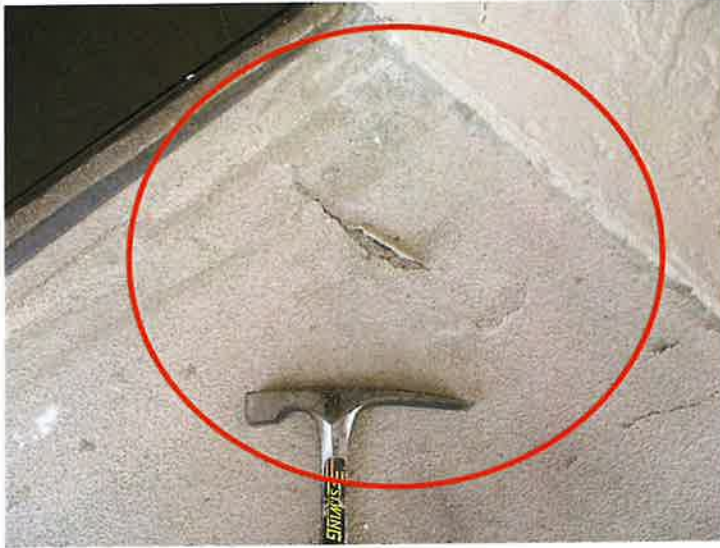
**PHOTOGRAPH #27**

**ELEVATED BALCONIES  
CONCRETE SPALLING  
TOWER 4  
UNIT 206**

Concrete spalling was observed at several areas throughout the elevated balconies..

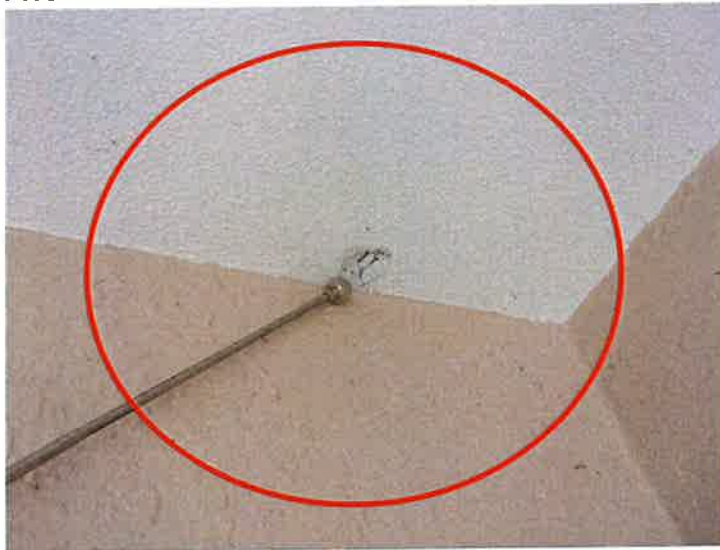
**PHOTOGRAPH #28**

**ELEVATED BALCONIES  
CONCRETE SPALLING  
TOWER 4  
UNIT 1407**

Concrete spalling was observed at several areas throughout the elevated balconies.

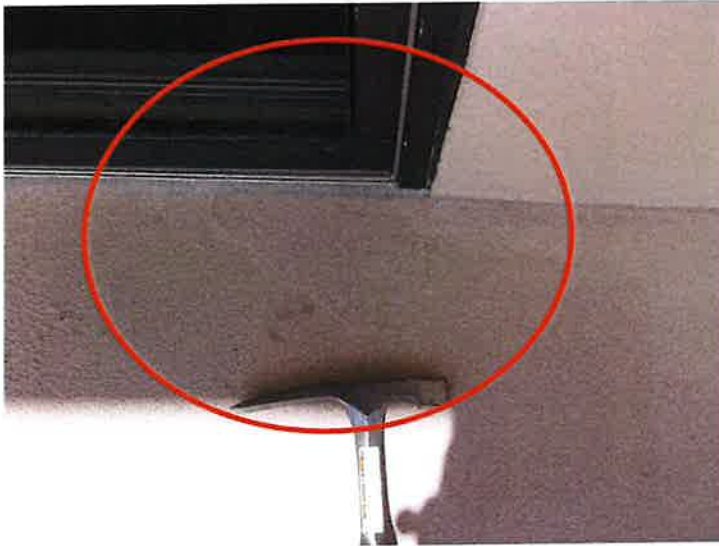
**PHOTOGRAPH #29**

**ELEVATED BALCONIES  
CONCRETE SPALLING  
TOWER 4  
UNIT 1409**

Concrete spalling was observed at several areas throughout the elevated balconies.

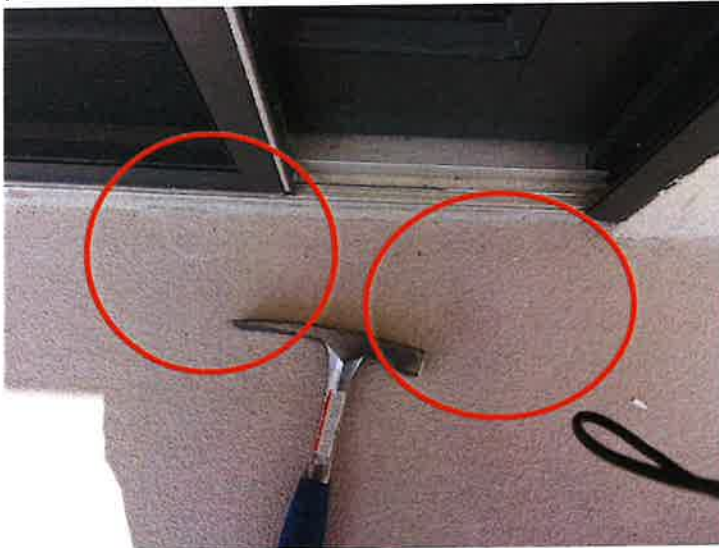
**PHOTOGRAPH #30**

**ELEVATED BALCONIES  
CONCRETE SPALLING  
TOWER 4  
UNIT 1409**

Concrete spalling was observed at several areas throughout the elevated balconies.

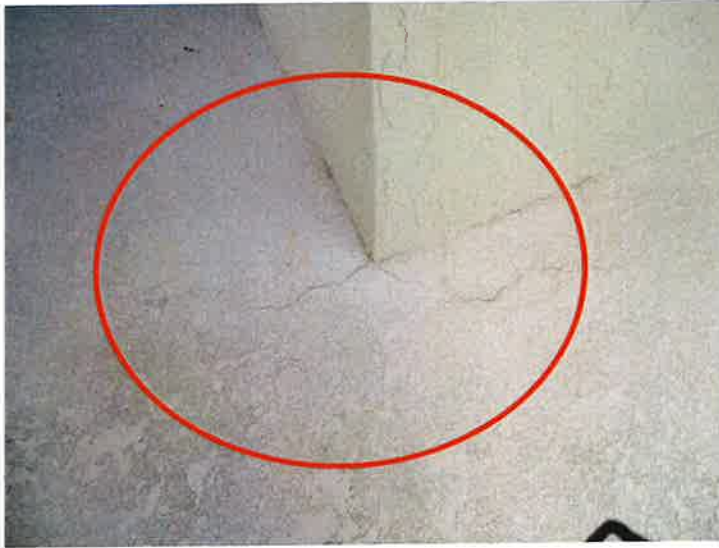
**PHOTOGRAPH #31**

**ELEVATED BALCONIES  
CONCRETE CRACKING  
TOWER 4  
UNIT 112**

Concrete cracks were observed at several areas throughout the elevated balconies.

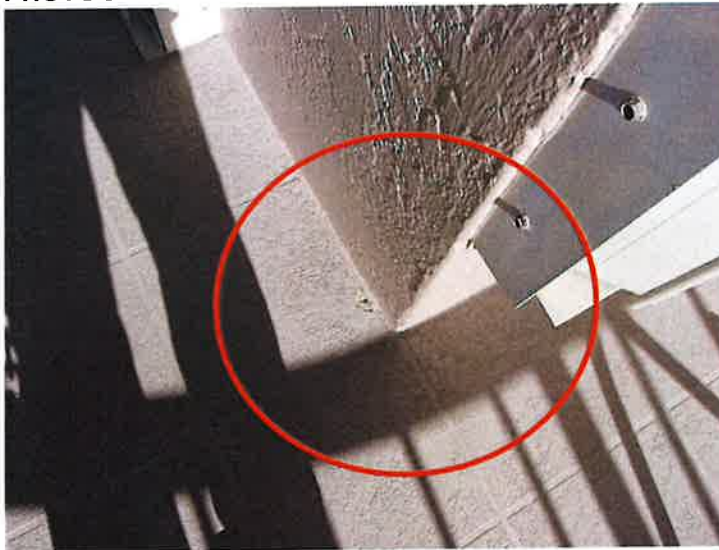
**PHOTOGRAPH #32**

**ELEVATED BALCONIES  
CONCRETE SPALLING  
TOWER 4  
UNIT 612**

Concrete spalling was observed at several areas throughout the elevated balconies.

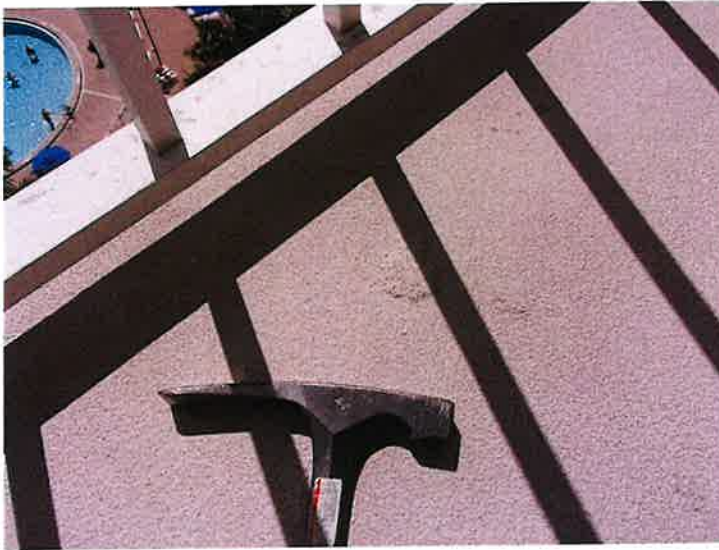
**PHOTOGRAPH #33**

**ELEVATED BALCONIES  
CONCRETE SPALLING  
TOWER 4  
UNIT 1409**

Concrete spalling was observed at several areas throughout the elevated balconies.

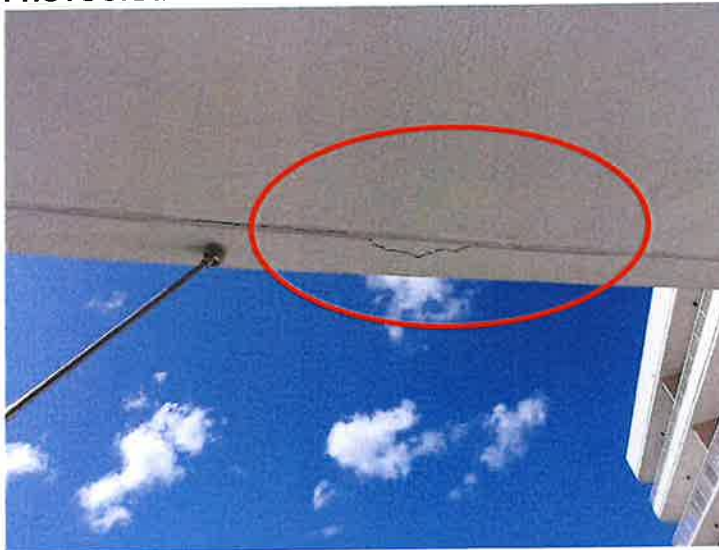
**PHOTOGRAPH #34**

**ELEVATED BALCONIES  
CONCRETE CRACKING  
TOWER 4  
UNIT 1405**

Concrete cracks were observed at several areas throughout the elevated balconies.

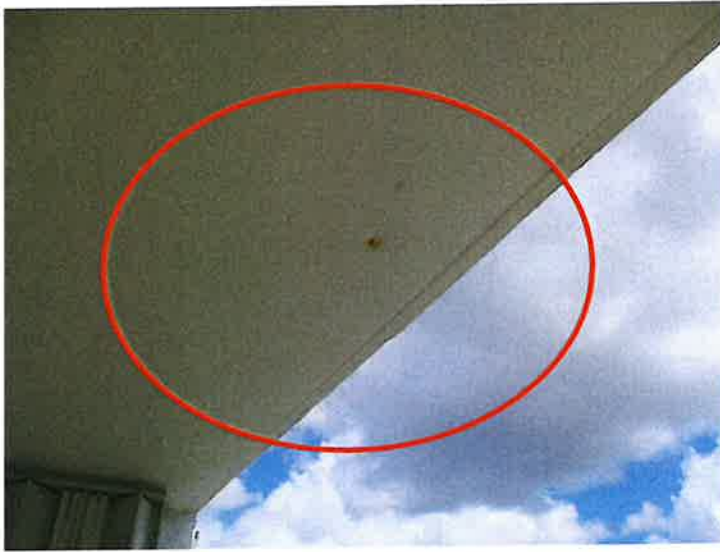
**PHOTOGRAPH #35**

- 3.4.7 Rust spots were observed at the ceiling slab and deck surfaces of the elevated balconies (**Photographs #35**). This condition is indicative corrosion of embedded reinforcement and metals, and lead to further deterioration and spalling of the concrete. This can lead to structurally significant damage.

**ELEVATED BALCONIES  
RUST SPOT & EXPOSED REBARS  
TOWER 4  
UNIT 1806**

Rust spots and exposed rebars were observed at several areas throughout the elevated balconies.

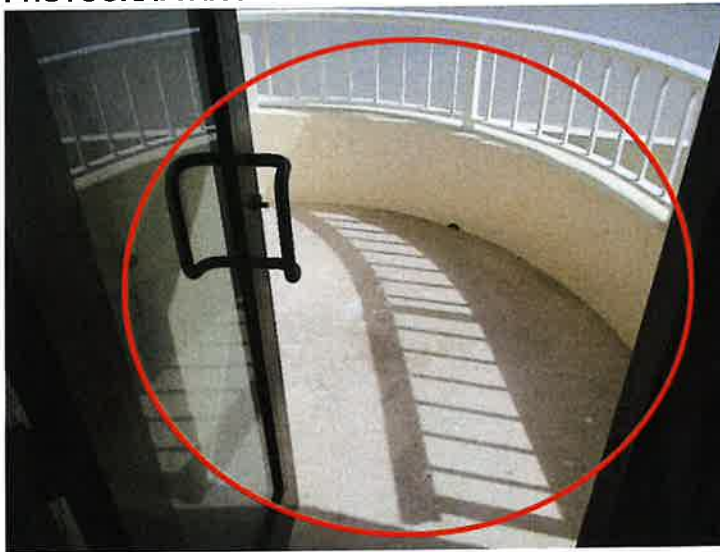
**PHOTOGRAPH #36**

**ELEVATED BALCONIES  
DAMAGED & DELAMINATING  
WATERPROOFING  
TOWER 4  
UNIT 206**

Damage and delamination of the waterproofing system was observed at throughout the elevated balconies.

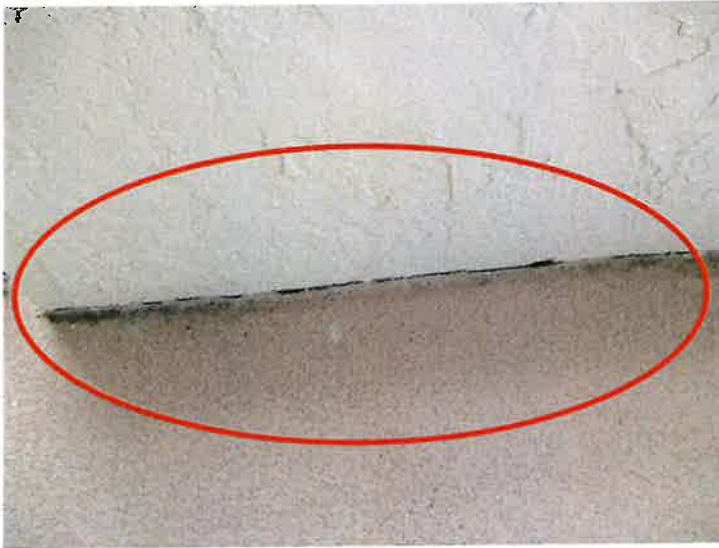
**PHOTOGRAPH #37**

- 3.4.8 Damage and delamination of the waterproofing coating was observed throughout the elevated balconies (**Photographs #9, #37**). This condition is the result of poor adhesion between the waterproofing system and the substrate, and it allows a path for water intrusion, which leads to the accelerated deterioration of the concrete deck and corrosion of the reinforcing steel. It is required for the damaged deck coating system to be repaired/replaced to provide continued waterproofing protection of the concrete decks.

**ELEVATED BALCONIES  
DAMAGED & DELAMINATING  
WATERPROOFING  
TOWER 4  
UNIT 403**

Damage and delamination of the waterproofing system was observed at throughout the elevated balconies.

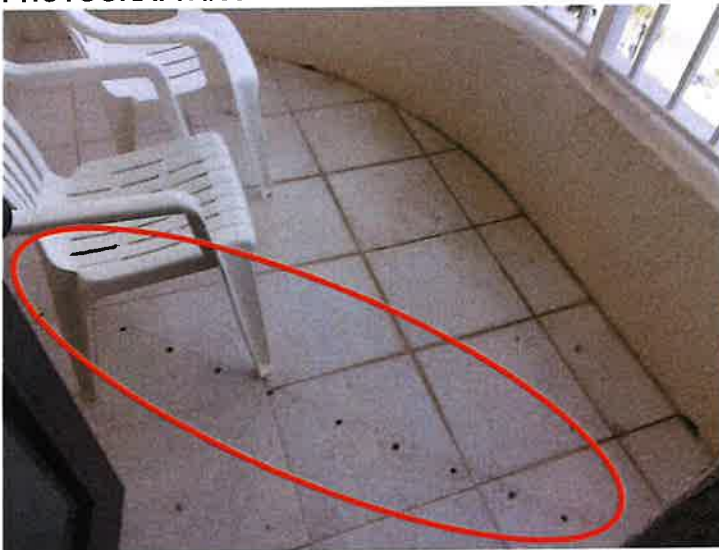
**PHOTOGRAPH #38**

- 3.4.9 Unsealed penetrations were observed at different areas of the elevated balcony deck surfaces (**Photographs #38**). This condition provides a pathway for water intrusion into the concrete deck and other structural components, and result in accelerated concrete deterioration, corrosion of the reinforcing steel at the penetration locations and water penetration into the building. This can lead to structurally significant damage.

**ELEVATED BALCONIES  
UNSEALED PENETRATIONS  
TOWER 4  
UNIT 1106**

Unsealed penetrations were observed at several areas throughout the elevated balconies.

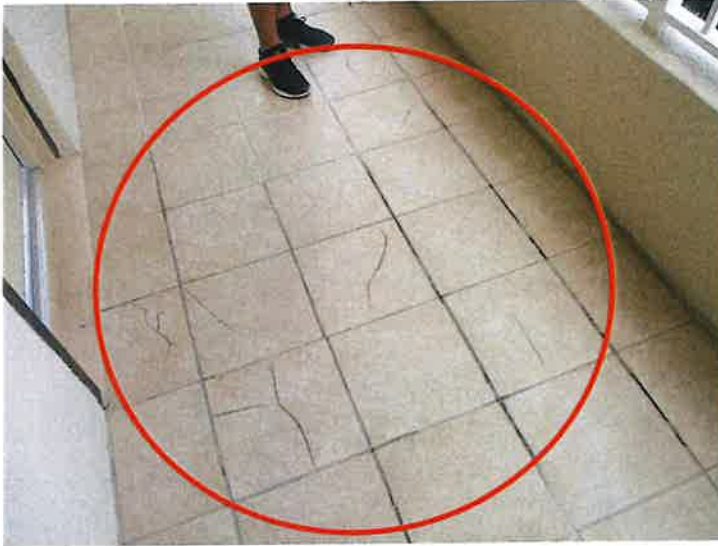
**PHOTOGRAPH #39**

- 3.5.3 Concrete spalling and corrosion related cracks were visually observed at the walkway's slab surfaces, slab edges and knee-walls as well as unbonded concrete and stucco when these areas were mechanical sounding using light-weight hammers and delamination detection tools. These conditions are the result of corrosion of the embedded steel reinforcement (rebar) and/or insufficient concrete coverage over the rebar (**Photographs**

**WALKWAYS  
DAMAGED TILES  
TOWER 4  
FLOOR 18**

Buckling, broken and dislodged tiles were observed throughout the building's walkways.

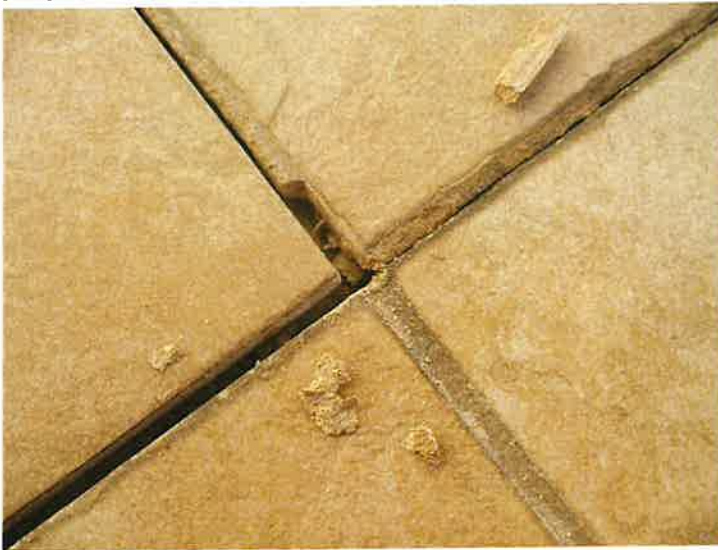
**PHOTOGRAPH #40**

**WALKWAYS  
DAMAGED TILES  
TOWER 4  
FLOOR 11**

Buckling, broken and dislodged tiles were observed throughout the building's walkways.

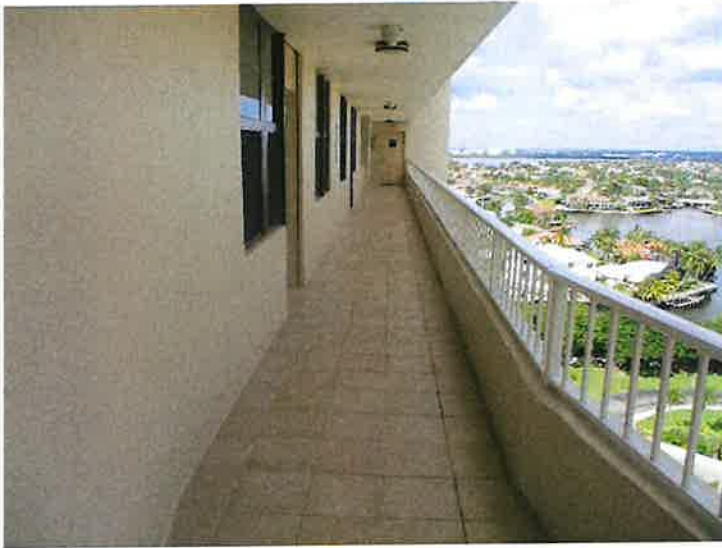
**PHOTOGRAPH #41**

**WALKWAYS  
UNBONDED STUCCO**

Hollow sounding stucco was observed throughout several areas of the building's walkways.

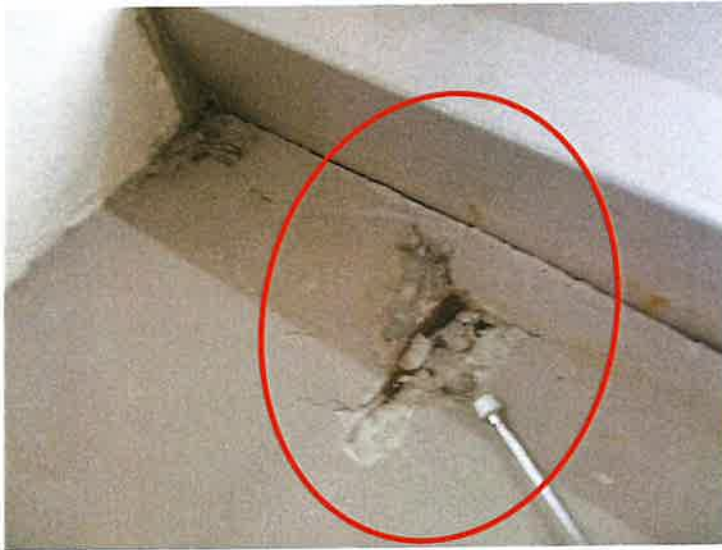
**PHOTOGRAPH #42**

- 3.6.1 The concrete infill installed on top of the metal pan stair assembly at the landing exhibited spalling. These conditions are the result of corrosion of the embedded steel reinforcement (rebar) and/or insufficient concrete coverage over the rebar (**Photograph #42**). This is structurally significant damage.

**STAIR ASSEMBLIES  
CONCRETE SPALLING**

Concrete spalling was observed at the stair assemblies.

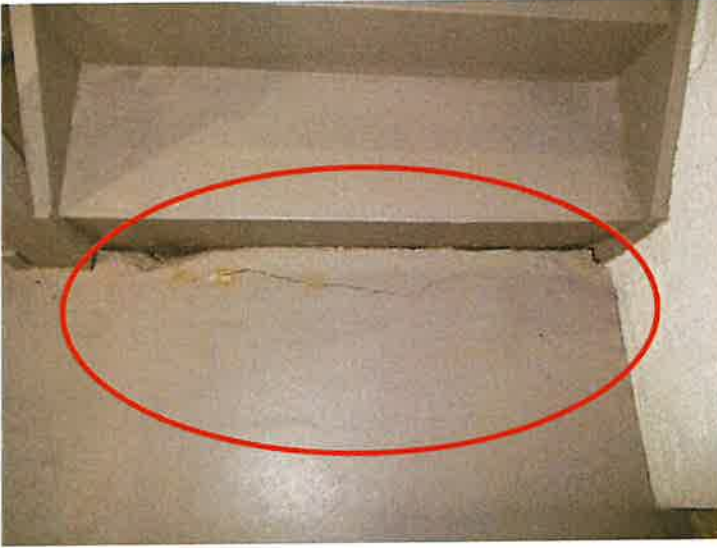
**PHOTOGRAPH #43**

- 3.6.2 Cracks varying in width were observed at the landing decks of the stair assemblies (**Photographs #43 and #44**). This condition does not comply with the American Concrete Institute Guideline for (ACI) 224R Committee's Tolerable Crack Widths which indicates a maximum crack width of 0.012 inch when exposed to humidity and moist air. Cracks compromise the integrity of the concrete and provide a direct pathway for water intrusion (leaking and leaching) resulting in accelerated concrete deterioration and corrosion of the reinforcing steel. This is structurally significant damage.

**STAIR ASSEMBLIES  
CONCRETE CRACKS**

Concrete cracks were observed at several locations throughout the stair assemblies.

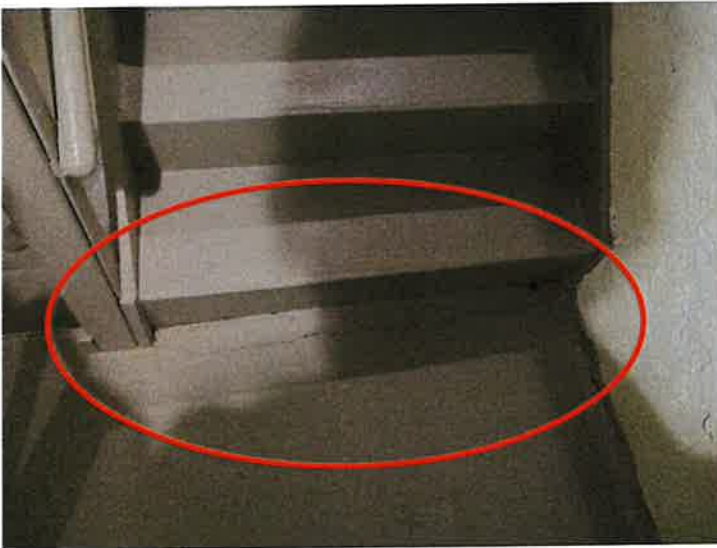
**PHOTOGRAPH #44**

**STAIR ASSEMBLIES  
CONCRETE CRACKS**

Concrete cracks were observed at several locations throughout the stair assemblies.

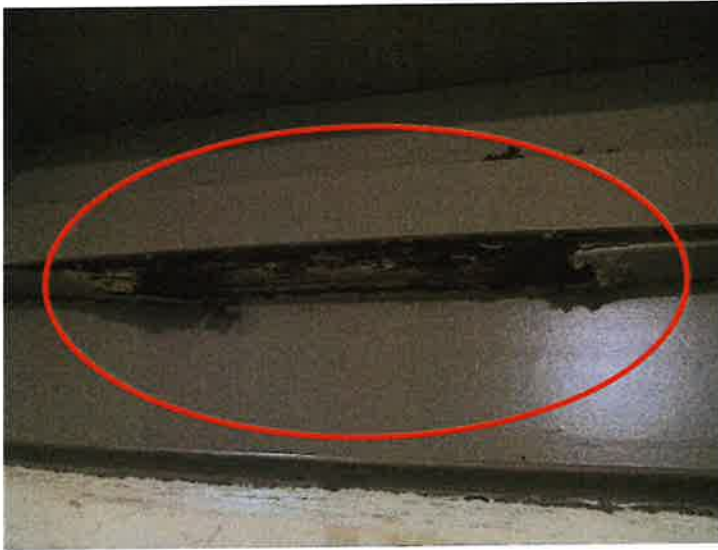
**PHOTOGRAPH #45**

- 3.6.3 The stair railing support, stringer and steps, and the rail posts exhibited corrosion ranging from minor surface rust to severe corrosion exhibiting 100% section loss (**Photographs #11 to #55**).
- 3.6.4 When viewed from the underside of the landings, the steel decks exhibited corrosion ranging from minor surface rust to severe corrosion exhibiting 100% section loss.

**STAIR ASSEMBLIES  
CORROSION**

Corrosion of the stair's structural members was observed at several locations throughout the stair assemblies.

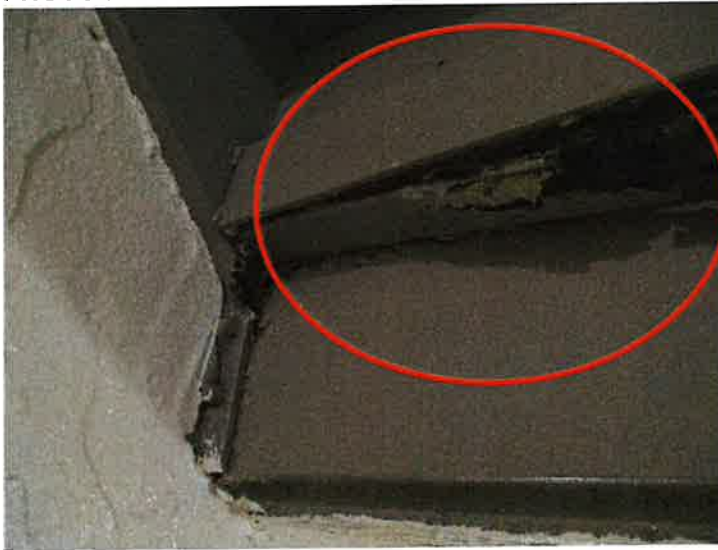
**PHOTOGRAPH #46**

**STAIR ASSEMBLIES  
CORROSION**

Corrosion of the stair's structural members was observed at several locations throughout the stair assemblies.

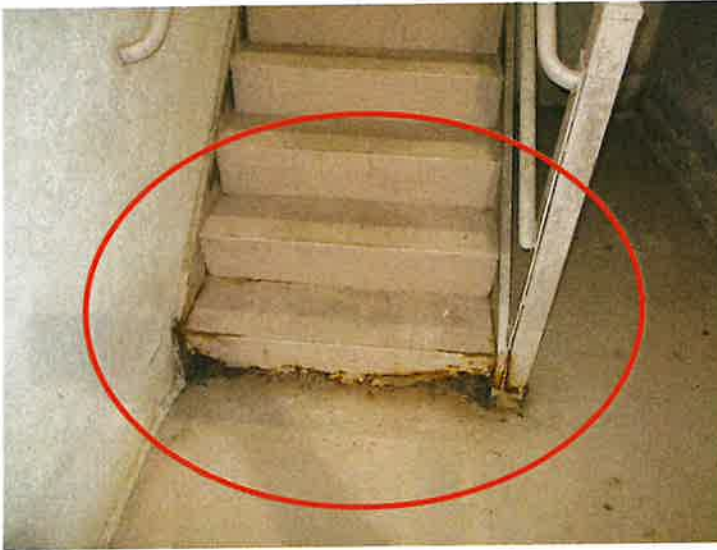
**PHOTOGRAPH #47**

**STAIR ASSEMBLIES  
CORROSION**

Corrosion of the stair's structural members was observed at several locations throughout the stair assemblies.

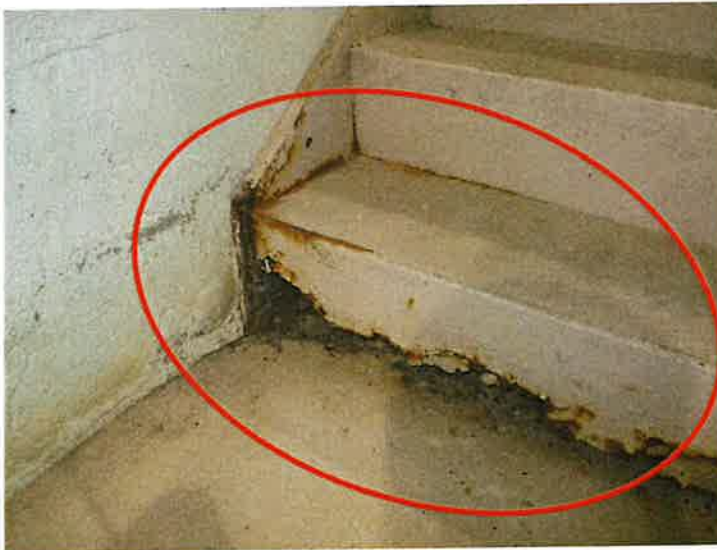
**STAIR ASSEMBLIES  
CORROSION**

Corrosion of the stair's structural members was observed at several locations throughout the stair assemblies.

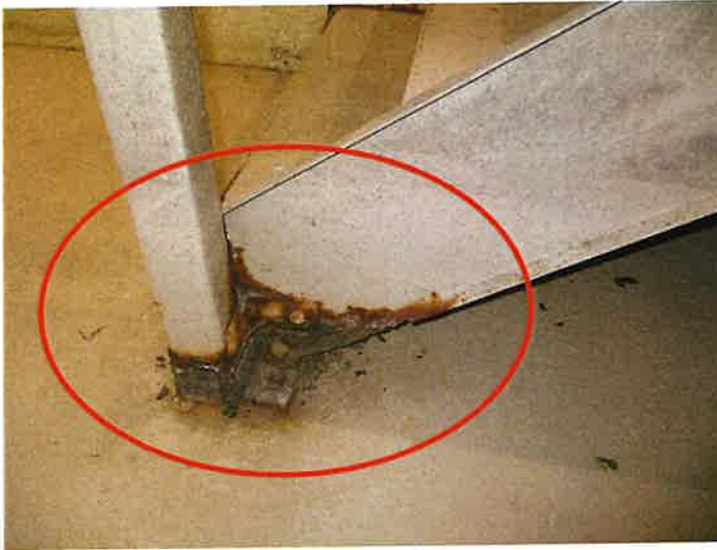
**PHOTOGRAPH #48**

**STAIR ASSEMBLIES  
CORROSION**

Corrosion of the stair's structural members was observed at several locations throughout the stair assemblies.
