# Structural Milestone Inspection - Phase I & II -

Property Located at:  
South Seas Northwest  
440 Seaview Court, Tower IV  
Marco Island, FL 34145

Prepared for:  
South Seas Northwest Condo Apts.  
of Marco Island Inc.  
c/o Resort Management Group

August 8, 2023

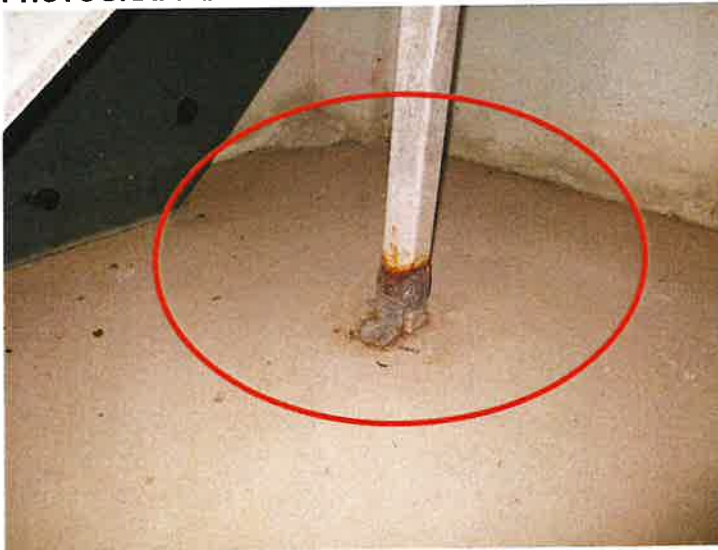
**PHOTOGRAPH #49**

**STAIR ASSEMBLIES  
CORROSION**

Corrosion of the stair's structural members was observed at several locations throughout the stair assemblies.

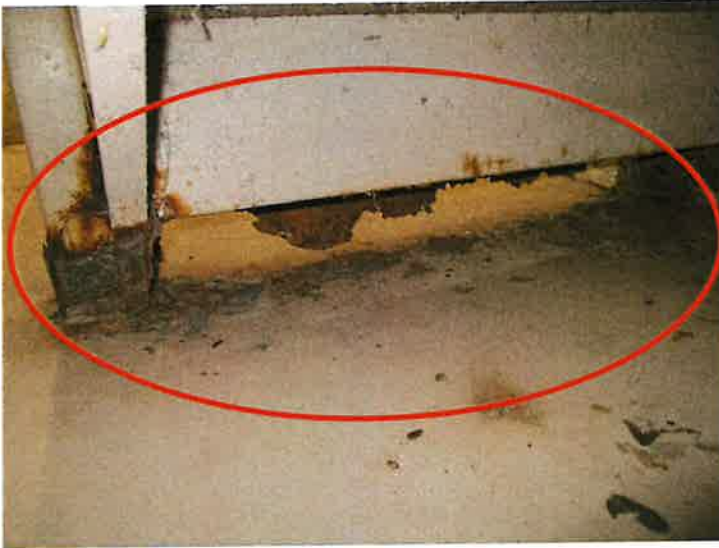
**PHOTOGRAPH #50**

**STAIR ASSEMBLIES  
CORROSION**

Corrosion of the stair's structural members was observed at several locations throughout the stair assemblies.

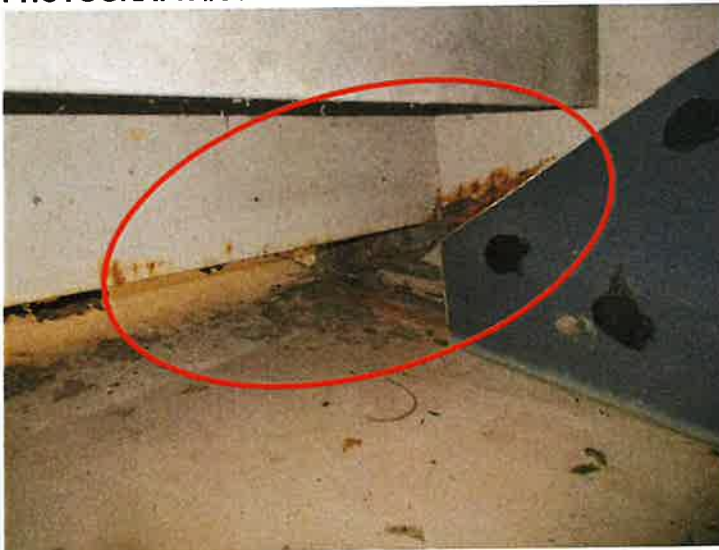
**PHOTOGRAPH #51**

**STAIR ASSEMBLIES  
CORROSION**

Corrosion of the stair's structural members was observed at several locations throughout the stair assemblies.

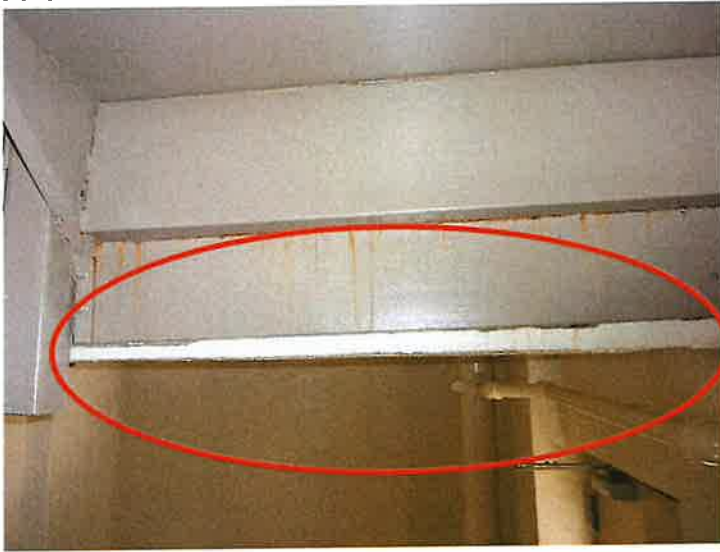
**PHOTOGRAPH #52**

**STAIR ASSEMBLIES  
CORROSION**

Corrosion was observed at several locations throughout the stair assemblies.

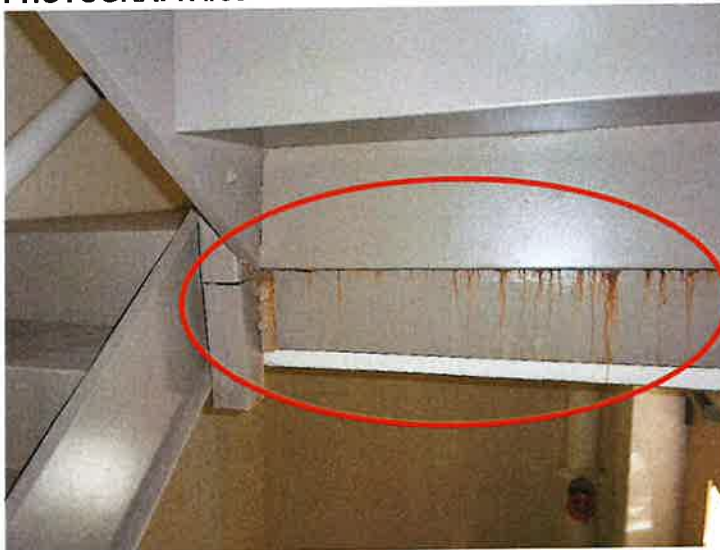
**PHOTOGRAPH #53**

**STAIR ASSEMBLIES  
CORROSION**

Corrosion was observed at several locations throughout the stair assemblies.

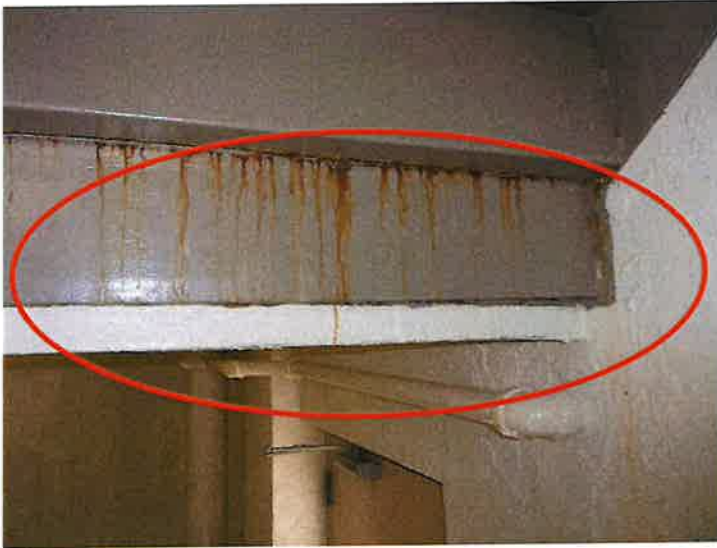
**PHOTOGRAPH #54**

**STAIR ASSEMBLIES  
CORROSION**

Corrosion was observed at several locations throughout the stair assemblies.

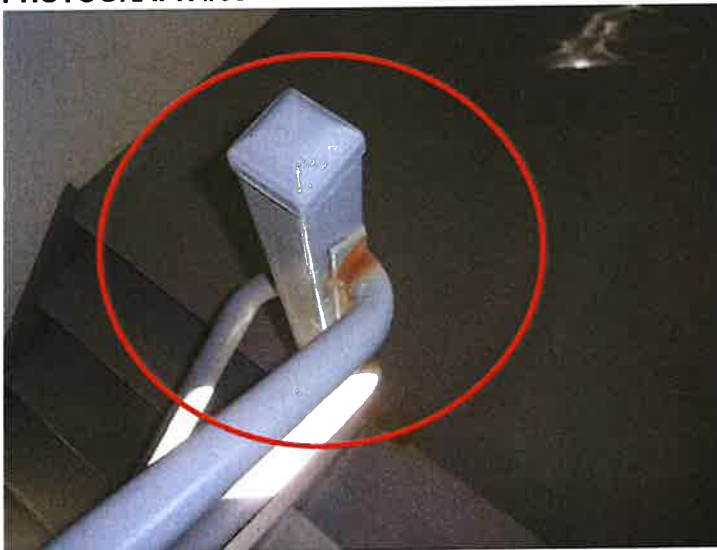
**PHOTOGRAPH #55**

**STAIR ASSEMBLIES  
CORROSION**

Corrosion was observed at several locations throughout the stair assemblies.

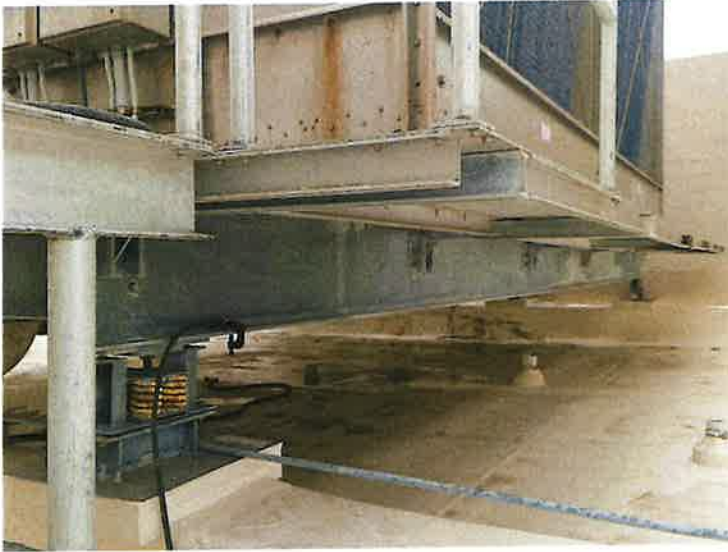
**PHOTOGRAPH #56**

**COOLING TOWER SUPPORT  
FRAME**

Corrosion was observed at several locations on the cooling tower support frame.

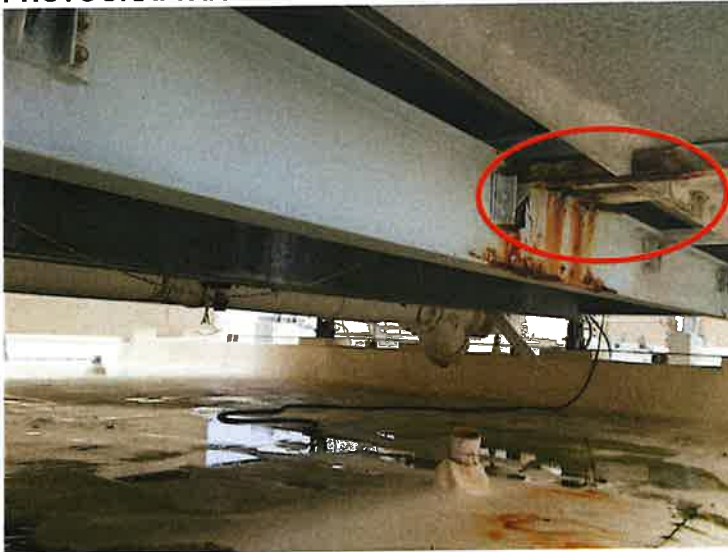
**PHOTOGRAPH #57**

**COOLING TOWER SUPPORT  
FRAME**

Corrosion with delamination on the catwalk supports.

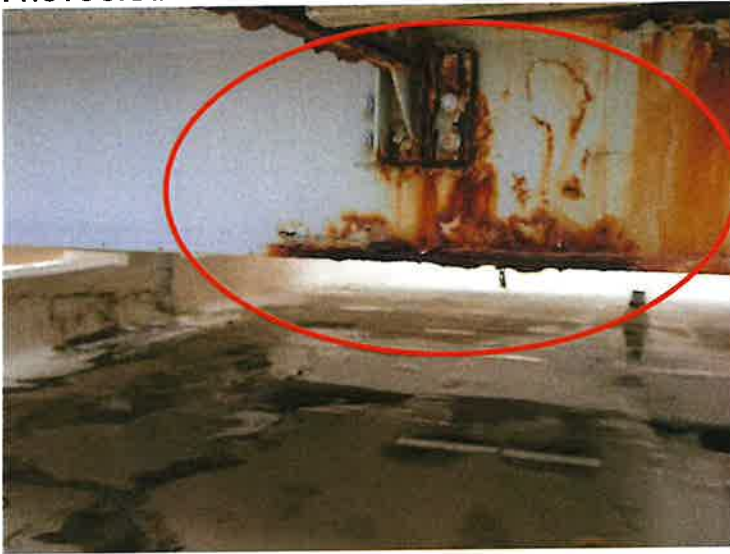
**PHOTOGRAPH #58**

**COOLING TOWER SUPPORT  
FRAME**

Corrosion with delamination on the  
support beam.

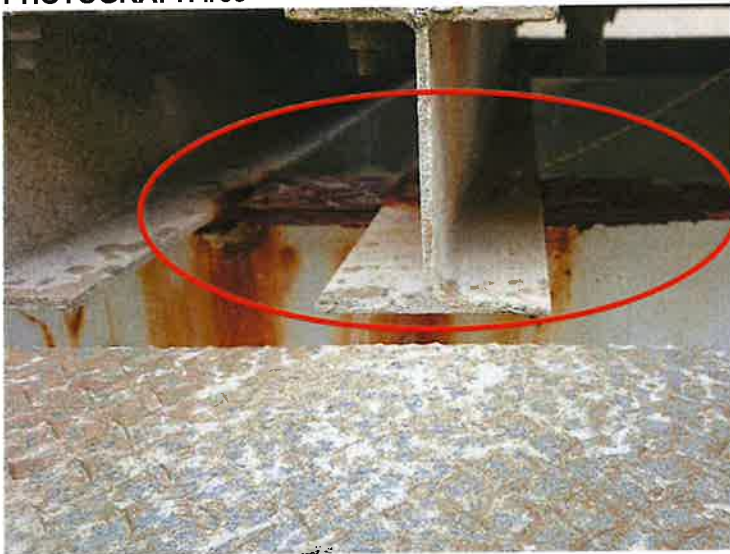
**PHOTOGRAPH #59**

**COOLING TOWER SUPPORT  
FRAME**

Corrosion with delamination on the  
support beam.
