### STEVENS LANDING CONDOMINIUMS

**100, 200, & 300**

**STEVENS LANDING DR.**

Bondurant Architecture, LLC ("BA") conducted a Phase One Structural Assessment of the five-story residential condominium buildings, located at 100, 200, and 300 Stevens Landing Dr., in Marco Island, Florida ("Subject Property"). The Subject Property was originally constructed in 1986.

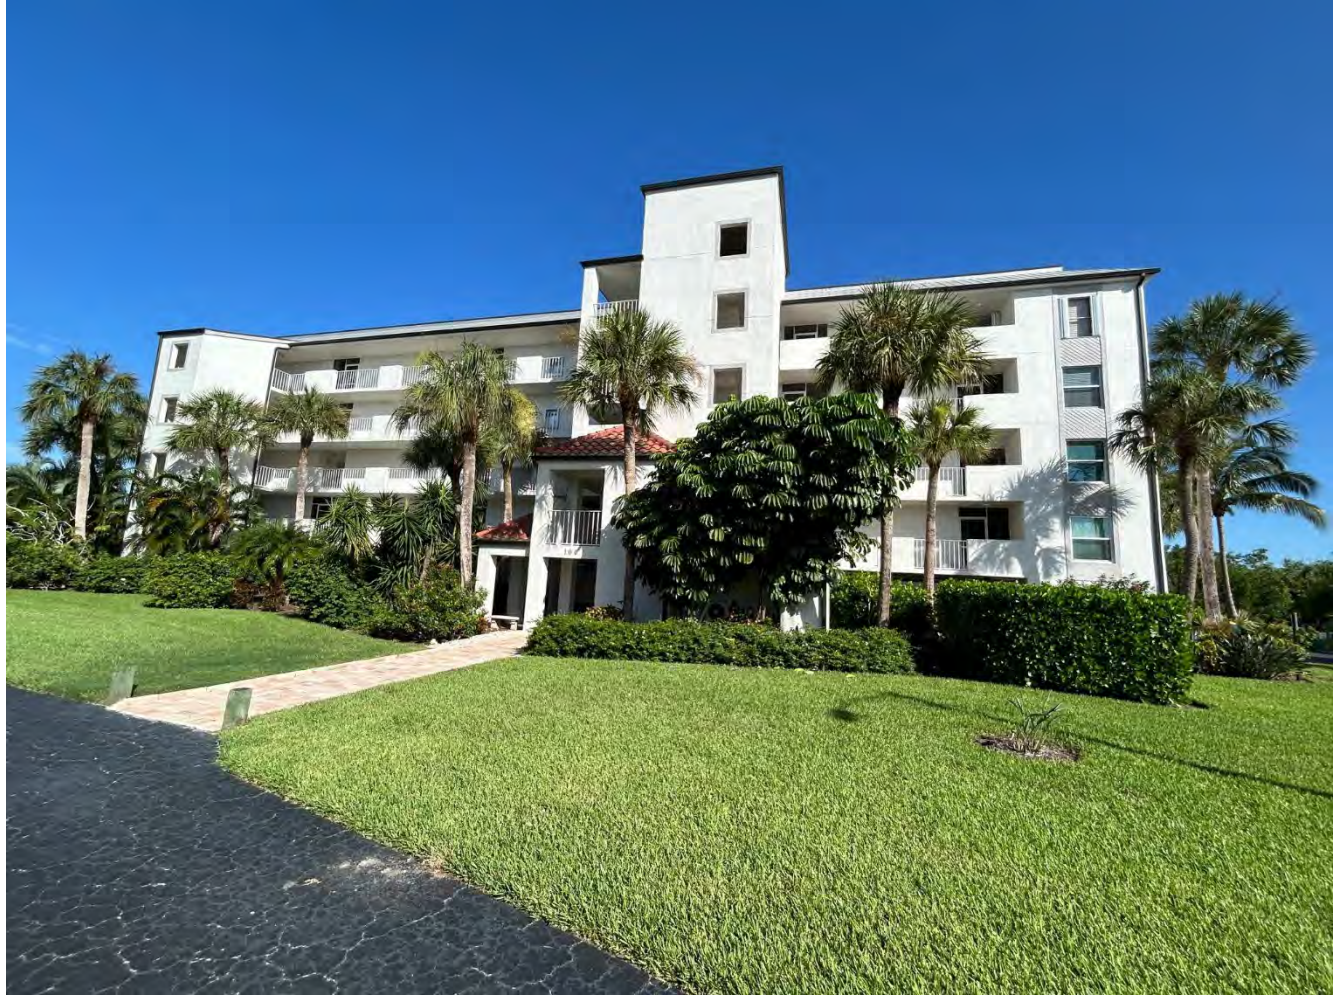
#### **Front View**

100 Stevens Landing Drive has an exterior of cementitious stucco. Exterior is generally in excellent condition with no observed hairline cracks in the stucco. Note other conditions on the exterior needing to be addressed. See photos below for recommendations.

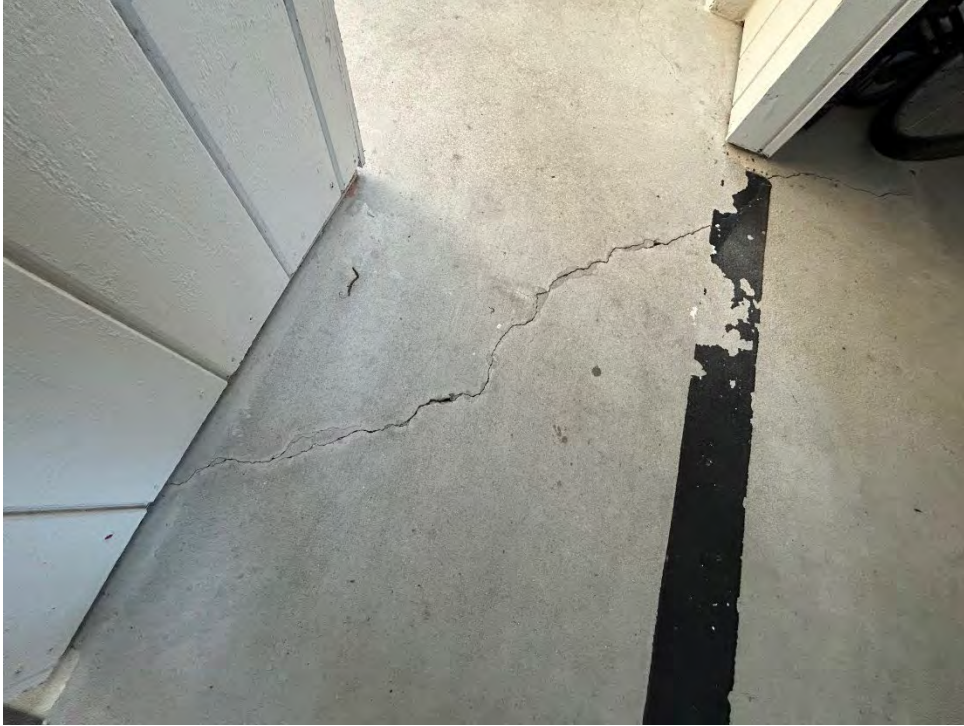
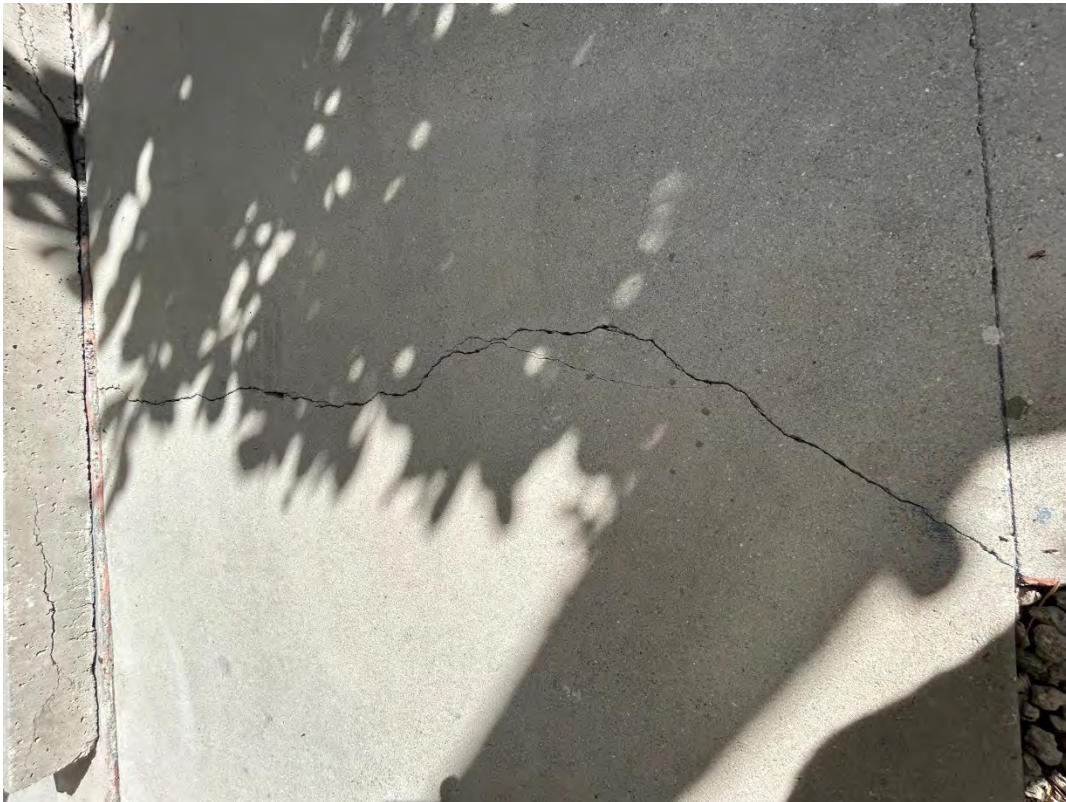
### Sidewalk Recommendation

There were several significant cracks in the sidewalks around the building. Over time these can become trip hazards. Cracks allow water to migrate below the slab and erode the supporting soils. Repairing these cracks will extend the useful life of the concrete walks significantly.

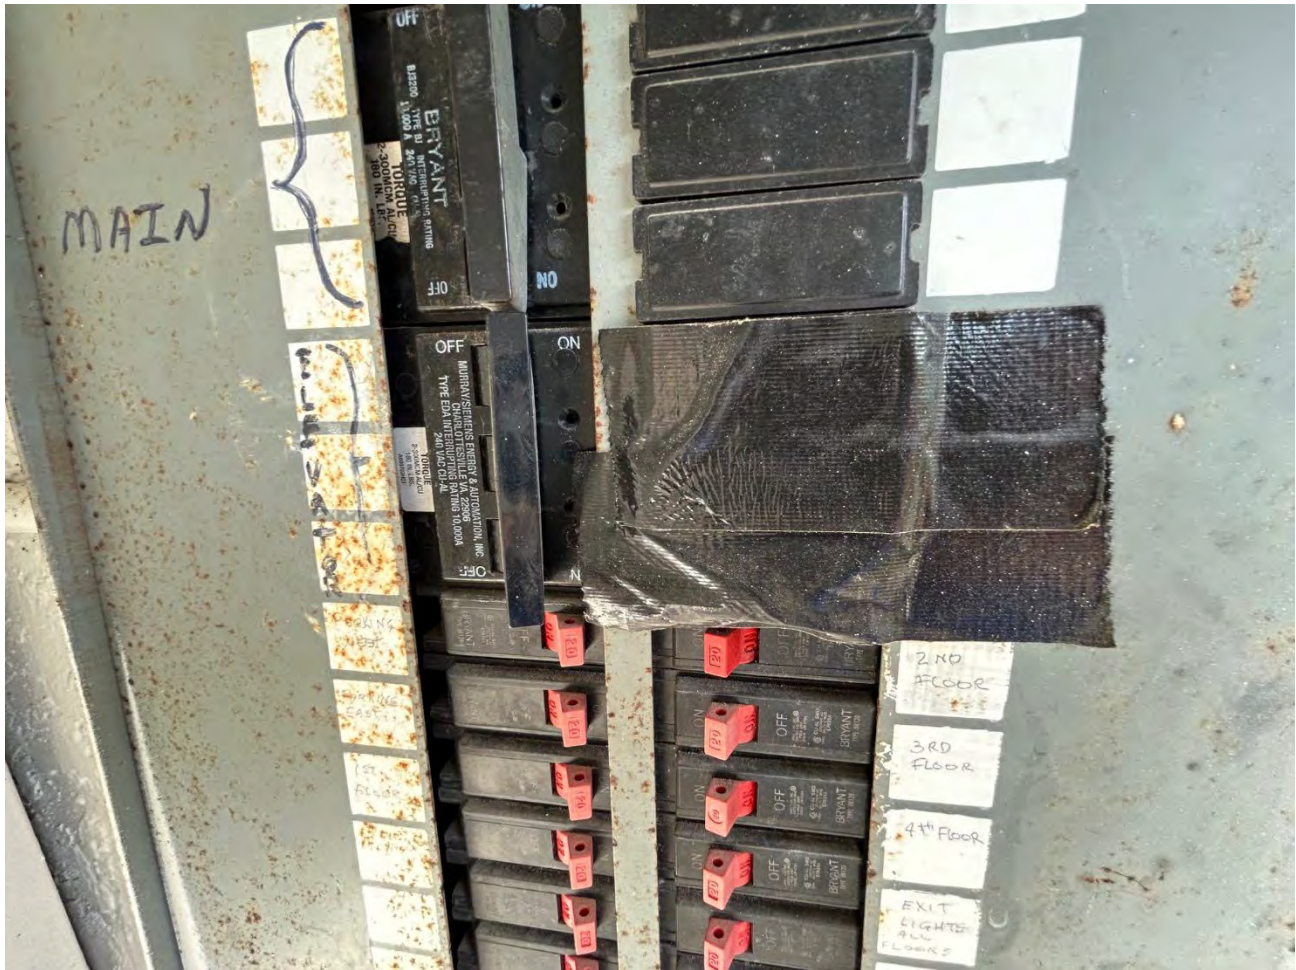
## Exterior Lighting Panel

This panel is located to the right of the bank of electrical meters. It had three blank spaces to the right of the elevator breaker that were covered with electrical tape rather than the metal covers that are required by code. Suggest having the correct metal covers installed by a licensed electrician as a safety precaution.

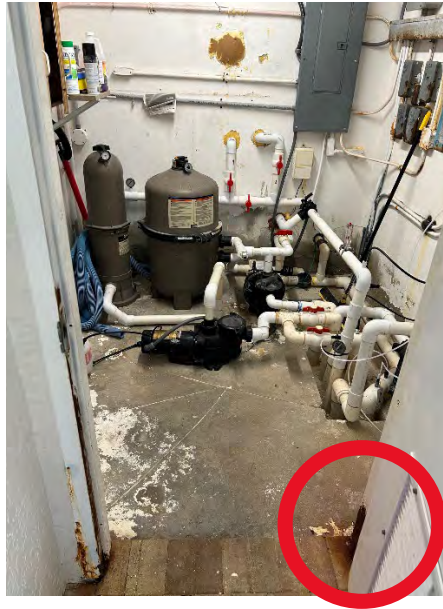
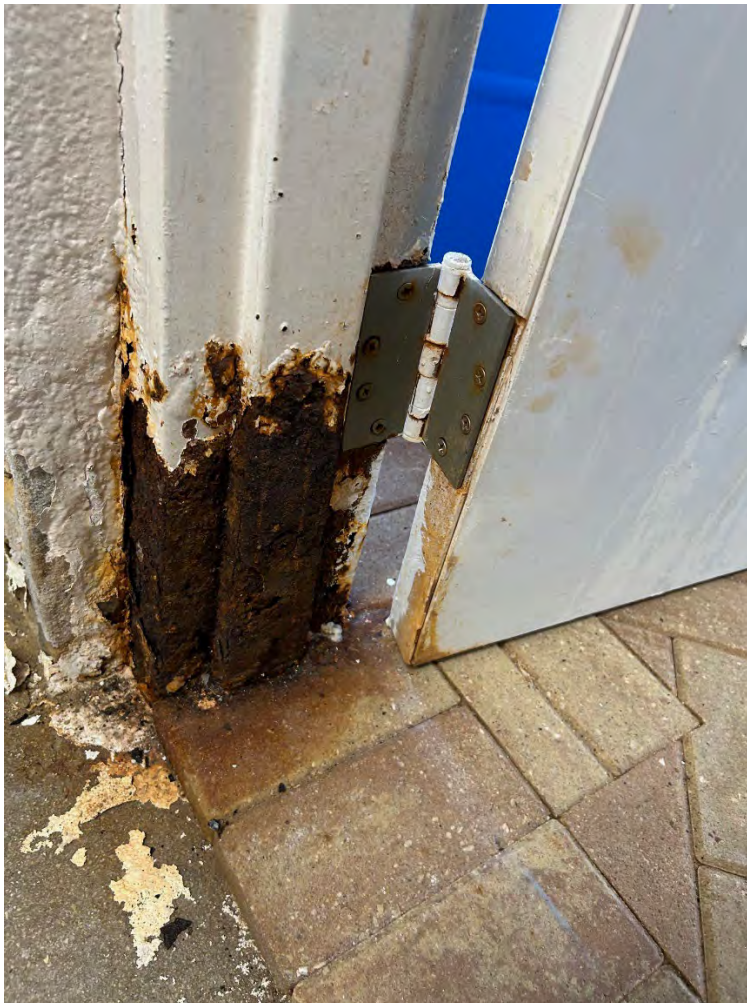
### Door to Pool Equipment Room

The steel jambs that support the pool equipment door were badly rusted. This can lead to a failure of the door in the high winds of a hurricane, which would turn the door into a flying debris hazard. Suggest having this door frame replaced at some point in the near future.

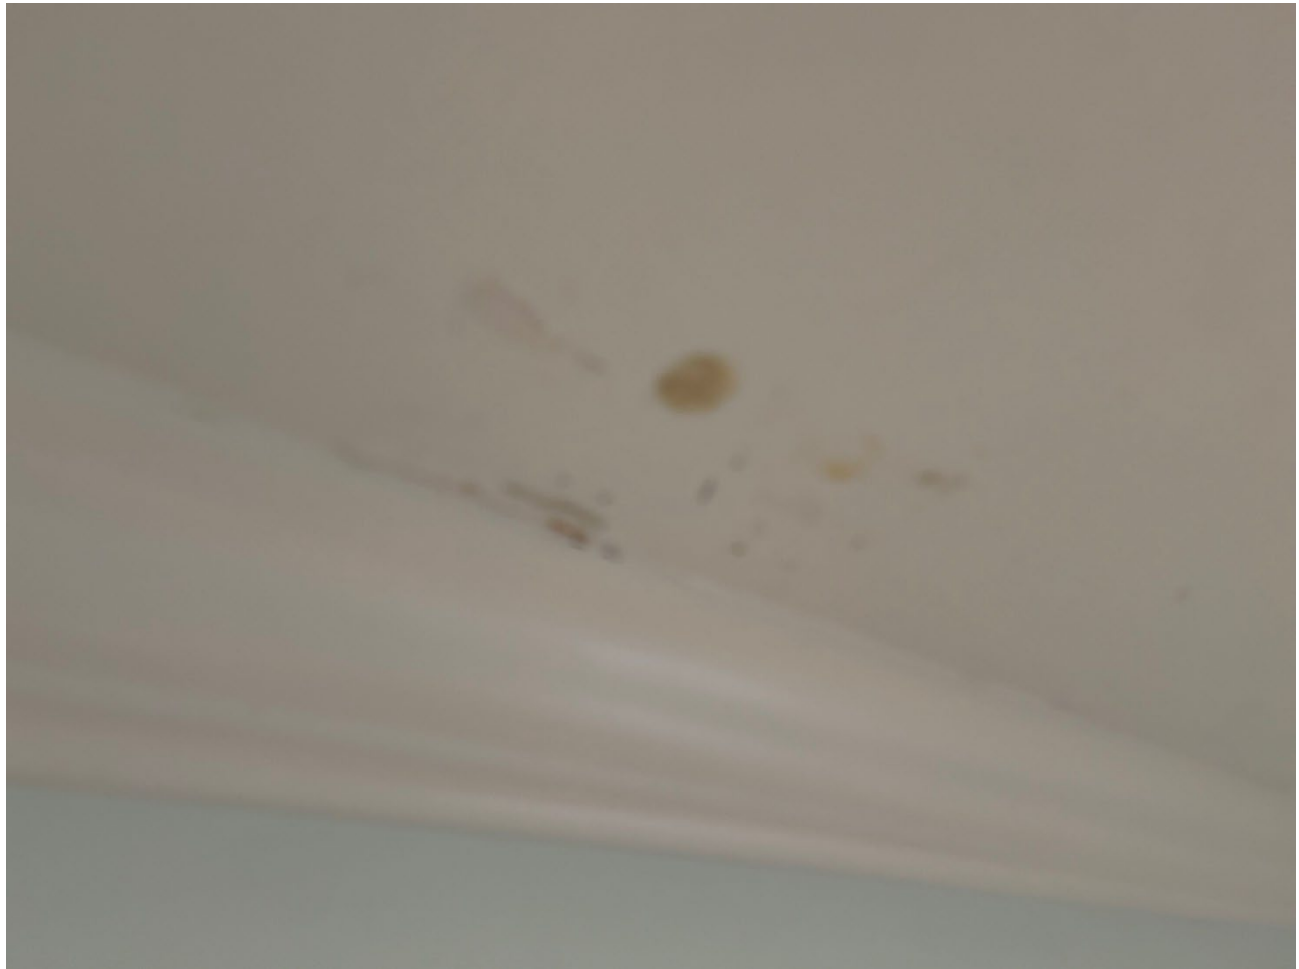
### Unit 101

Unit 101 had a water stain on the ceiling of the guest bedroom. The source of this water needs to be determined and repaired if not already. Suggest painting over this stain with a high hide concealer (ie, Kilz) then monitor the area to see if stains reappear.

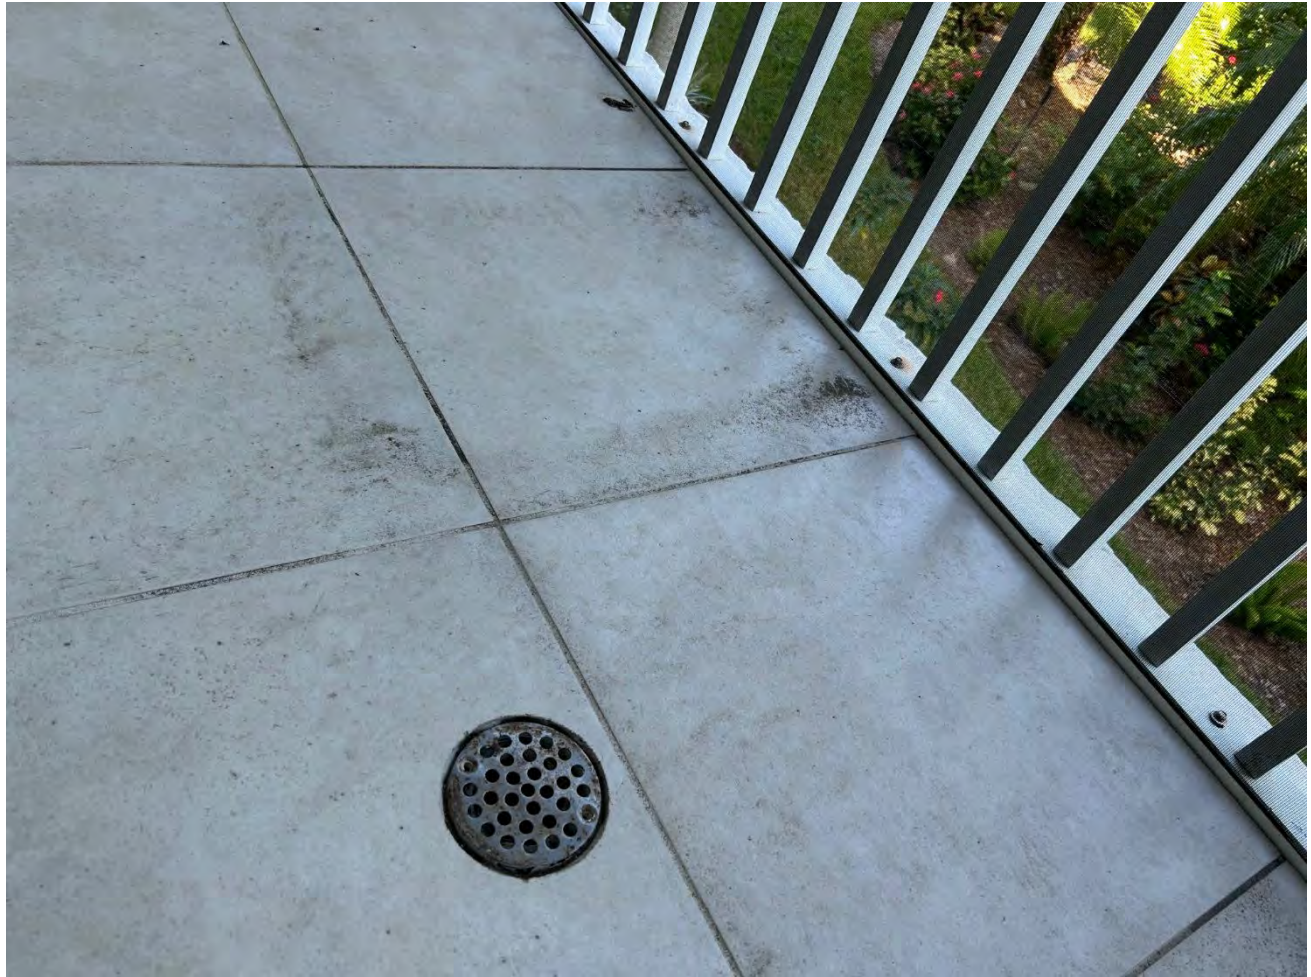
Unit 101 also had some evidence that the porch lanai had ponding water on it in spite of the fact there was a floor drain in this space. Suggest having this drain checked to be sure it is draining freely. Standing water on a porch like this can lead to deterioration of the underlying concrete slab. The tile that has been installed on the floor may have covered the weep holes in the bottom of the aluminum framing. Might be a good idea to have new weep holes drilled into this frame.

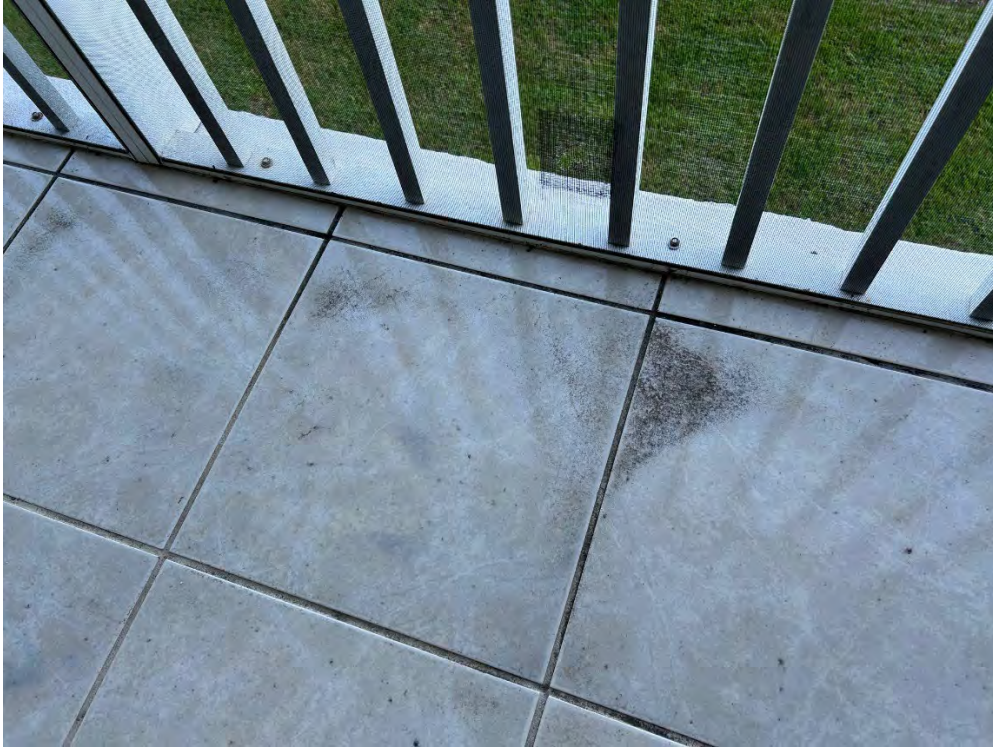
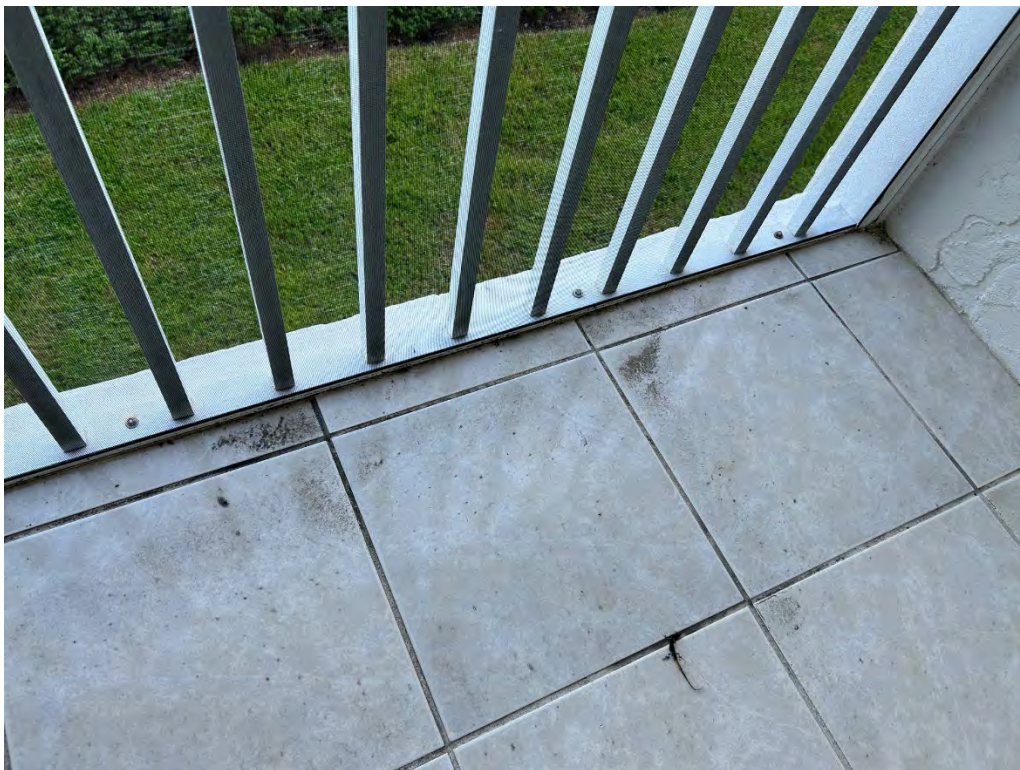
## Unit 102

Unit 102 also had evidence of ponding on the porch lanai as evidenced by accumulation of dirt where ponding water is left to evaporate. For the reasons stated above, it is best to allow water that accumulates on the porches to run-off and not be allowed to soak down into the supporting slab. Suggest having new weep holes drilled in the aluminum framing at the top of the tile that will allow water to run off porch.

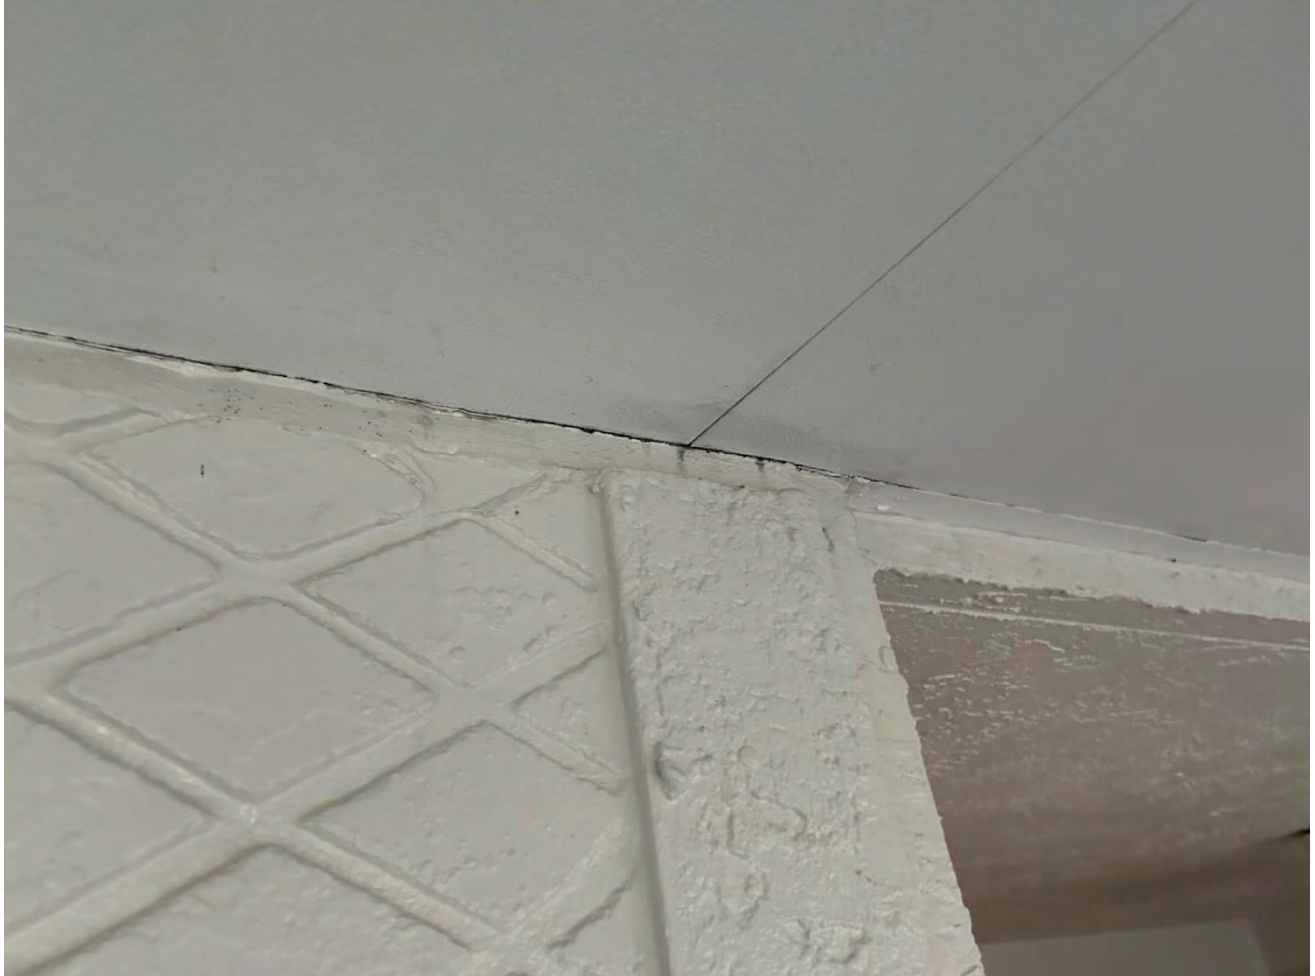
### Unit 106

Unit 106 had some staining on the porch ceiling that may be from the porch above. If the porch above does not have adequate weep holes in the aluminum framing, this could allow accumulating rainwater to run down to unit below. Suggest having this staining repaired then monitored over time to see if it returns and check weep holes in porch framing above.

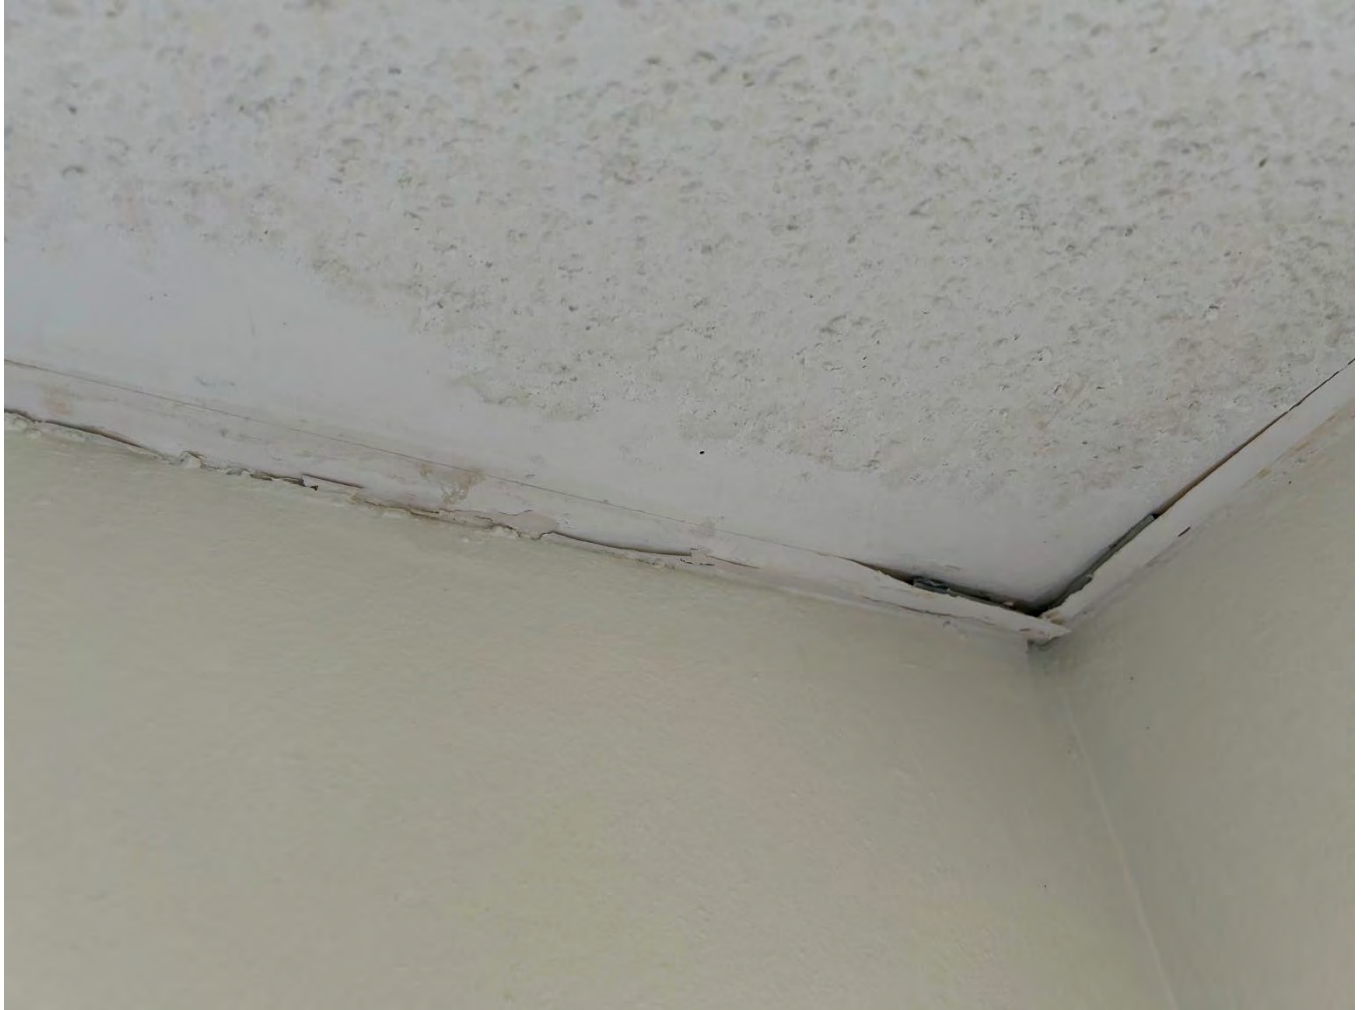
### Unit 303

Unit 303 had some water damage on the ceiling of the Master Bedroom. There did not seem to be any wetness or evidence that this leak was active. Suggest having this water damage repaired then monitor the area for any signs of further water penetration.

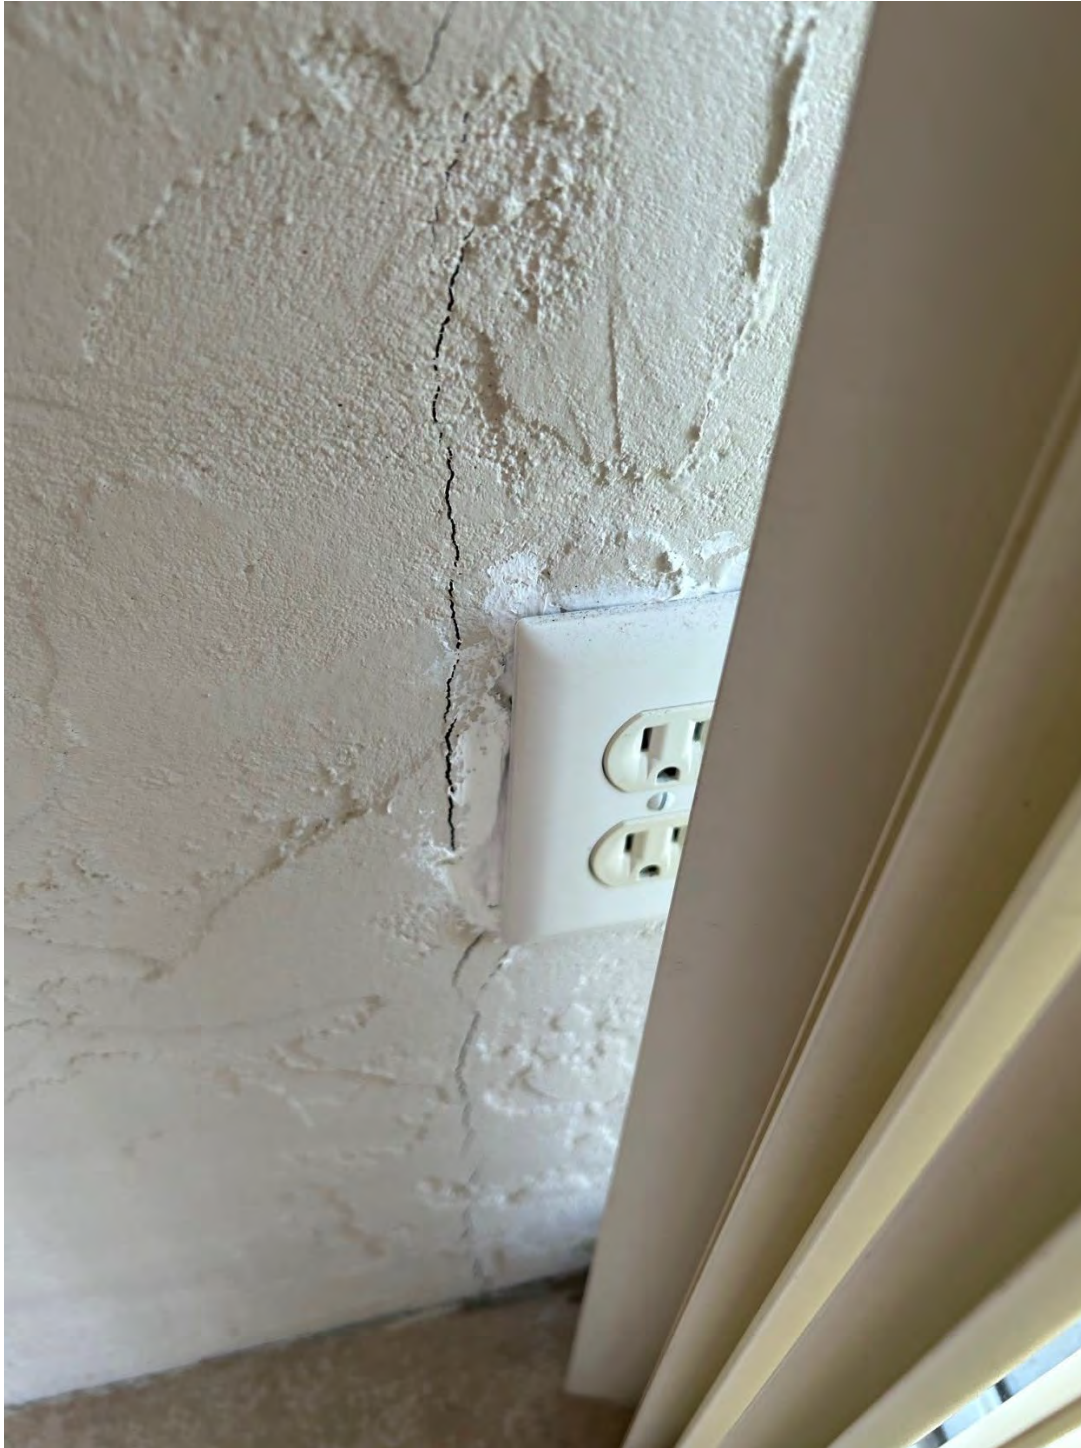
### Unit 305

Unit 305 had a hairline crack adjacent on outlet on the left side of the enclosed porch. This appeared to be strictly cosmetic but inspector suggested the crack be repaired to be sure it does not try to reappear. Resident said she would have the crack repaired in the near future.

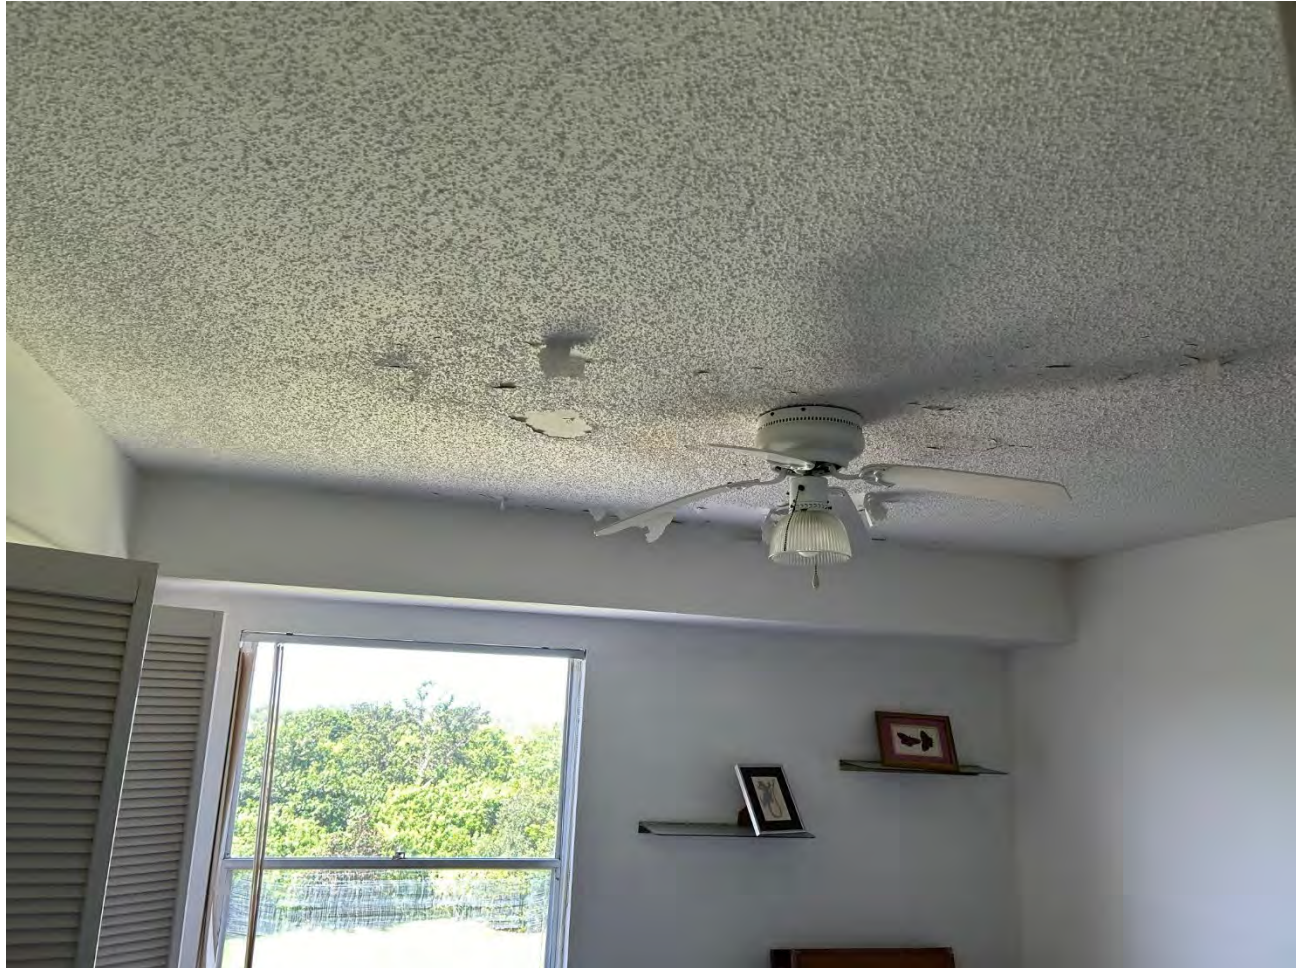
## Unit 401

Unit 401 had some water damage on the ceiling of the Guest Bedroom and a water stain on the ceiling of the Living Room. Residents said the leaks have not been an issue since the new roof was installed. Suggest having this water damage repaired to be sure the issue has been adequately resolved.

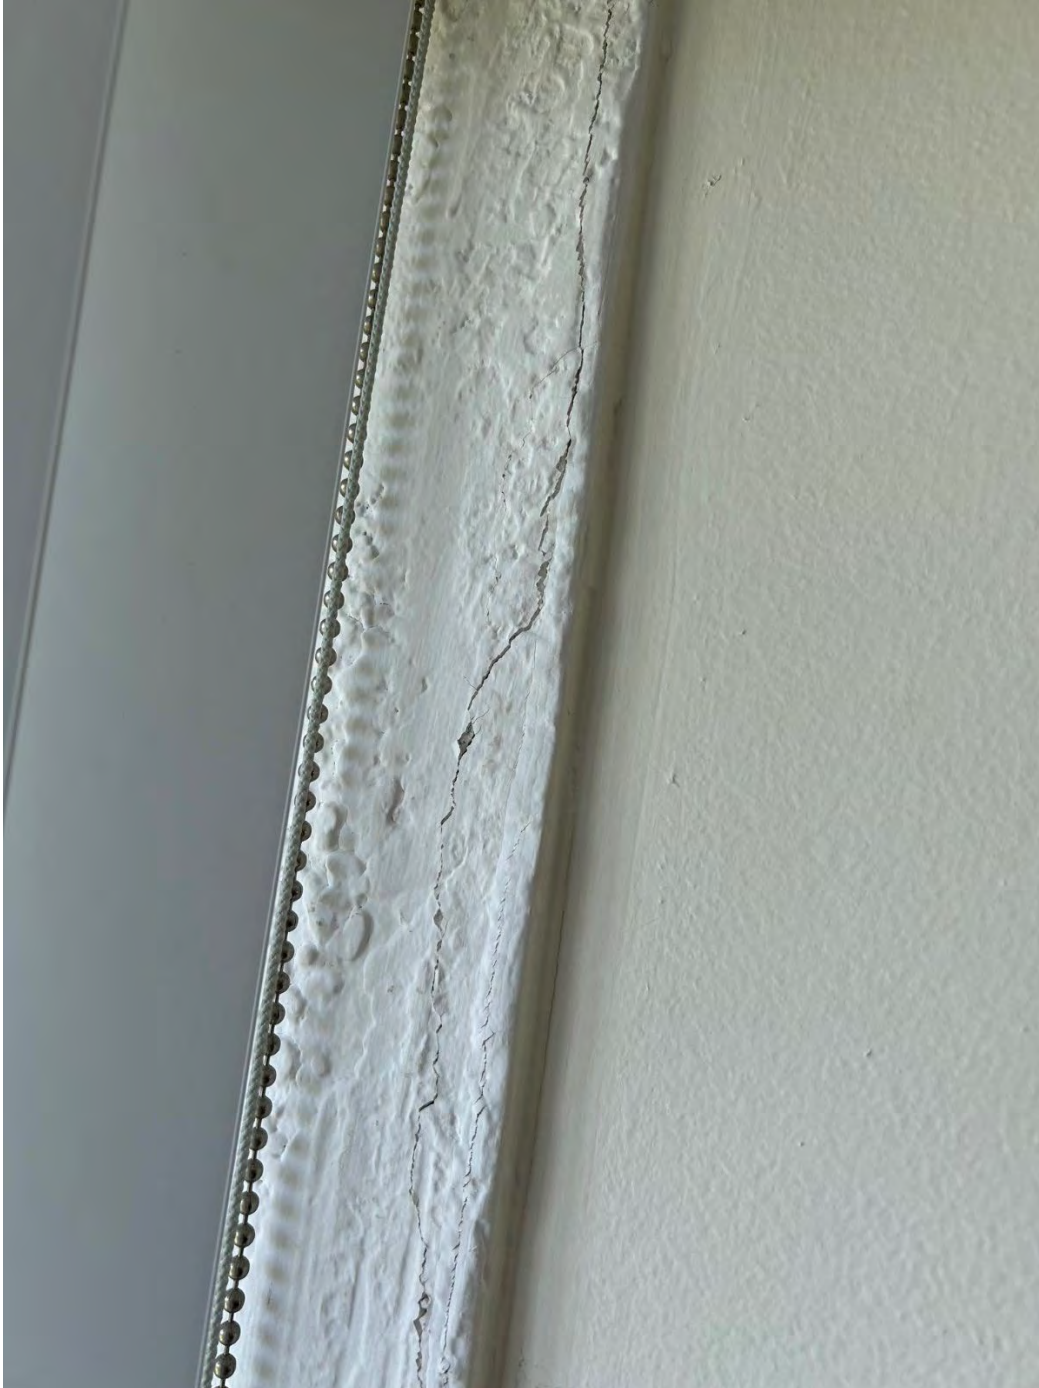
## Unit 404

Unit 404 had a hairline crack that ran almost from ceiling to floor on the right end of the sliding glass door on the enclosed porch. Suggest having this crack repaired and then monitored to see if it tries to reappear.

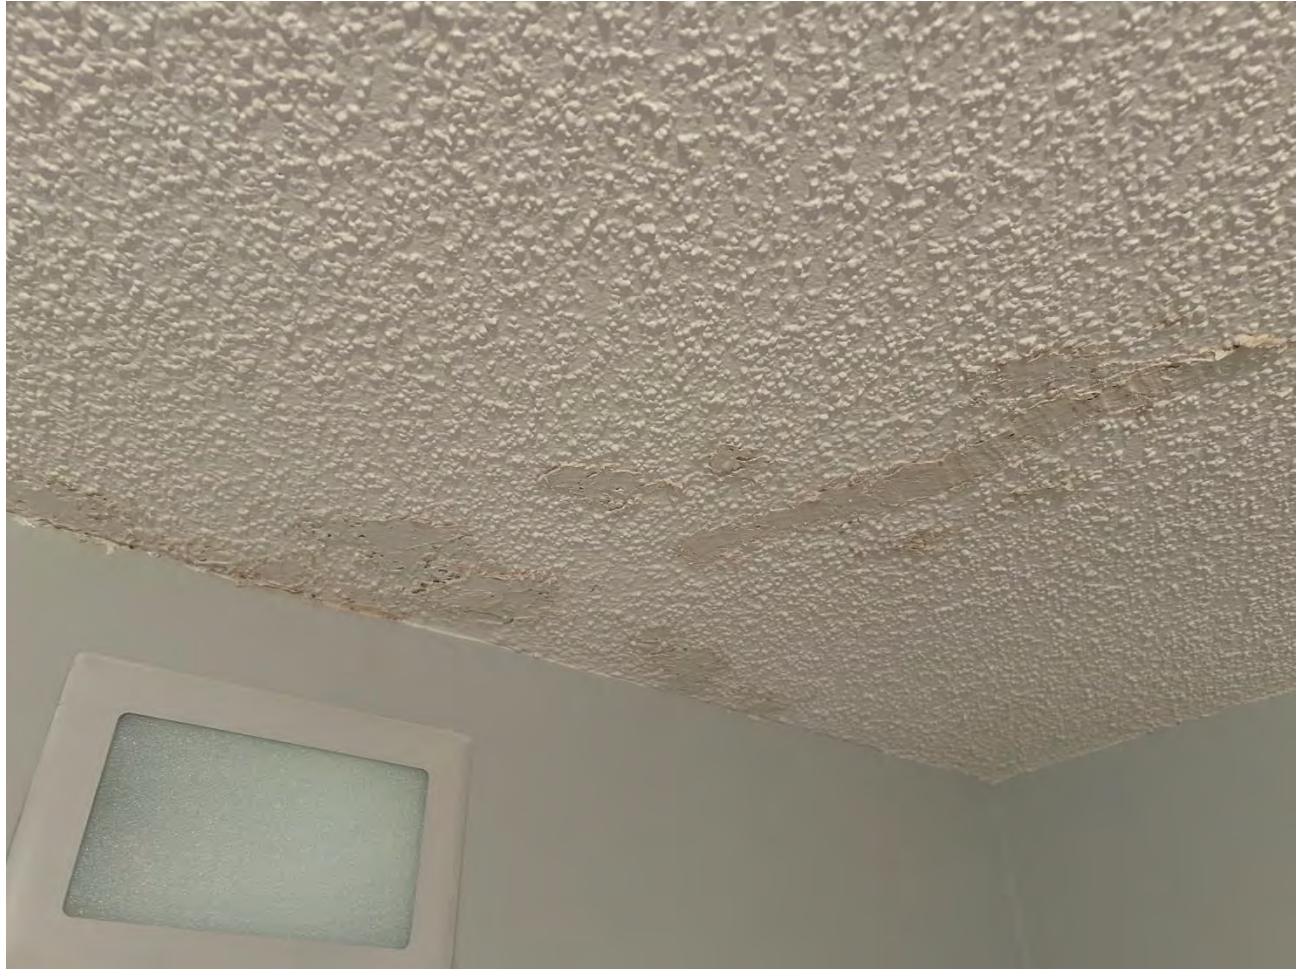
Unit 404 also had some water damage to the ceiling of the Guest Bedroom. This issue seems to have been addressed when the new roof was installed. Suggest having this area repaired to be sure no further water stains appear.

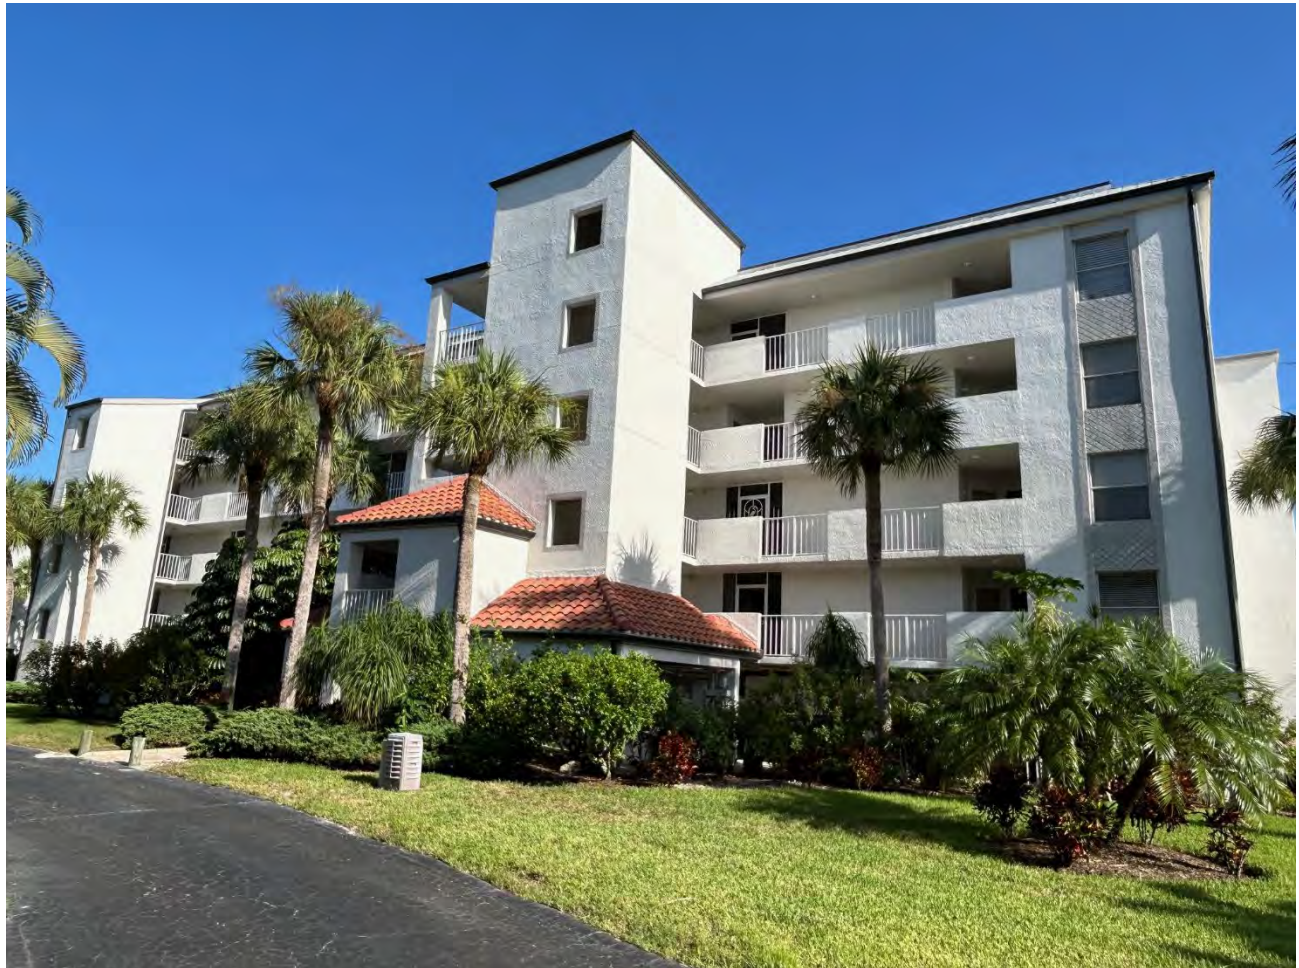
#### Front View

200 Stevens Landing Dr has an exterior of cementitious stucco. Exterior is generally in excellent condition with no observed hairline cracks in the stucco. See photos below for recommendations

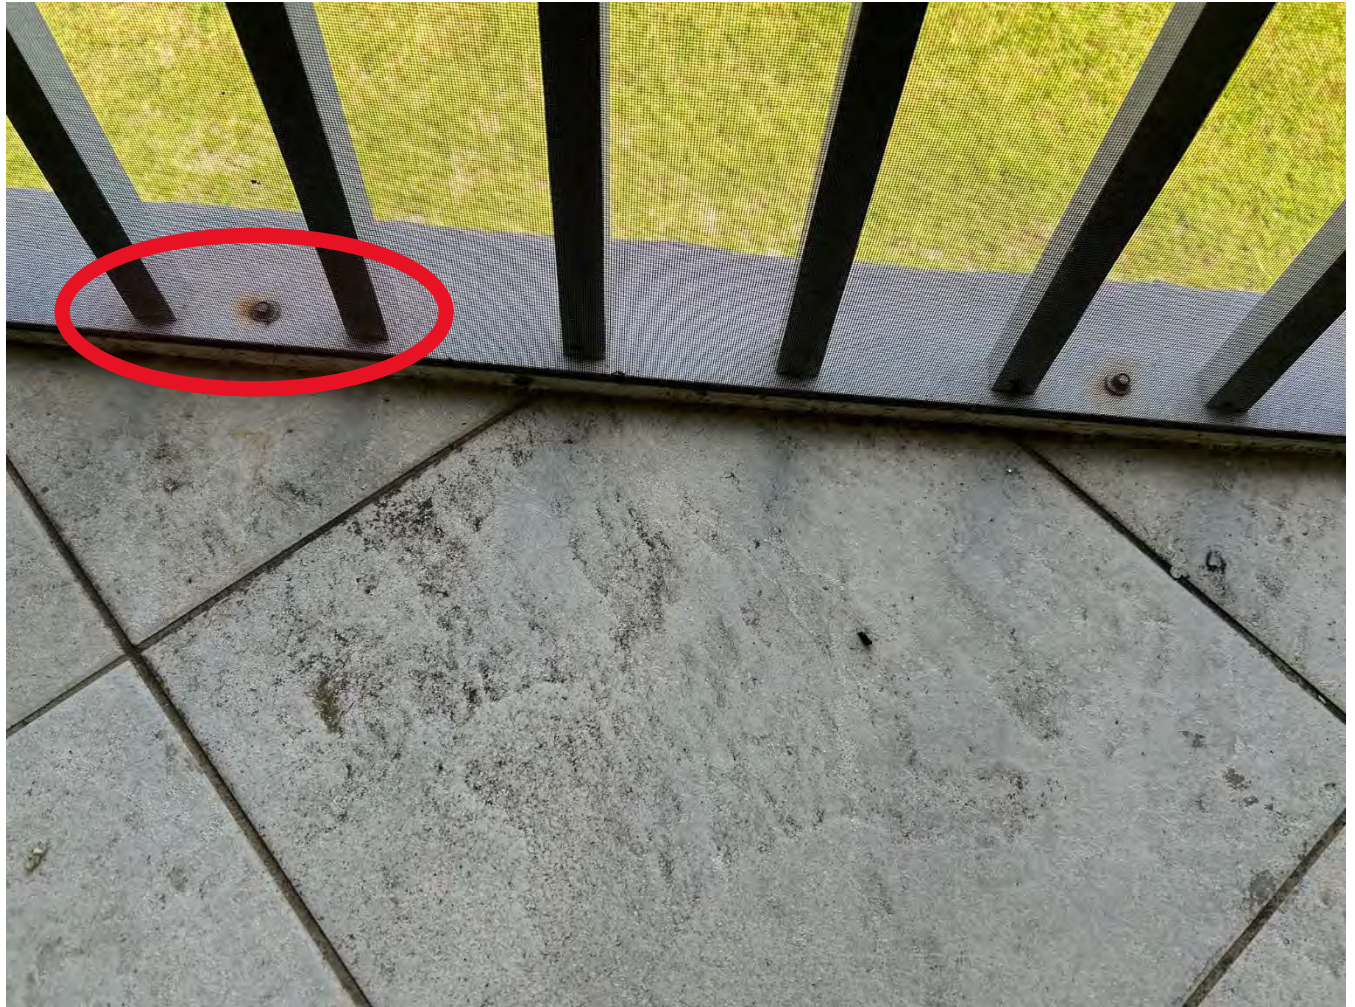
### Unit 101

Unit 101 also had issues with ponding water on the porch lanai. The problem was significant enough to cause rusting of the screws supporting the aluminum framing. There was at least one weep hole evident in the bottom rail but it may be blocked. Suggest clearing of all weep holes to be sure they are free flowing, and considering adding a few more to increase the drain rate to more quickly route rain water off this porch.
