### STEVENS LANDING CONDOMINIUMS

**100, 200, & 300**

**STEVENS LANDING DR.**

Bondurant Architecture, LLC ("BA") conducted a Phase One Structural Assessment of the five-story residential condominium buildings, located at 100, 200, and 300 Stevens Landing Dr., in Marco Island, Florida ("Subject Property"). The Subject Property was originally constructed in 1986.

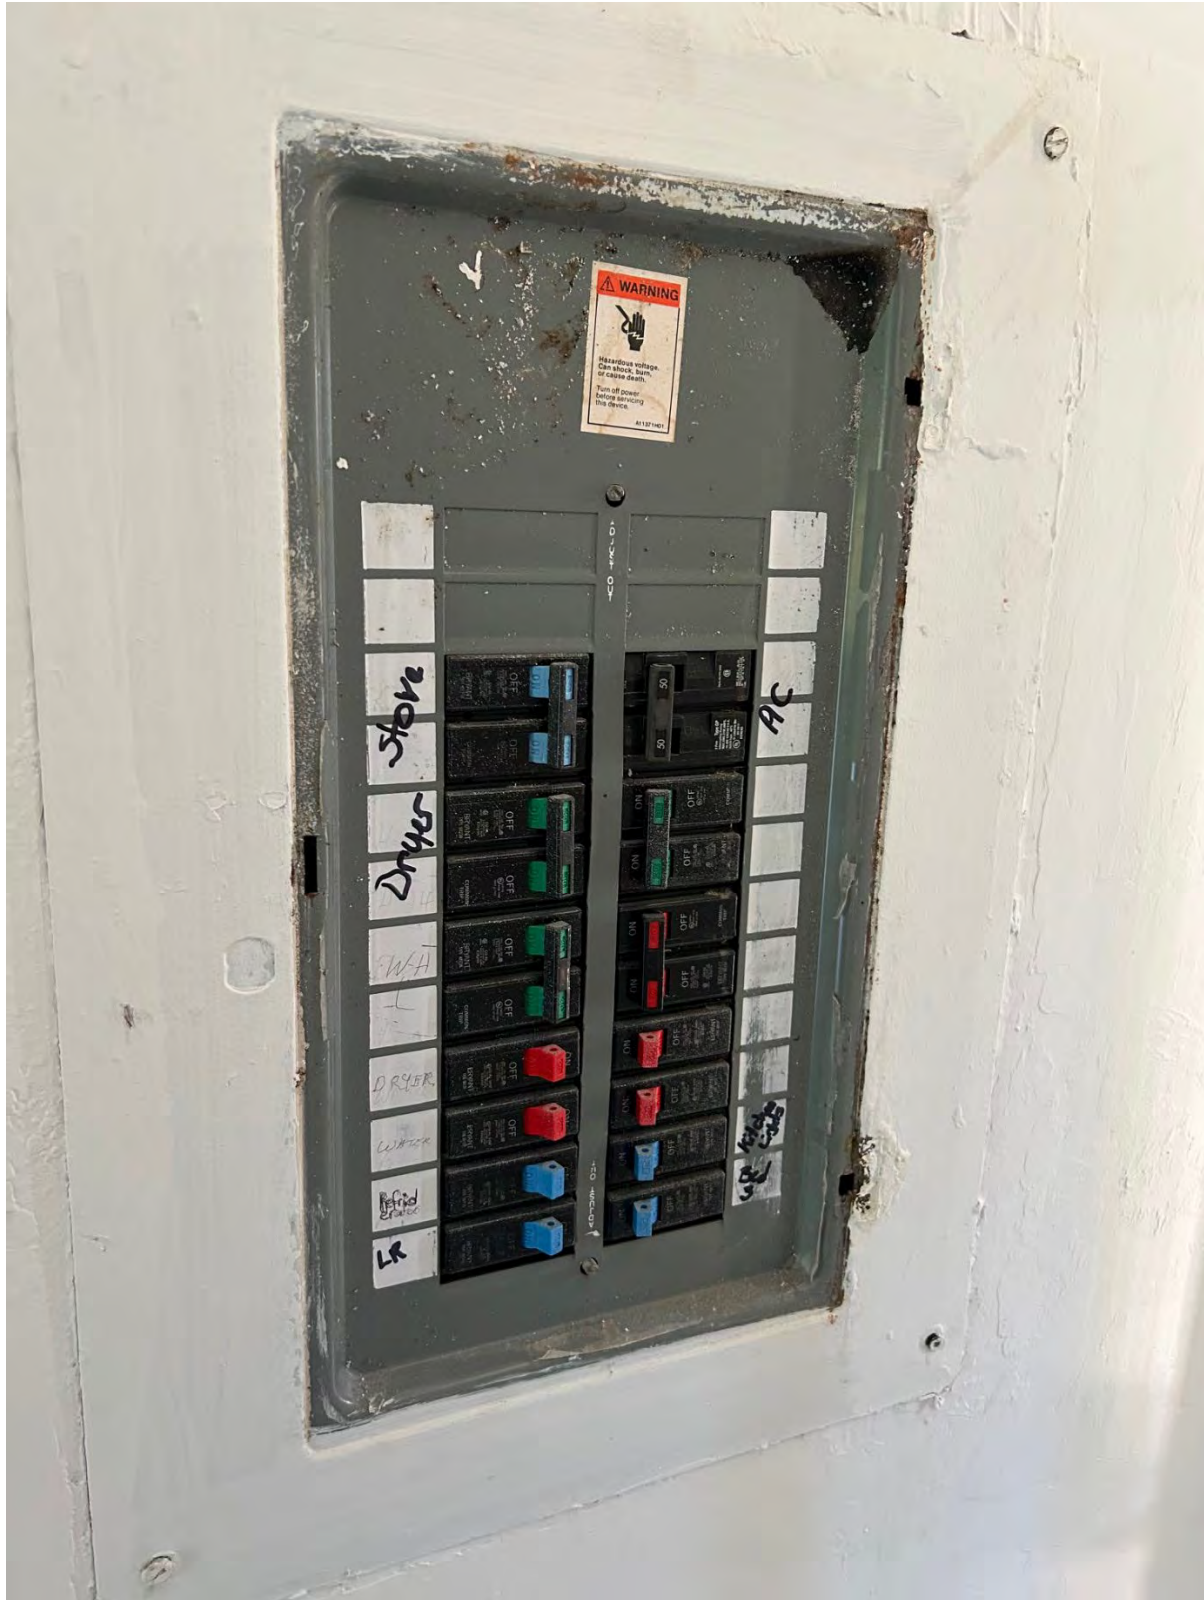
## Unit 106

Unit 106 was missing a cover for the electrical panel. Also some of the screws holding the panel face were not code compliant. Suggest having this panel face replaced and proper screws installed by a licensed electrician.

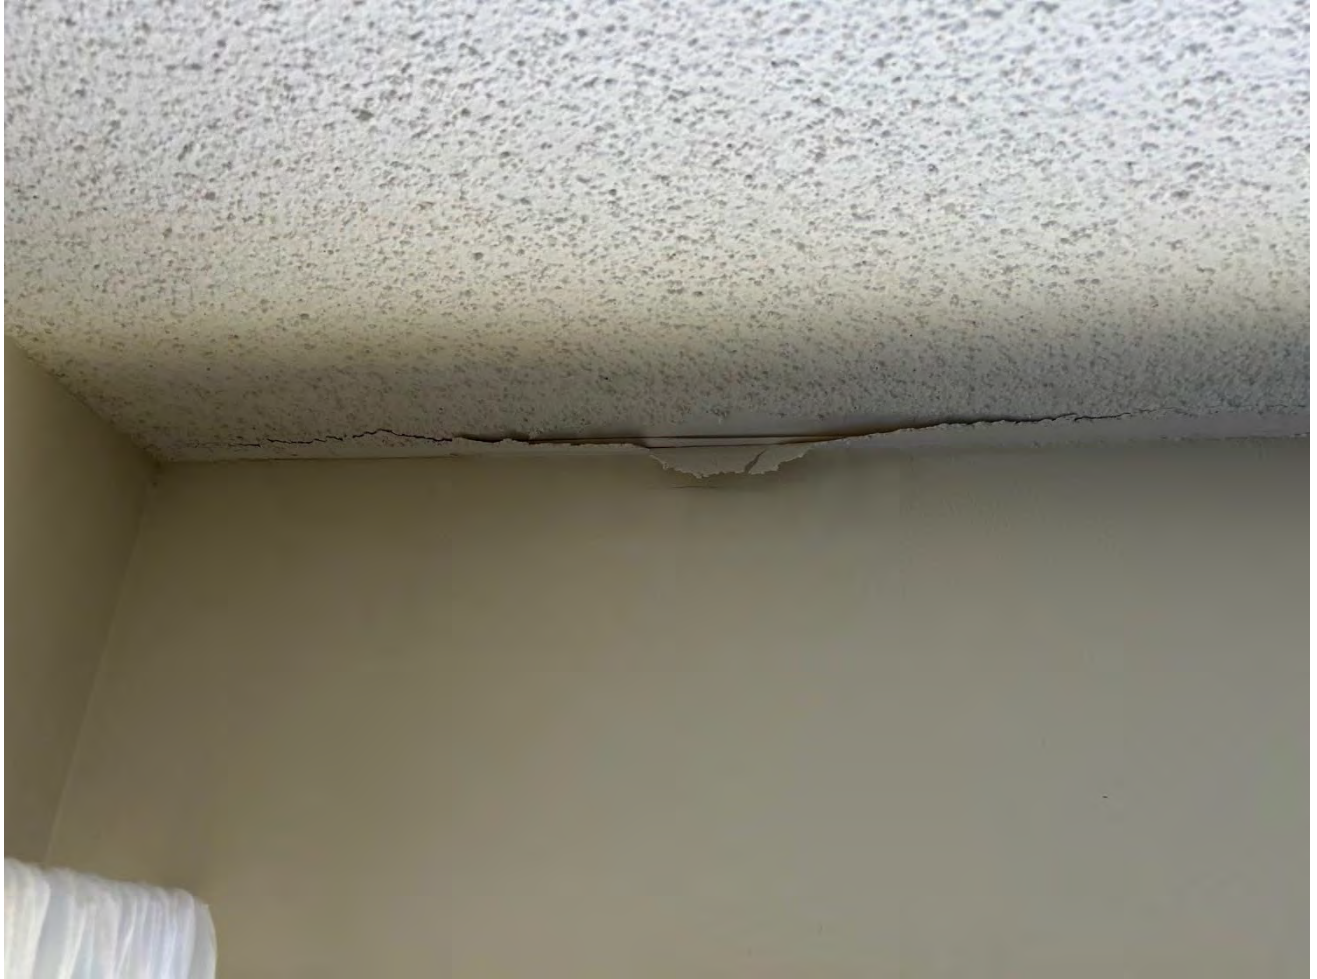
## Unit 202

Unit 202 had some signs of water damage on the ceiling of the Master Bedroom. Leak did not appear active as there was no dampness or discoloration. Suggest having this ceiling damage repaired then monitored over time for any further signs of water leaks.

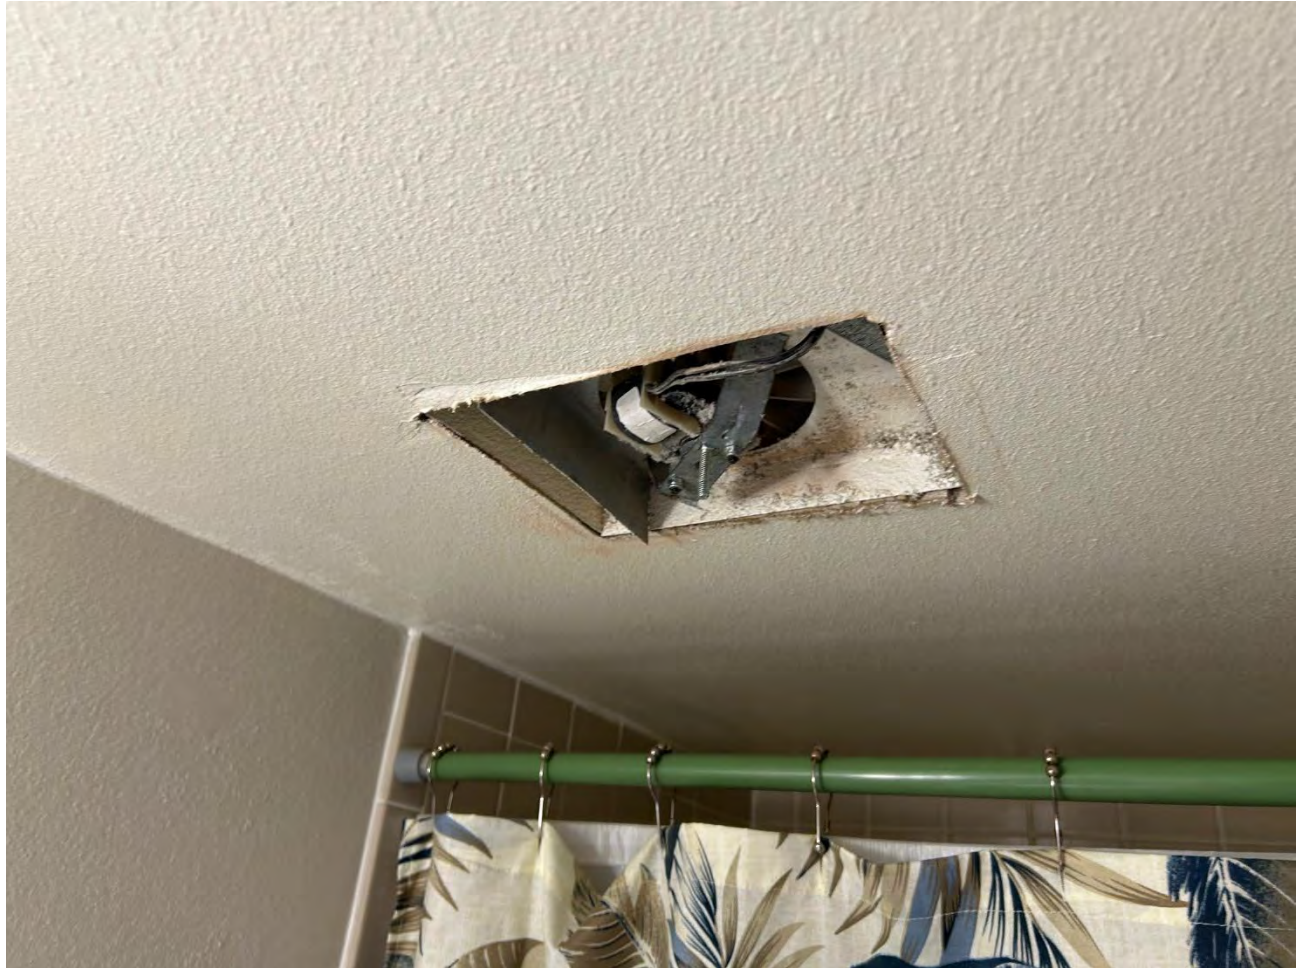
### Unit 306

Unit 306 was missing a cover for the Guest Bathroom vent fan. Cover was located in the bath cabinet but the Nut was missing that secures it to the fixture. This is considered a safety concern so inspector recommends having this cover replaced as soon as possible.

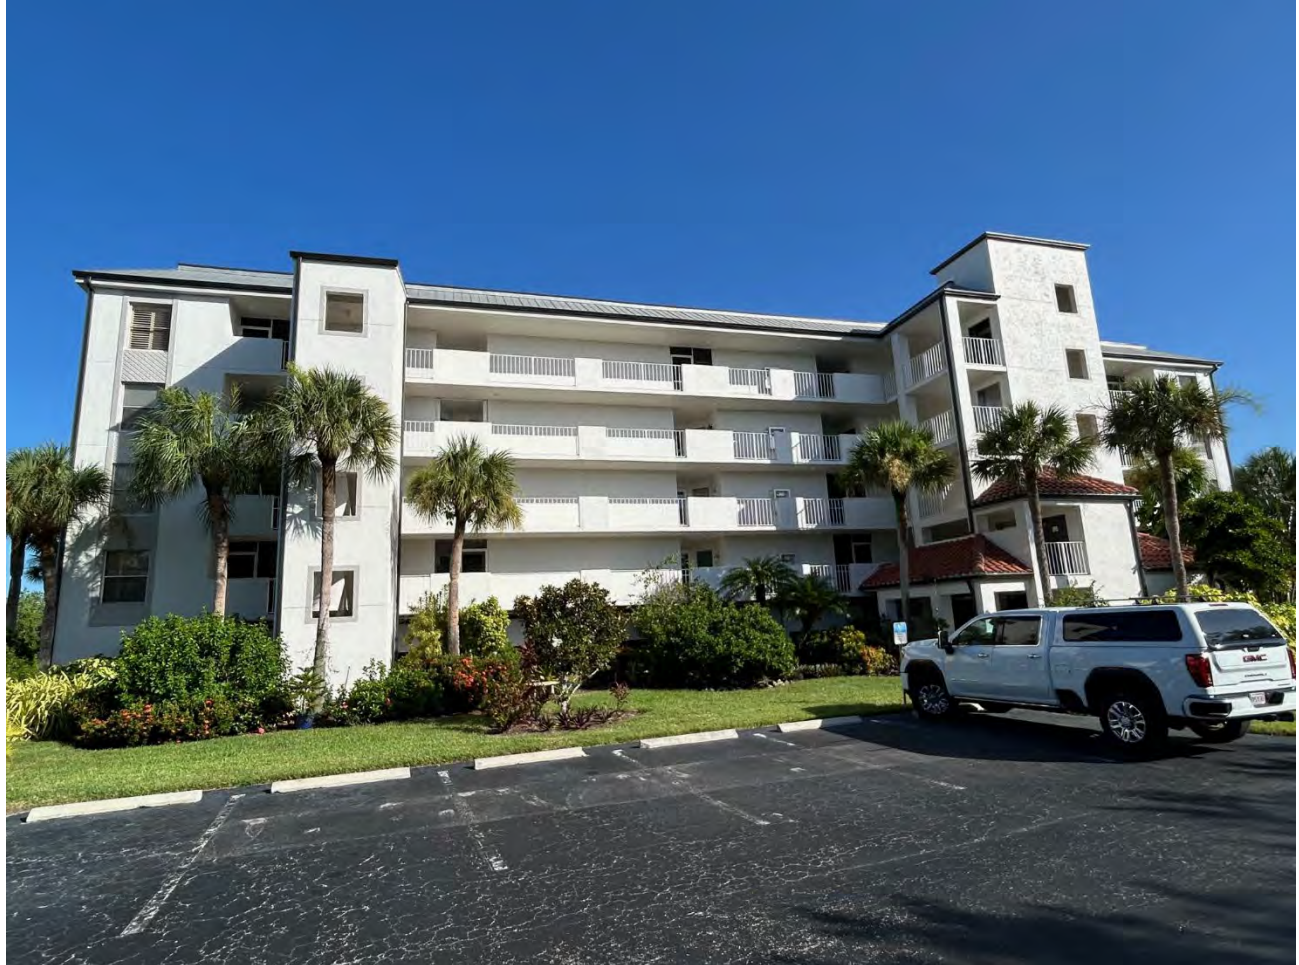
#### Front View

300 Stevens Landing Drive has an exterior of cementitious stucco. Exterior is generally in excellent condition with no observed hairline cracks in the stucco. See photos below for additional recommendations.

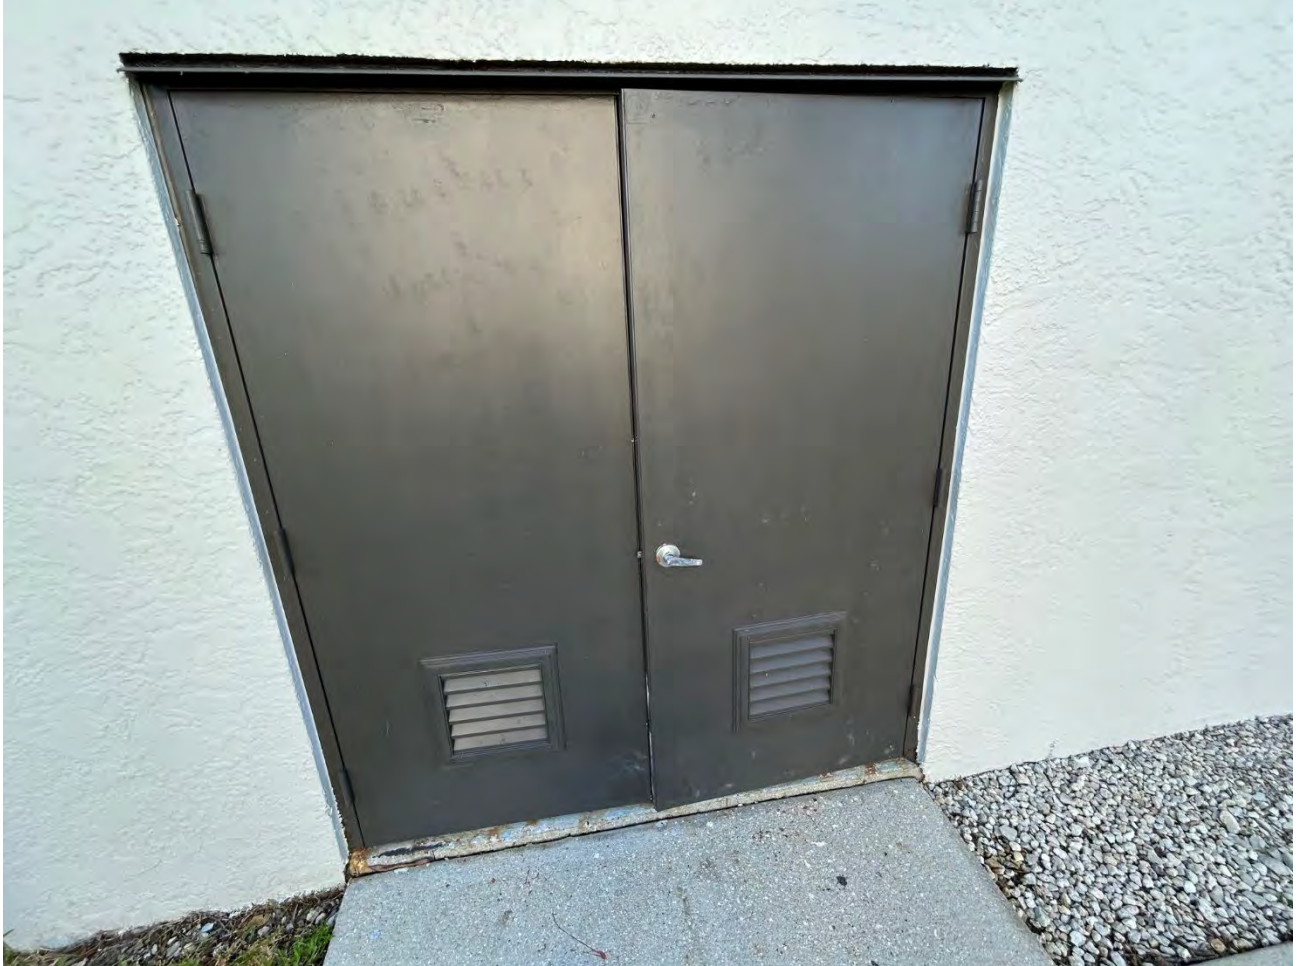
### **Exterior Doors to Storage Area**

This pair of doors would not fully close and latch. Also the interior of this storage area smelled very musty. This smell may be from moisture which has migrated through these ill-fitting doors. Suggest having these doors adjusted or replaced as needed to establish a tight seal from the weather.

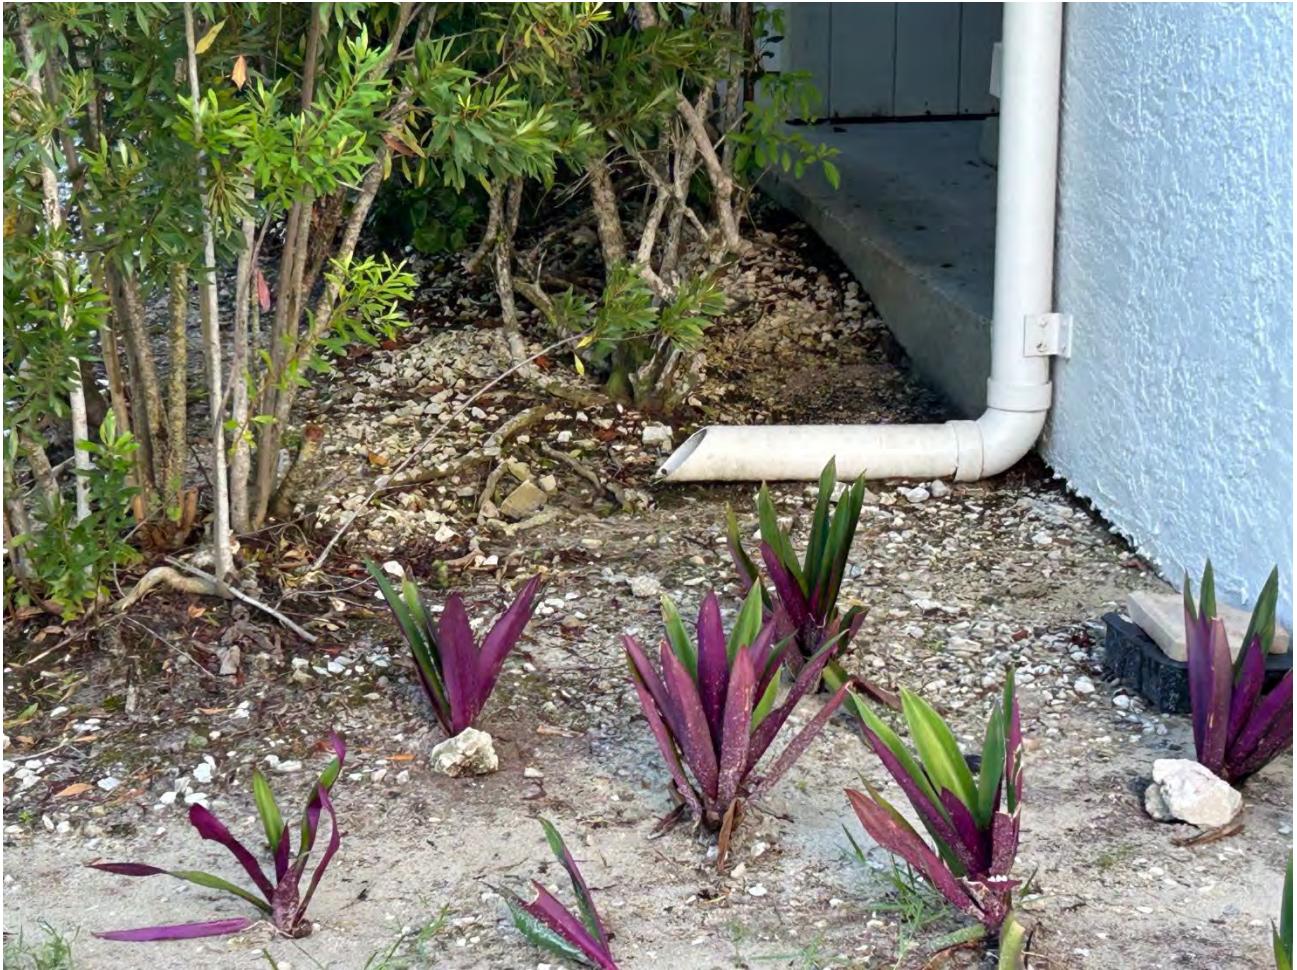
### **Downspout on back left corner**

This PVC downspout is in very good condition but it lacks a splash block under the end, allowing the soil to erode at the exit. Suggest having a splash block installed under the end to prevent any further erosion and protect the soils supporting the foundation of the building.

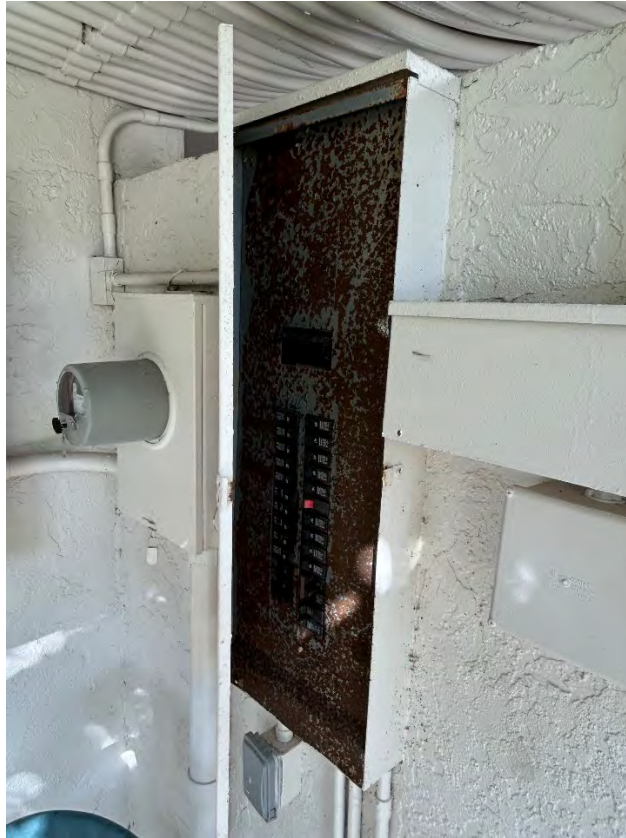
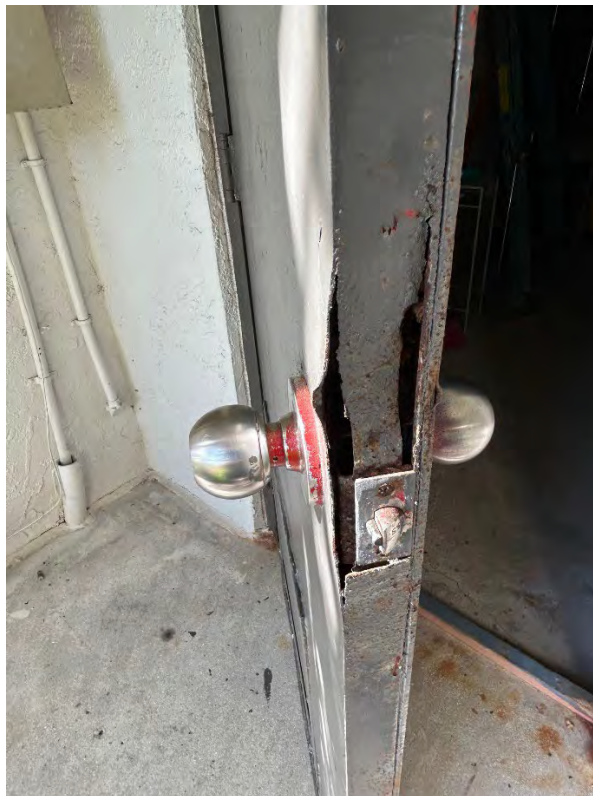
## Electrical Panel and Electrical Room Door

Both of these components are badly rusted and suggest having them replaced in the near future.

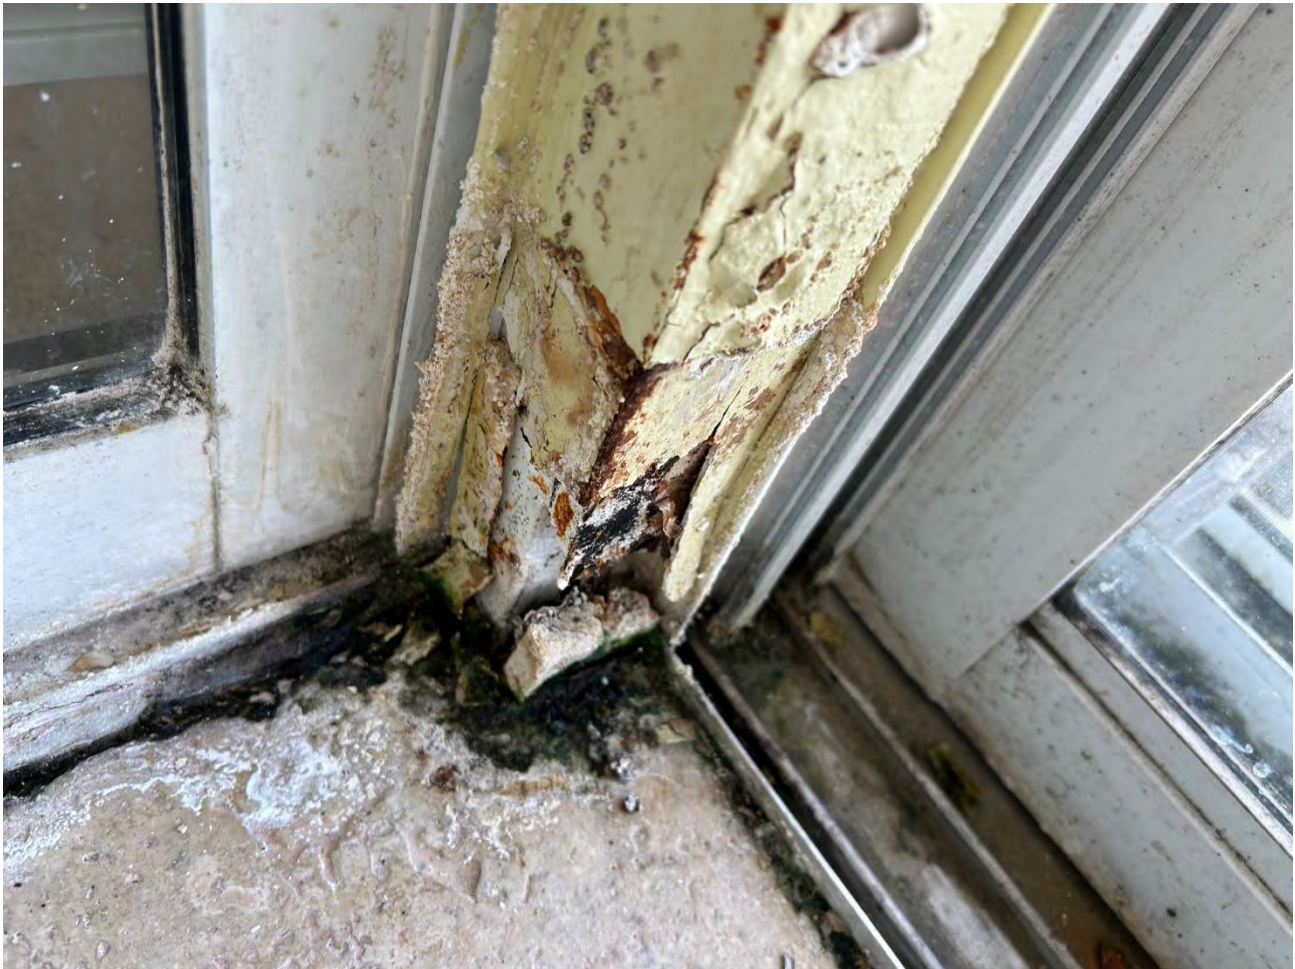
### Unit 303

Unit 303 had some significant water damage in a corner of the porch lanai. The bottom of this corner was severely corroded and in need of immediate repair. The water damaged extended up the corner as evidence by a rusting corner bead. Suggest having this bead replaced with a water resistant material.

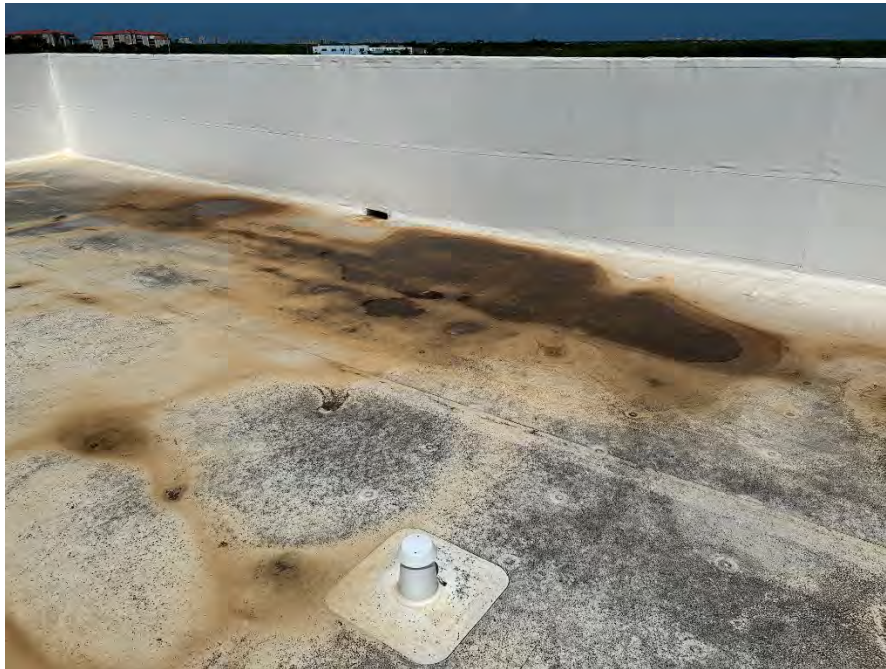
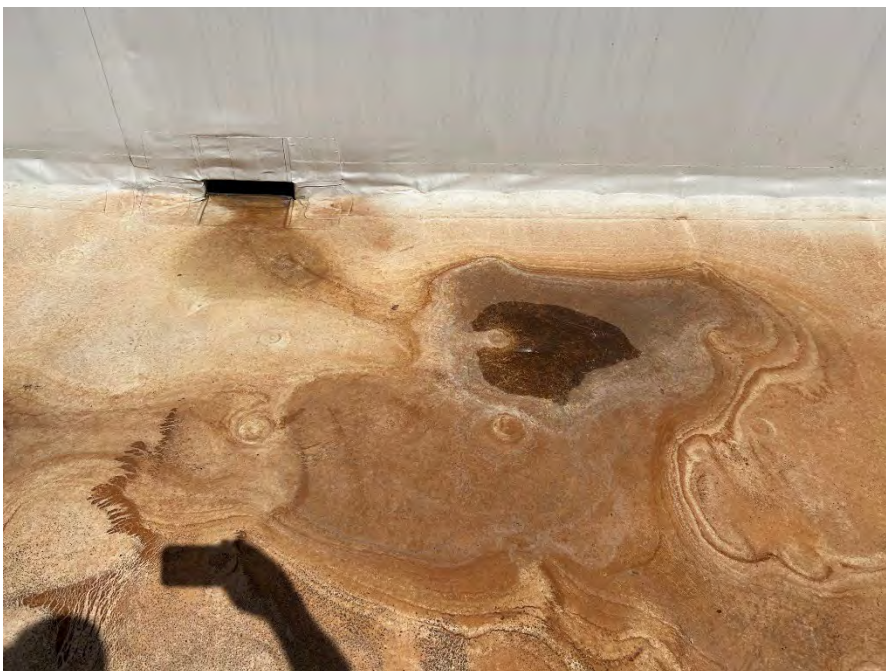
#### Areas of Excessive Ponding

The roofing on these buildings appeared to be in like new condition. Board members confirmed that the roofs were replaced only two years ago, so that would account for them being in excellent condition. Flat roof material appears to be Thermoplastic Polyolefin (TPO) which has a good track record in south Florida. Roof should last another 25 years with proper maintenance. There were a few areas of excessing ponding which can shorten the life of this roof material. Suggest discussing these ponds with the installer of the roof to see if they can be reduced or eliminated.

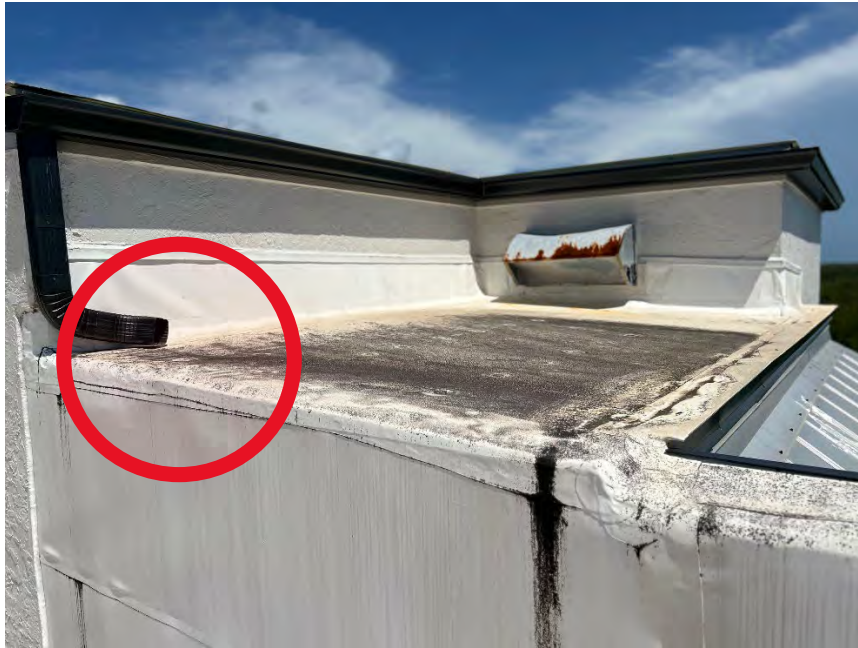
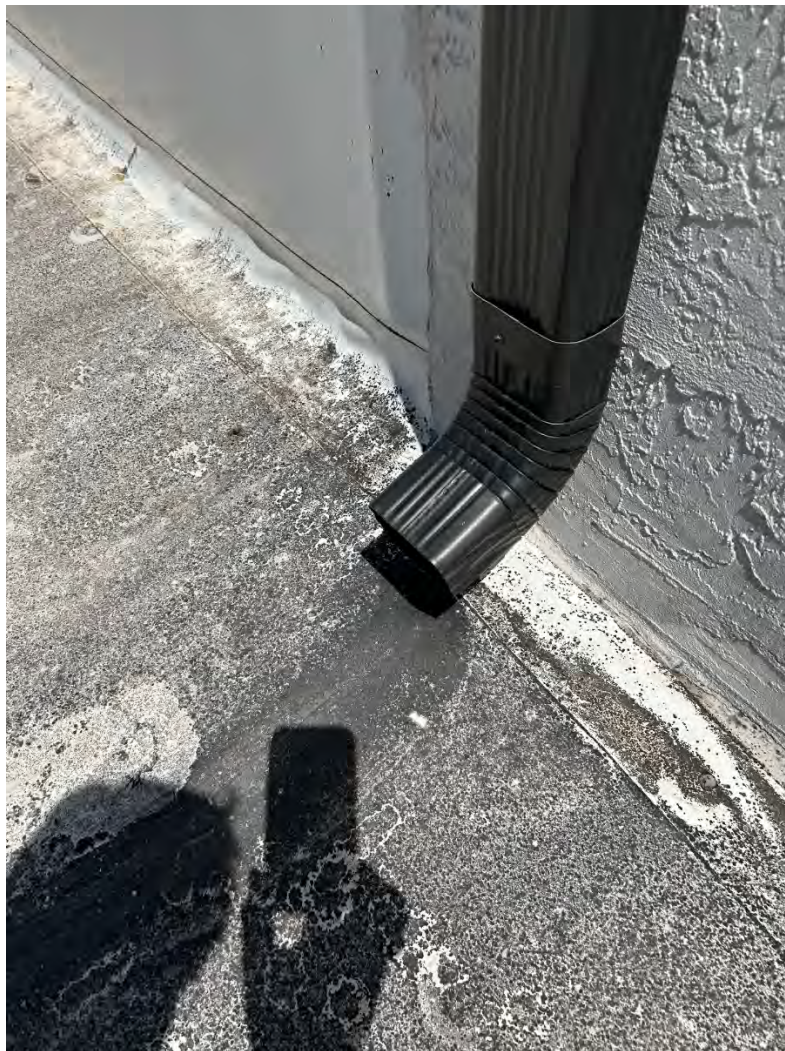
Two locations on the Roof of the 300 building had downspouts emptying directly onto roof surface. Suggest installing a wear layer under the ends of the downspouts to protect roof surface.
