# The Summit House

July 10, 2024

September 22, 2021

**SUBJECT: Limited Structural Review Inspection  
Summit House Condominium of Marco Island  
Project #: 21037.01**

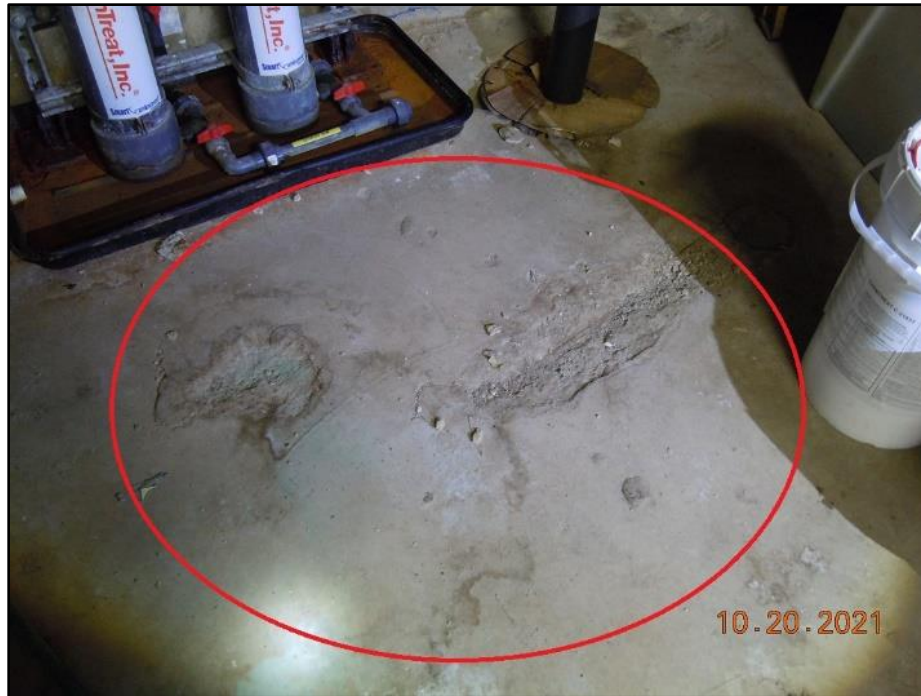
The roof top pump room has an area of concrete deterioration near the chemical feed system. This should be addressed within the next year's maintenance cycle.

- Cooling Tower Pump Room: Concrete repairs completed on 10/7/2022.
- Cooling Tower Support: Completed on 1/19/2023. Awaiting COC from the City of Marco, permit #COMM-22-05826. \*\*\*COC received

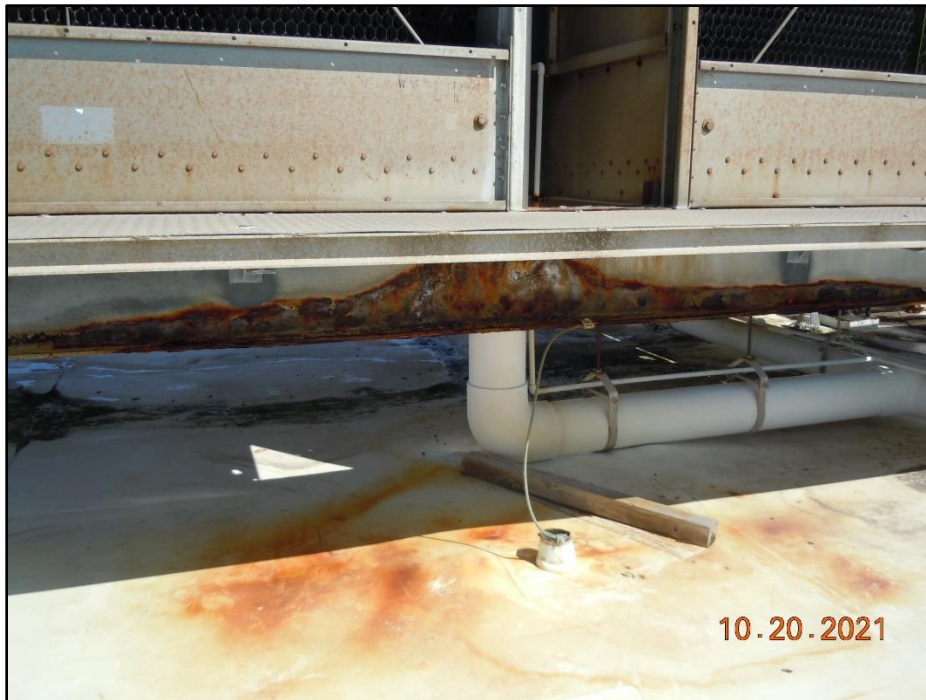
The Cooling tower support steel is showing significant corrosion. According to Ms. Hennings, the cooling tower is scheduled for replacement in the near future.

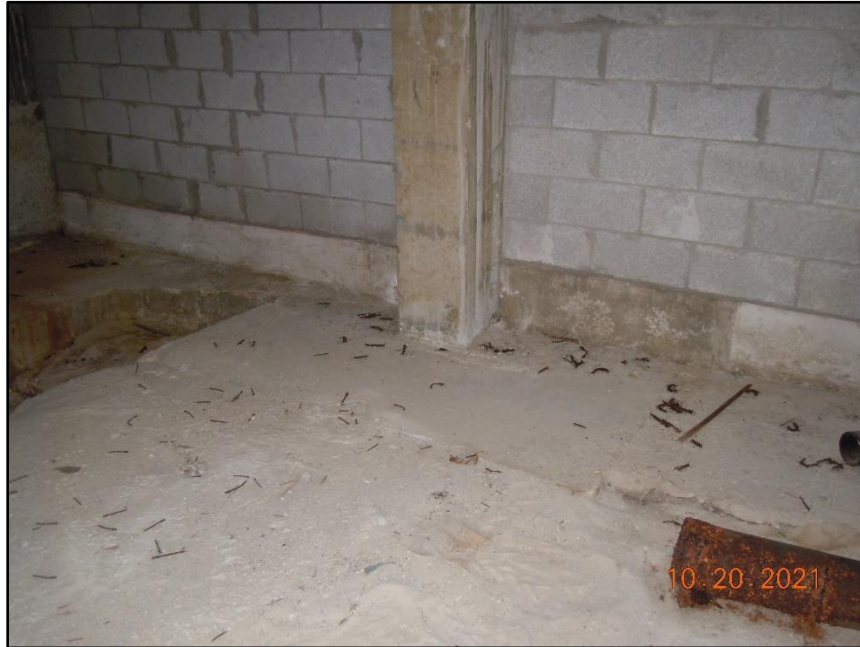
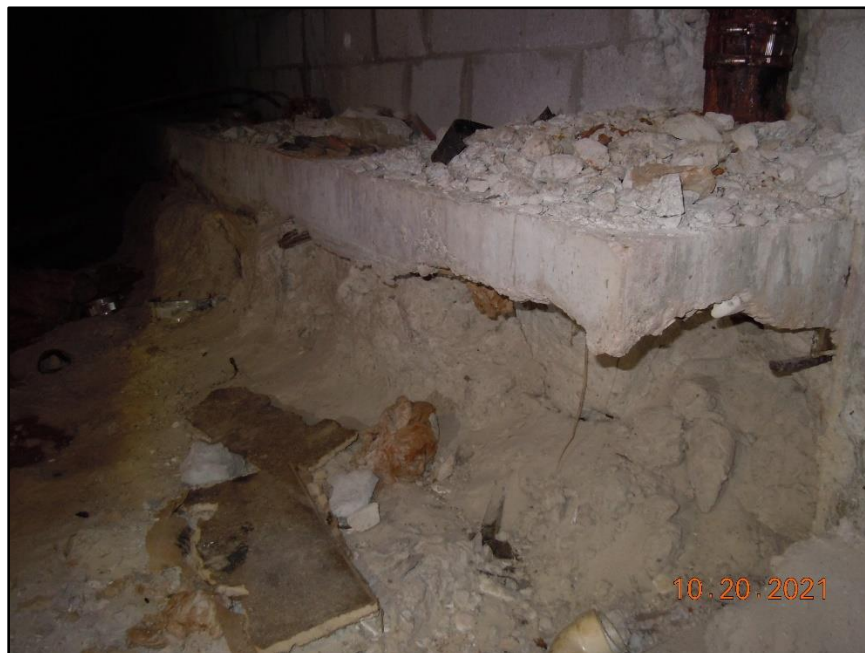
**Undermined spread footing**

A portion of the building has an accessible basement / crawl space. Here you can see the foundation pile caps. It appears that this area has been flooded with water in the past. There is a small spread footing which has been undermined due to a roof drain pipe break. Although this does not affect the overall of the main superstructure, this should be stabilized promptly.

- Basement: Completed, permit #COMM-22-01774, on 5/26/2022.

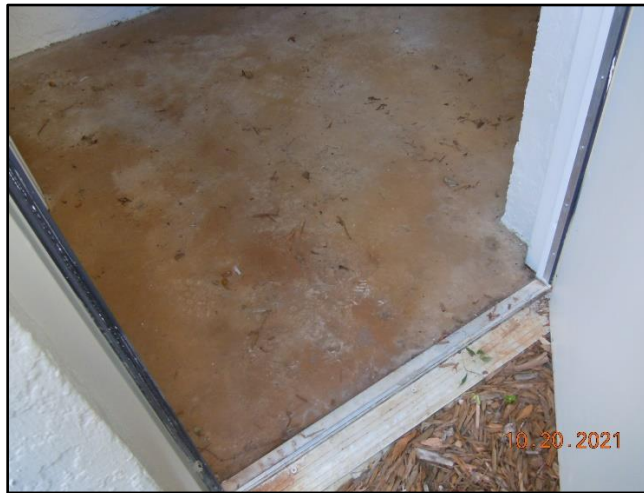
**Stairwell #06**

The Southeast stairwell (#6) is experiencing flooding during heavy rains. The existing grade should be graded to drain away from the exit door.

- Stairwells: Problem resolved.
- 23rd Floor Rooftop Landing: Concrete repaired on 10/7/2022.

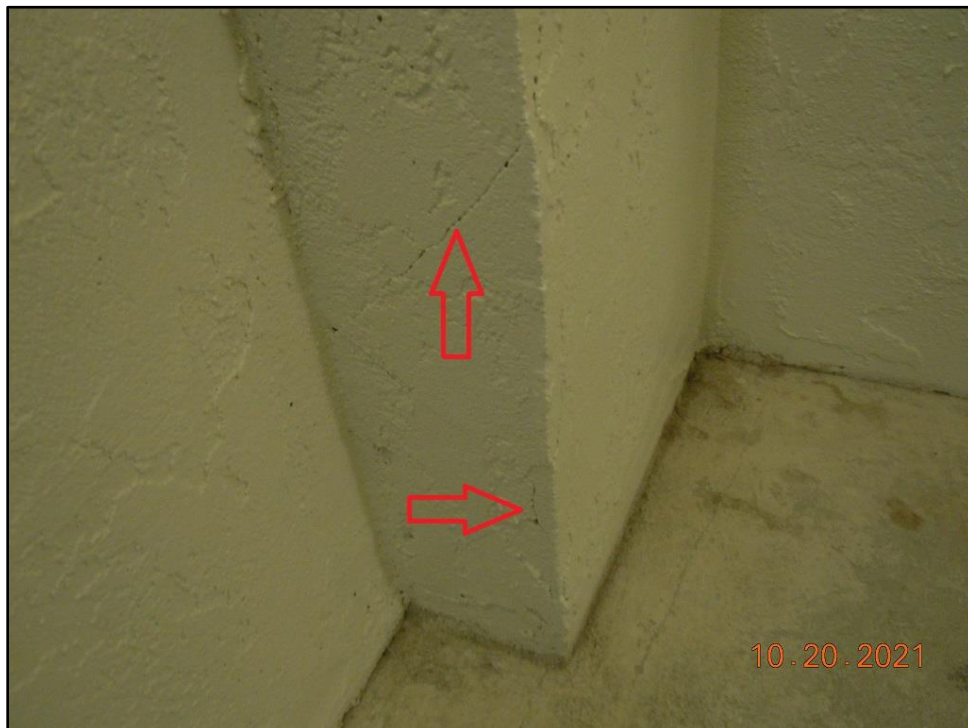
**Stairwell #06**

A crack in the concrete was observed at the 23<sup>rd</sup> to rooftop landing, stairwell # 06.

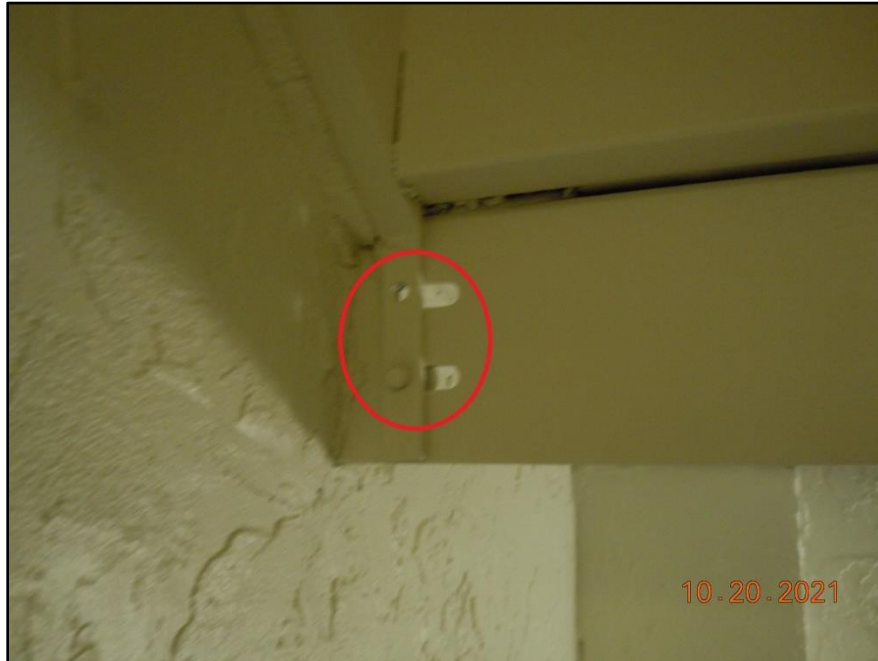
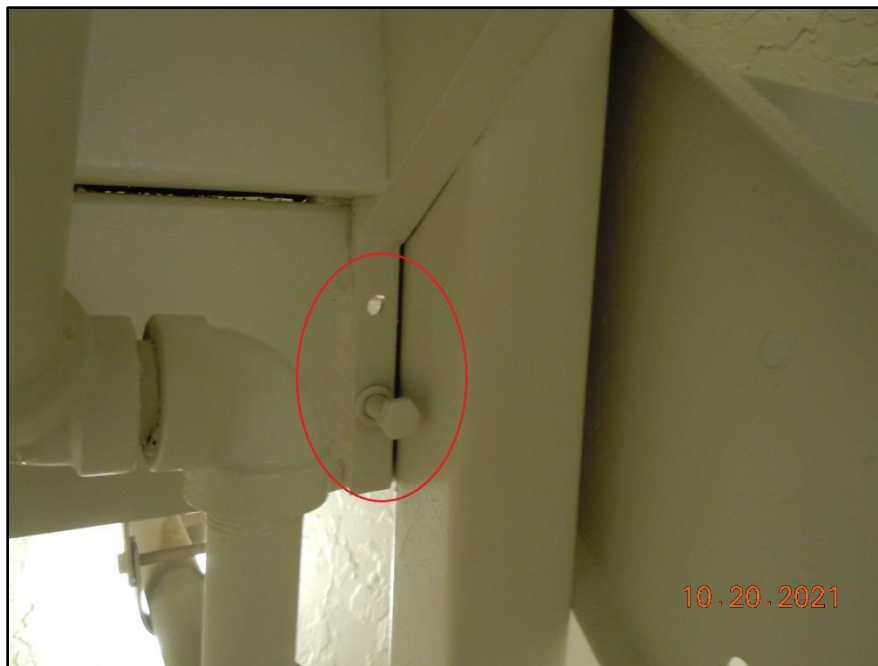
**Stairwell #03 - 04**

The West stairwell #03 – 04, has several loose bolts and missing bolts.

- Stairwells: Replaced random missing nuts and bolts (in-house).

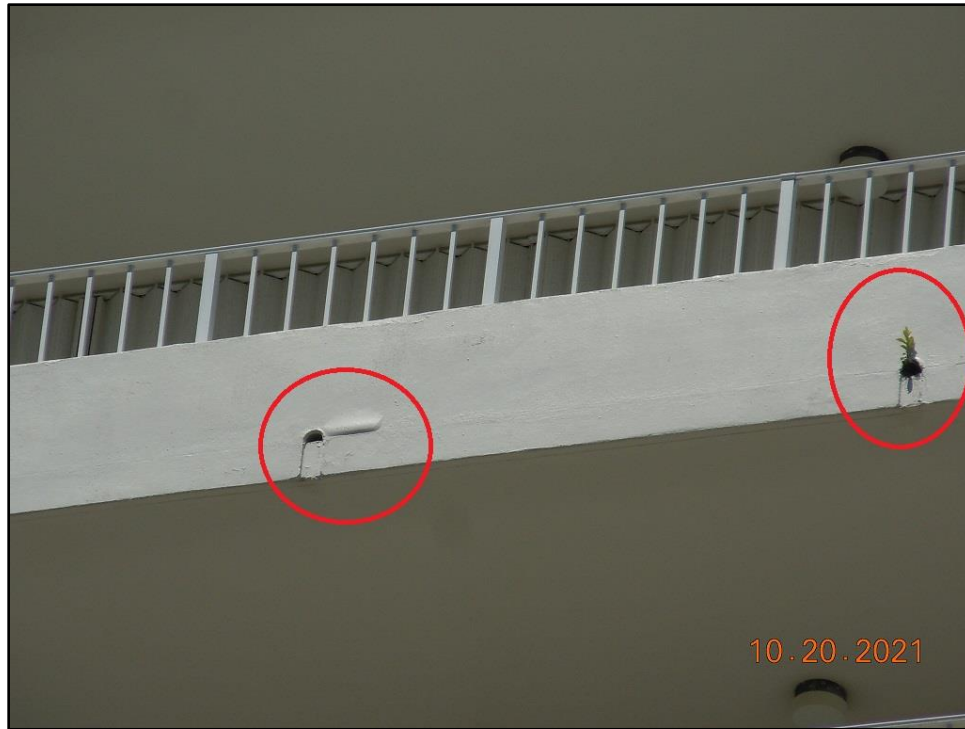
**Coating failure / Scupper debris**

- Debris Scuppers: Cleared; painting repaired during routine maintenance.

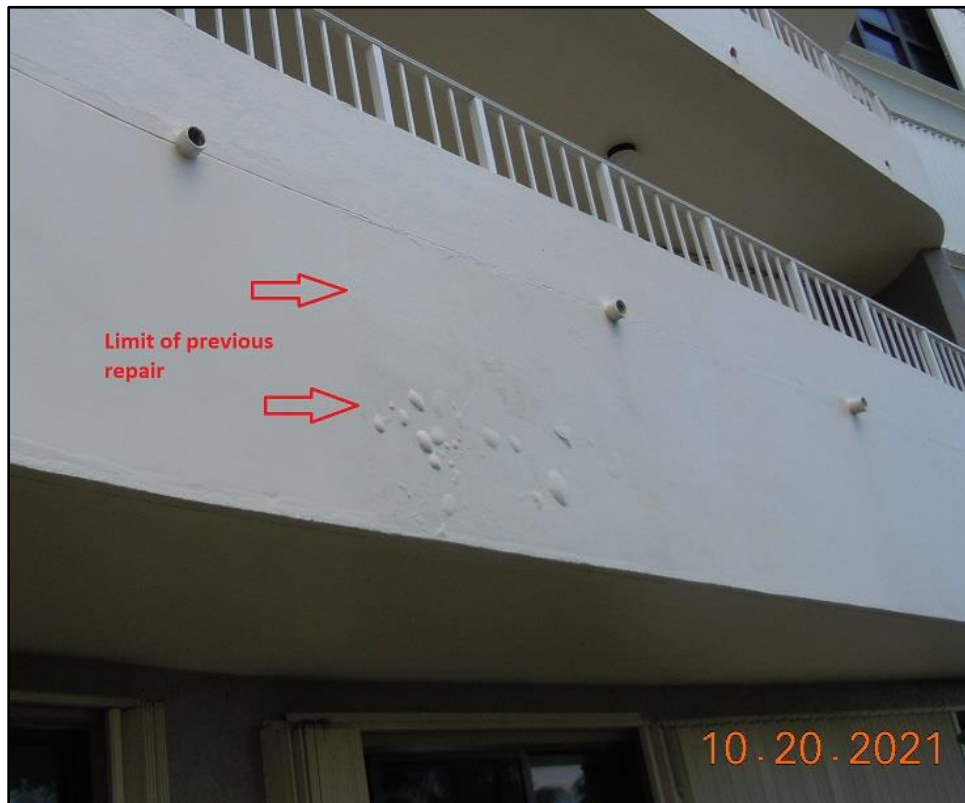
**North Elevation, Coating failure near the previous concrete repair**

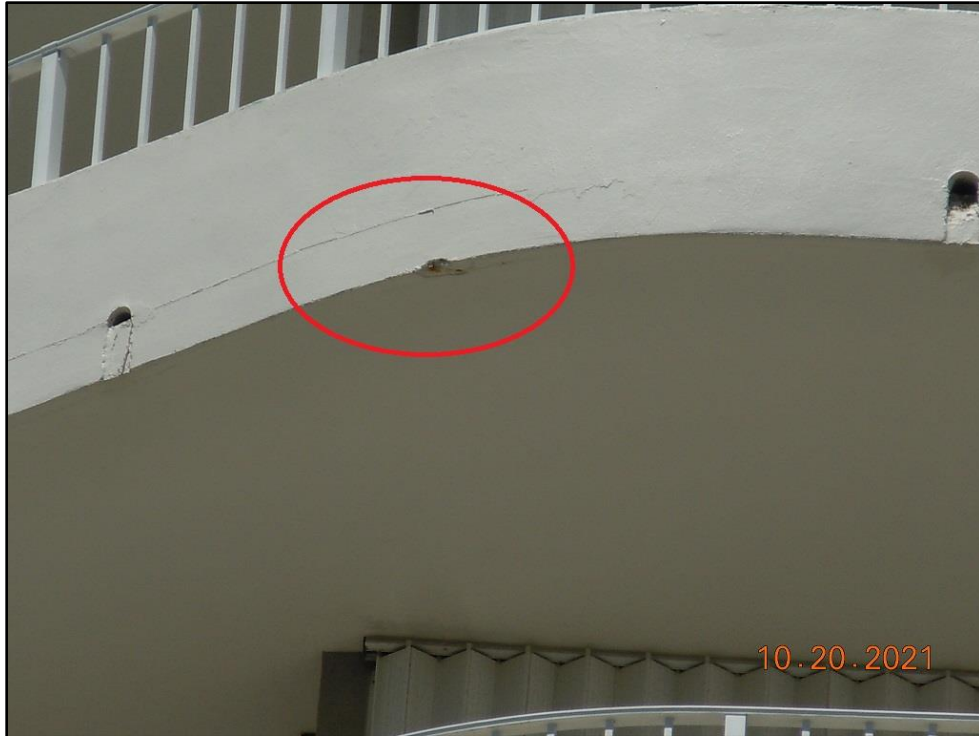
**Concrete spalling 9<sup>th</sup> floor South elevation**

- Spalling on 9th Floor: Repairs completed on 10/7/2021.

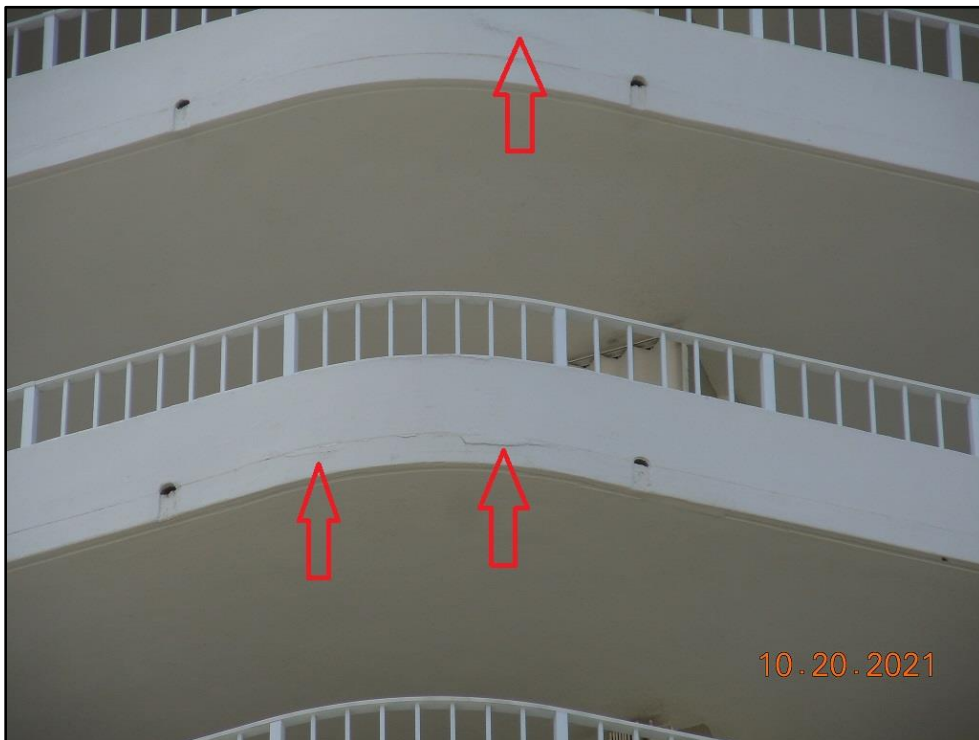
**Potential damage, Northeast elevation**

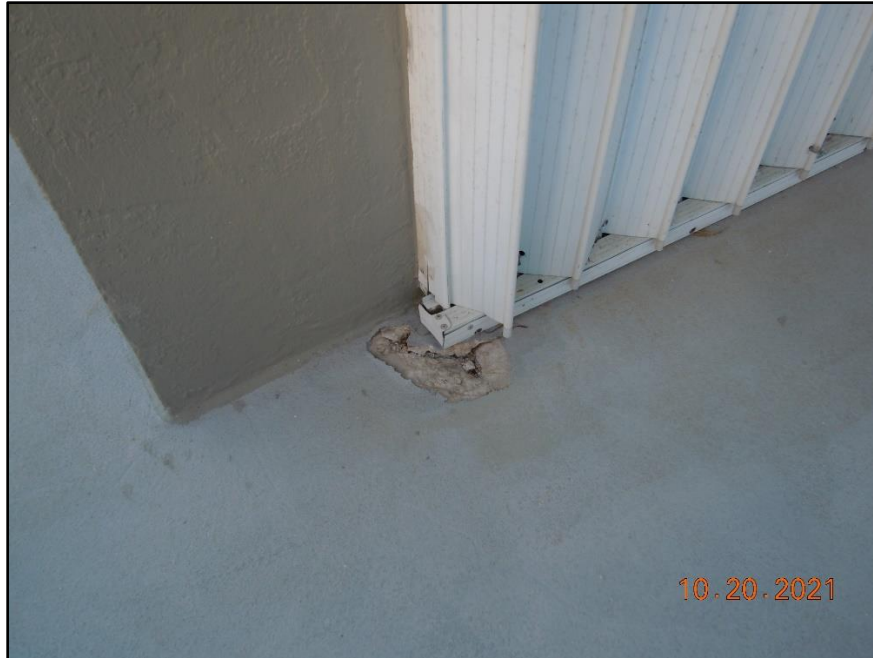
Unit 205 has several areas of concern. Concrete damage from the hurricane shutter requires repair. Damaged shutters should be replaced as they can become a projectile during a high wind event. The concrete deck waterproofing has failed and should be replaced.

**Unit 205 Concrete damage due to damaged shutters**

- Unit Owner Responsibility: Awaiting unit #205 to contract for shutters/windows and doors to become compliant. Repairs will be made once shutters are removed. If not completed by March 2024, legal action will be pursued. \*\*\*Summer of 2023, unit owner replaced shutters and re-waterproofed the deck; Summit House repaired concrete. SHUT-23-04355

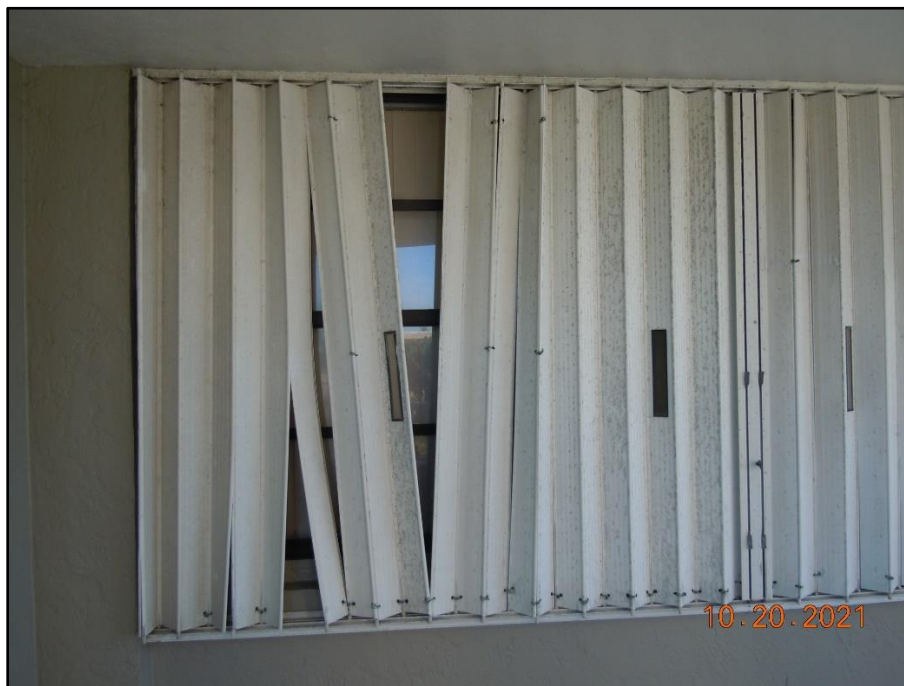
**Unit 205, damaged shutters**

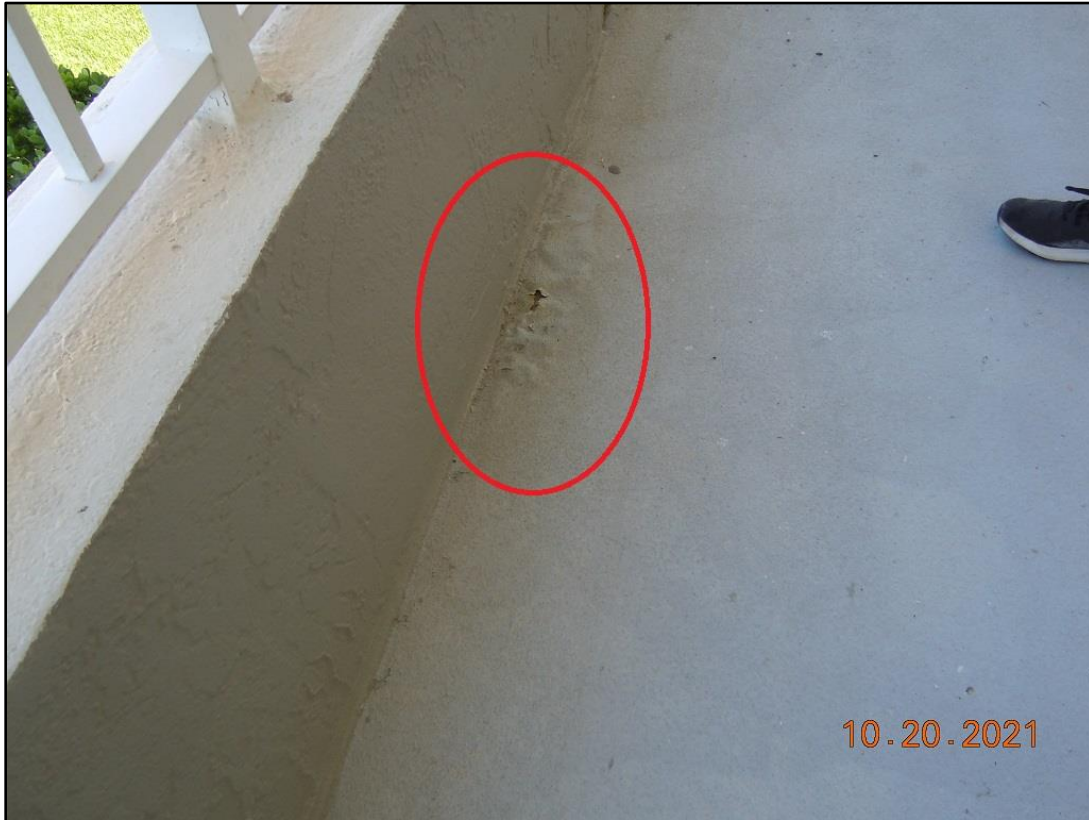
**Unit 205 Failed water proofing**

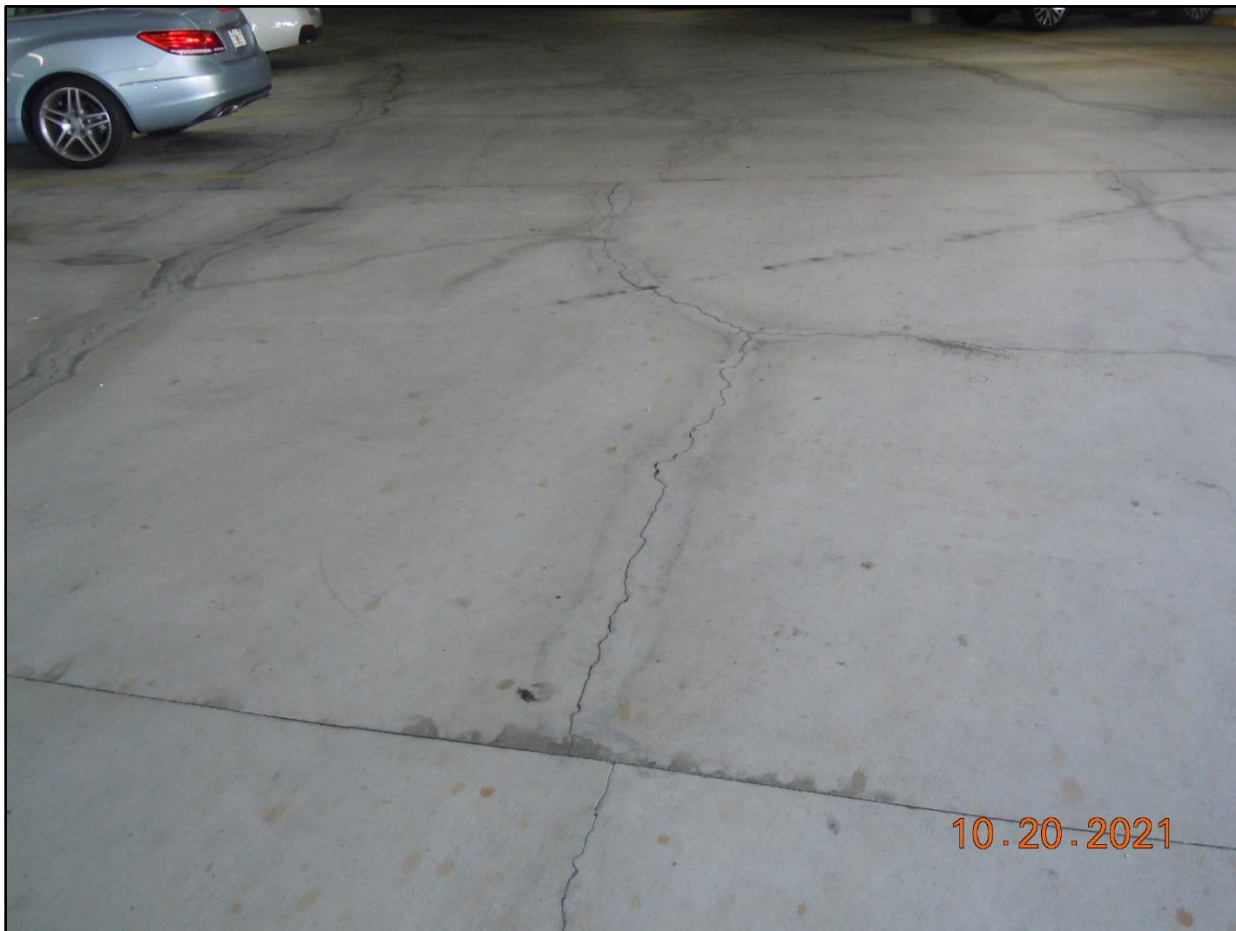
Unsightly contraction cracking. This is a slab on grade and does not compromise the structural integrity of the superstructure. This is potentially due to poor concrete and installation control during the installation and / or poor subsurface soil and soil compaction.

- Garage Concrete Floors: Cosmetic issues due to poor installation. No need for repairs.

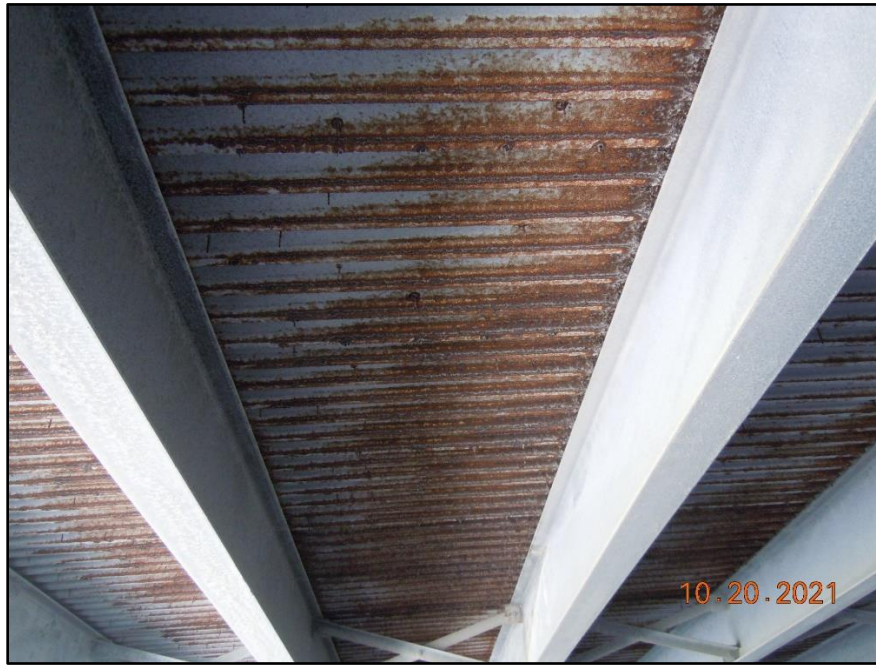
**Northeast area**

The new roof structure was construction using galvanized structural steel and a galvanized steel roof deck. There is an area at the Northeast section of the roof that has significant rusting. In addition, the roof is a screw down attachment system. The roof fasteners are experiencing significant corrosion. This condition can compromise the uplift capacity of the roof system during a high wind event. The roof contractor and Architect of record should be contacted to discuss this situation.

- Garage Roof: Replaced and coated garage metal in 4 sections; re-roofed the garage, permit #ROOF-22-02481.

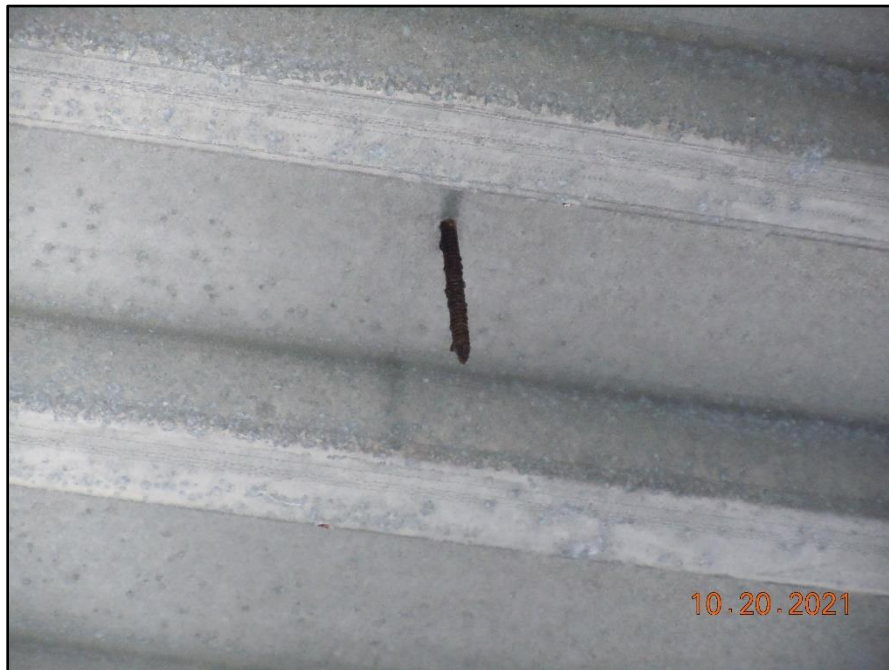
**Fastener corrosion**
