# Milestone Inspection Report Phase 1

## The Tradewinds Apartments of Marco Island Inc.

**180 Seaview Ct.  
Marco Island, FL 34145**

Prepared on:  
**7/31/2023**

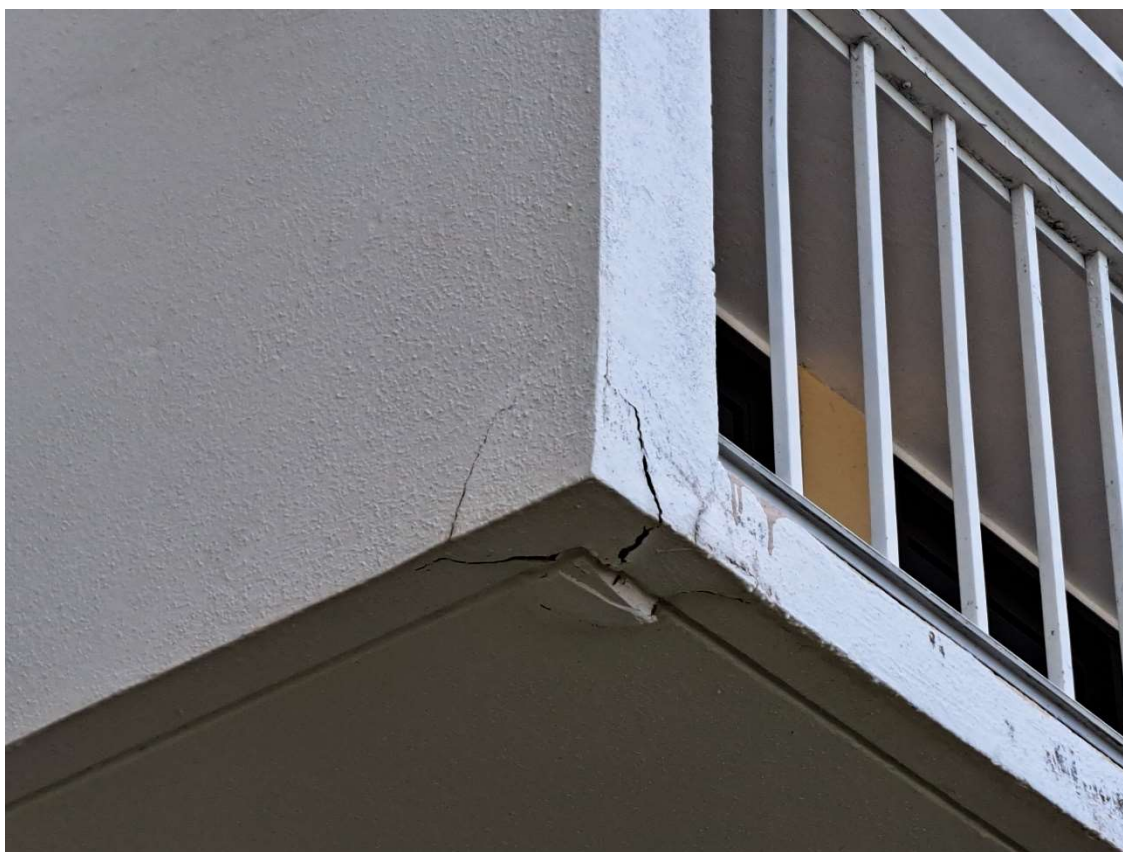
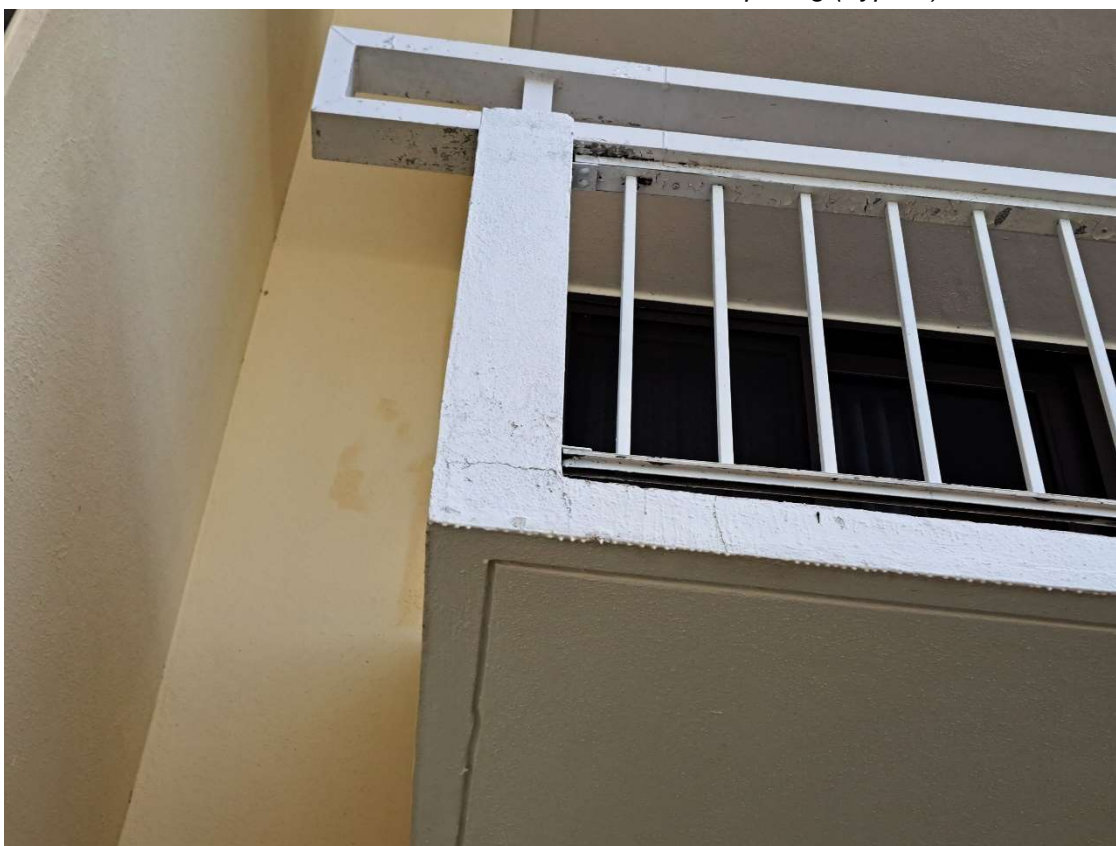
- 2.1.1.1 Consult observed two corners of private balconies to be cracked / spalled (Photos 01, 02 Typical). More may probably be present but a full inventory was not part of the scope of this report. Cracked concrete in this form indicates the carbonation has reached the rebar. The degradation will accelerate at these locations and spread from there.

*Photo 01 Ref:2.1.1.1 – Slab Corner Cracks/Spalling (Typical)*

*Photo 02 Ref: 2.1.1.1 – Slab Corner Cracks/Spalling (Typical)*

- 3.3 Consult Engineering, Inc. (Consult) recommends the following actions be taken by the Association or Cooperative Board:
  - 3.3.1 Correct all concrete deficiencies including concrete cracks and spalls identified in this report.

- 3.3.1.1 Concrete repairs should be completed per ICRI (International Concrete Repair Institute) and ACI (American Concrete Institute) standards following the specifications and details prepared by a Florida Registered licensed professional engineer specializing in structural restoration and strengthening of existing structures. These repairs are considered “structural” repairs and must be performed by a licensed General Contractor working under a permit issued by the municipality.

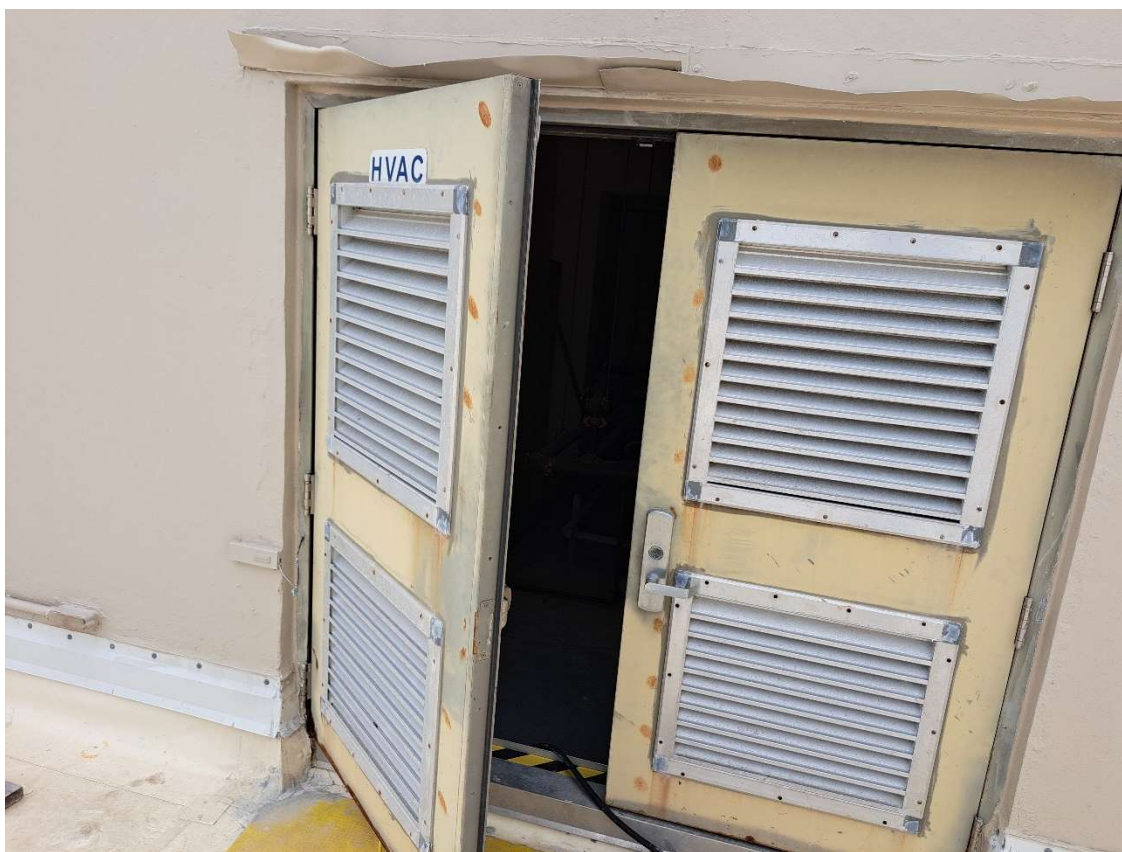
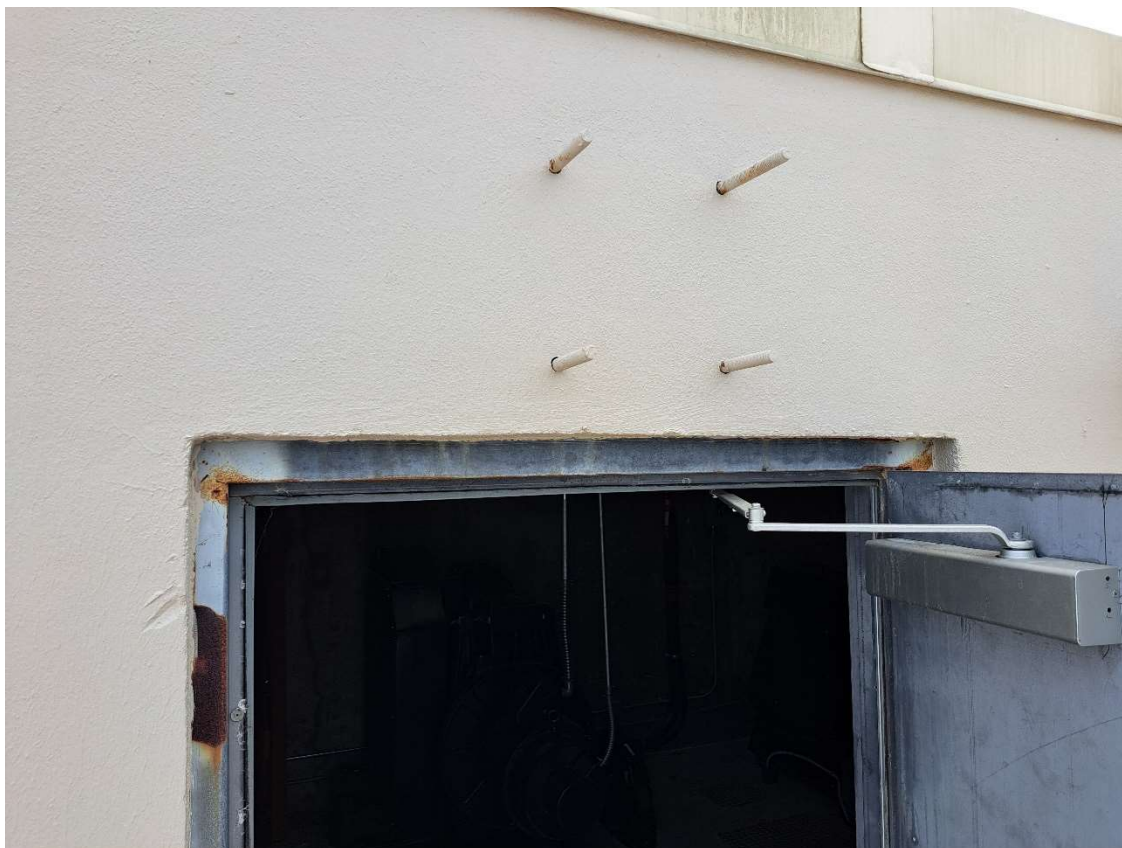
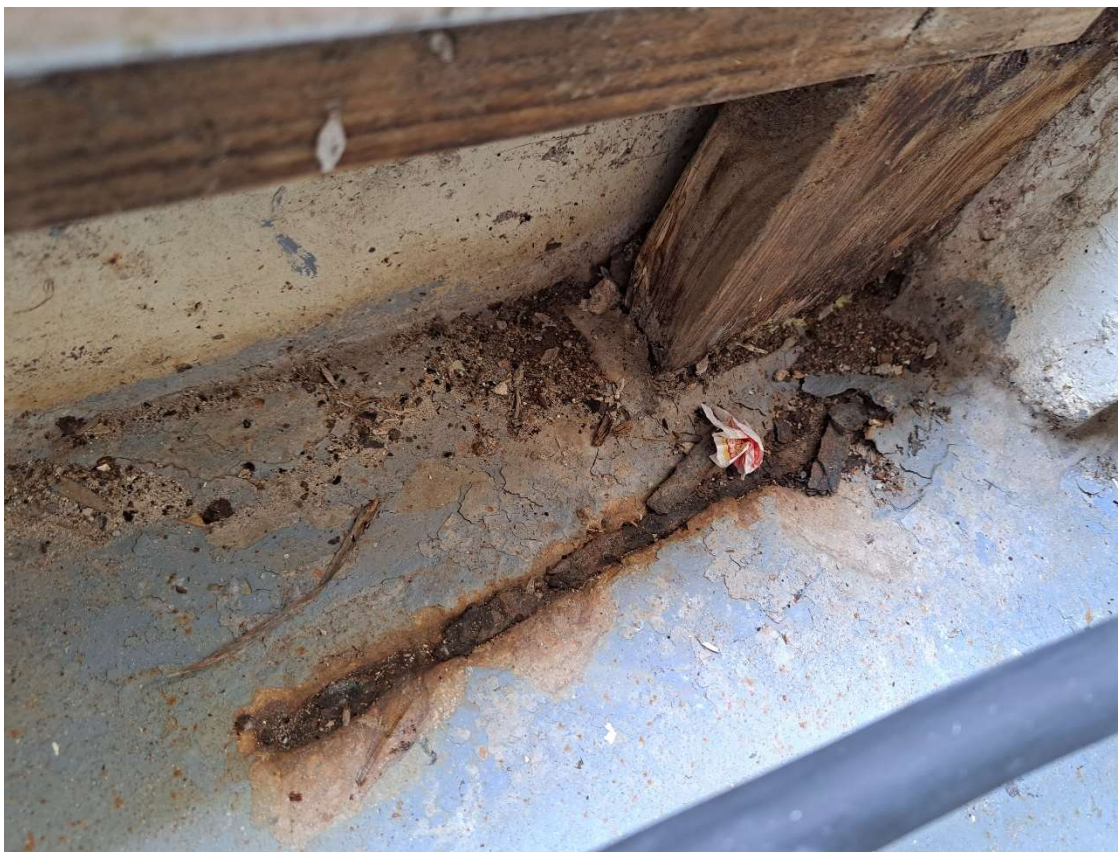
- 2.1.2.1 Water damage was observed on the floor just inside the rooftop doors. The exterior doors had no (or damaged) overhead flashing which is supposed to prevent rain from getting behind the door from the top. The damage could also possibly result from improperly sloped door thresholds. (Photos 03, 04, 05 Typical). Water running along the back or sides of the door degrades the metal and if the water pools on the floor on the back side of the door, it can increase the carbonation rate of the concrete, resulting in spalling.

*Photo 03 Ref: 2.1.2.1 – Missing / Damaged Exterior Doorway Overhead Flashing (Typical)*

*Photo 04 Ref: 2.1.2.1 – Missing / Damaged Exterior Doorway Overhead Flashing (Typical)*

*Photo 05 Ref: 2.1.2.1 – Missing / Damaged Exterior Doorway Overhead Flashing (Typical)*

- 3.3.3 All exterior doorways not under an overhang should have flashing installed above them.
  - 3.3.4 All Aluminum railings should have stainless fasteners.

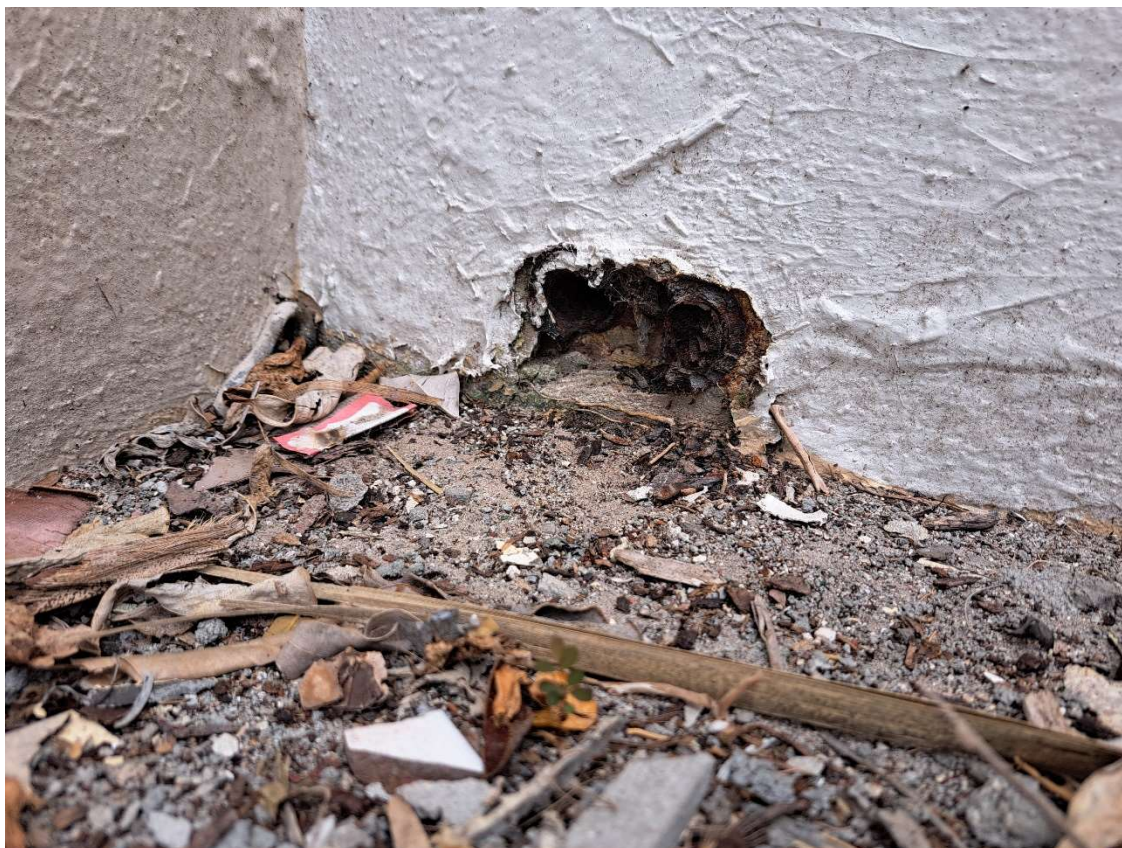
- 2.1.3.1 A penetration into the outside wall was observed just above grade (Photo 06). This penetration can allow the interior of the wall to chronically be exposed to moisture and water which can accelerate concrete carbonation around it.

*Photo 06 Ref: 2.1.3.1 – Ground-Level Wall Penetration*

- 3.3.10 The wall penetration at grade should be evaluated and if it has no purpose, it should be excavated and plugged with masonry.
  - 3.3.11 The crack in the non-structural wall in the ground floor meter closet, should be monitored for further settling.

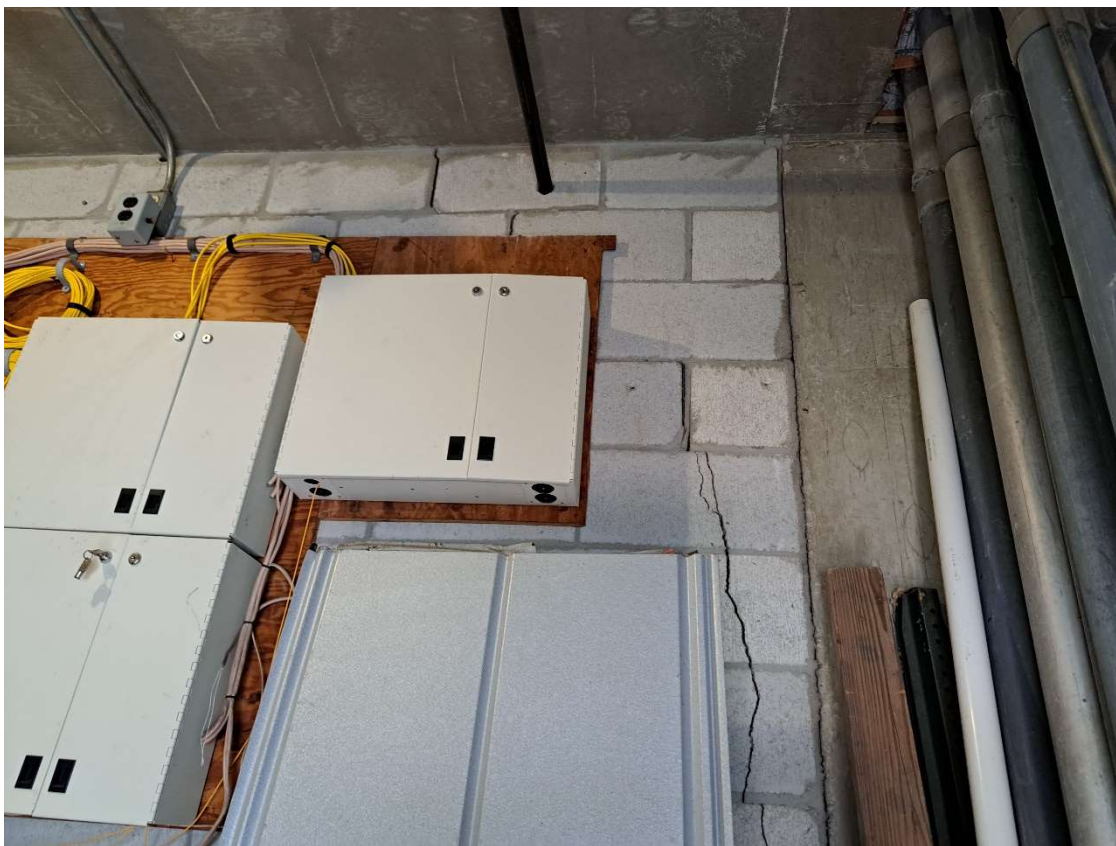
- 2.1.4.1 A crack across a non-supporting wall was observed inside the ground floor meter room (Photo 07). This crack indicates some differential settling of the foundation.

*Photo 07 Ref: 2.1.4.1 – Ground-Level Meter Room Wall Crack*

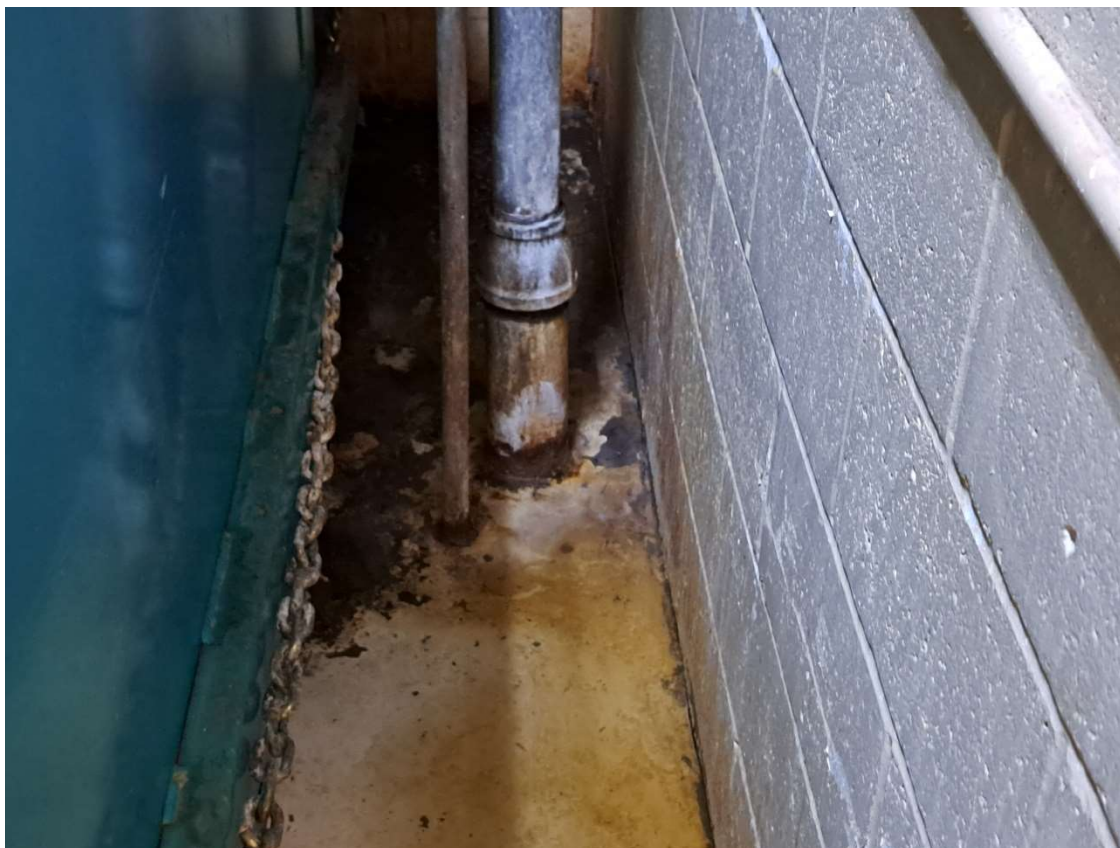
- 2.1.5.1 Standing water and traces of chronic standing water was observed between the trash dumpster and the closest wall. (Photo 08). Consult could not verify the source of the water leak but it looked to be occasional condensation on an overhead pipe or a leaking pipe or valve. Multiple pipes coming out of the ceiling and valves above showed signs of prolonged water exposure in the form of corrosion. One pipe looked as if

someone had attempted to patch it's ceiling penetration with duct tape. This standing water runs against the wall instead of to the local floor drain. This water will eventually degrade the base of the wall or any structural member that is adjacent to it.

*Photo 08 Ref: 2.1.5.1 – Garbage Room Chronic Leaking or Condensation*

- 3.3.8 Find and repair the source of chronic water seepage next to the garbage dumpster.
  - 3.3.9 Ensure that rain is not currently entering the louvered window of the HVAC Pump room. If it is a current problem, repair or re-install the exterior louver.

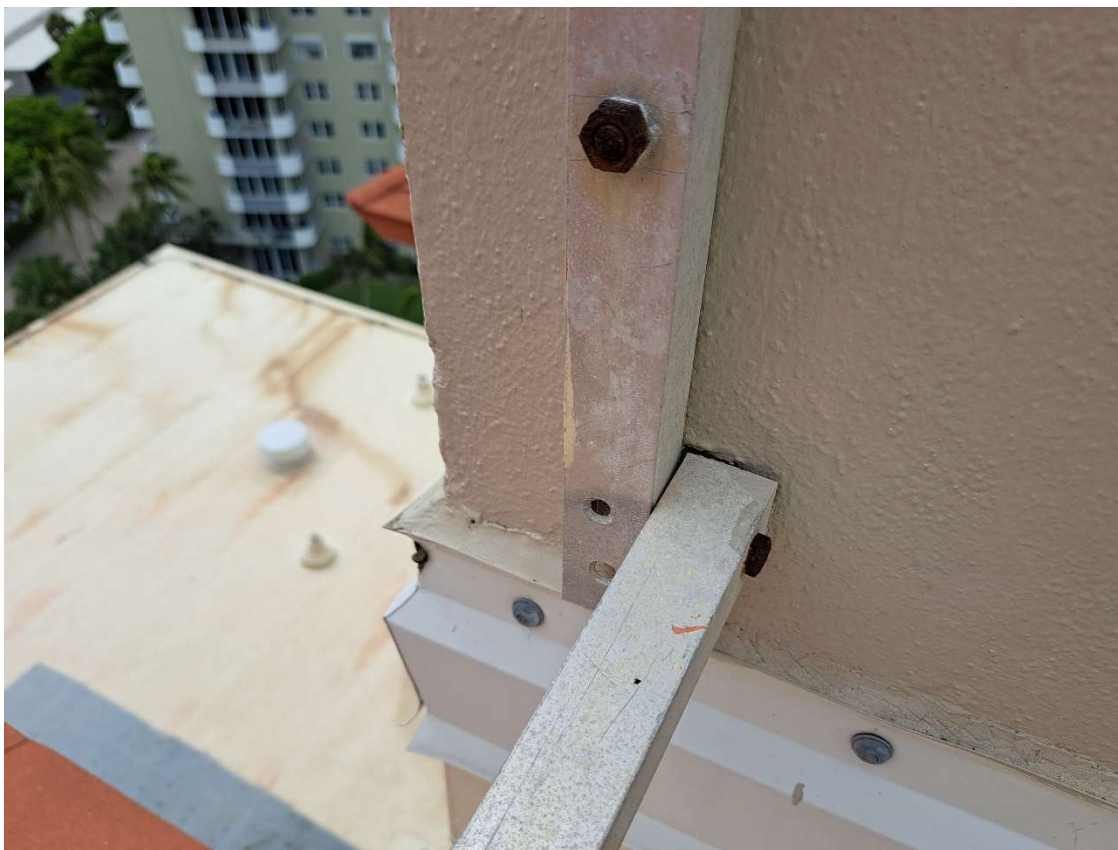
- 2.1.6.1 The aluminum railings on the roofs are anchored to the wall and to each other using corroded steel hardware (Photo 09 Typical). This hardware will fail prematurely for the railing and if it is embedded into the masonry wall, it will eventually push the concrete apart as it corrodes, creating a spall where more moisture can then enter the concrete and create more damage.

*Photo 09 Ref: 2.1.6.1 – Fasteners for Aluminum Roof Railing (Typical)*

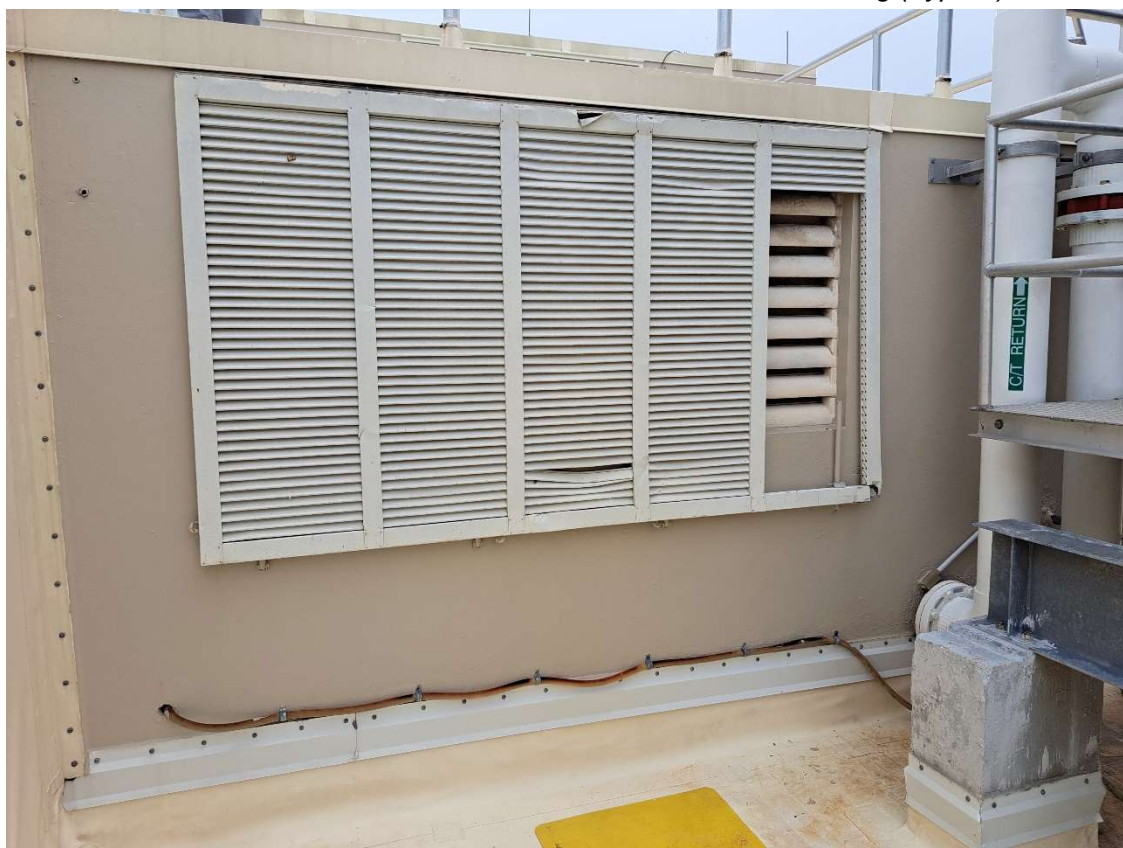
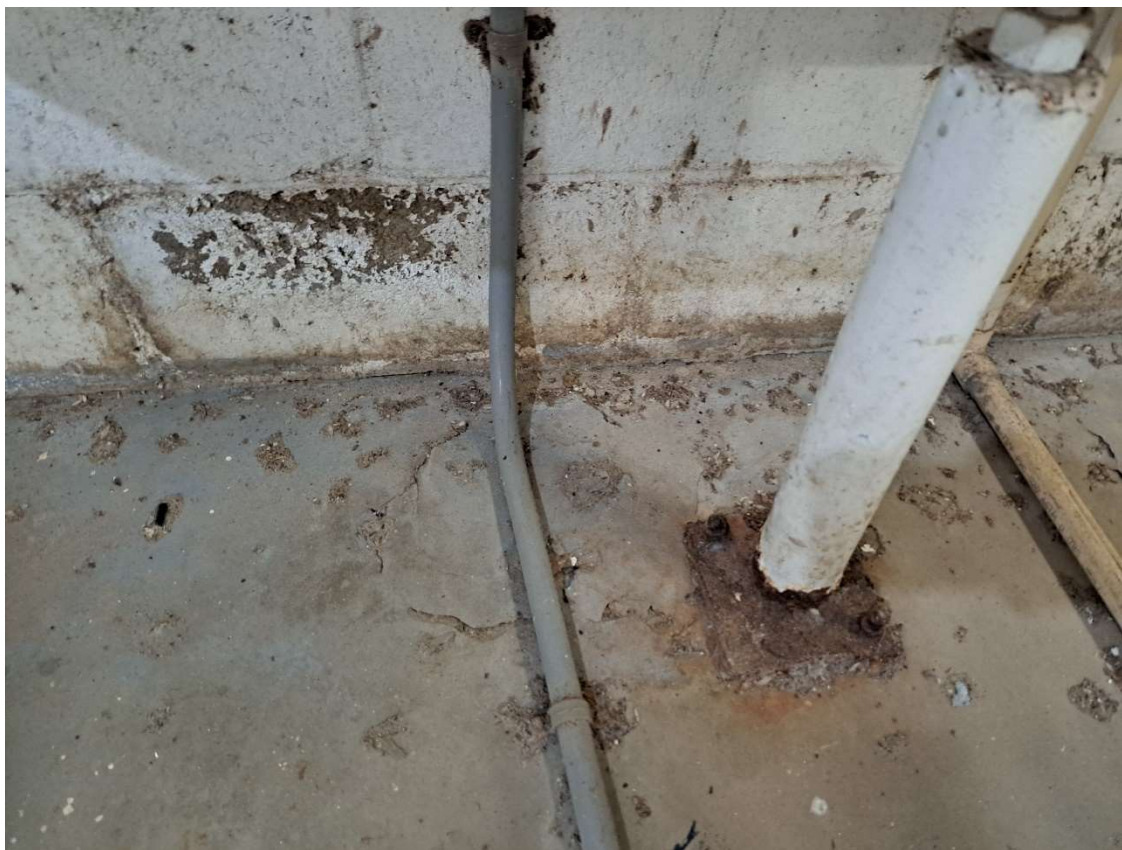
- 2.1.7.1 Water has been chronically entering the pump room past the window vent louvers resulting in cracking around the window penetration and spalling on the floor underneath the window (Photo 10, 11). The rain might be entering through the original concrete louvered grill at the area where the new louvered grill has been broken away.

*Photo 10 Ref: 2.1.7.1 – Rooftop HVAC Pumphouse Window Covering*

*Photo 11 Ref: 2.1.7.1 – Rooftop HVAC Pumproom Window Covering*

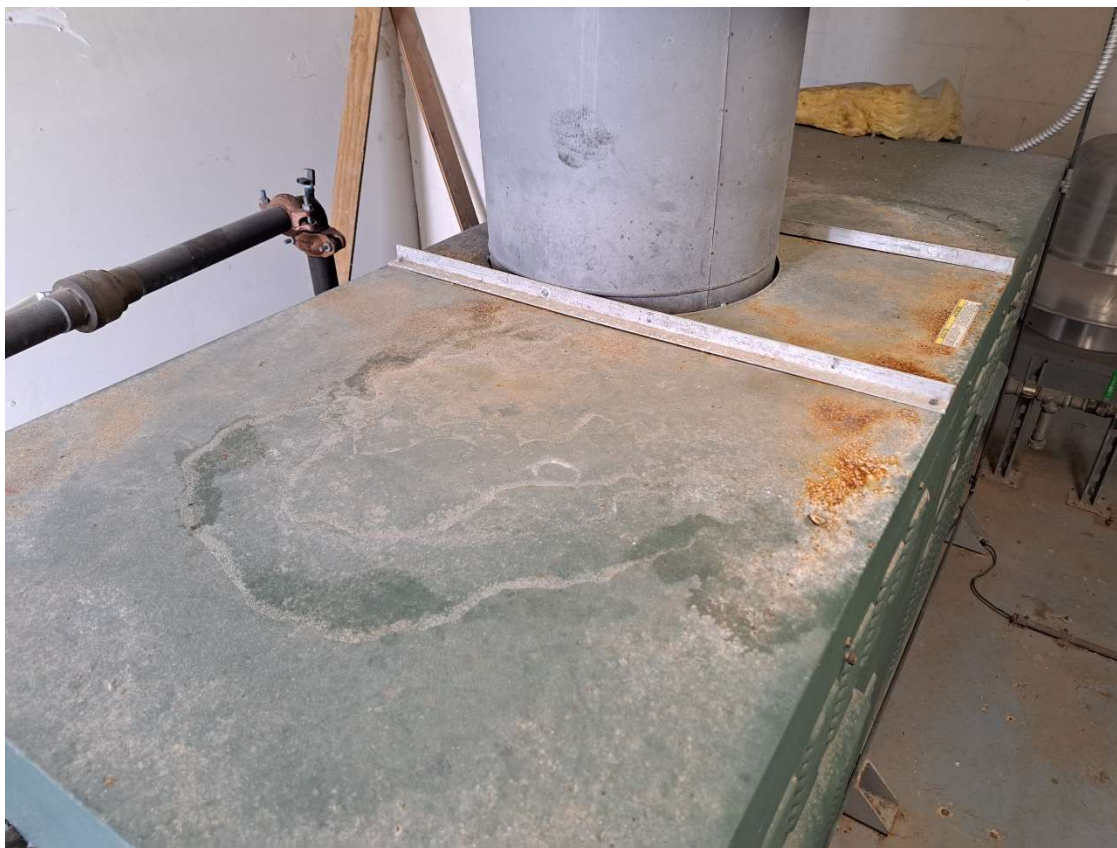
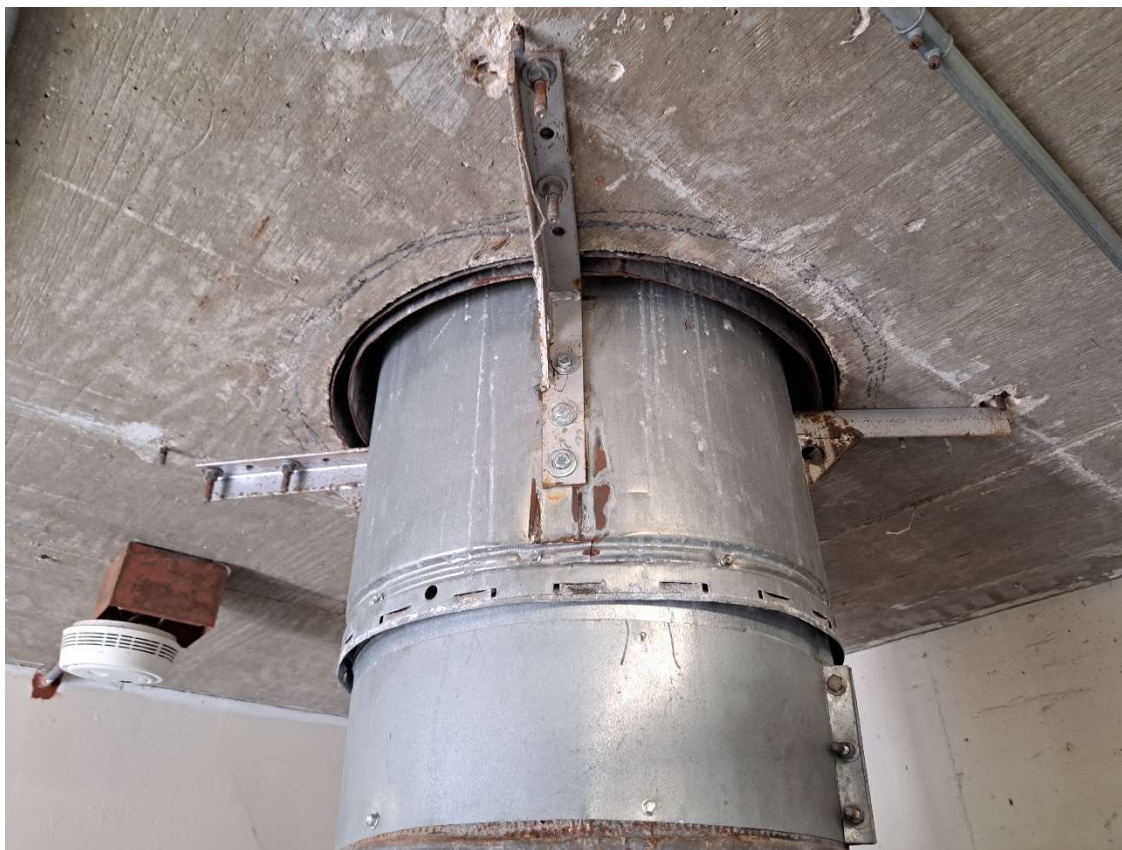
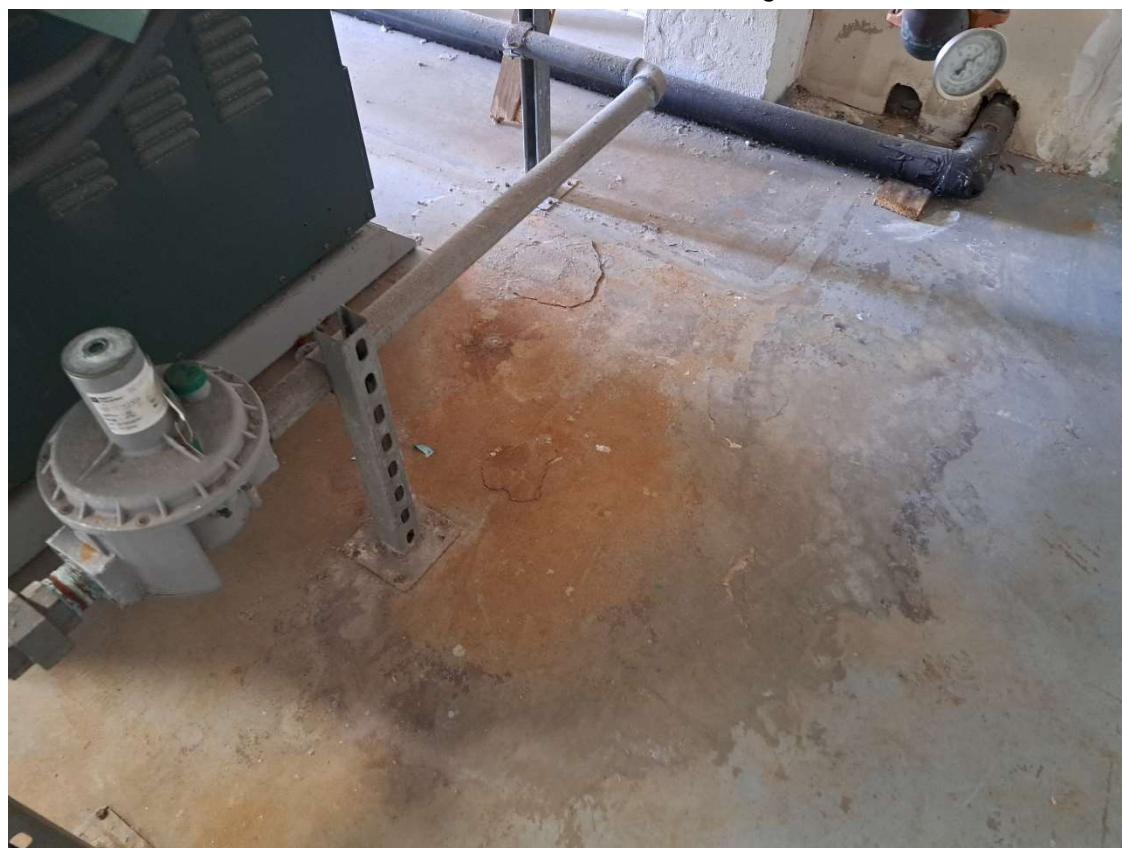
- 2.1.8.1 Evidence of chronic water exposure was present on the floor of this room (Photo 12, 13, 14). It seems one of the water sources was from the ceiling penetration for the boiler exhaust stack. The floor drain was slightly corroded around it's perimeter as well.

*Photo 12 Ref: 2.1.8.1 – Boiler Room Leaking Vent Stack*

*Photo 13 Ref: 2.1.8.1 – Boiler Room Leaking Vent Stack*

*Photo 14 Ref: 2.1.8.1 – Boiler Room Leaking Vent Stack*

- 3.3.5 Ensure Roof HVAC Boiler room vent stack is watertight.
  - 3.3.6 Ensure the HVAC Boiler room floor drain is watertight and that water is not seeping into the floor around the drain.

- 3.3.7 Repair the exposed steel in the floor just inside the door of the HVAC Boiler room.

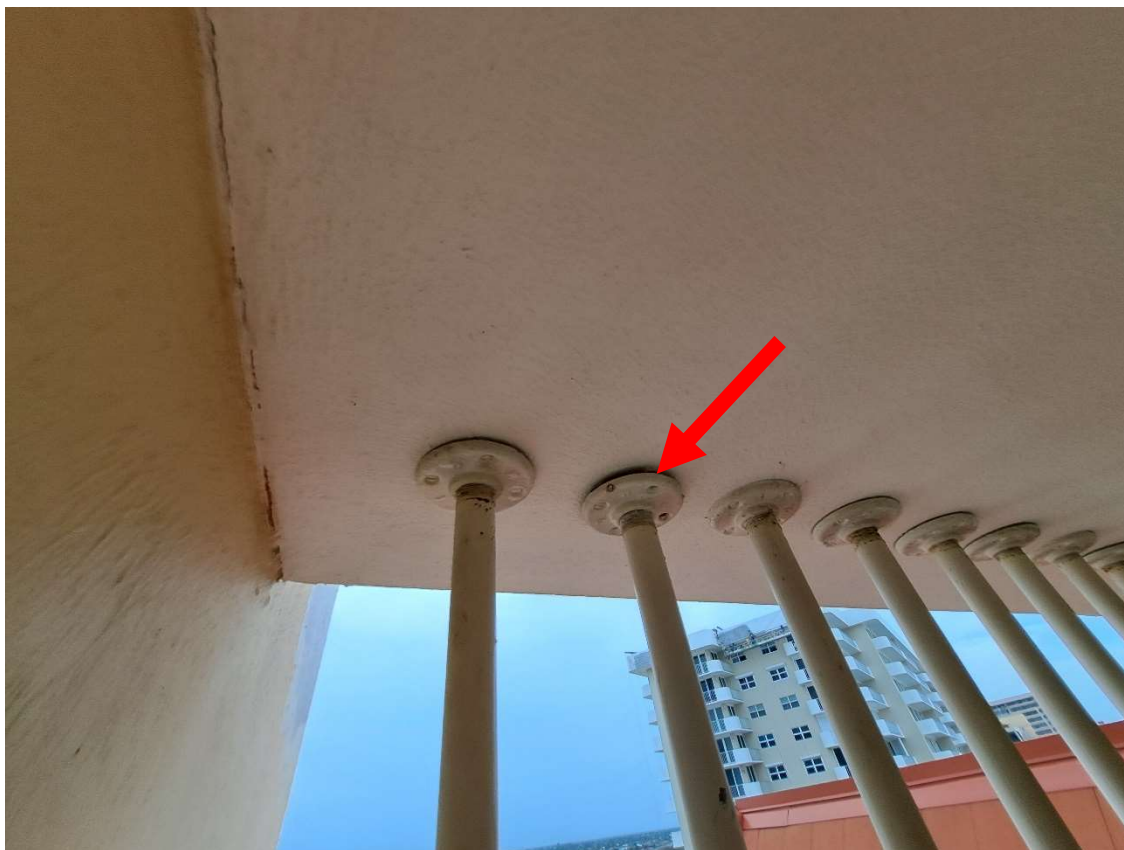
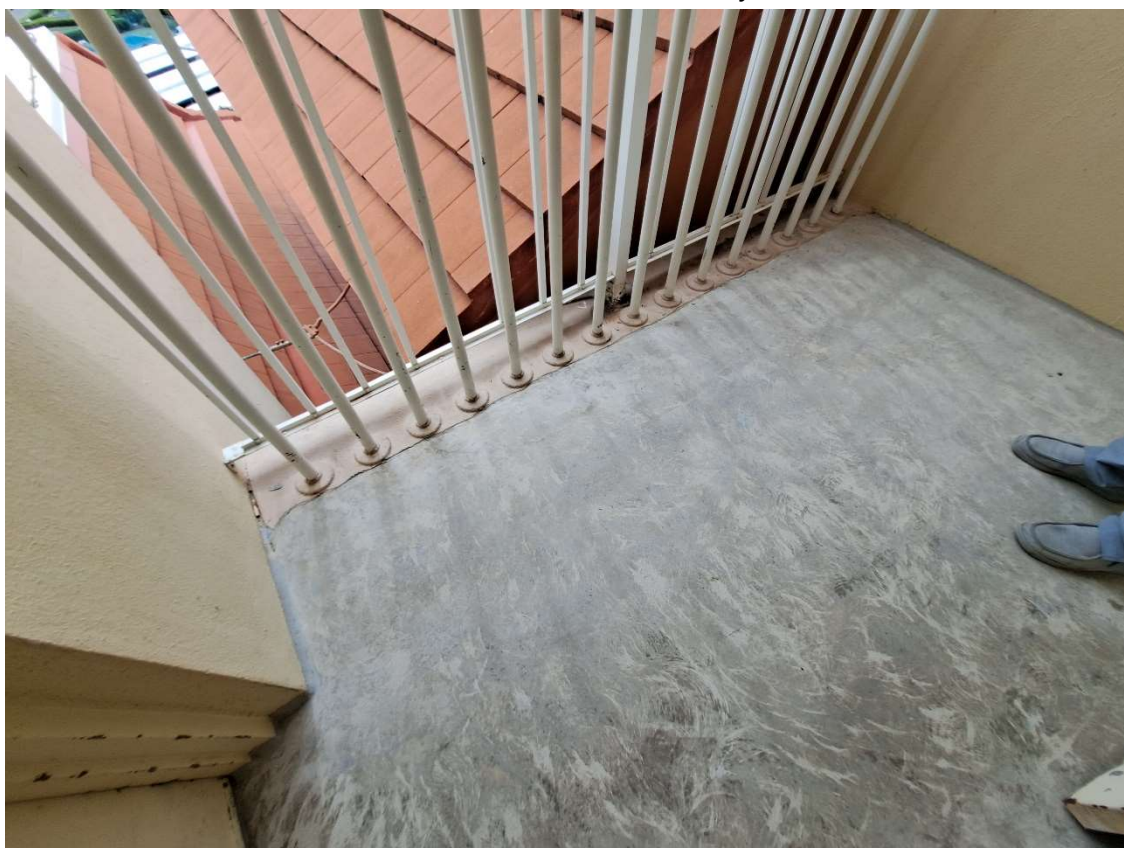
- 2.1.9.1 Some of the fastening plates on the floor-to-ceiling round bars, along the exterior stair balconies, are loose (Photo 15). These fasteners also seem to be made from steel which will corrode and spall the concrete in which they are embedded.
- 2.1.9.2 The floors of these balconies have been stripped of any sealants, leaving the bare concrete exposed (Photo 16). This stripping of waterproofing may be part of a current project.

*Photo 15 Ref: 2.1.9.1 – Exterior Stair Balcony Barrier Anchors*

*Photo 16 Ref: 2.1.9.2 – Exterior Stair Balcony Stripped Waterproofing*

- 3.3.2 Identify the type of waterproofing (if any) on the balconies exposed to the weather. Any topcoat failures should be addressed. If the slabs do not have a waterproofing membrane, waterproof all balconies exposed to the weather. This aids in water runoff and prevents water penetration into the concrete slabs. Spalled slab edges are common on balconies without waterproofing. Concrete and stucco repairs should be finalized beforehand.
