# JMC Engineering Inc.

VILLE DE MARCO WEST, A CONDOMINIUM, INC.  
1200-1208 Edington Place  
Marco Island, FL 34145

Reference: MILESTONE PHASE 1 INSPECTION REPORT  
Ville De Marco West, A Condominium, Inc.  
JMC Project Number: 119BPM.12

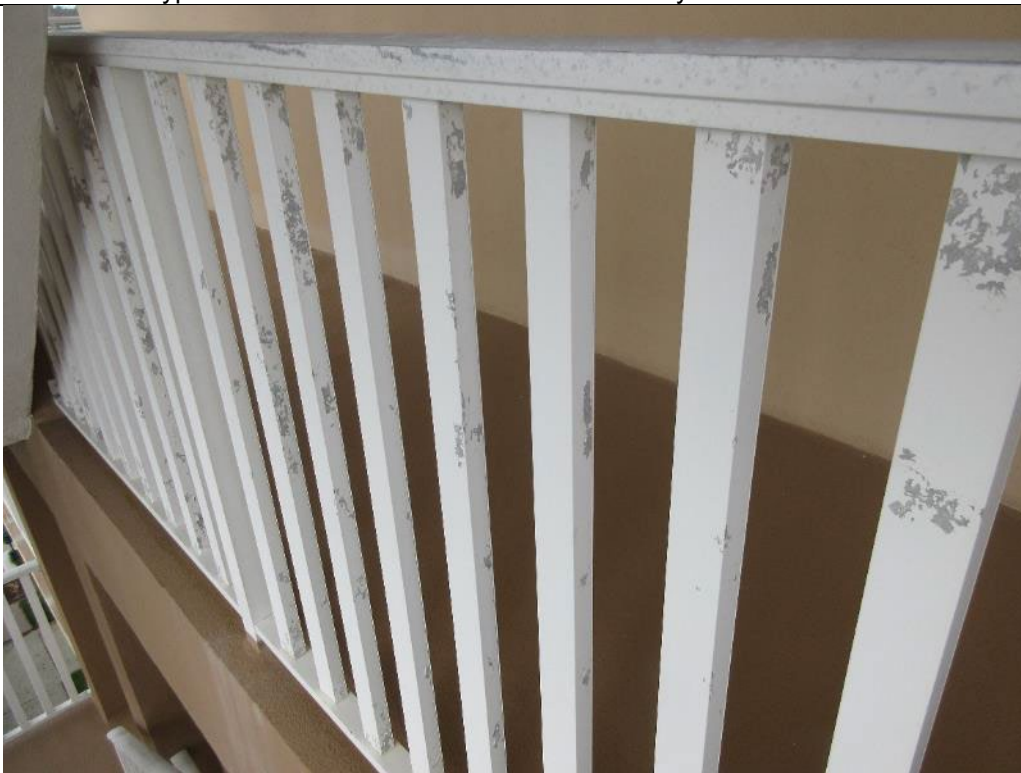
Photo 6. Typical Failed Guard Railing Coating

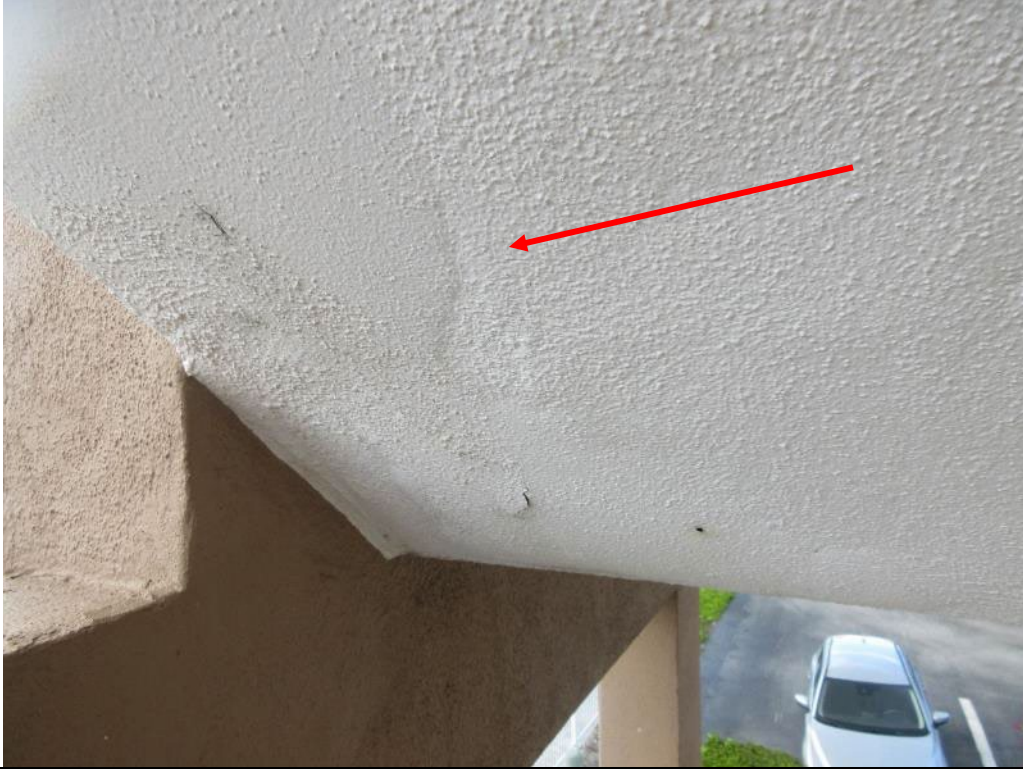
Photo 7. Apparent Spalling Concrete at Stairs

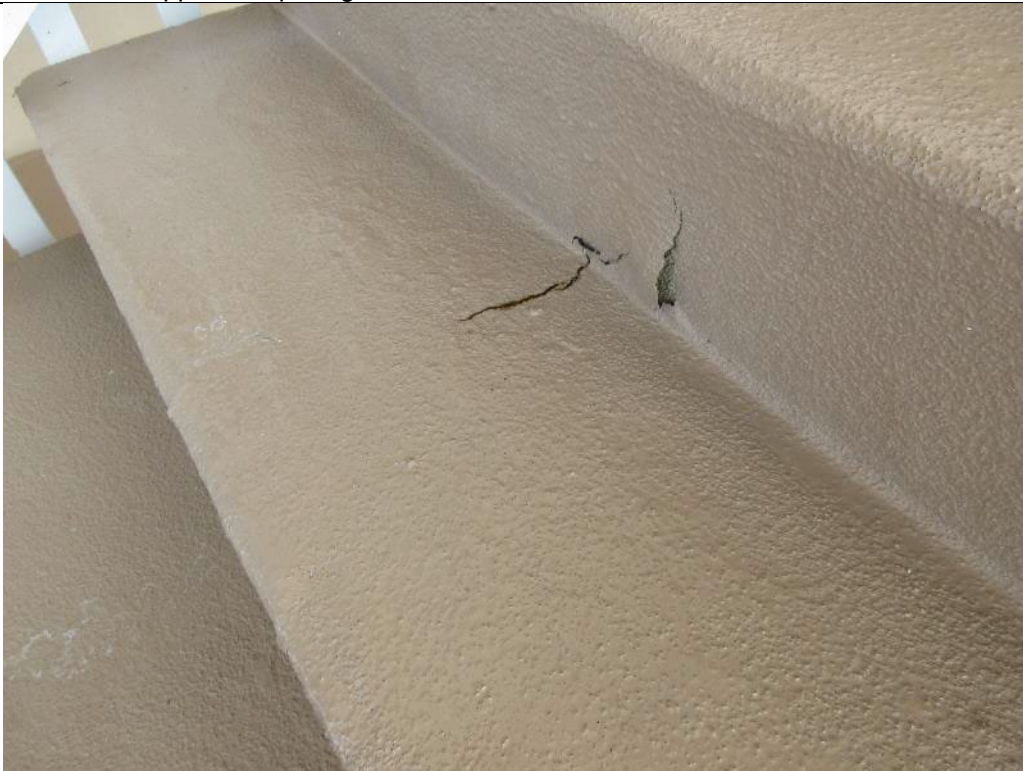
Photo 8. Failed Waterproofing Coating at Stairs

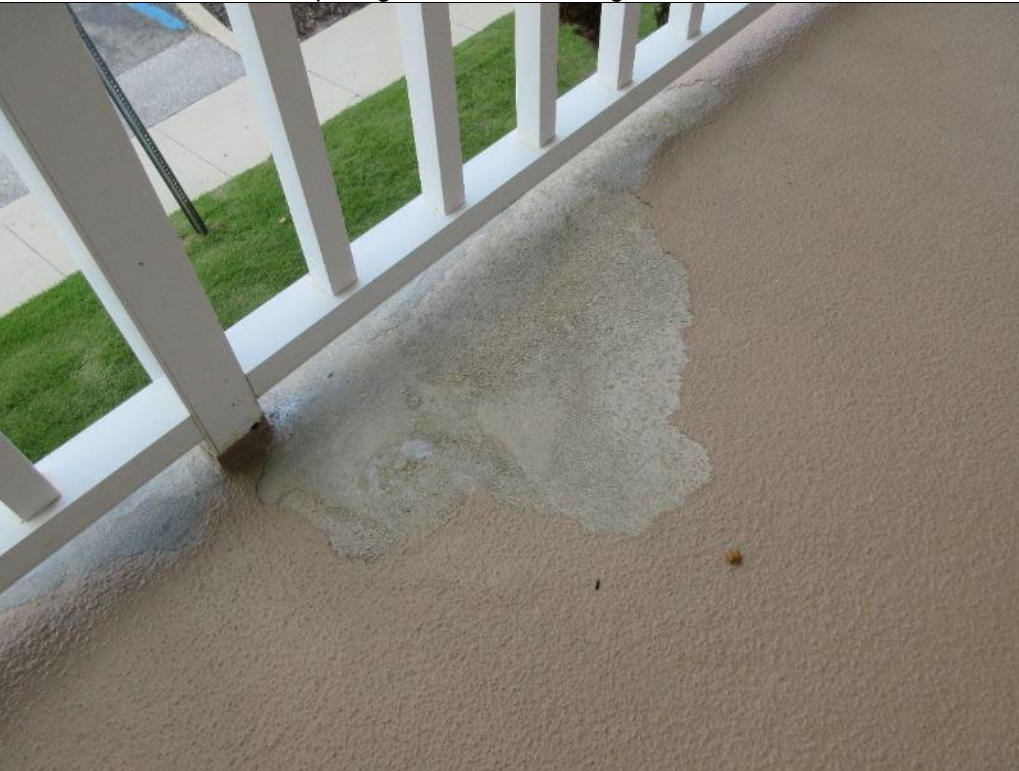
Photo 10. Failed Deck Coating

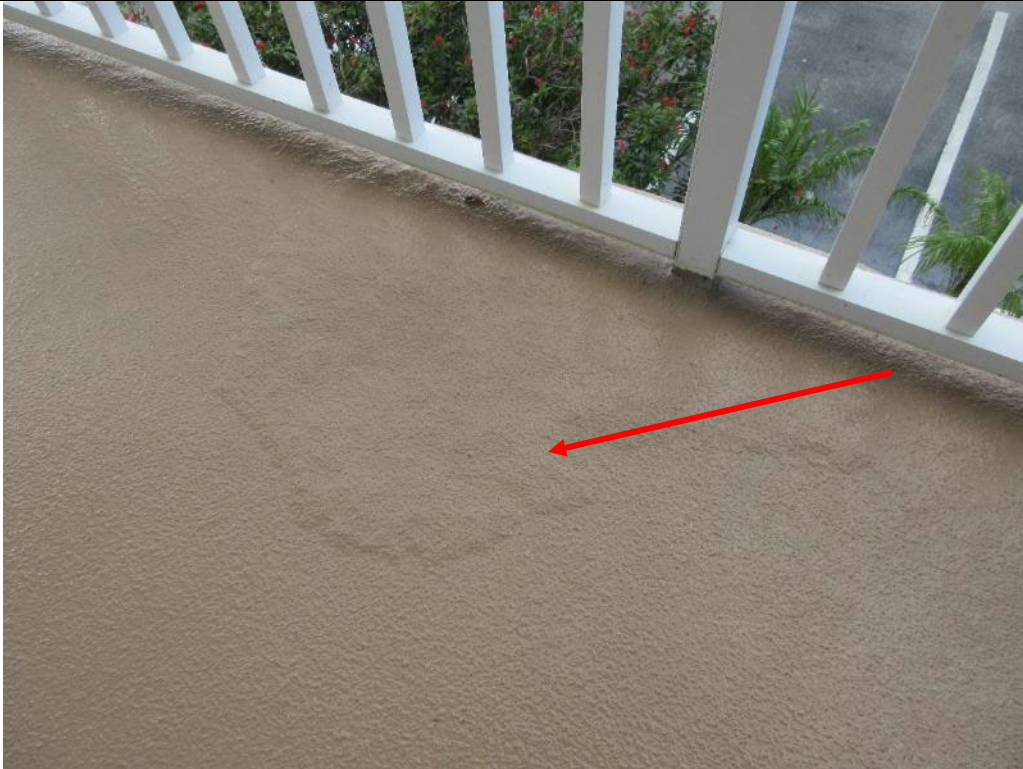
Photo 11. Apparent Spalling Concrete

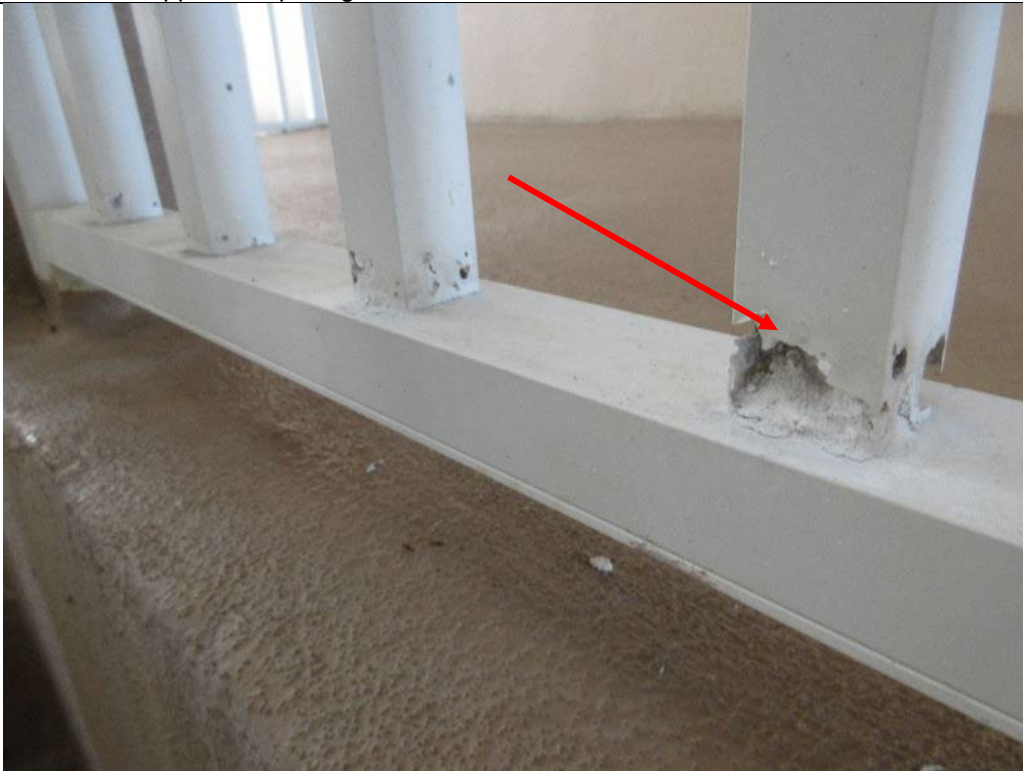
Photo 12. Railing Picket Deterioration at Attachment to Bottom Rail

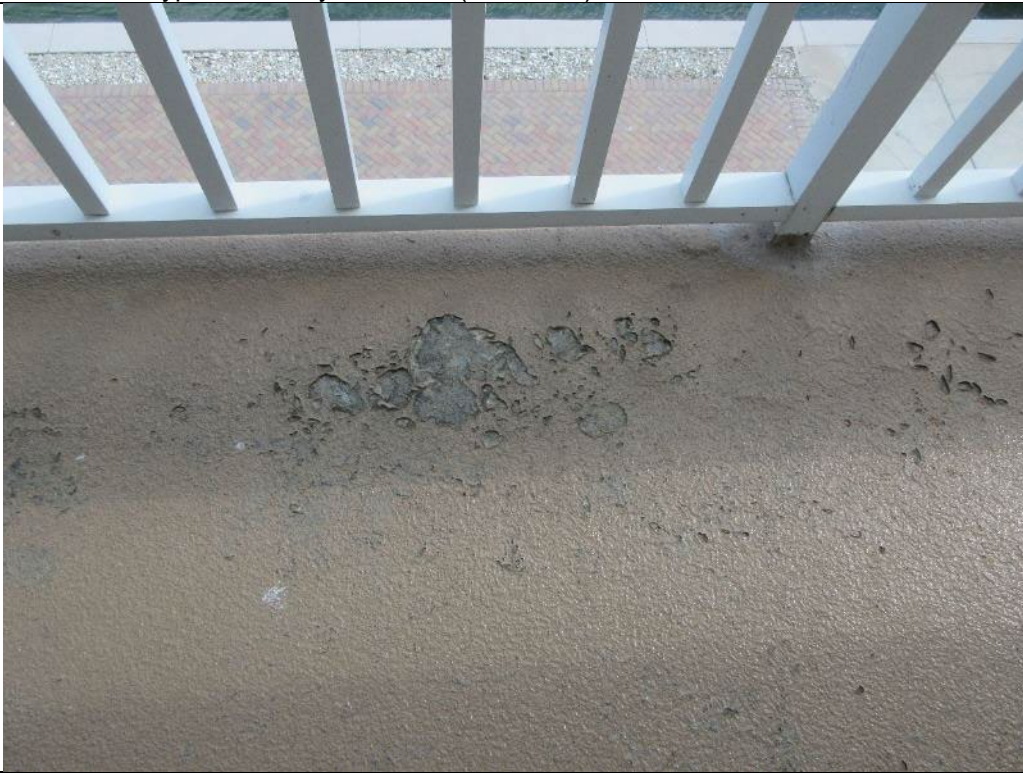
Photo 14. Close-Up Failed Deck Coating A301 (Typical)

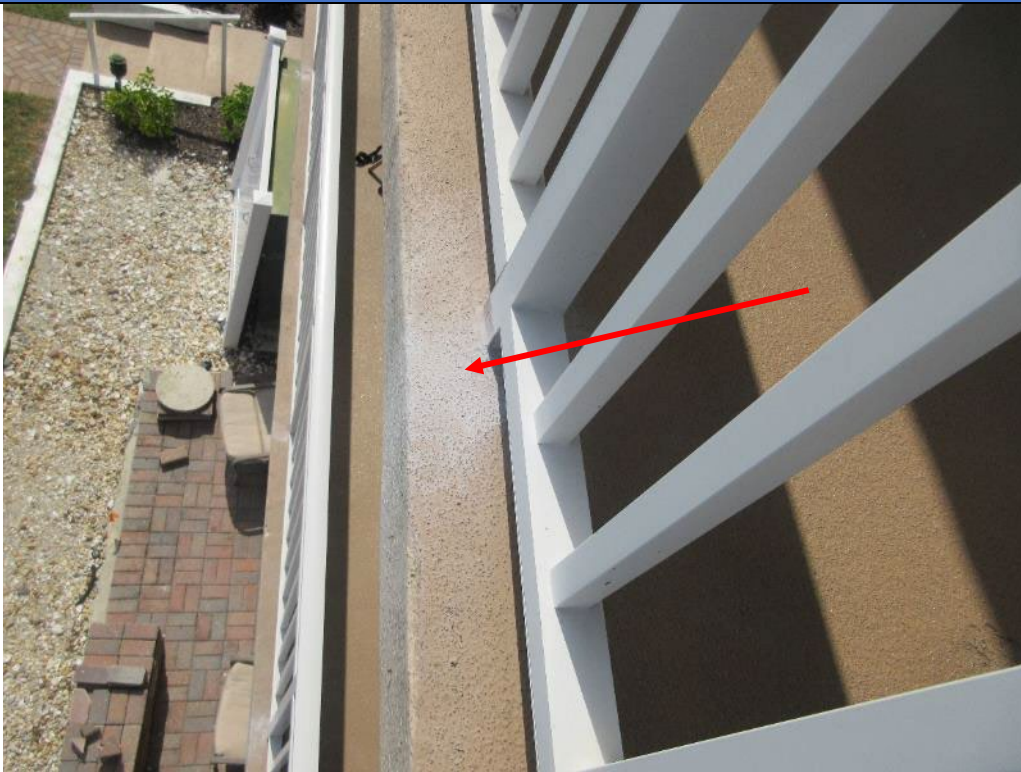
Photo 15. Typical Efflorescence at Railing Post

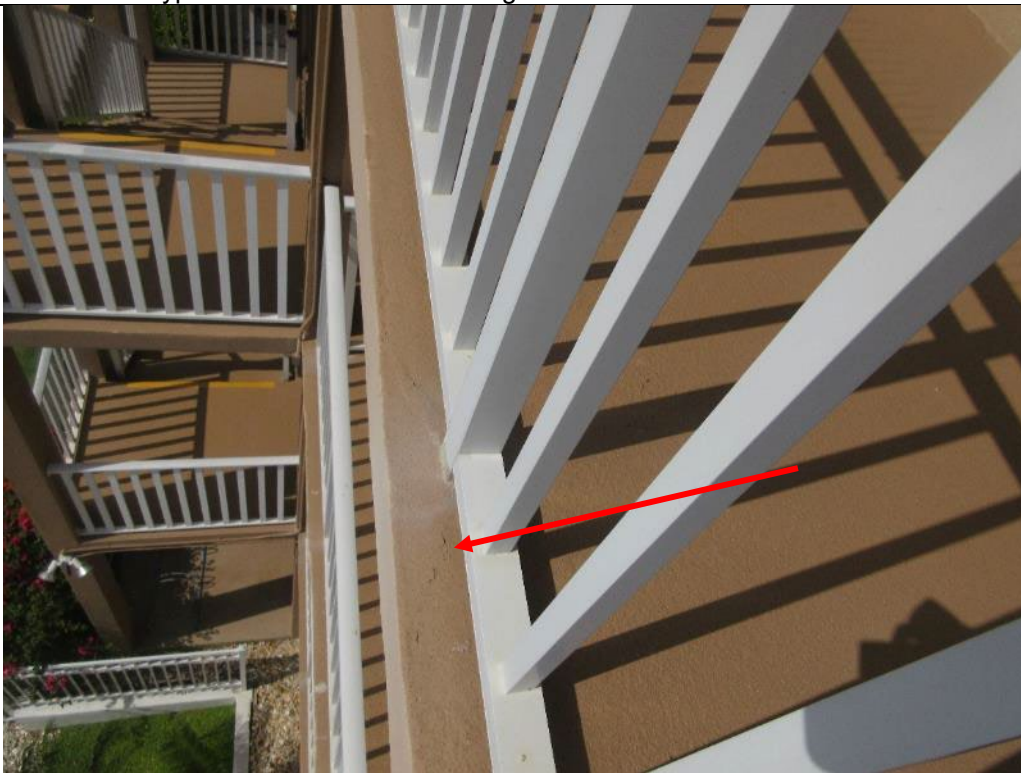
Photo 16. Apparent Concrete Spall at Post Pocket A401

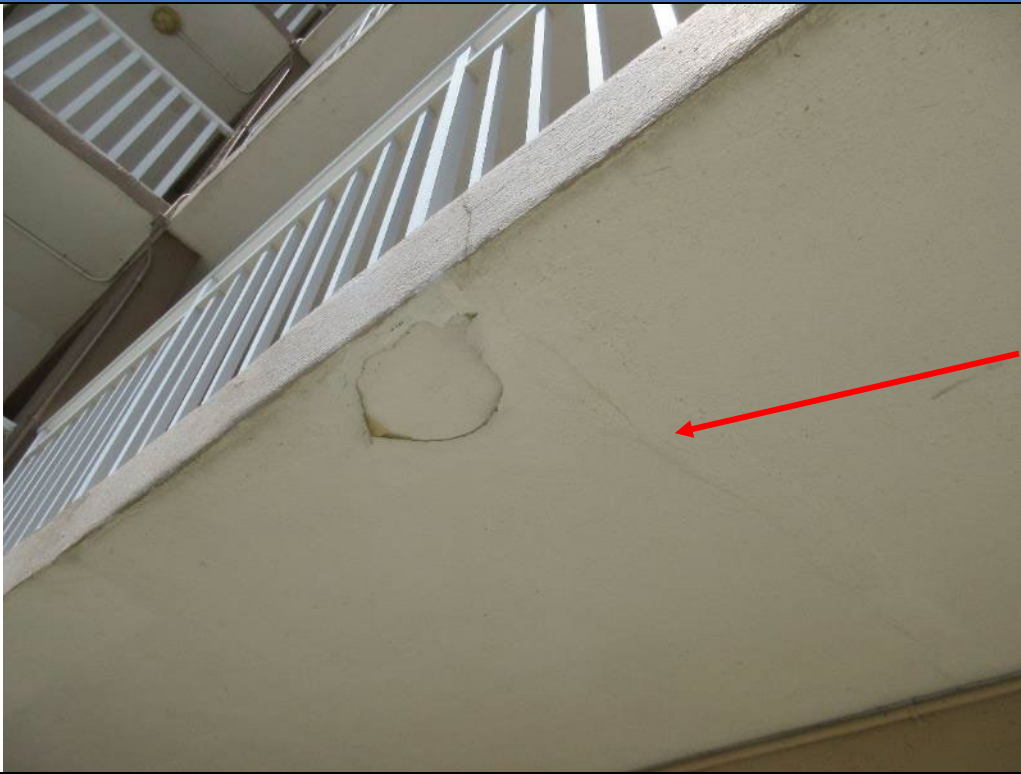
Photo 17. Unit A101 Ceiling with Crack and Delaminated Stucco

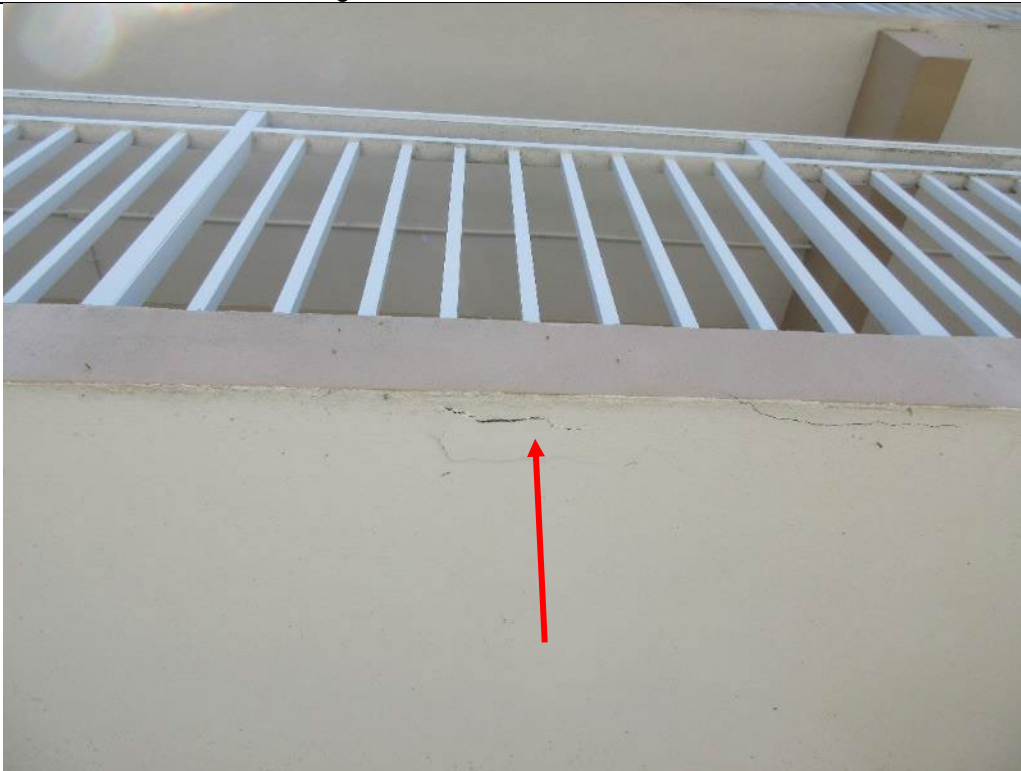
Photo 18. Slab Edge Crack and Spall at A201

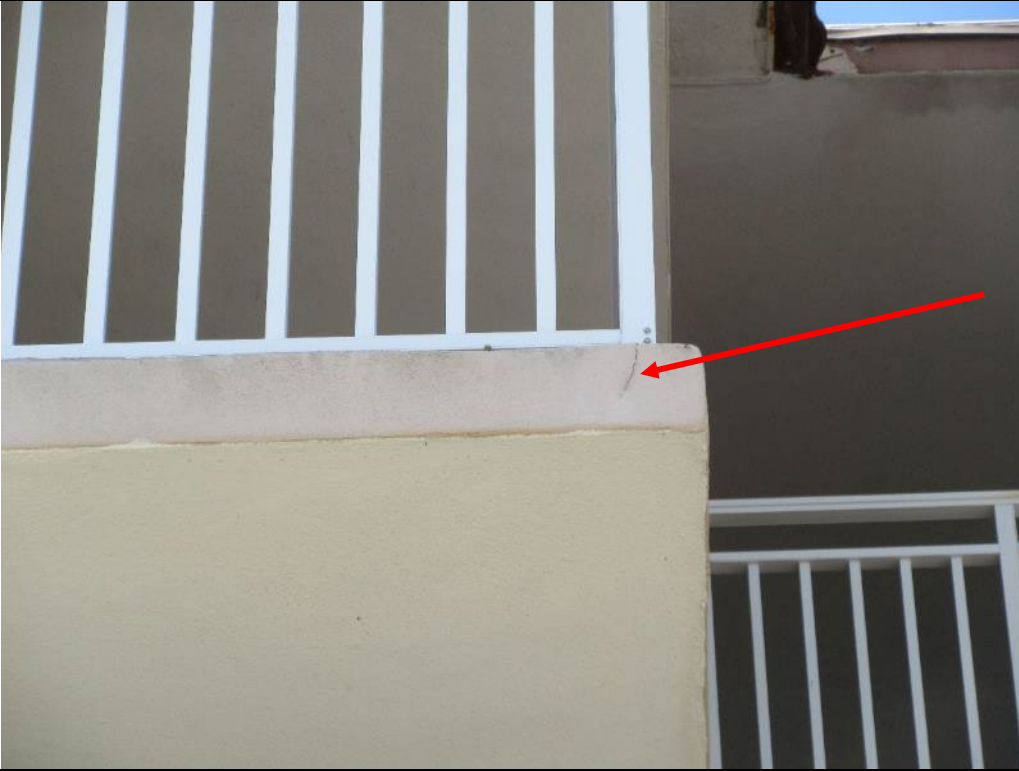
Photo 19. Slab Edge Crack and Spall A304

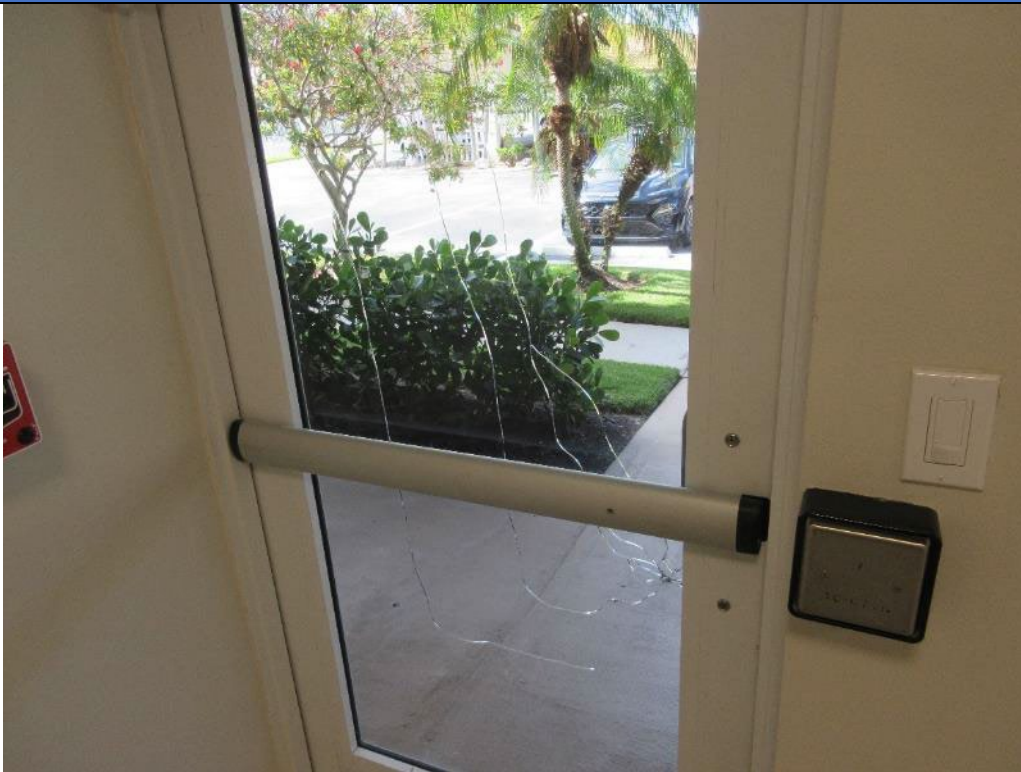
Photo 23. Broken Glazing at Common Area Door Building A

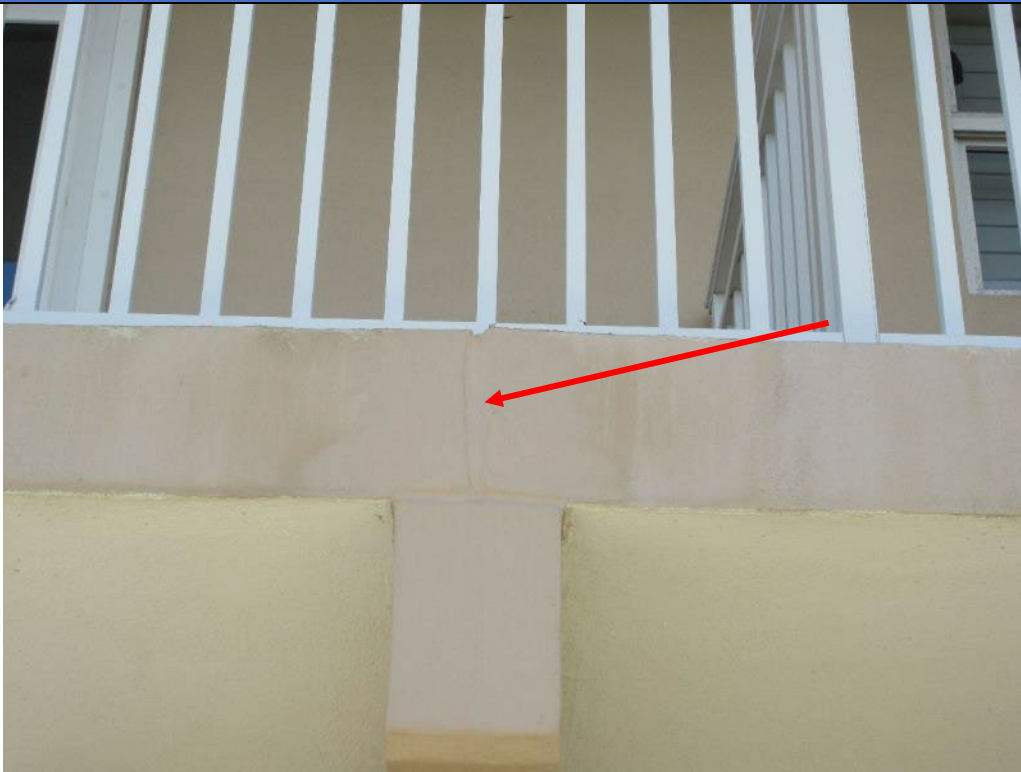
Photo 25. Crack at Slab Edge B201

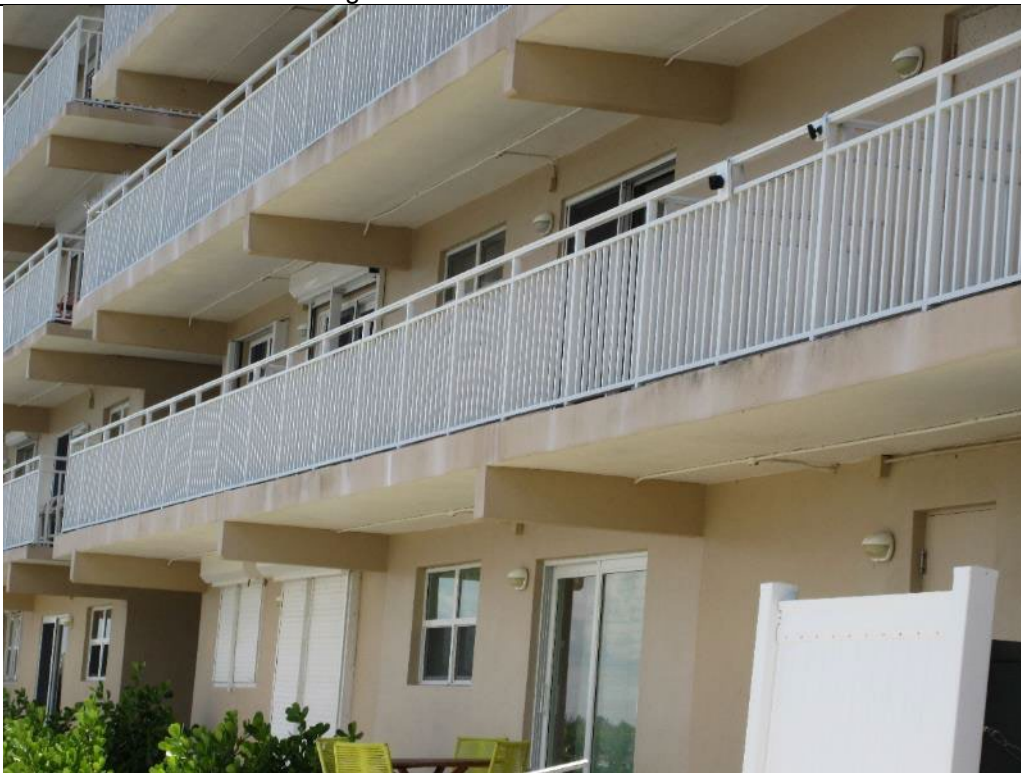
Photo 26. Typical Slab Edge Efflorescence at Unit Balconies Building B

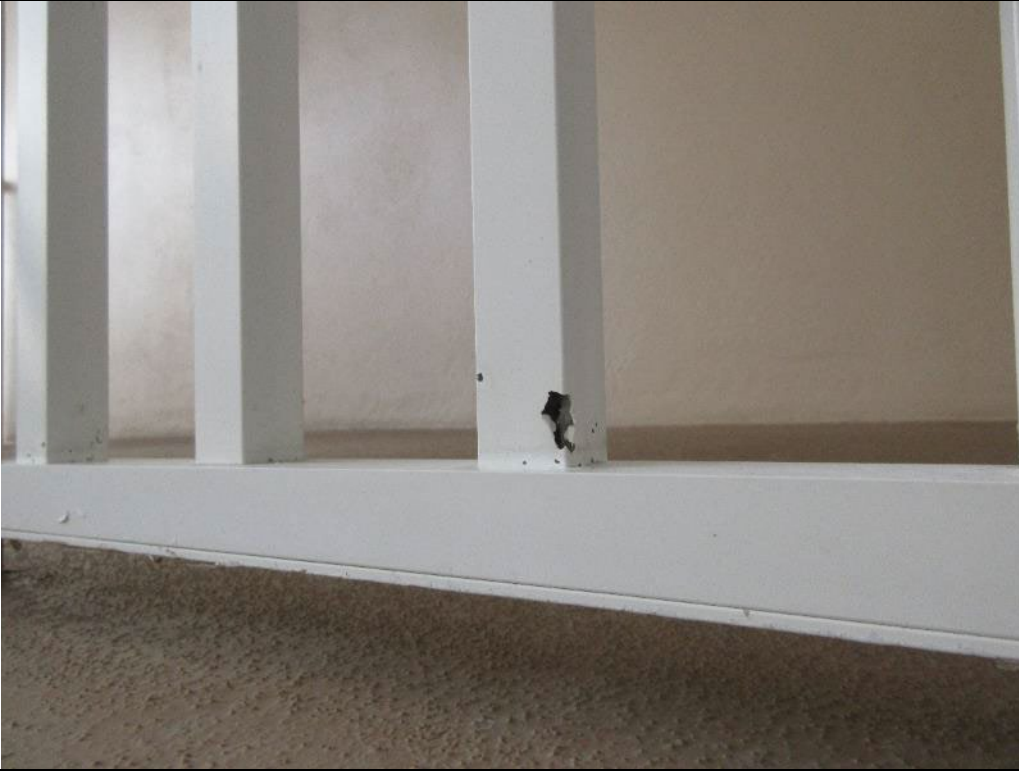
Photo 27. Damaged Rail Picket at Building B West Stair

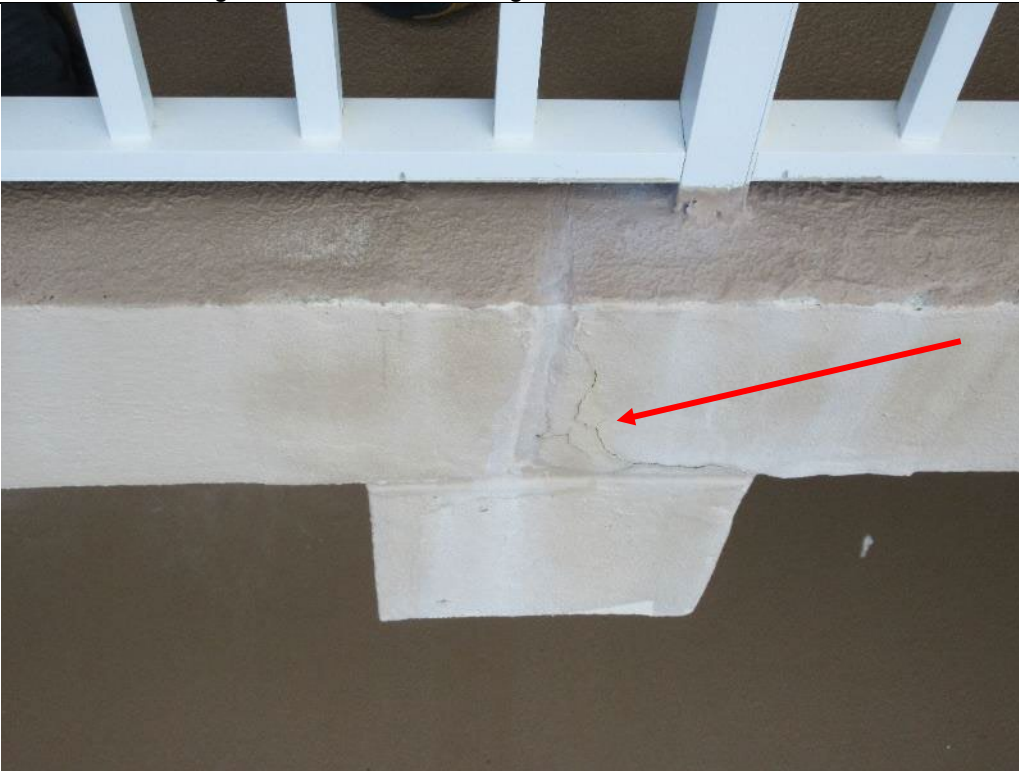
Photo 28. Crack at Slab Edge with Efflorescence near B403

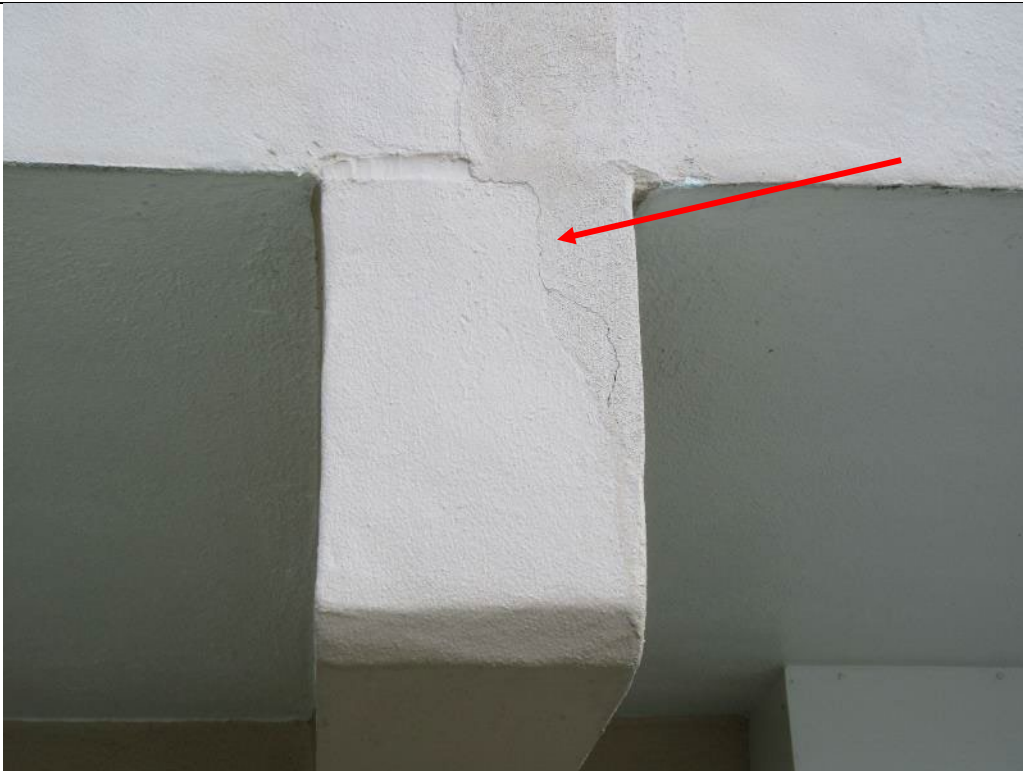
Photo 30. Crack at End of Cantilever Beam Near B101 and Failed Prev Repair

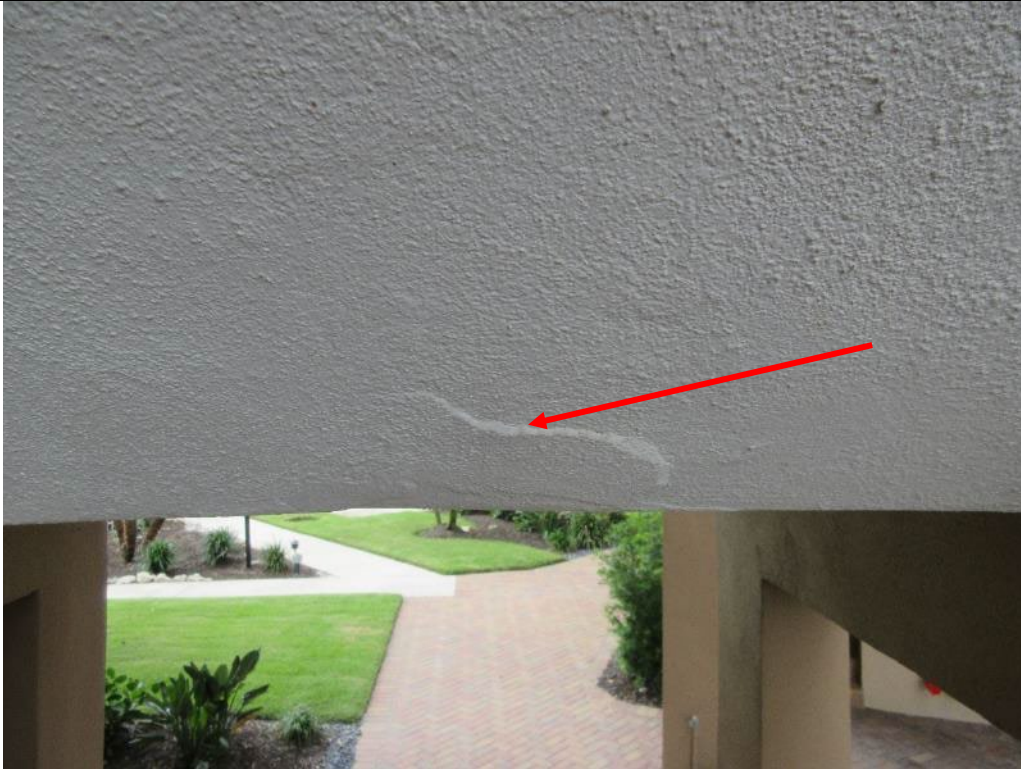
Photo 31. Spalling Concrete at West Stair Level 1

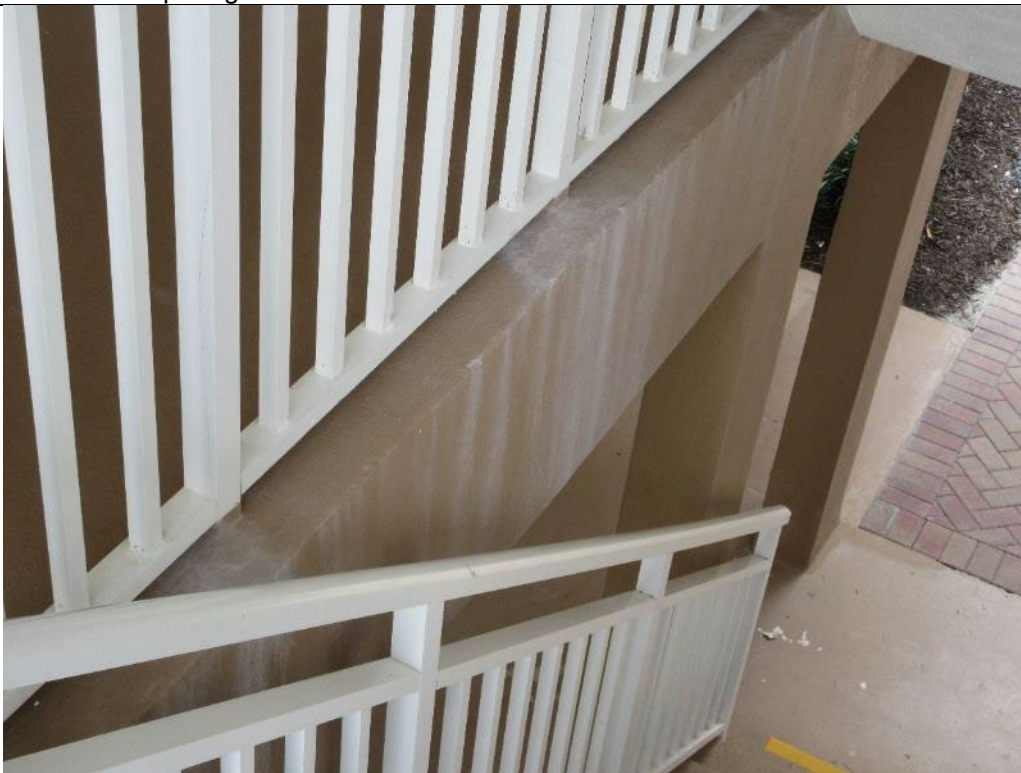
Photo 32. Efflorescence at Slab Edge Near Stairs

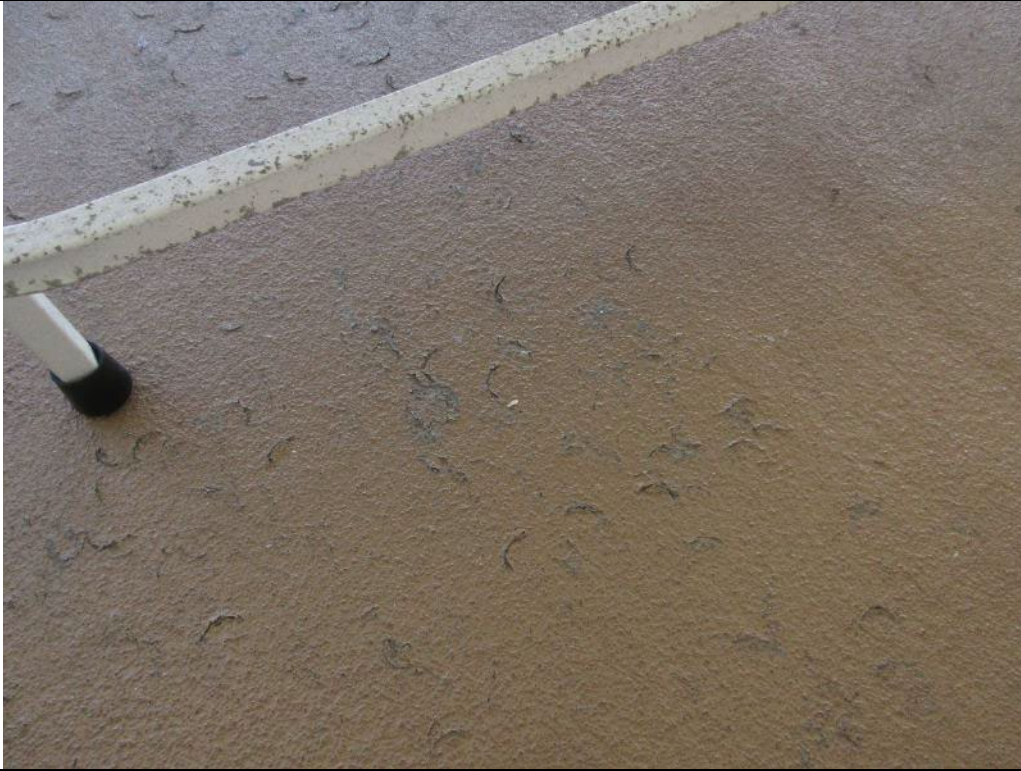
Photo 33. Typical Failed Deck Coating B403

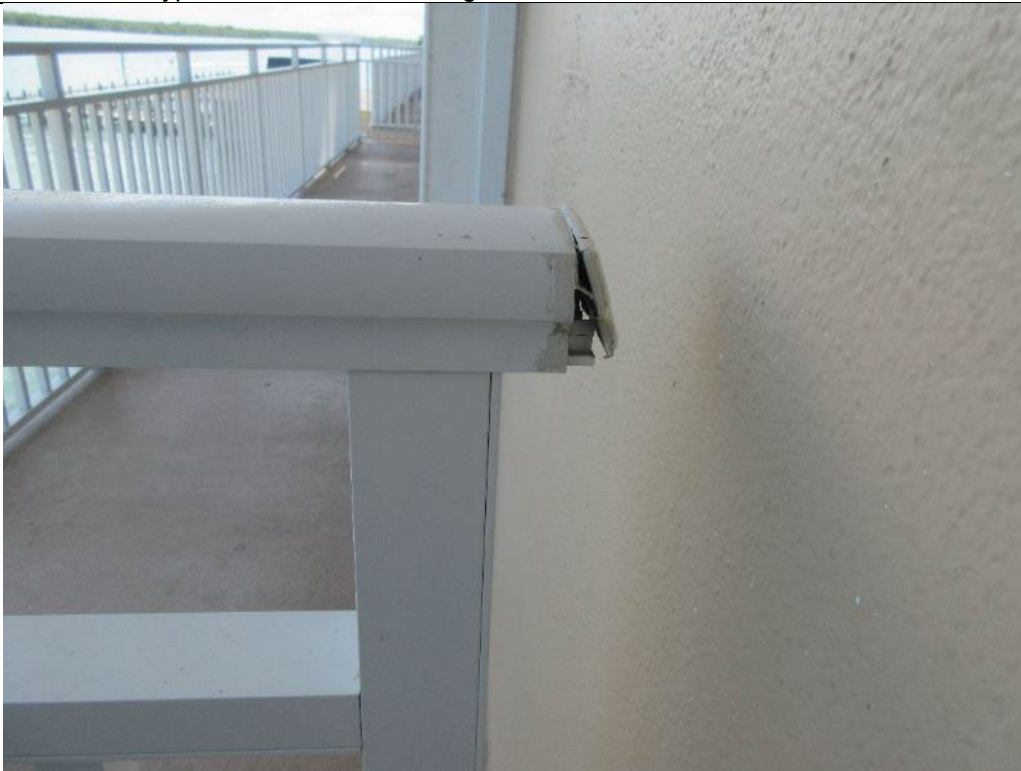
Photo 34. Damaged Rail Top Cap at B302

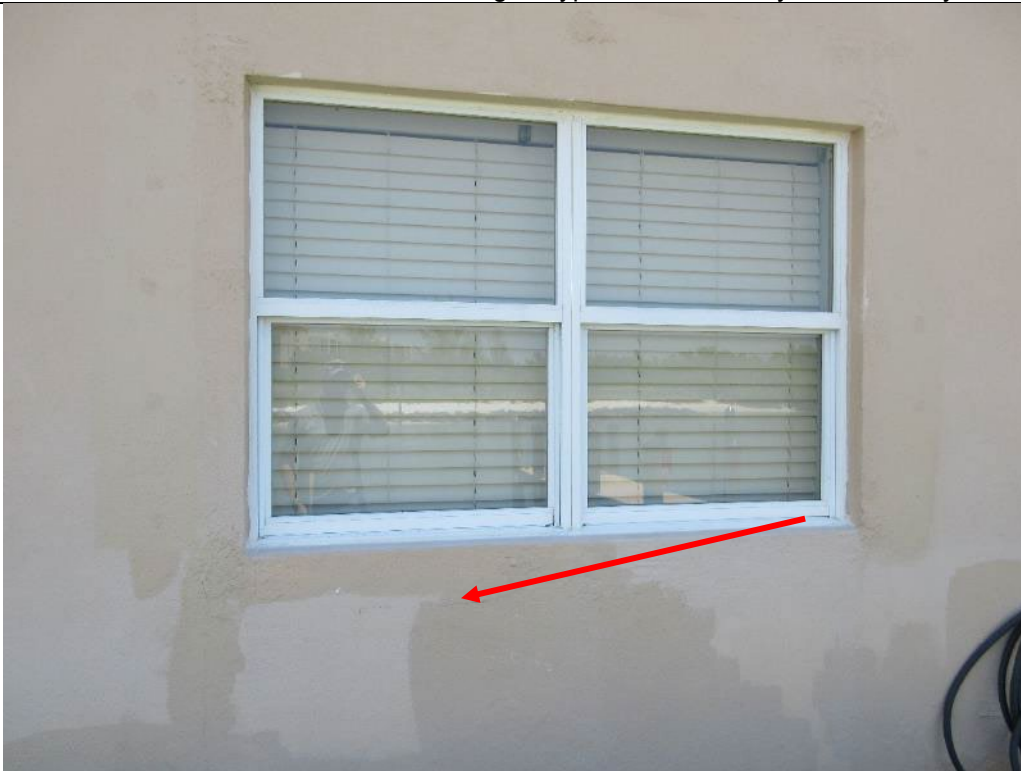
Photo 38. C103 Crack and Damaged Windowsill with Failed Previous Repair

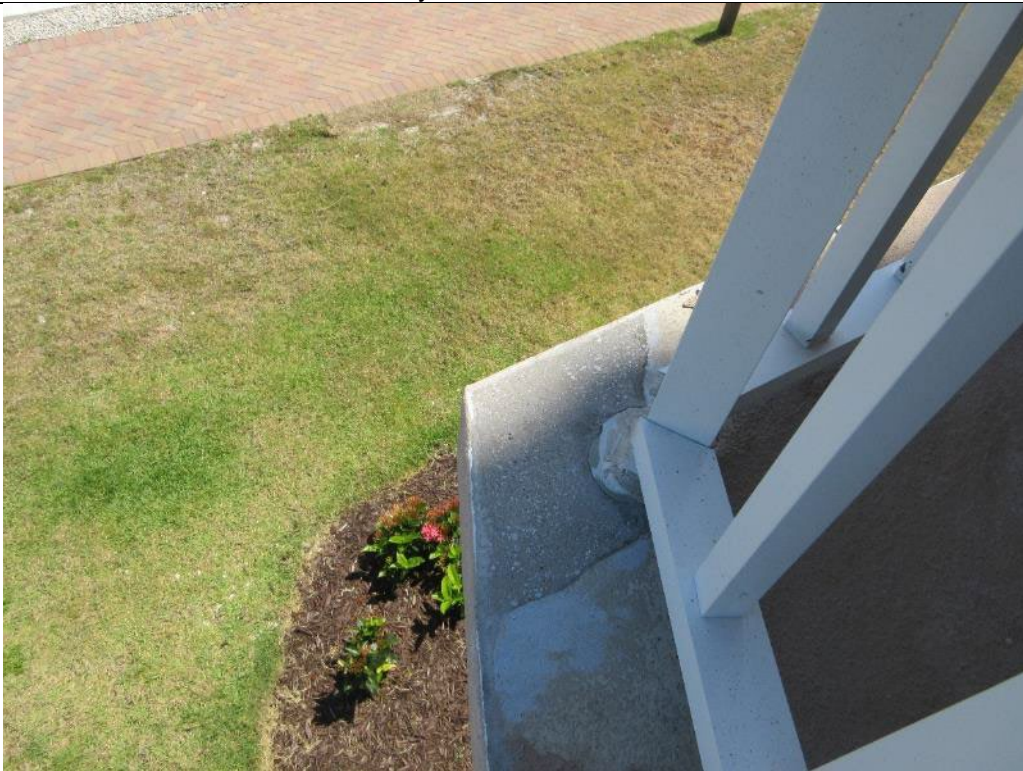
Photo 40. Previous Slab Edge Repair without Waterproofing C201

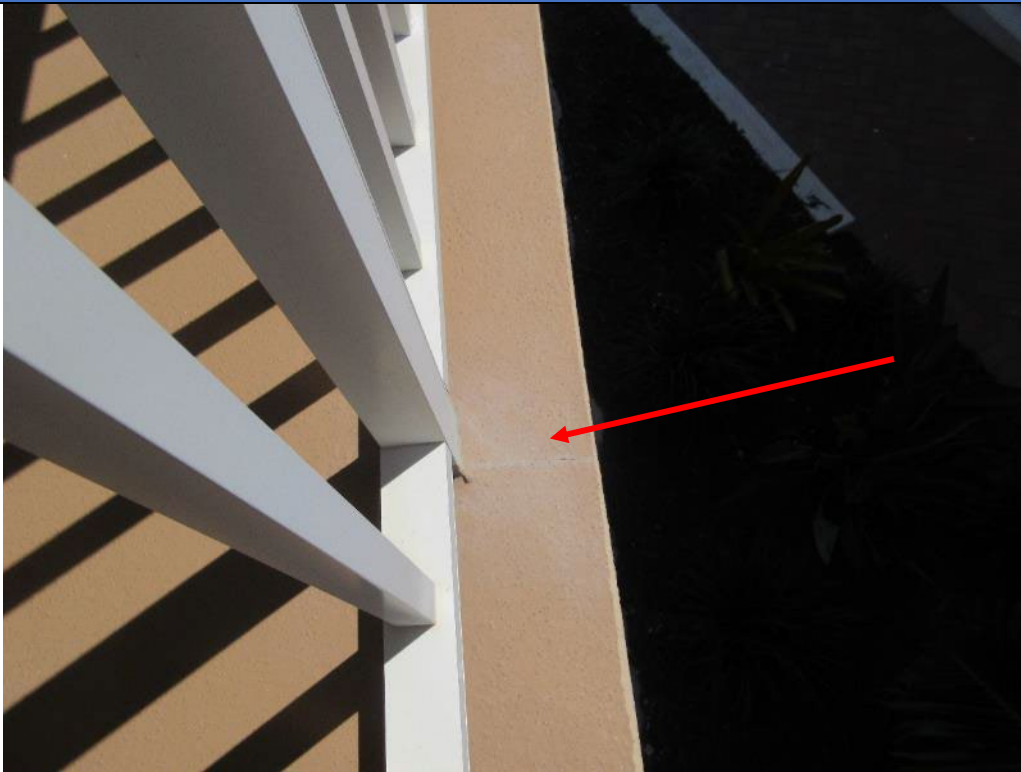
Photo 41. Crack at Slab Edge with Efflorescence C201 Balcony 2

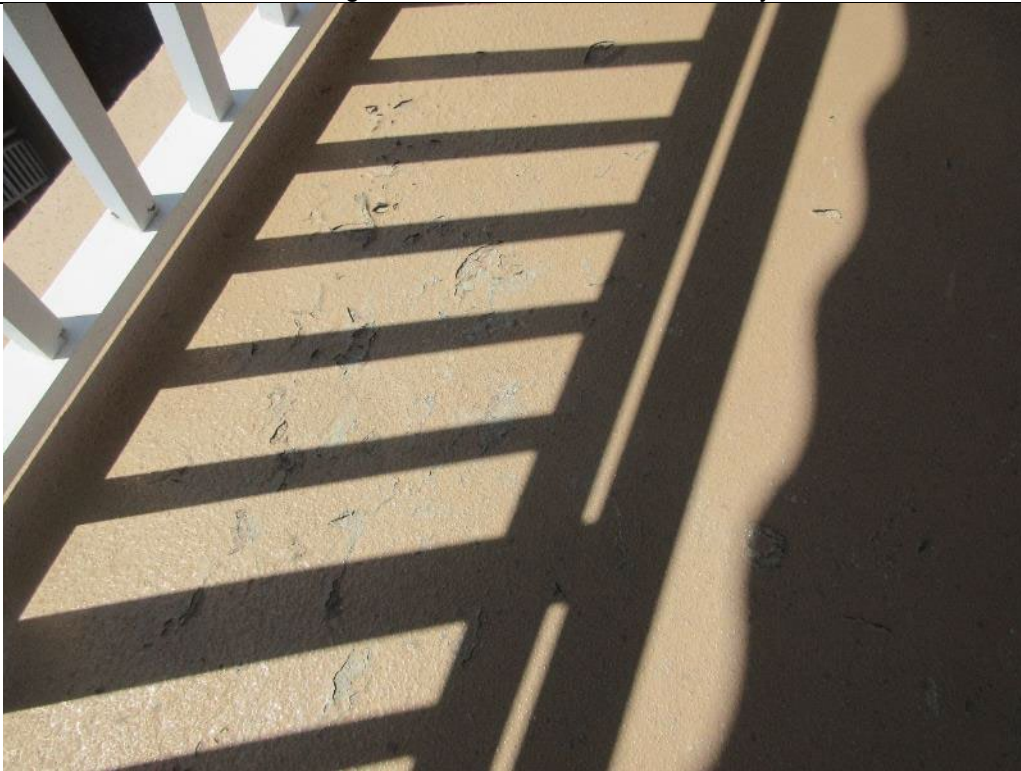
Photo 42. Typical Failed Waterproofing C401

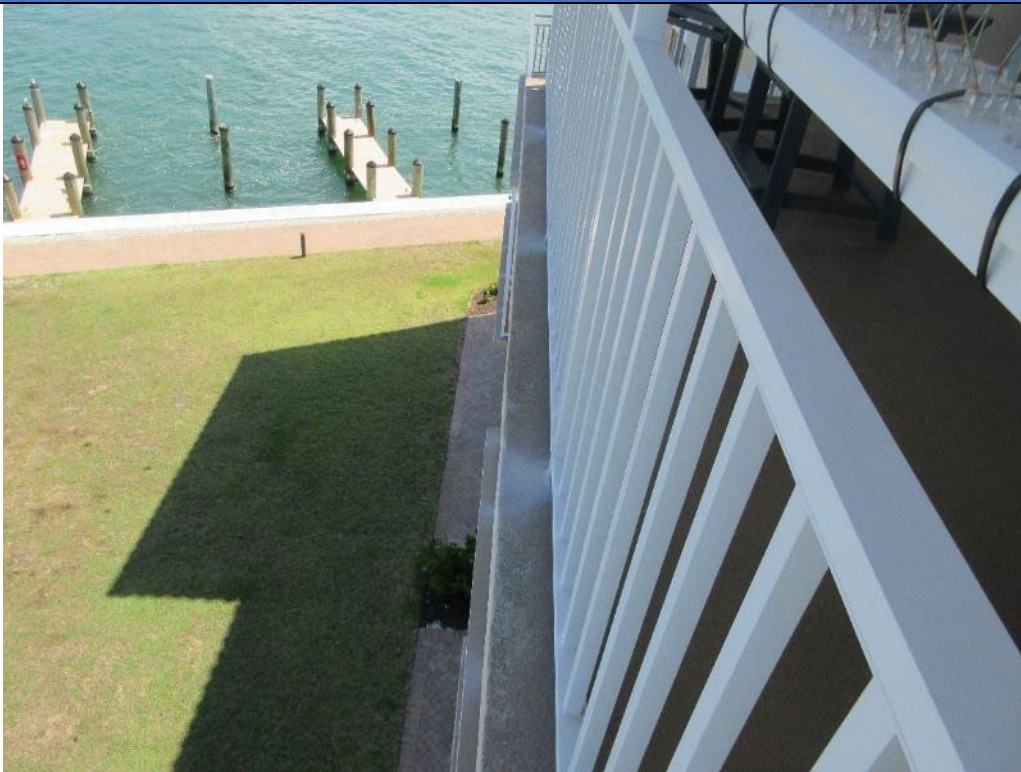
Photo 43. Typical Failed Waterproofing and Efflorescence at Slab Edge C402

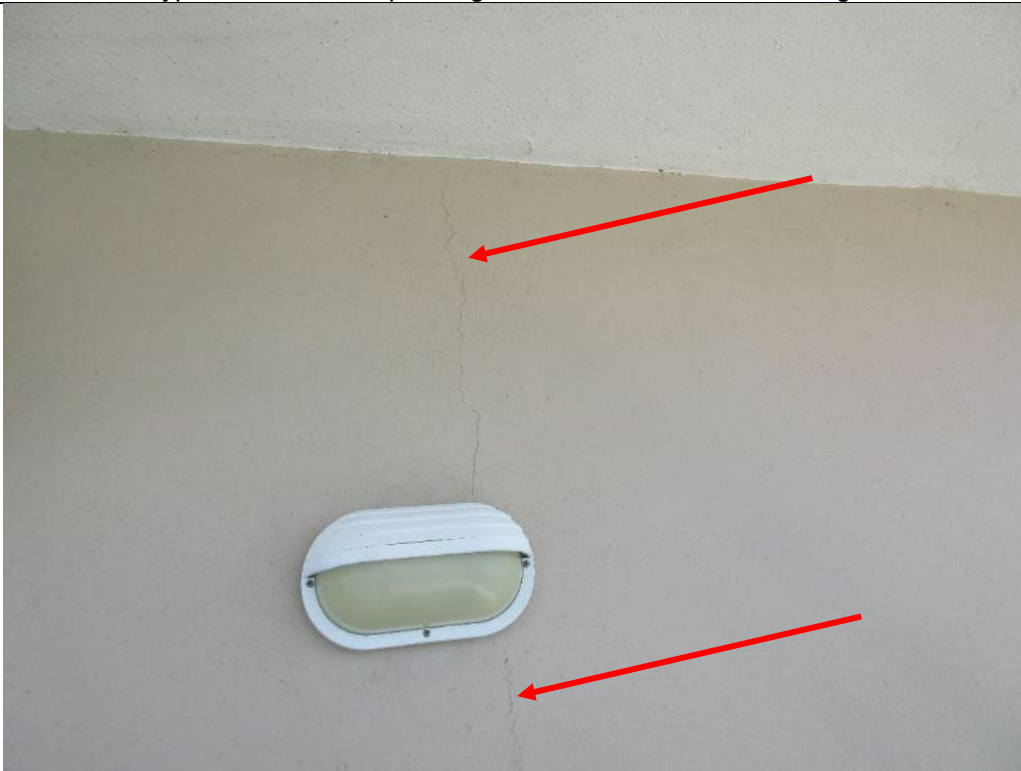
Photo 44. Crack at Stucco Wall C402

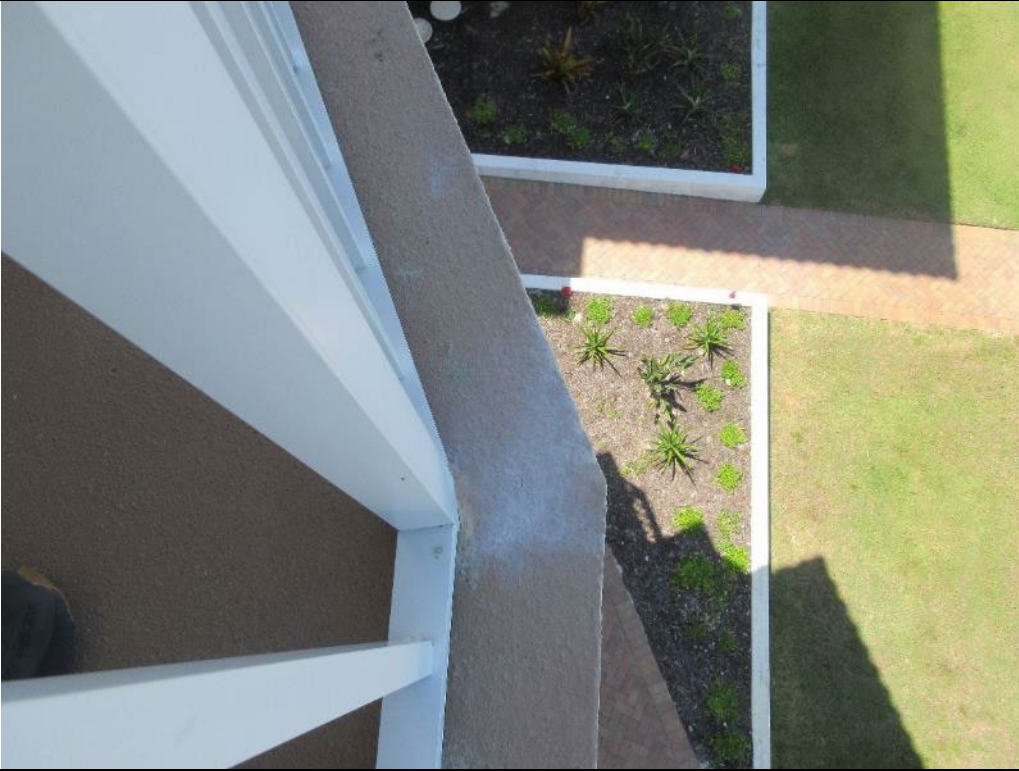
Photo 47. Crack and Apparent Spall at Slab Edge with Efflorescence
