# JMC Engineering Inc.

VILLE DE MARCO WEST, A CONDOMINIUM, INC.  
1200-1208 Edington Place  
Marco Island, FL 34145

Reference: MILESTONE PHASE 1 INSPECTION REPORT  
Ville De Marco West, A Condominium, Inc.  
JMC Project Number: 119BPM.12

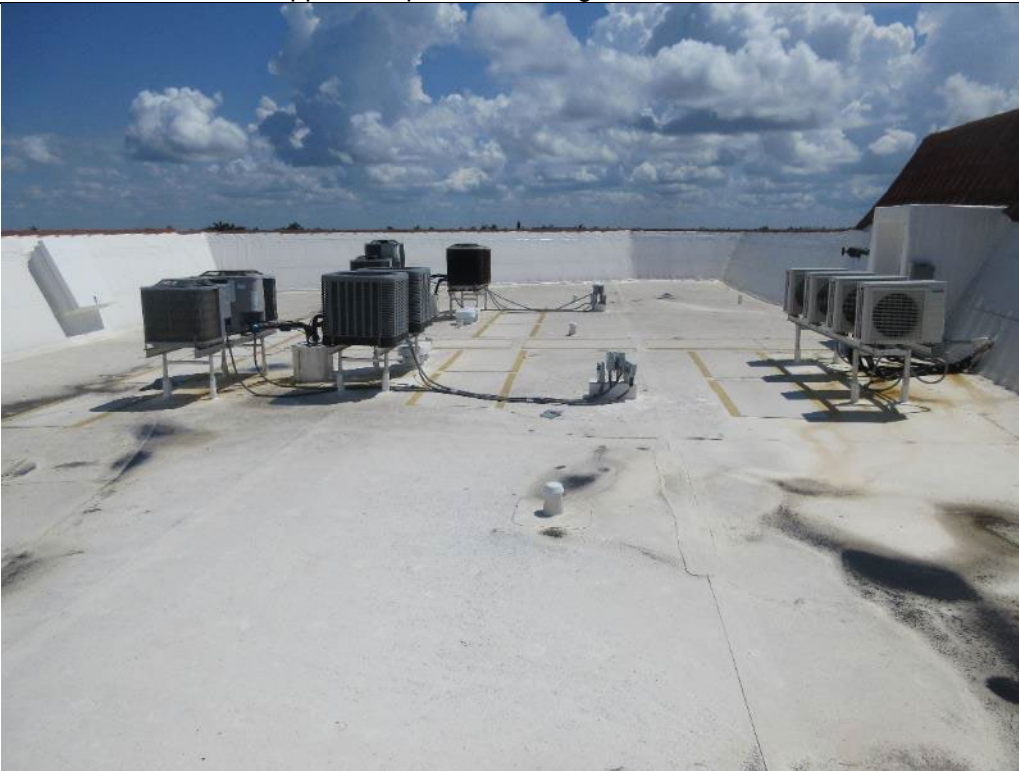
Photo 48. Overview Building C Roof Typical Ponding Areas

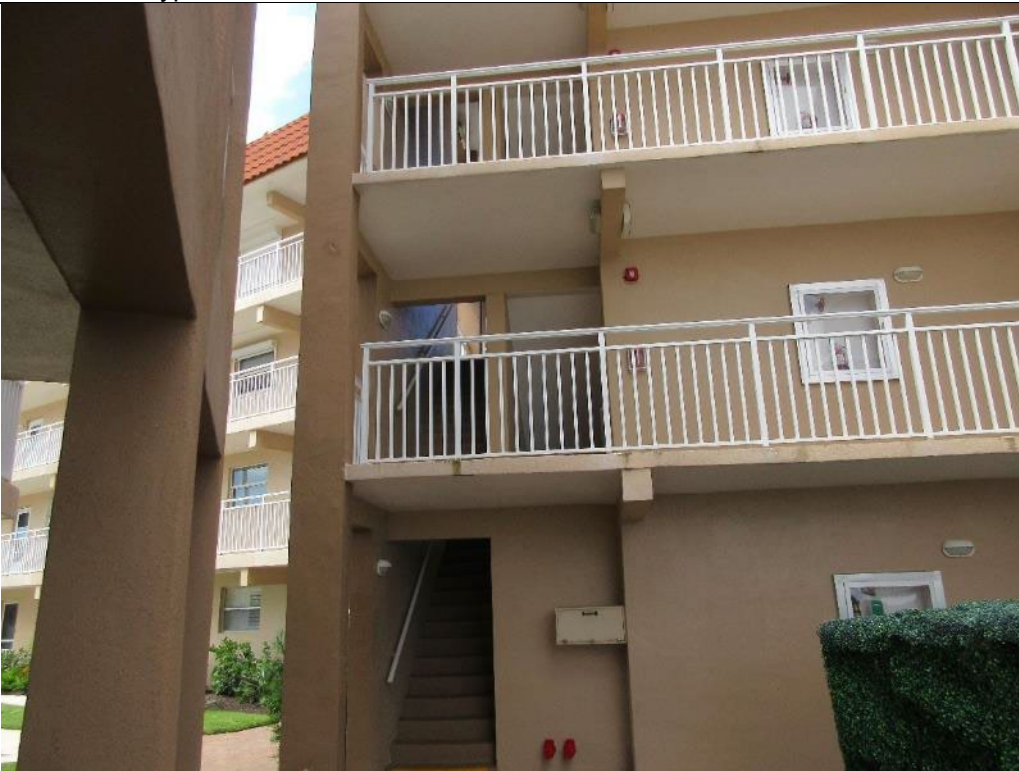
Photo 50. Typical Stairs Building C with Staining and Efflorescence at Slab Edges

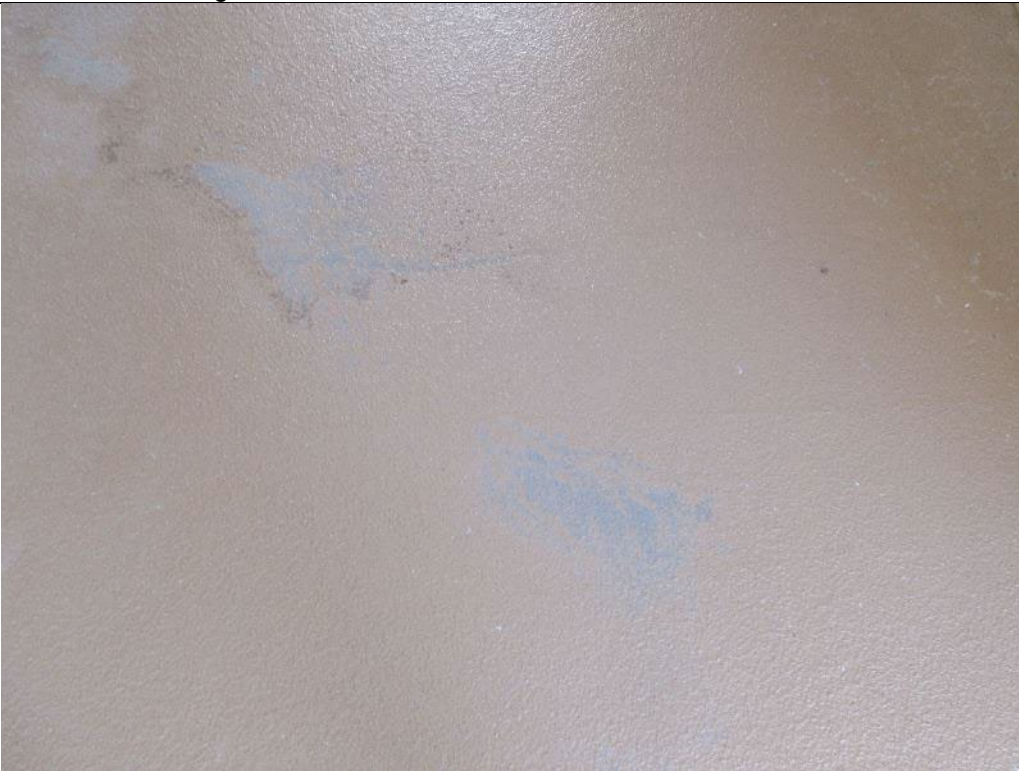
Photo 52. Typical Failed Deck Coating at Walkways

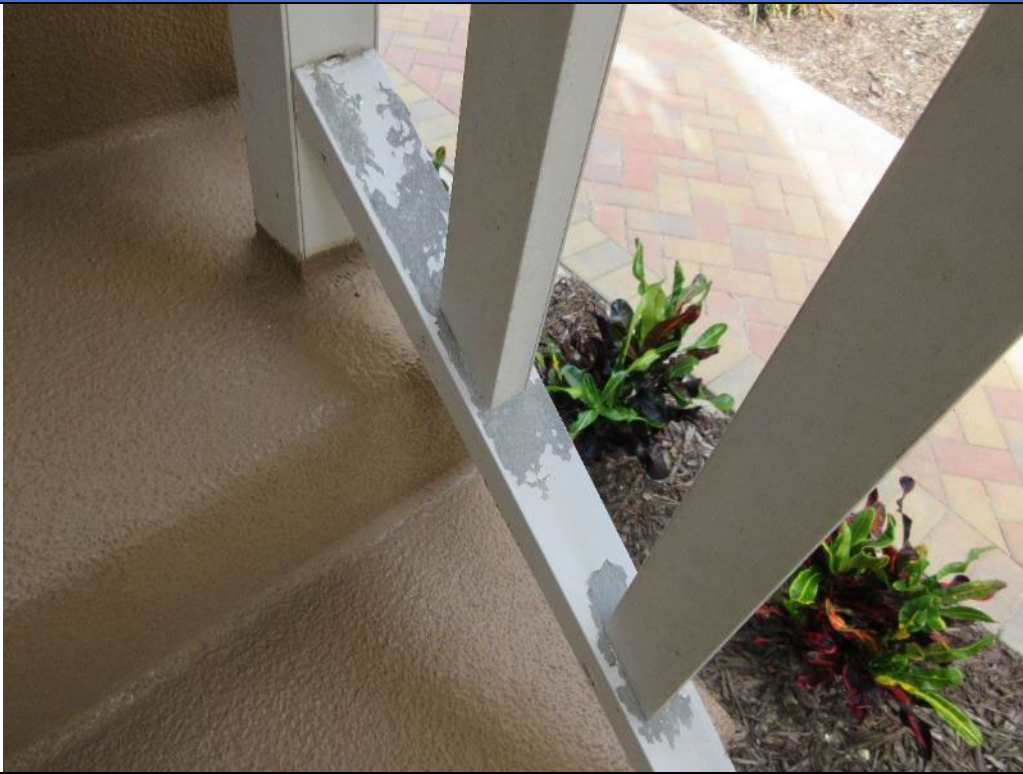
Photo 55. Typical Failed Railing Coating Building D

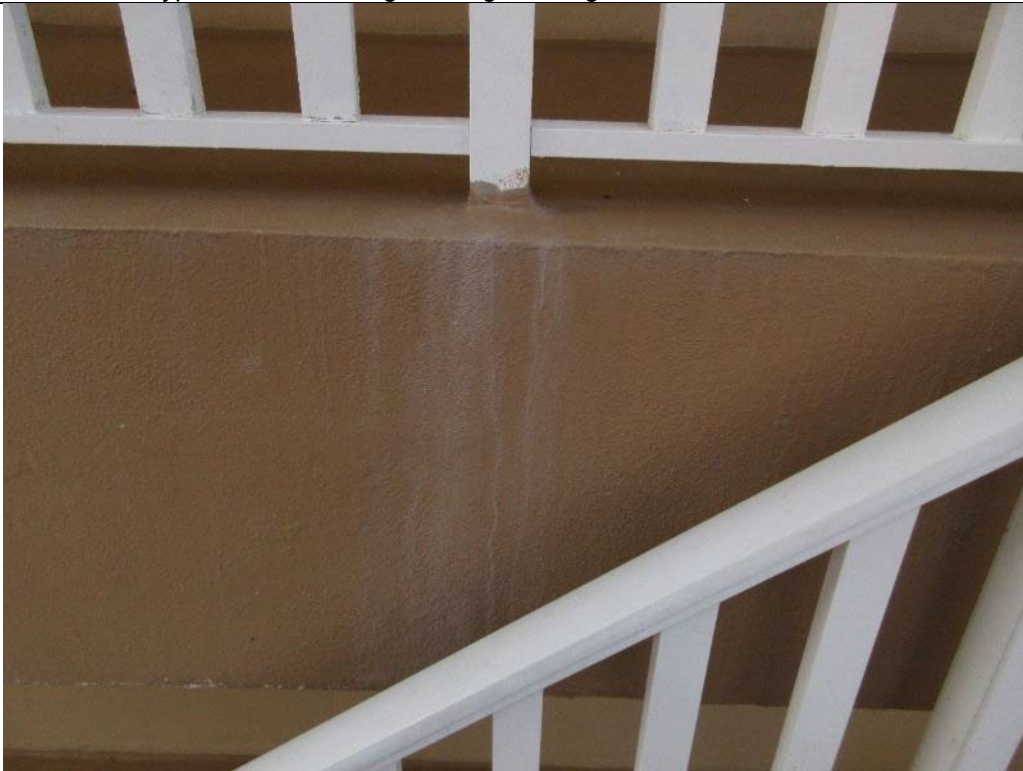
Photo 56. Typical Efflorescence at Slab Edge Railing Post

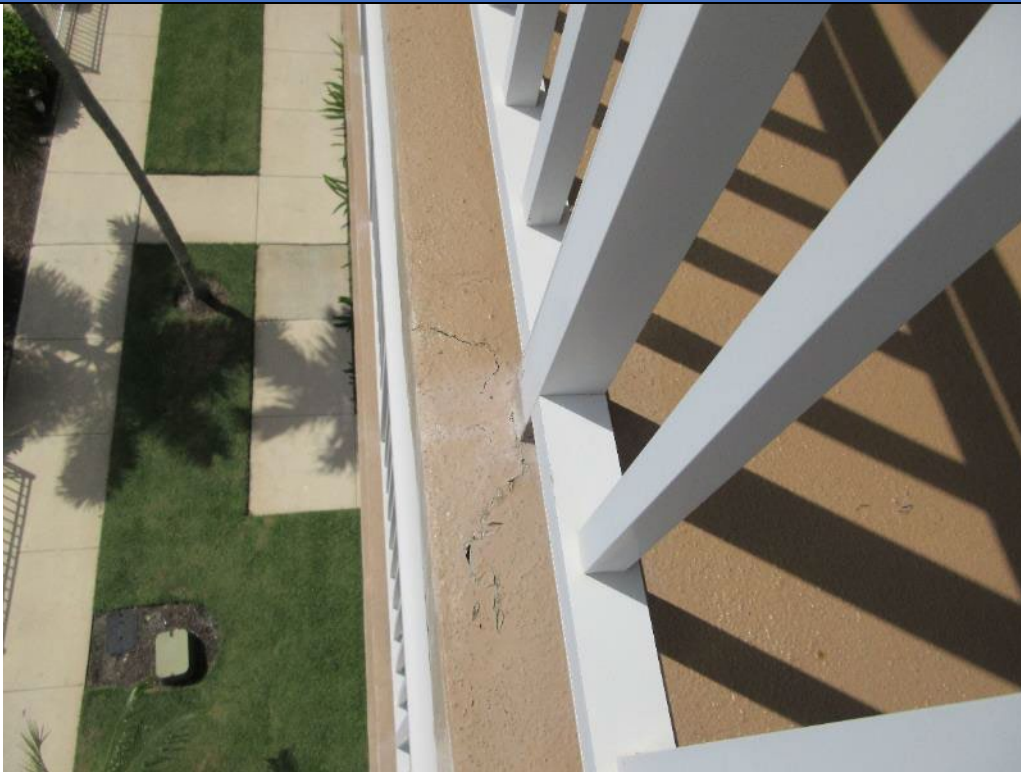
Photo 57. Spalling Concrete at Slab Edge Post Pocket Near D404

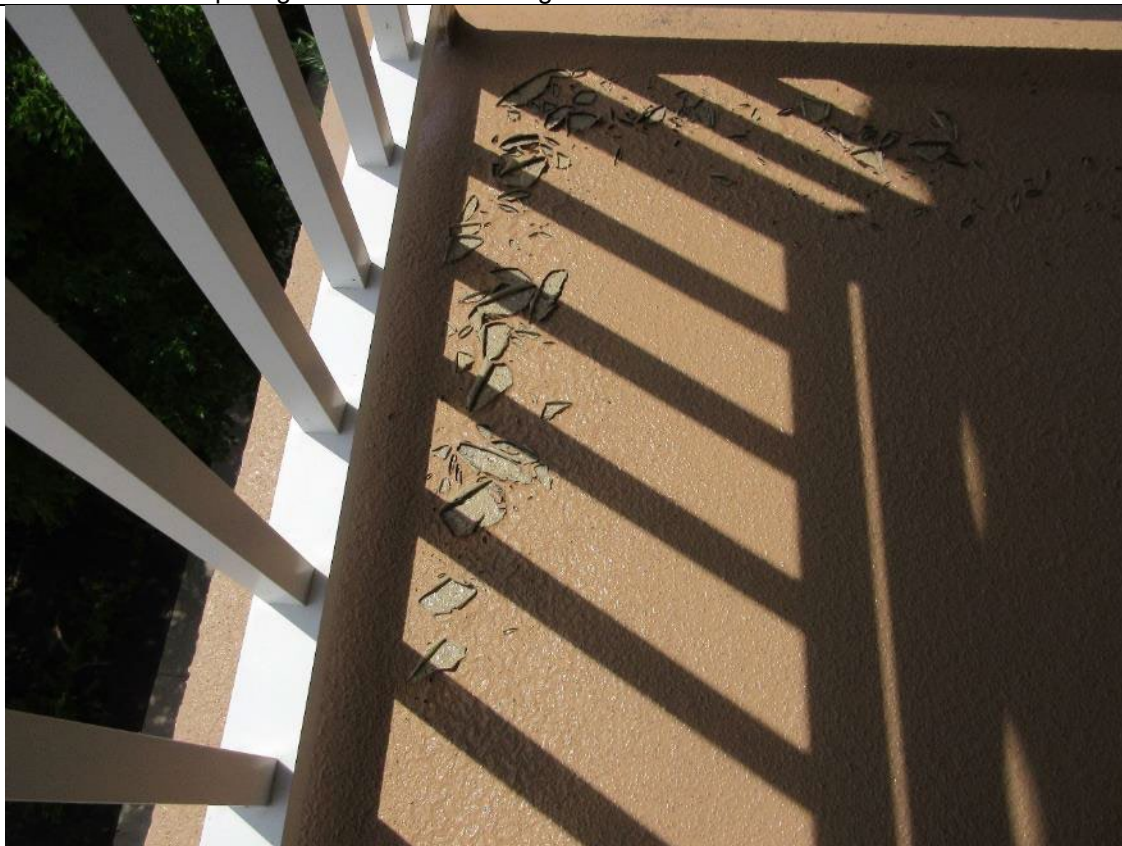
Photo 58. Typical Failed Waterproofing

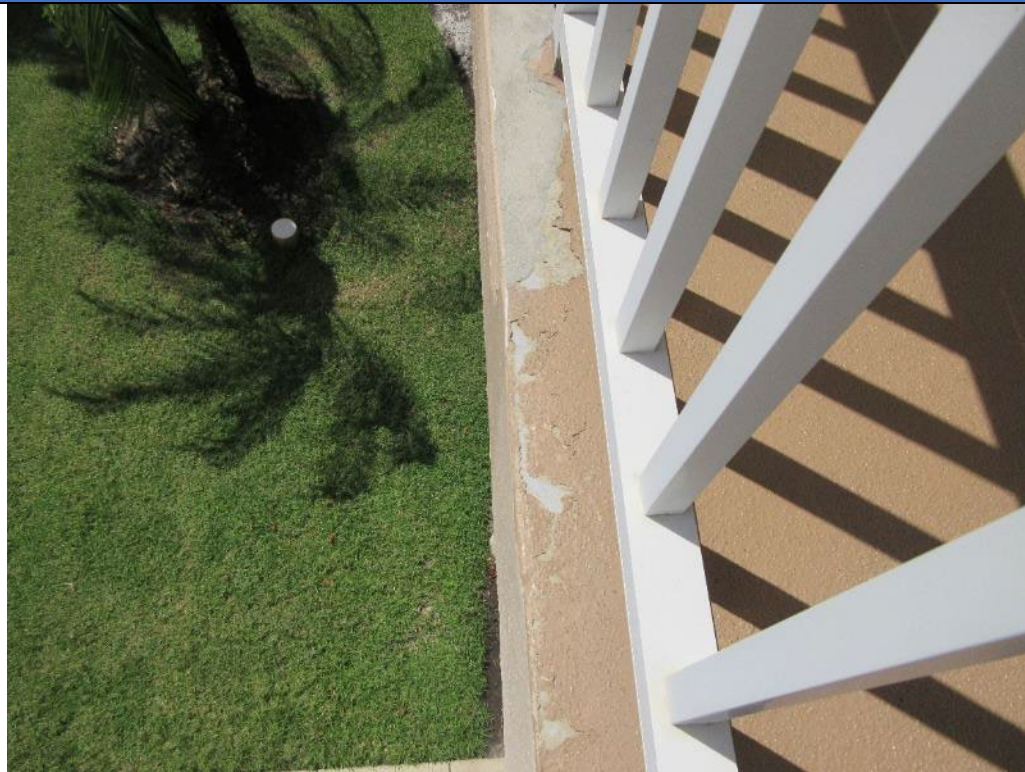
Photo 59. Crack in Concrete and Failed Waterproofing Deck Coating Near D204

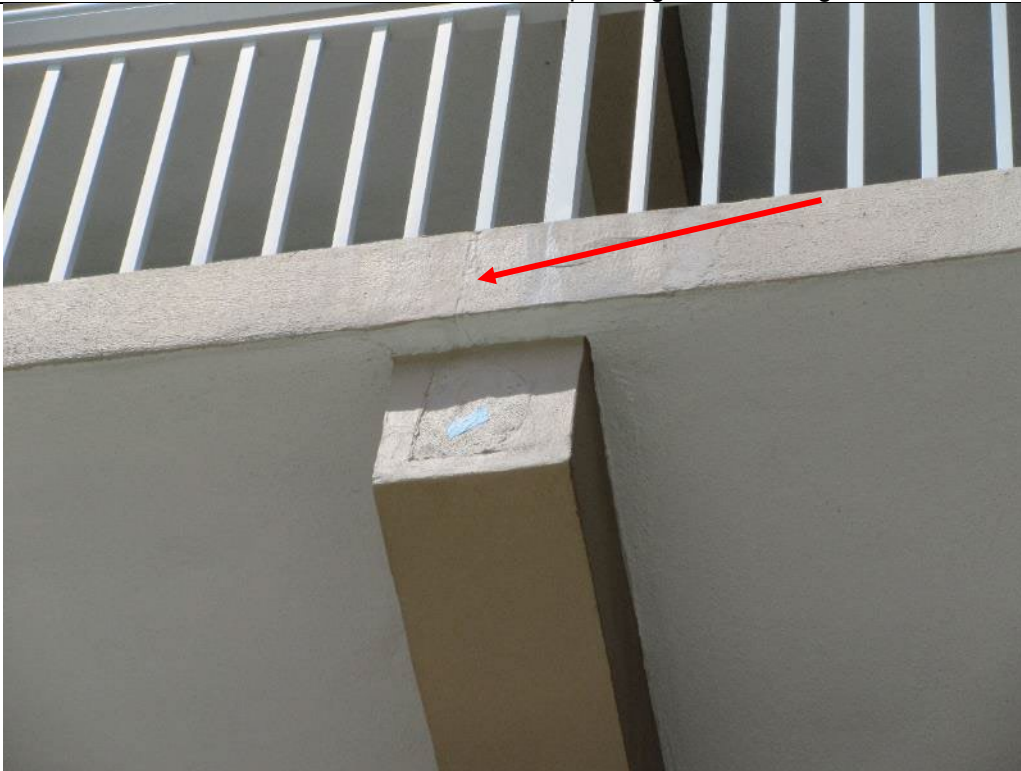
Photo 60. Crack at Slab Edge and Apparent Failed Previous Repair Near D10

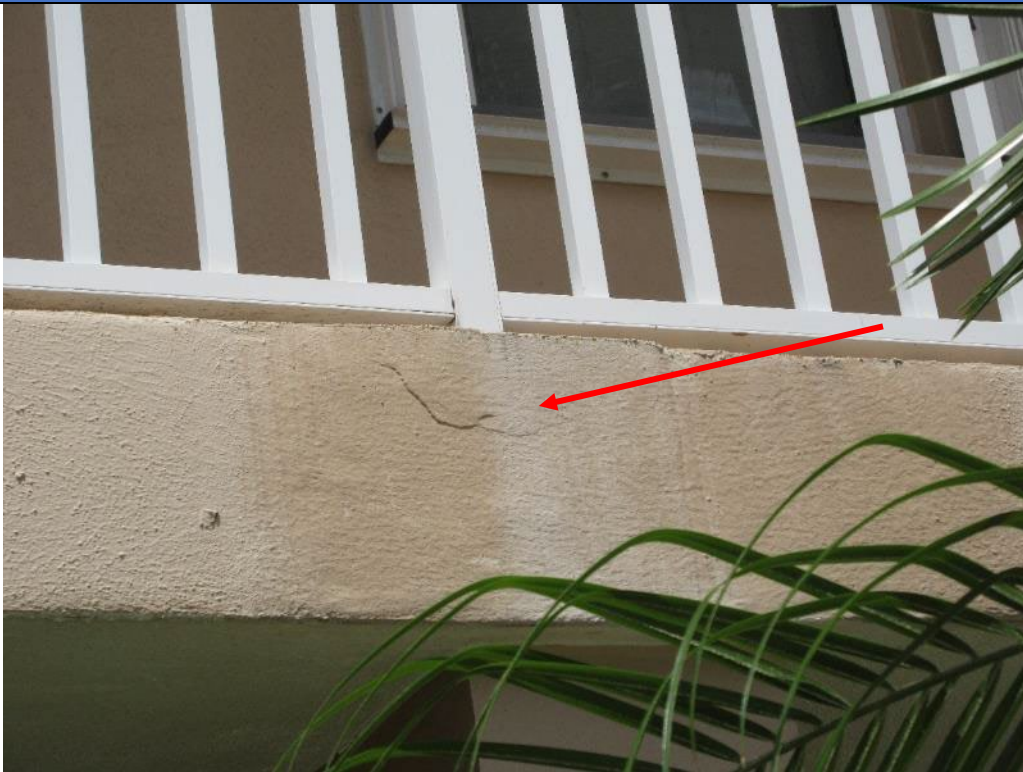
Photo 61. Spall at Slab Edge Railing Post Near D102

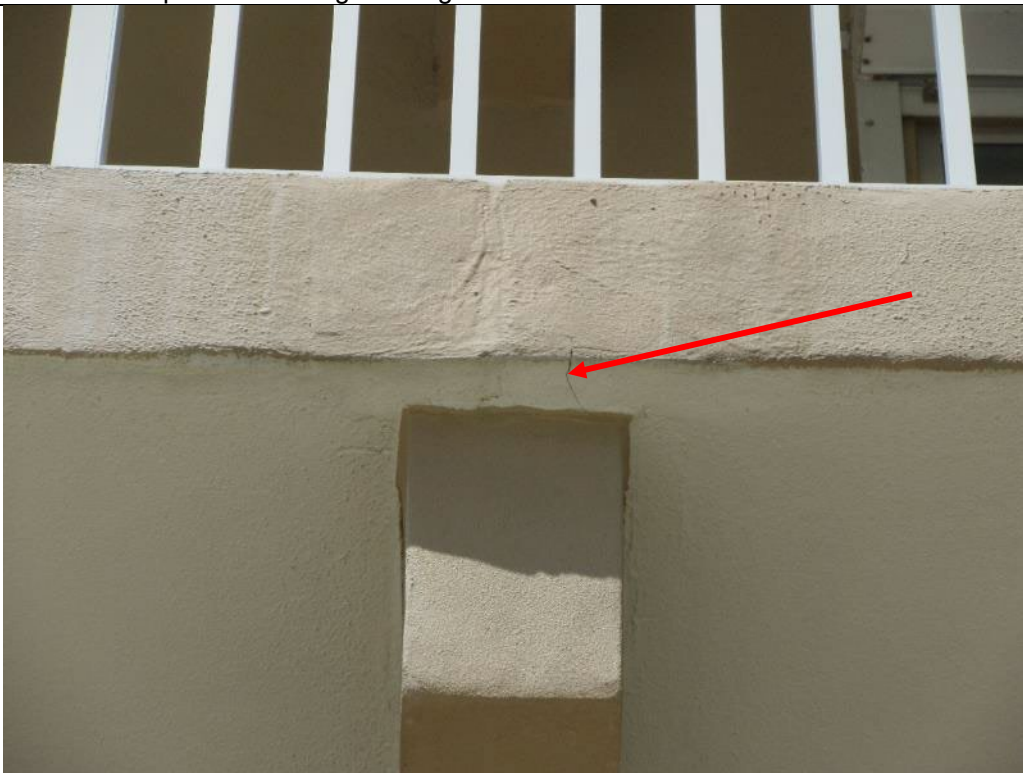
Photo 62. Crack at Failed Previous Repair Near D201

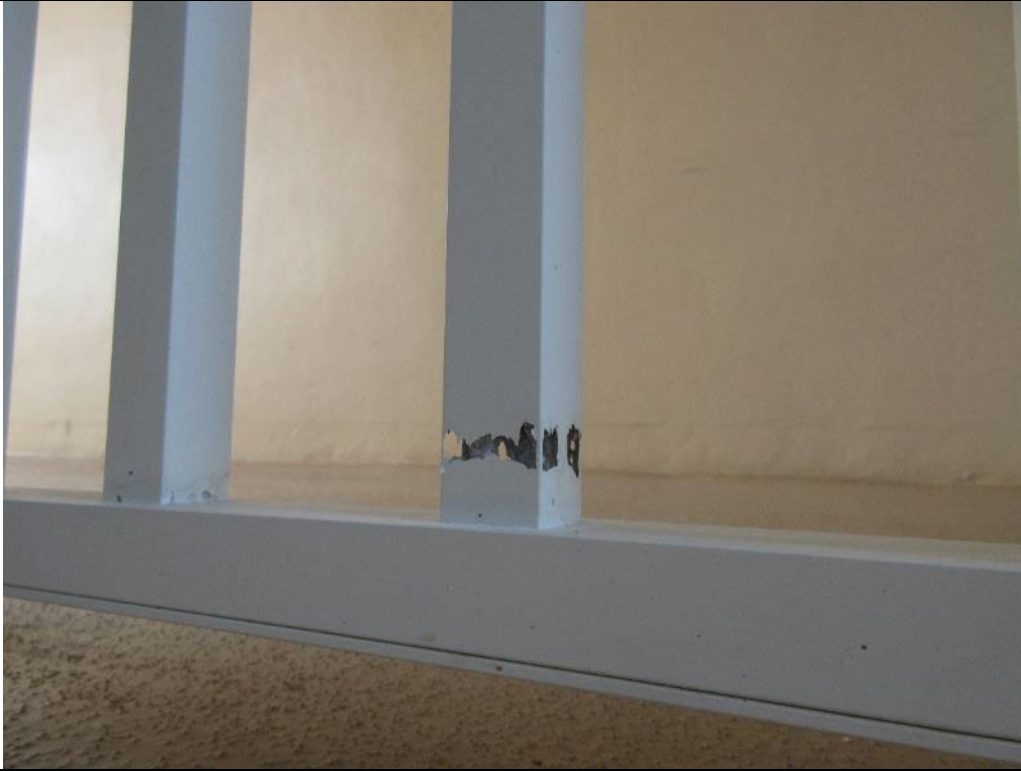
Photo 63. Typical Damaged Railing Picket at Attachment

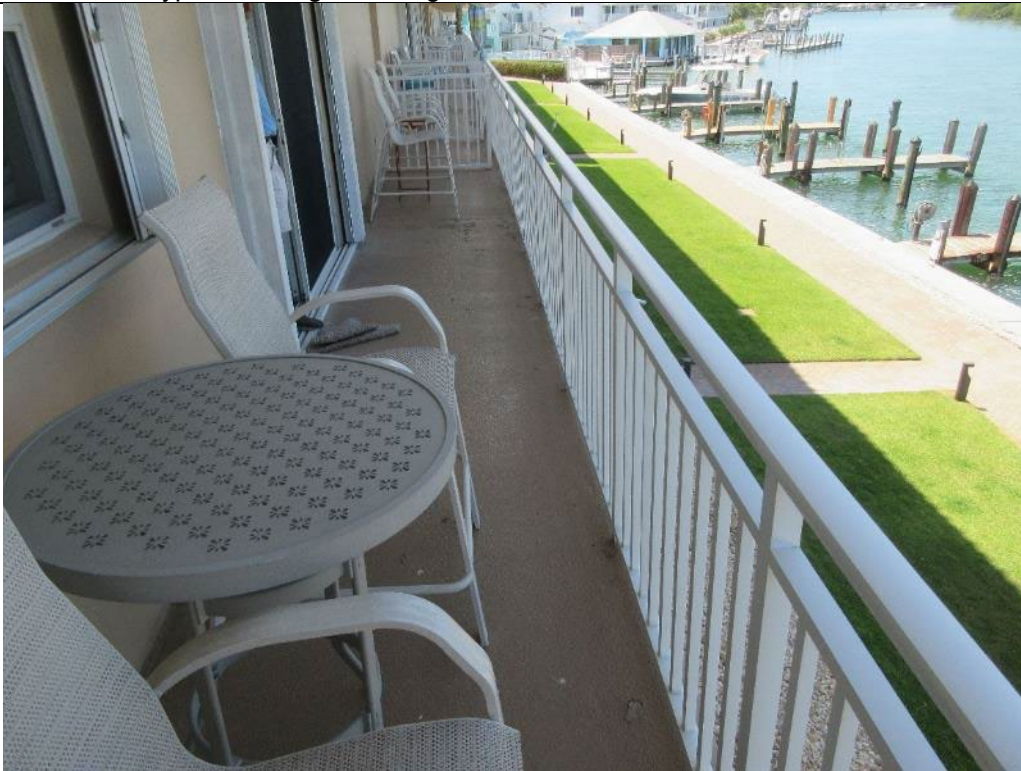
Photo 64. Balcony Overview D202 with Failed Waterproofing Typical

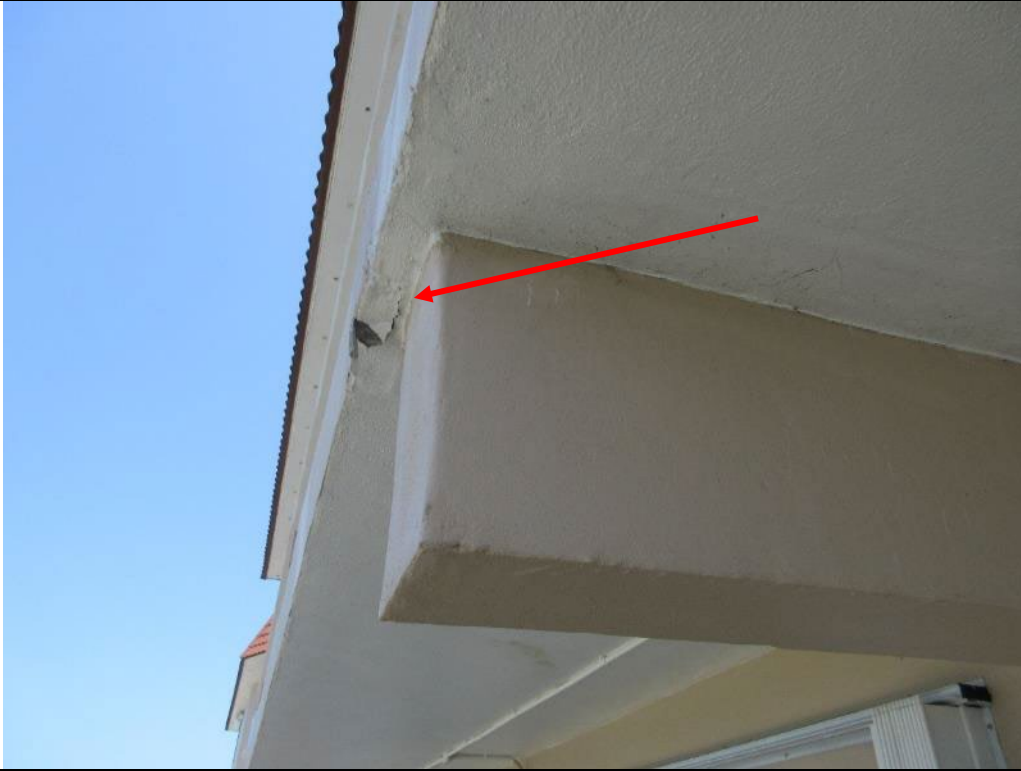
Photo 65. D202 Concrete Spall at Slab Edge at Cantilever Beam

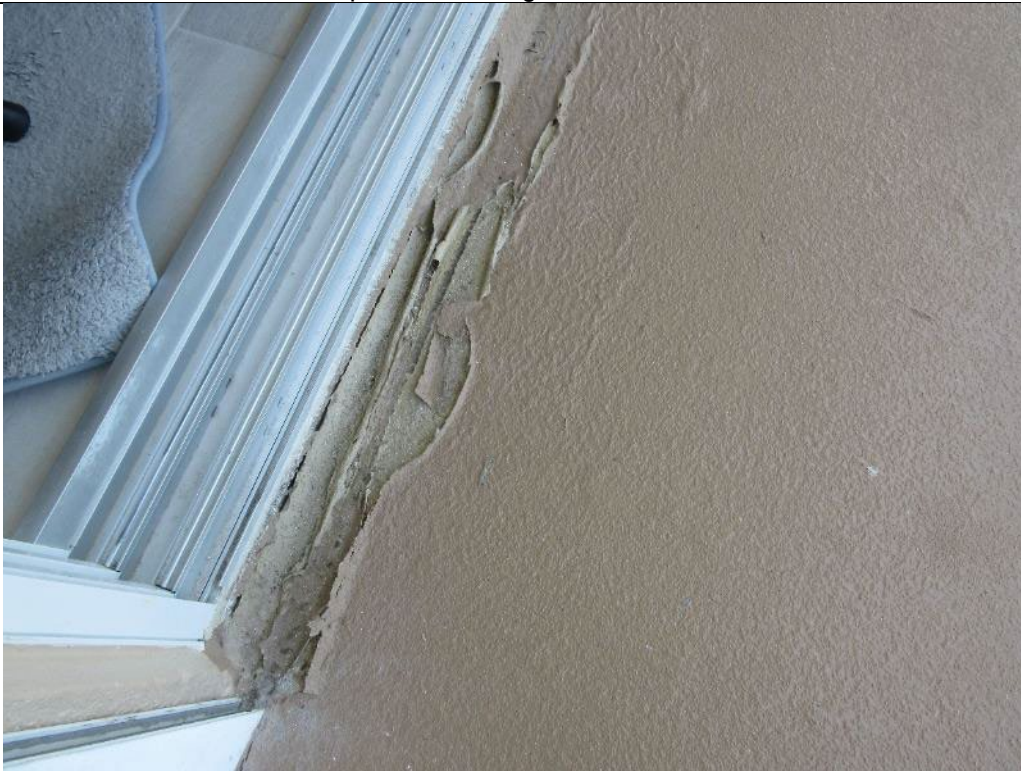
Photo 66. Failed Waterproofing Coating at D302

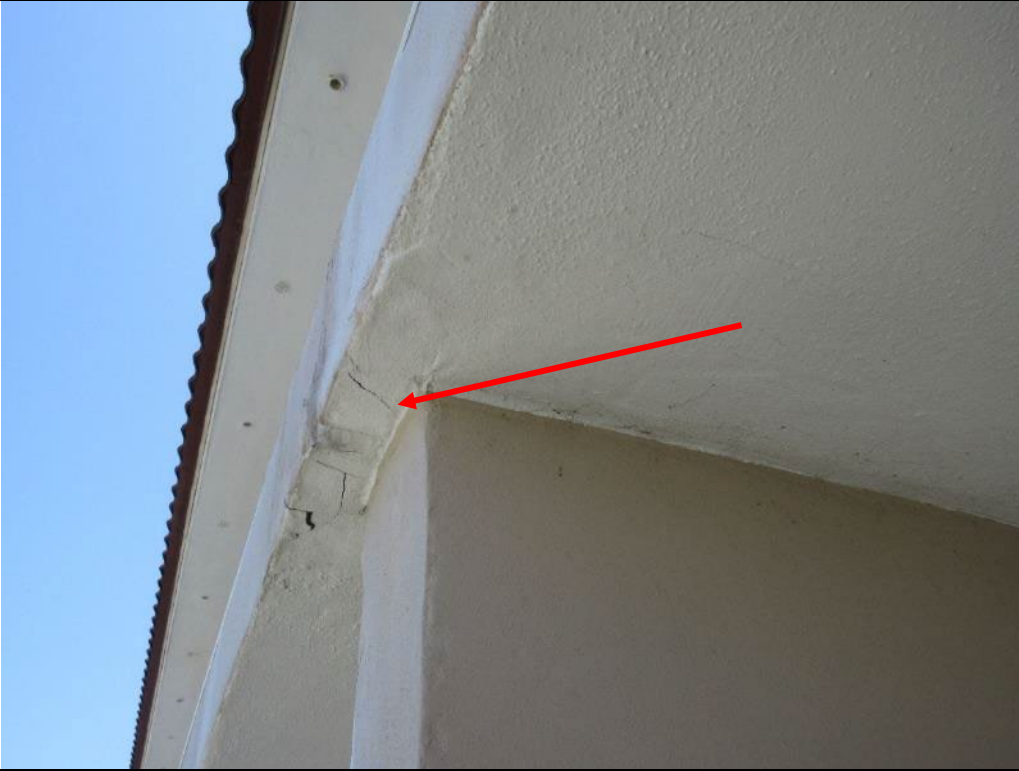
Photo 67. Slab Edge Spall at Cantilever Beam D302

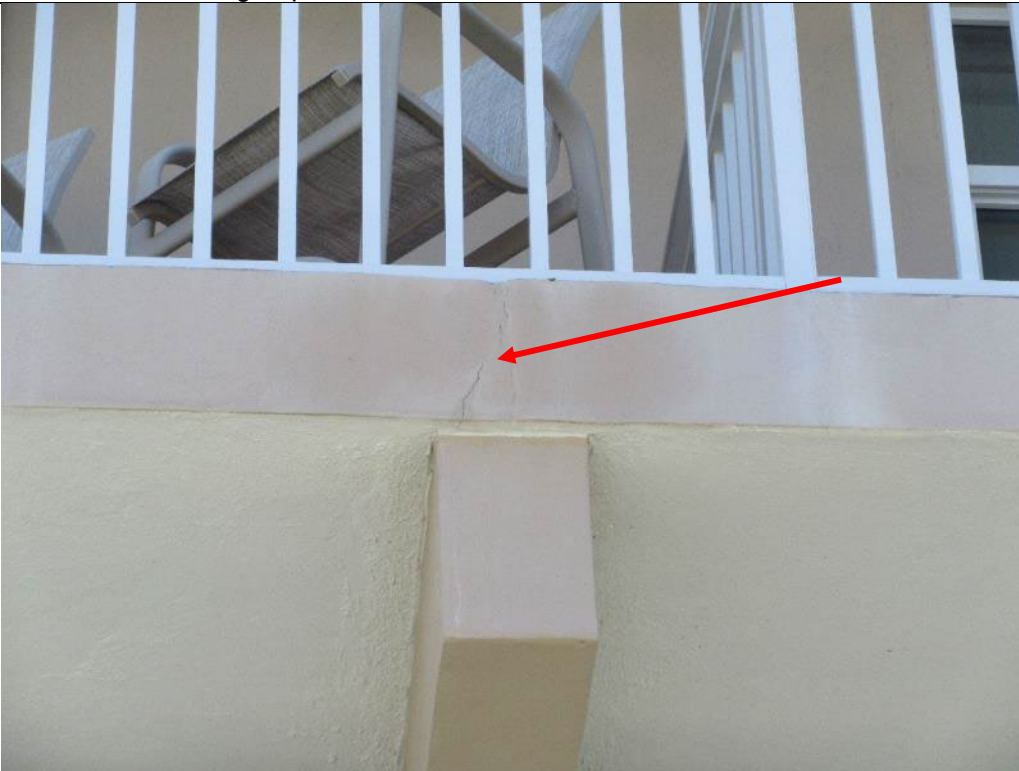
Photo 68. D301 Balcony Slab Edge with Crack at Beam

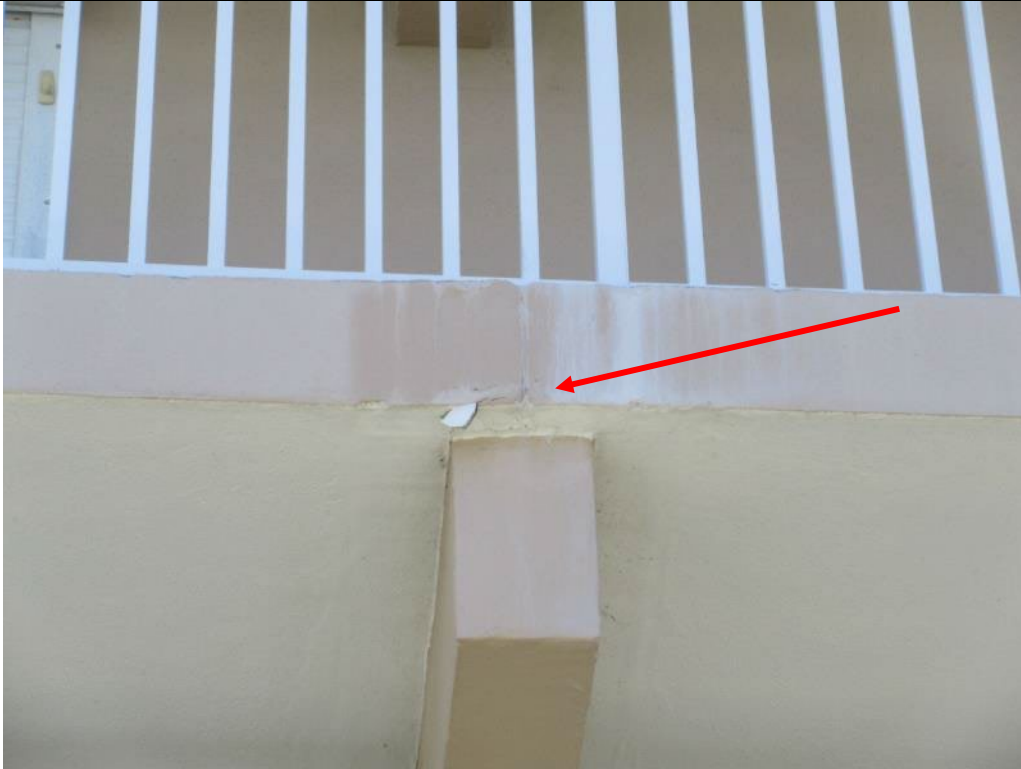
Photo 69. Spalling Concrete at Slab Edge D302

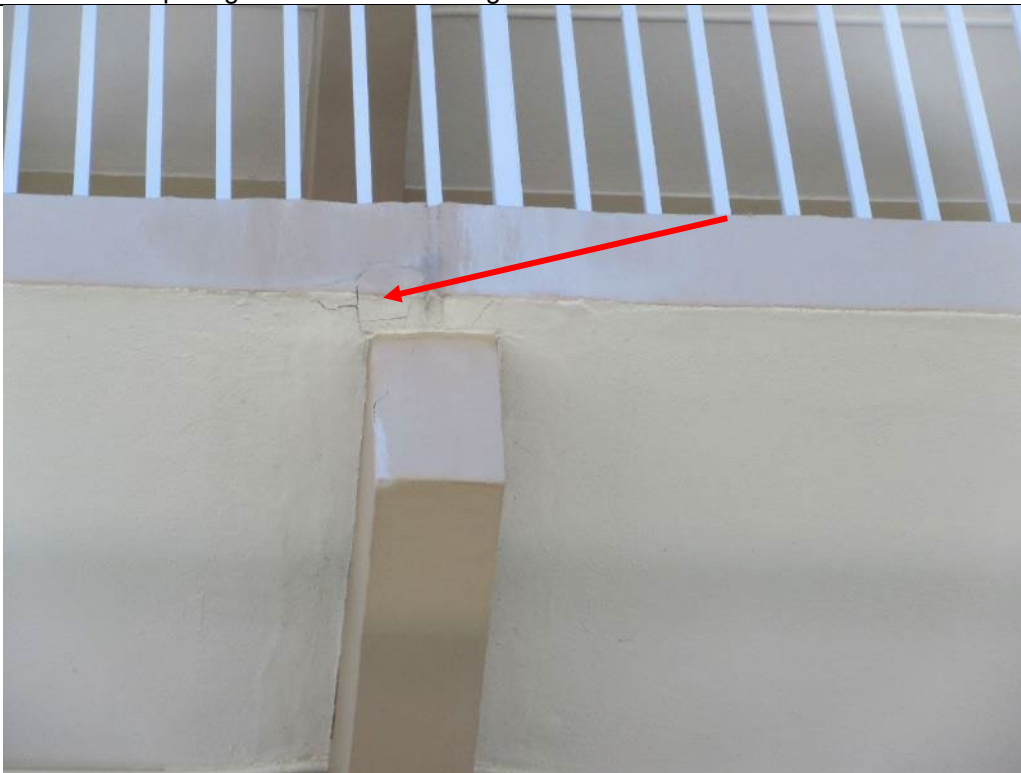
Photo 70. Spalling Concrete at Slab Edge D402

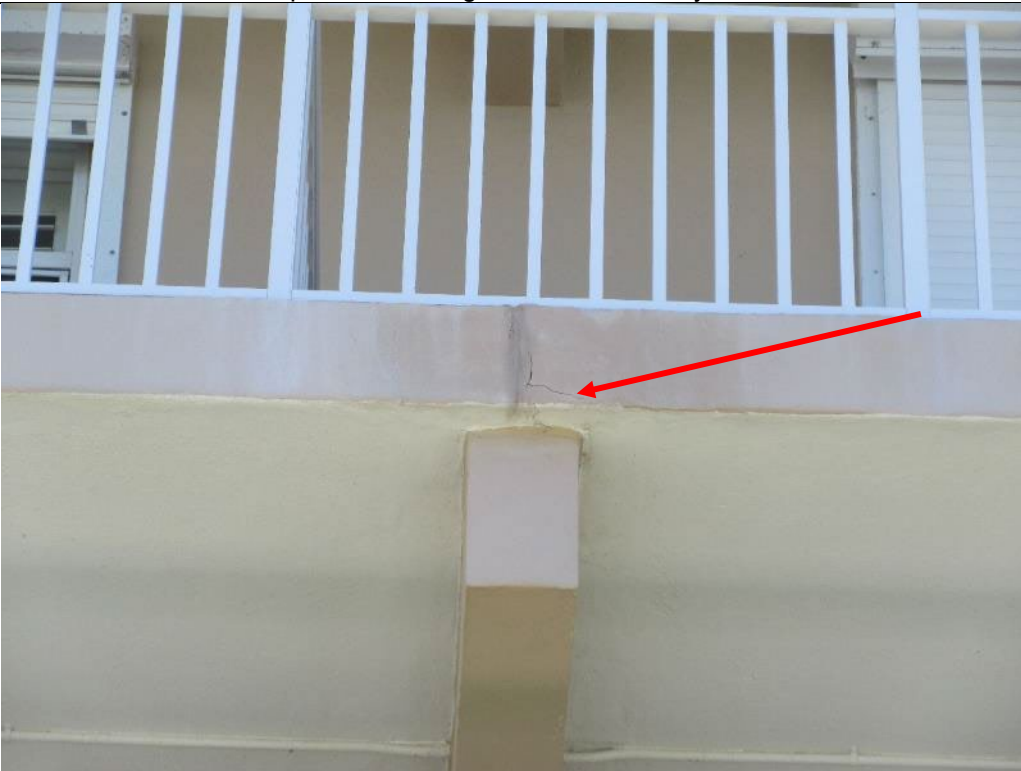
Photo 72. Spalling Concrete at Slab Edge D404

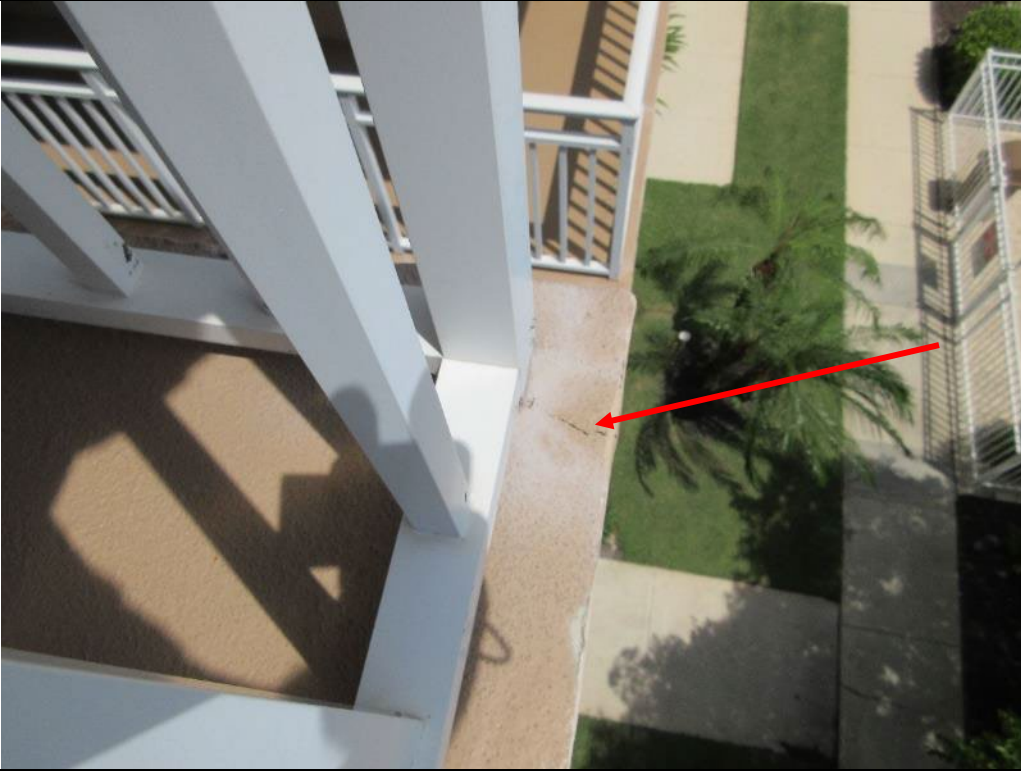
Photo 77. Slab Edge Crack and Spall Near E401

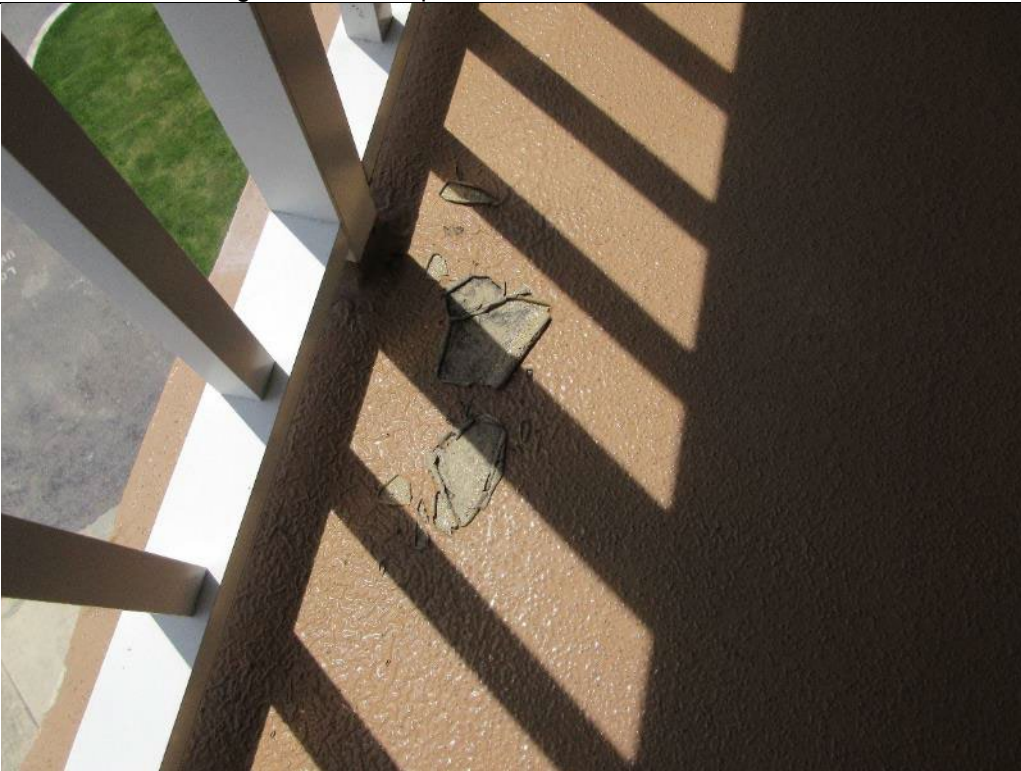
Photo 78. Typical Failed Deck Coating Building E

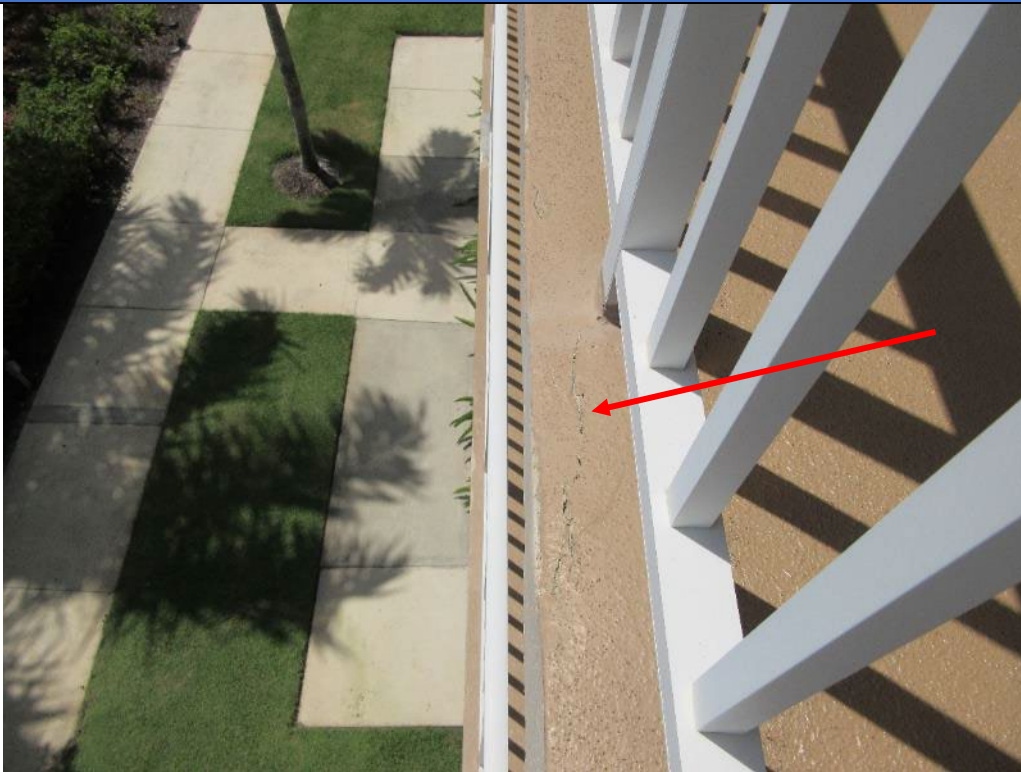
Photo 79. Spalling Concrete and Crack at Slab Edge Near Post Pocket E301

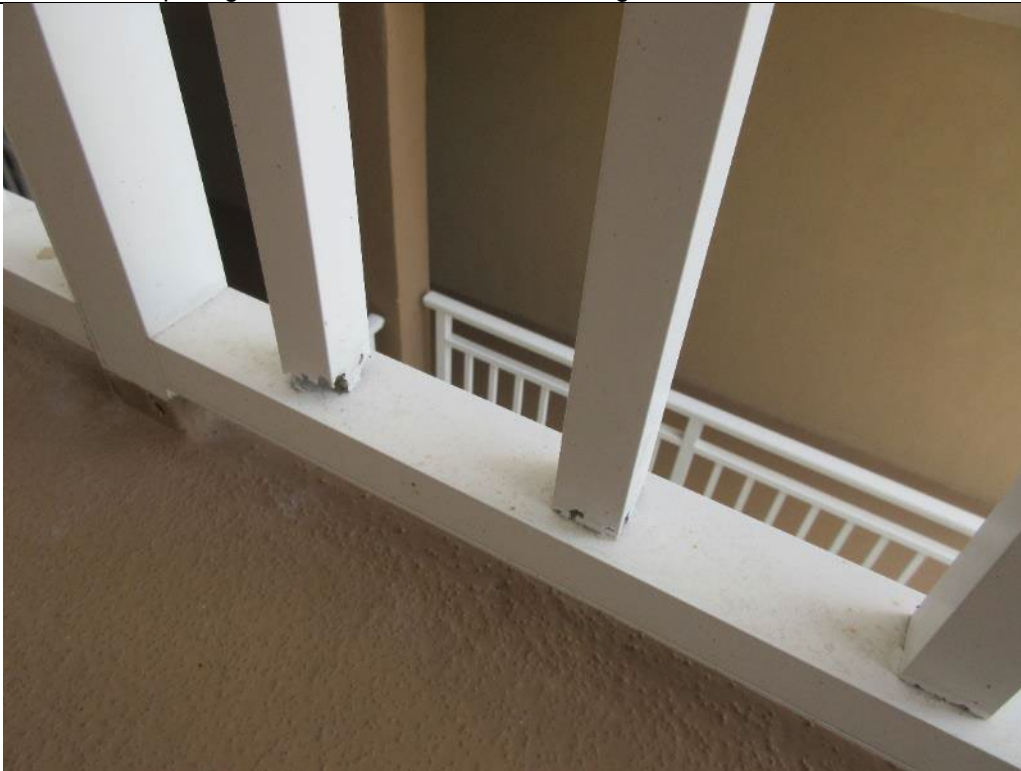
Photo 80. Typical Railing Picket Damage at Attachment Building E

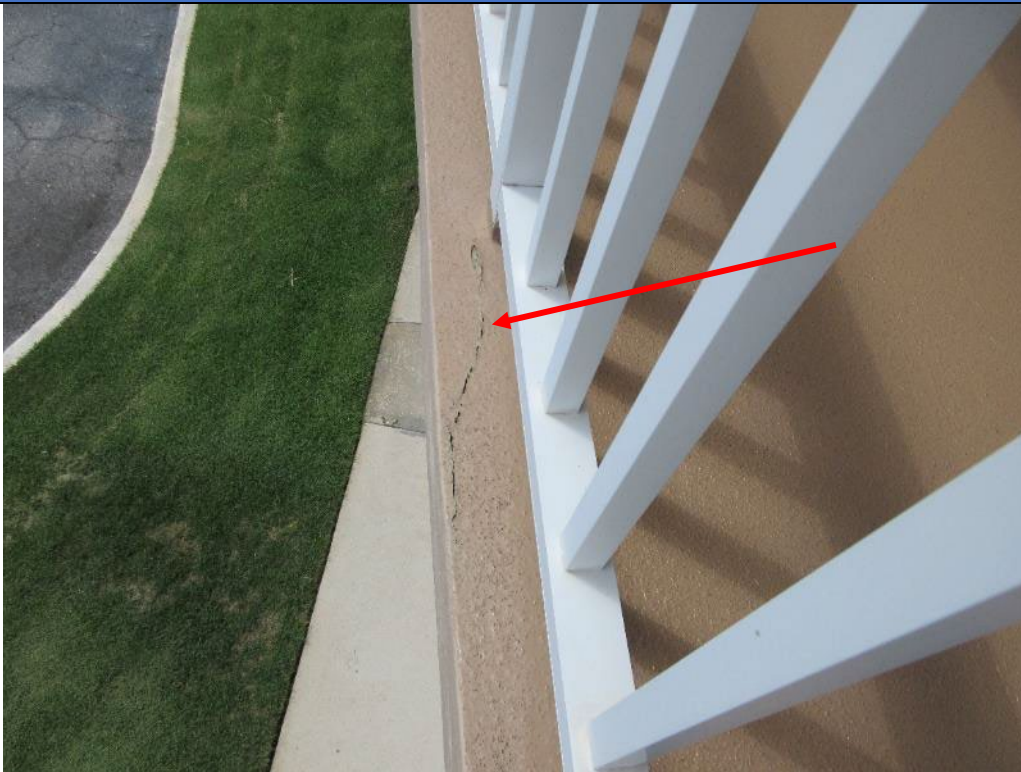
Photo 81. Spalling Concrete and Crack at Slab Edge Near Post Pocket E204

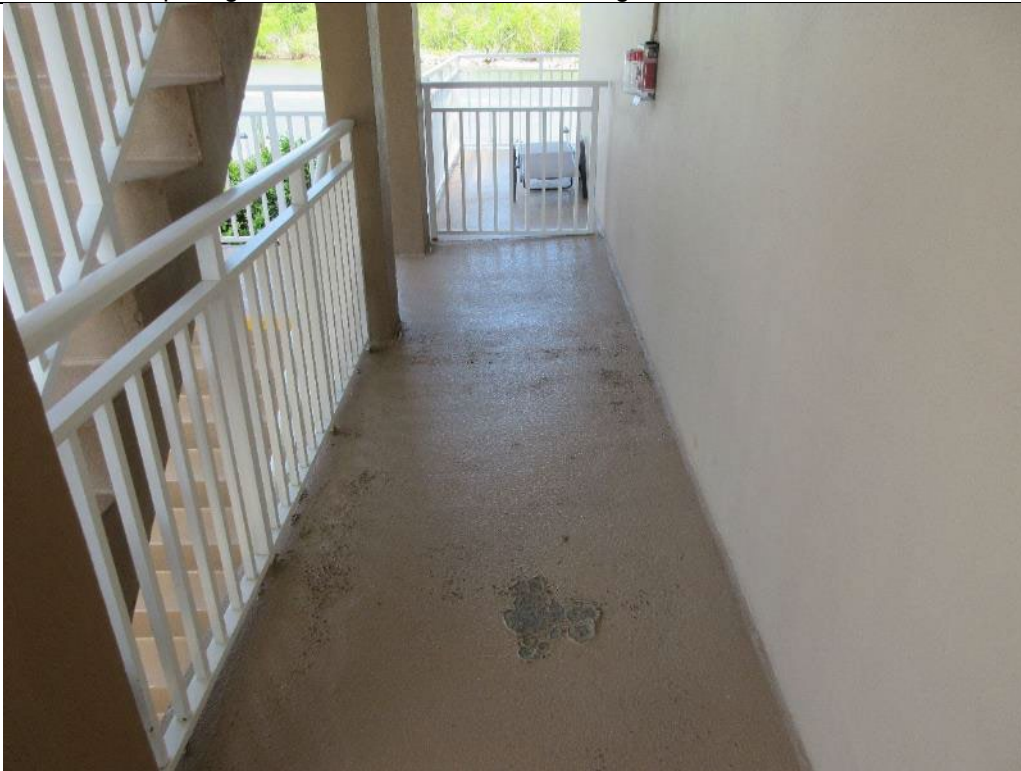
Photo 82. Typical Failed Waterproofing Building E

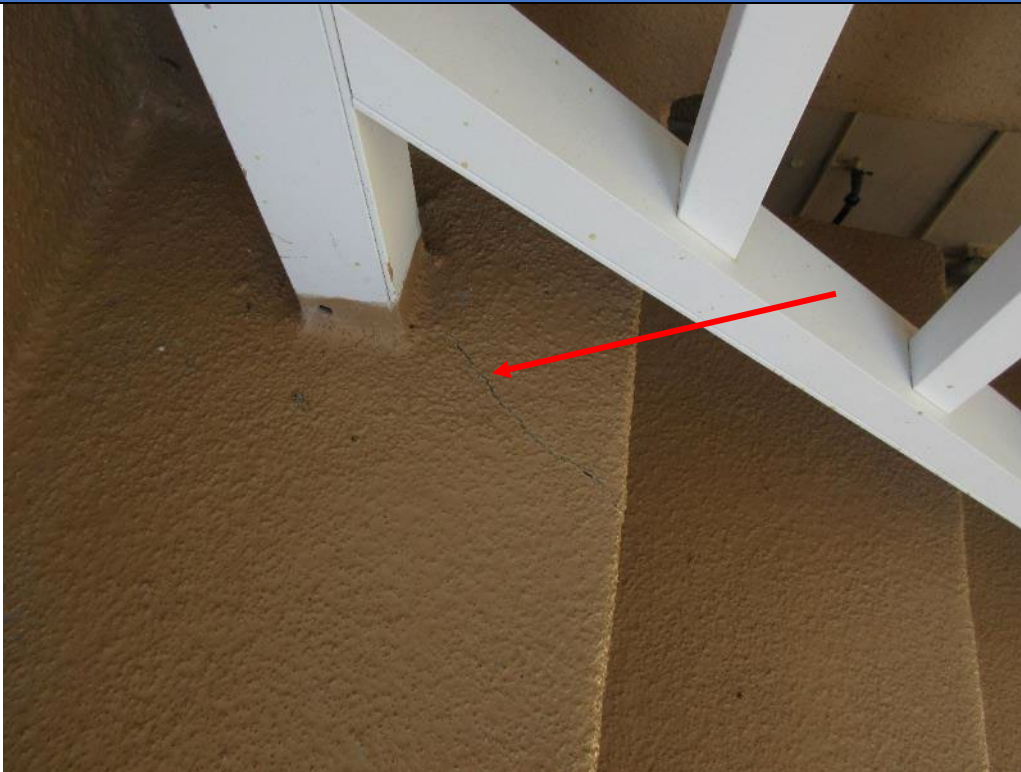
Photo 83. Concrete Spall and Crack at Stair Railing Post Building E East Stair

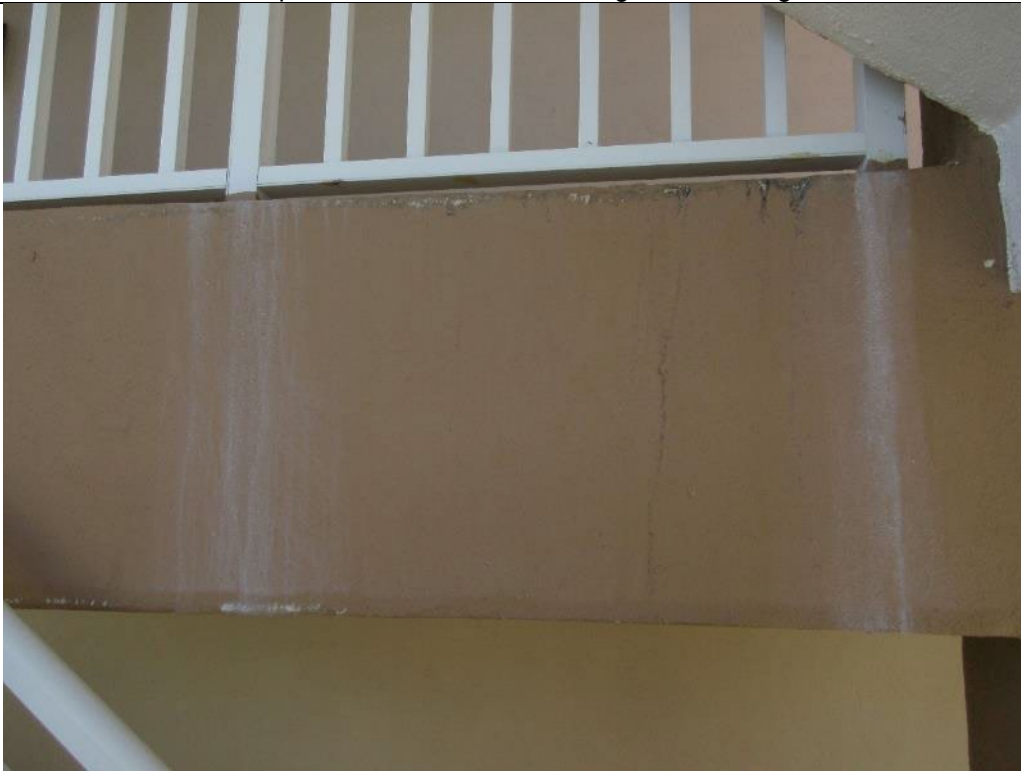
Photo 84. Typical Efflorescence at Railing Post
