# JMC Engineering Inc.

VILLE DE MARCO WEST, A CONDOMINIUM, INC.  
1200-1208 Edington Place  
Marco Island, FL 34145

Reference: MILESTONE PHASE 1 INSPECTION REPORT  
Ville De Marco West, A Condominium, Inc.  
JMC Project Number: 119BPM.12

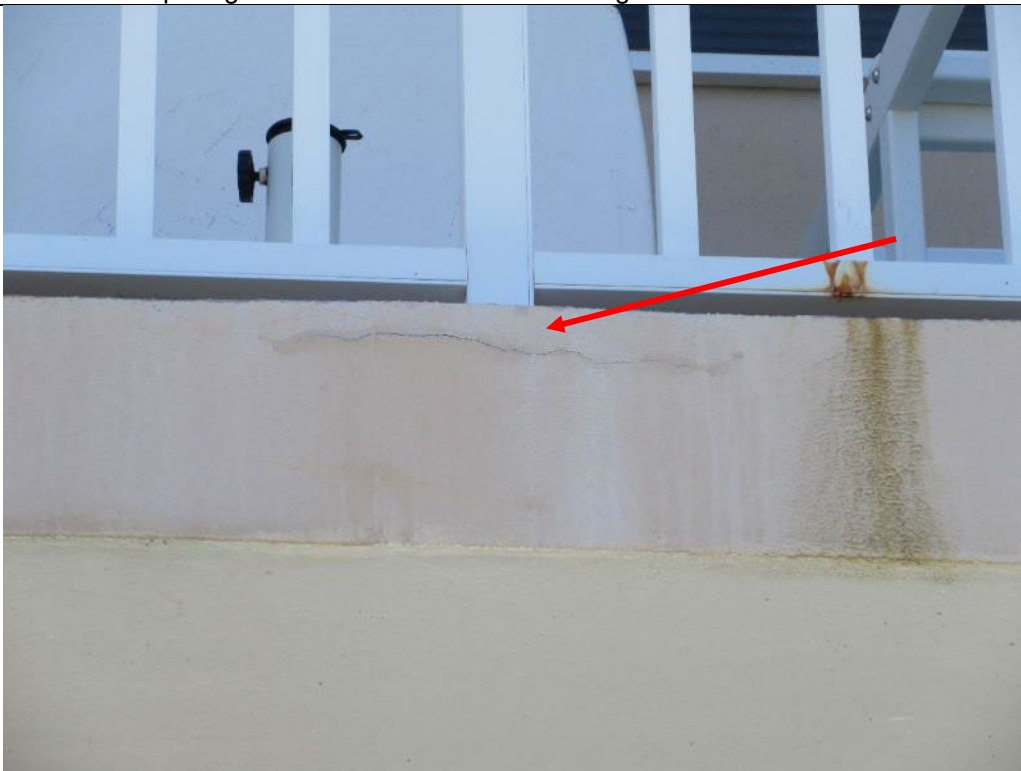
Photo 86. Crack and Spalling Concrete at Slab Edge E203 Corrosion at Railing

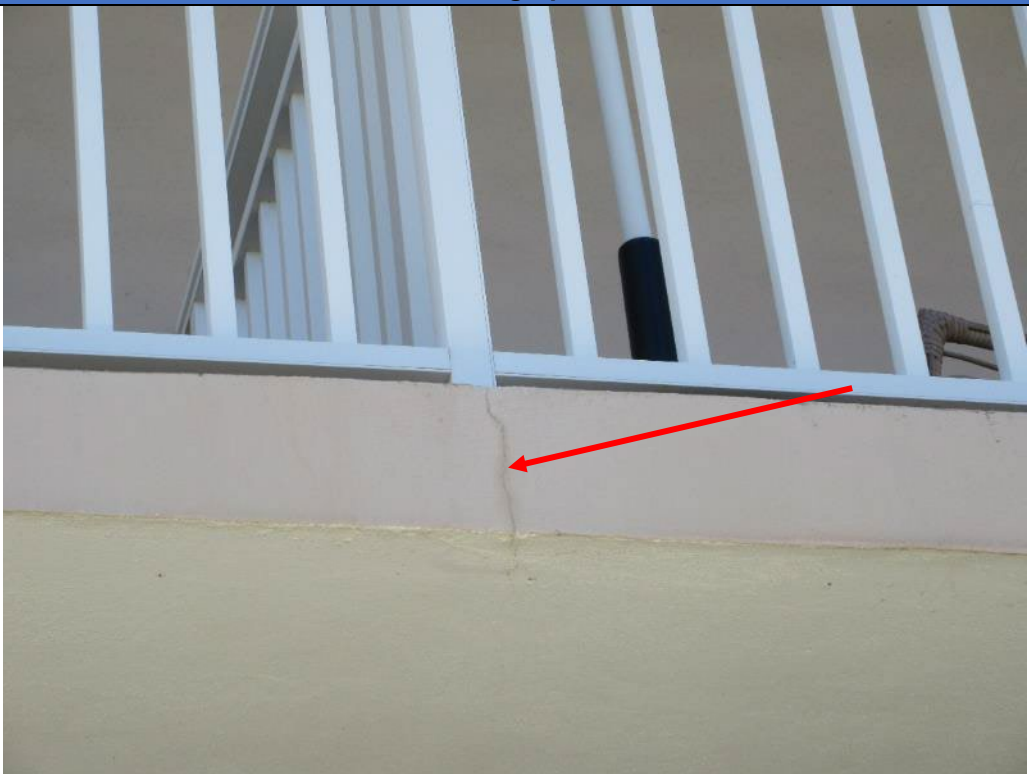
Photo 87. Crack at Slab Edge First Floor Lobby

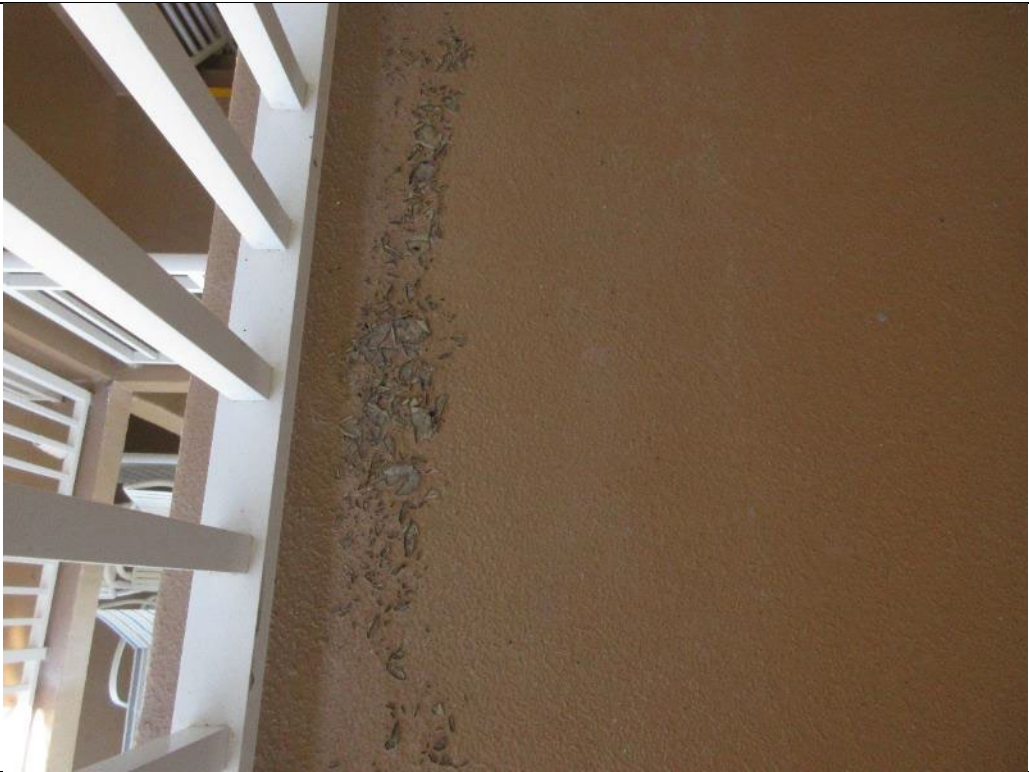
Photo 89. Typical Failed Waterproofing E401

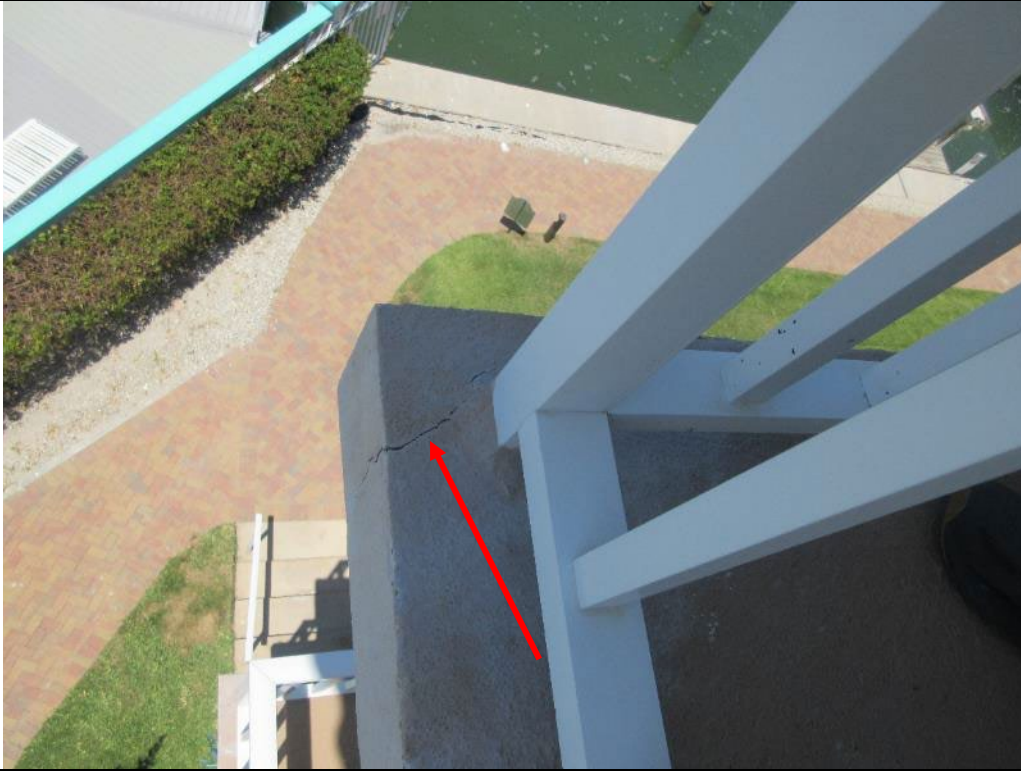
Photo 90. Cracked and Spalled Slab Edge E404

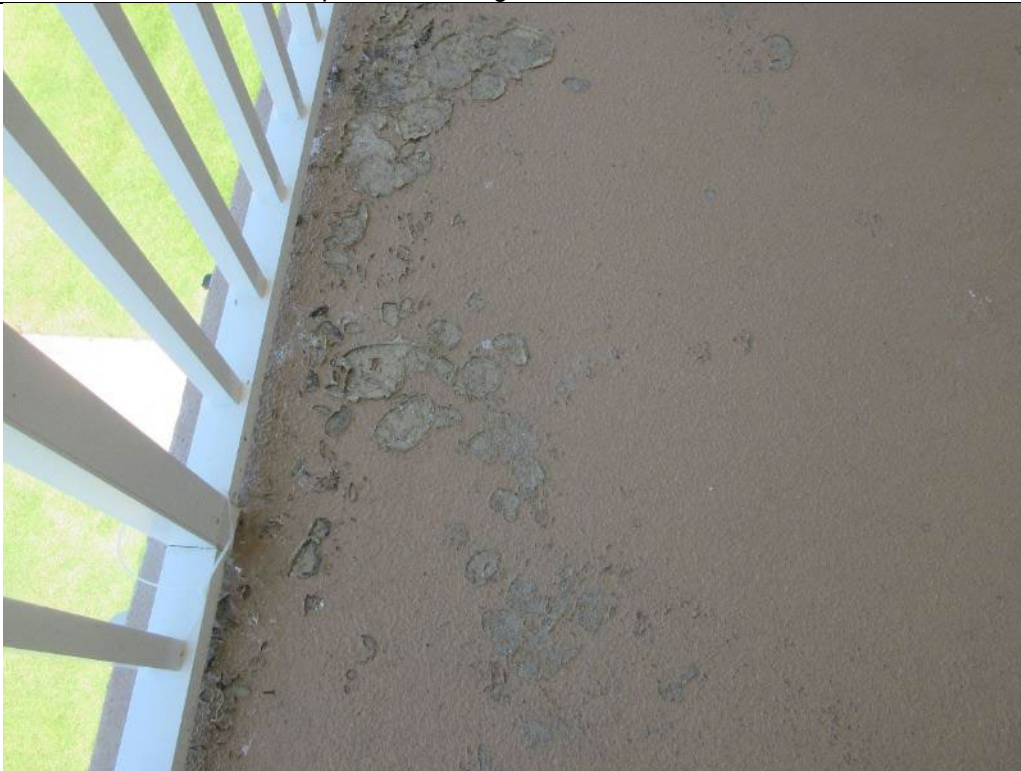
Photo 91. Typical Failed Waterproofing E303

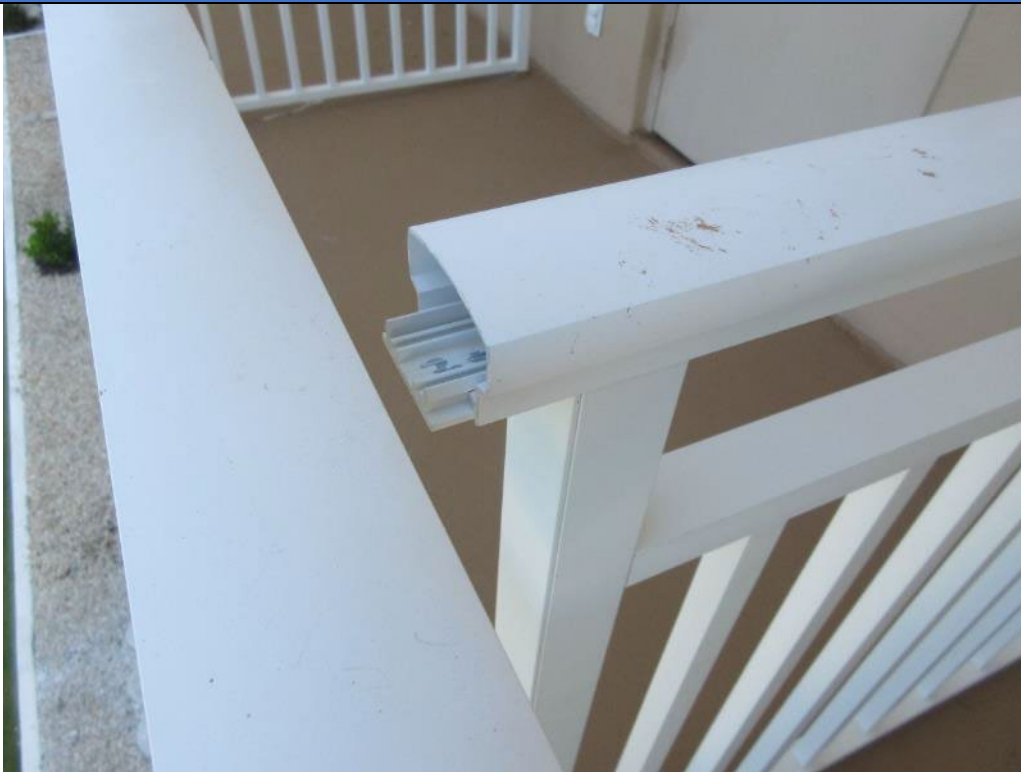
Photo 92. Missing Railing End Cap E303

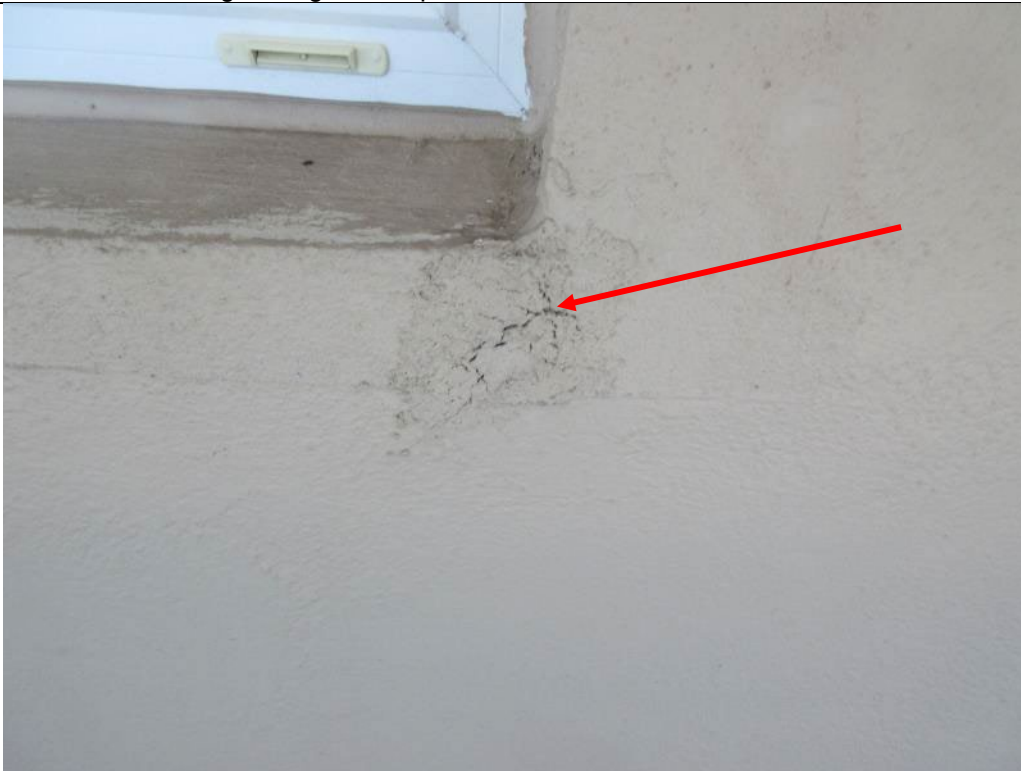
Photo 93. Damaged Windowsill at E303
