# Ville De Marco West, A Condominium, Inc.

Marco Island, Florida

## *Structural Integrity Reserve Study*

December 4, 2024

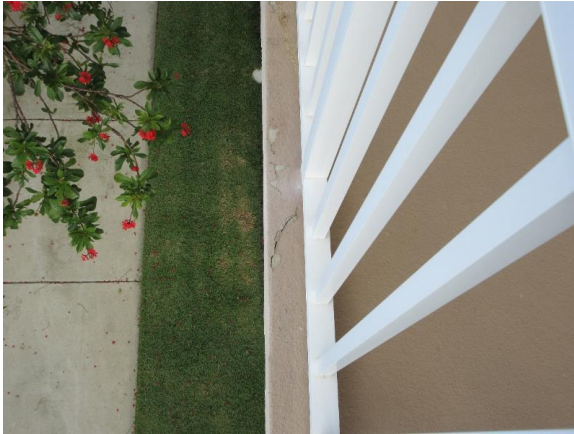
Typical Spalling Concrete at Rail Post Pocket

1. Address efflorescence, isolated concrete spalling, and crack repairs observed at exterior walkways and balconies of all buildings as a typical condition. Perform these repairs promptly to prevent further damage to the structural concrete and underlying steel reinforcement, which could lead to unsafe or dangerous conditions in the future.

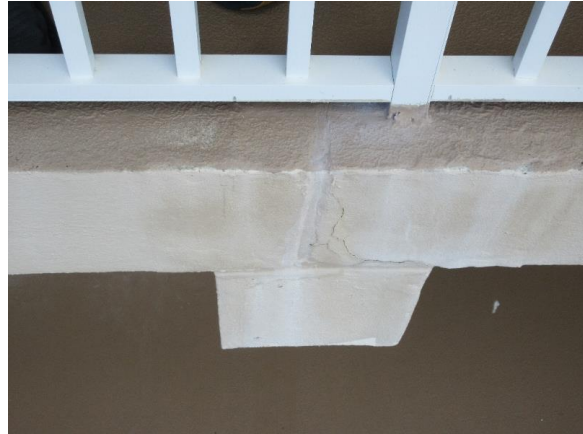
Typical Efflorescence and Crack/Spall at Slab Edge

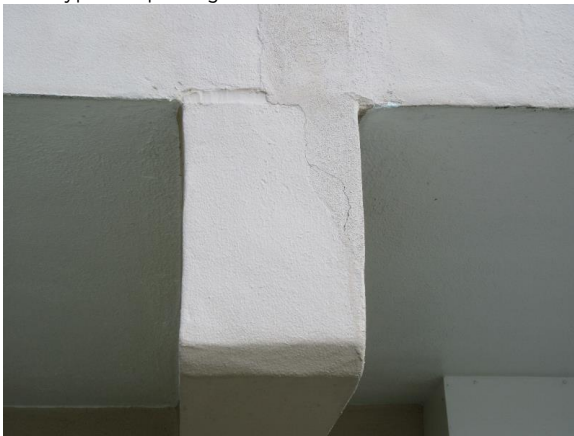
Typical Failed Prev Repair

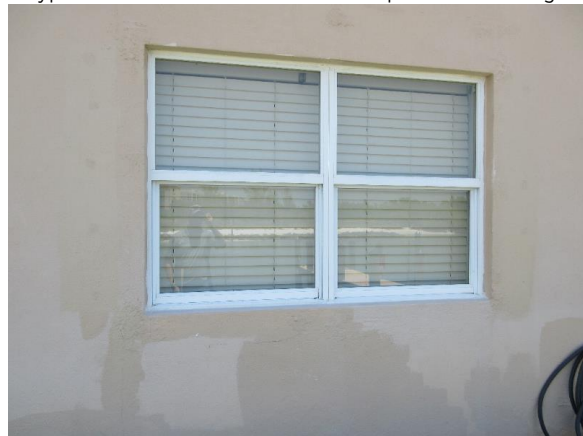
Cracked and Damaged Window Sill Building C

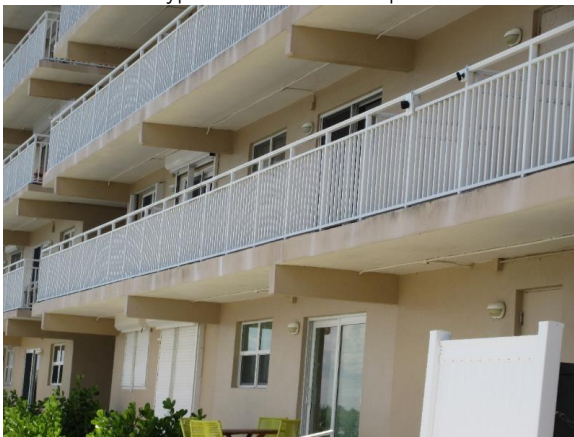
Typical Efflorescence at Slab Edge

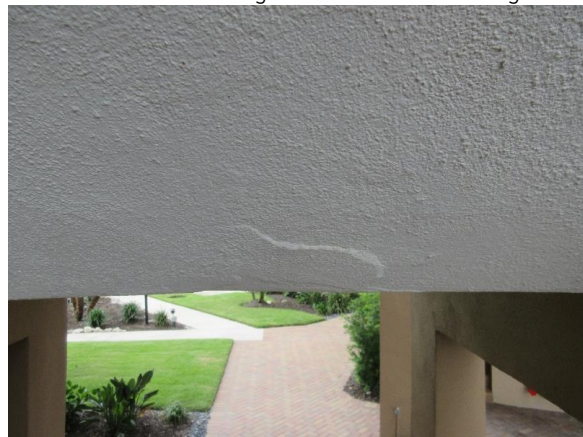
Spalling Concrete at Stairs

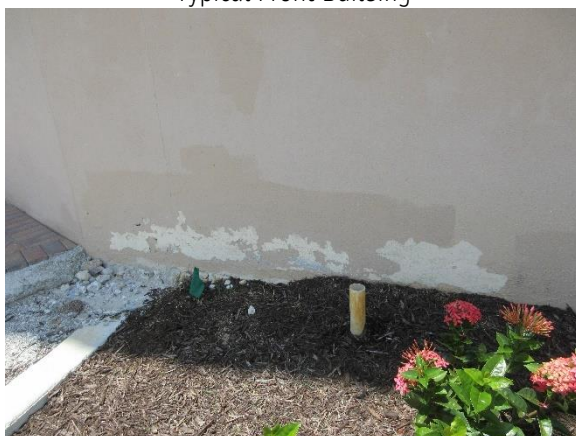
Peeling Paint

3. The paint and sealants at all five buildings have reached the end of their useful life. MSC recommends repainting the buildings with a new 7-year coating of acrylic exterior paint. Due to the harsh environmental factors the community is exposed to, MSC also recommends the painting of buildings painting should be performed on a 7-year interval.

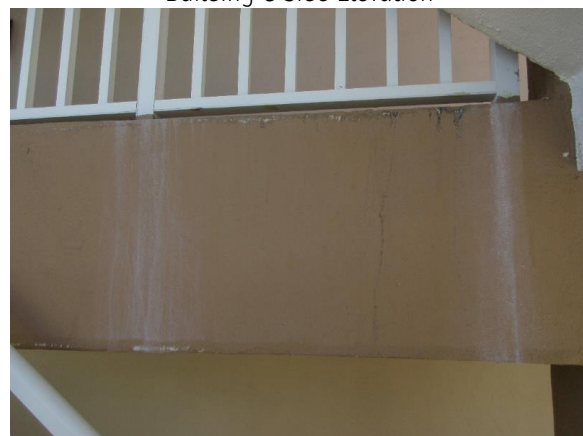
Typical Efflorescence

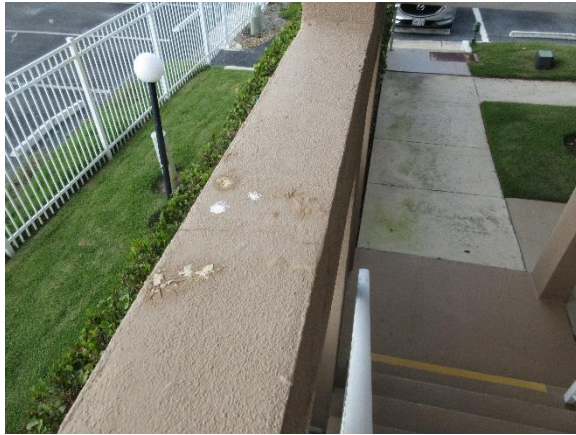
Peeling Paint

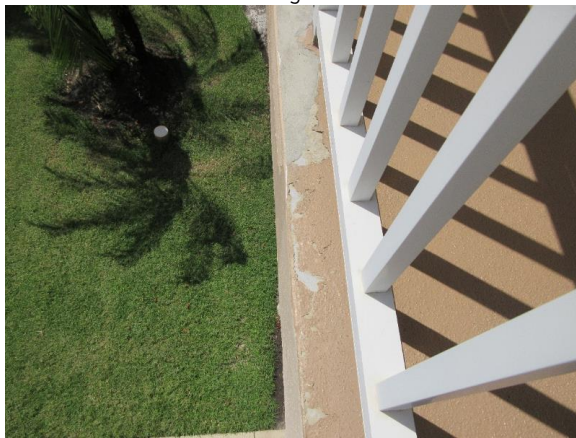
Typical Failed Waterproofing

2. The existing waterproof coatings on walkways, balconies, and stairs have surpassed their useful life and are in poor condition. Following the completion of the structural repairs mentioned above, MSC recommends that the association install a new urethane cold fluid-applied waterproofing coating, such as SIKa Masterseal 1500, on all elevated horizontal reinforced concrete surfaces of the building, including walkways, balconies, and stair towers.

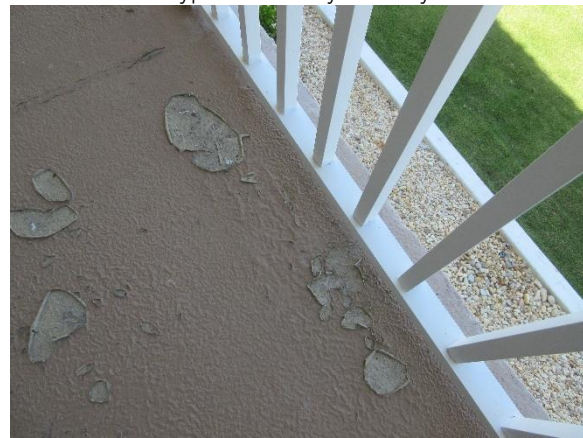
Typical Failed Waterproofing

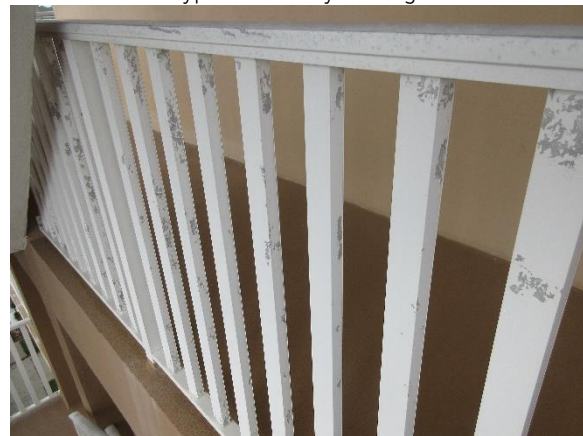
4. The guardrails were observed to be in fair condition overall, with some isolated areas in poor condition. Common issues included failed railing coatings and loss of member sections at railing picket structural connections. MSC recommends that the association consider replacing the guardrails during the recommended building envelope and waterproofing project to take advantage of economies of scale. At a minimum, MSC advises performing deferred maintenance repairs on damaged guardrail components and applying a new protective coating to the aluminum. This will protect the elements from coastal exposure and help achieve their estimated useful life.

Wear on Railing Coating

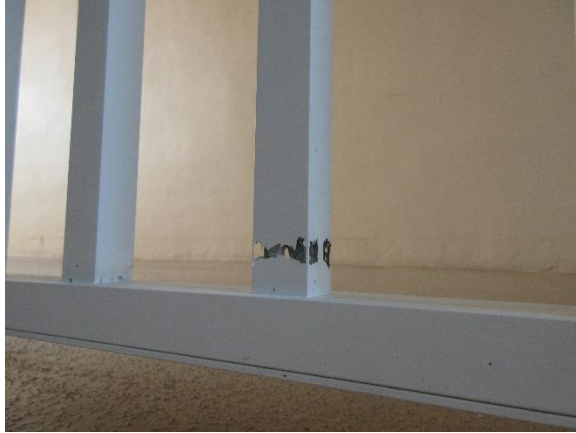
Damage to Railing Pickets

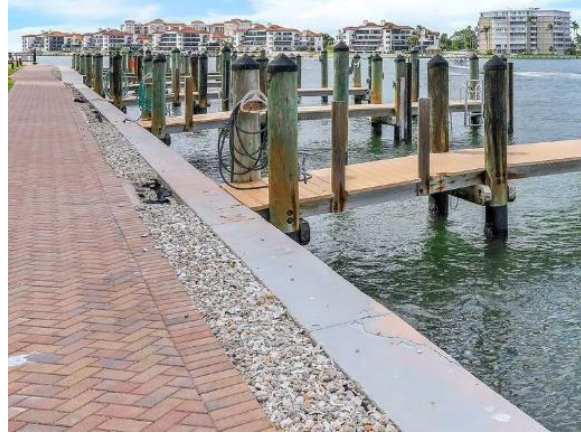
Typical Seawall Overview

5. Based on visual observation and review of the association reserve recommendations and the age and estimated useful life of the components, MSC recommends the association engage with a licensed professional for a condition assessment of the existing "River" Seawall. This recommendation is primarily based on the age of the component having exceeded the typical estimated useful life periods associated with seawalls of 40 years.
