# Structural Integrity Reserve Study -SIRS (Structural Assets)

## Vintage Bay Condominium Association, Inc. Building D

337 Vintage Bay Drive  
Marco Island, FL 34145

Prepared on:  
10/31/2024

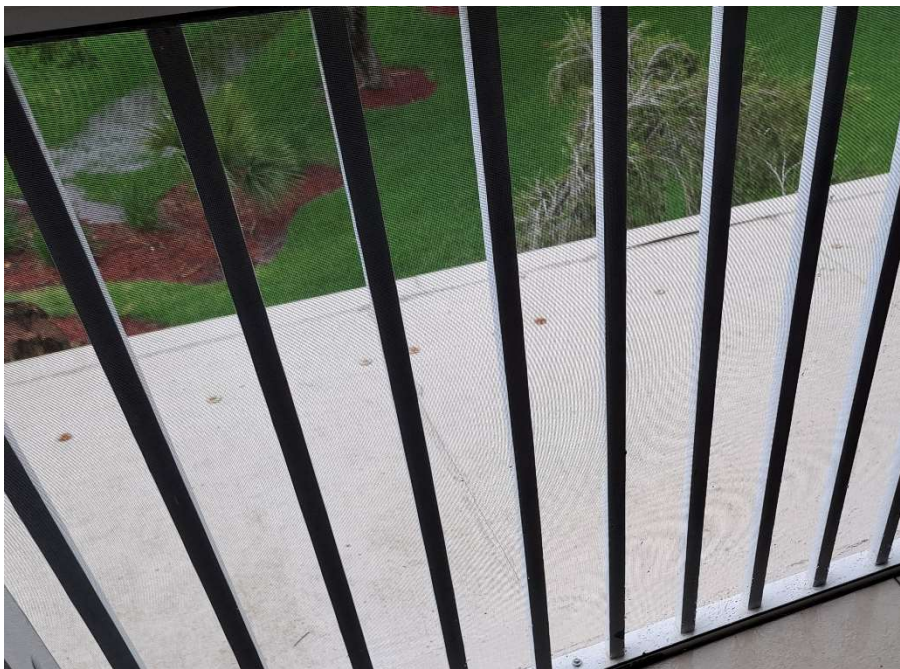
1.5 Roof, First Floor Lanais

These roofs, which cover the lanais on the floor above the ground floor parking garage; will be removed from common funding in ten years and have an insignificant impact on the funding plan over those ten years.

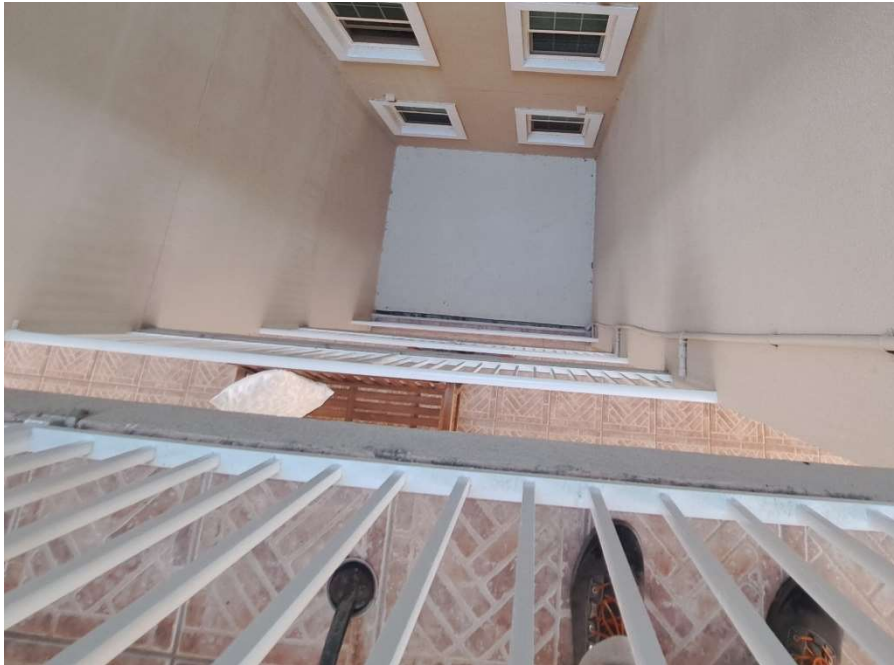
**2.2 Railing Replacement, Atriums ~\$114/LF in 2025**

This section of railing is much more sheltered from the weather than those along the open portion of the walkways.

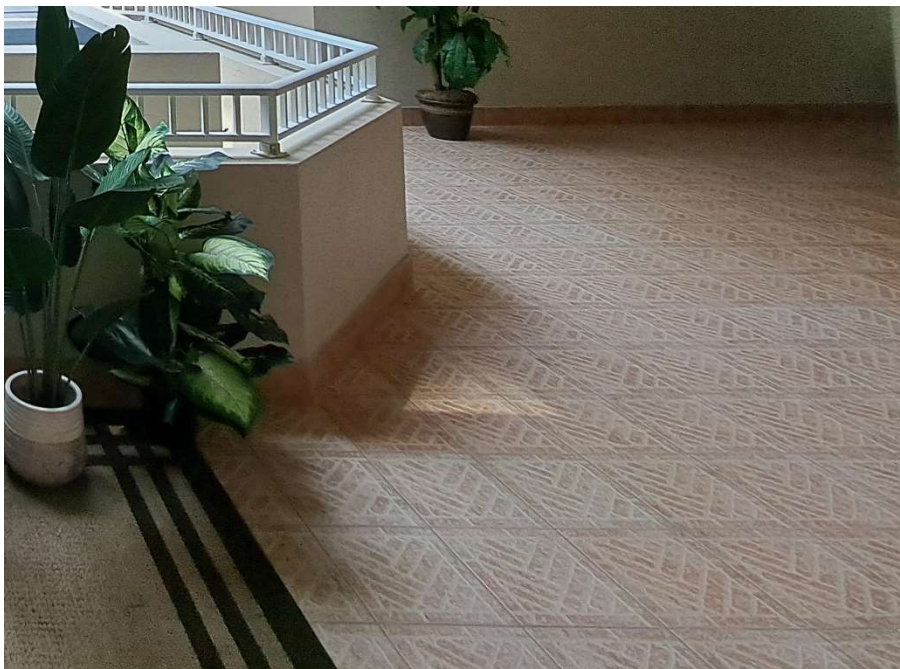
2.5 Waterproofing & Tile Removal & Re-Installation, Penthouse Walkways

| Estimate Useful Life (Years) | Estimate Remaining Life (Years) | Estimated Current Cost (\$) |
|---|---|---|
| 40 | 5 | \$67,200.00 |

Typically, the waterproofing under the tile surfaces on this floor should last longer than those on the open walkways below. This may affect the schedule in the future after the next replacement project.

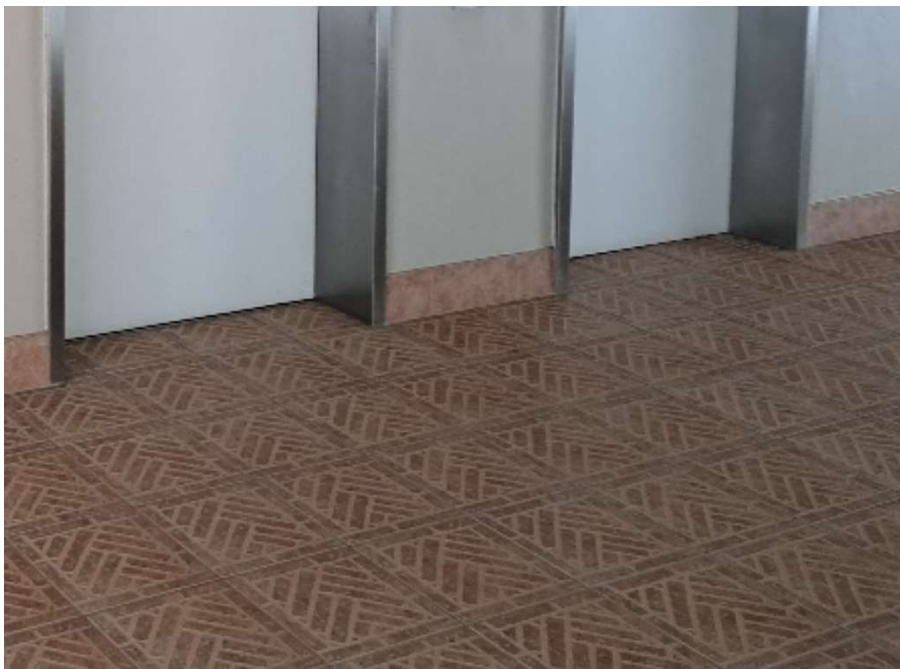
**2.6    Waterproofing & Tile Removal & Re-Installation, Lower Walkways**

| Estimate Useful Life (Years) | Estimate Remaining Life (Years) | Estimated Current Cost (\$) |
|---|---|---|
| 24 | 5 | \$470,400.00 |

Most of these walkway areas are open to the weather.

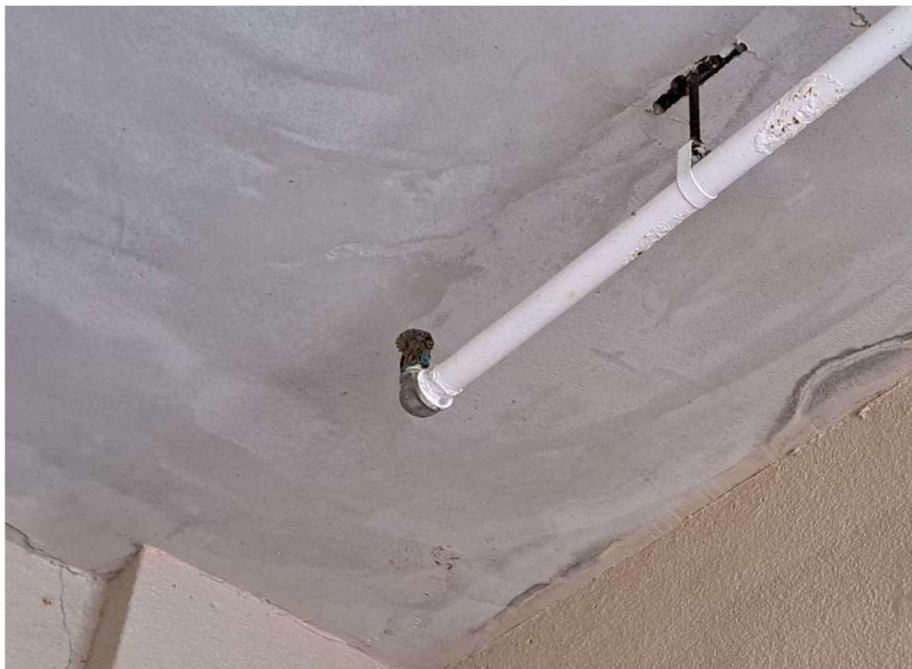
3.3 Sprinkler Head Replacement Budget

| Estimate Useful Life (Years) | Estimate Remaining Life (Years) | Estimated Current Cost (\$) |
|---|---|---|
| 35 | 9 | \$26,000.00 |

Sprinkler heads need to be replaced periodically as fire system inspection see fit.
