Eagle Cay Condominium, Inc.

**Structural Integrity Reserve Study**

889 to 901 Collier Court , Marco Island, FL, 34145

SOCOTEC Consulting, Inc

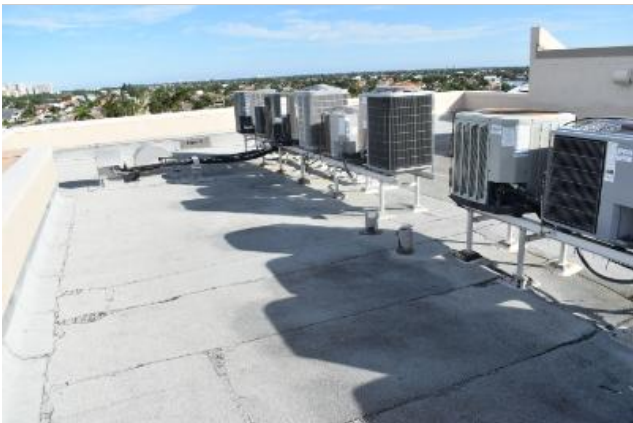
1 - Flat Roofing

The flat roof portion of the subject condominium is covered with a Modified-Bitumen roofing system. Modified-bitumen roofing systems typically have a useful life of 20 years under normal operating conditions with routine yearly maintenance. We understand that the Association had the subject flat roof sections replaced in 2011. At the time of our site visit, the subject roof system was observed to be in good condition. We have included a reserve item for the replacement of the subject main tower flat roofing system. Opinion of cost is based on the lightweight insulated concrete being left in place during the roof replacement project.

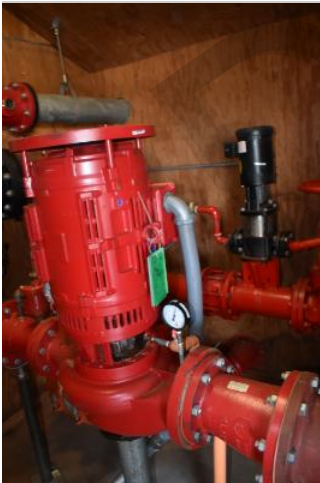
# 7 - Fire Pump/Equipment

The fire pump and controls are located in the fire pump room in the pool patio. The fire pump and controls are original and were installed circa 1988. These types of systems generally have a useful life of 30- to 35-years under routine maintenance. We have included a reserve for replacement/repairs to the system as needed.

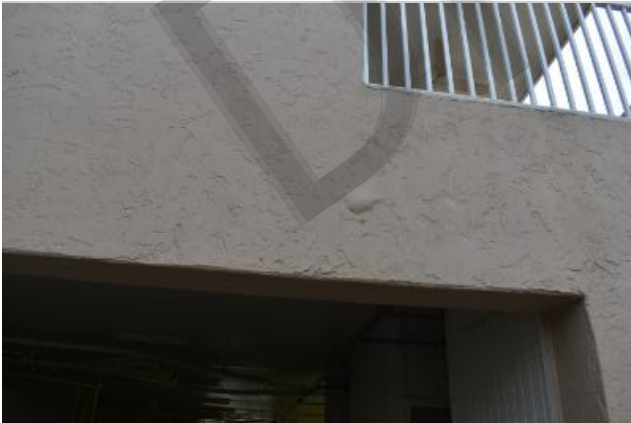
# 11 - Painting

We understand the building was last recoated circa 2017. During our site inspection, the existing paint was in fair overall condition. Buildings located in the Southwest Florida region, are recommended to have their exteriors recoated on a 7-year basis. A reserve has been included for periodically recoating the buildings' exterior on a 7-year cycle. At our site visit, paint bubbles formed on the exterior walls. We recommend at the start of the next paint cycle periodically begin stripping the walls of the old paint.

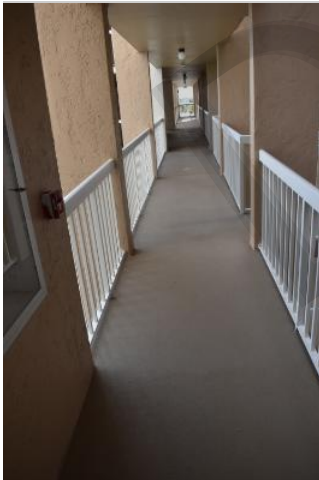
We assume the entry walkways are surfaced with tile over a cold-applied waterproofing system. Typical systems installed generally have a useful life of 10 to 15 years before having to be replaced. Therefore, we are recommending the replacement of the tile/ waterproofing system along the front walkways to be replaced in 2027.

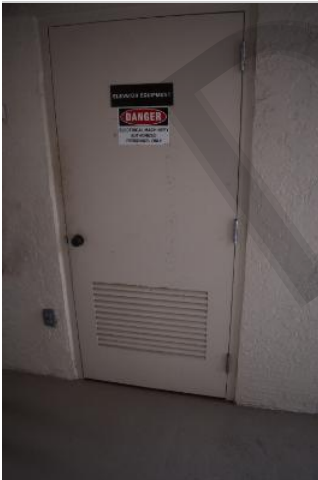
# 13 - Common Area Doors

We understand that the unit owners are responsible for their own windows and doors, however, there are several commonly owned metal doors across each entry staircase and equipment rooms. Since all the doors are not the same age, we have included a deferred maintenance reserve to repair/replace these doors as needed across the building.
