## MILESTONE INSPECTION REPORT FORM

## PHASE 1 - Milestone Inspection

- Name on Title: Island Manor Condominium Association, Inc.
- Street Address: 87 North Collier Boulevard, Marco Island, Florida 34145 (Building N)
- Legal Description: ISL MANOR APTS MARCO ISL, THE (CONDO) HOUSE
- Owner's Name: Island Manor Condominium Association, Inc.

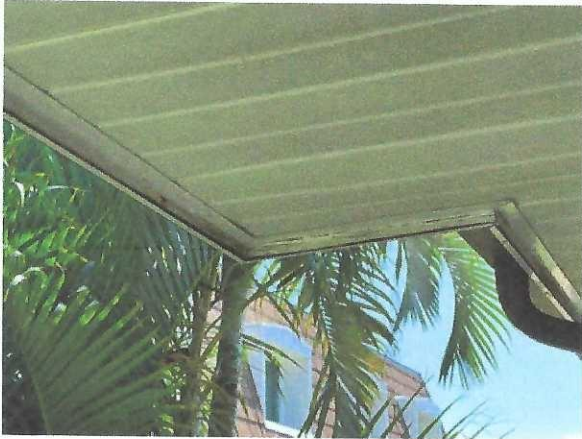
A.1

1. Fascia rot observed above the North stairway.

The following items are considered to be minor and not of significant structural concern. Therefore, they are considered to be general maintenance items, and not to be considered a mandatory structural repair.
