# Structural Integrity Reserve Study -SIRS (Structural Assets)

## Admiralty House, Inc.

140 Seaview Ct.  
Marco Island, FL 34145

Prepared on:  
6/7/2023

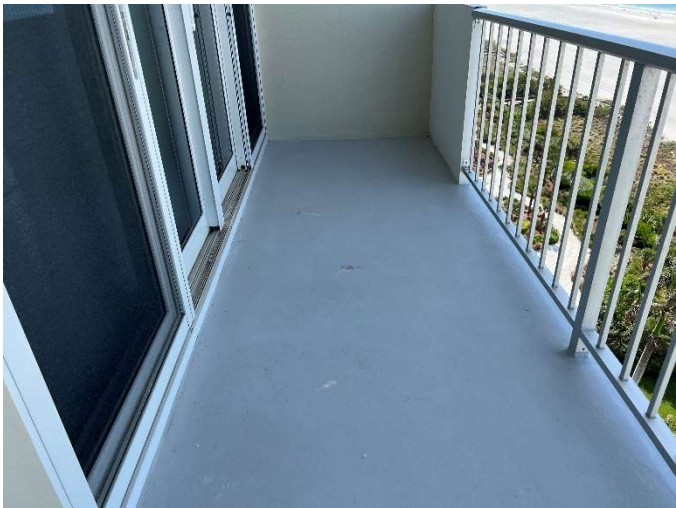
2.4 Balconies, Private Floor Waterproofing Application, Non-Tiled

This item refers to the waterproofing of even fewer untiled private balconies than are present now, when it is time to re-waterproof untiled balconies in 15 years. The reason is that residents will continue to tile their waterproofed balconies before this 15 years has passed.

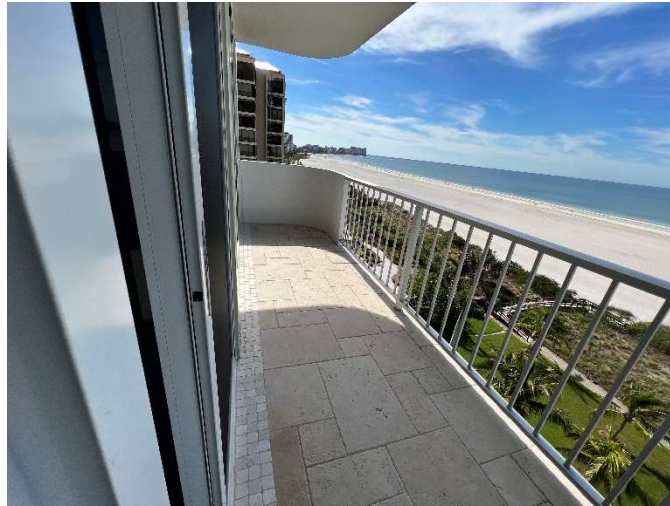
## 2.5 Balconies, Private Floor Waterproofing Application, All

After approximately 29 years, all private balconies should be stripped of old waterproofing and / or tile, and waterproofed. A properly draining, properly waterproofed and tiled exterior floor can last 30 to 40 years (even though the waterproofing warranties are not this long).

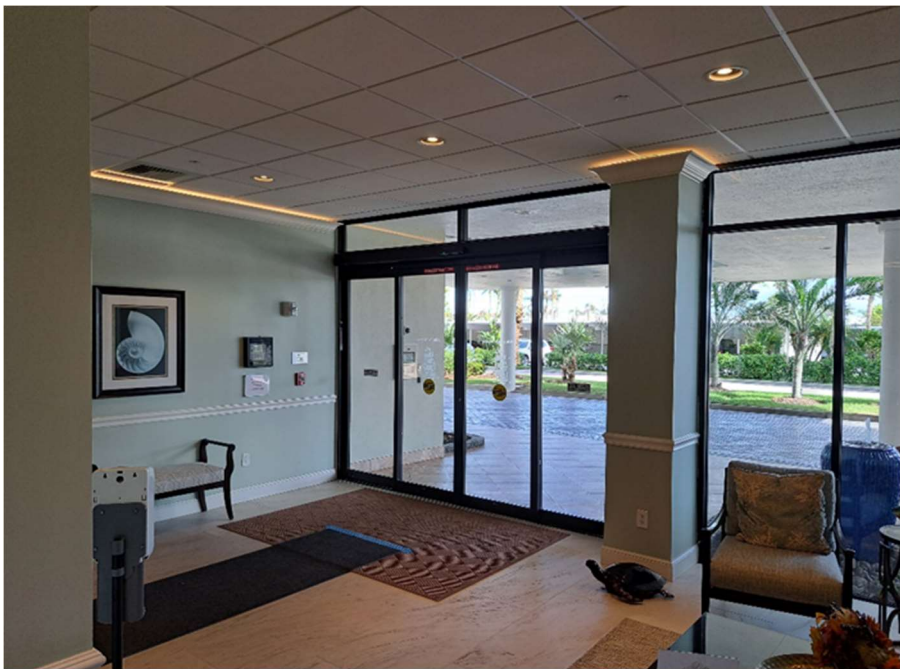
7.2 Exterior Doors, Automatic Slider, Common

The largest percentage of these doors on this building consist of the exterior stairwell doors (not shown).
